Climate Change and Glen Falloch (4) â?? hydro failures and their impact

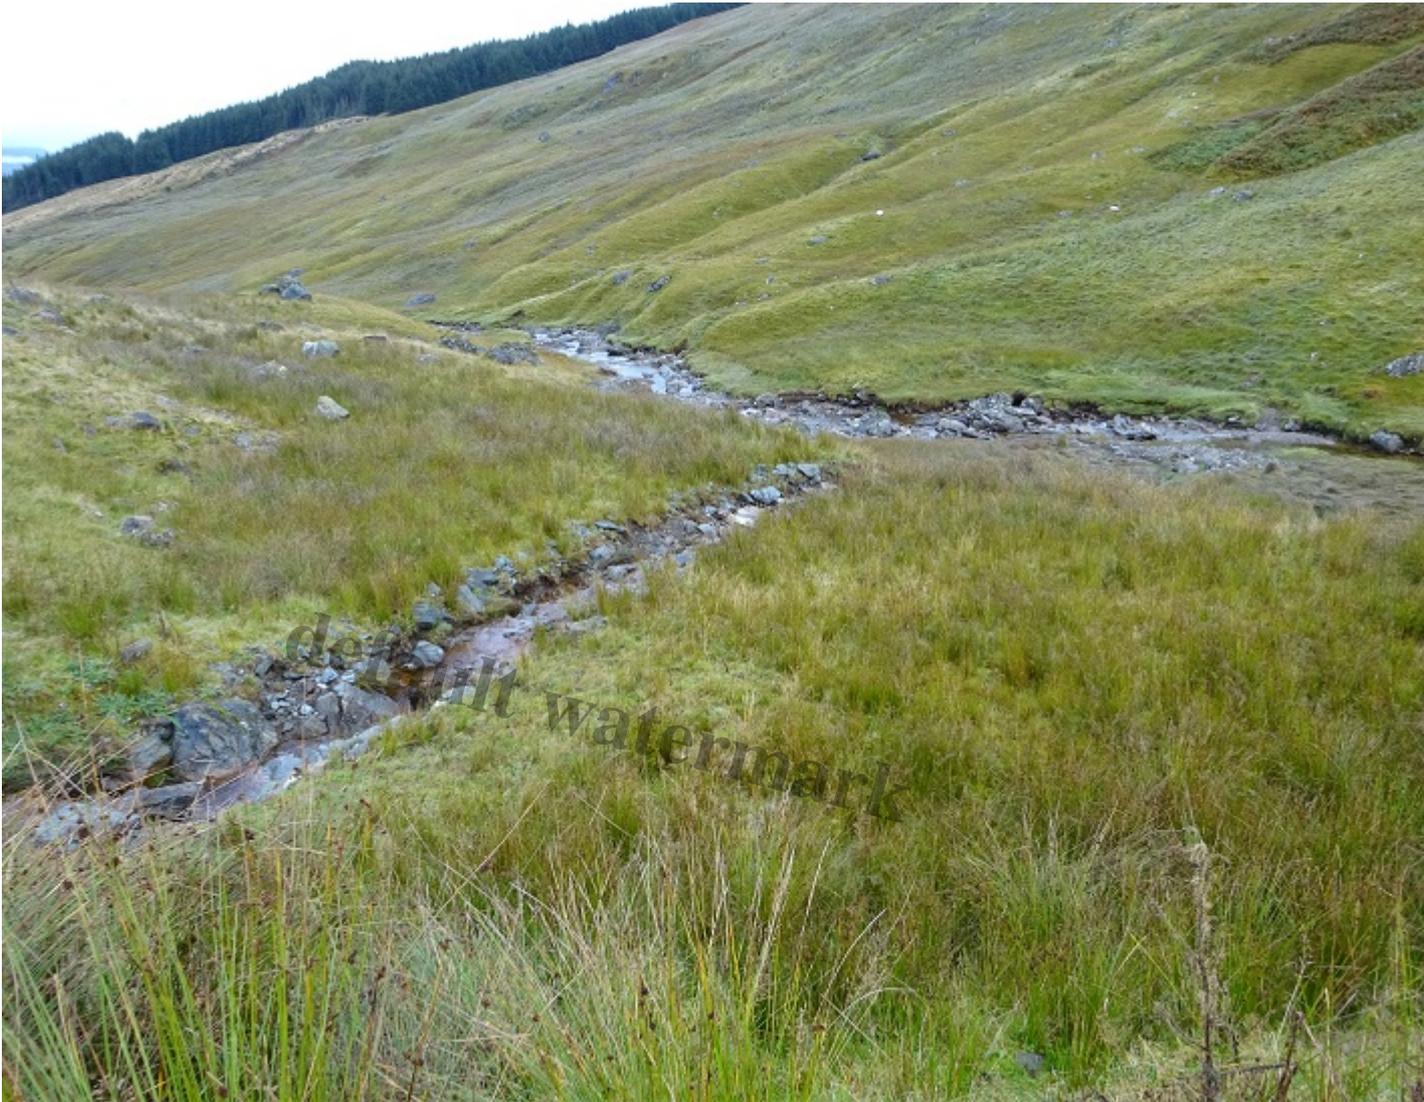
Looking down the Upper River Falloch where relatively little damage is evident to the river banks. The hydro pipeline has been dug UNDER the burn in the foreground and the banks by the rush are the work of humans not of nature. Photo credit Kevin McGrath.

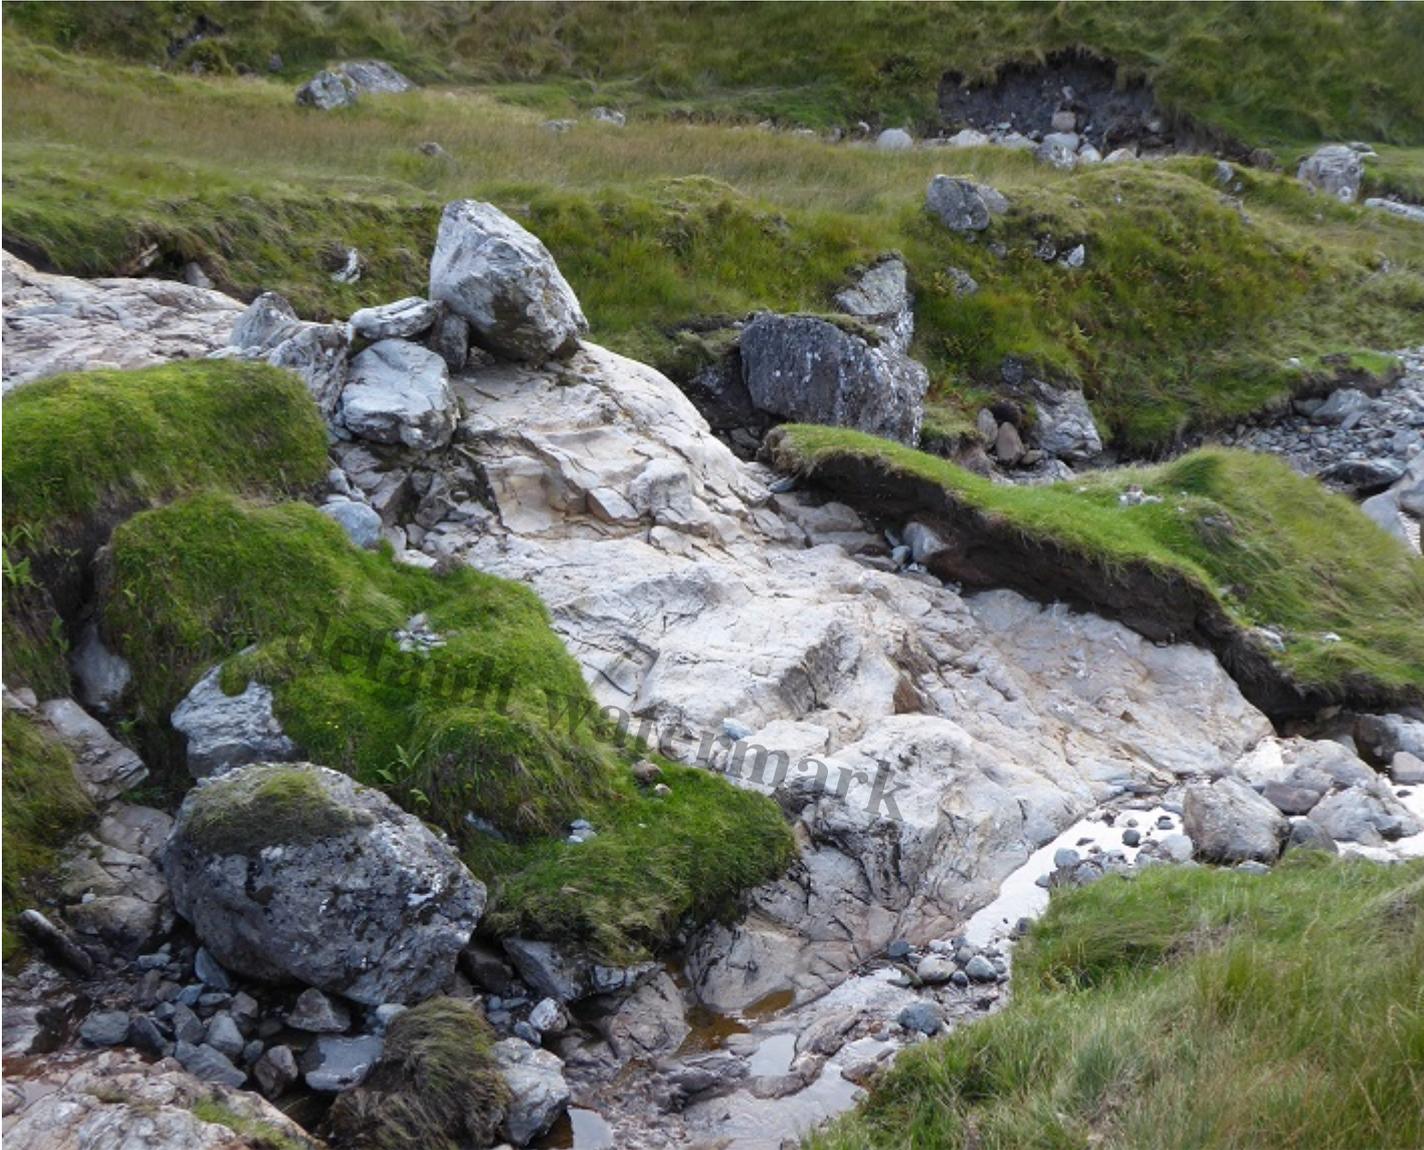
Vegetation has been swept clean off this island in the middle of the Allt a Chuillinn well above the main intake

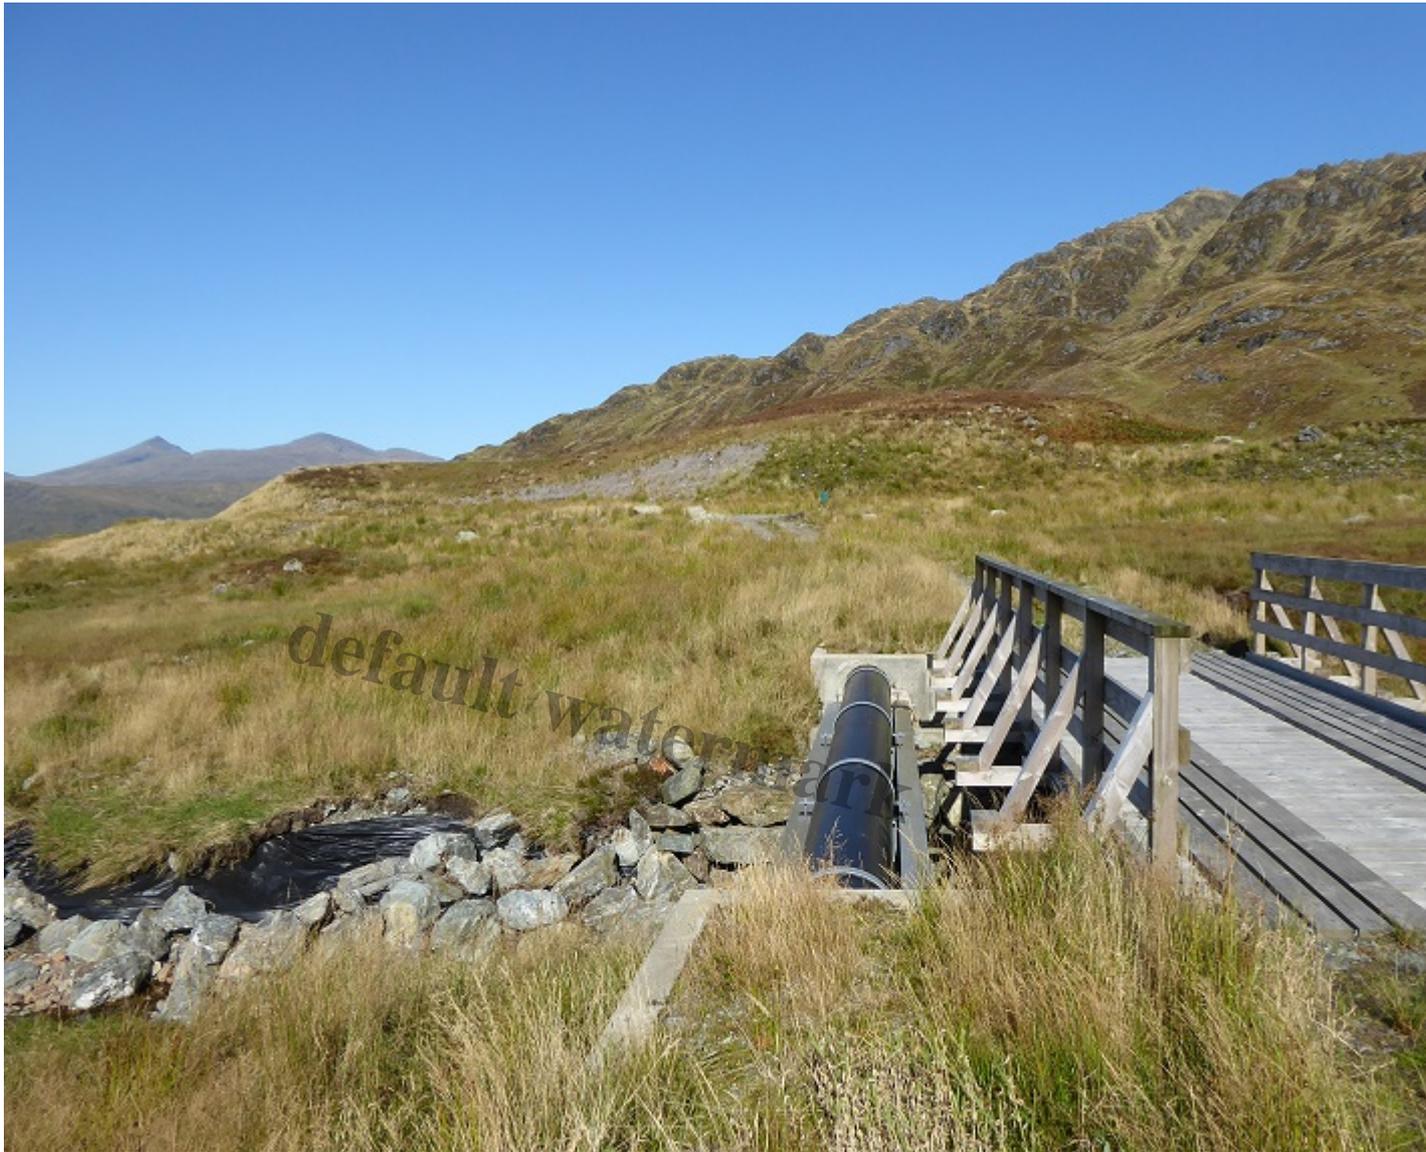
Plastic sheeting on bank below Ben Glas intake bridge. The level of the flood here reached the bottom of the bridge as you could tell from vegetation left high and dry after the flood.

At first glance I thought, how ugly! Then I realised the top of the bank has been swept away. The problem is as soon as water gets between whatever is on the surface and the sheeting, its much easier for whatever is on the surface, whether boulders or turf, to get swept away.

Perhaps its time to put a moratorium on any plastic sheeting being used to line the ground as part of the restoration of hydro schemes? Whether that will address the whole problem, however, is another question. What wouldn't be acceptable is a solution that involves embedding the boulders in concrete.

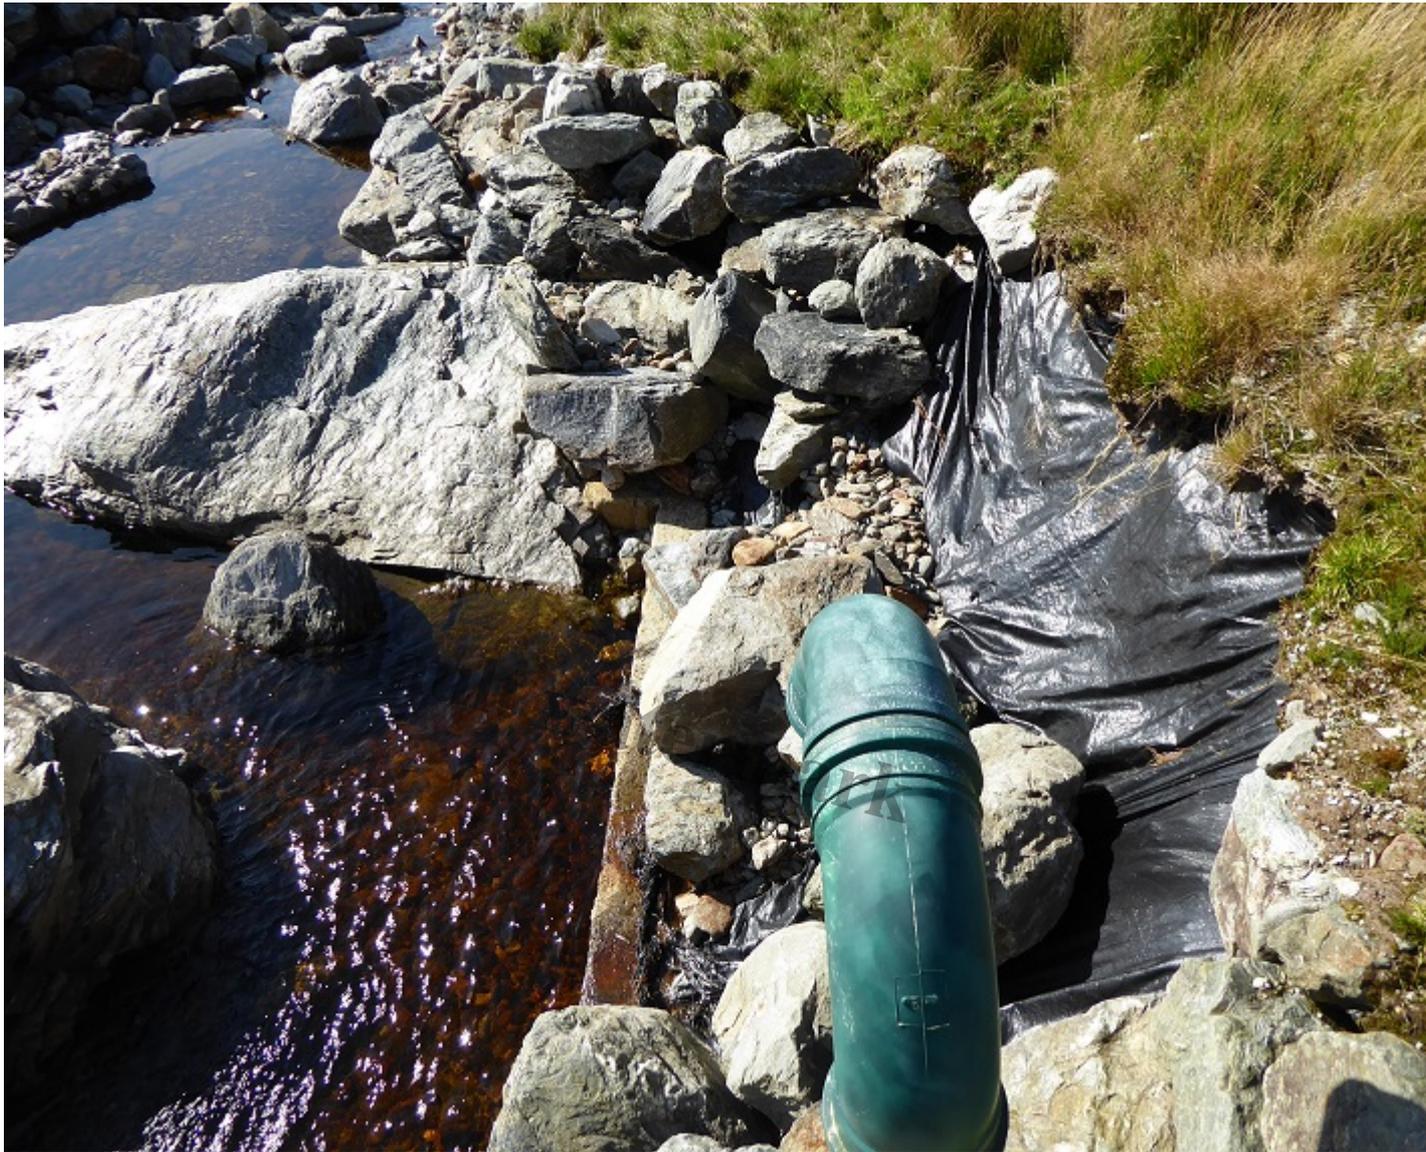
Another example at Ben Glas. The sheeting also stops roots penetrating into the soil below binding

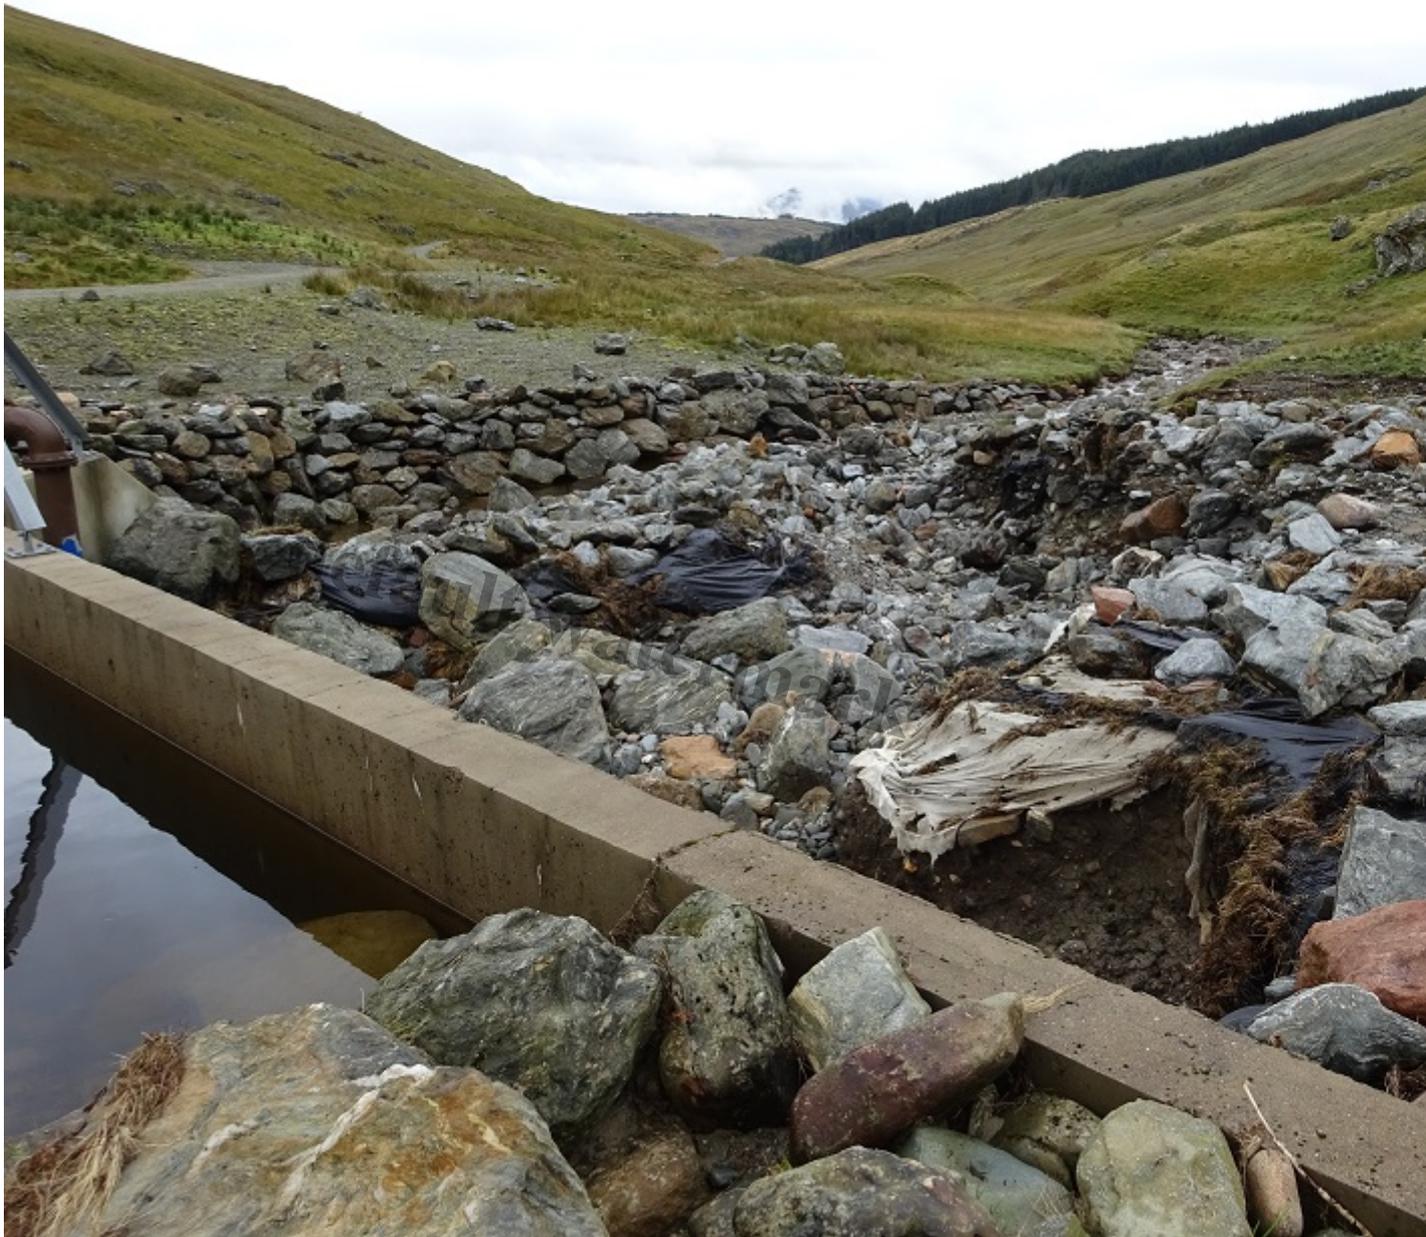
A closer view down from Upper Glen Falloch showing how boulders have been swept off the plastic

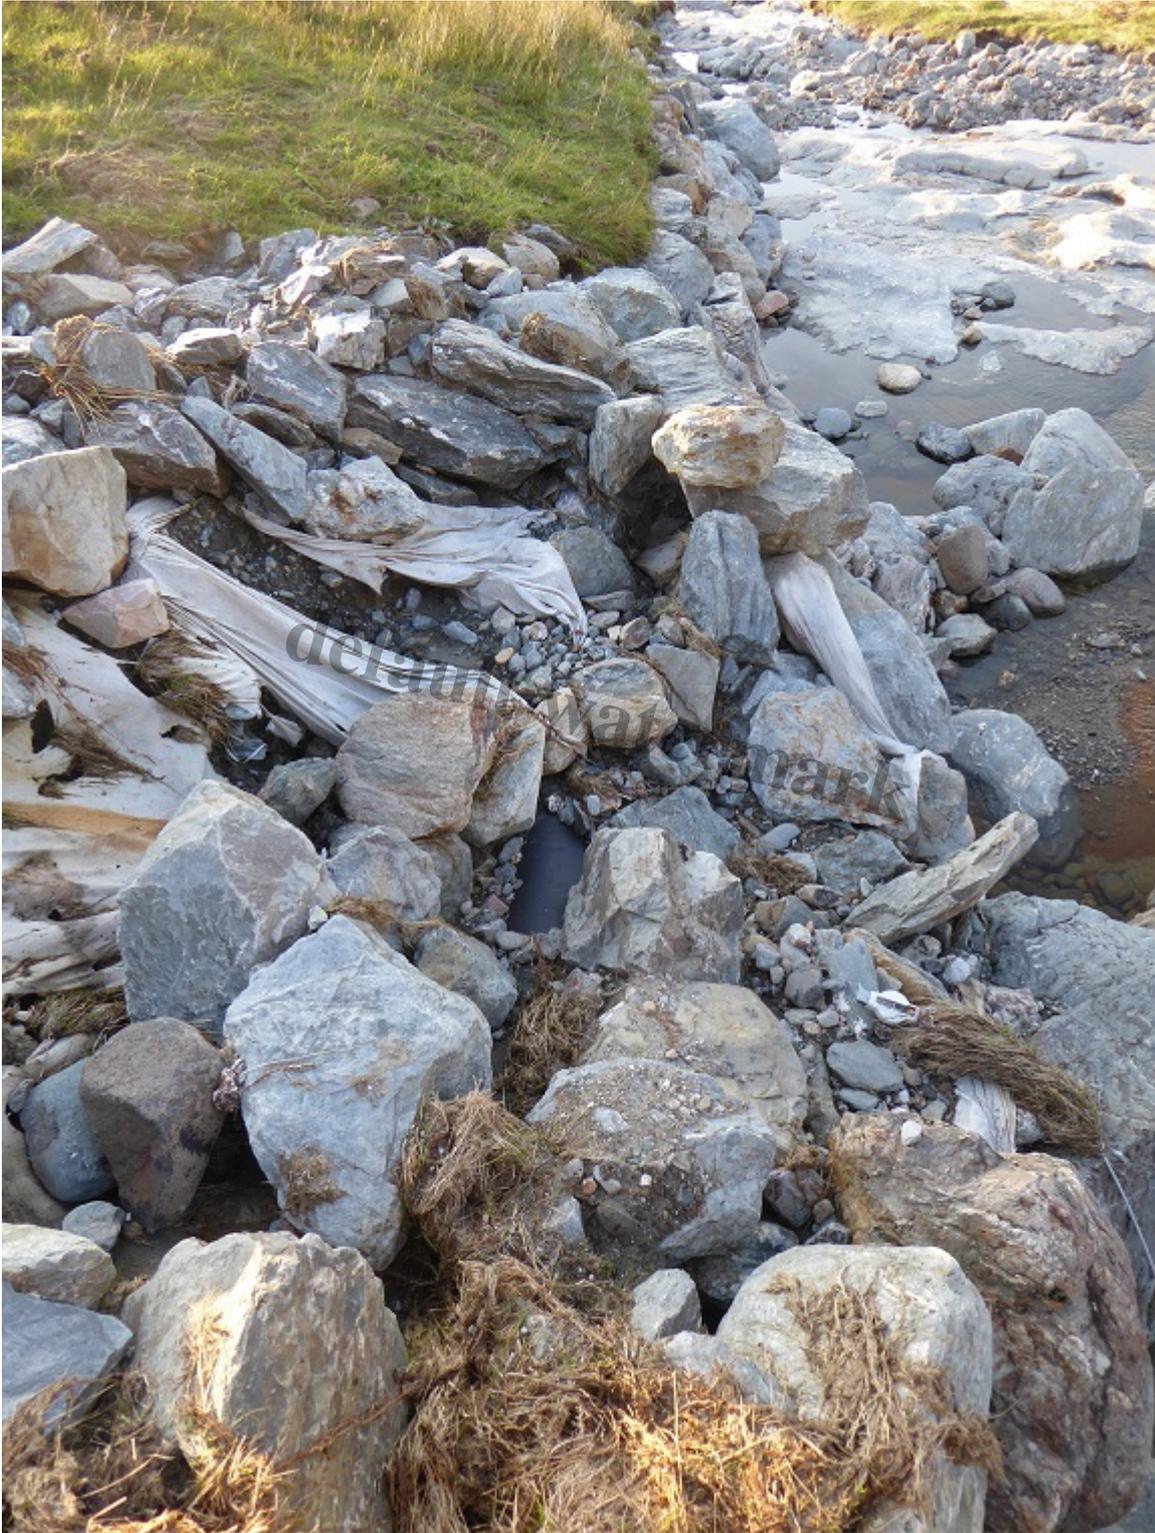
Left bank below Allt Andoran, with cloth sheeting and section of pipe visible centre

This is not, however, just a problem about plastic sheeting. Water forced through the boulders by the flood then collides and bounces off the intake pipes which form an erosion surface. I don't think its coincidence that two different sections of intake pipe have been revealed by the flood event in Glen Falloch. It appears from the photo above that even permeable membranes may facilitate erosion of

material placed on them.
