Climate Change and Glen Falloch (4) – hydro failures and their impact

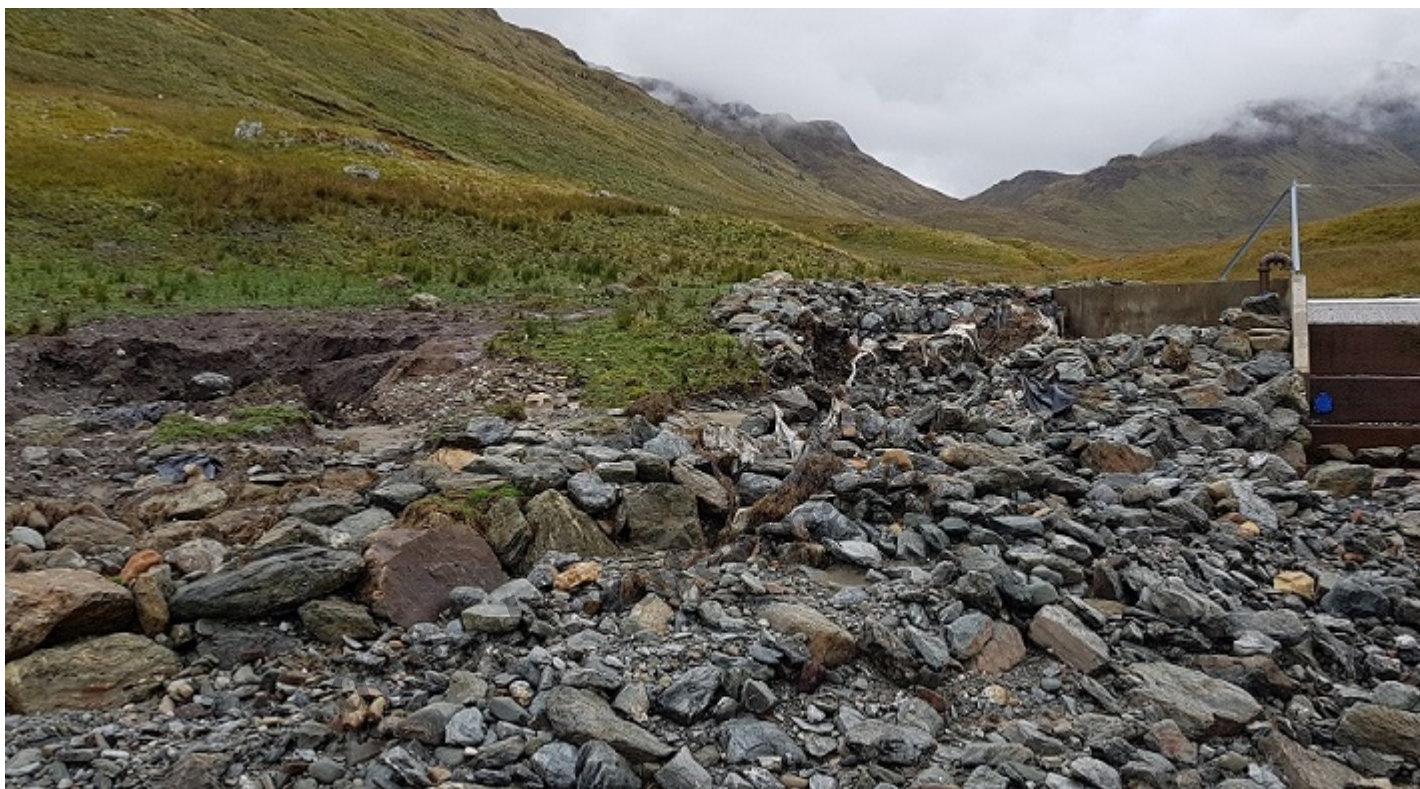
Upper Glen Falloch hydro intake 25th September 2019 – photo credit Kevin McGrath

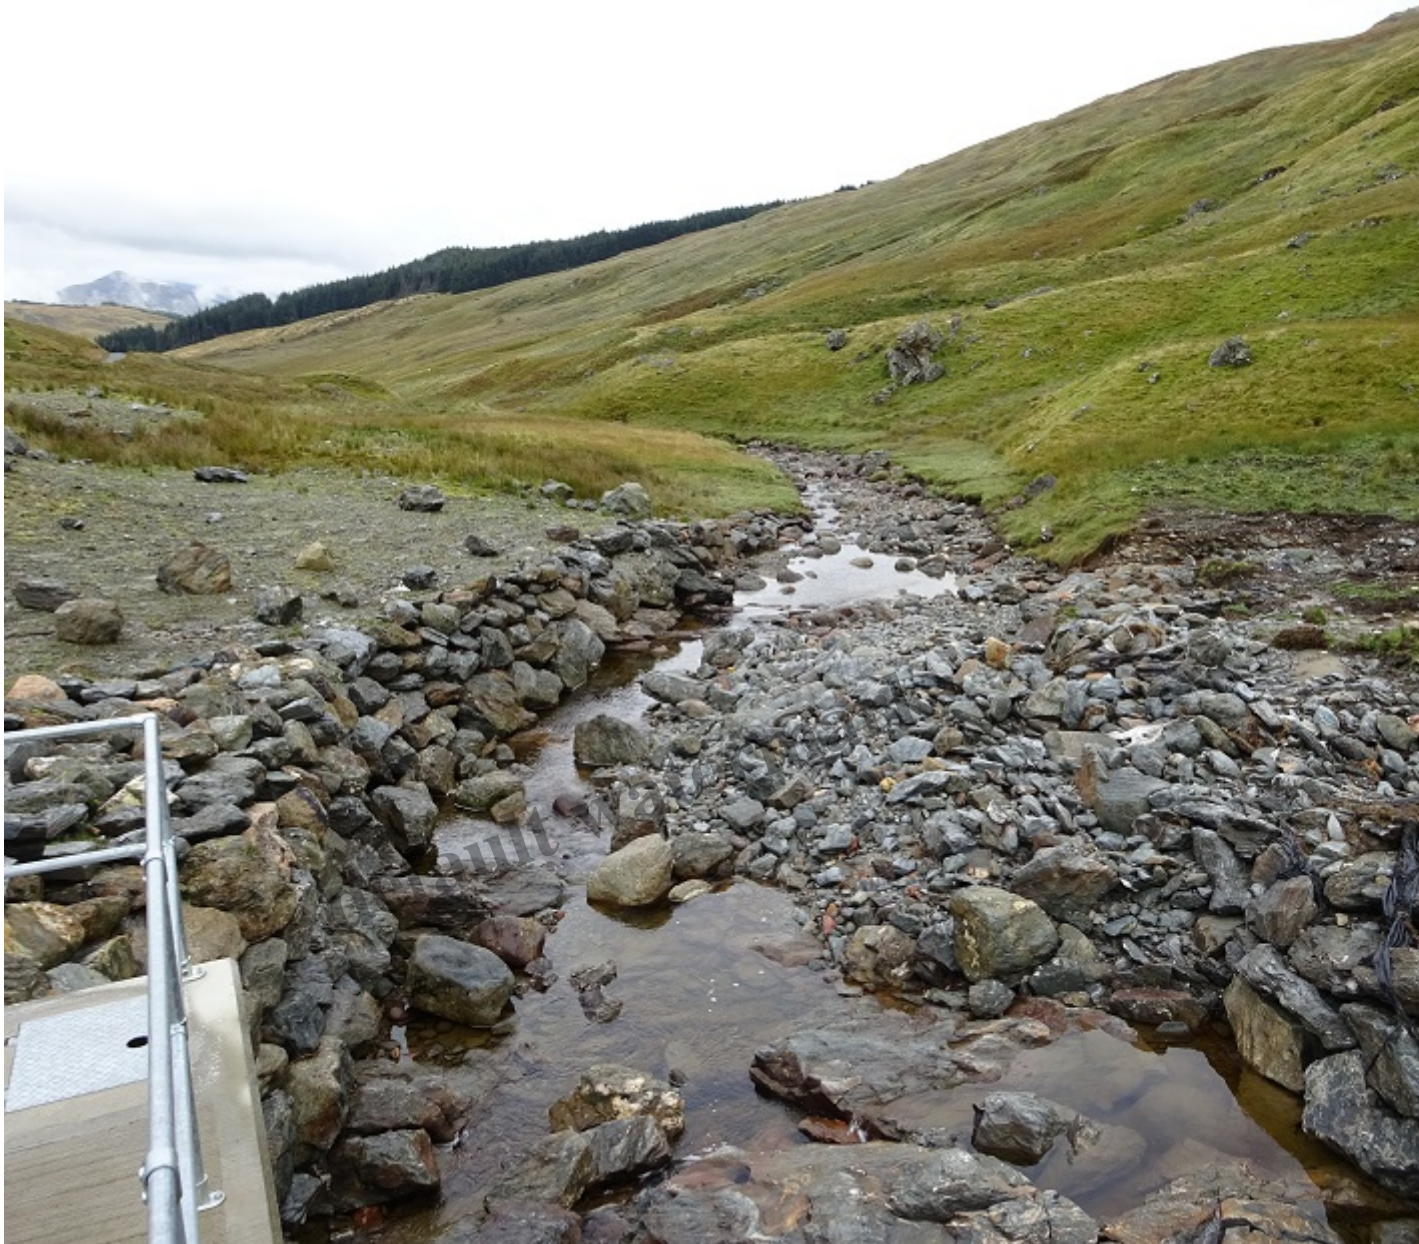
Looking downstream from the intake the rip rap bouldering on the right bank, which used to mirror the left bank, has mostly been swept away making this side of the river appear far more natural. Photo Credit: Crea McGrath.

The force of the flood water to remove the rip rap bouldering must have been quite something. The boulders were placed here to protect the river bank after the construction of the intakes but have failed. And it's not just on the Upper Falloch where this has happened, but on four of the other eight Glen Falloch intakes.

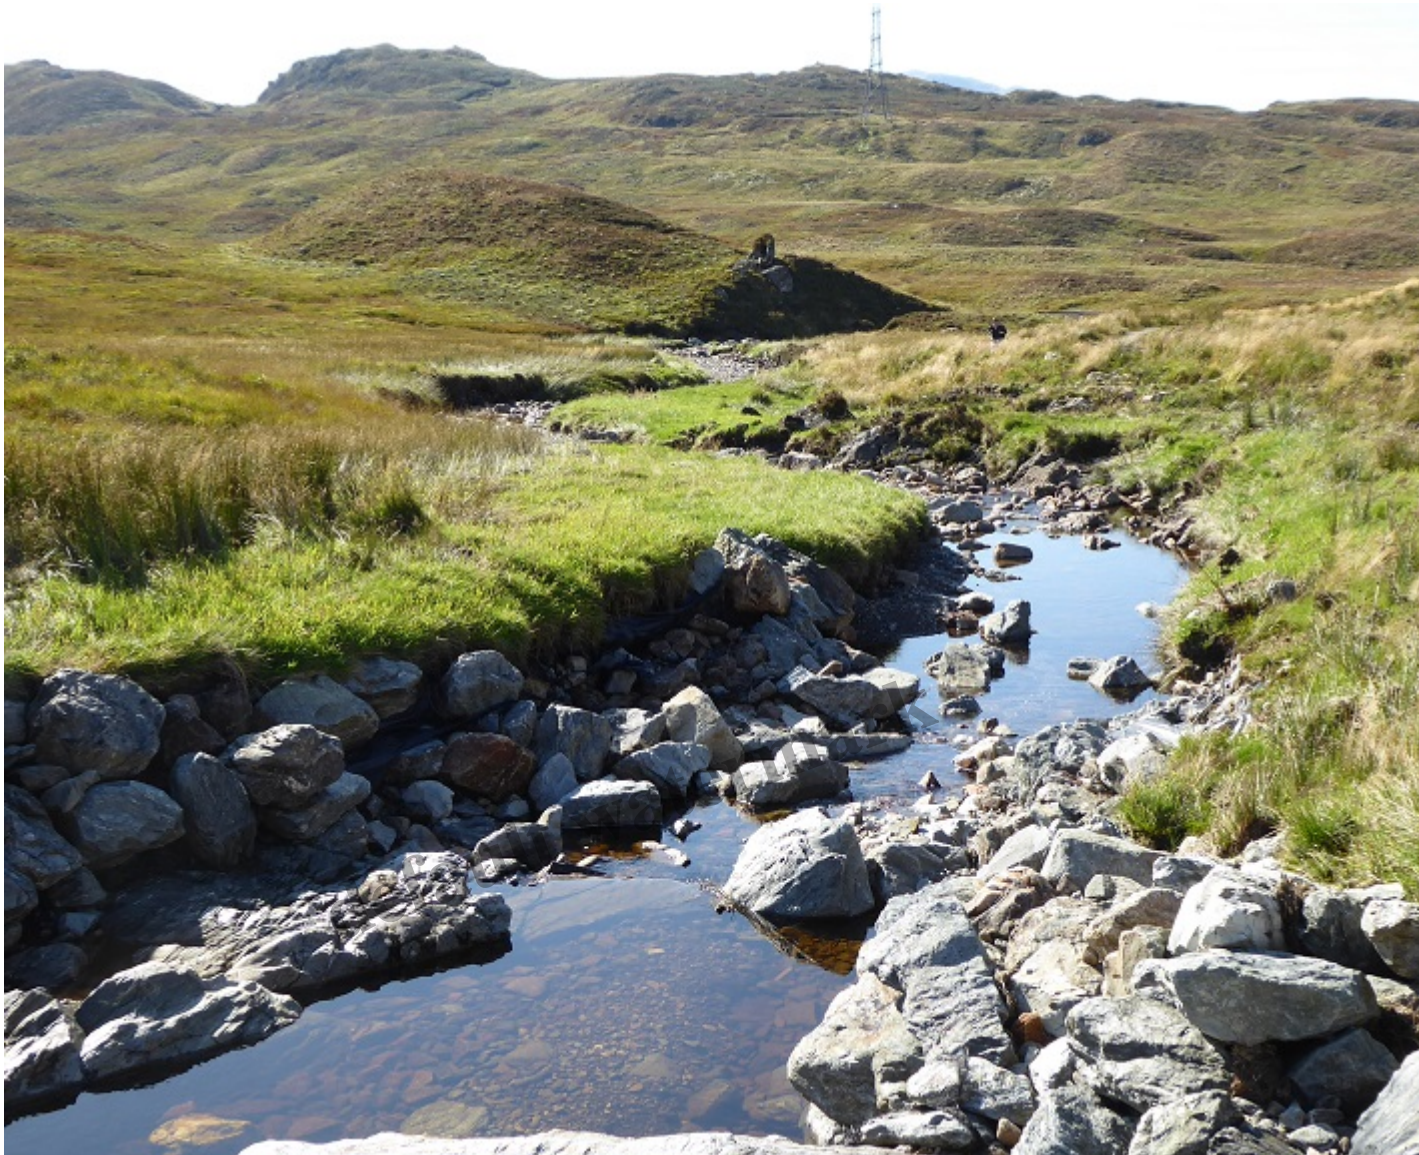
View down from Ben Glas intake on walkers path to Beinn Chabhair Sept 2019. It looked to me like boulders had been stripped from the left bank mid-photo.

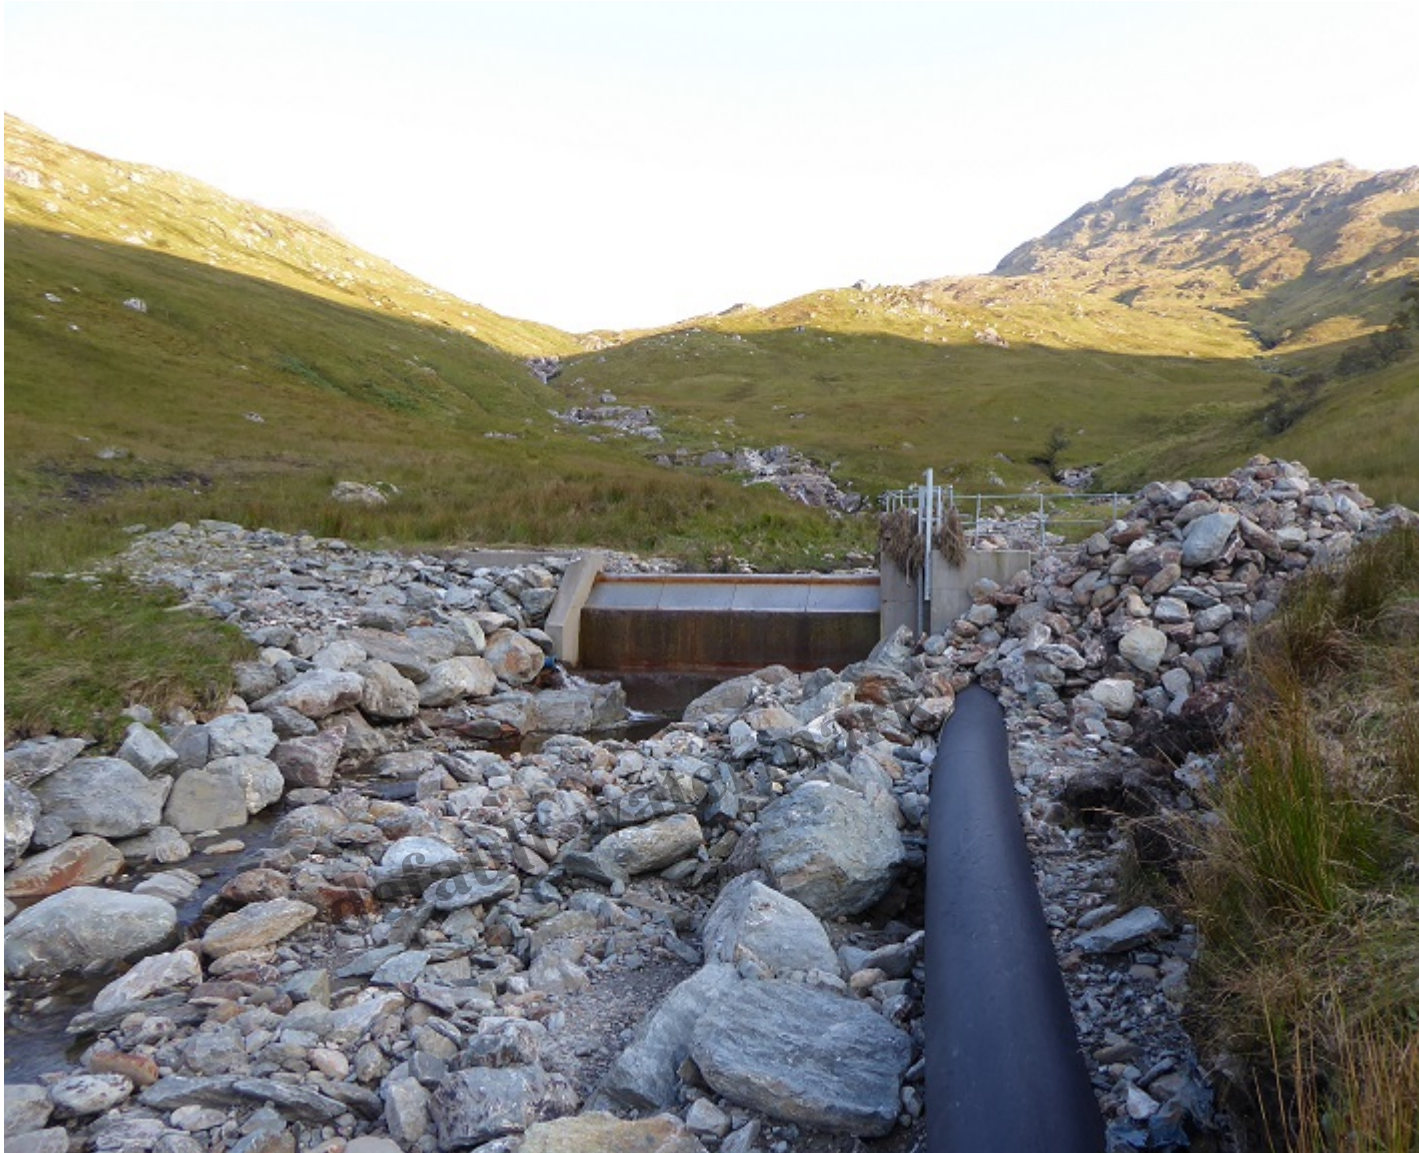
Looking up to Allt a Chuillin main intake along section of pipeline that was, until recently, under the “restored” bank of the river (photo of this from above featured in my last post). The pile of boulders on right appears to have been excavated from the pool and is perhaps intended for use to cover up this pipeline again. Unlikely to work!

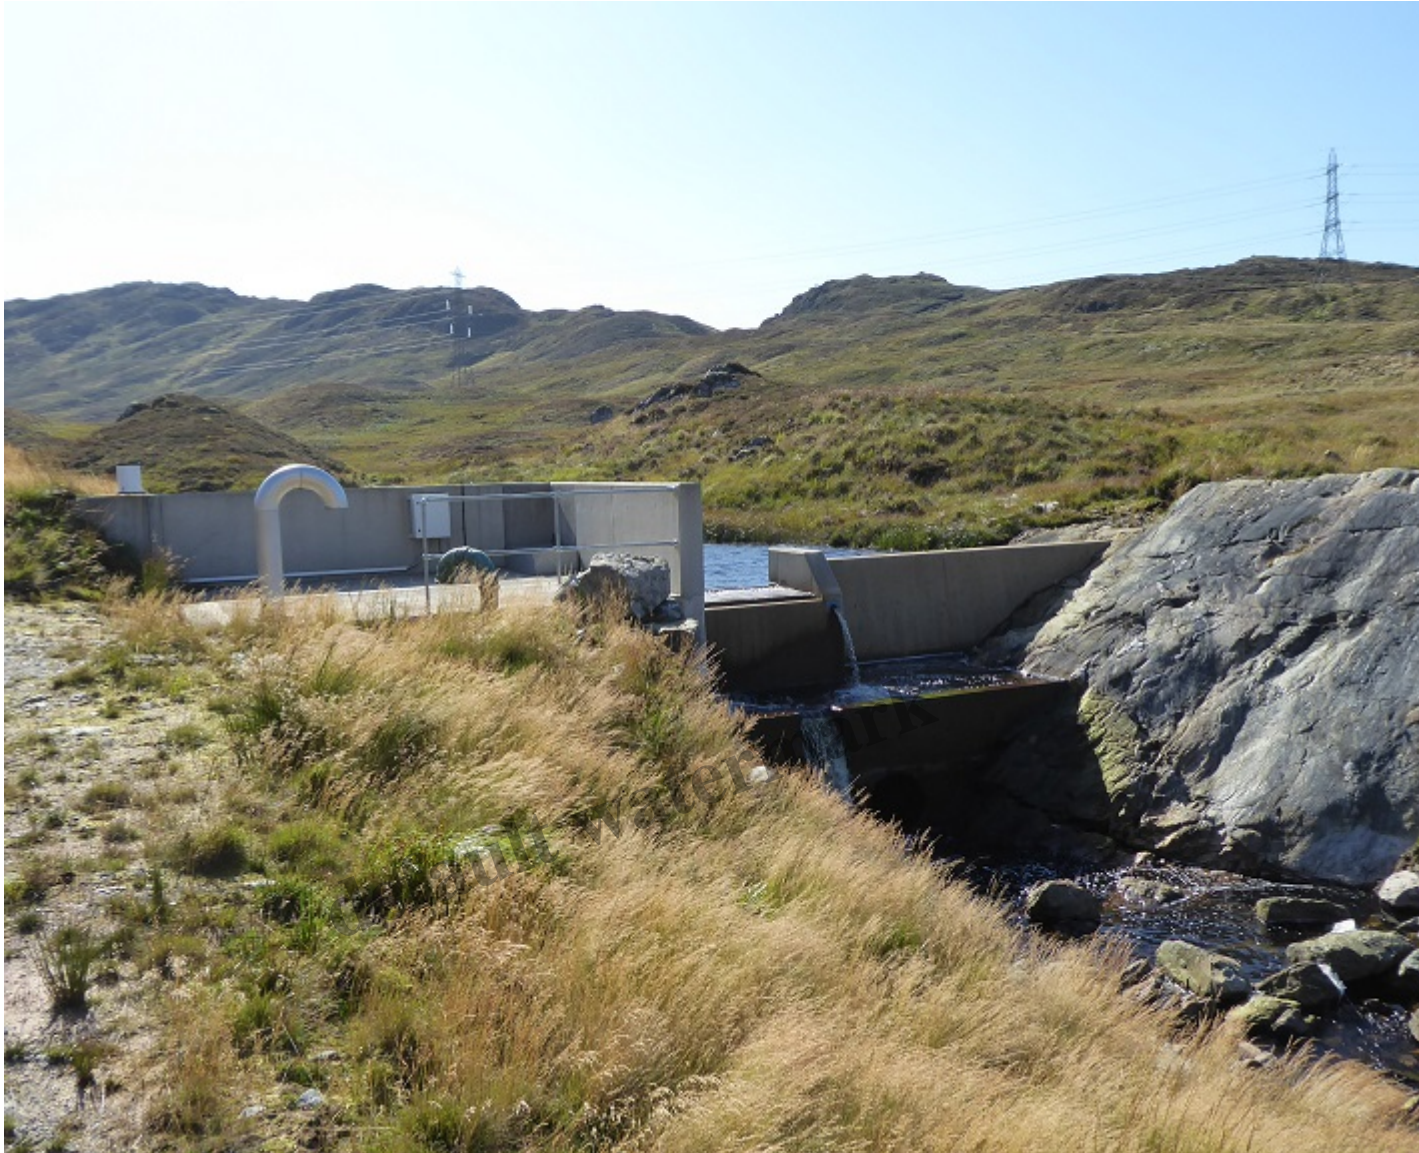
The other Ben Glas intake (see above), with a large pool and constructed into rock, is little damaged compared to its neighbour. Had the highest section of concrete retaining wall be faced with stone, a Park Best Practice Guidance, the landscape impact of this impact would have been reduced further.

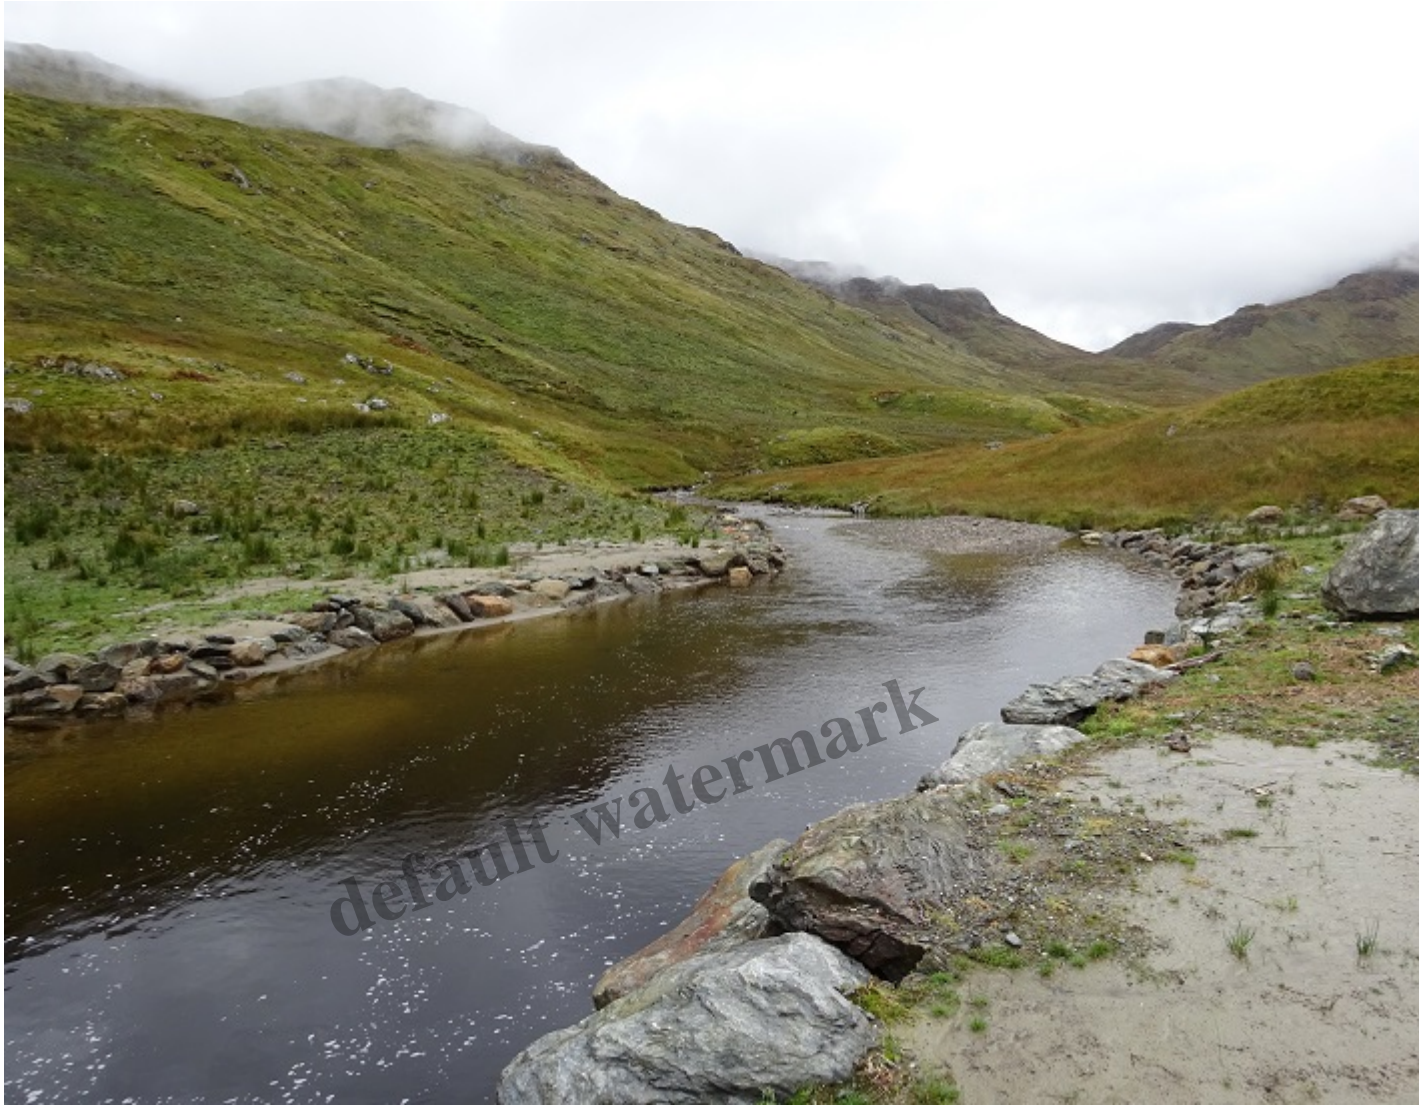
Looking across the intake pool to the rip rap bouldering embankment September 2019 – it now looks far more natural than it did four months ago. Photo credit Kevin McGrath.

View over to same embankment May 2019

Besides the large amount of silt washed over the bank in the top photo – which could help it eventually revegetate and stabilise – many of the boulders visible in the earlier photo are no longer there and appear to have been washed away (I blew both photos up to compare them).

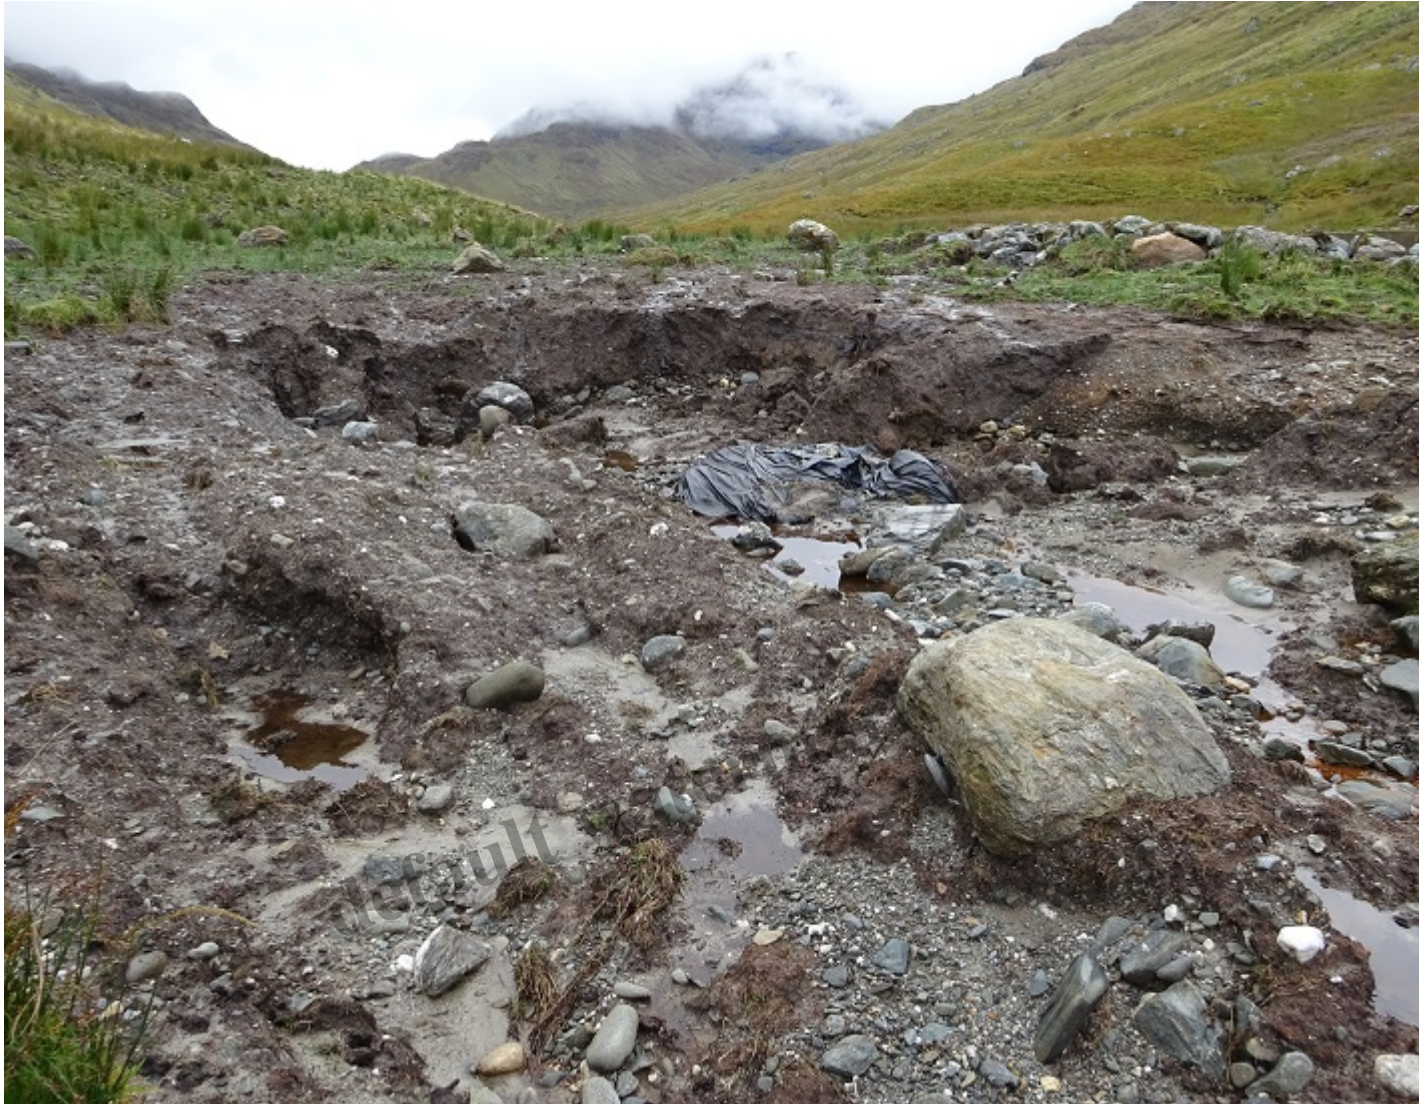
New river formation on the Upper Falloch (intake pool just visible to right)? The erosive impact of the river overflowing here has been accentuated because this a diversionary channel was constructed on this line while the intake was being built. This section of ground is not “natural” and helps explain that where peat has just been placed on the surface it's been washed away. Destruction of peat of course releases yet more carbon into the atmosphere.

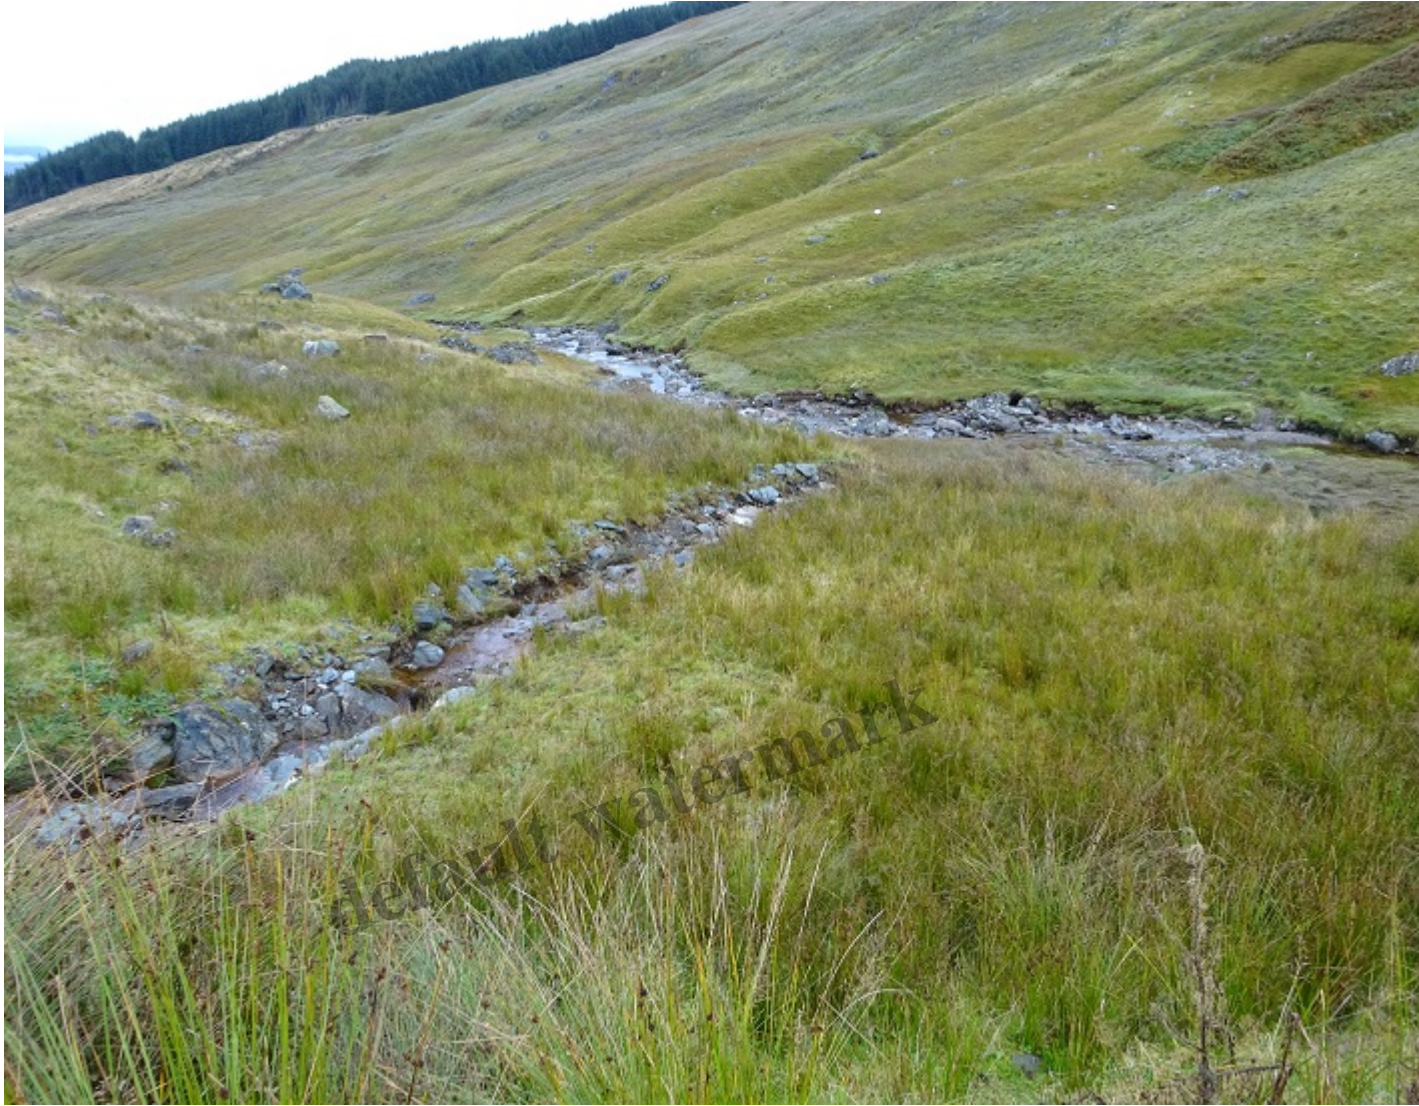
Looking down the Upper River Falloch where relatively little damage is evident to the river banks. The hydro pipeline has been dug UNDER the burn in the foreground and the banks by the rush are the work of humans not of nature. Photo credit Kevin McGrath.

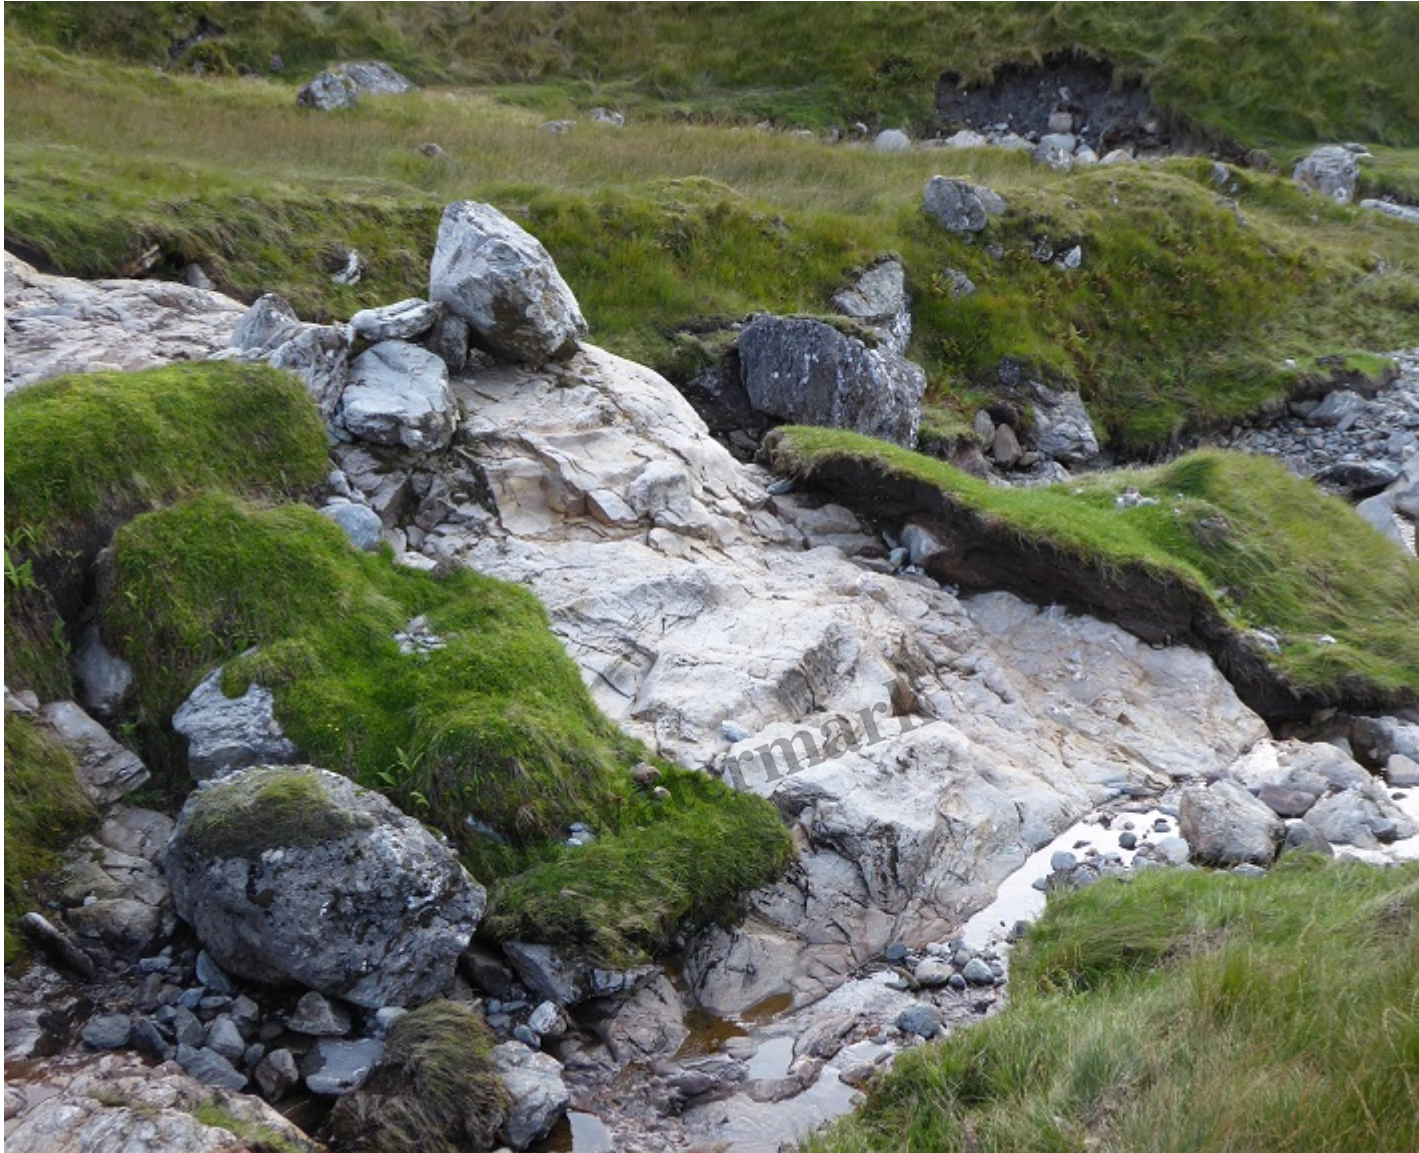
Vegetation has been swept clean off this island in the middle of the Allt a Chuillinn well above the main intake

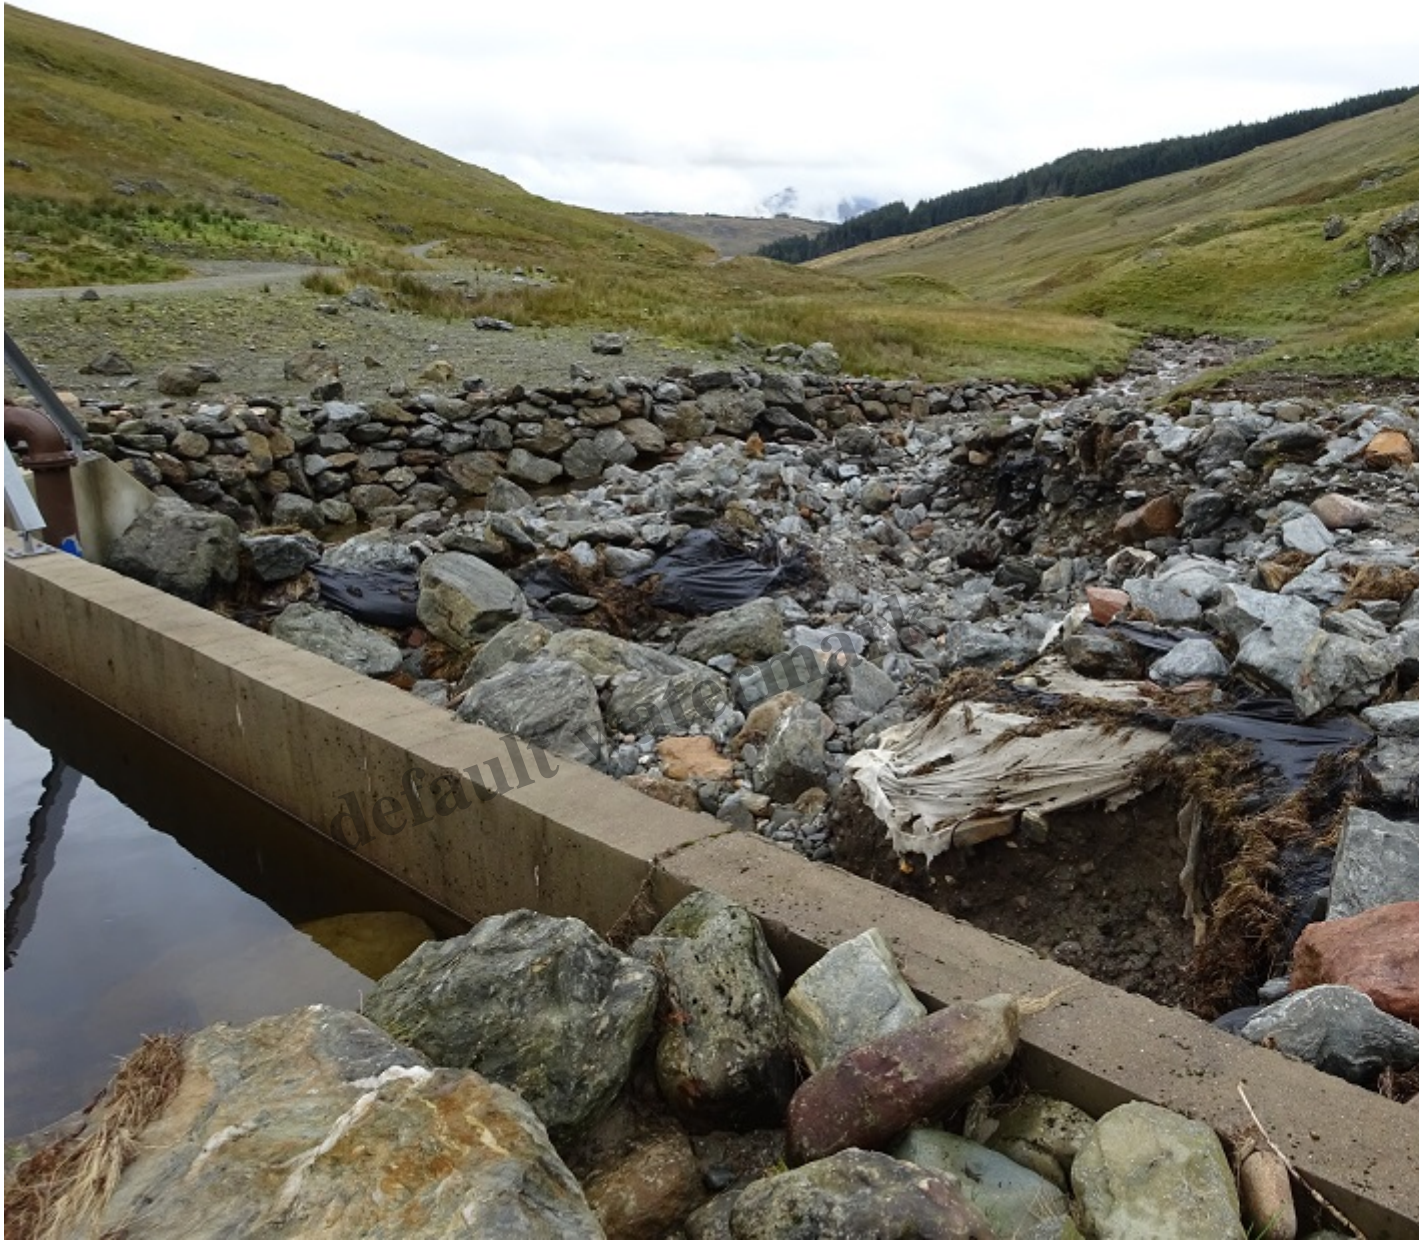
A closer view down from Upper Glen Falloch showing how boulders have been swept off the plastic

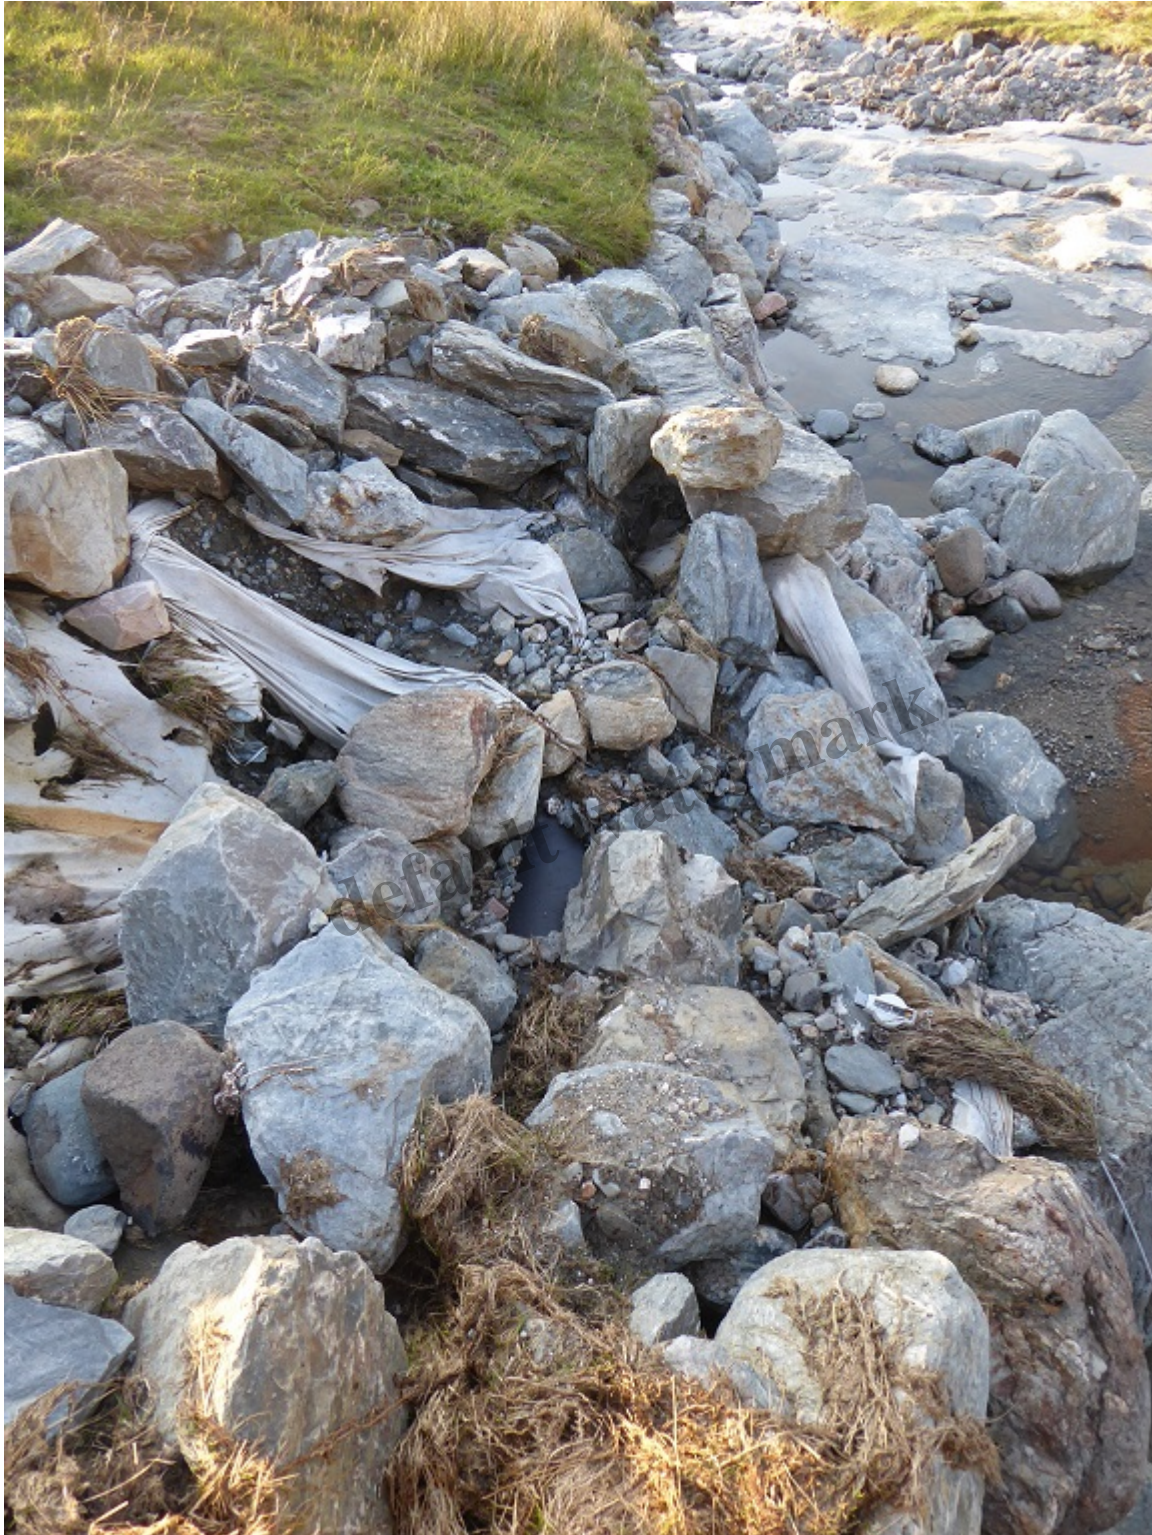
Left bank below Allt Andoran, with cloth sheeting and section of pipe visible centre

This is not, however, just a problem about plastic sheeting. Water forced through the boulders by the flood then collides and bounces off the intake pipes which form an erosion surface. I don't think its coincidence that two different sections of intake pipe have been revealed by the flood event in Glen

Falloch. It appears from the photo above that even permeable membranes may facilitate erosion of material placed on them.

Perhaps its time to put a moratorium on any plastic sheeting being used to line the ground as part of the restoration of hydro schemes? Whether that will address the whole problem, however, is another question. What wouldn't be acceptable is a solution that involves embedding the boulders in concrete.
