Climate Change and Glen Falloch (4) – hydro failures and their impact

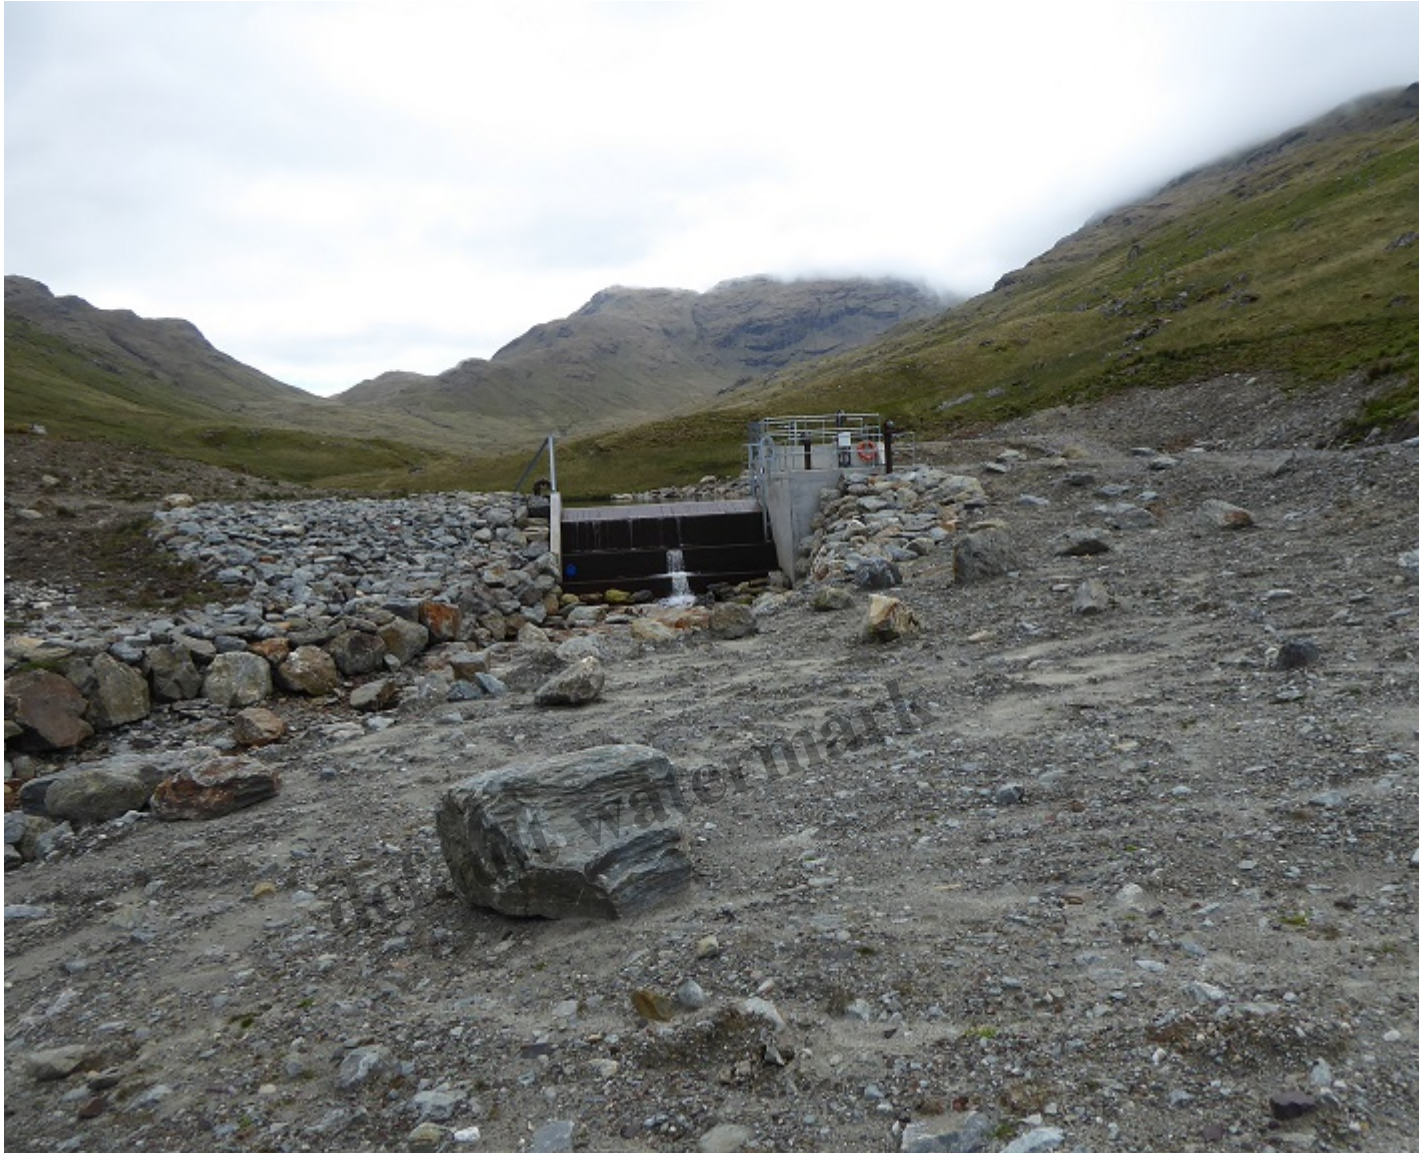
View up to intake May 2019. The bare foreground is a consequence of further work the Park approved in 2018 (see below). Photo Author.

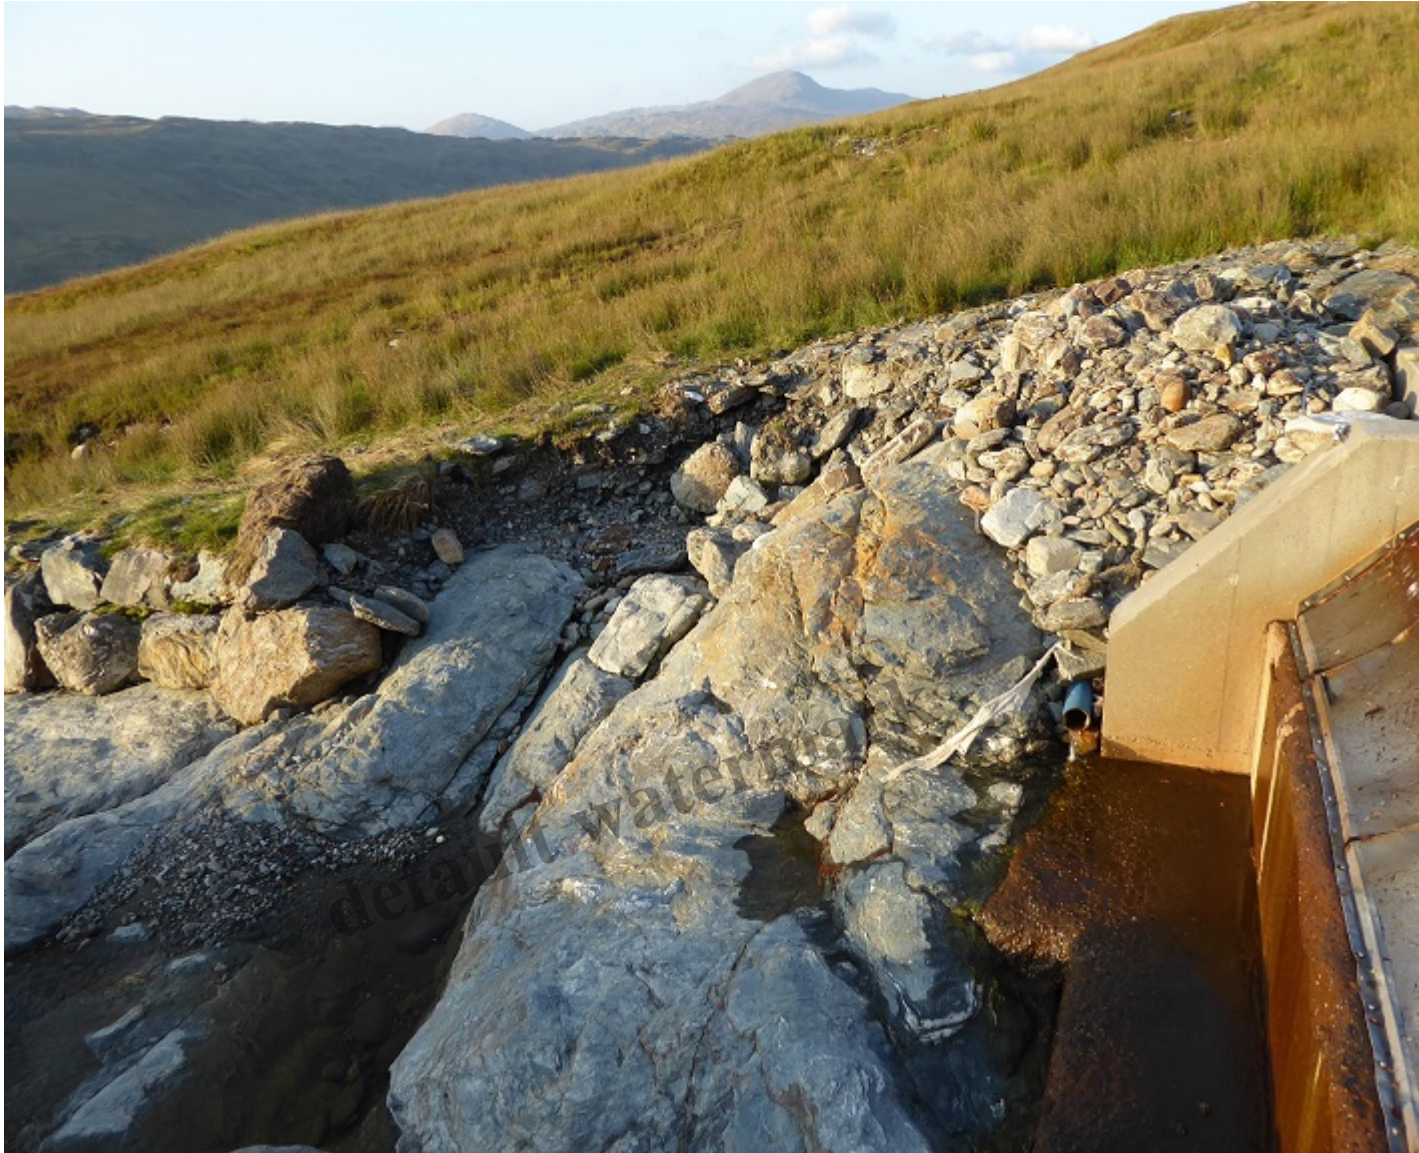
Large chunk of restored bank removed from below Allt Andoran Intake, leaving bare bank behind – E Chalum in distance. Both banks below this intake have been seriously damaged. Photo Author.

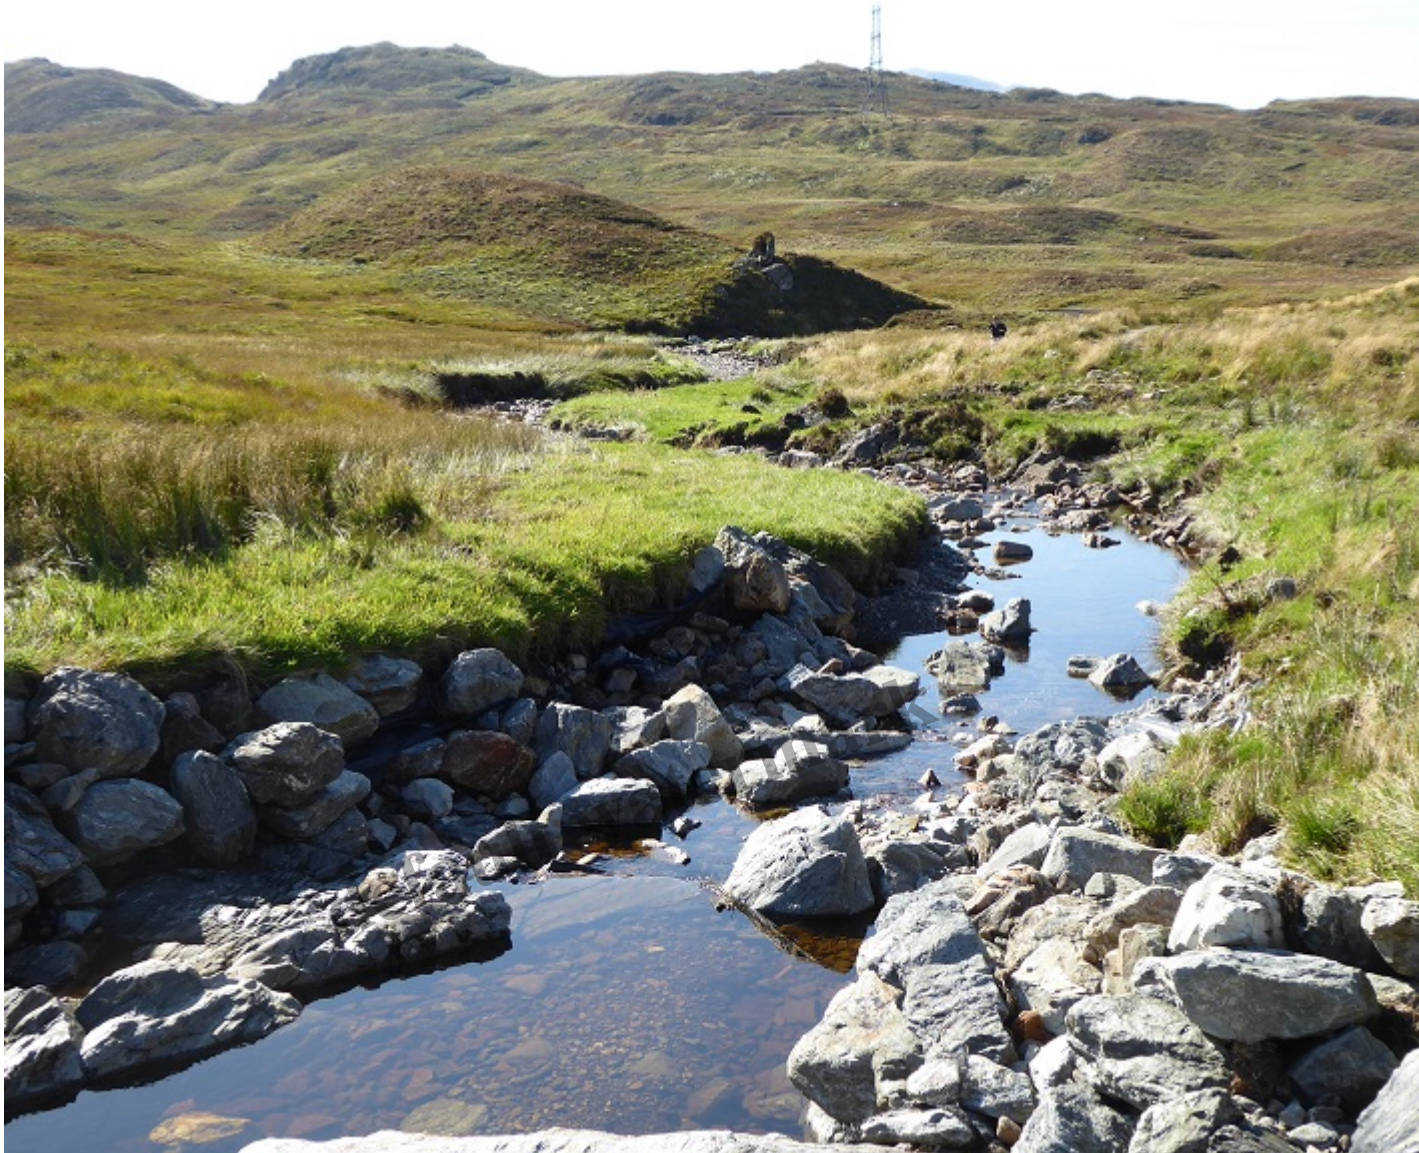
View down from Ben Glas intake on walkers path to Beinn Chabhair Sept 2019. It looked to me like boulders had been stripped from the left bank mid-photo.

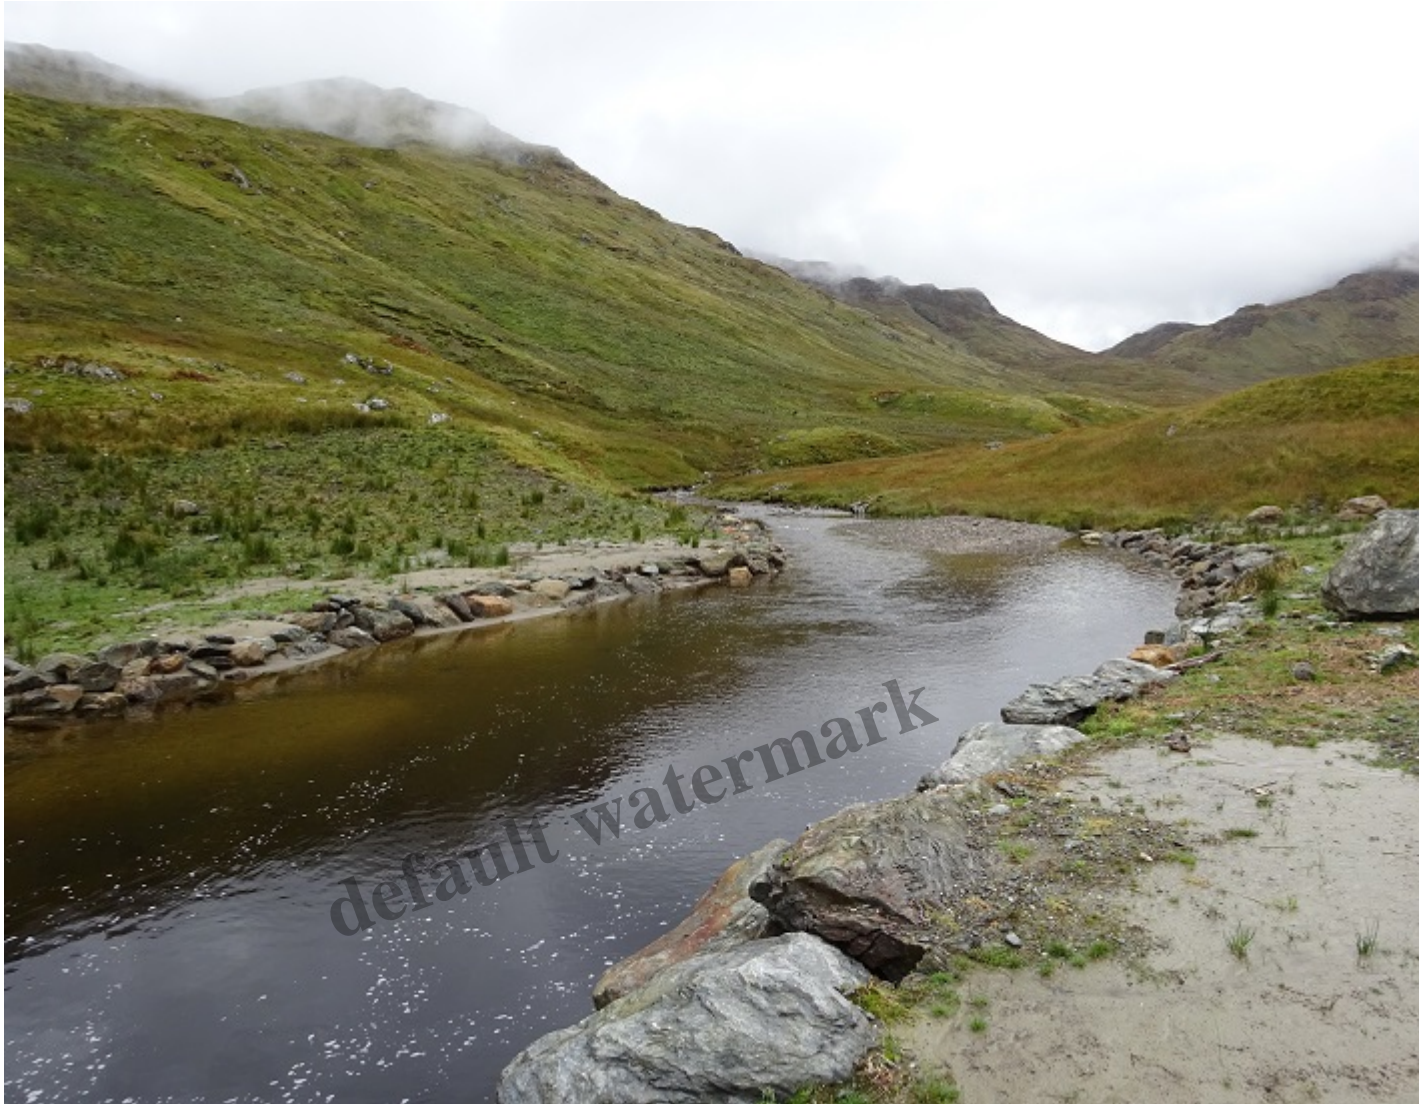
Looking across the intake pool to the rip rap bouldering embankment September 2019 – it now looks far more natural than it did four months ago. Photo credit Kevin McGrath.

Besides the large amount of silt washed over the bank in the top photo – which could help it eventually revegetate and stabilise – many of the boulders visible in the earlier photo are no longer there and appear to have been washed away (I blew both photos up to compare them).

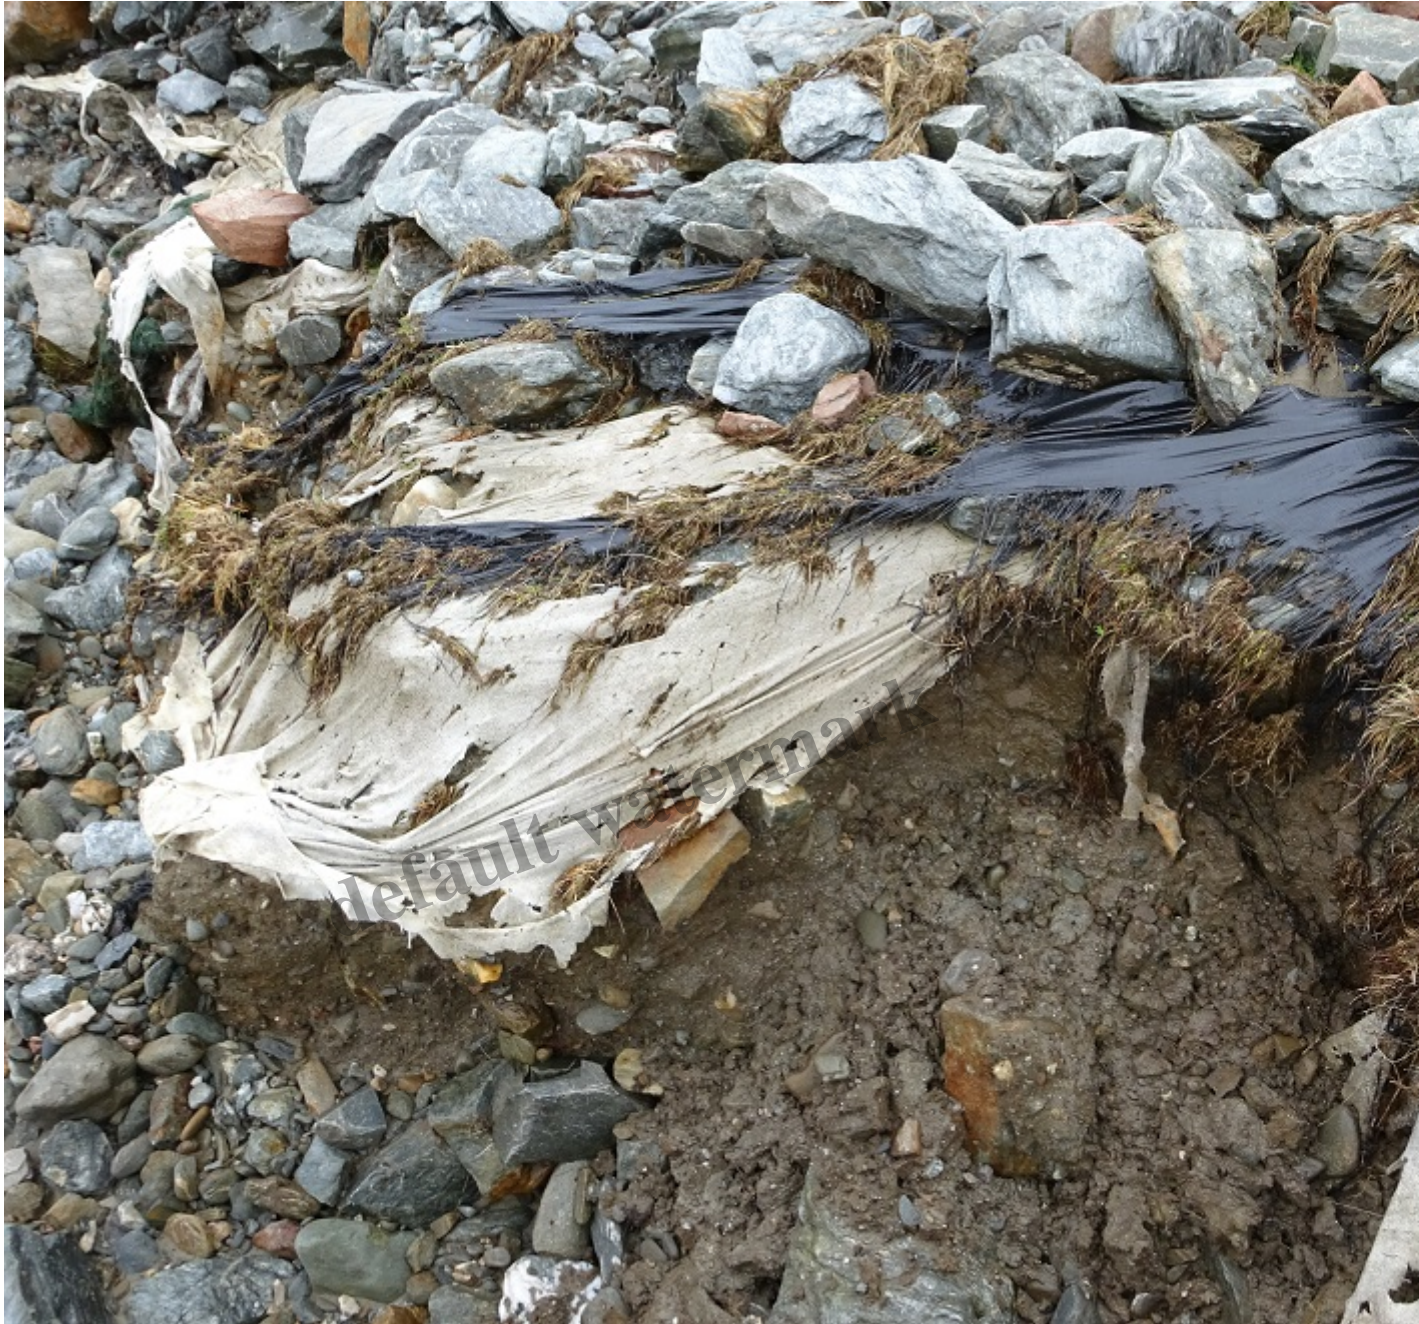
Eroded bank and ripped up sheeting below the Upper Falloch intake. Photo Credit Kevin McGrath

Perhaps its time to put a moratorium on any plastic sheeting being used to line the ground as part of the restoration of hydro schemes? Whether that will address the whole problem, however, is another question. What wouldn't be acceptable is a solution that involves embedding the boulders in concrete.

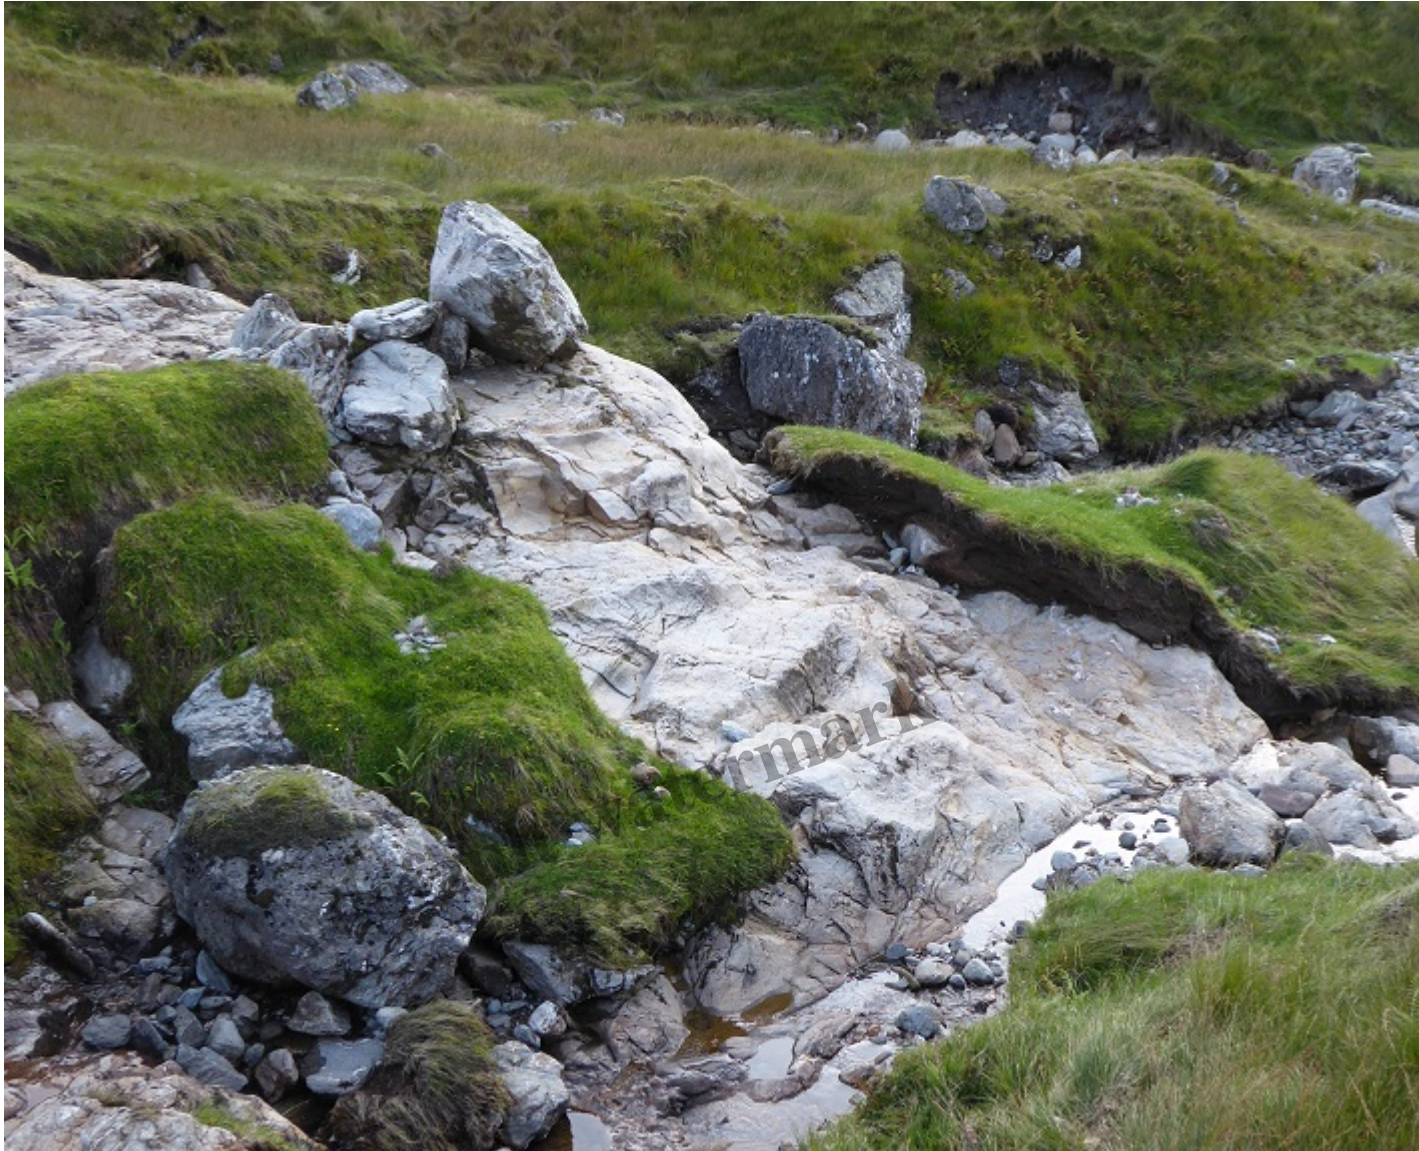
Vegetation has been swept clean off this island in the middle of the Allt a Chuillinn well above the main intake

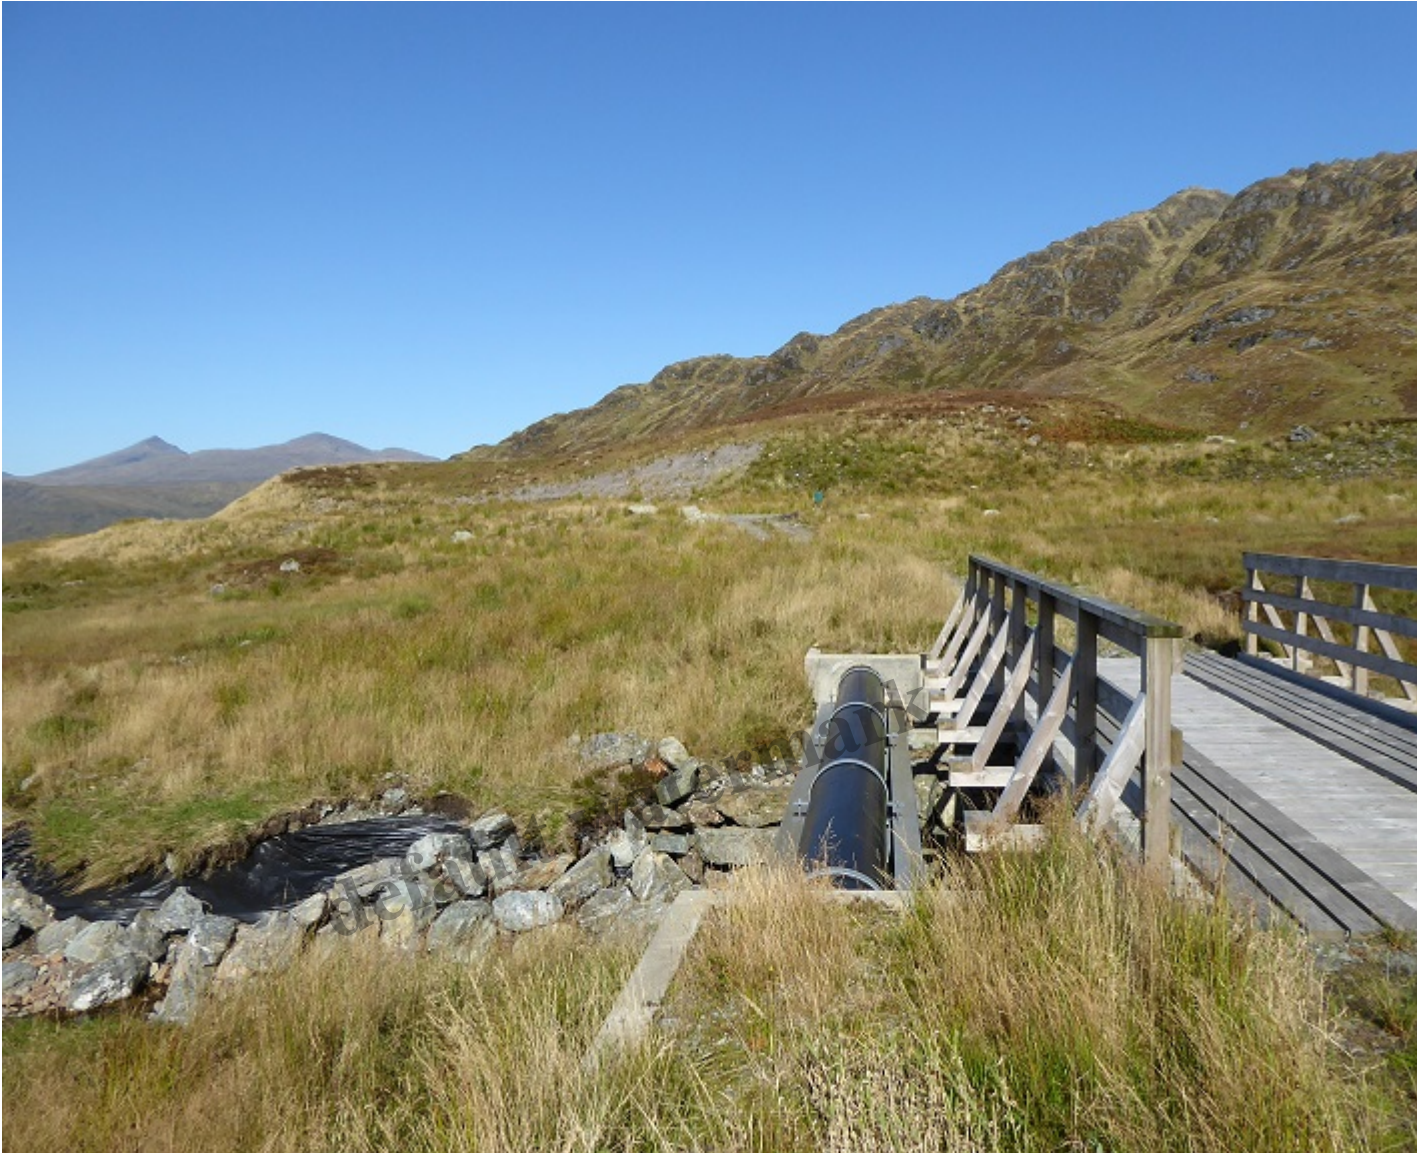
Plastic sheeting on bank below Ben Glas intake bridge. The level of the flood here reached the bottom of the bridge – as you could tell from vegetation left high and dry after the flood.

At first glance I thought, how ugly! Then I realised the top of the bank has been swept away. The problem is as soon as water gets between whatever is on the surface and the sheeting, its much easier for whatever is on the surface, whether boulders or turf, to get swept away.

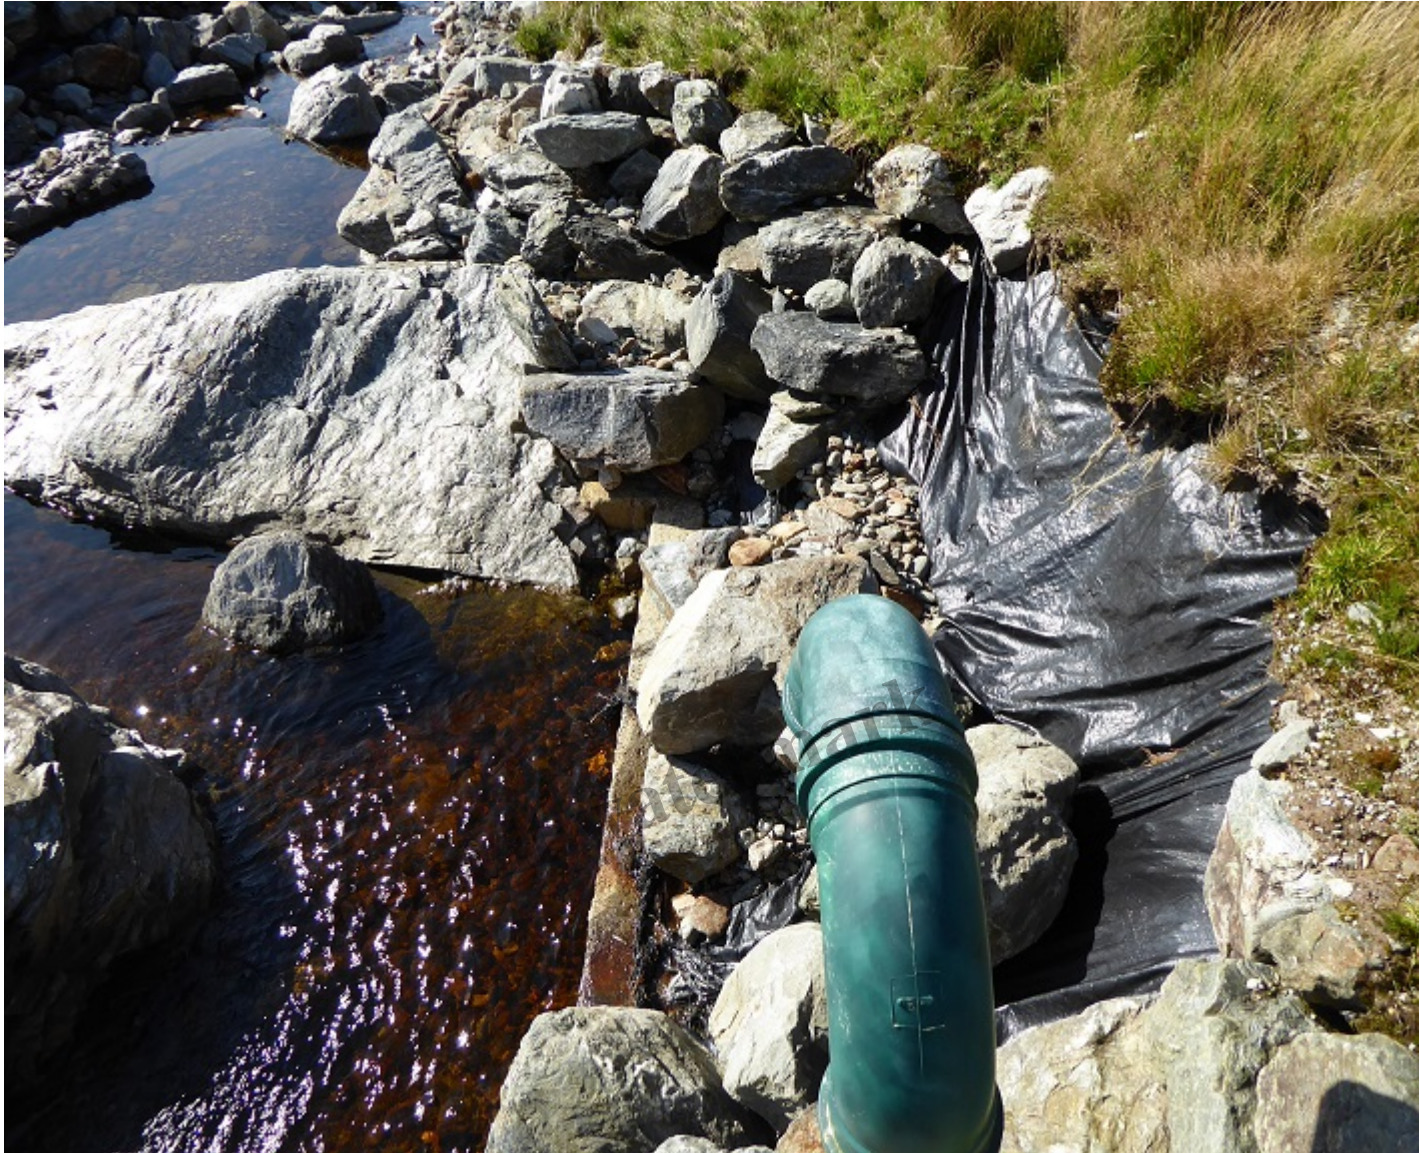
Another example at Ben Glas. The sheeting also stops roots penetrating into the soil below binding

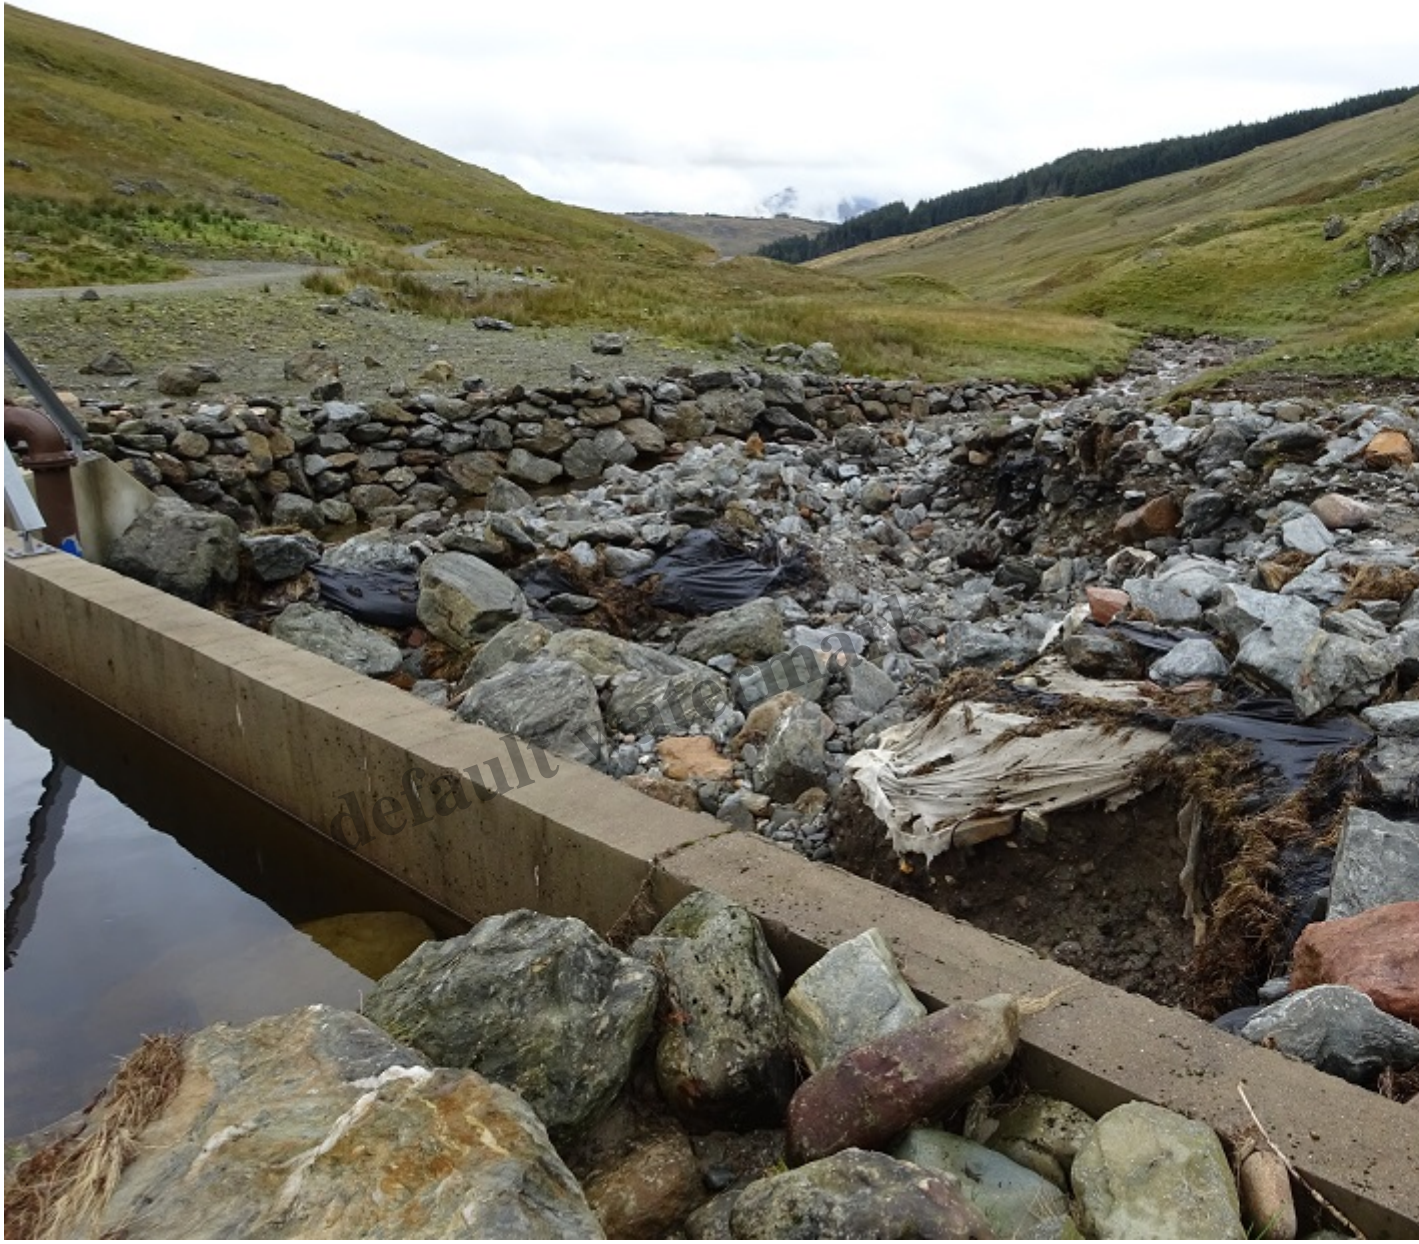
A closer view down from Upper Glen Falloch showing how boulders have been swept off the plastic
