Climate Change and Glen Falloch (4) – hydro failures and their impact

October 1, 2019

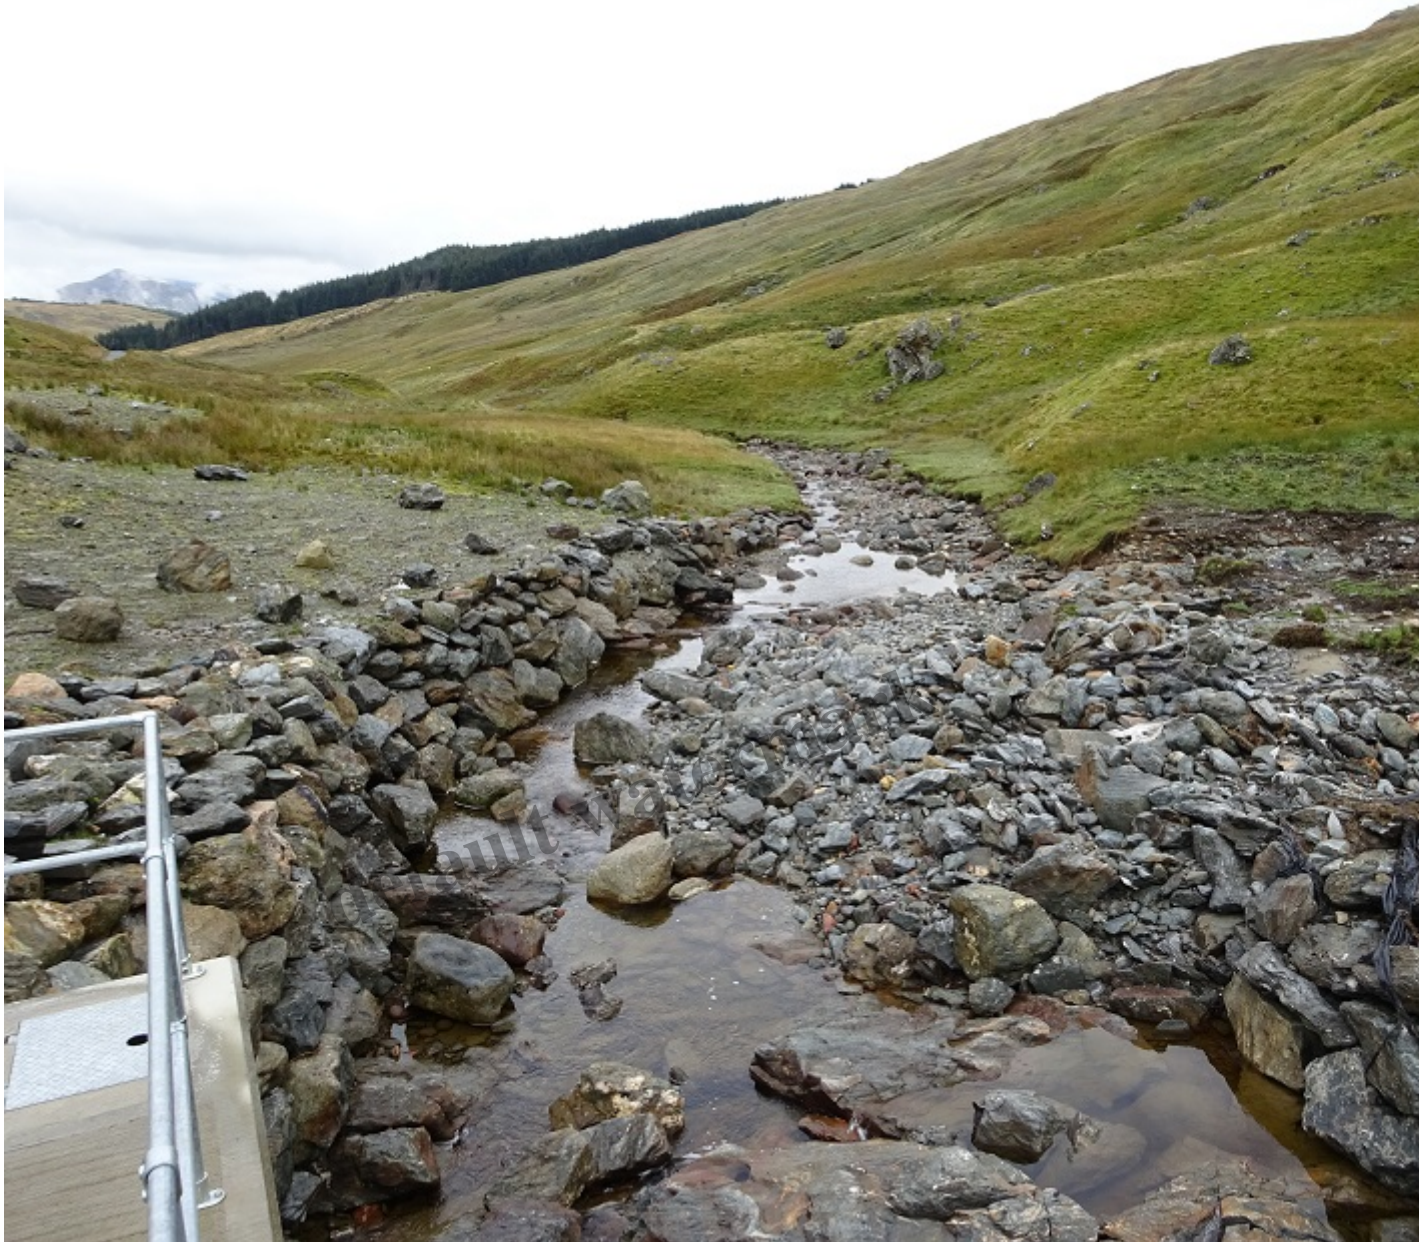
Looking downstream from the intake the rip rap bouldering on the right bank, which used to mirror the left bank, has mostly been swept away making this side of the river appear far more natural. Photo Credit: Crennagh McGrath.

The force of the flood water to remove the rip rap bouldering must have been quite something. The boulders were placed here to protect the river bank after the construction of the intakes but have failed. And it's not just on the Upper Falloch where this has happened, but on four of the other eight Glen Falloch intakes.

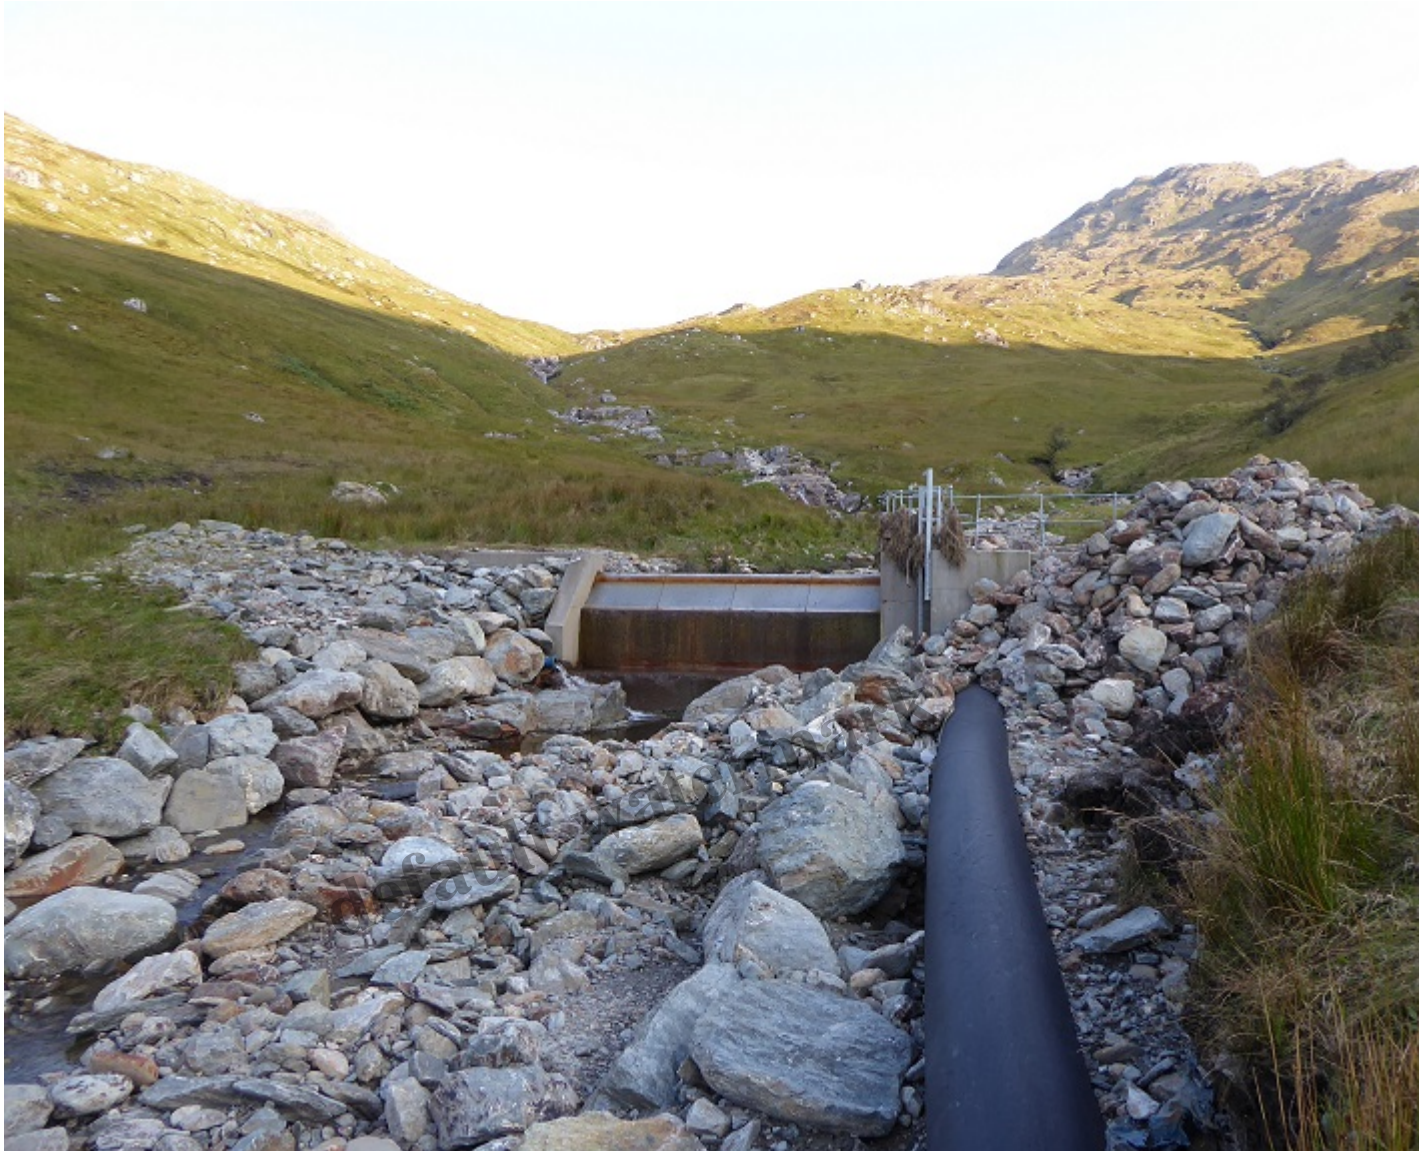
Looking up to Allt a Chuillin main intake along section of pipeline that was, until recently, under the “restored” bank of the river (photo of this from above featured in my last post). The pile of boulders on right appears to have been excavated from the pool and is perhaps intended for use to cover up this pipeline again. Unlikely to work!

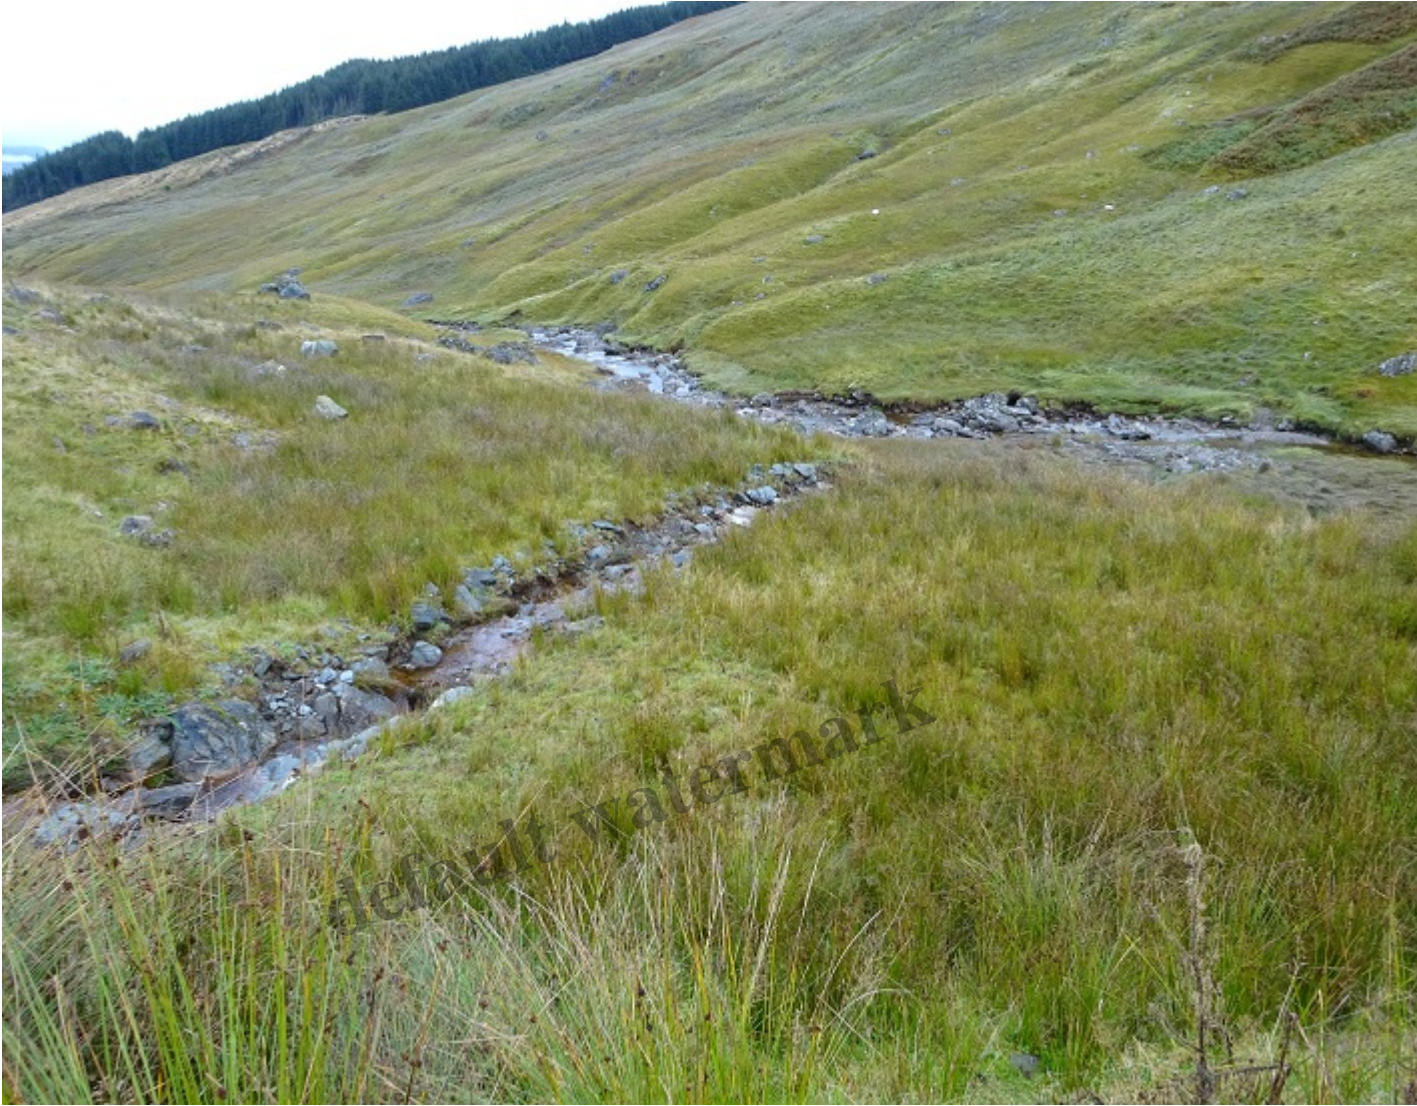
Looking down the Upper River Falloch where relatively little damage is evident to the river banks. The hydro pipeline has been dug UNDER the burn in the foreground and the banks by the rush are the work of humans not of nature. Photo credit Kevin McGrath.
