The Funicular Railway Report July 2018 – HIE’s cover up and the implications

Background

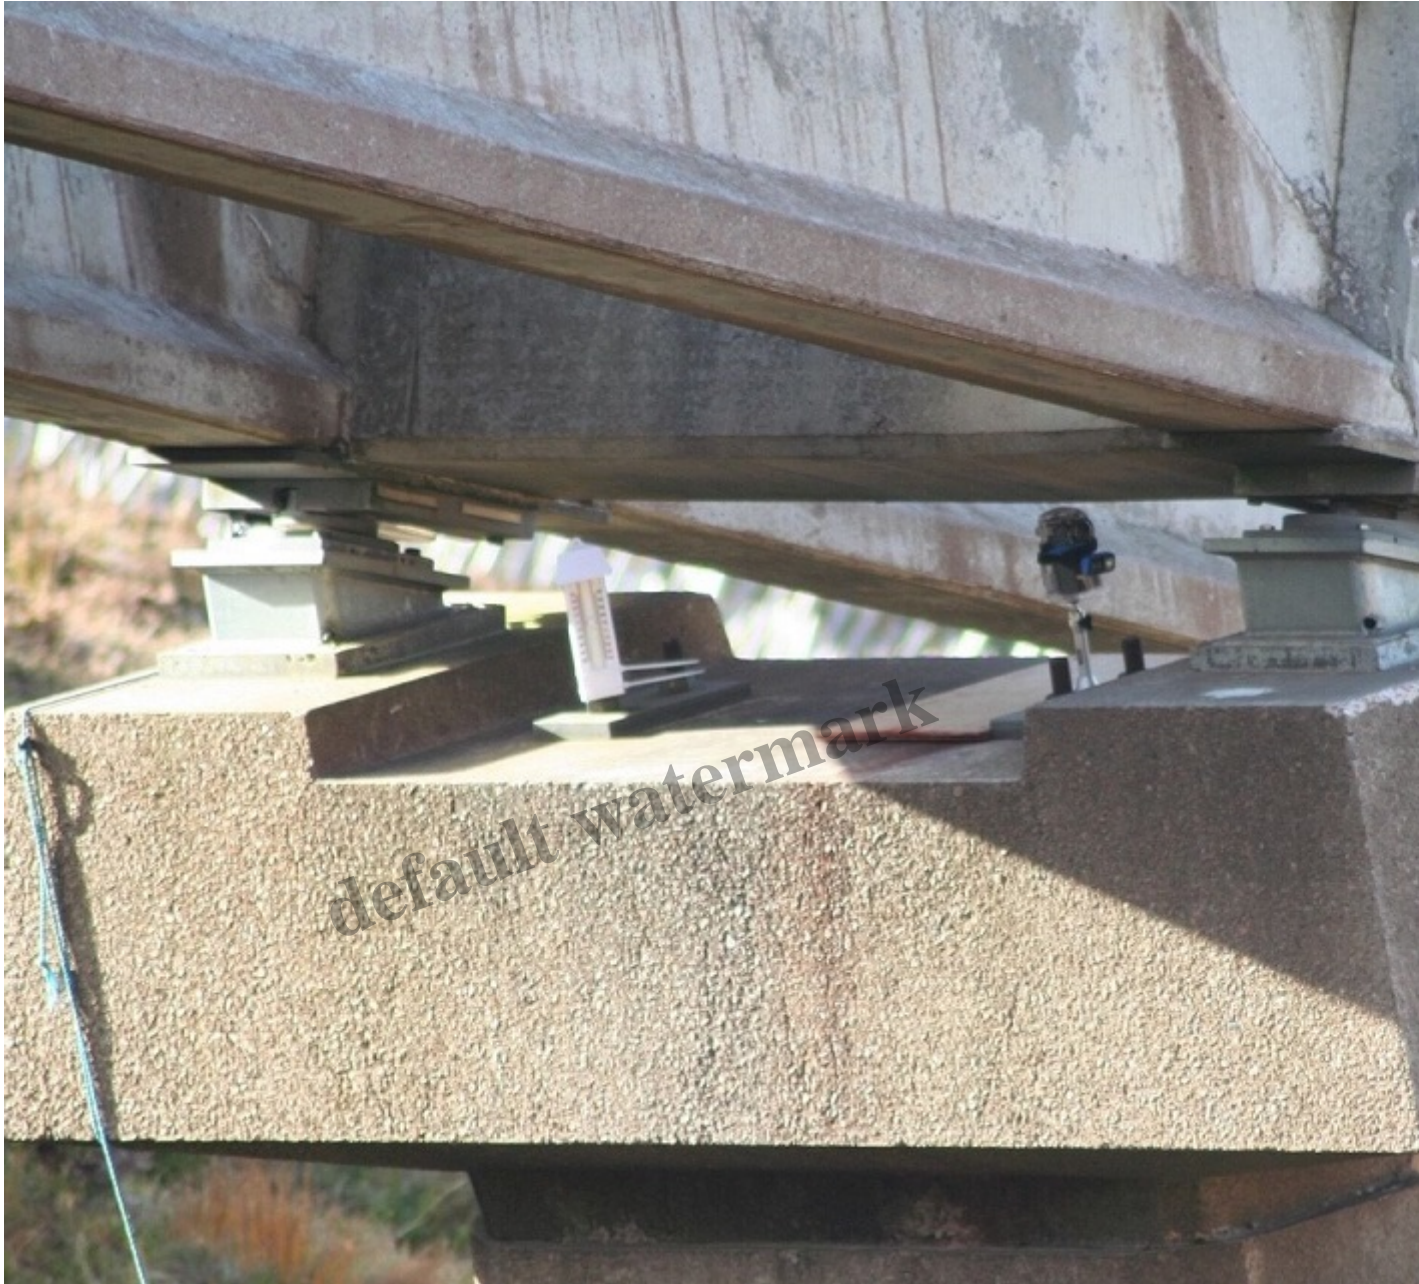
(1) Not going to be cheap to repair, remembering this is not the fully detailed inspection, e.g. the photo below shows monitoring equipment installed on one of the piers,
