The Funicular Railway Report July 2018 - HIE's cover up and the implications

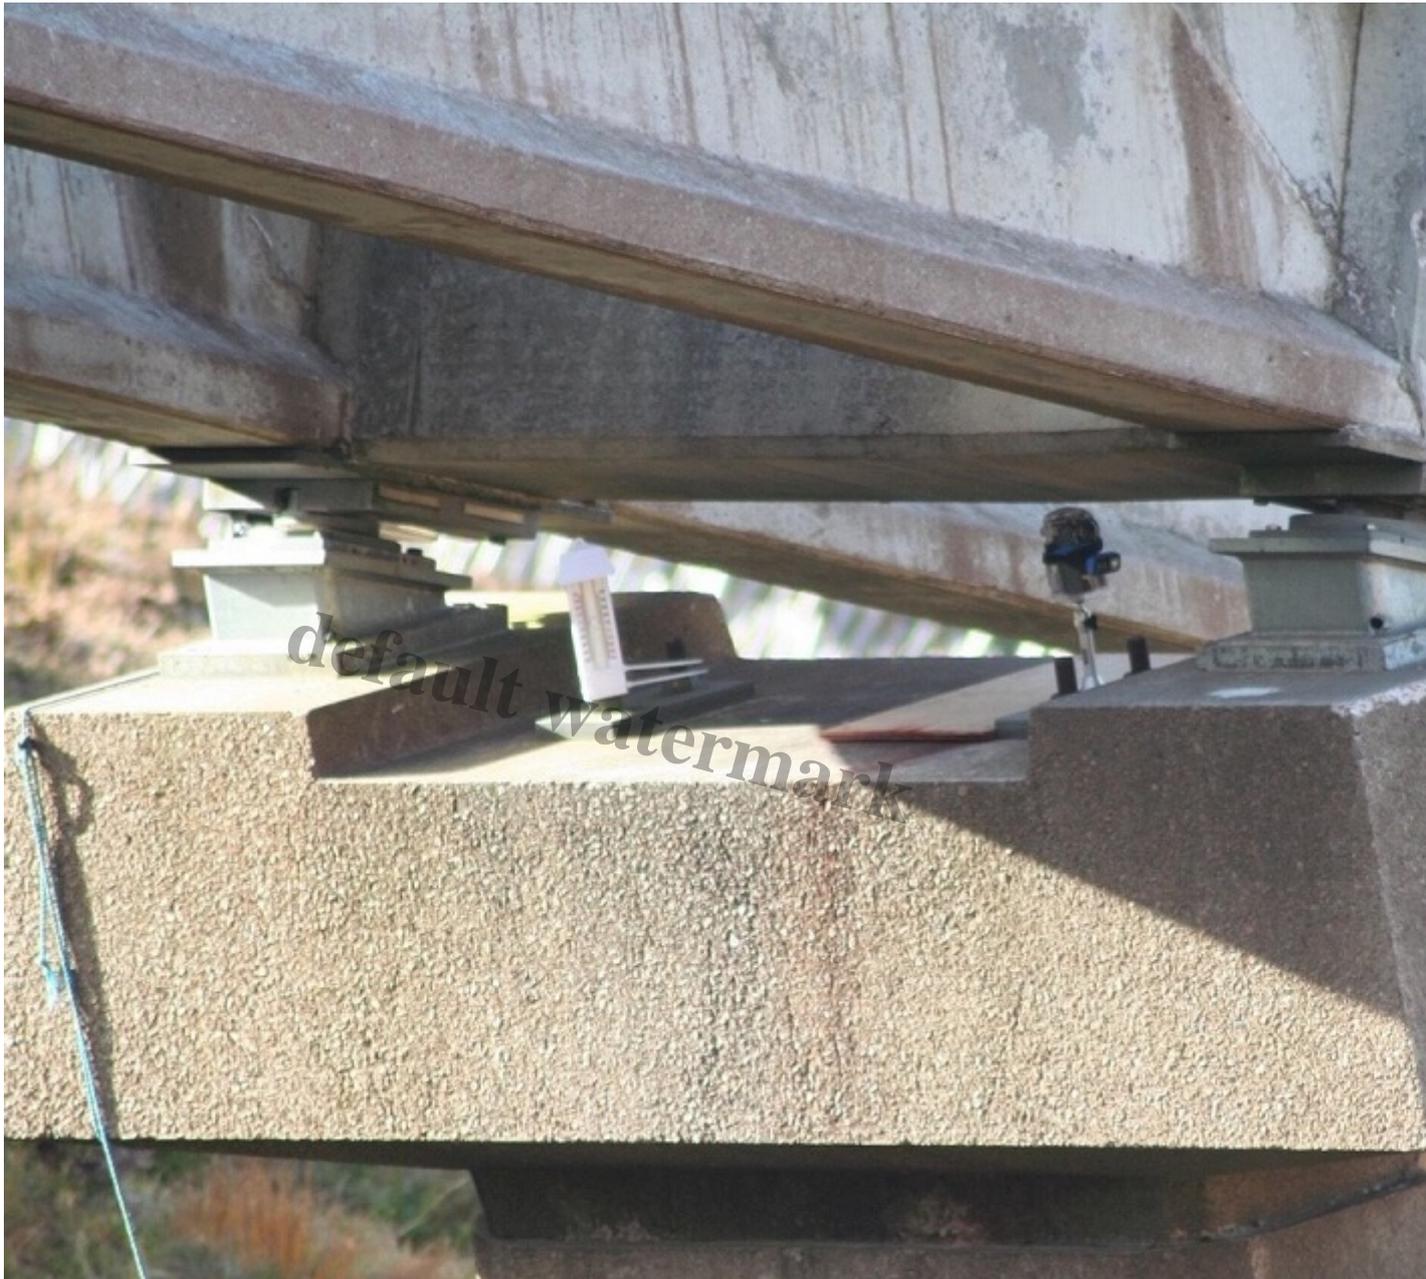
(1) Not going to be cheap to repair, remembering this is not the fully detailed inspection, e.g. the photo below shows monitoring equipment installed on one of the piers,
