The Gynack flood diversion channel above Kingussie – at what environmental and financial cost?

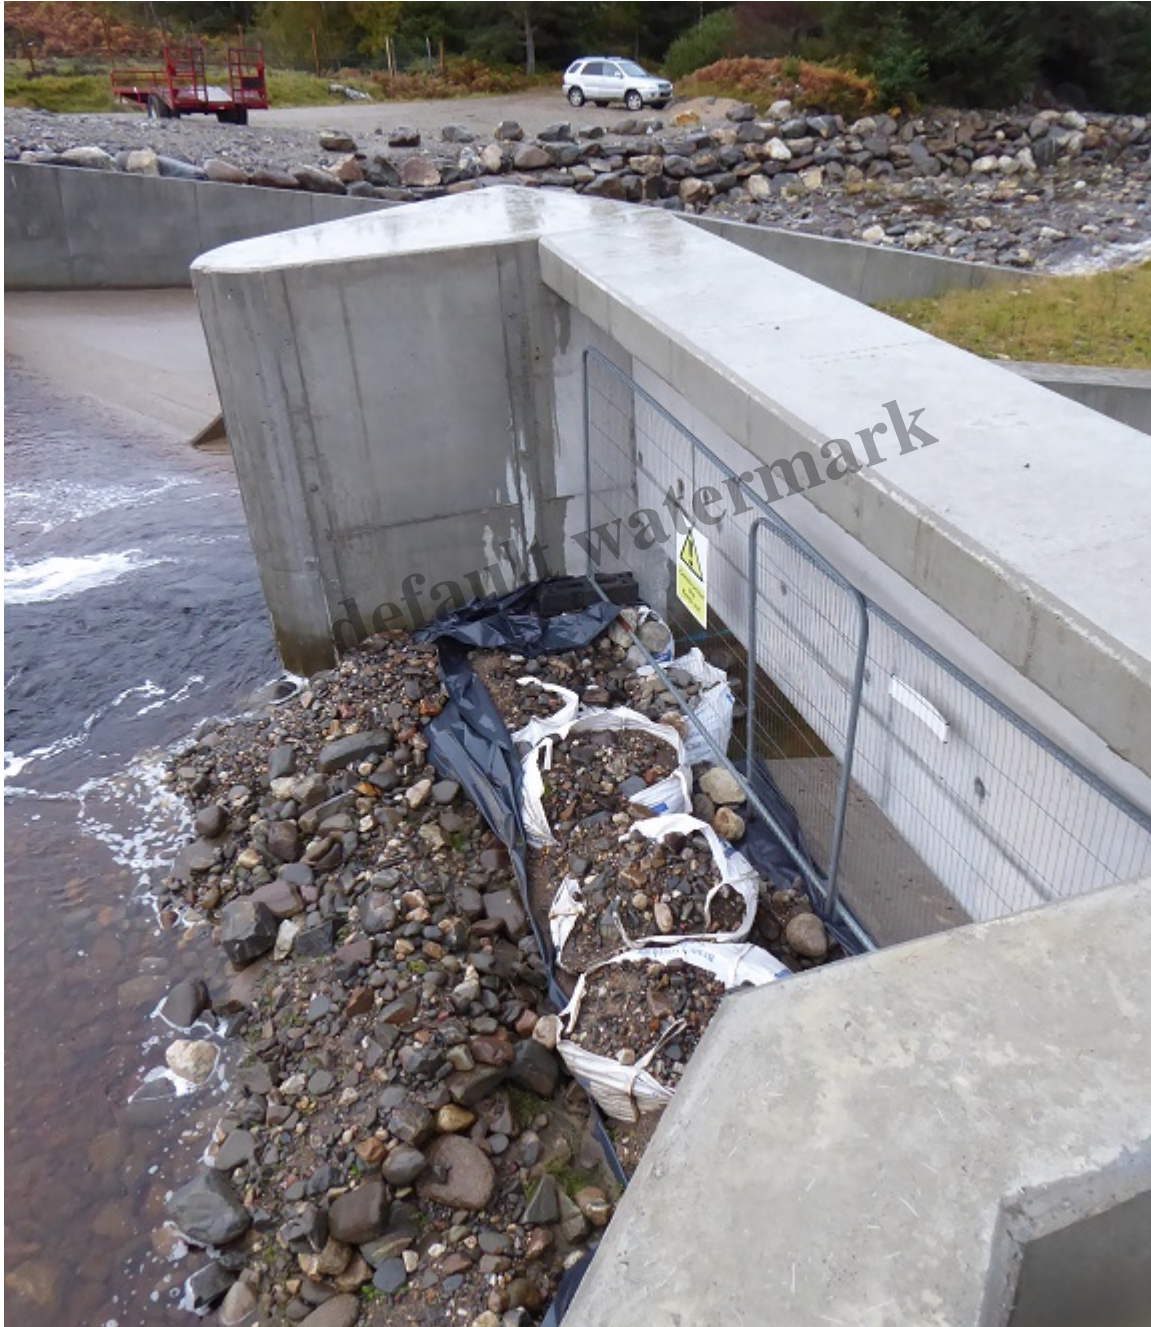
The Gynack overflow channel has been blocked off to prevent it eroding further so that now it will only function in the highest floods October 2019.

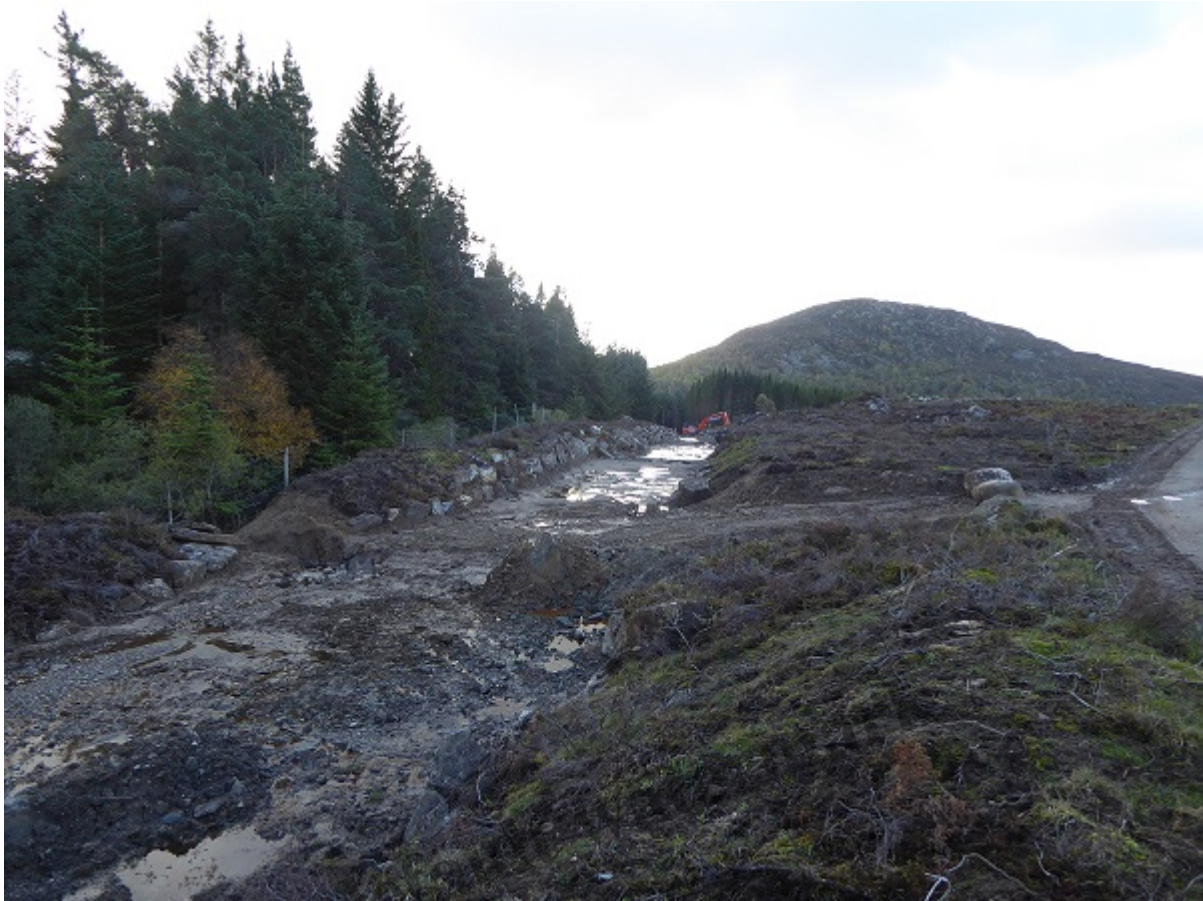
The overflow channel under construction October 2017 – note the new bank on the left

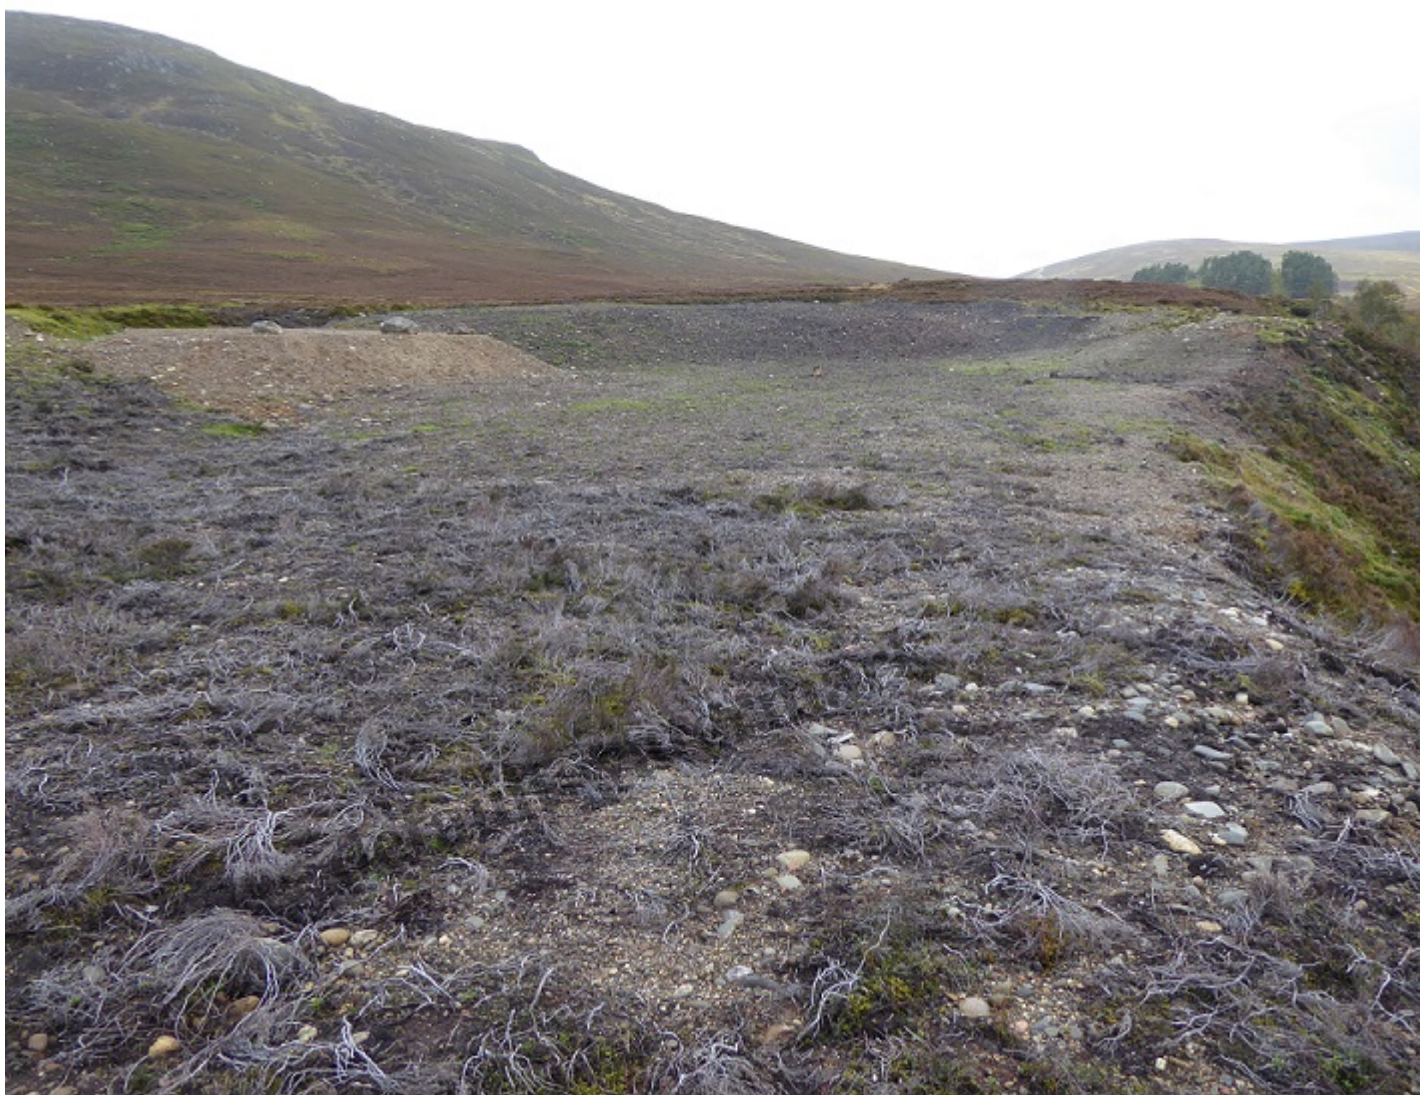
This large re-landscaped area above the overflow intake (Allt Mhor to right) appears to have been used as a borrow pit. October 2017.

There was no development identified on the planning portal for the area pictured above and it falls outside any planning application boundary. In addition there was nothing in the planning documents that I can find ([see here](#)) to indicate that borrow pits would be required. Indeed the planning consent required the applicant to provide details of details of *“the process for excavation (including machine access and working corridor) and the sorting and storage of materials for re-use”*. This suggests that the CNPA expected the developer and contractors to source materials for the banks from the site. If the area up the hill was used therefore to source material to construct the banks to the overflow that was probably unlawful. So, why was no action taken to stop this?

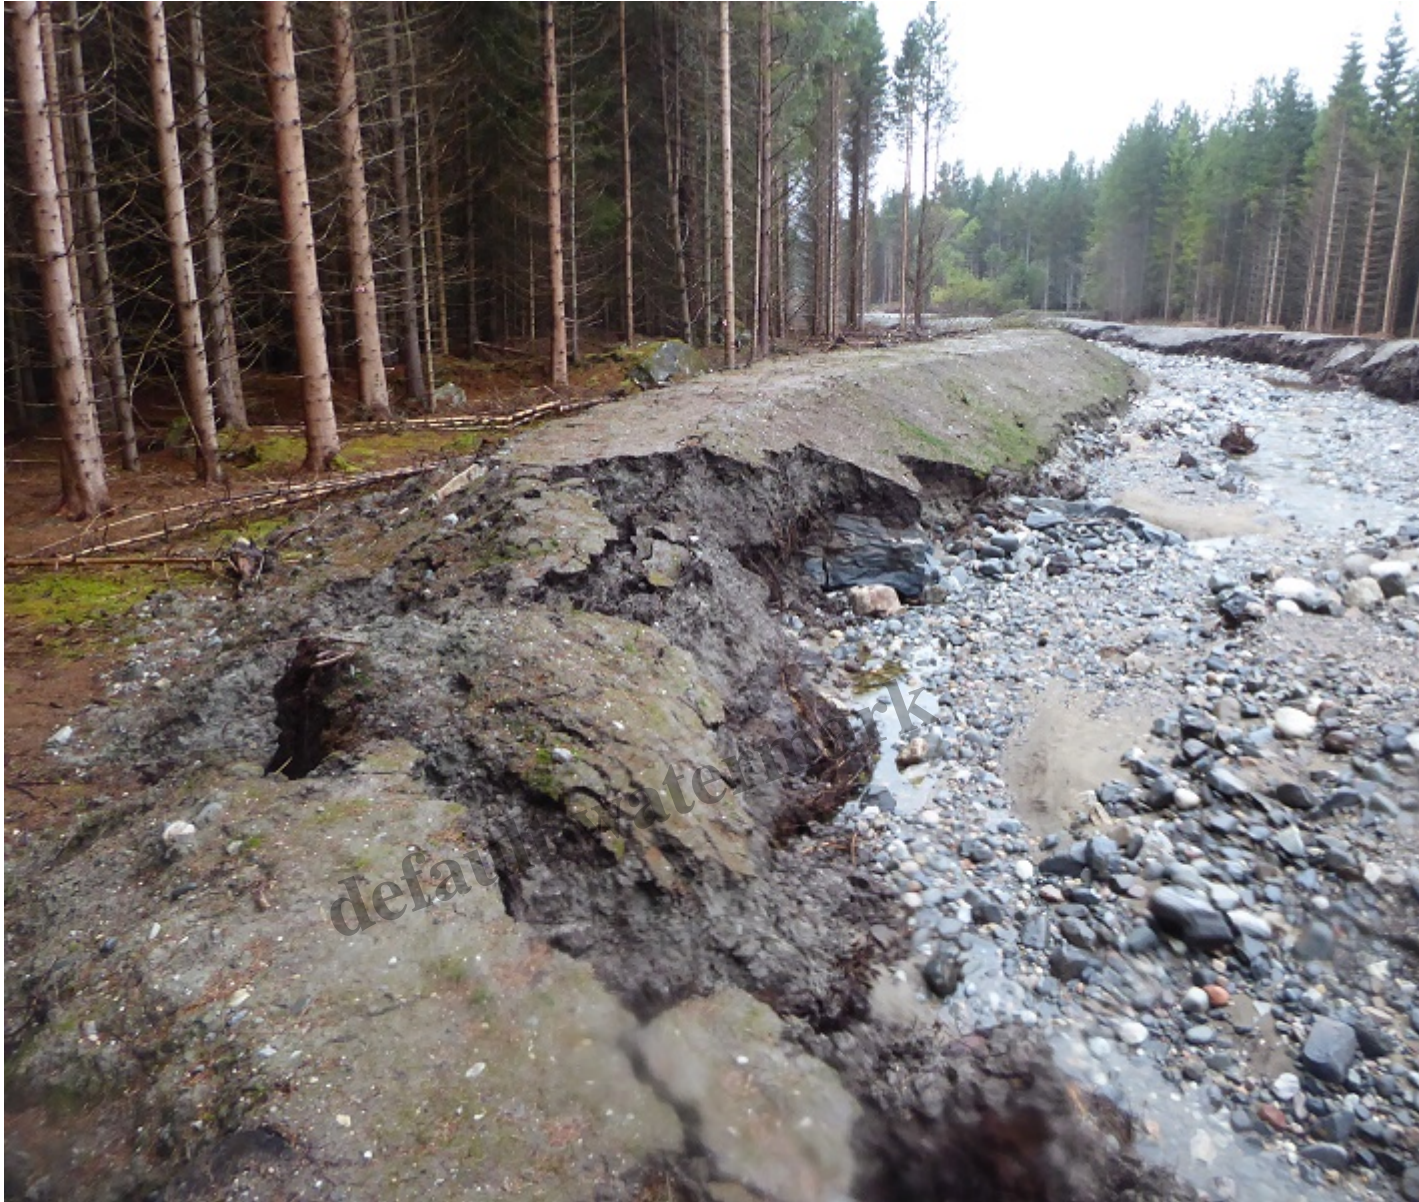
Section of banks in October 2018

Six months later, when I next visited, the possible consequences were even more obvious. What engineer thought that these earth banks could withstand a river in spate? Why was water allowed to run through the channel before they had had any chance to vegetate? Even if that had been allowed to happen, earth banks such as this would have been highly vulnerable to high water flows, but without vegetation and without any protective matting, the consequences of allowing water to run through the channel should have been obvious. So why the CNPA allow this to happen?

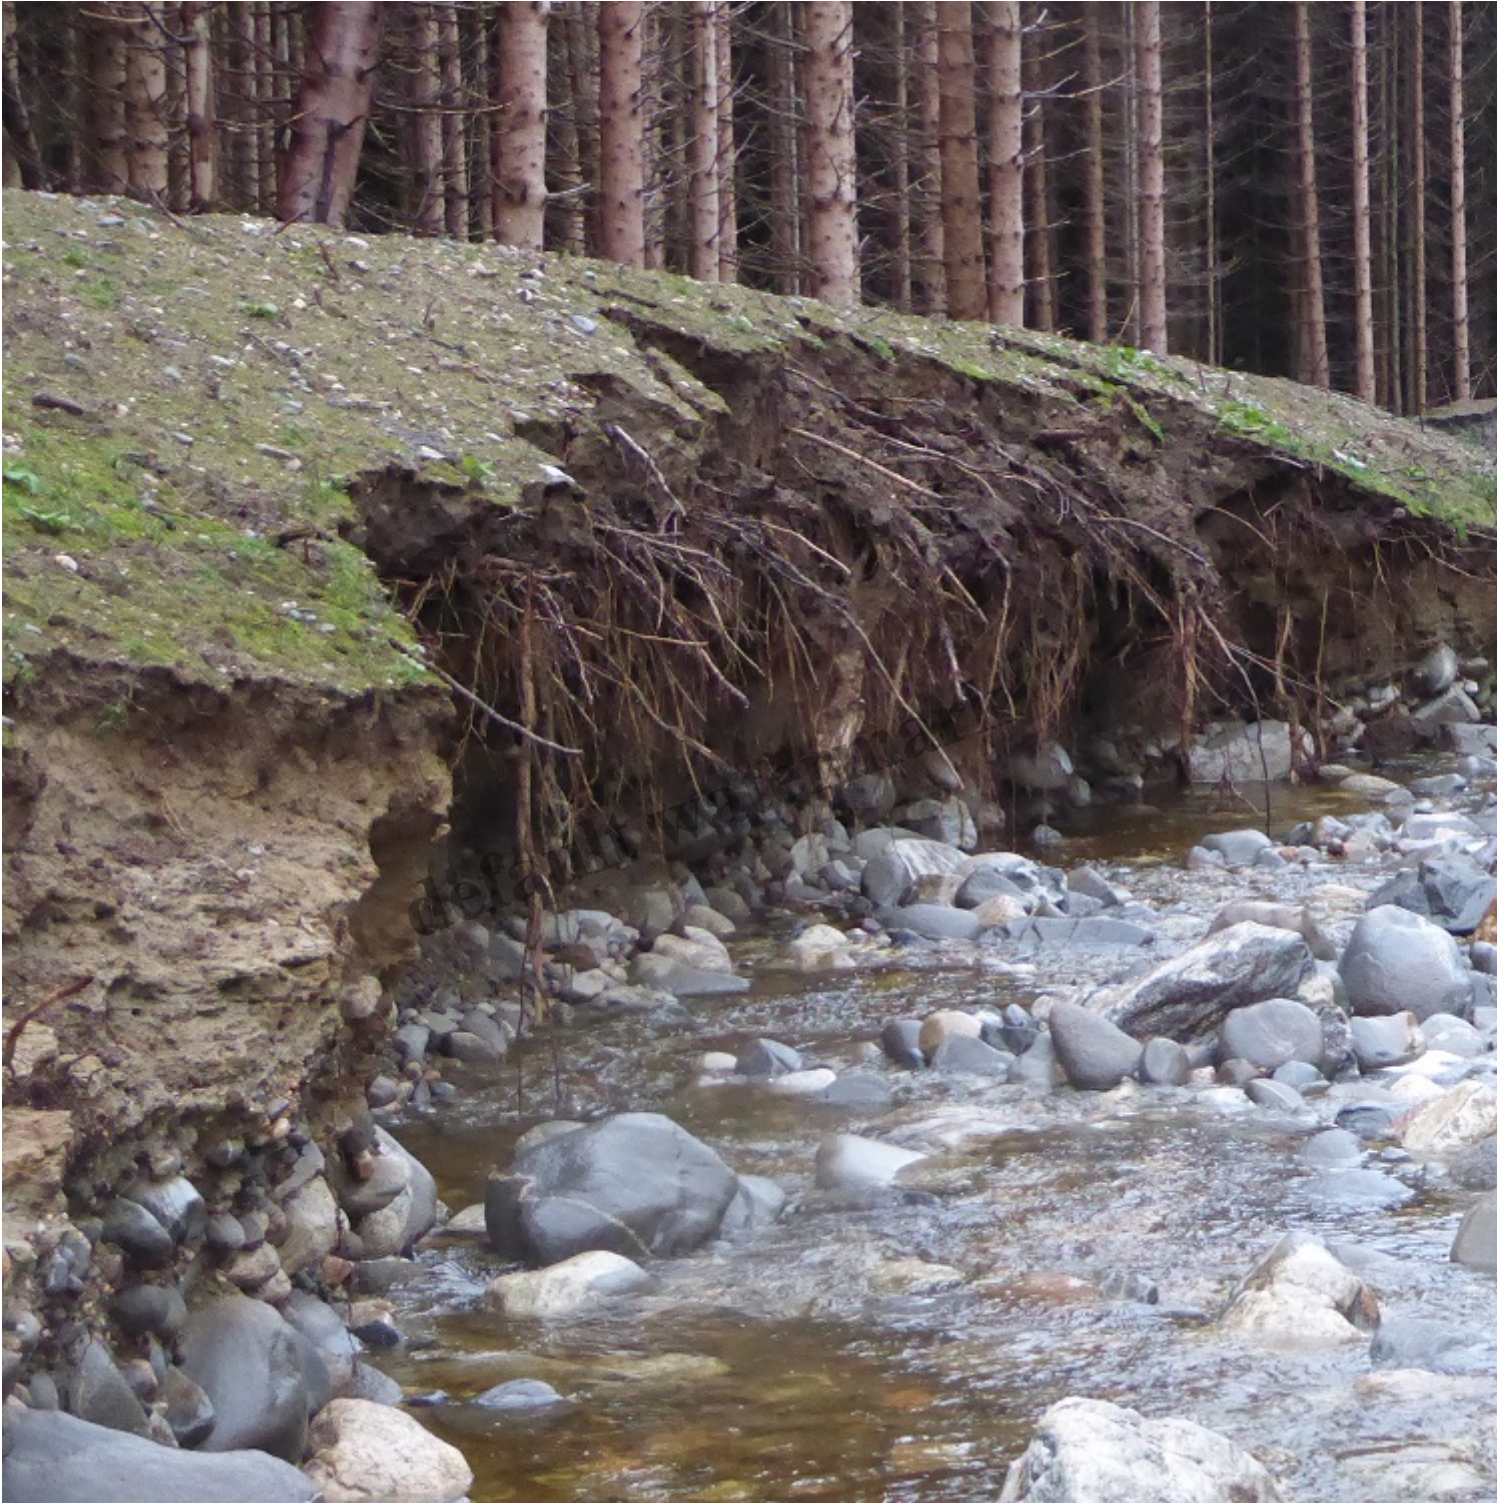
By October 2018 the banks were in places being severely undercut. It appears that in designing the overflow little consideration had been given to the impact of the water on the banks. In the Supporting Information to the planning application consideration had been given to the mobile nature

a result the developer, while rightly highlighting that the area above the intake would infill and require regular maintenance (I cannot recall this ever being considered in any hydro application), completely failed to consider what would happen in the channel itself. As a consequences, in just six months in places the water had almost cut through the bank entirely. Had it done so the overflow could have changed course and flooded Pitmain Lodge which lies on the other side of the plantation below this bank! Poetic justice?

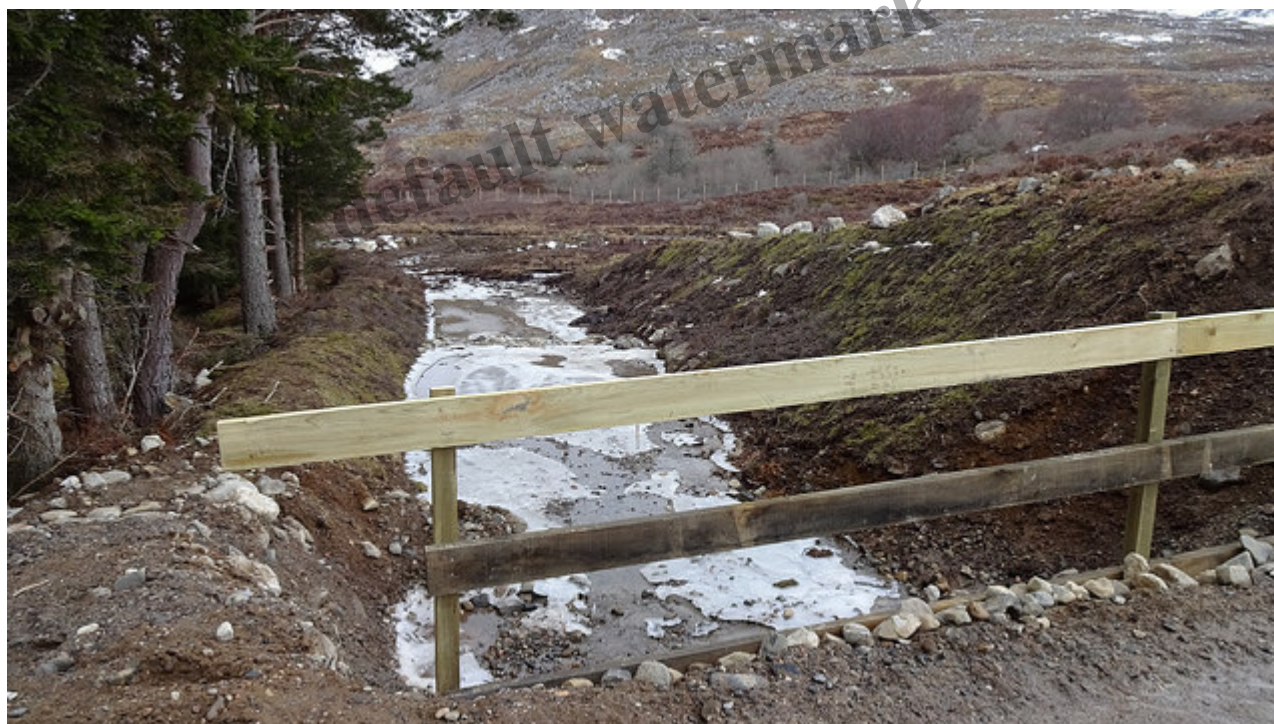
In April 2018 Highland Council published this view of the overflow from the road bridge near the intake

The view of the restoration downstream from the bridge looked not bad in April 2018 though if you look carefully on the right a section of bank behind the fence has already been subject to significant erosion.

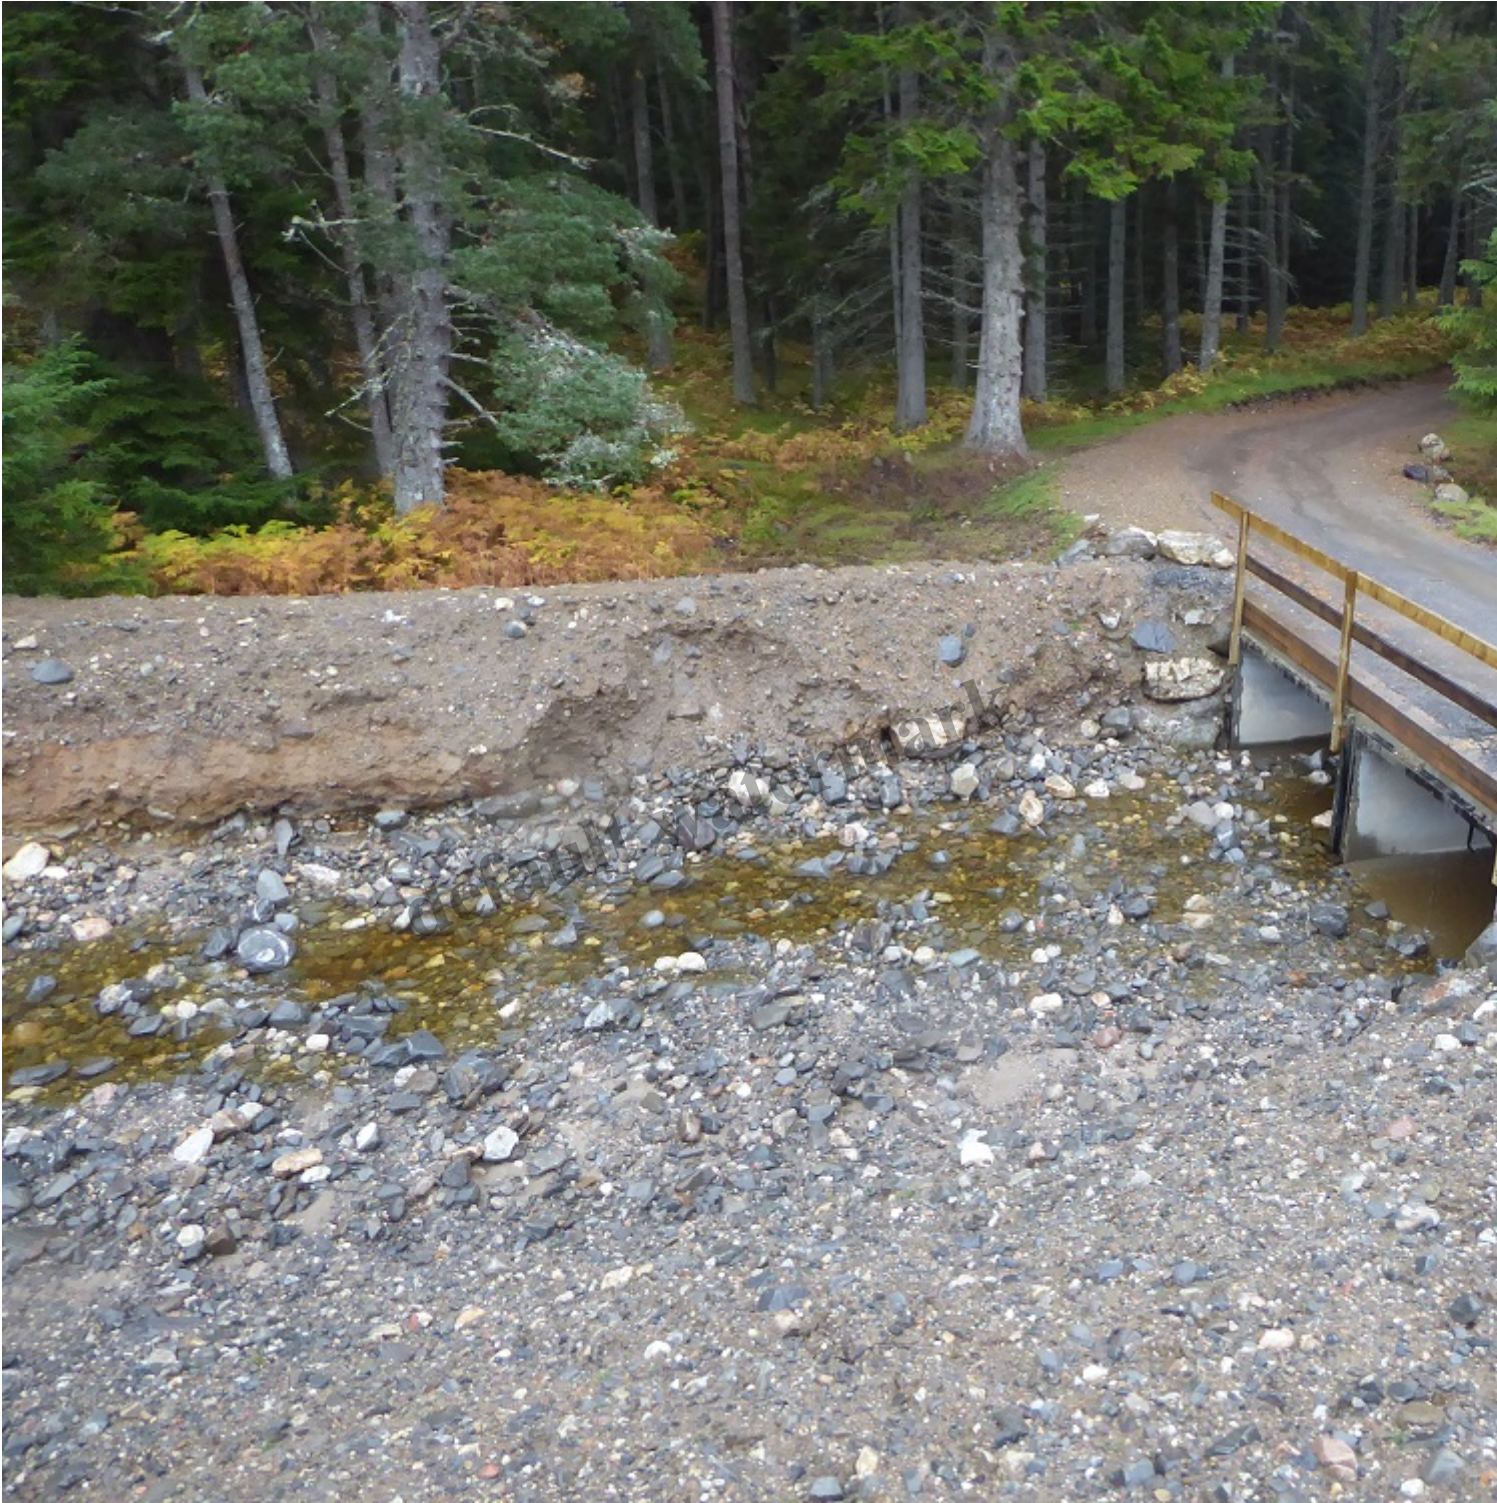
Six months later and the water flowing down the overflow had almost cut right through the bank ABOVE the bridge.

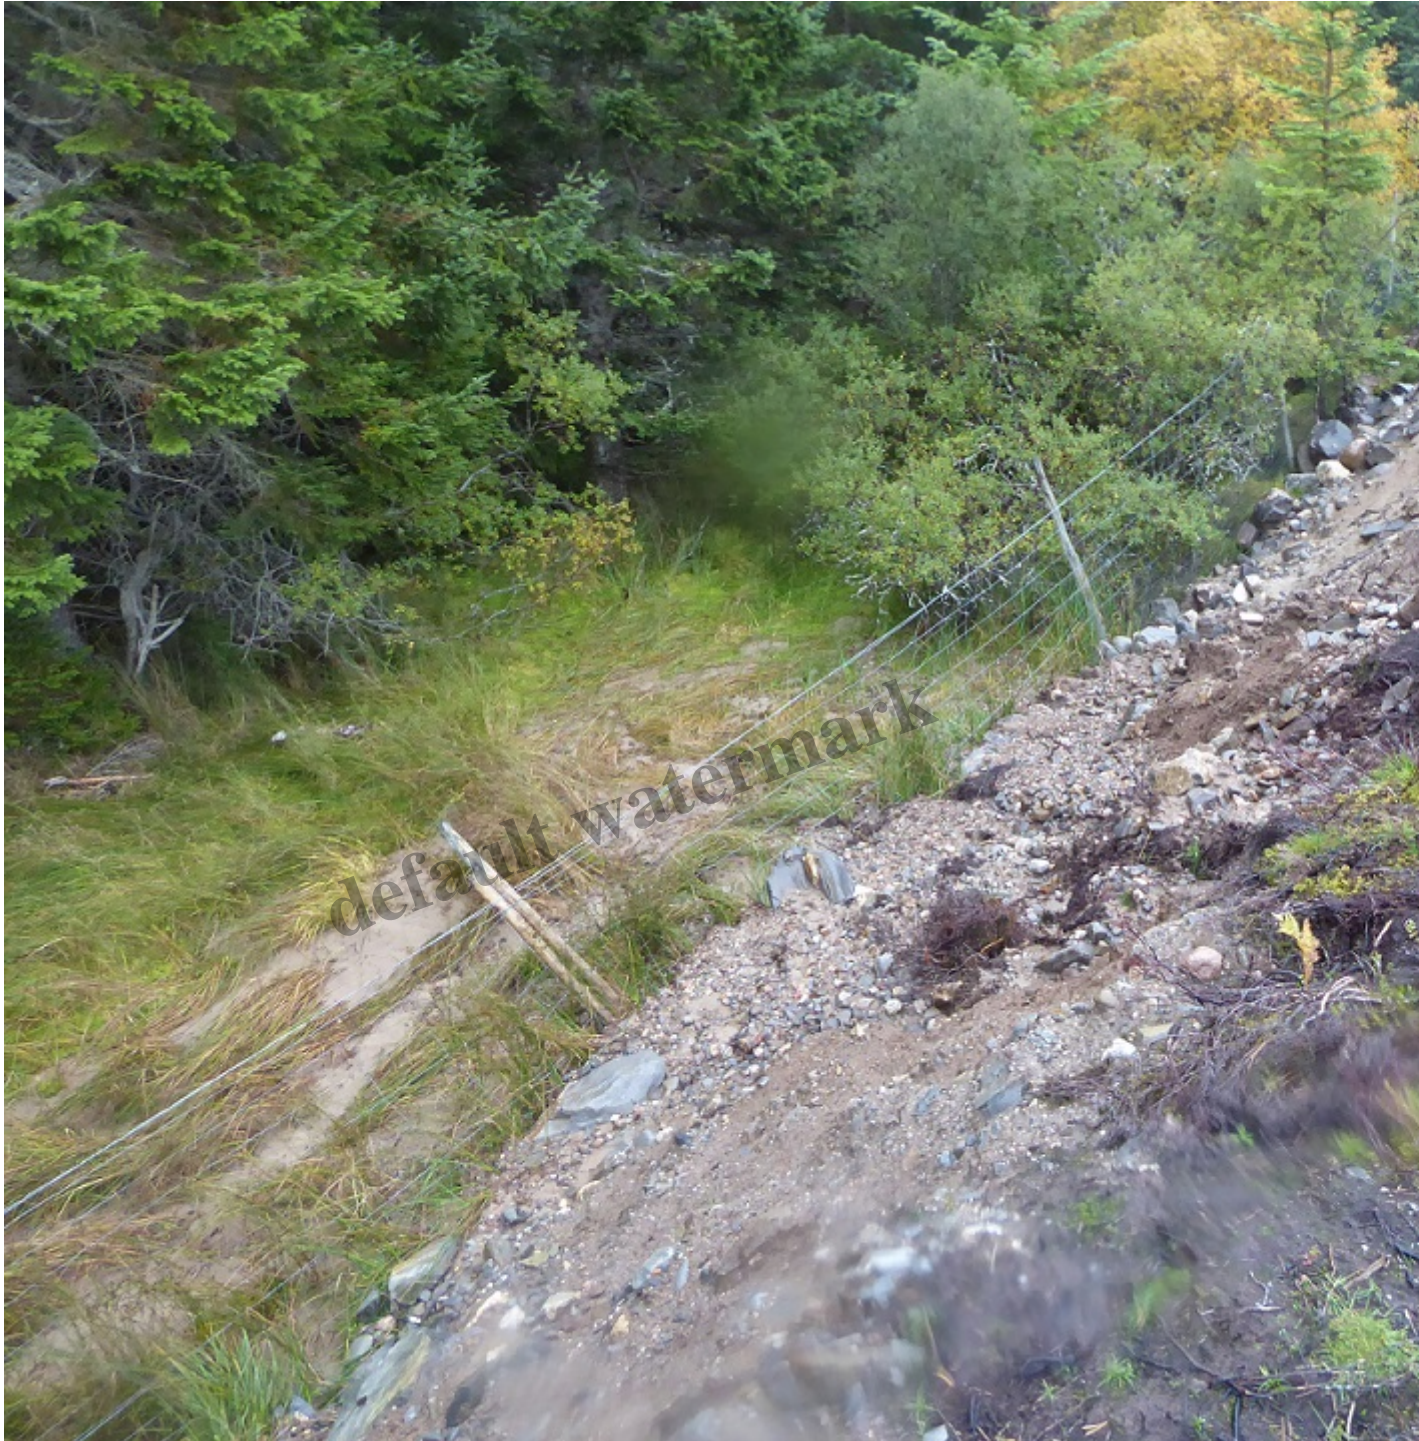
Note the silt that had been washed through the collapsed fence – the boulder on the top of the bank

By October 2018 there was also one section of bank which was eroding from the OUTSIDE. This appears mainly to have been a consequence of poor design, the outside slope of the bank being too steep to retain vegetation easily, and poor restoration, with most of this steep slope having been left bare.

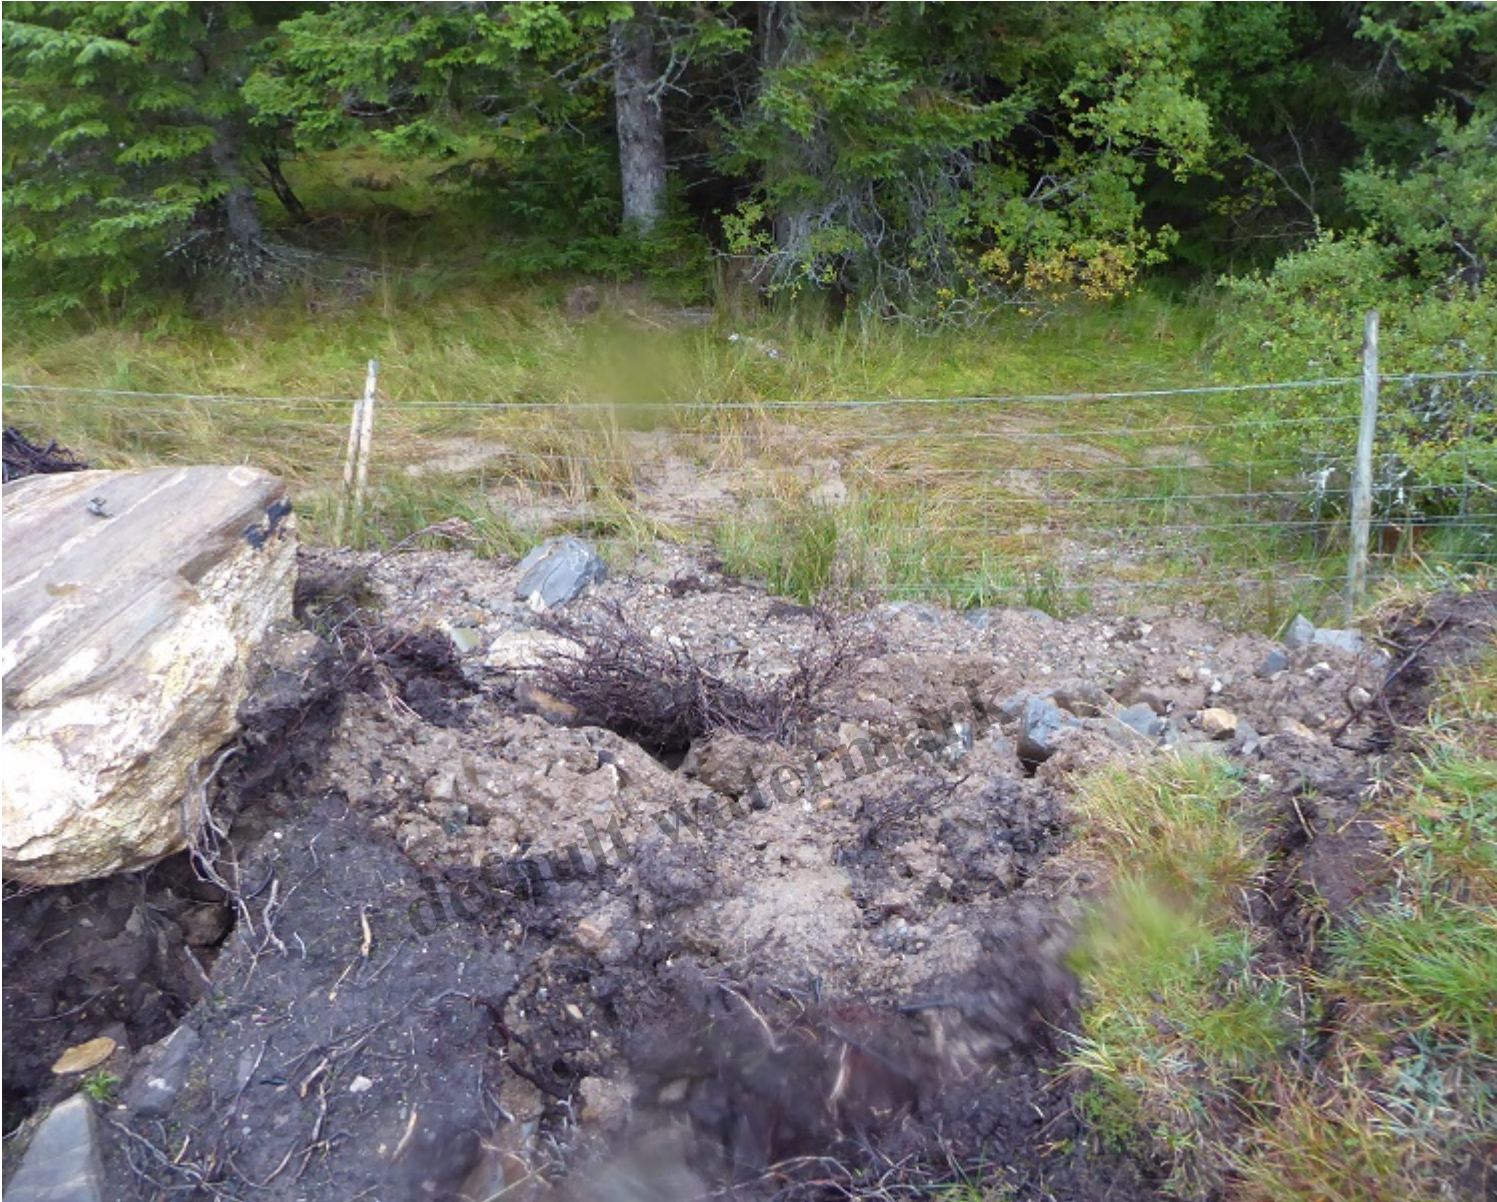
In one place, however, it appeared this section of bank had been breached by flood water adding further to the erosion.

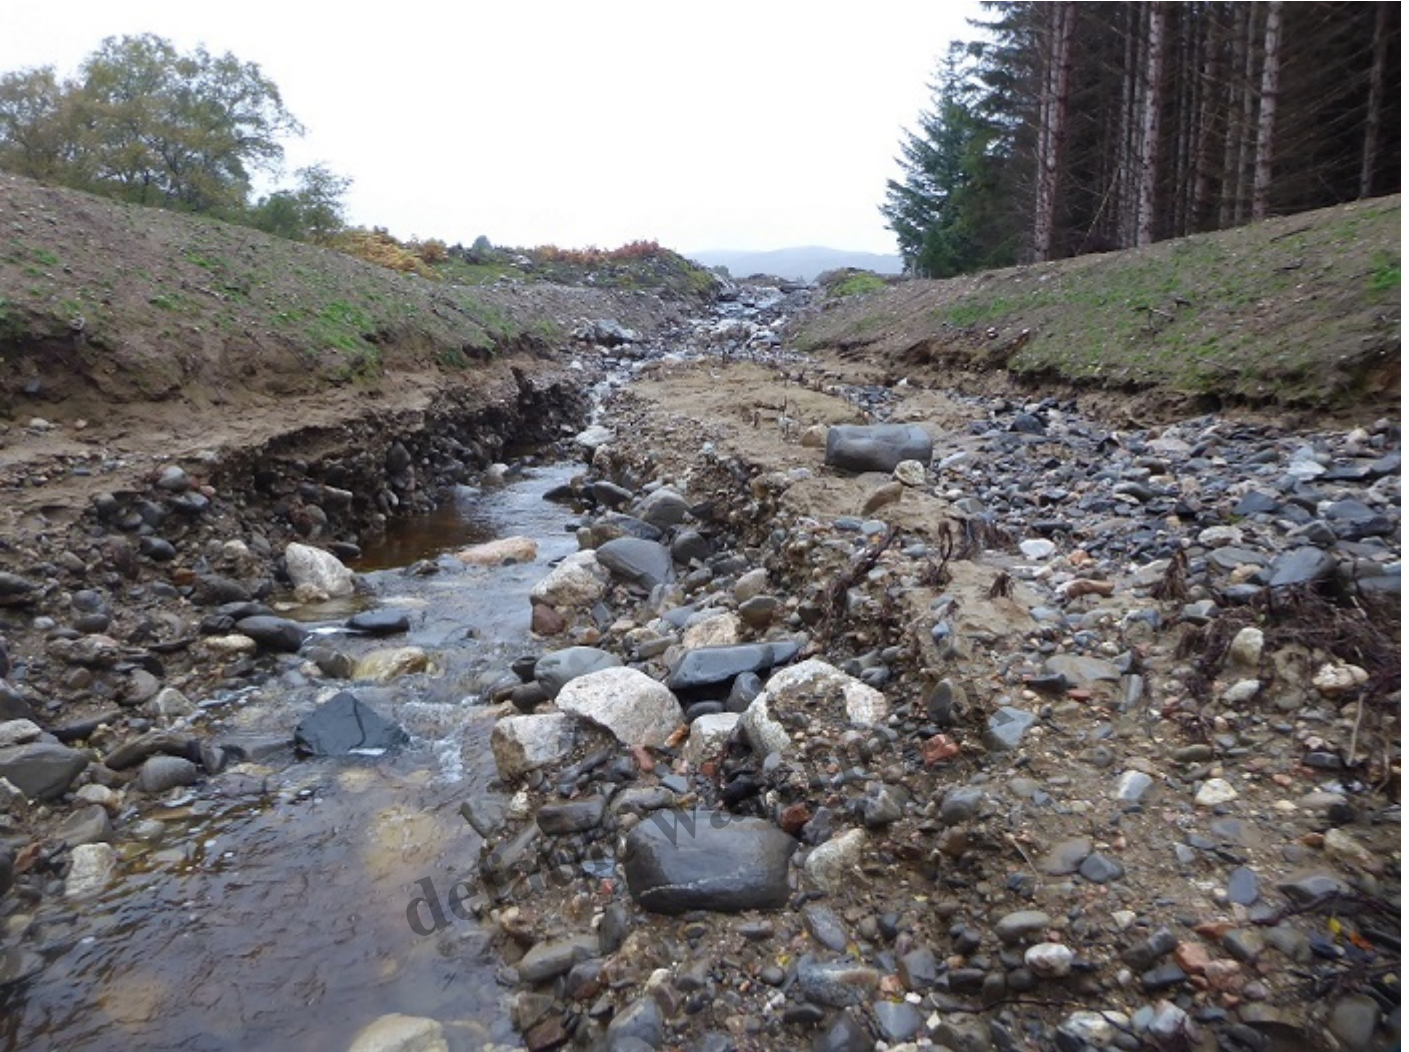
Even more striking was how the channel had cut down below through the original base, doing what rivers that have changed course do, washing away loose material. A good place to study how river channels develop – an ideal geography project for the pupils at Kingussie High School – but in planning terms a disaster. The CEMP required to developer “*to provide details of the substrate of the channel when flat*”. Whatever these plans were, they have not prevented large amounts of material being flushed into the freshwater system. What is the point of the CNPA and the Scottish Environment Protection Agency requiring developers to take measures *during* the construction phase to prevent silt being washed into the freshwater river systems (to protect otters, salmon etc) if *post* construction this happens?

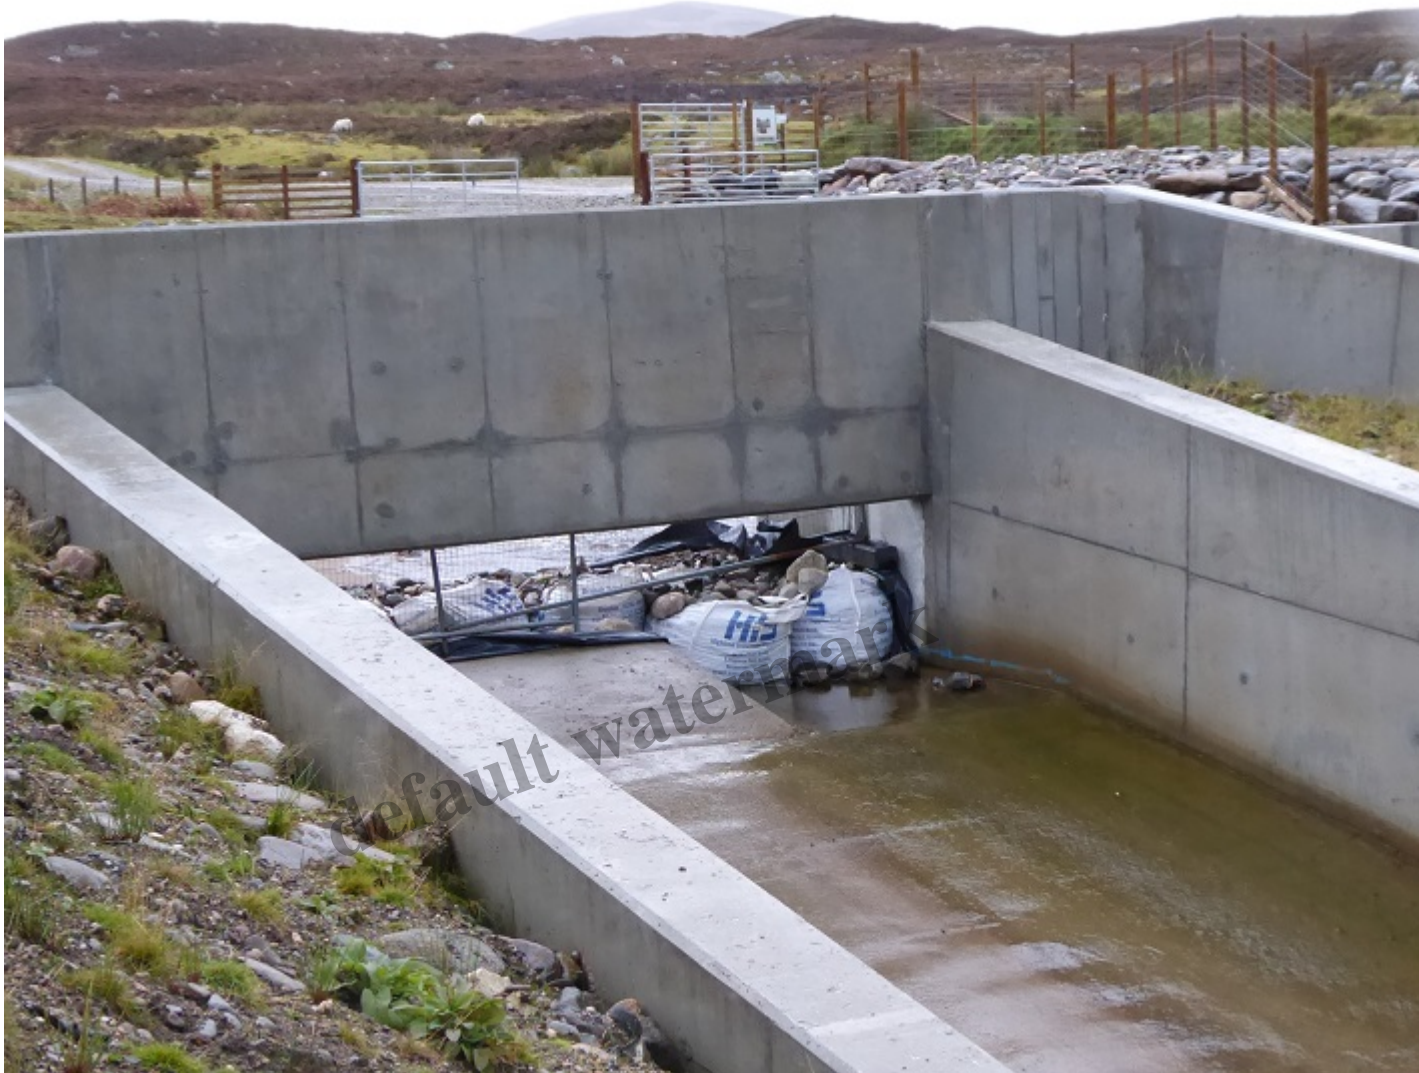
Overflow intake – note the channel within the channel. This was designed to ensure that water flows over the overflow at all times.

I had intended to blog about what I found at the Kingussie overflow a year ago but left it too long and then decided I needed to visit again in case the position had changed. When I did visit in October, I found the intake had been blocked off. This had limited the amount of further damage that had been caused but made the ugly concrete structures effectively redundant.

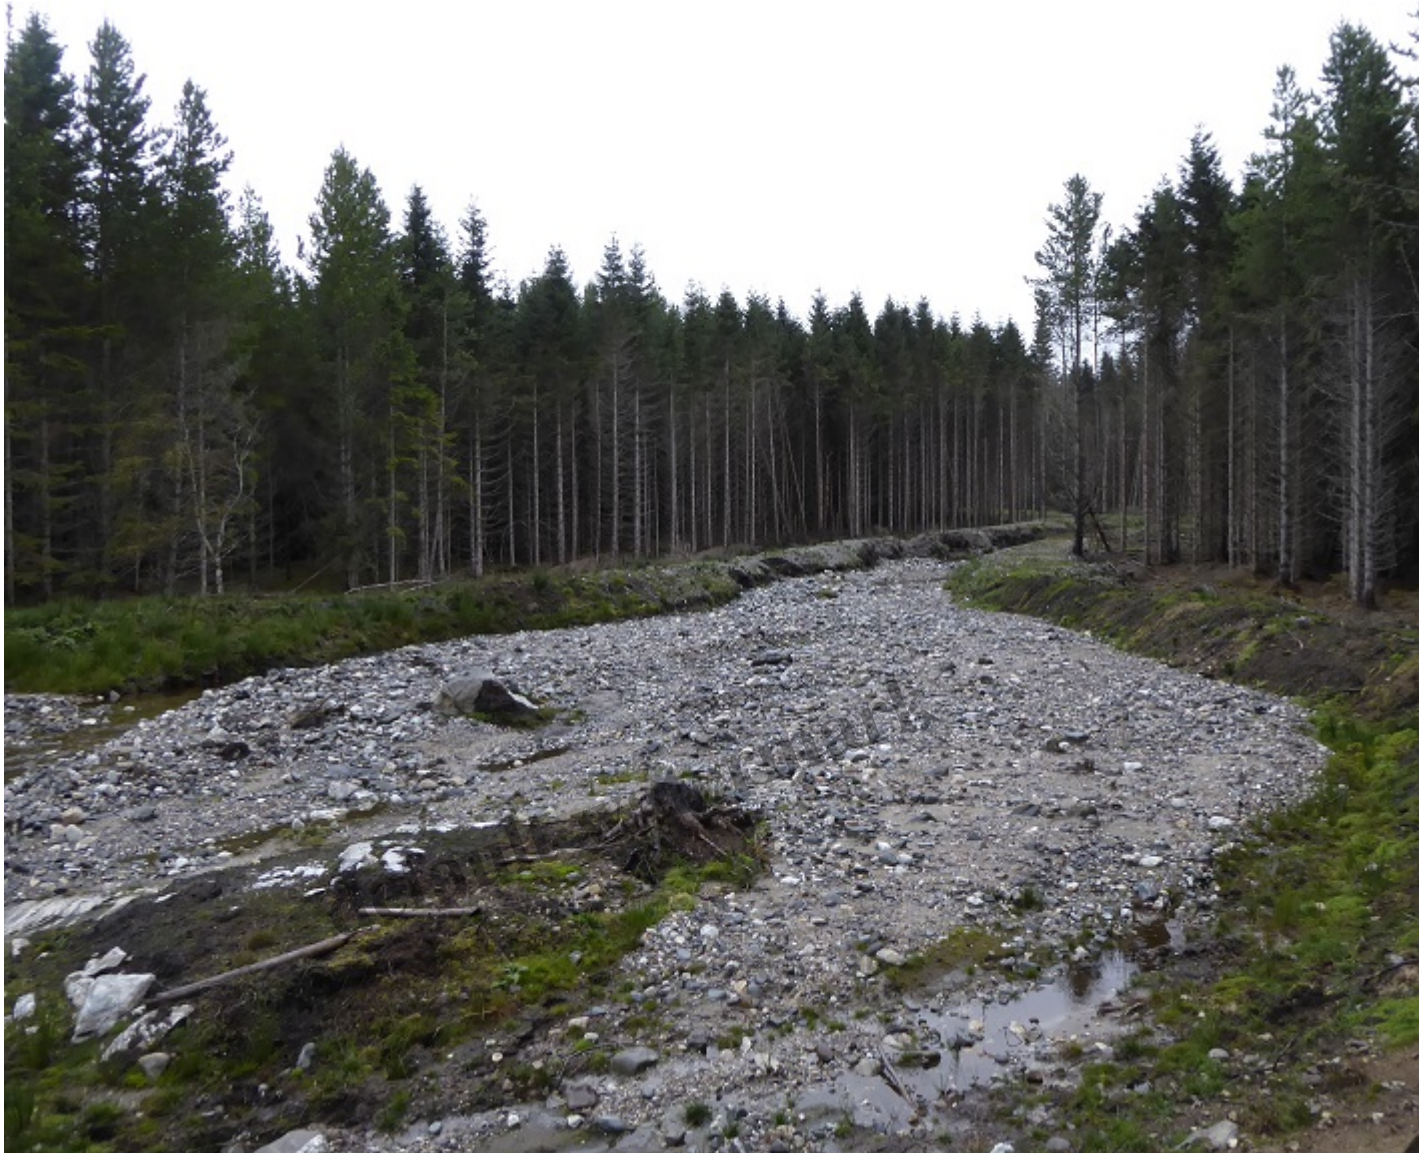
Below this photo logs have been placed across the channel in an attempt to dam the water – another in engineering. Perhaps beavers would have made a better job of it?

A broader area was deliberately excavated lower down to create a new wetland area. Instead boulders and silt have been washed down from above effectively creating a flood plain – nothing wrong with that but NOT what was intended.

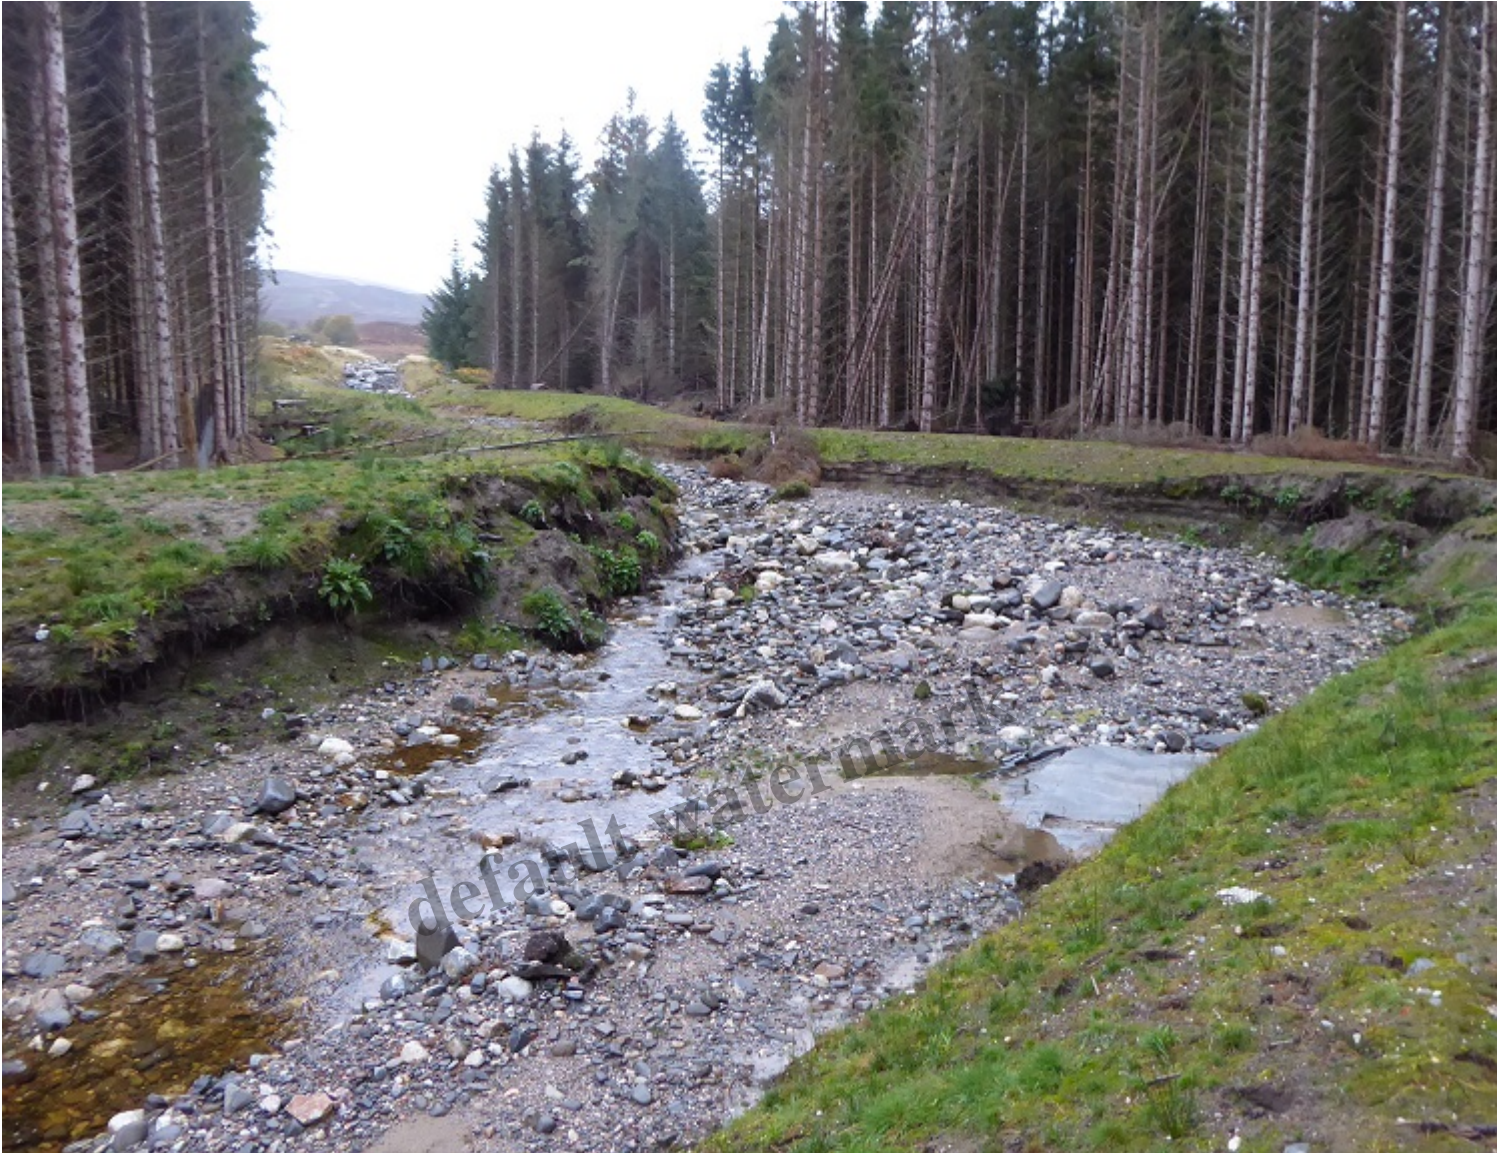
While plants have re-colonised some of the bare banks along the lower half of the overflow, this is not sufficient to prevent them eroding further.
