The Gynack flood diversion channel above Kingussie – at what environmental and financial cost?

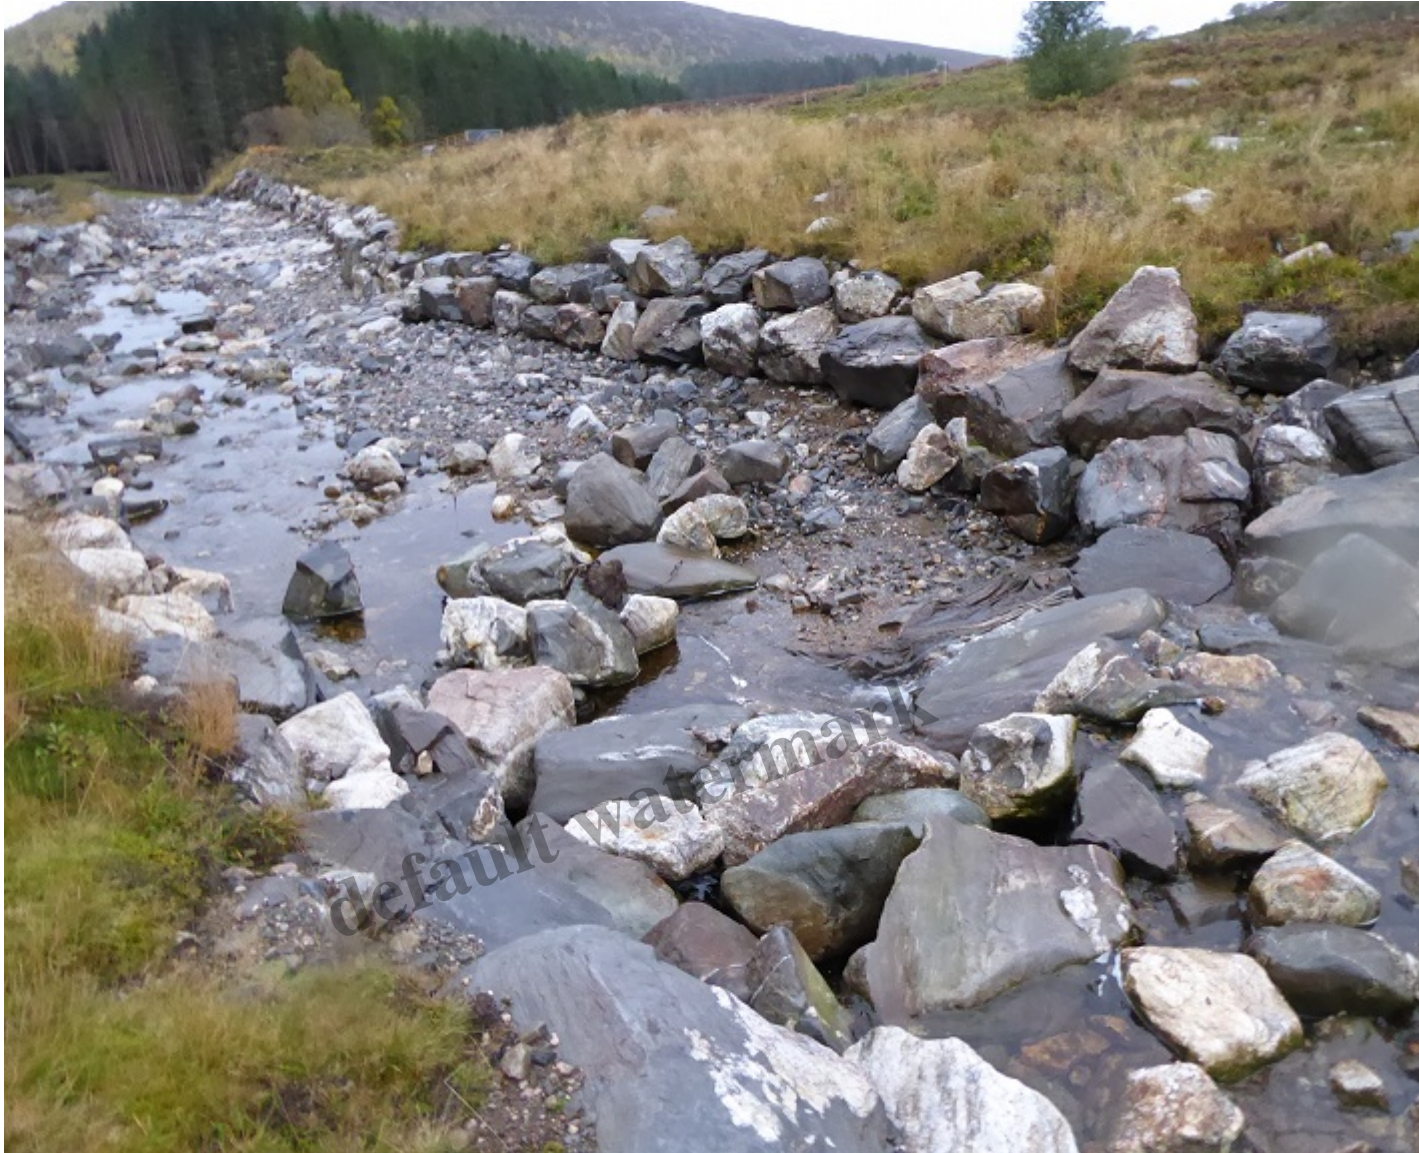
Large boulders have been washed down into the channel both plucked from the rip rap bouldering a banks and from boulders lining the steeper sections of the channel. Note centre right the hessian mat this has been revealed by boulder/s above being swept away – and the much healthier vegetation on section of bank (a consequence of some restoration taking place here).

Higher up there are extensive sections of bank with rip rap bouldering. While most of this is still intact, unlike the bouldering used in the Glen Falloch hydro schemes ([see here](#)), there are several places where you can see boulders have been plucked out from the banks. Had the overflow not been blocked off, the damage might have become as extensive as that in Glen Falloch.

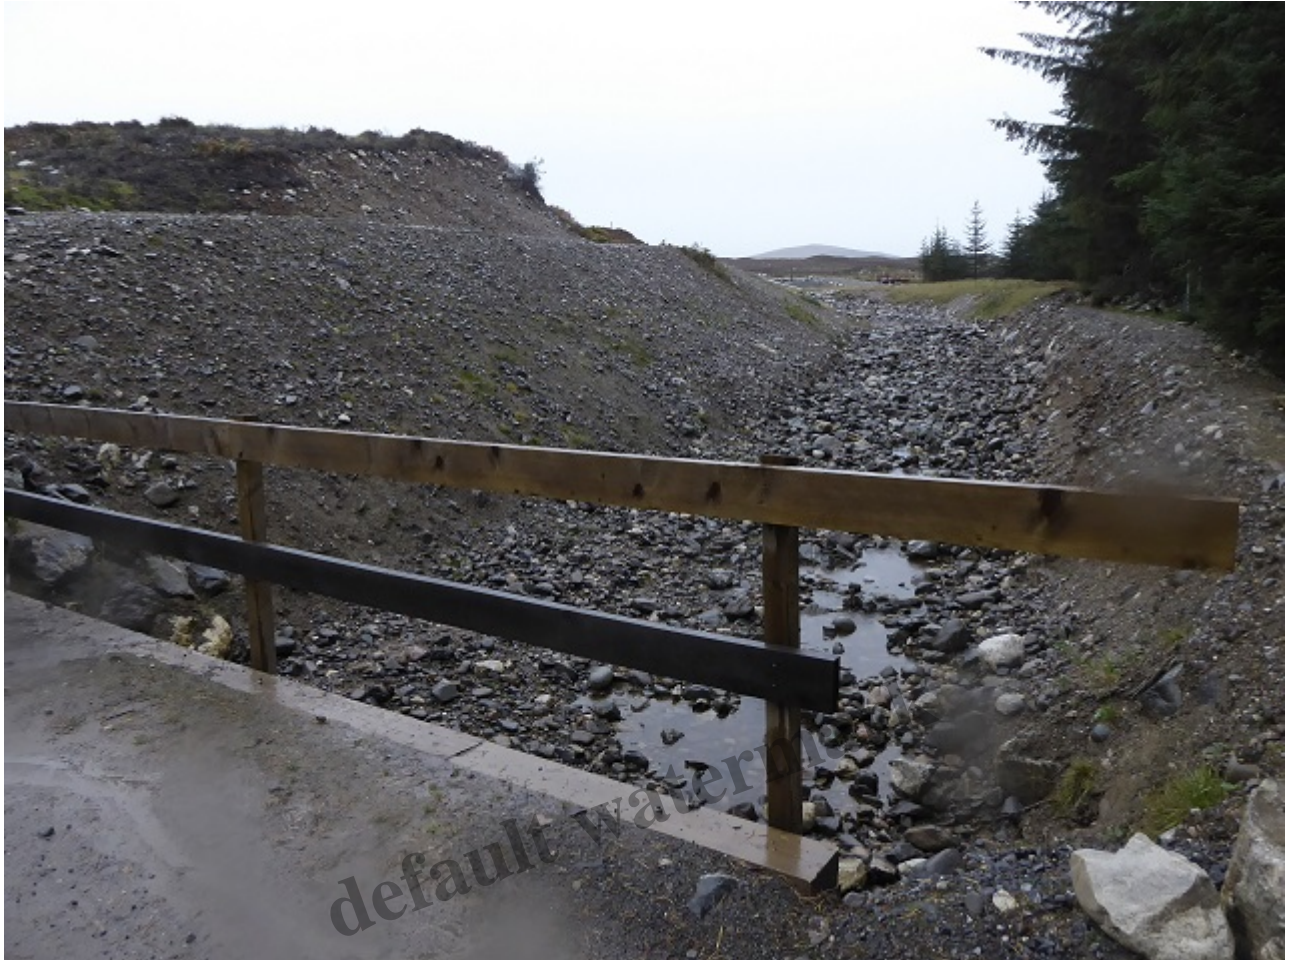
There appears to have been no attempt to re-seed or otherwise restore the bank above the bridge. Both are too steep for vegetation to stabilise effectively.

There are still large areas where there has been no restoration to the banks and they are very vulnerable to erosion. The only reason the bank on the left has not eroded is because the water flow has been directed along the other side of the river – where the bank is eroding seriously.

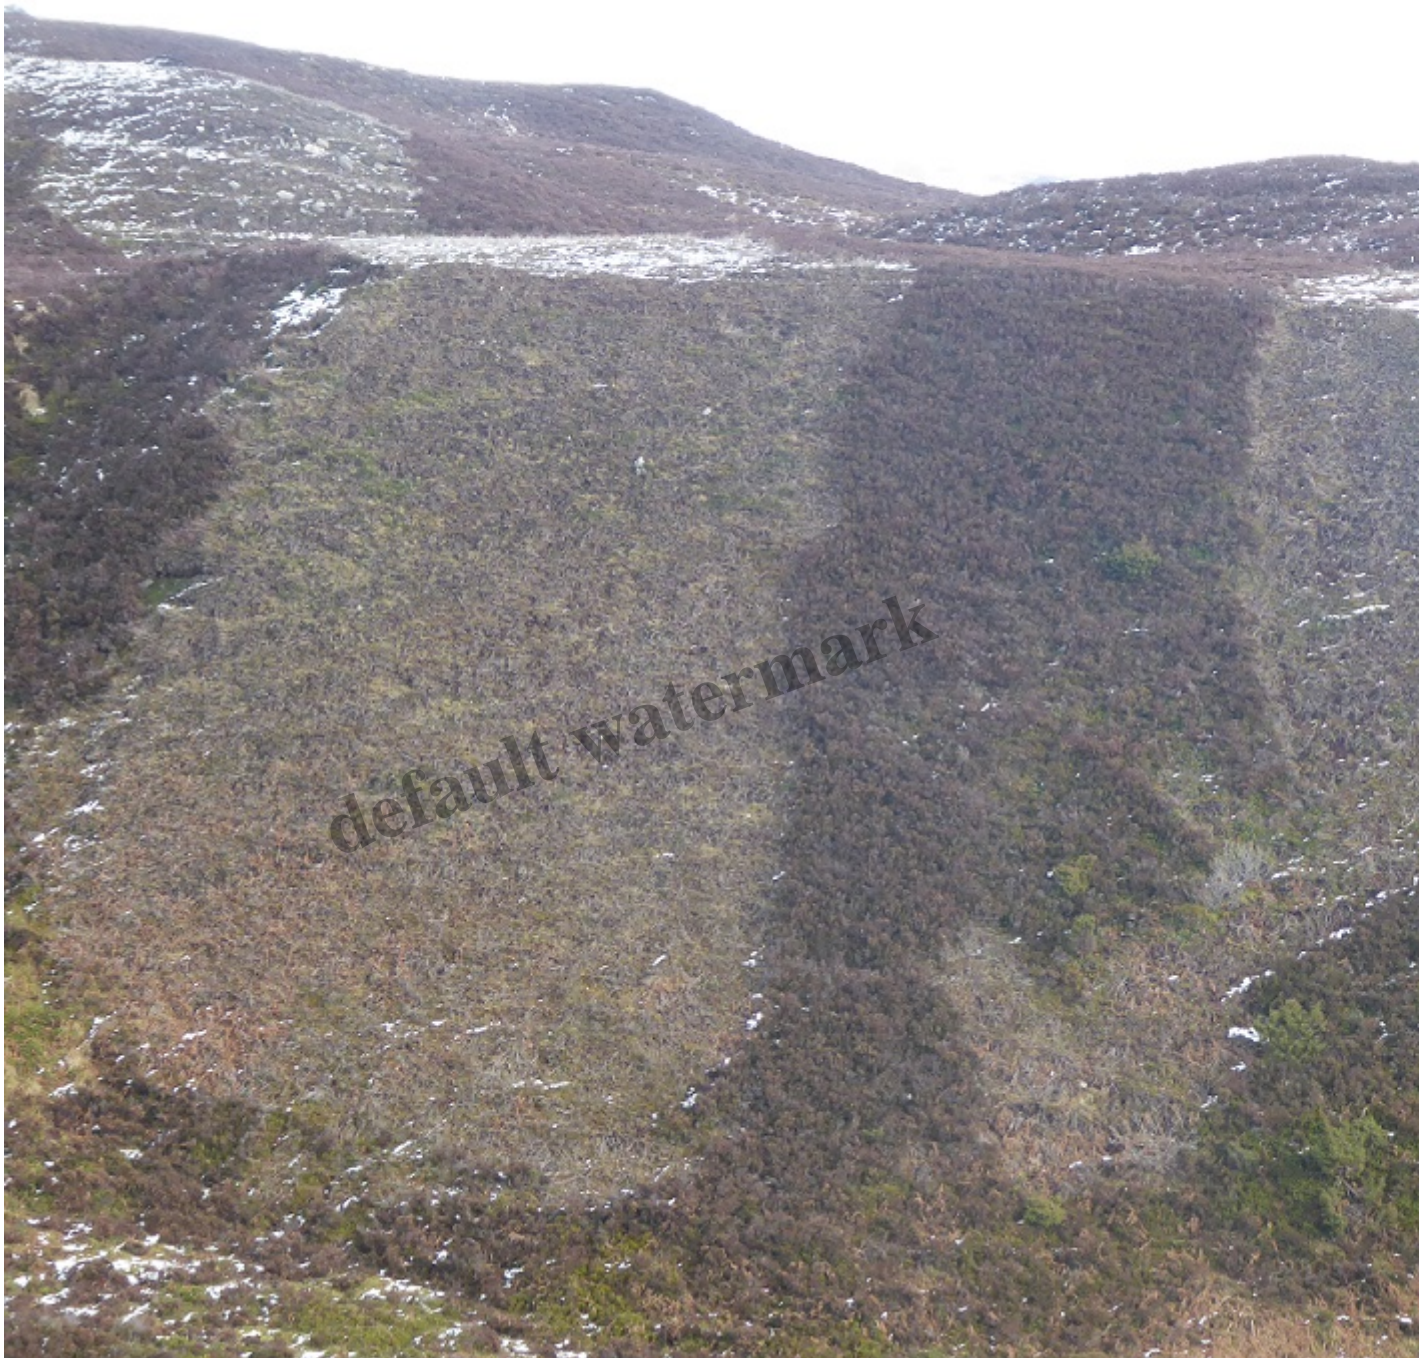
Muirburn on the steep sided banks of the Allt Mhor, which flows down to the Gynack overflow – note juniper has been destroyed by the fire

Muirburn, in particular, promotes water run off and in flood prevention terms its a disastrous practice. Yet here we are in a National Park, allowing the Pitmain Estate to burn the moor, increasing the flood risk to Kingussie, while at the same time the public sector, in the form of Highland Council, has paid for half the cost of a flood diversion scheme. The fact its no longer functioning is simply salt in the wound! People living in Kingussie should have every right to be angry.
