The Gynack flood diversion channel above Kingussie â?? at what environmental and financial cost?

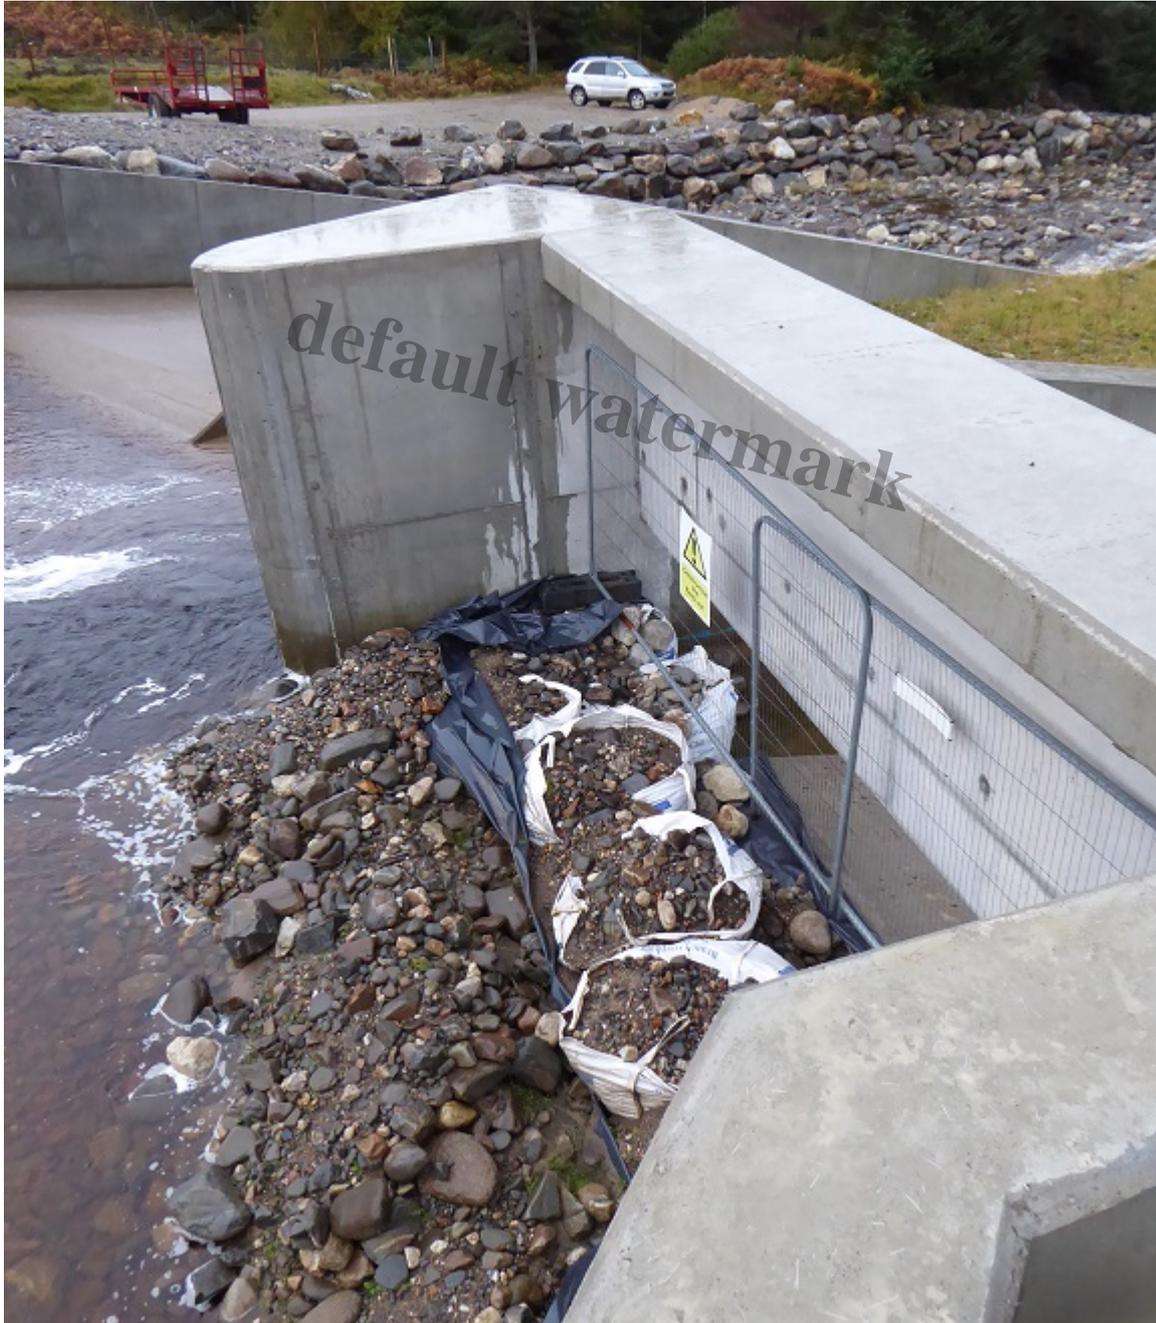
The Gynack overflow channel has been blocked off to prevent it eroding further so that now it will only function in the highest floods October 2019.

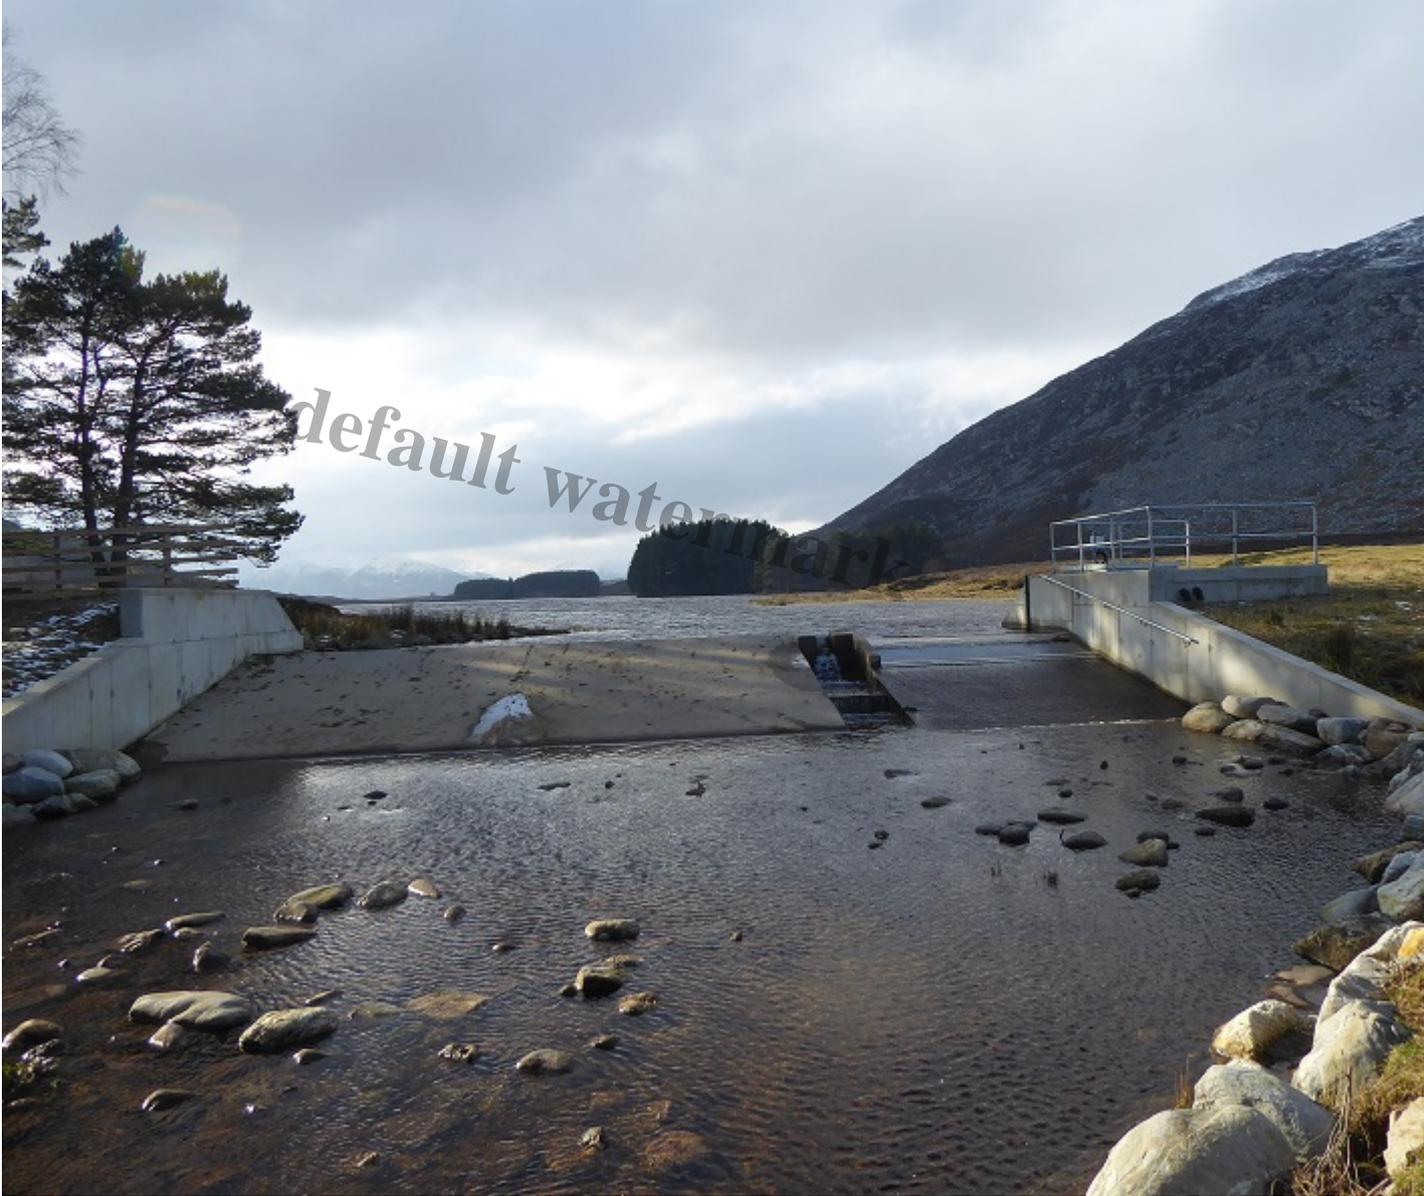
The hydro intake at the outflow of Loch Gynack which abstracts much of the water flowing out of the

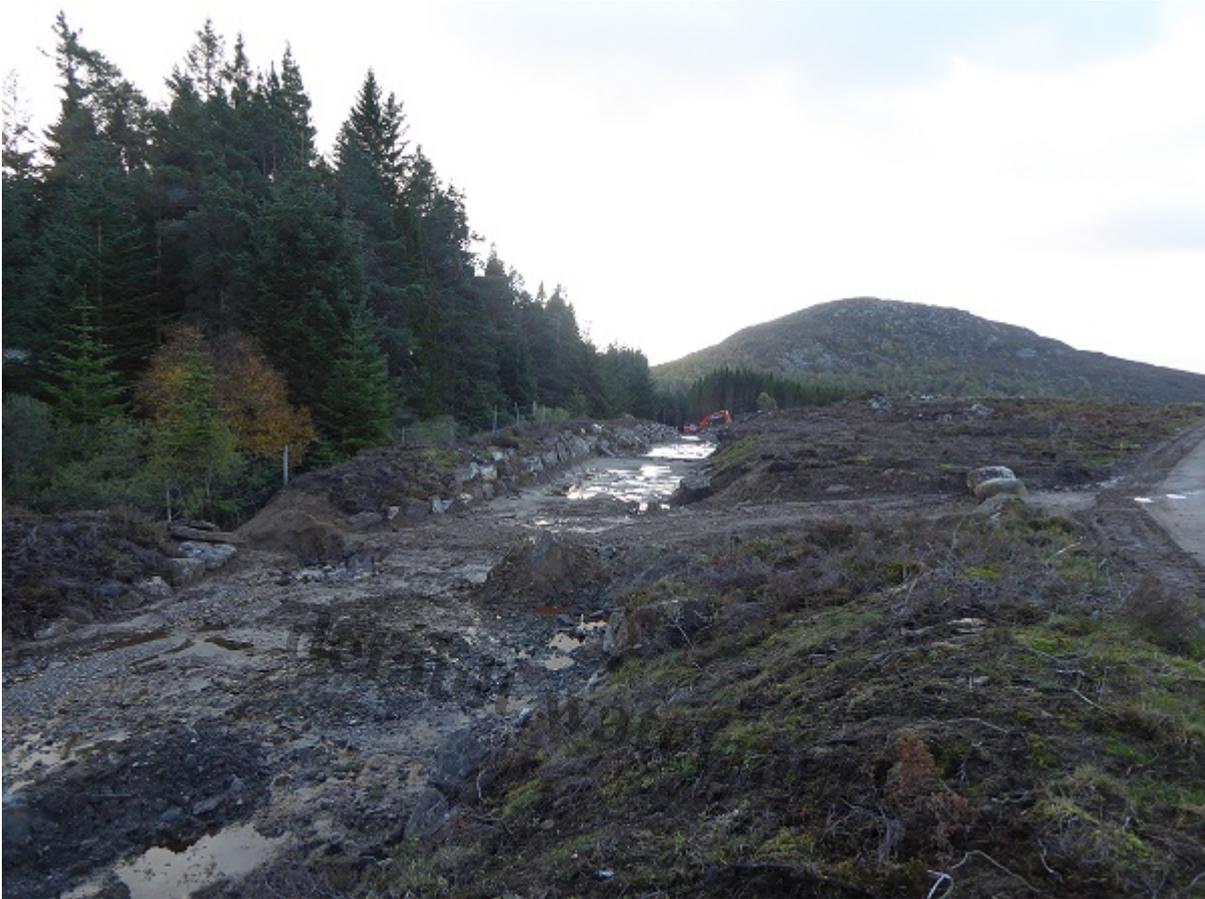
The overflow channel under construction October 2017 – note the new bank on the left

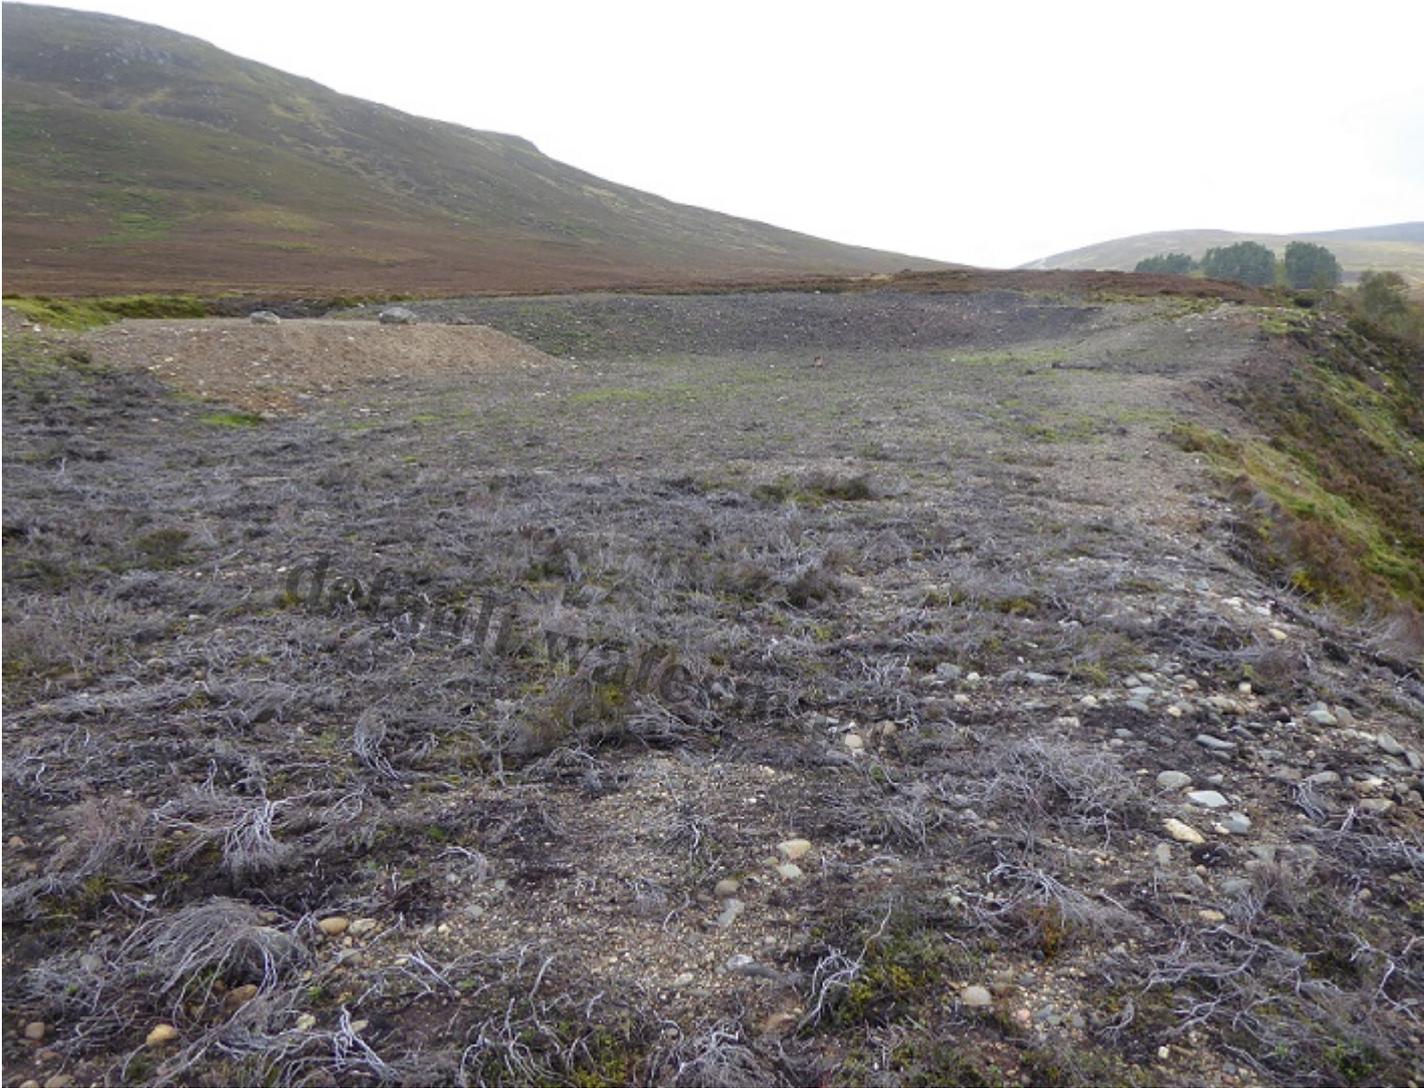
This large re-landscaped area above the overflow intake (Allt Mhor to right) appears to have been used as a borrow pit. October 2017.

There was no development identified on the planning portal for the area pictured above and it falls outside any planning application boundary. In addition there was nothing in the planning documents that I can find ([see here](#)) to indicate that borrow pits would be required. Indeed the planning consent required the applicant to provide details of details of *the process for excavation (including machine access and working corridor) and the sorting and storage of materials for re-use*. This suggests that the CNPA expected the developer and contractors to source materials for the banks from the site. If the area up the hill was used therefore to source material to construct the banks to the overflow that was probably unlawful. So, why was no action taken to stop this?

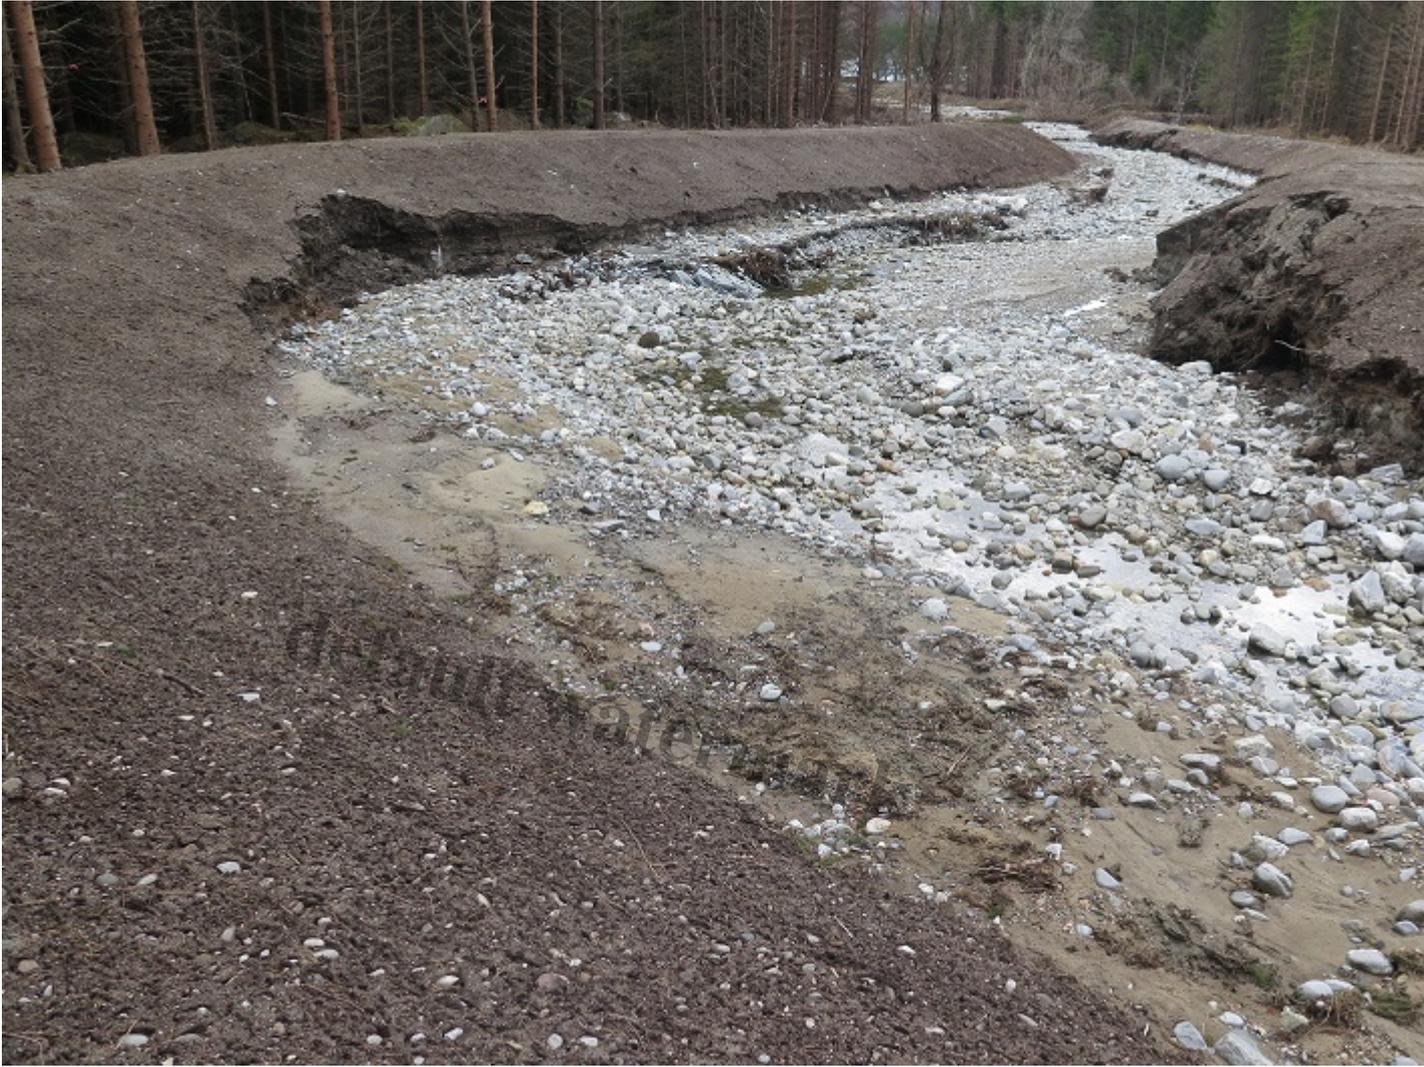
Channel with manicured banks already eroding â?? 29th April 2018. This view was not shown by Highland Council

One wonders if Highland Council sent anyone to check the channel in April 2018 before announcing it was complete. Anyone with a modicum of knowledge should have been able to tell then that the banks were unfit for purpose and that might have serious consequences.

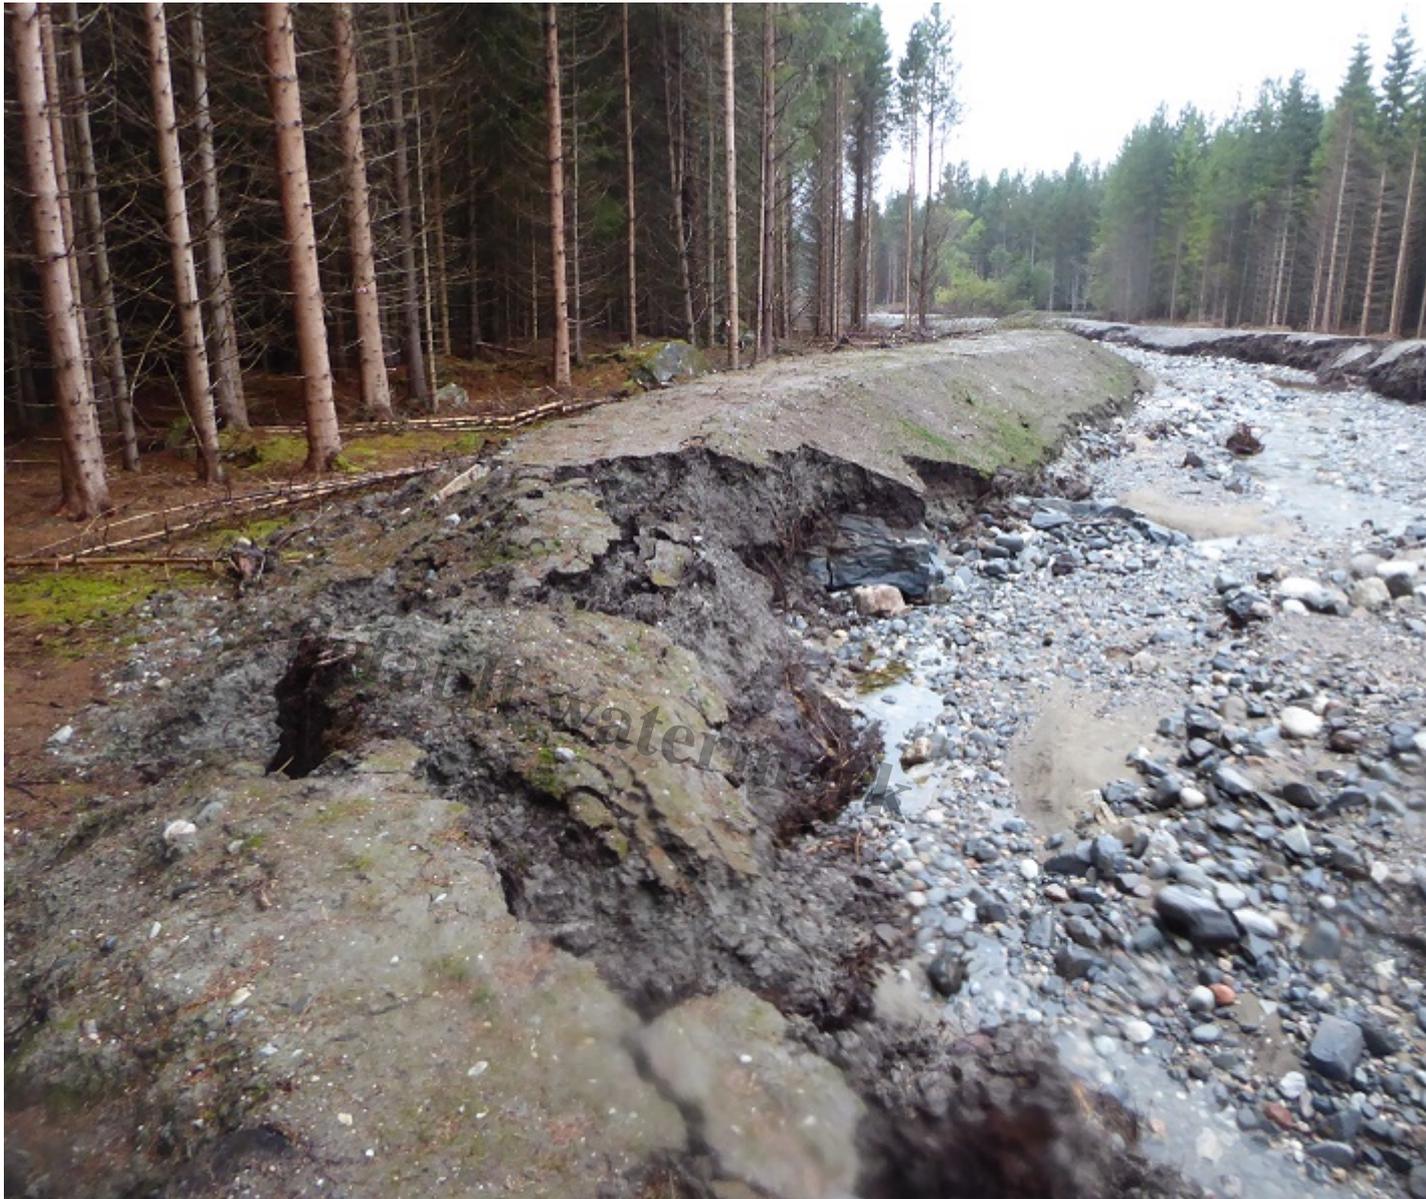
Section of banks in October 2018

Six months later, when I next visited, the possible consequences were even more obvious. What engineer thought that these earth banks could withstand a river in spate? Why was water allowed to run through the channel before they had had any chance to vegetate? Even if that had been allowed to happen, earth banks such as this would have been highly vulnerable to high water flows, but without vegetation and without any protective matting, the consequences of allowing water to run through the channel should have been obvious. So why the CNPA allow this to happen?

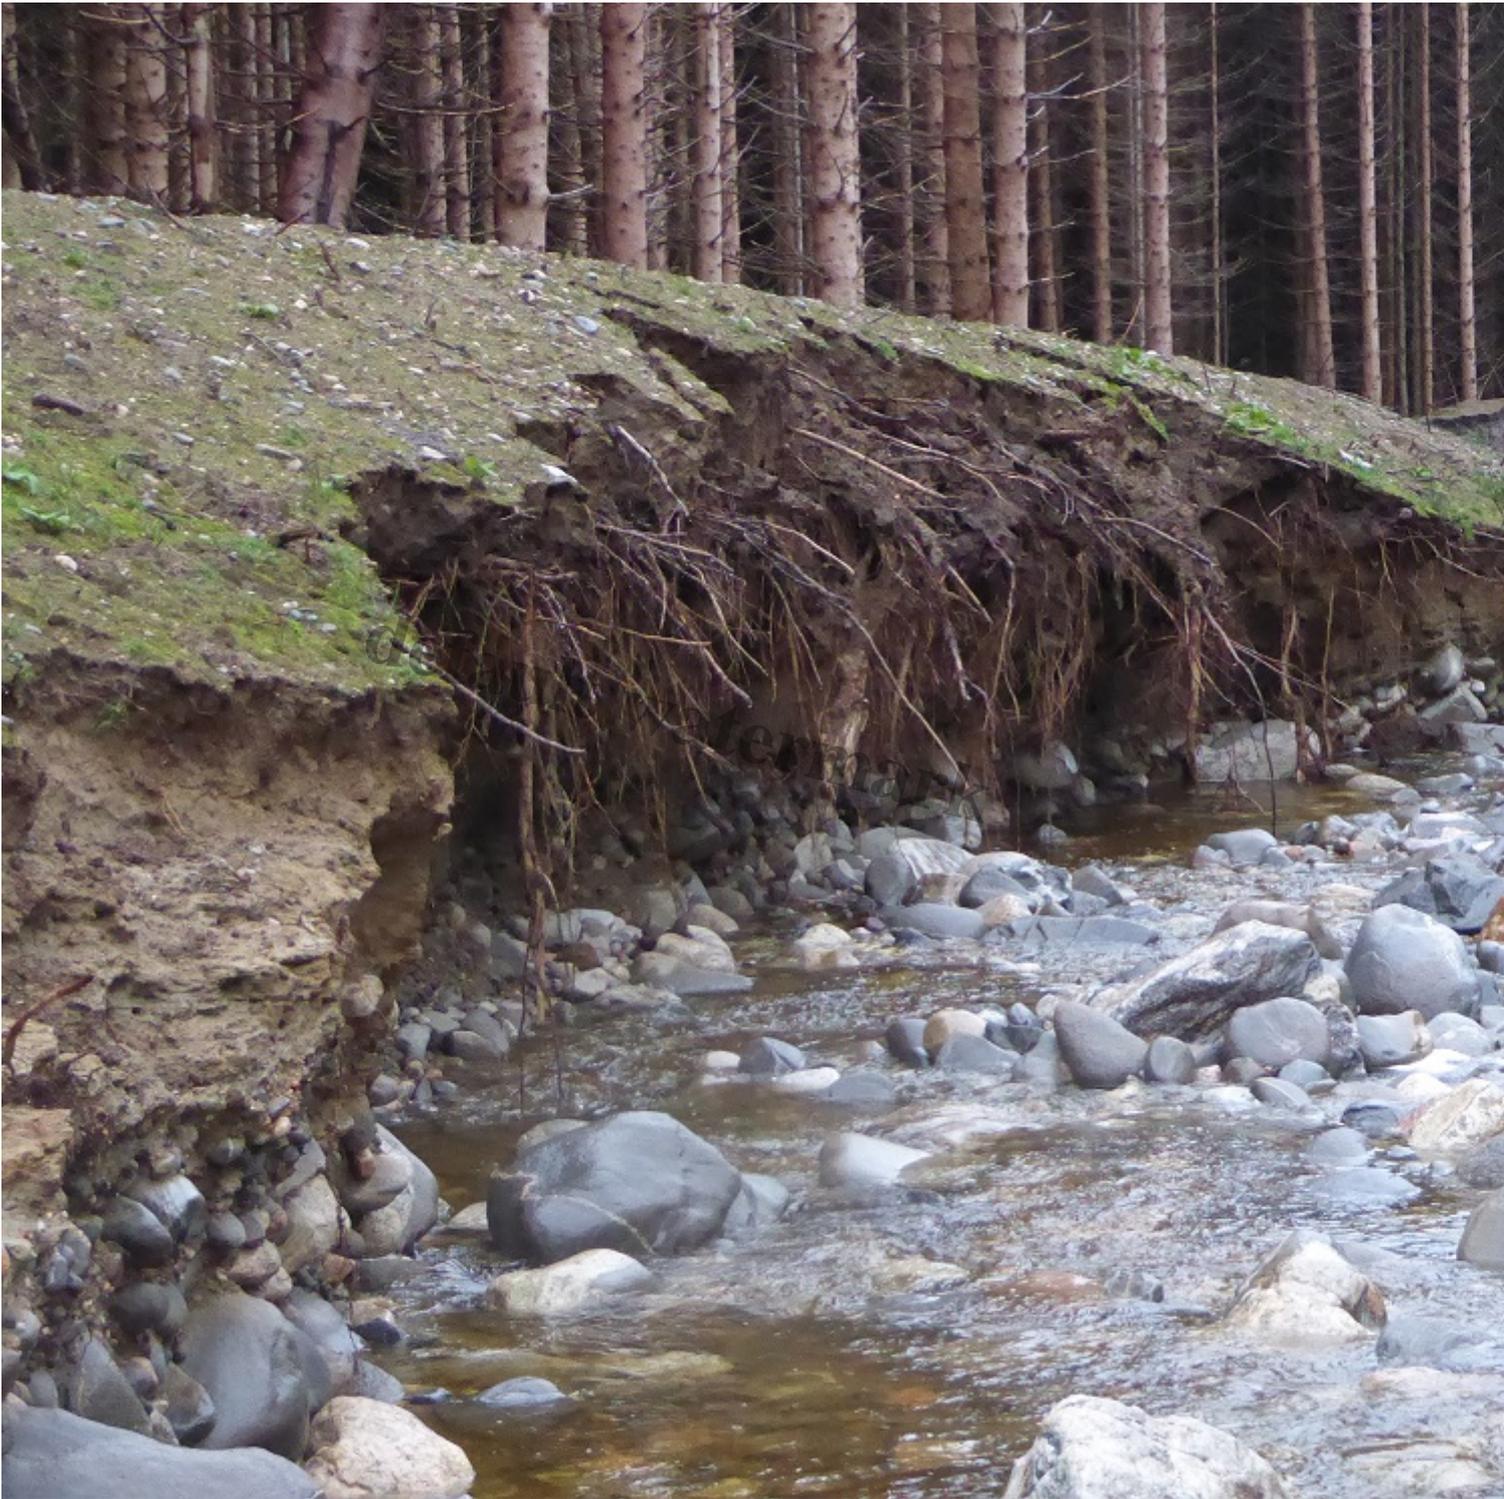
By October 2018 the banks were in places being severely undercut. It appears that in designing the overflow little consideration had been given to the impact of the water on the banks. In the Supporting Information to the planning application consideration had been given to the mobile nature of the natural rivers ABOVE the channel but NOT to the channel itself:

a result the developer, while rightly highlighting that the area above the intake would infill and require regular maintenance (I cannot recall this ever being considered in any hydro application), completely failed to consider what would happen in the channel itself. As a consequences, in just six months in places the water had almost cut through the bank entirely. Had it done so the overflow could have changed course and flooded Pitmain Lodge which lies on the other side of the plantation below this bank! Poetic justice?

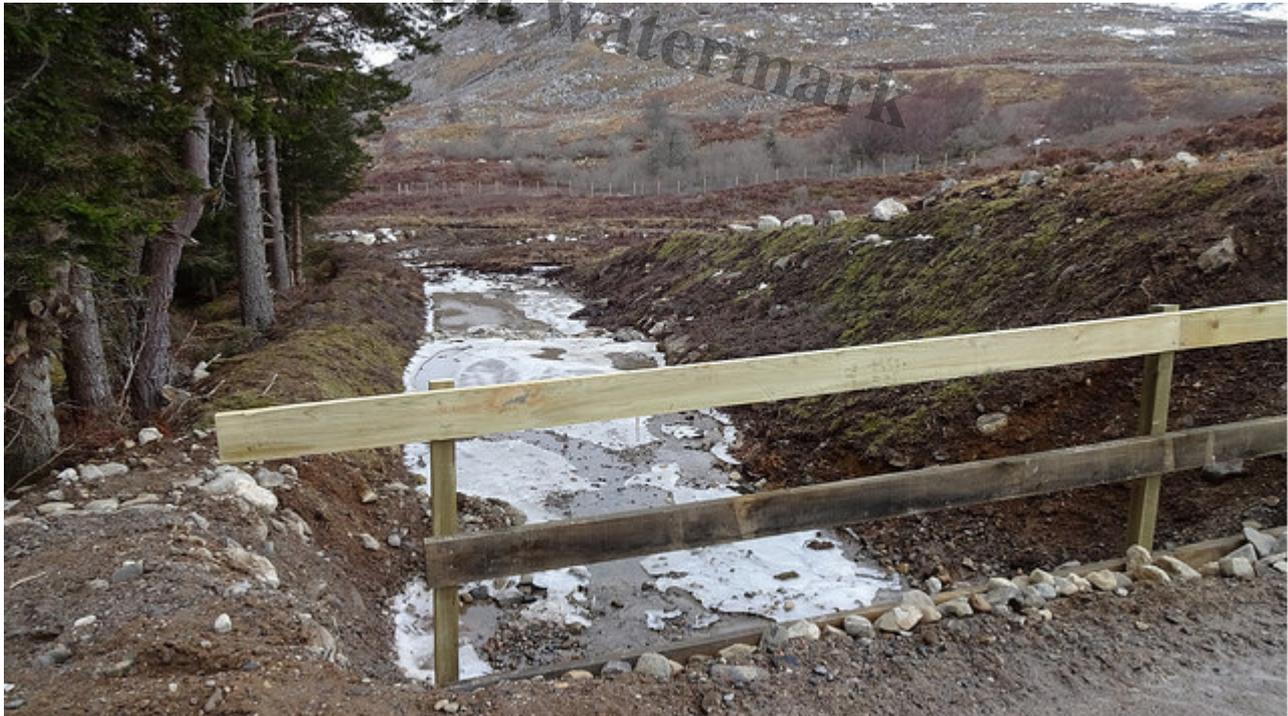
In April 2018 Highland Council published this view of the overflow from the road bridge near the intake

The view of the restoration downstream from the bridge looked not bad in April 2018 though if you look carefully on the right a section of bank behind the fence has already been subject to significant erosion.

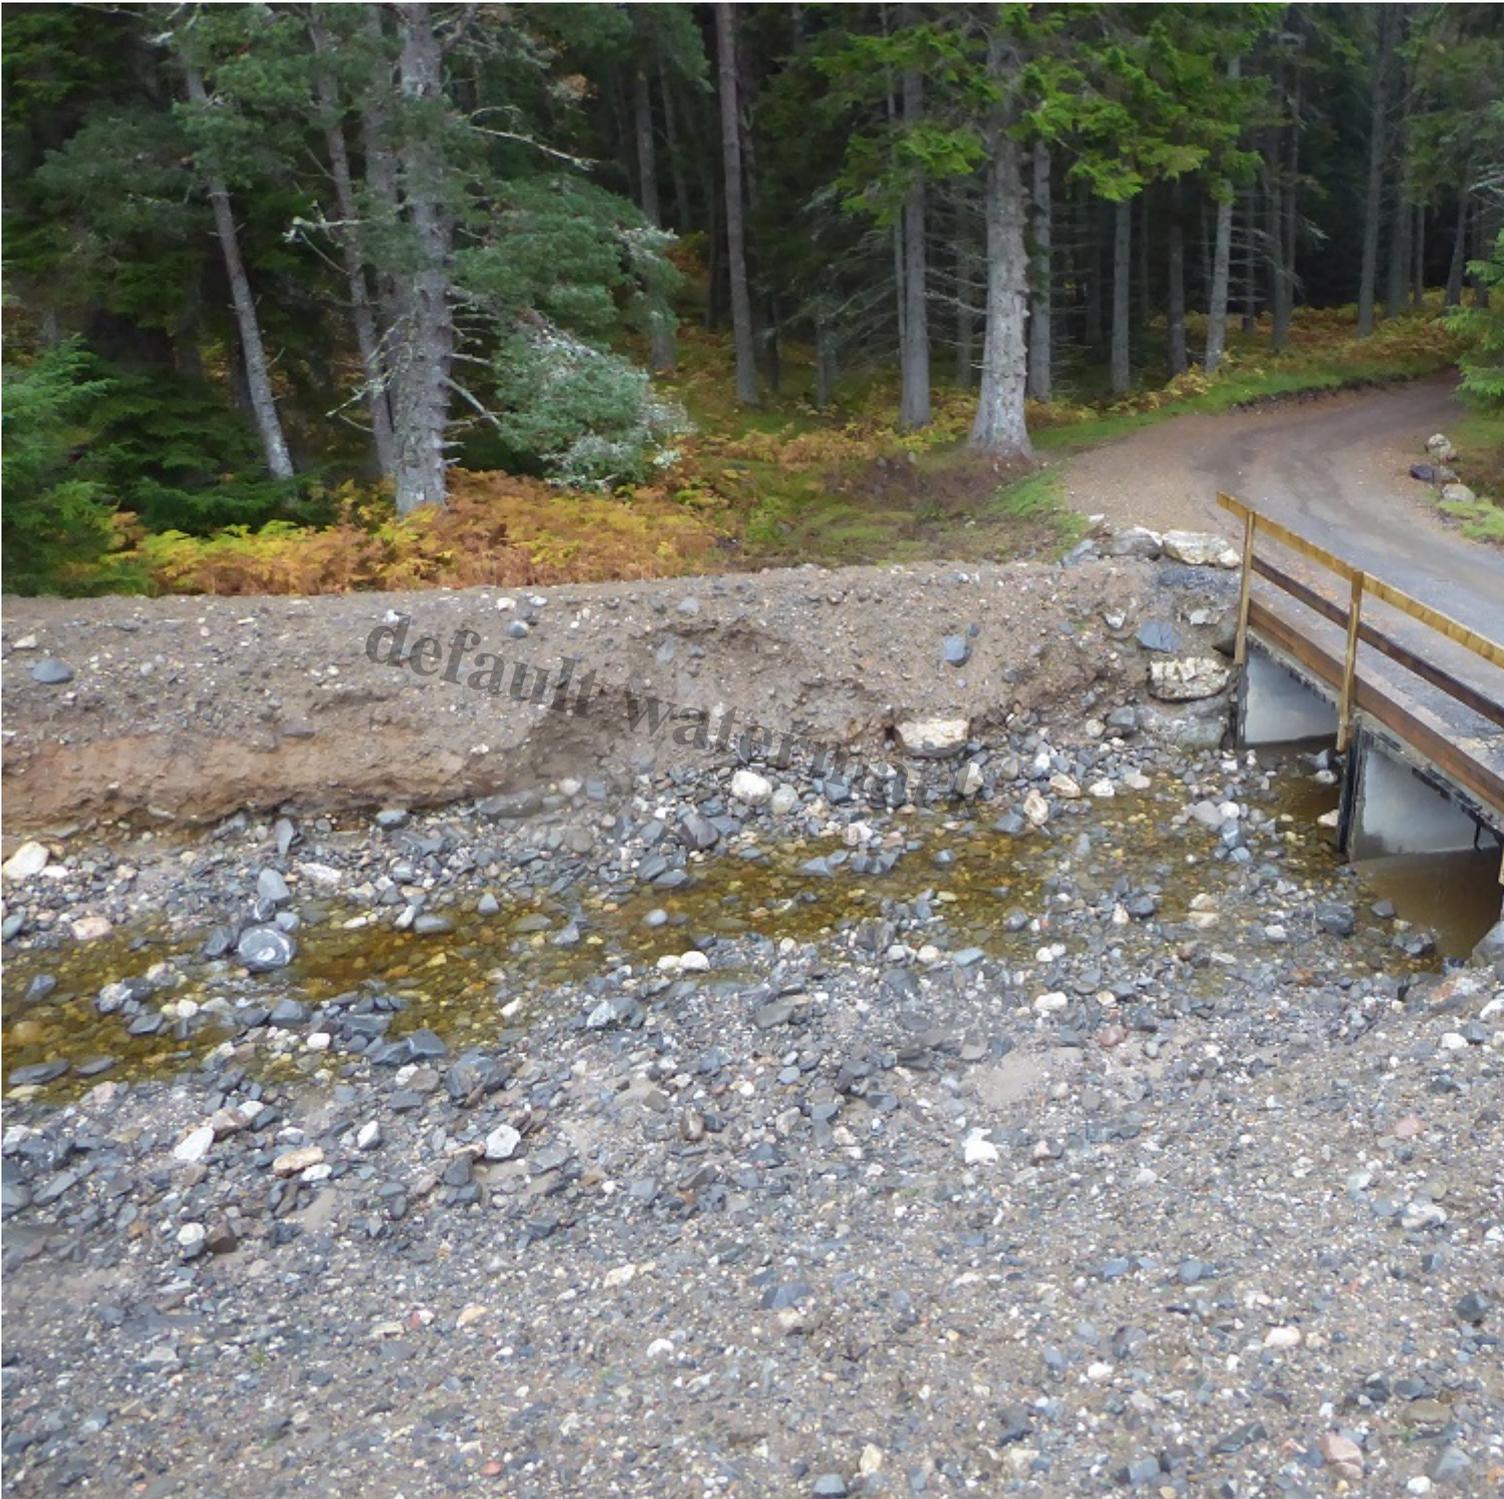
Six months later and the water flowing down the overflow had almost cut right through the bank ABOVE the bridge.

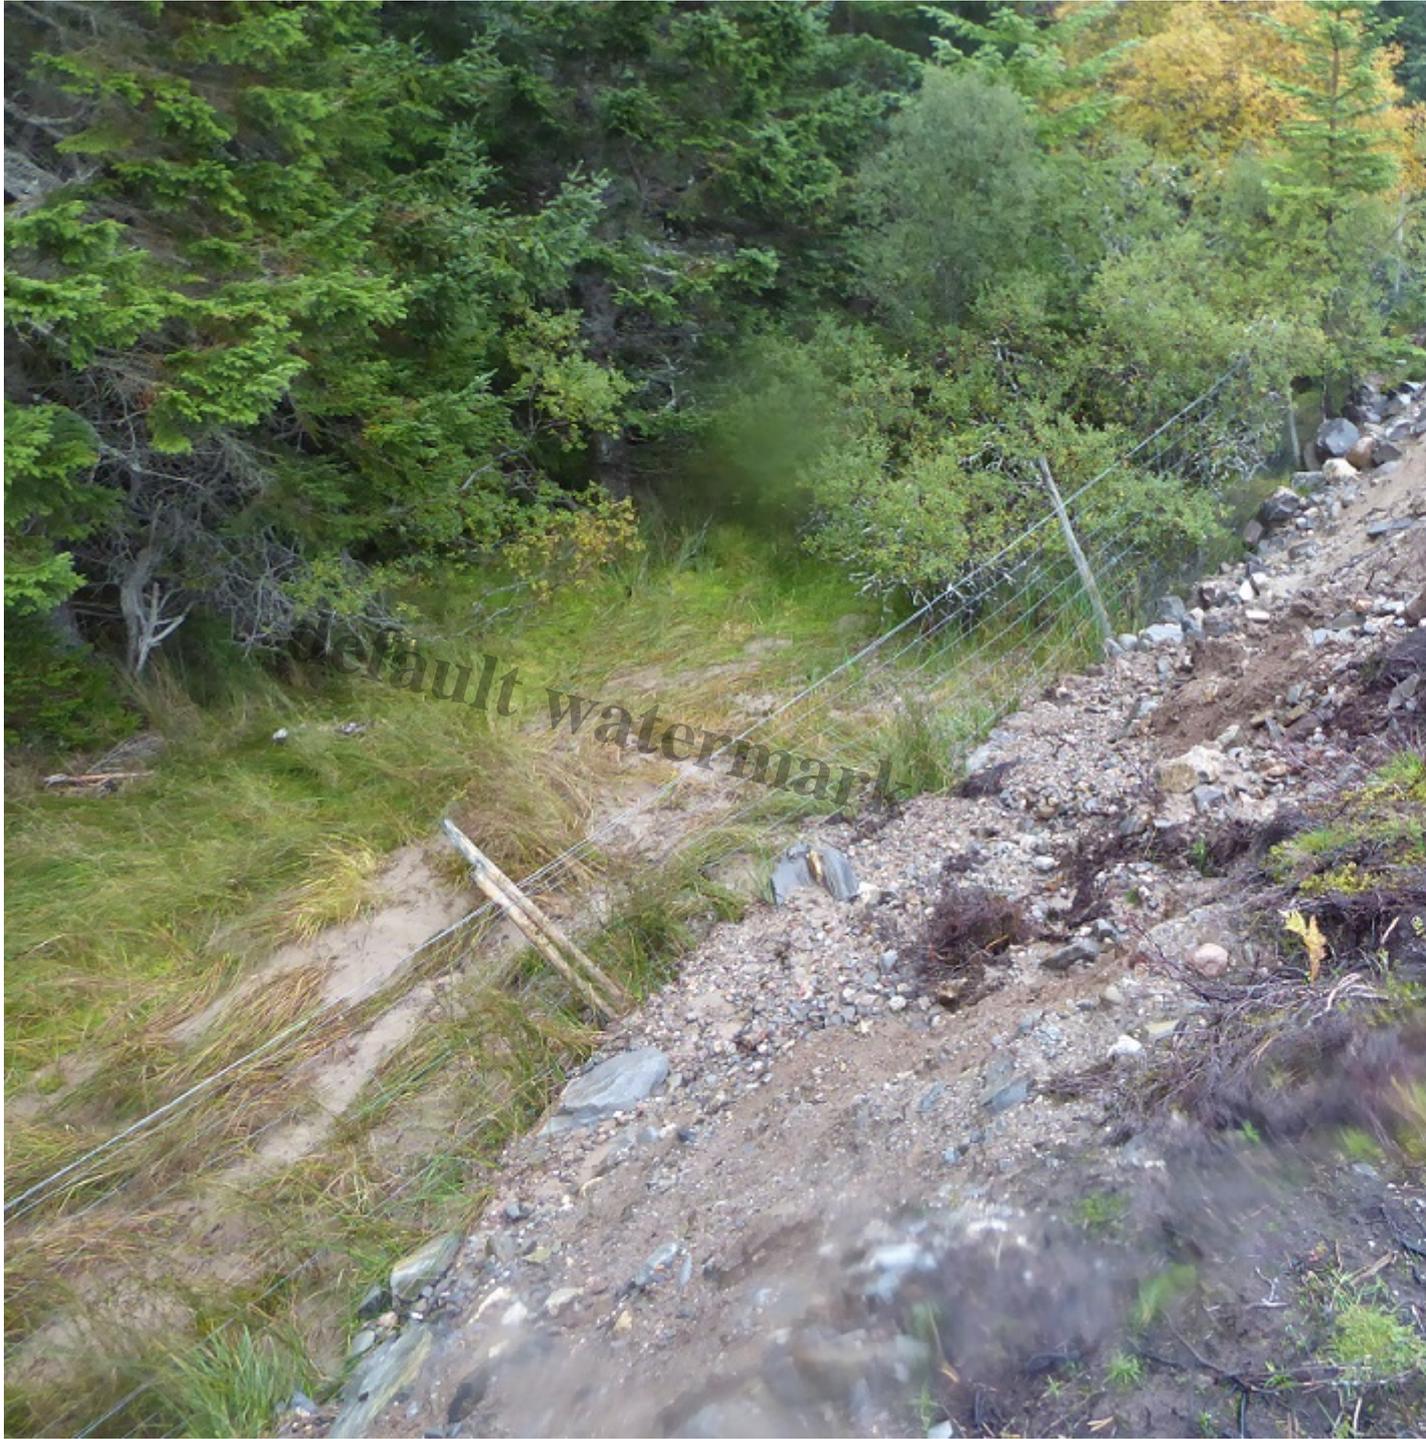
Note the silt that had been washed through the collapsed fence – the boulder on the top of the bank below

By October 2018 there was also one section of bank which was eroding from the OUTSIDE. This appears mainly to have been a consequence of poor design, the outside slope of the bank being too steep to retain vegetation easily, and poor restoration, with most of this steep slope having been left bare.

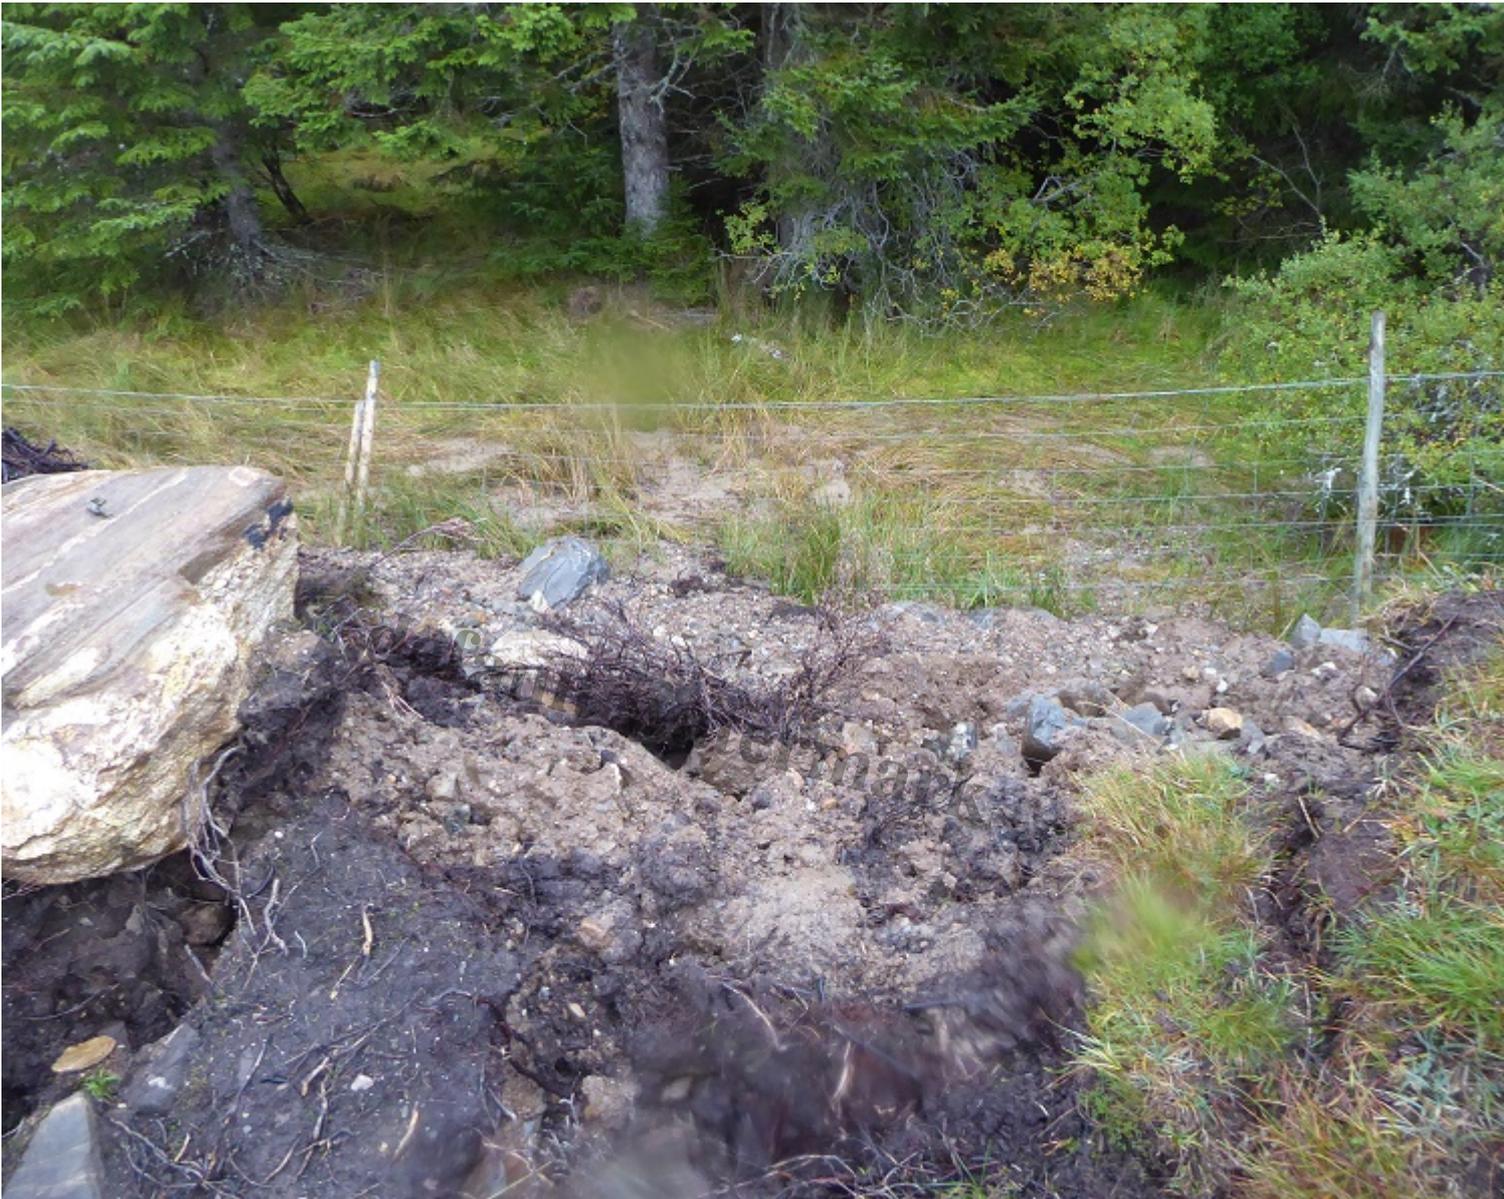
In one place, however, it appeared this section of bank had been breached by flood water adding further to the erosion.

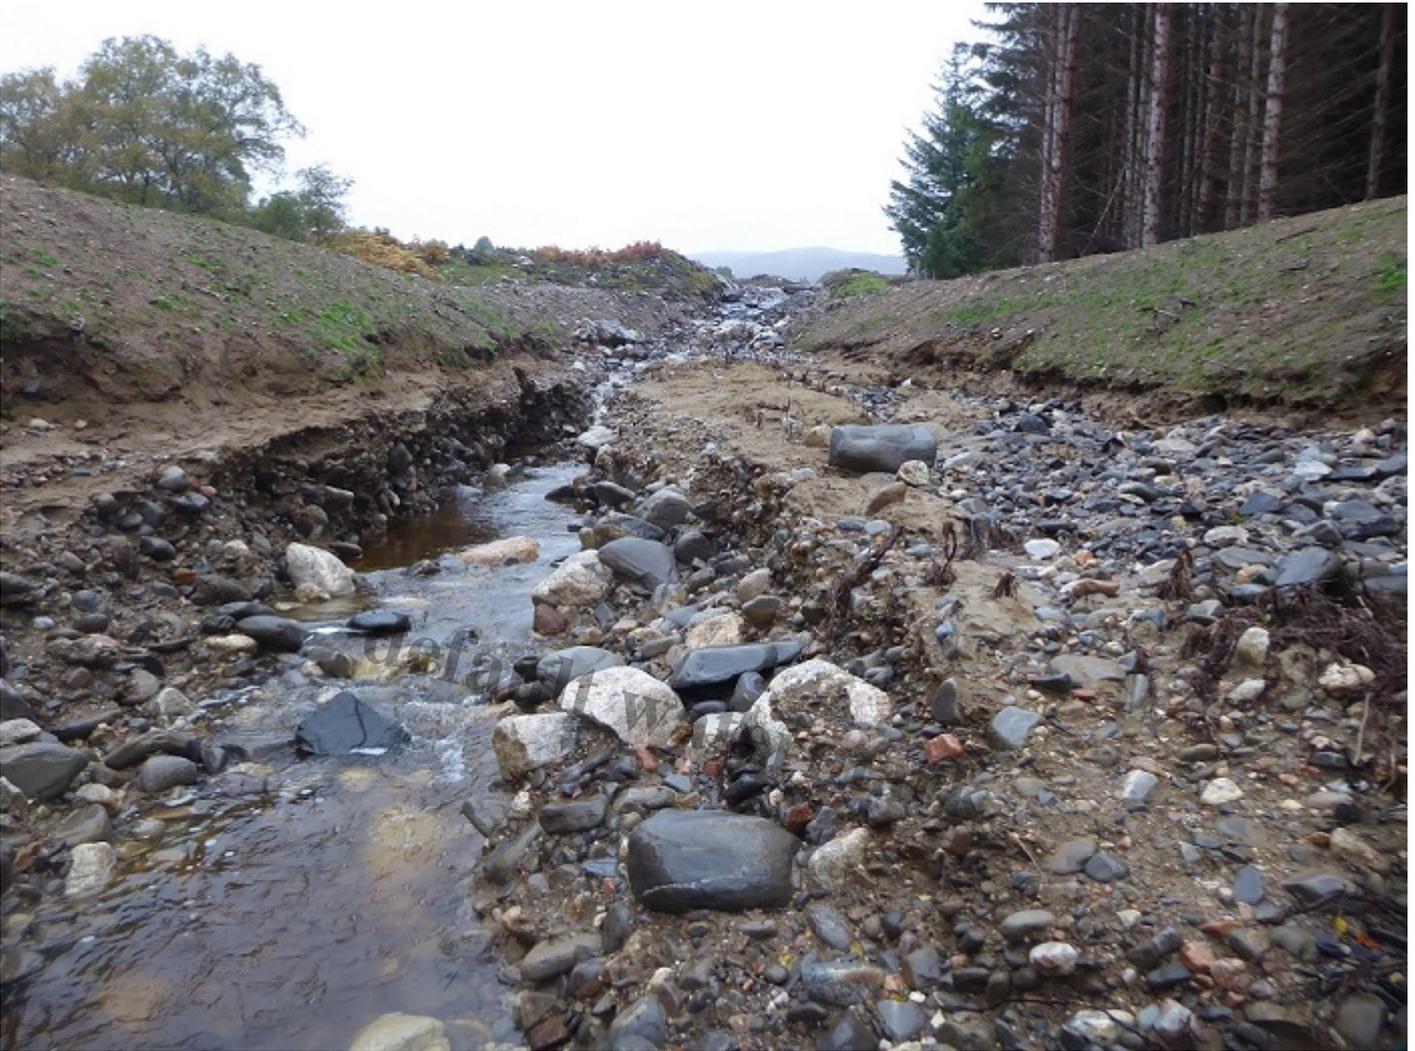
Even more striking was how the channel had cut down below through the original base, doing what rivers that have changed course do, washing away loose material. A good place to study how river channels develop – an ideal geography project for the pupils at Kingussie High School – but in planning terms a disaster. The CEMP required to developer – *to provide details of the substrate of the channel when flat* –. Whatever these plans were, they have not prevented large amounts of material being flushed into the freshwater system. What is the point of the CNPA and the Scottish Environment Protection Agency requiring developers to take measures *during* the construction phase to prevent silt being washed into the freshwater river systems (to protect otters, salmon etc) if *post* construction this happens?

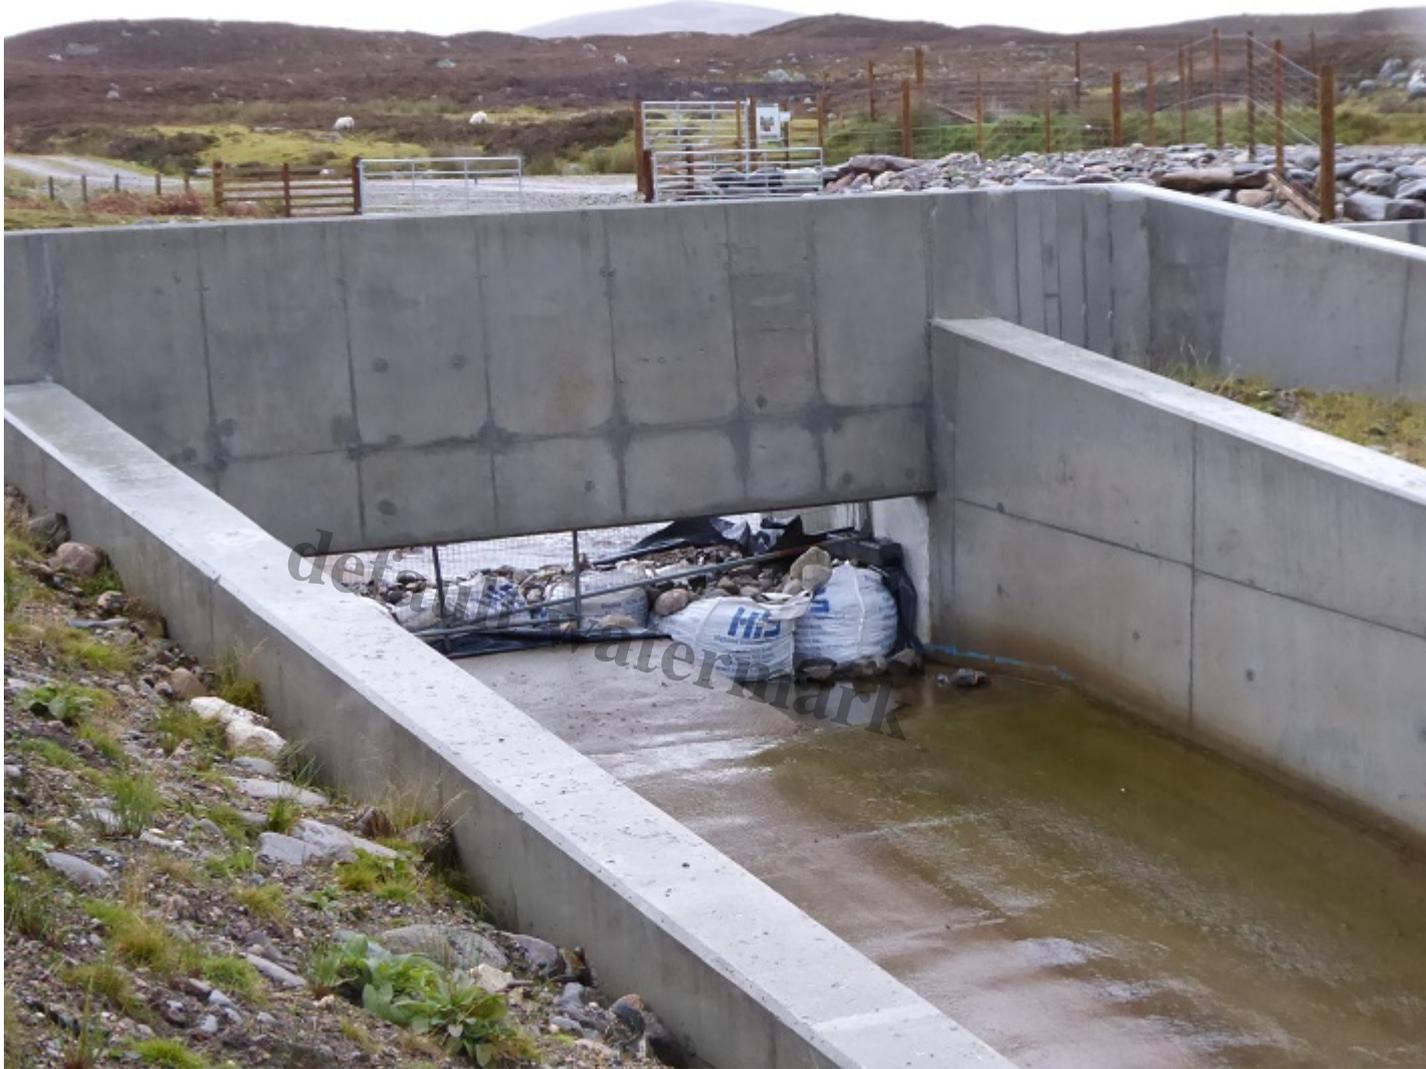
Overflow intake â?? note the channel within the channel. This was designed to ensure that water flows down the overflow at all times.

I had intended to blog about what I found at the Kingussie overflow a year ago but left it too long and then decided I needed to visit again in case the position had changed. When I did visit in October, I found the intake had been blocked off. This had limited the amount of further damage that had been caused but made the ugly concrete structures effectively redundant.
