The Gynack flood diversion channel above Kingussie â?? at what environmental and financial cost?

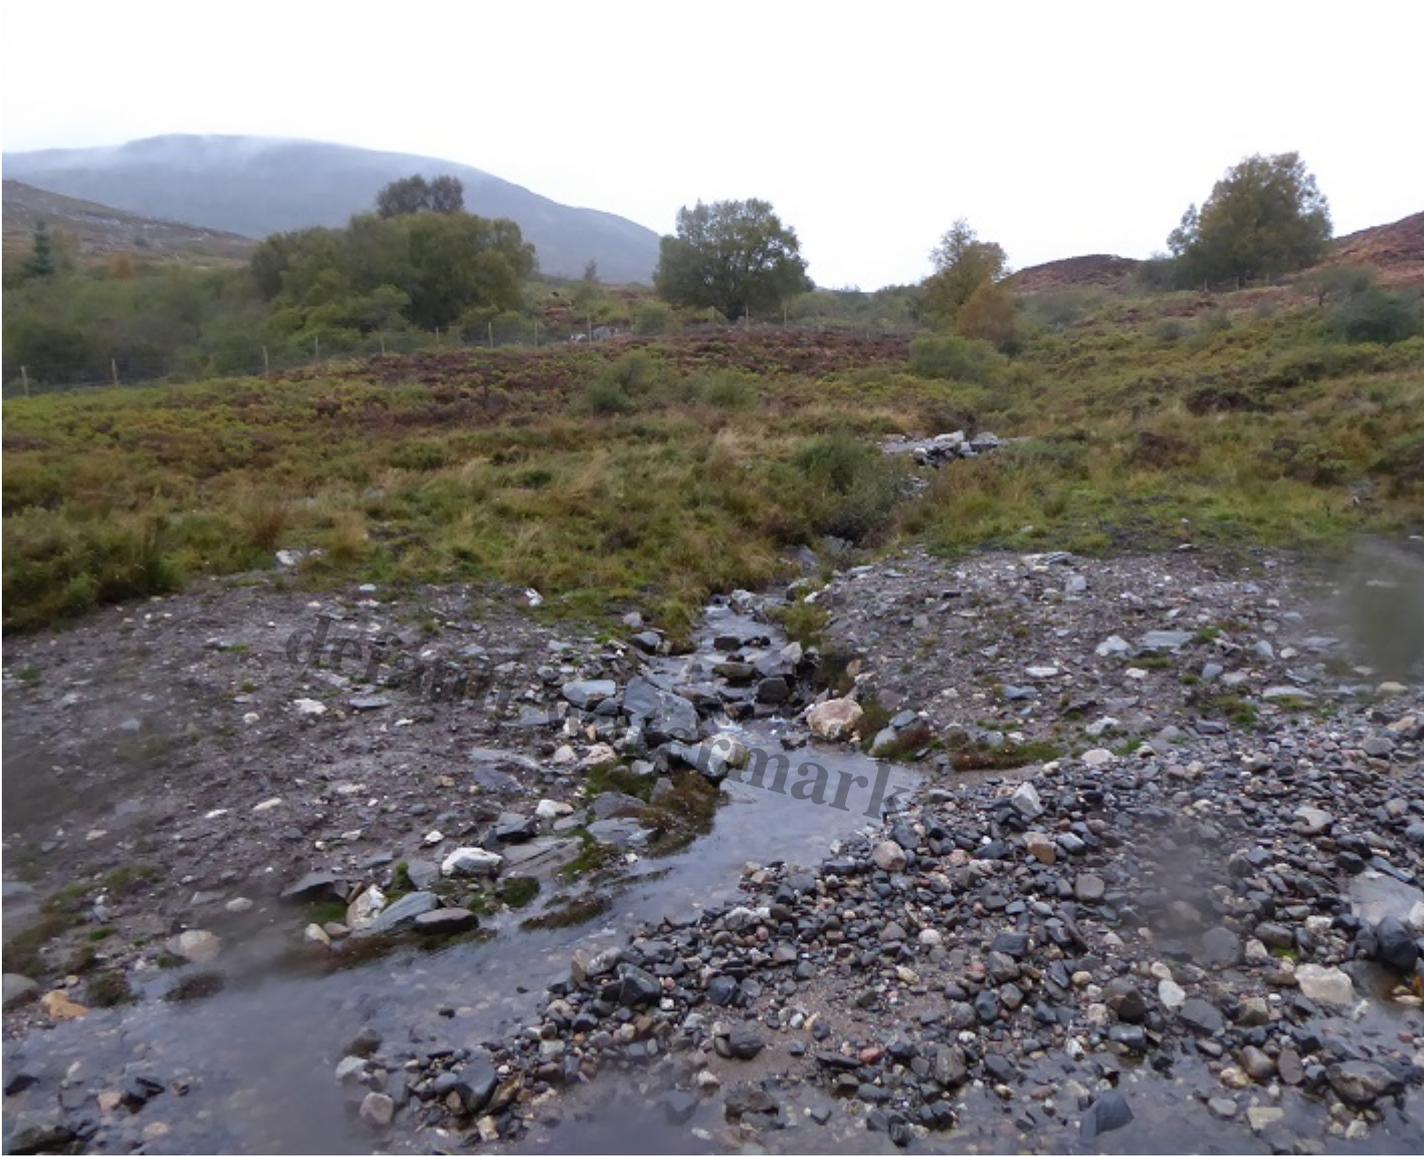
Confluence of overflow with tributary burn feeding into it below the intake

That now only happens if the Allt Mhor and River Gynack are very high although there is some flow below the bridge from feeder burns.

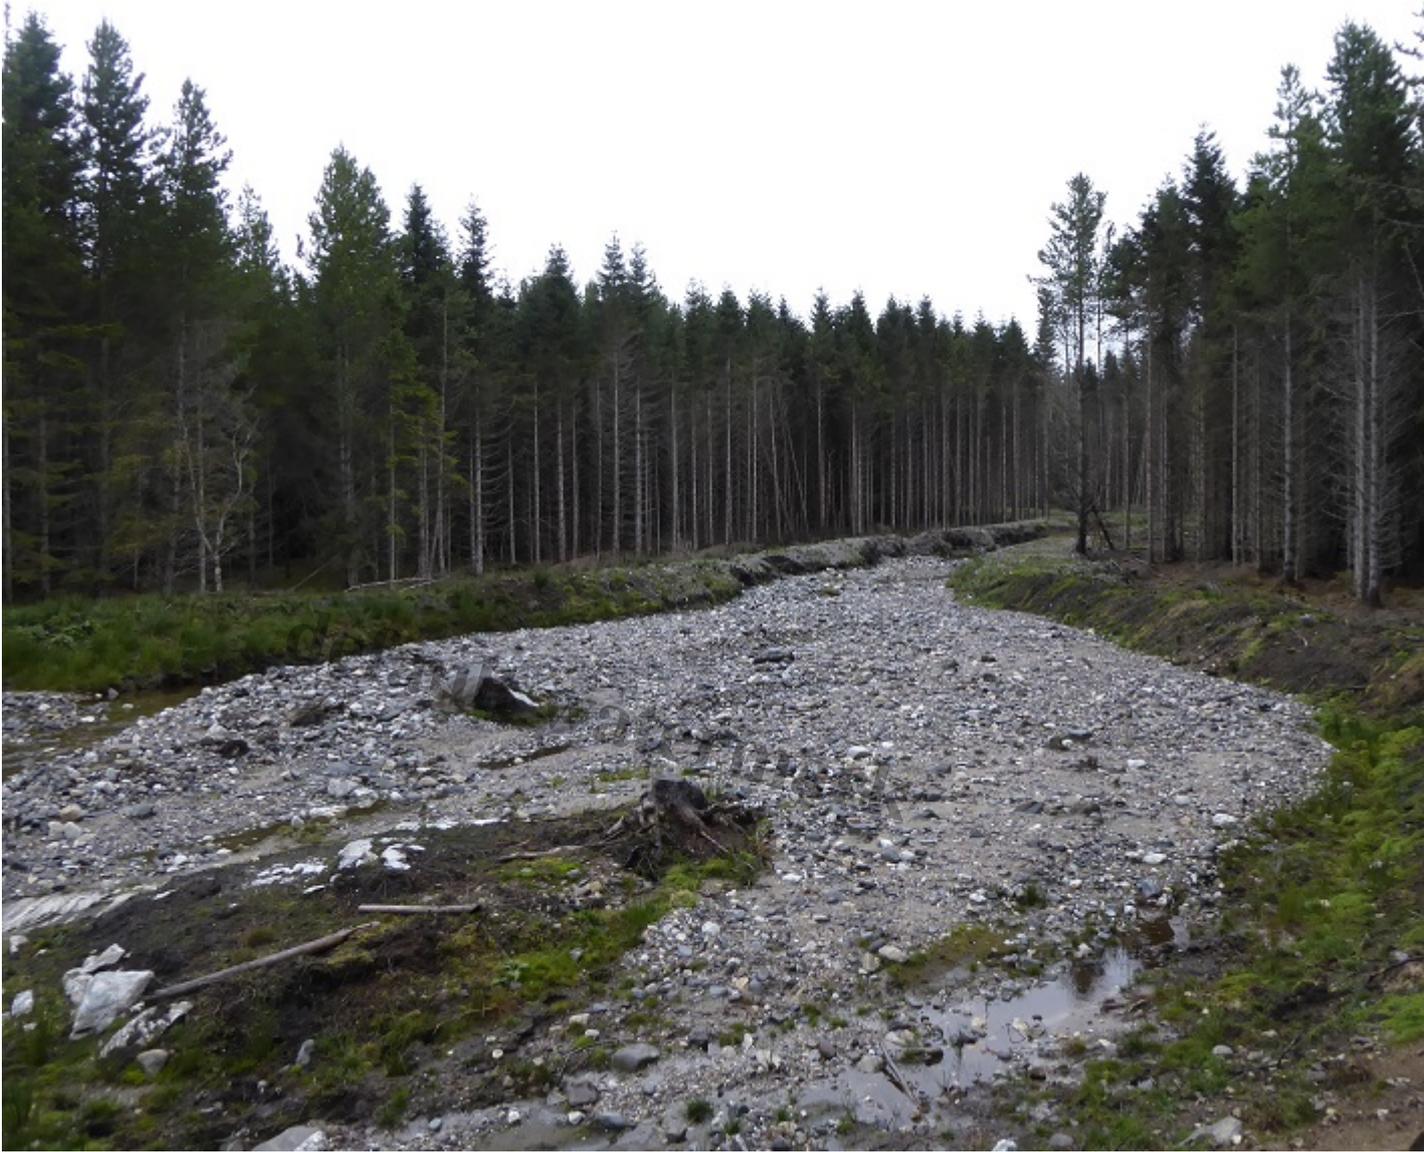
Below this photo logs have been placed across the channel in an attempt to dam the water â?? another failure in engineering. Perhaps beavers would have made a better job of it?

A broader area was deliberately excavated lower down to create a new wetland area. Instead boulders and silt have been washed down from above effectively creating a flood plain â?? nothing wrong with that but NOT what was intended.

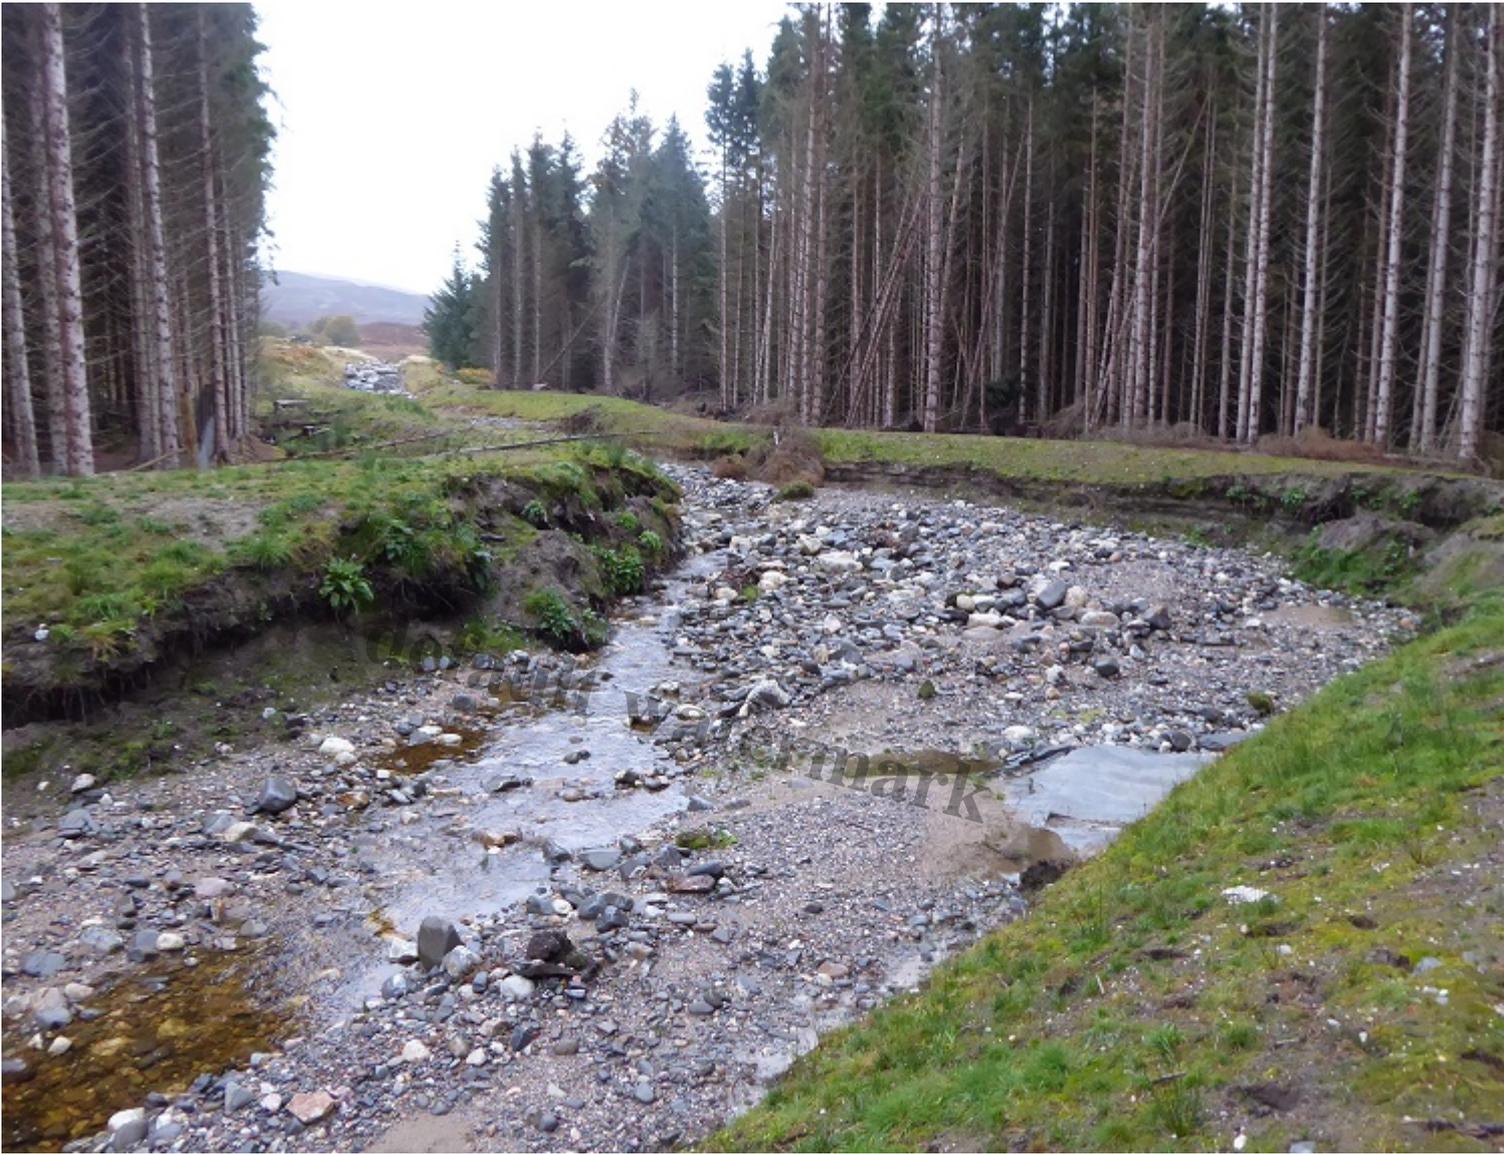
While plants have re-colonised some of the bare banks along the lower half of the overflow, this is not sufficient to prevent them eroding further.

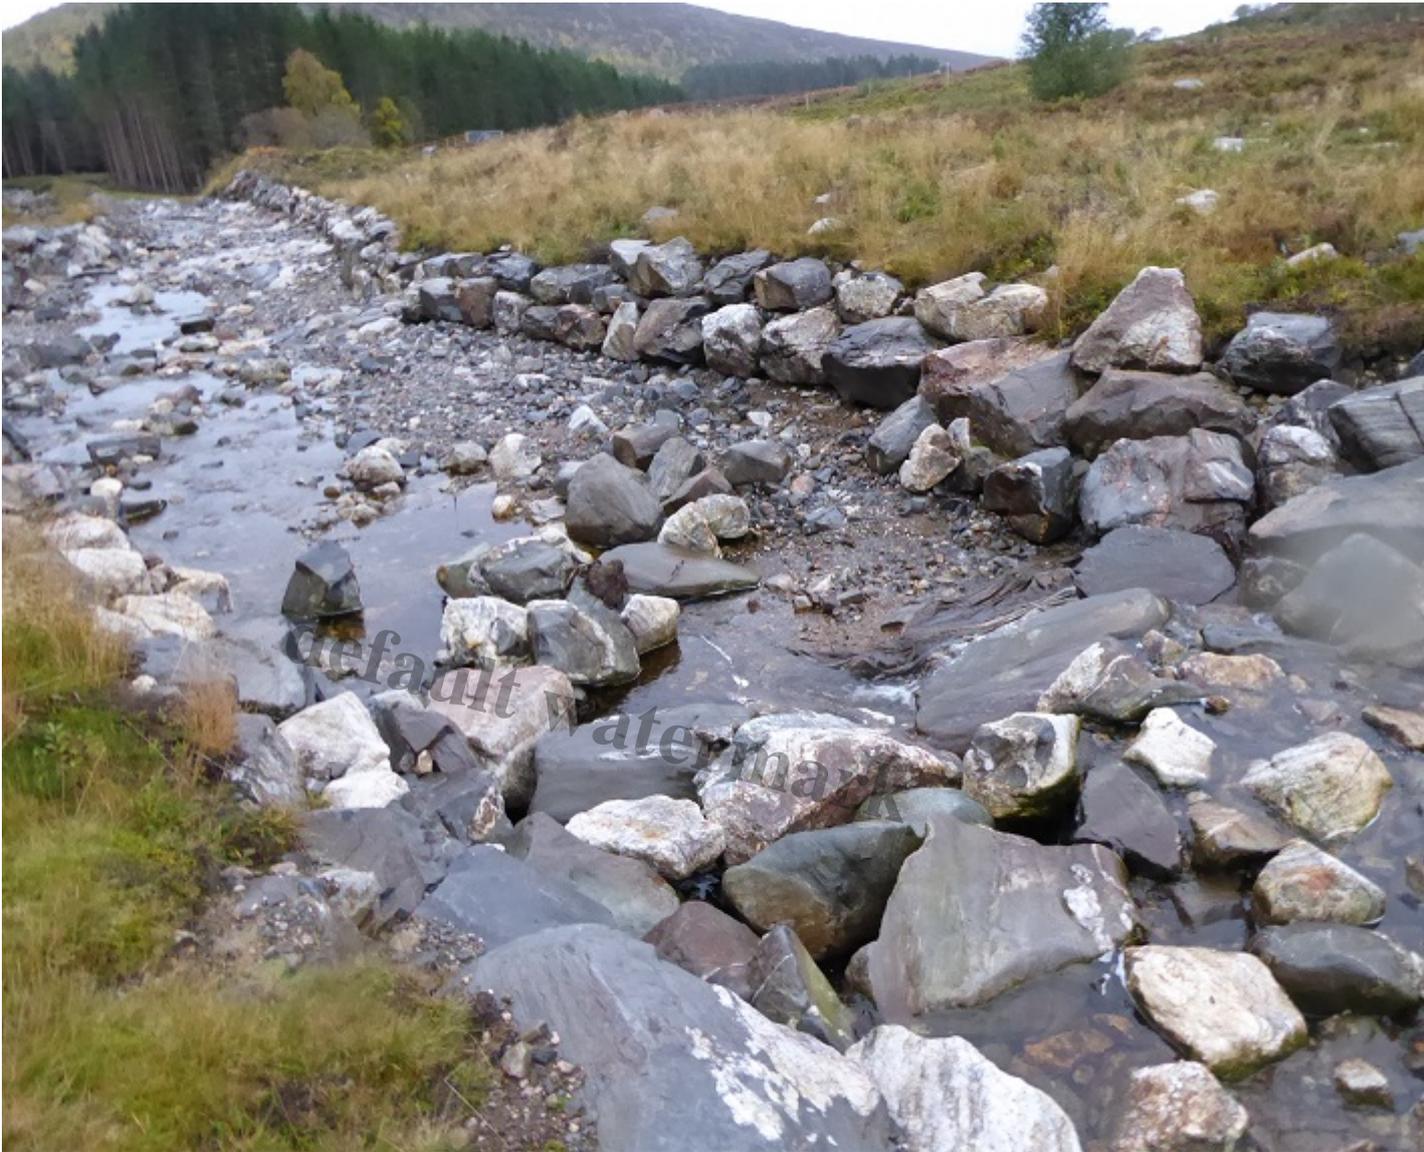
Large boulders have been washed down into the channel both plucked from the rip rap bouldering on the banks and from boulders lining the steeper sections of the channel. Note centre right the hessian matting - this has been revealed by boulder/s above being swept away and the much healthier vegetation on this section of bank (a consequence of some restoration taking place here).

Higher up there are extensive sections of bank with rip rap bouldering. While most of this is still intact, unlike the bouldering used in the Glen Falloch hydro schemes ([see here](#)), there are several places where you can see boulders have been plucked out from the banks. Had the overflow not been blocked off, the damage might have become as extensive as that in Glen Falloch.

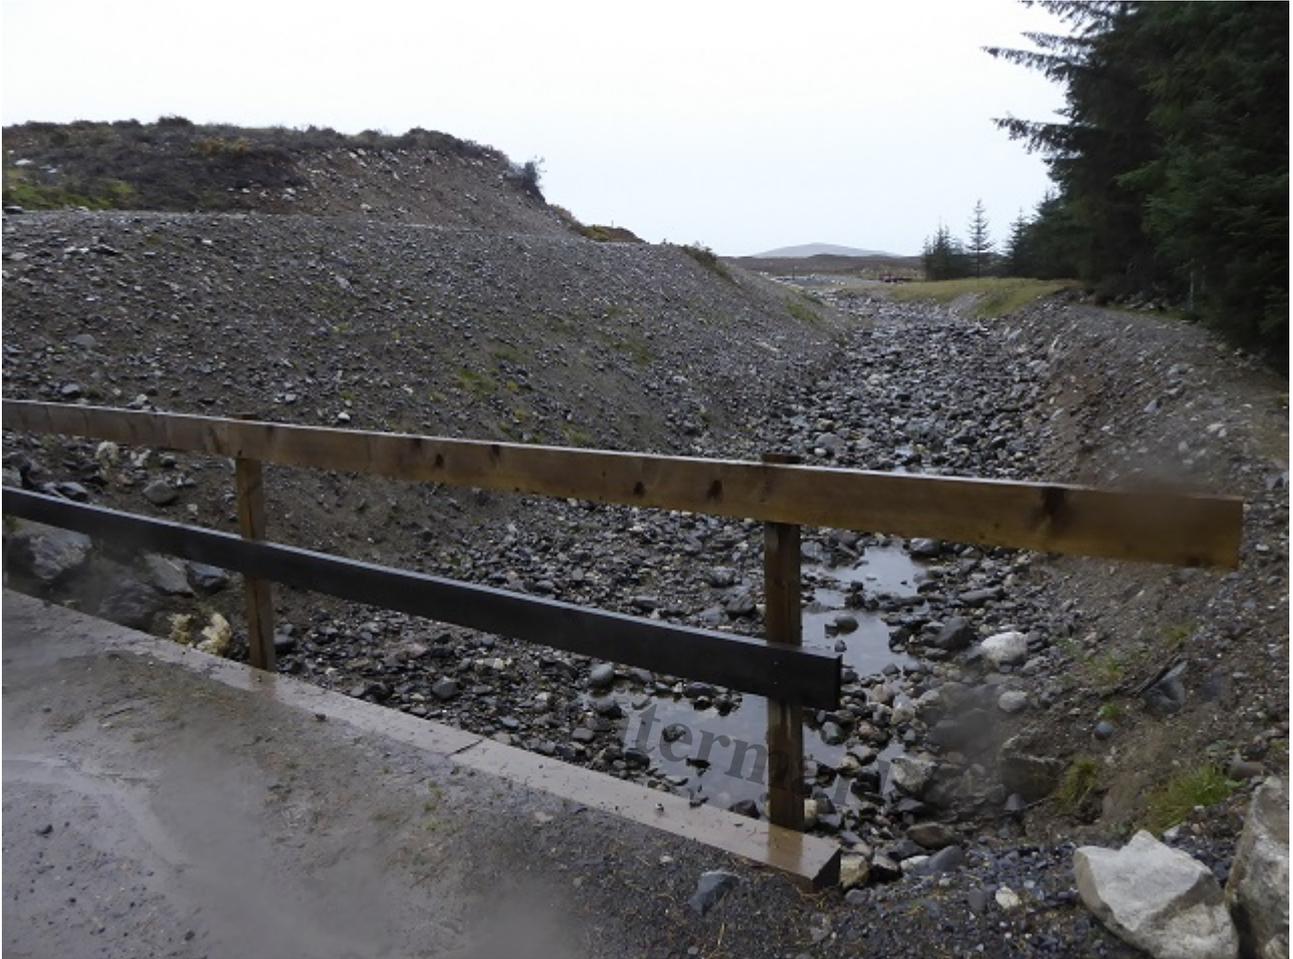
There appears to have been no attempt to re-seed or otherwise restore the bank above the bridge. Both are too steep for vegetation to stabilise effectively.

There are still large areas where there has been no restoration to the banks and they are very vulnerable to erosion. The only reason the bank on the left has not eroded is because the water flow has been directed along the other side of the river – where the bank is eroding seriously.

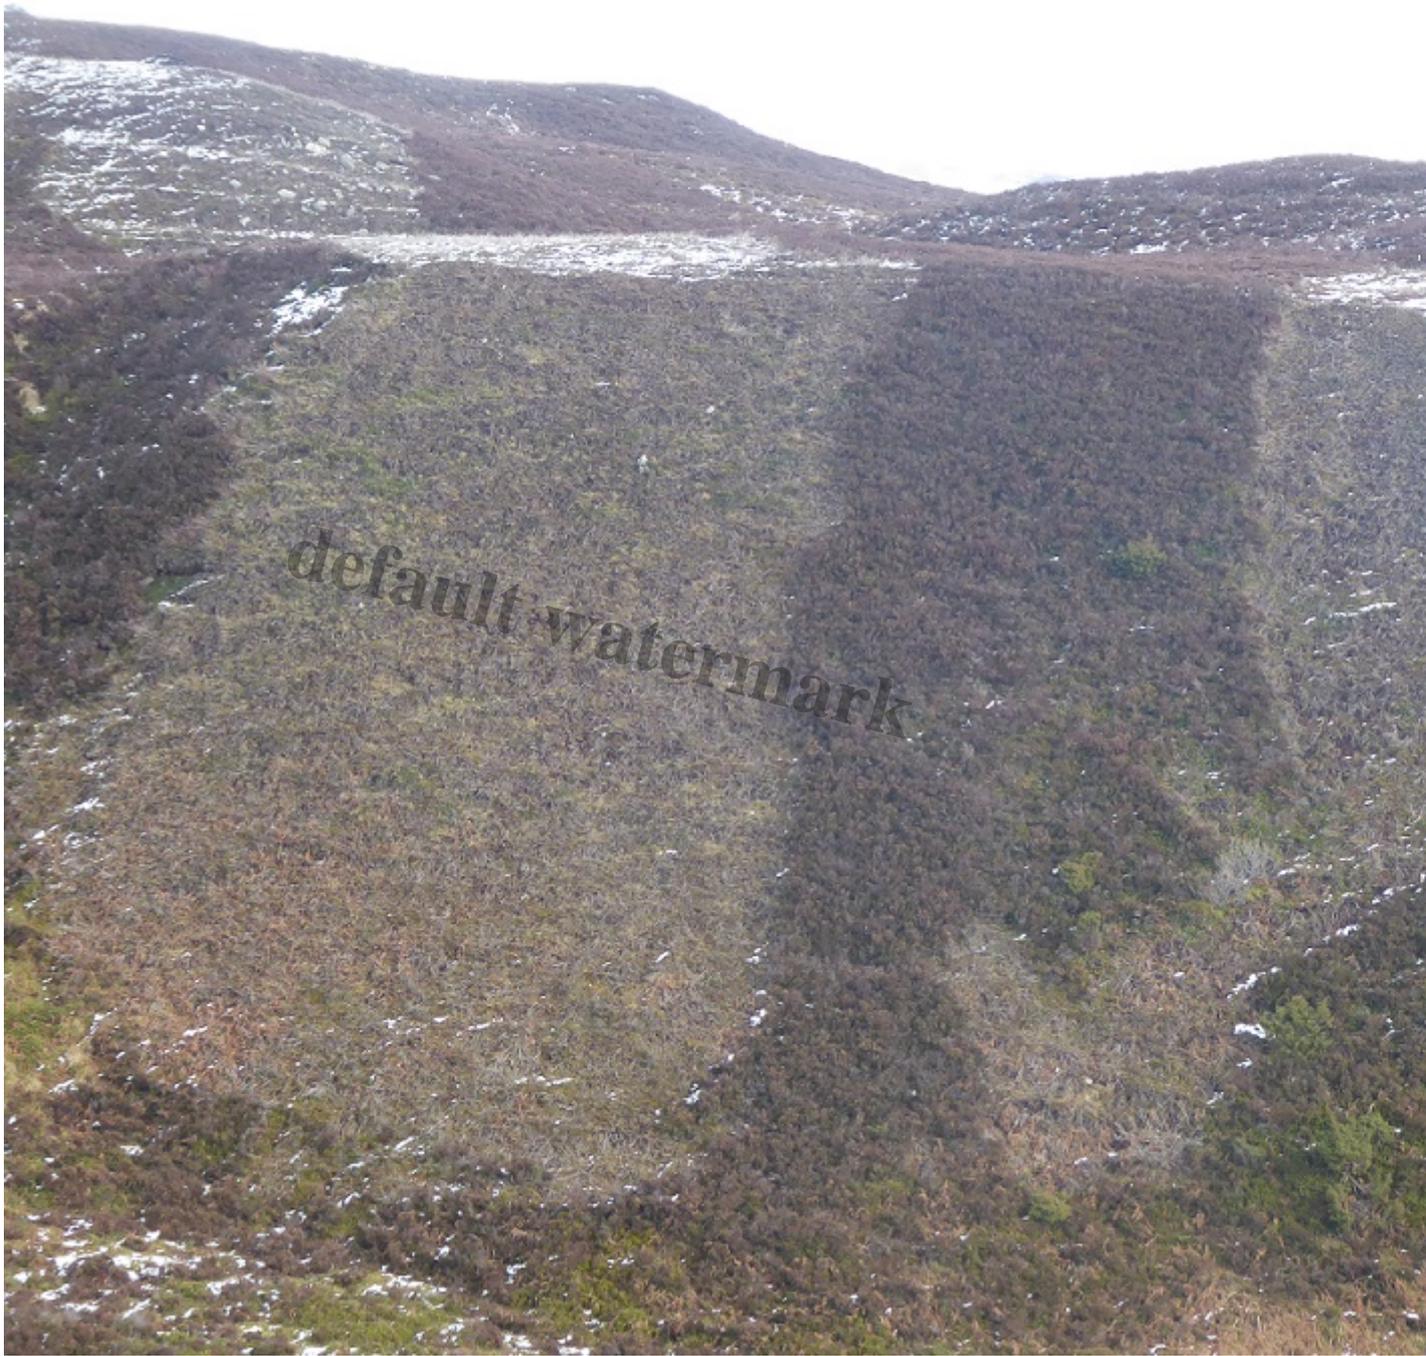
Muirburn on the steep sided banks of the Allt Mhor, which flows down to the Gynack overflow â?? no juniper has been destroyed by the fire

Muirburn, in particular, promotes water run off and in flood prevention terms its a disastrous practice. Yet here we are in a National Park, allowing the Pitmain Estate to burn the moor, increasing the flood risk to Kingussie, while at the same time the public sector, in the form of Highland Council, has paid for half the cost of a flood diversion scheme. The fact its no longer functioning is simply salt in the wound! People living in Kingussie should have every right to be angry.
