The Gynack flood diversion channel above Kingussie – at what environmental and financial cost?

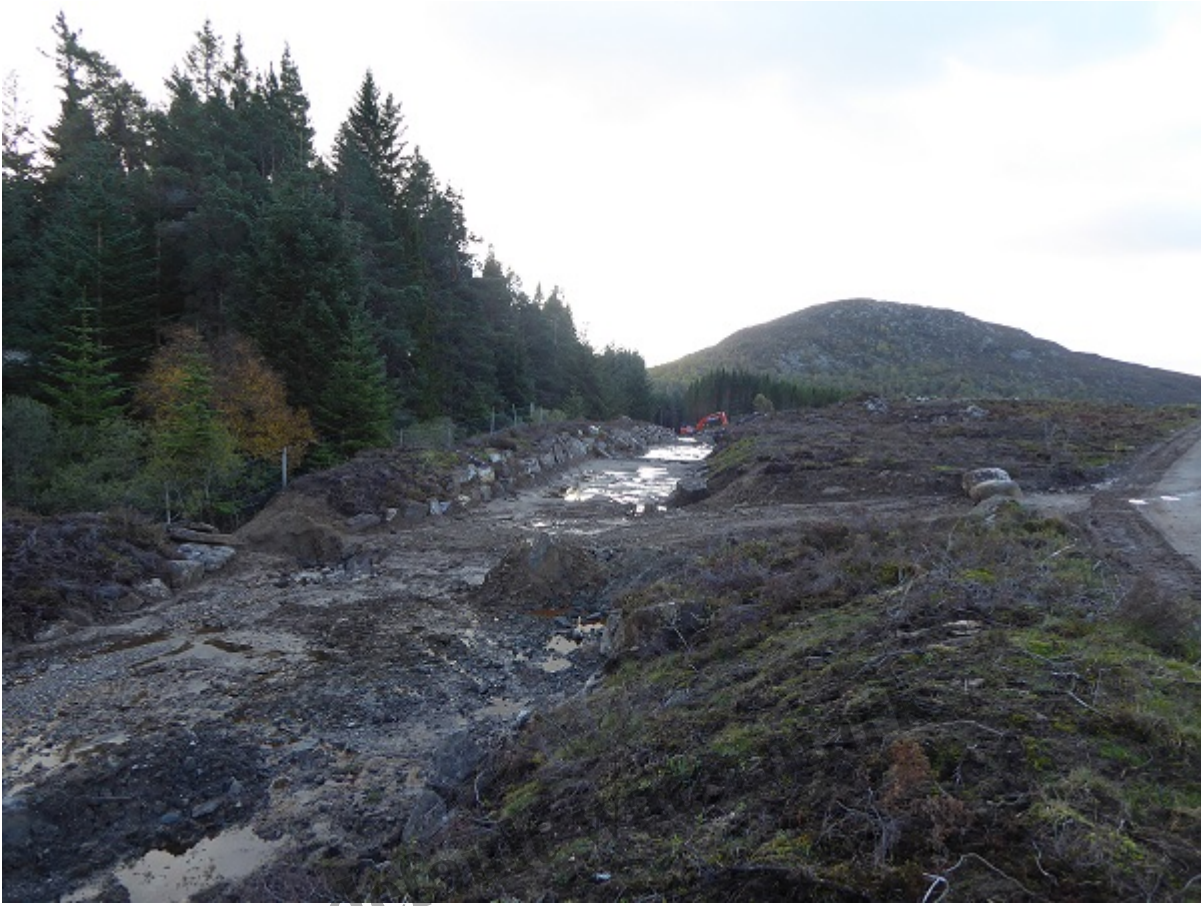
The overflow channel under construction October 2017 – note the new bank on the left

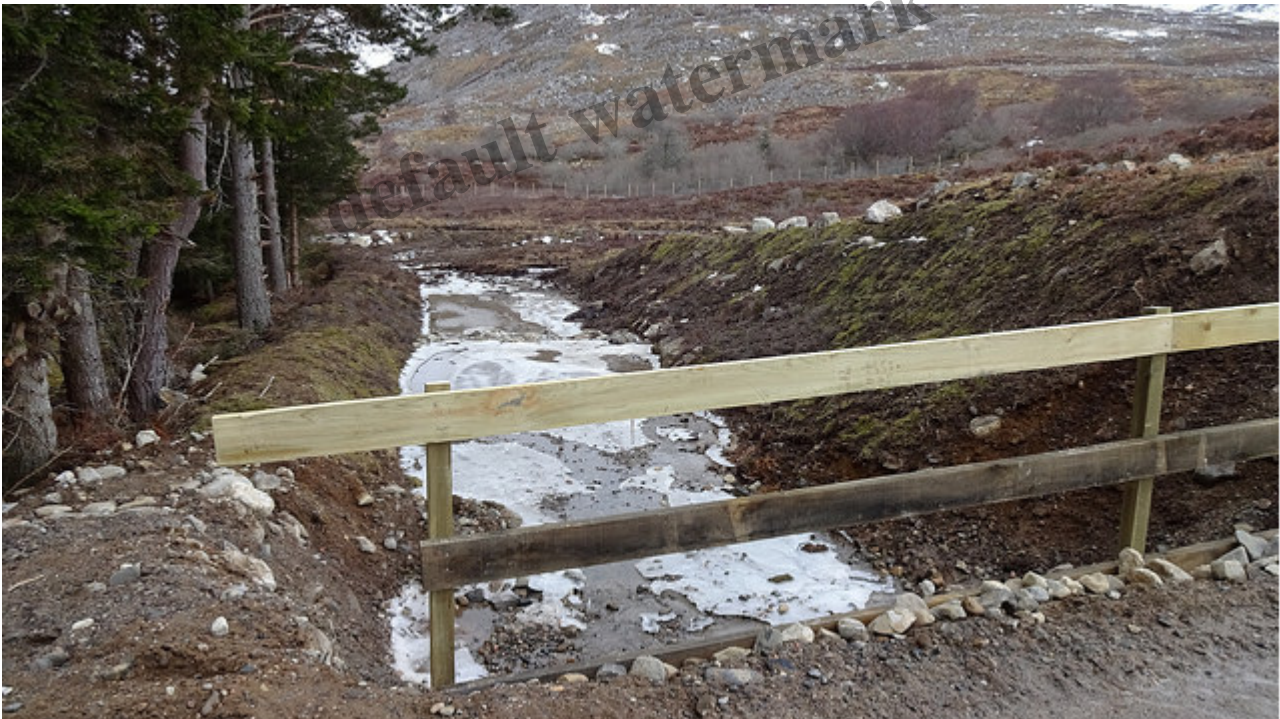
In April 2018 Highland Council published this view of the overflow from the road bridge near the intake

The view of the restoration downstream from the bridge looked not bad in April 2018 though if you look carefully on the right a section of bank behind the fence has already been subject to significant erosion.

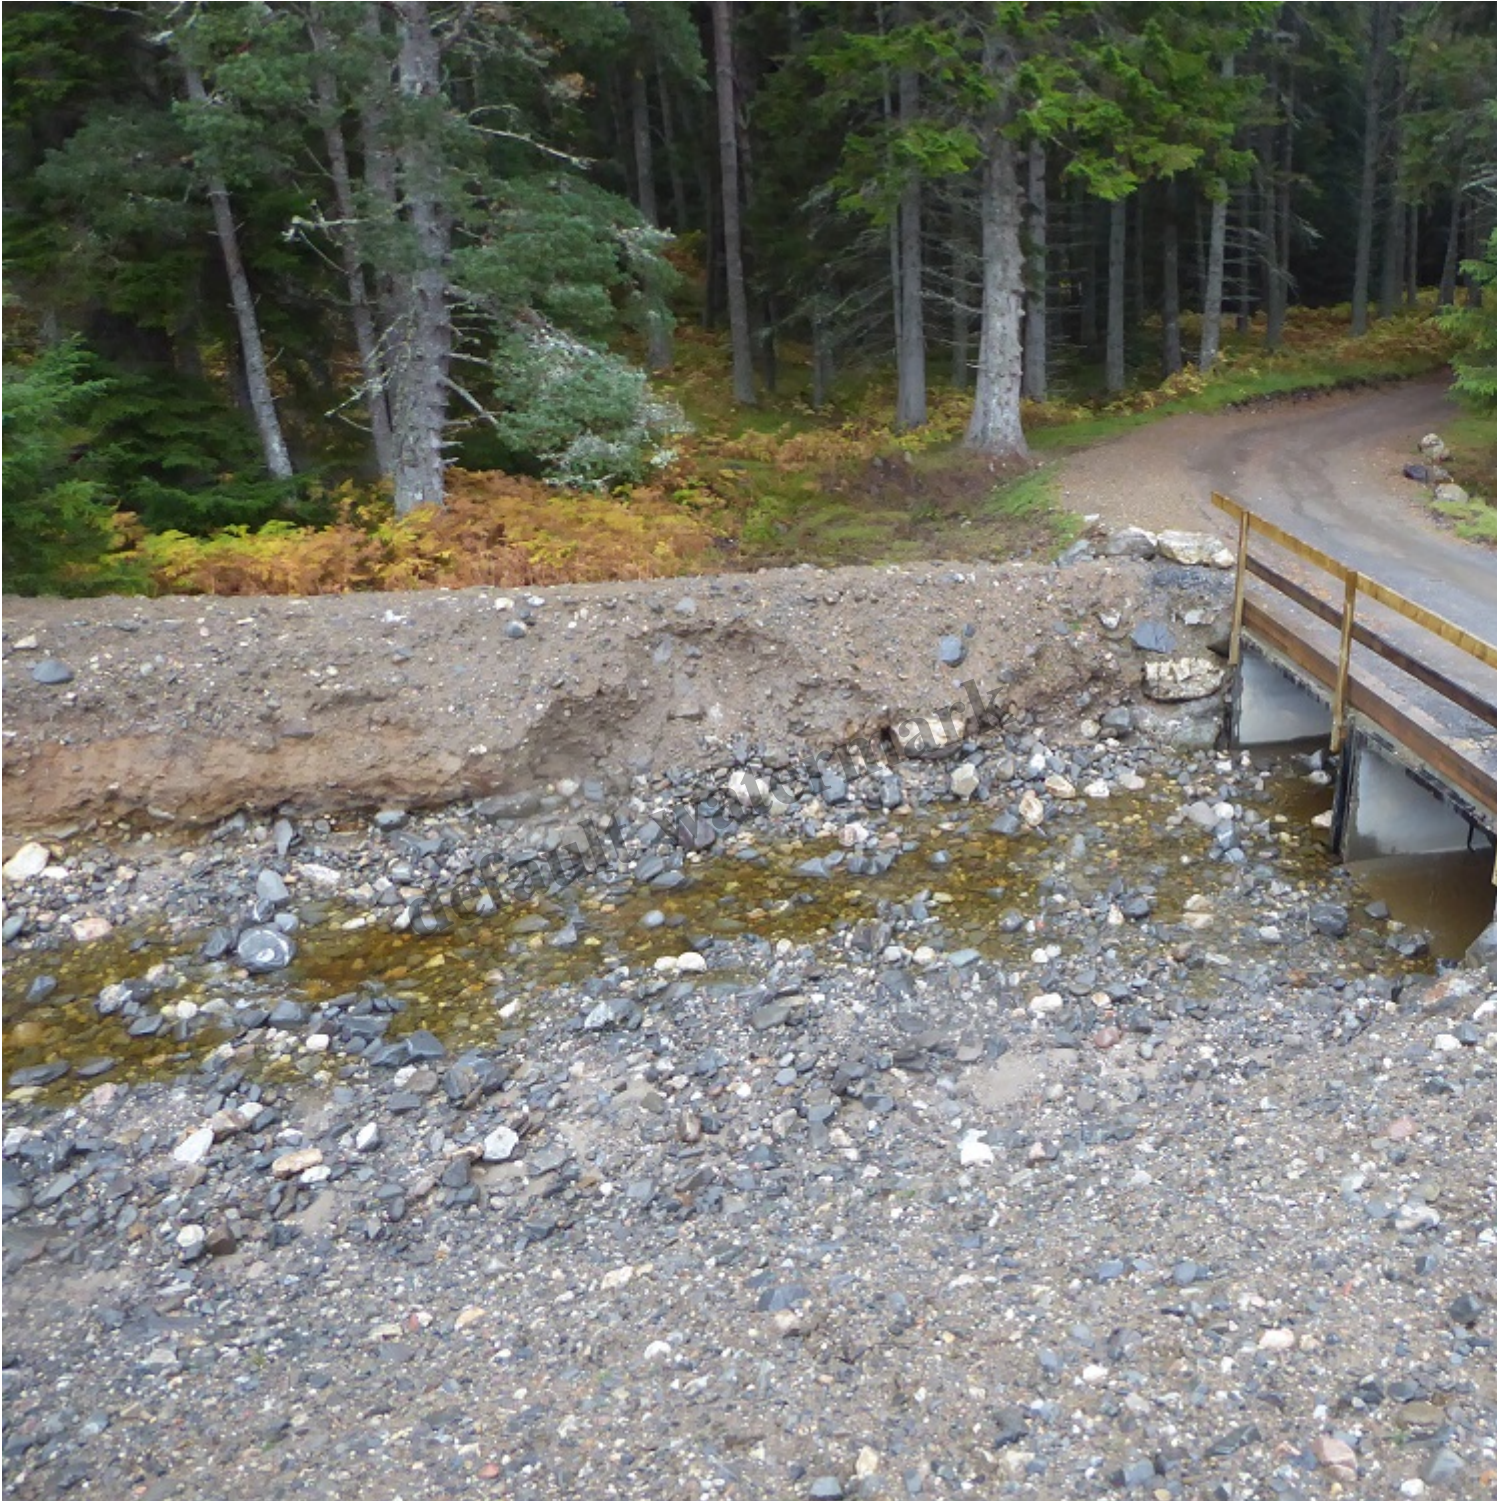
Six months later and the water flowing down the overflow had almost cut right through the bank ABOVE the bridge.

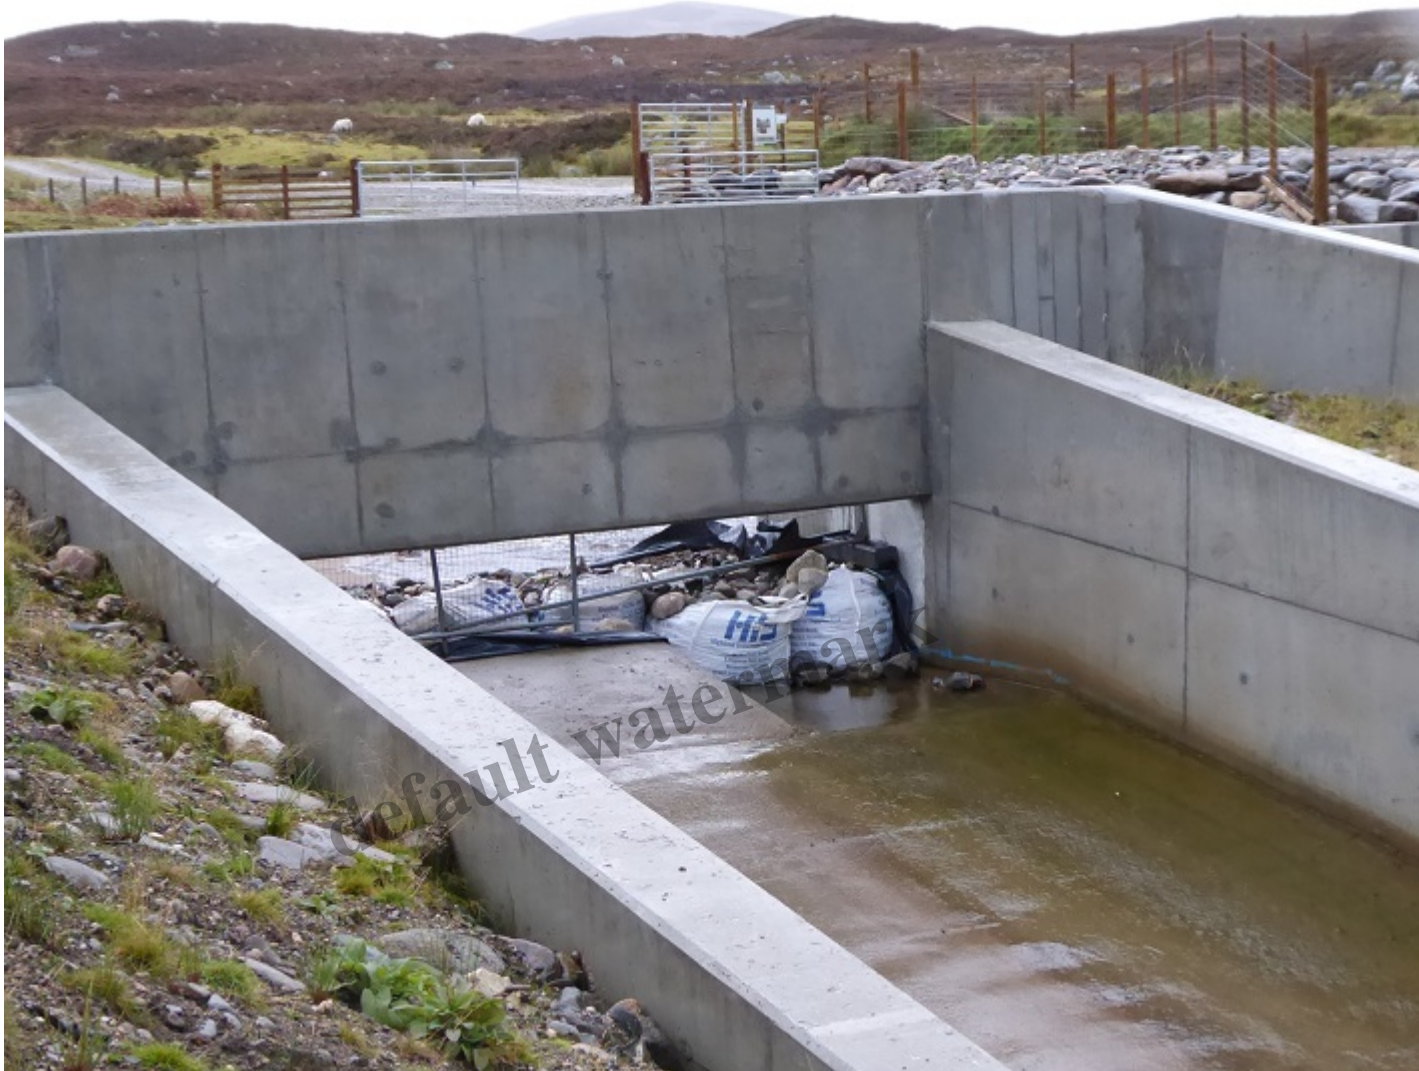
Overflow intake – note the channel within the channel. This was designed to ensure that water flows through the overflow at all times.

I had intended to blog about what I found at the Kingussie overflow a year ago but left it too long and then decided I needed to visit again in case the position had changed. When I did visit in October, I found the intake had been blocked off. This had limited the amount of further damage that had been caused but made the ugly concrete structures effectively redundant.

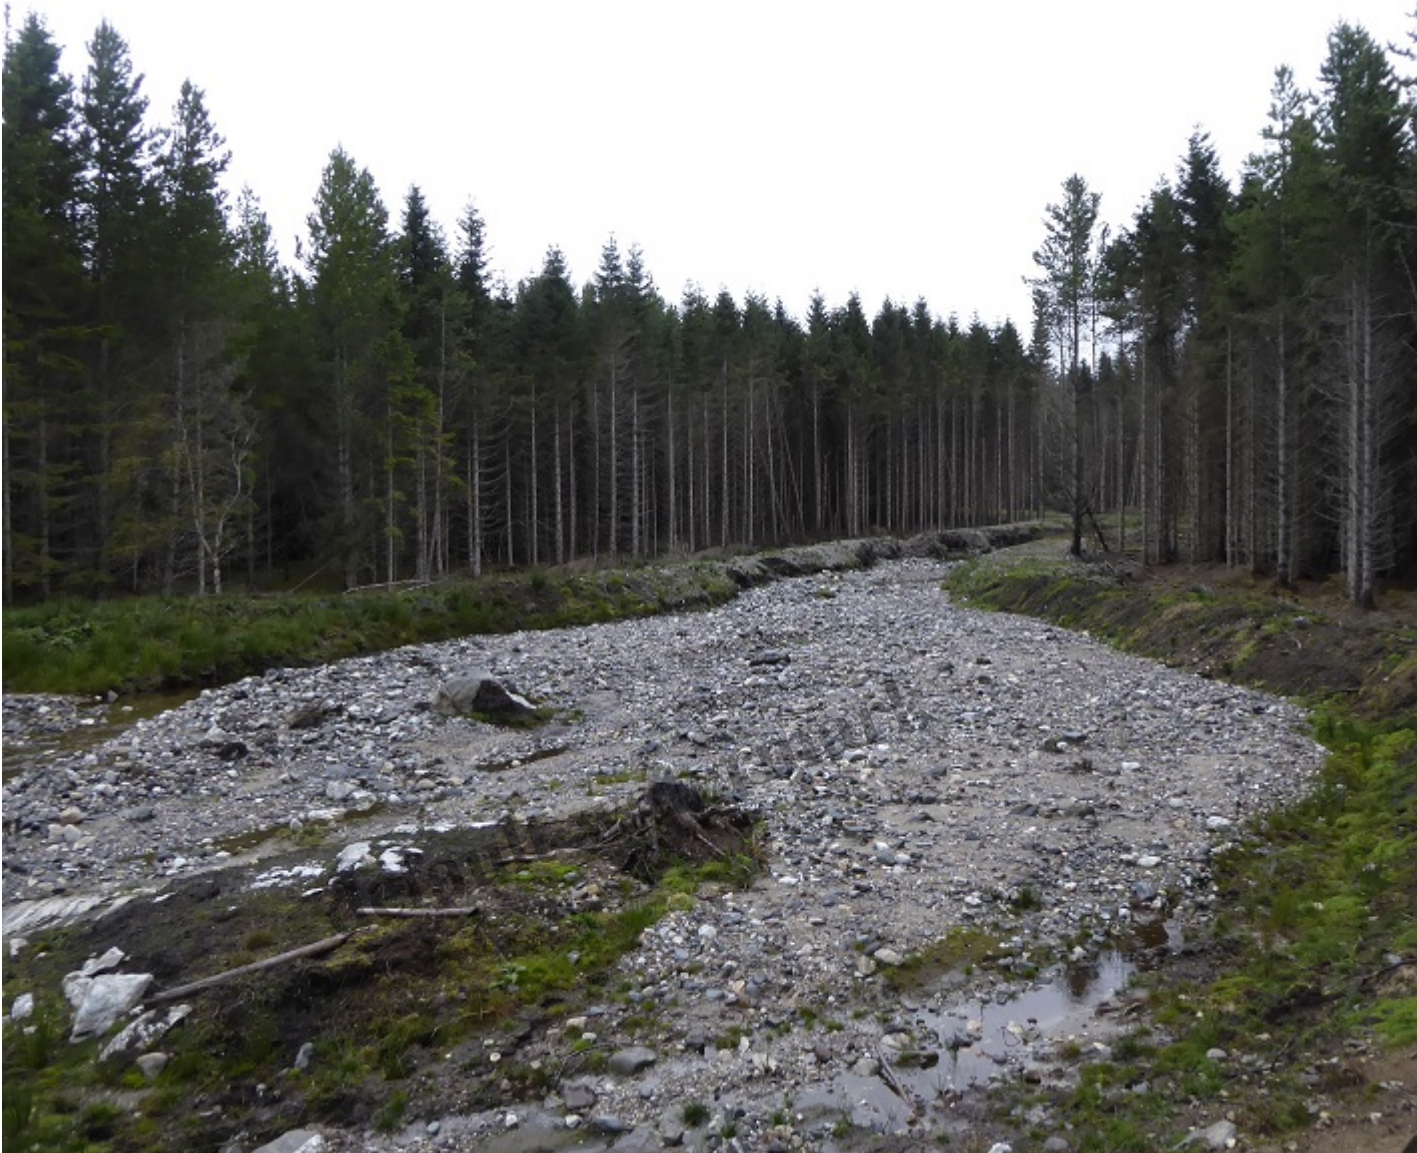
Below this photo logs have been placed across the channel in an attempt to dam the water – another in engineering. Perhaps beavers would have made a better job of it?

A broader area was deliberately excavated lower down to create a new wetland area. Instead boulders and silt have been washed down from above effectively creating a flood plain – nothing wrong with that but NOT what was intended.

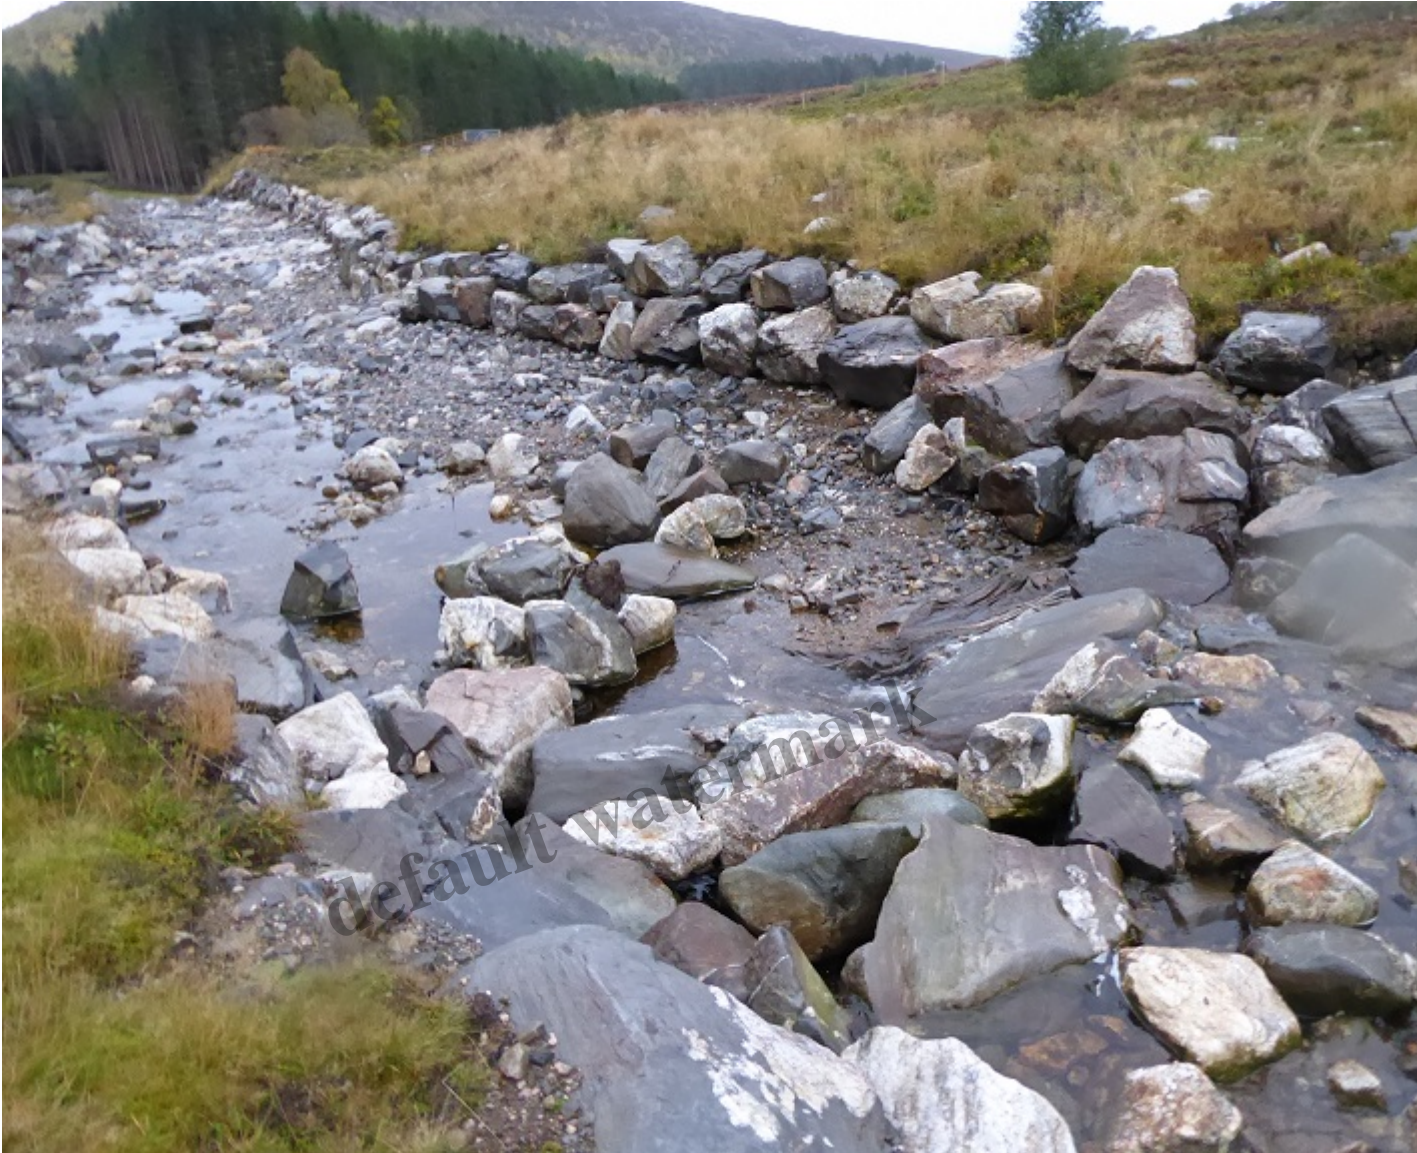
Large boulders have been washed down into the channel both plucked from the rip rap bouldering on the banks and from boulders lining the steeper sections of the channel. Note centre right the hessian matting this has been revealed by boulder/s above being swept away – and the much healthier vegetation on the lower section of bank (a consequence of some restoration taking place here).

Higher up there are extensive sections of bank with rip rap bouldering. While most of this is still intact, unlike the bouldering used in the Glen Falloch hydro schemes ([see here](#)), there are several places where you can see boulders have been plucked out from the banks. Had the overflow not been blocked off, the damage might have become as extensive as that in Glen Falloch.

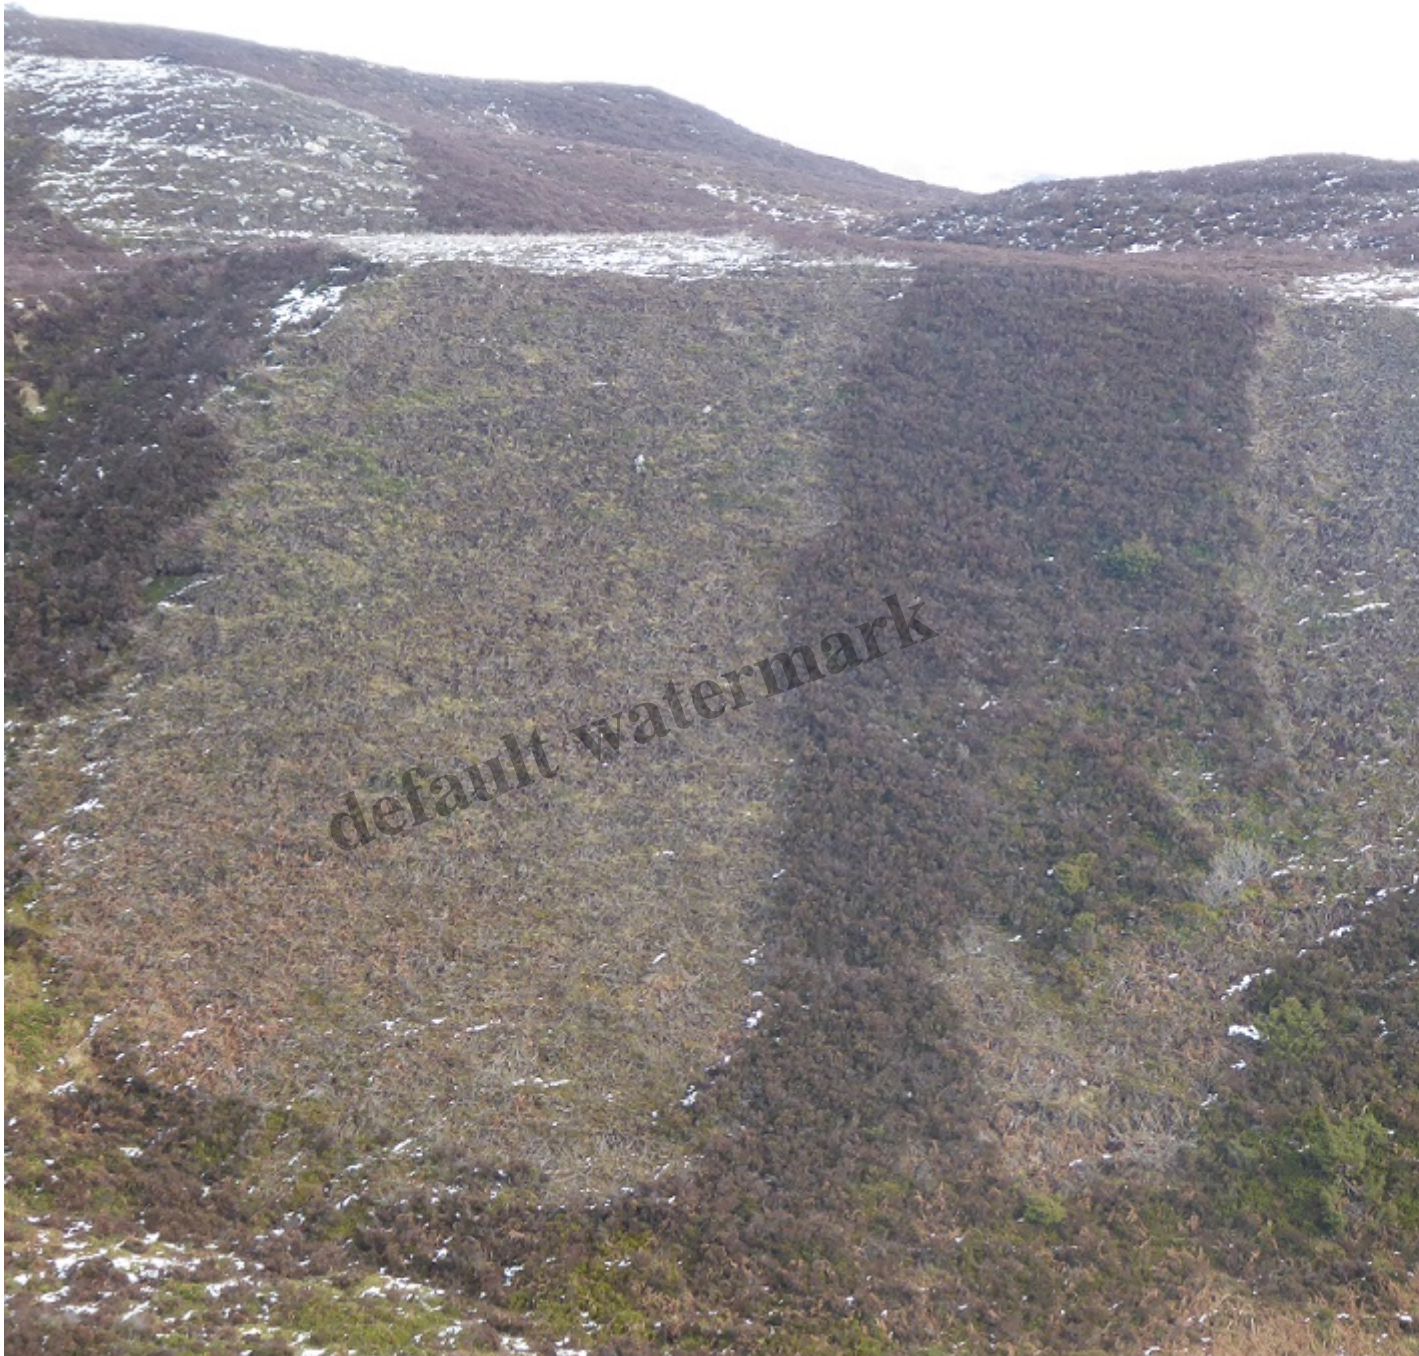
Muirburn on the steep sided banks of the Allt Mhor, which flows down to the Gynack overflow – note juniper has been destroyed by the fire

Muirburn, in particular, promotes water run off and in flood prevention terms its a disastrous practice. Yet here we are in a National Park, allowing the Pitmain Estate to burn the moor, increasing the flood risk to Kingussie, while at the same time the public sector, in the form of Highland Council, has paid for half the cost of a flood diversion scheme. The fact its no longer functioning is simply salt in the wound! People living in Kingussie should have every right to be angry.
