The Gynack flood diversion channel above Kingussie – at what environmental and financial cost?

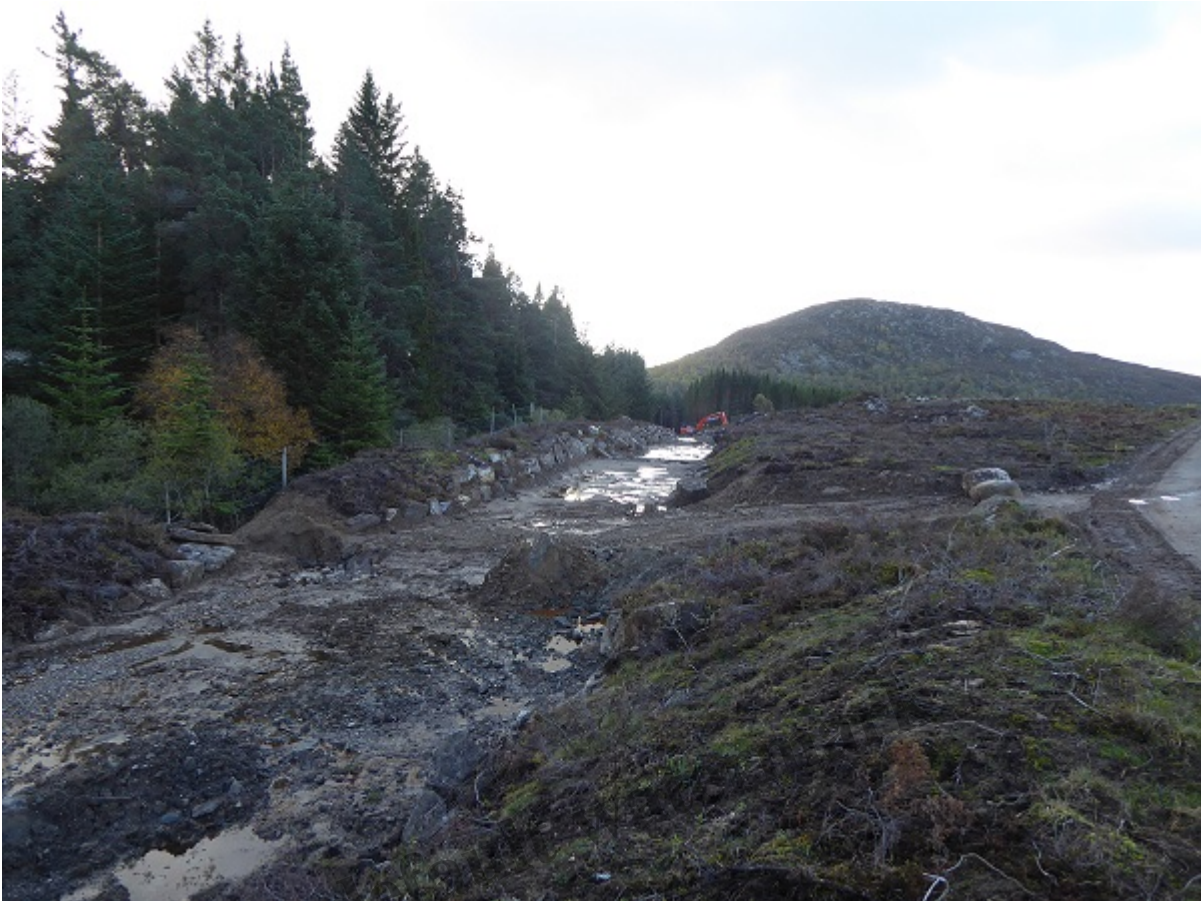
The overflow channel under construction October 2017 – note the new bank on the left

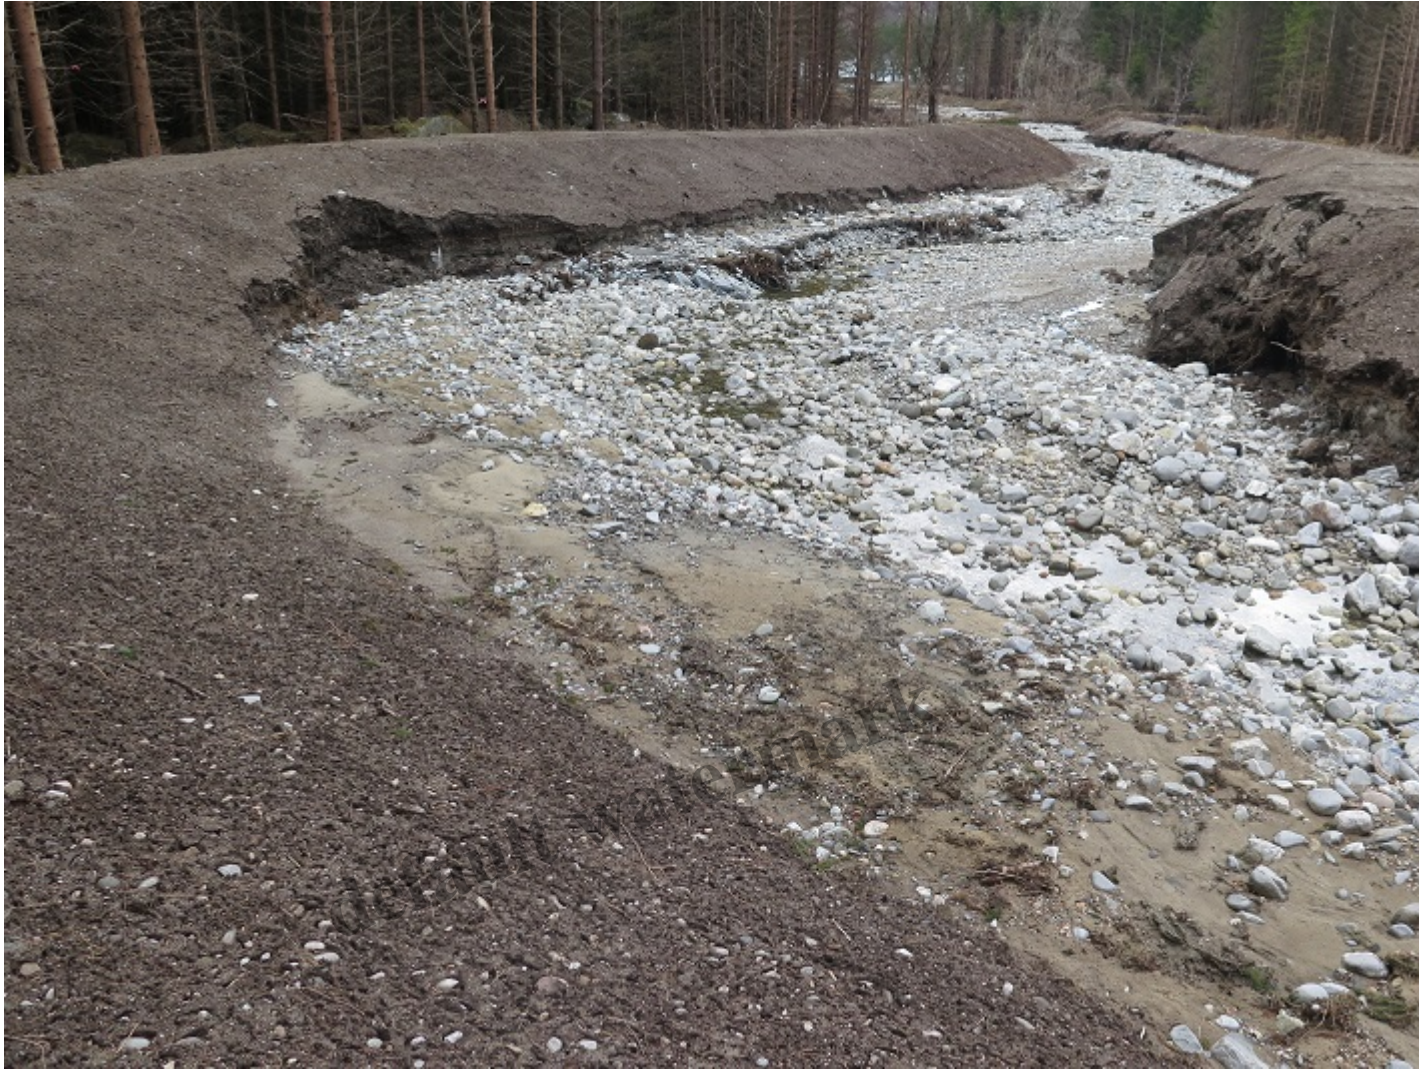
Channel with manicured banks already eroding – 29th April 2018. This view was not shown by High

One wonders if Highland Council sent anyone to check the channel in April 2018 before announcing it was complete. Anyone with a modicum of knowledge should have been able to tell then that the banks were unfit for purpose and that might have serious consequences.

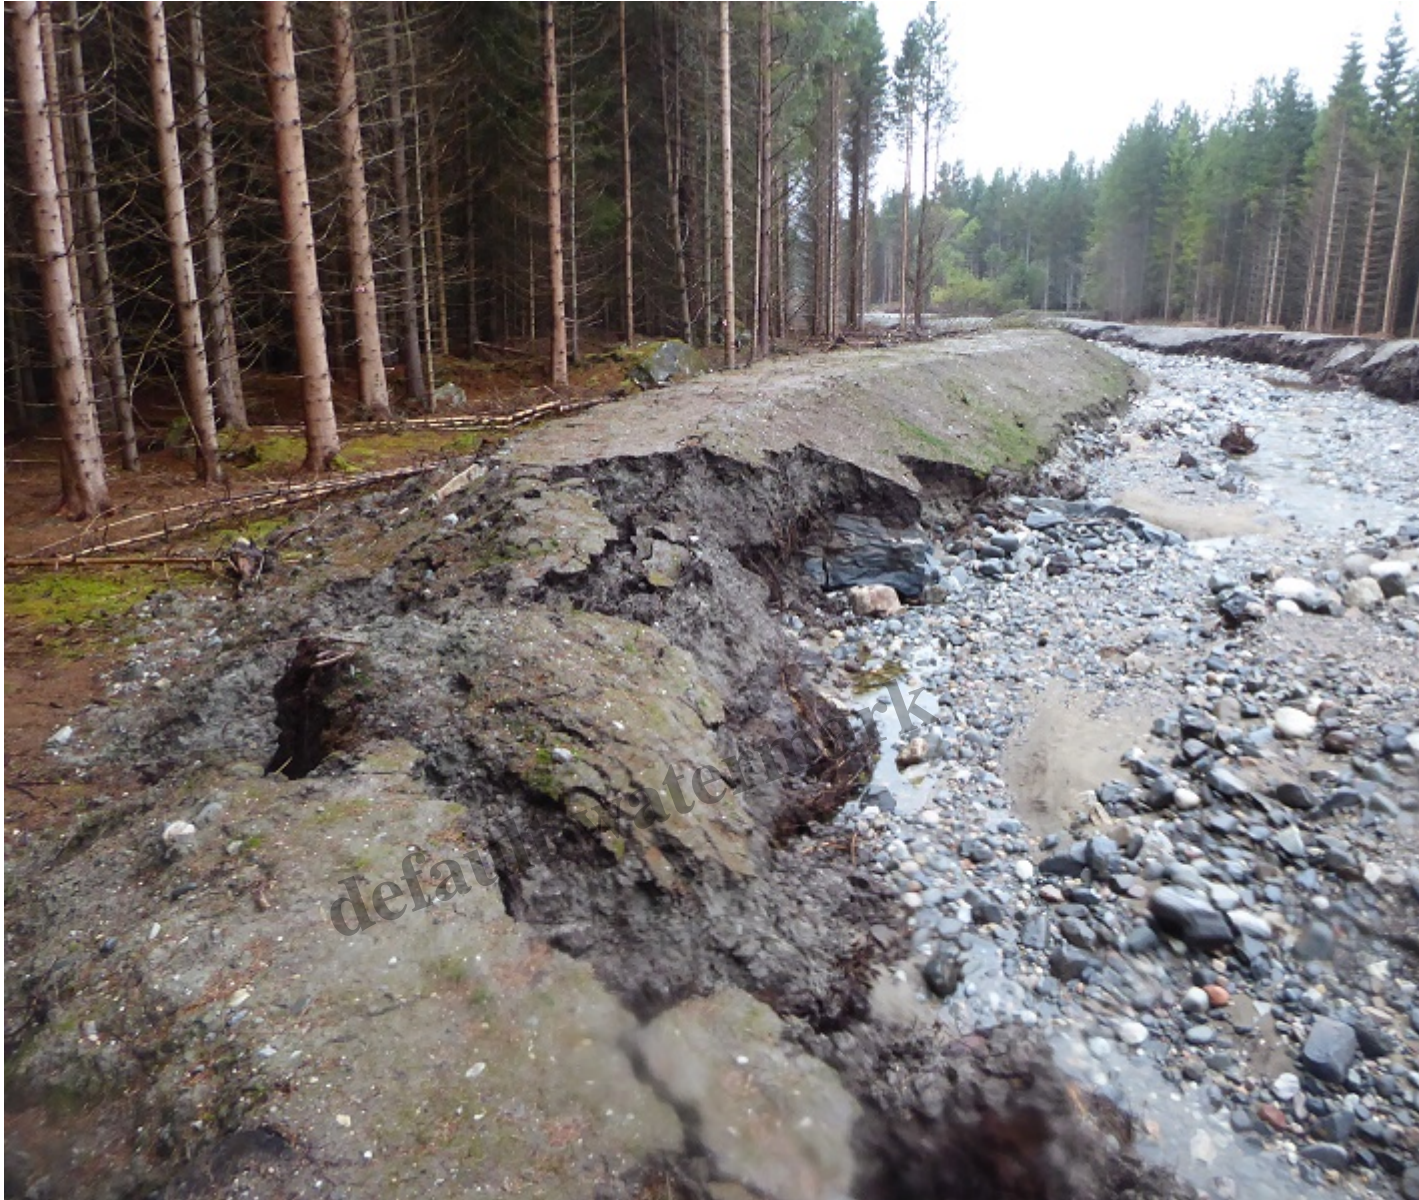
Section of banks in October 2018

Six months later, when I next visited, the possible consequences were even more obvious. What engineer thought that these earth banks could withstand a river in spate? Why was water allowed to run through the channel before they had had any chance to vegetate? Even if that had been allowed to happen, earth banks such as this would have been highly vulnerable to high water flows, but without vegetation and without any protective matting, the consequences of allowing water to run through the channel should have been obvious. So why the CNPA allow this to happen?

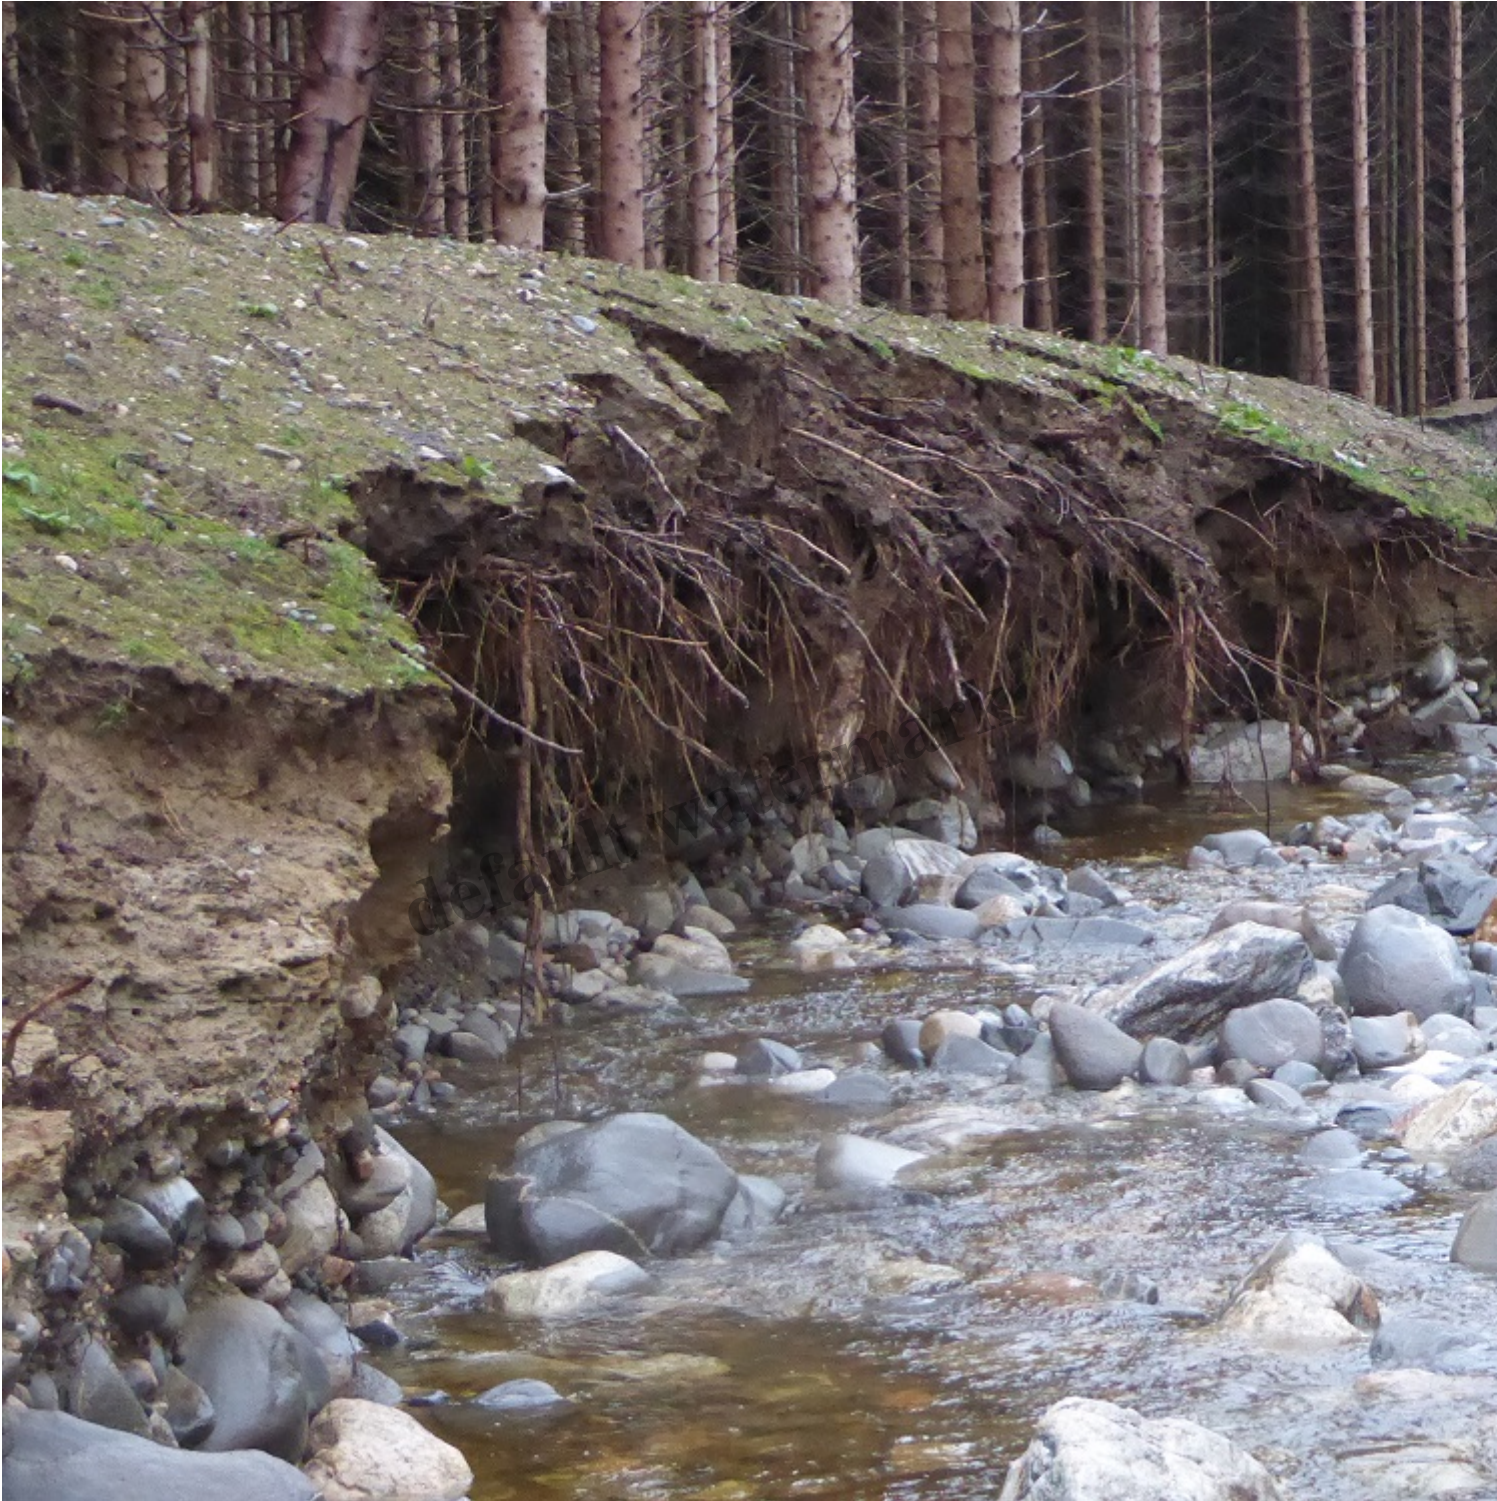
By October 2018 the banks were in places being severely undercut. It appears that in designing the overflow little consideration had been given to the impact of the water on the banks. In the Supporting Information to the planning application consideration had been given to the mobile nature

a result the developer, while rightly highlighting that the area above the intake would infill and require regular maintenance (I cannot recall this ever being considered in any hydro application), completely failed to consider what would happen in the channel itself. As a consequences, in just six months in places the water had almost cut through the bank entirely. Had it done so the overflow could have changed course and flooded Pitmain Lodge which lies on the other side of the plantation below this bank! Poetic justice?

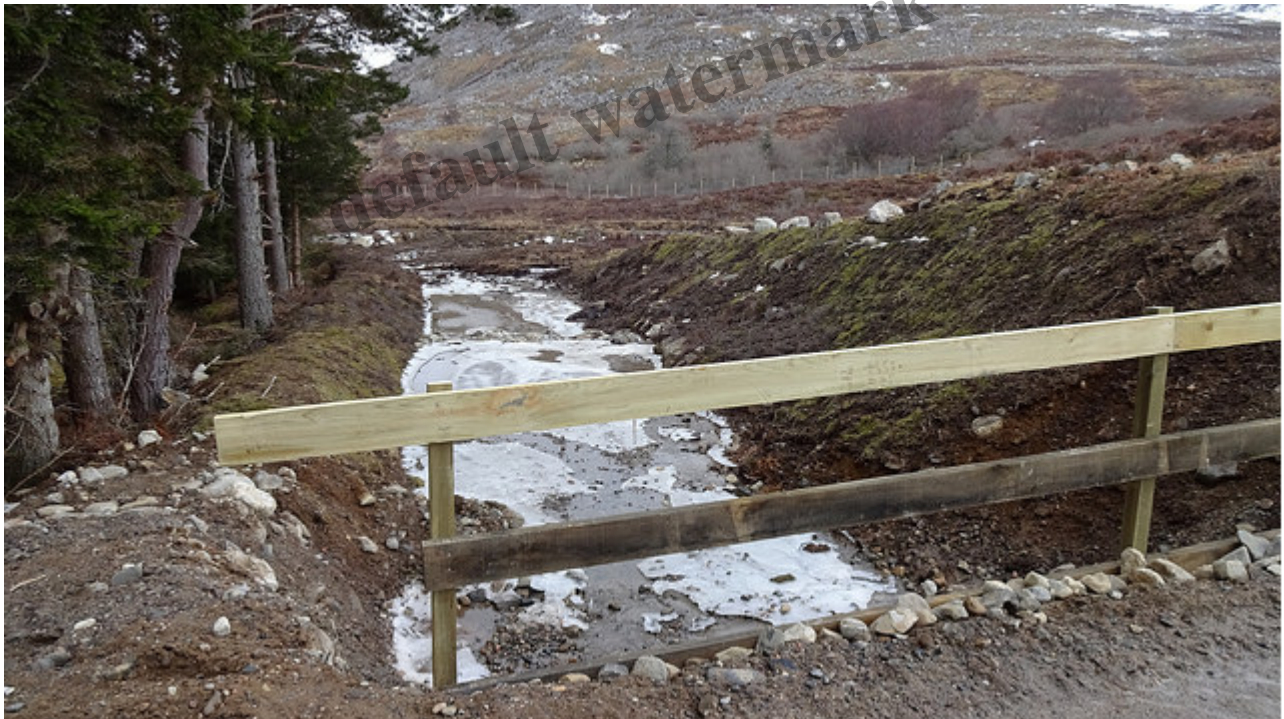
In April 2018 Highland Council published this view of the overflow from the road bridge near the intake

The view of the restoration downstream from the bridge looked not bad in April 2018 though if you look carefully on the right a section of bank behind the fence has already been subject to significant erosion.
