The Gynack flood diversion channel above Kingussie – at what environmental and financial cost?

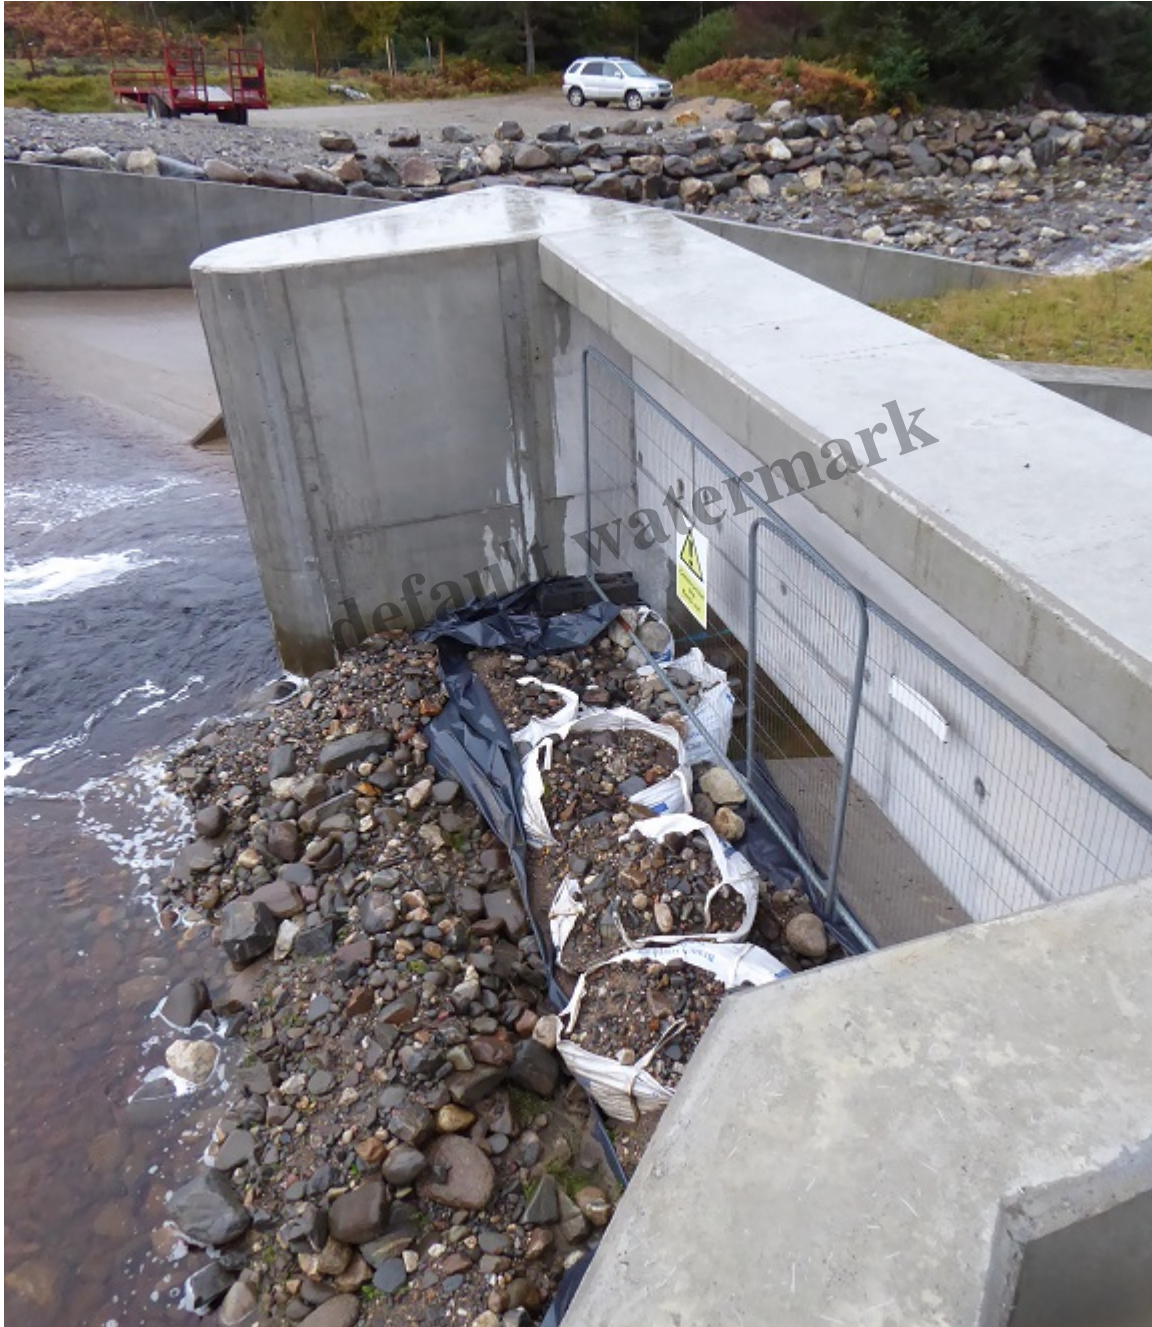
The Gynack overflow channel has been blocked off to prevent it eroding further so that now it will only function in the highest floods October 2019.

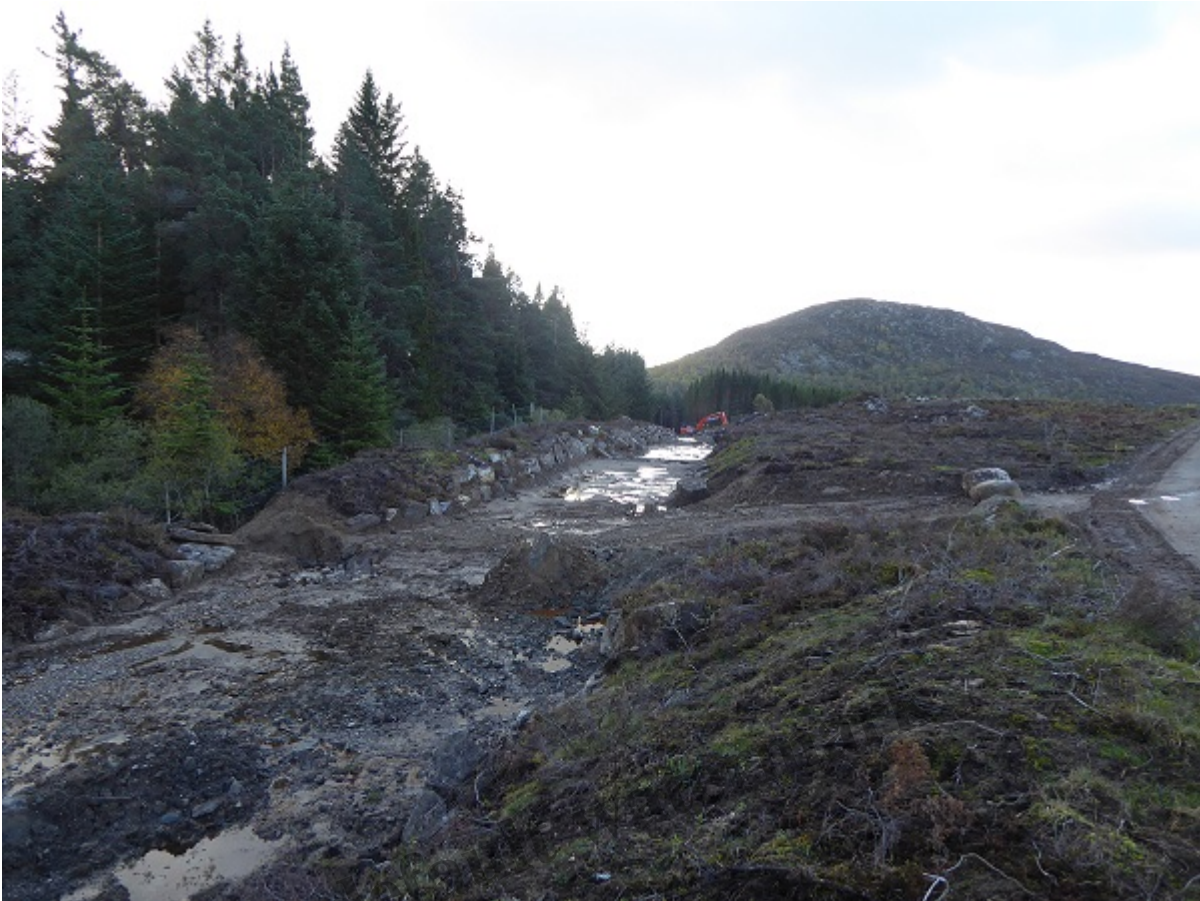
The overflow channel under construction October 2017 – note the new bank on the left

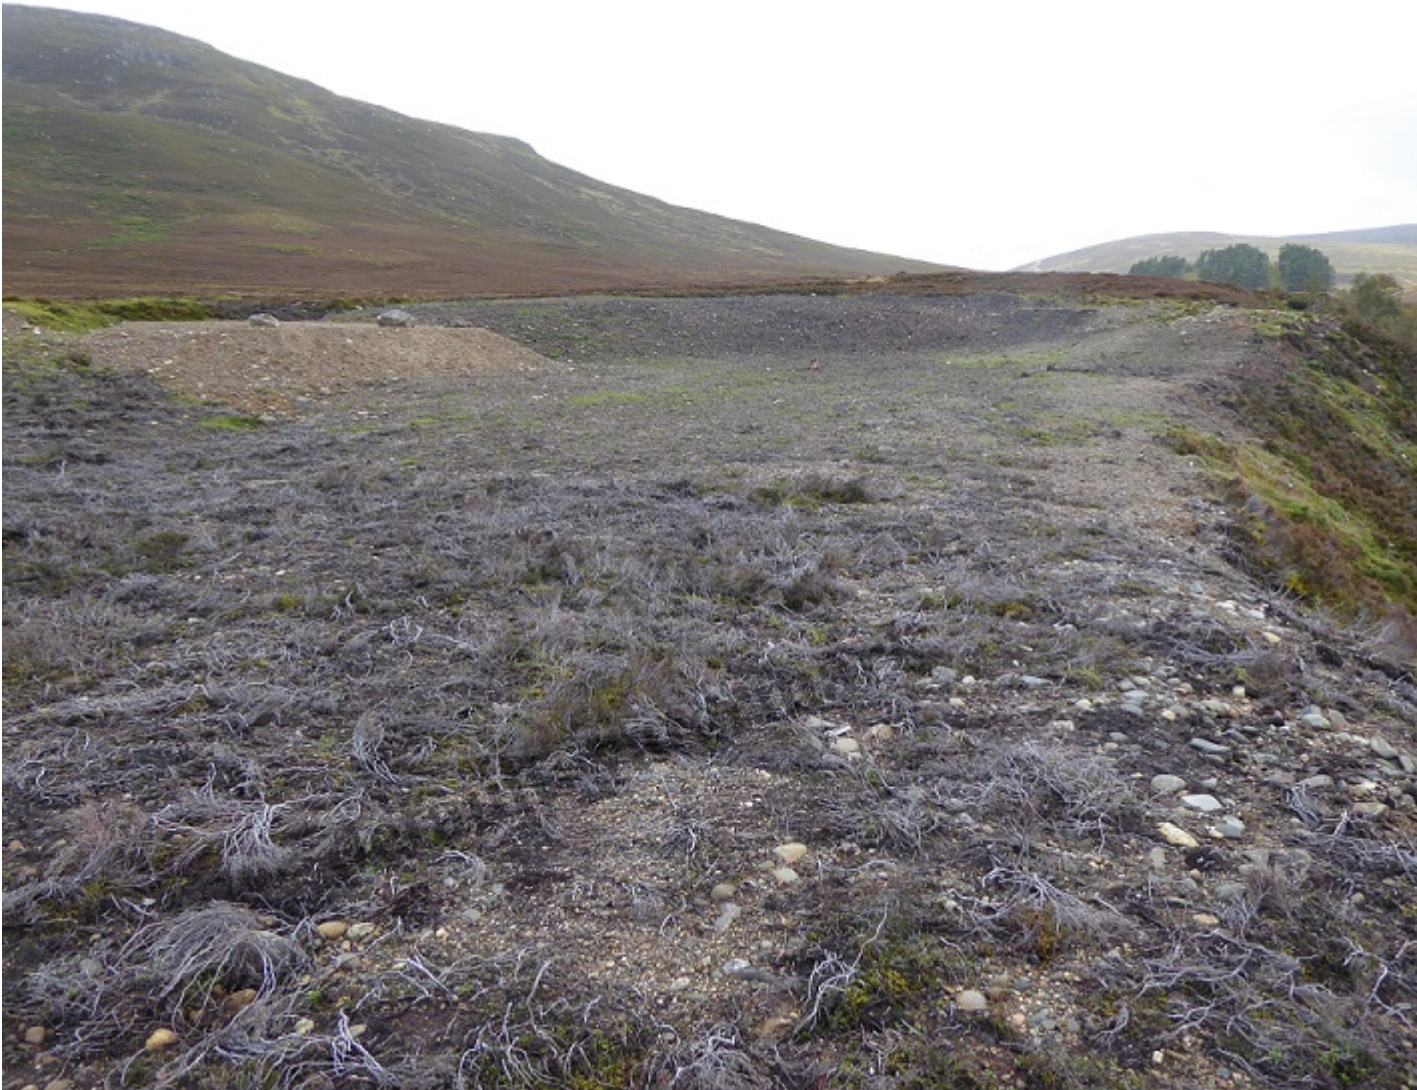
This large re-landscaped area above the overflow intake (Allt Mhor to right) appears to have been used as a borrow pit. October 2017.

There was no development identified on the planning portal for the area pictured above and it falls outside any planning application boundary. In addition there was nothing in the planning documents that I can find ([see here](#)) to indicate that borrow pits would be required. Indeed the planning consent required the applicant to provide details of details of “*the process for excavation (including machine access and working corridor) and the sorting and storage of materials for re-use*”. This suggests that the CNPA expected the developer and contractors to source materials for the banks from the site. If the area up the hill was used therefore to source material to construct the banks to the overflow that was probably unlawful. So, why was no action taken to stop this?

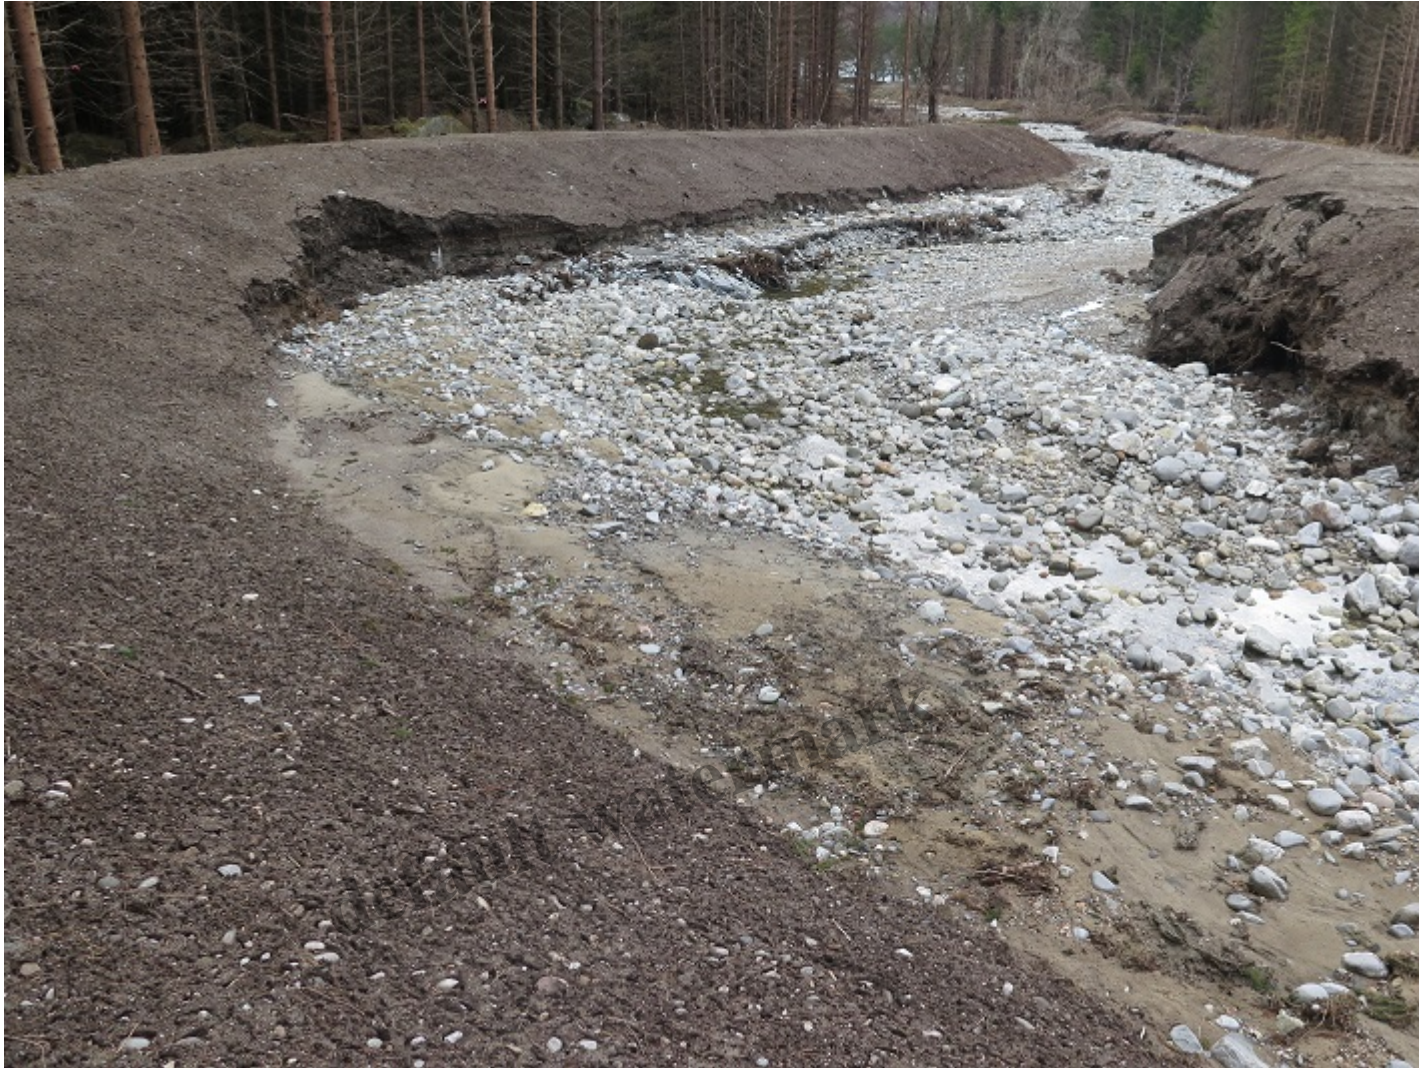
Channel with manicured banks already eroding – 29th April 2018. This view was not shown by High

One wonders if Highland Council sent anyone to check the channel in April 2018 before announcing it was complete. Anyone with a modicum of knowledge should have been able to tell then that the banks were unfit for purpose and that might have serious consequences.

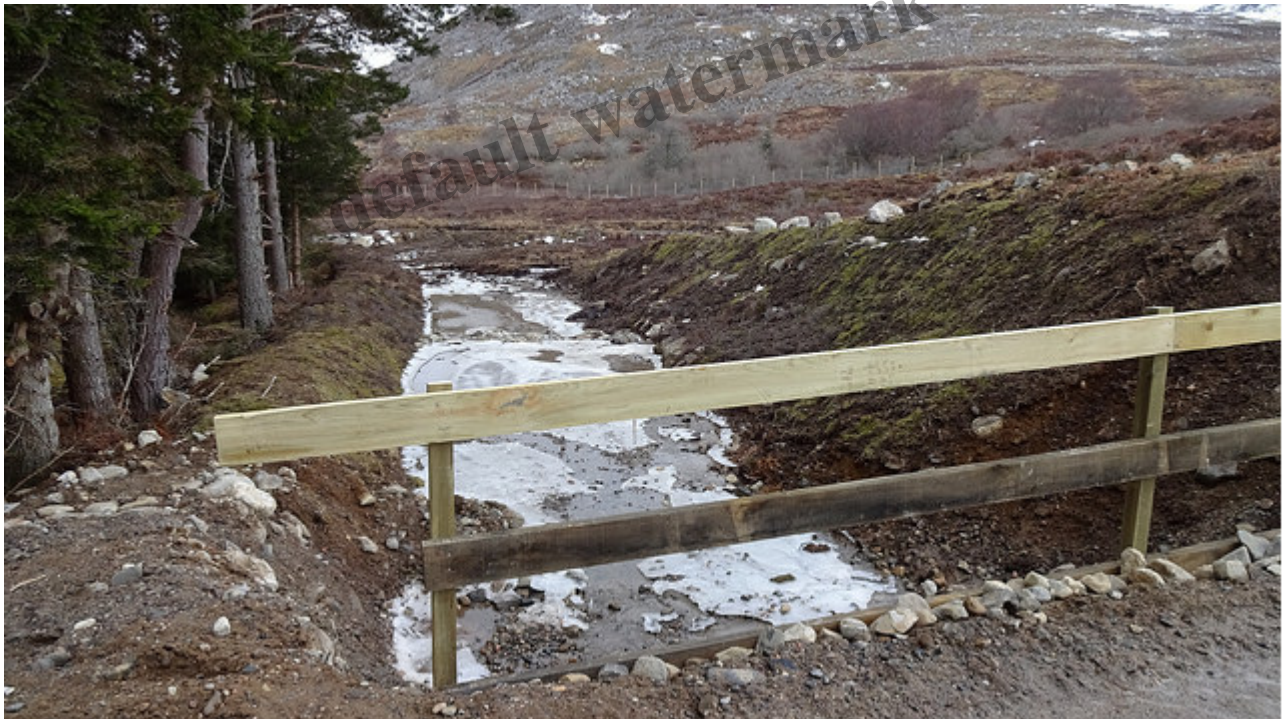
In April 2018 Highland Council published this view of the overflow from the road bridge near the intake

The view of the restoration downstream from the bridge looked not bad in April 2018 though if you look carefully on the right a section of bank behind the fence has already been subject to significant erosion.

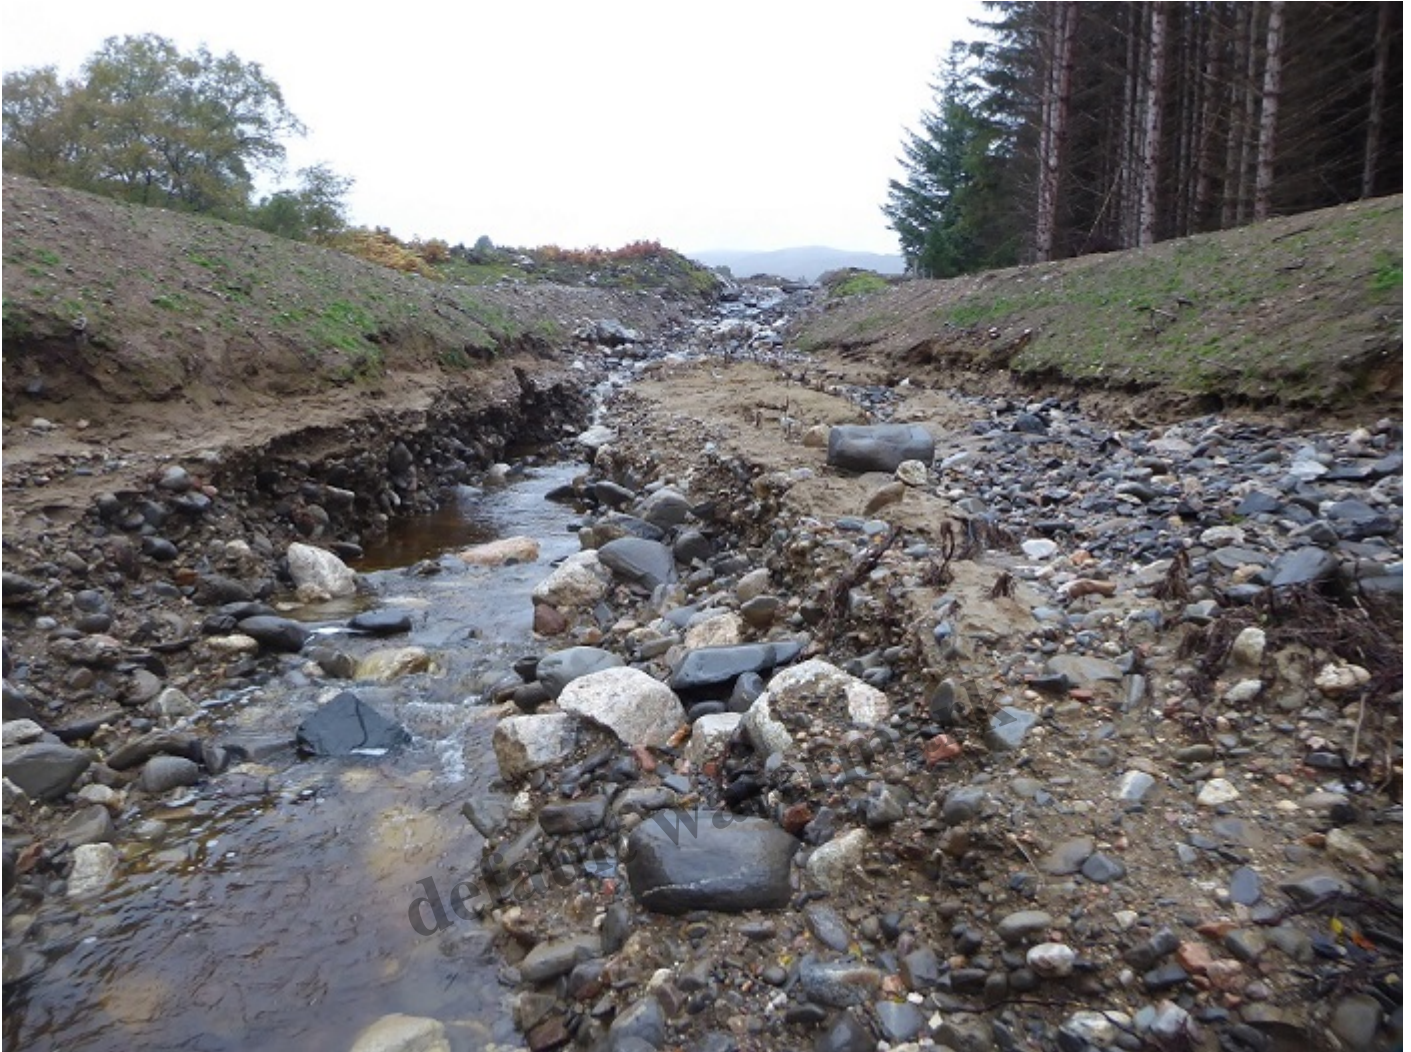
Even more striking was how the channel had cut down below through the original base, doing what rivers that have changed course do, washing away loose material. A good place to study how river channels develop – an ideal geography project for the pupils at Kingussie High School – but in planning terms a disaster. The CEMP required to developer “*to provide details of the substrate of the channel when flat*”. Whatever these plans were, they have not prevented large amounts of material being flushed into the freshwater system. What is the point of the CNPA and the Scottish Environment Protection Agency requiring developers to take measures *during* the construction phase to prevent silt being washed into the freshwater river systems (to protect otters, salmon etc) if *post* construction this happens?
