More National Park hydro planning failures – Ballimore and Glen Ample

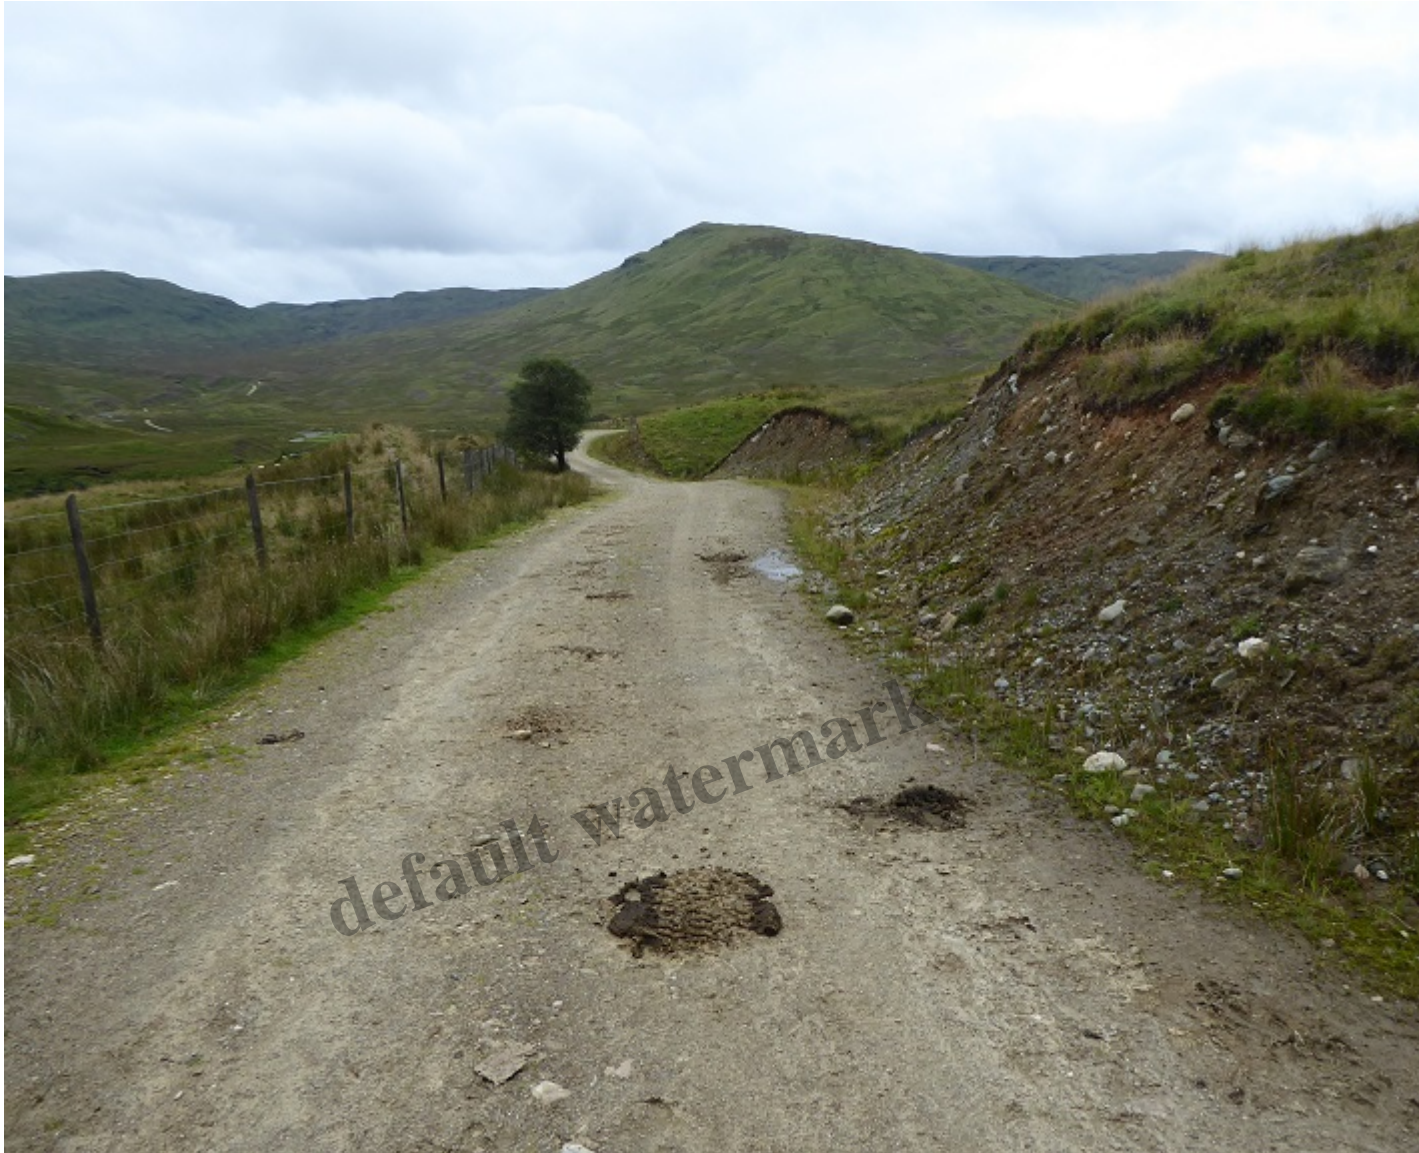
Note new hydro track in distance.

Beyond the second gate the old farm track had been widened for the construction of a hydro scheme, known as the Ballimore hydro, up Gleann Dubh. Its width has not been narrowed subsequently and no attempt has been made to restore the cut banks, all contrary to the LLTNPA good practice guidance on renewables and the Construction Method Statement approved by the planning application:

The Planning Application also contains the usual turf management plan and landscape provisions but all have been ignored.

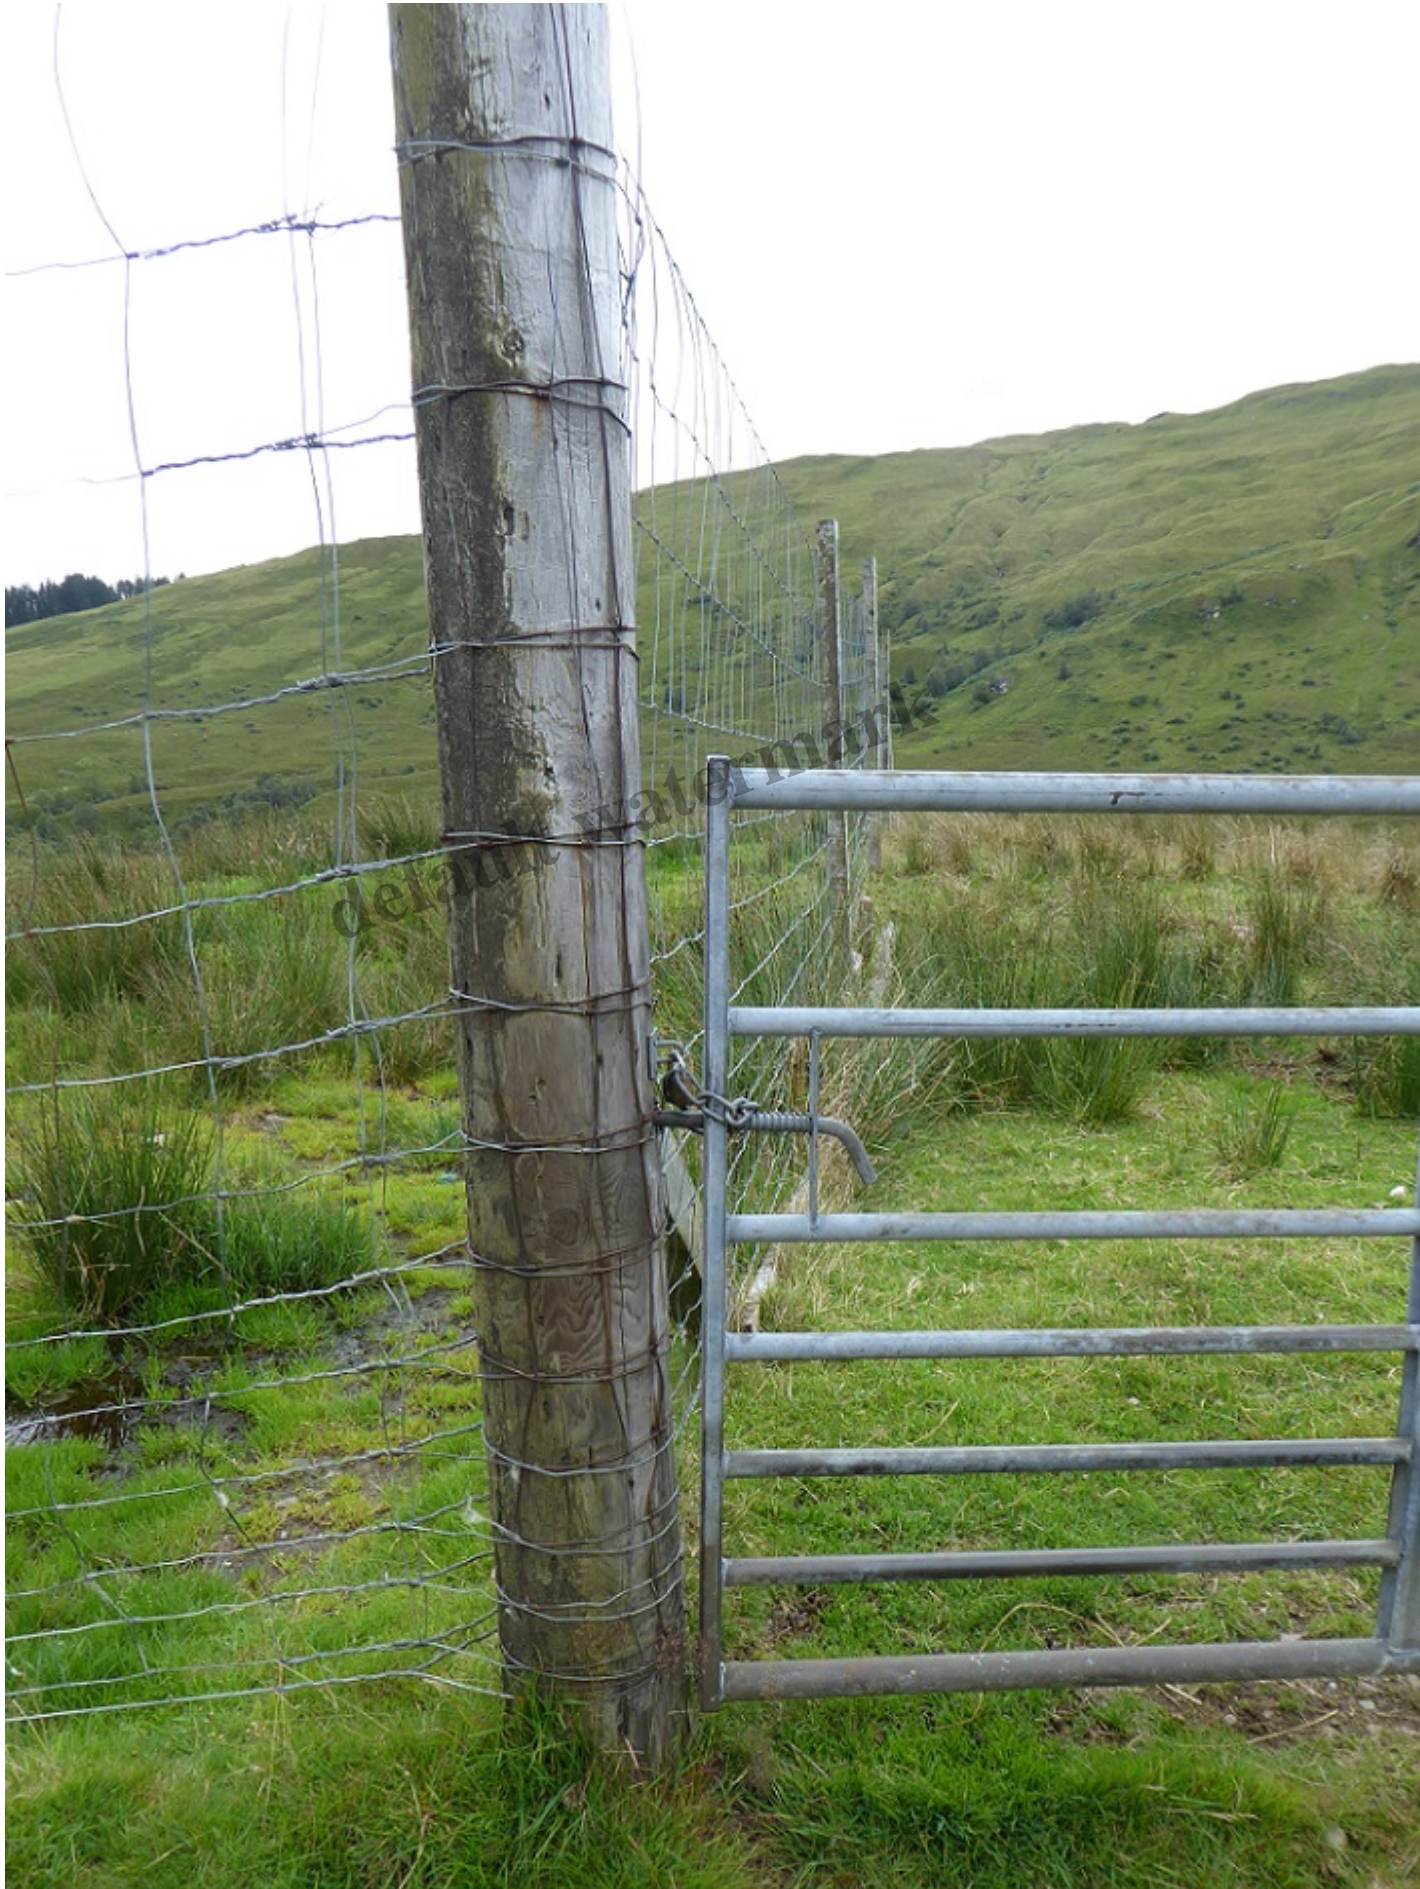
Third locked gate, this one easier to hop over.

The pipeline lies behind the gate and the ground above has, as is usual where hydro schemes are constructed on in-bye land, recovered far better than the track. It is now, however, covered in soft rush which is generally avoided by cattle. Hydro schemes are not without their costs to farmers and food production.

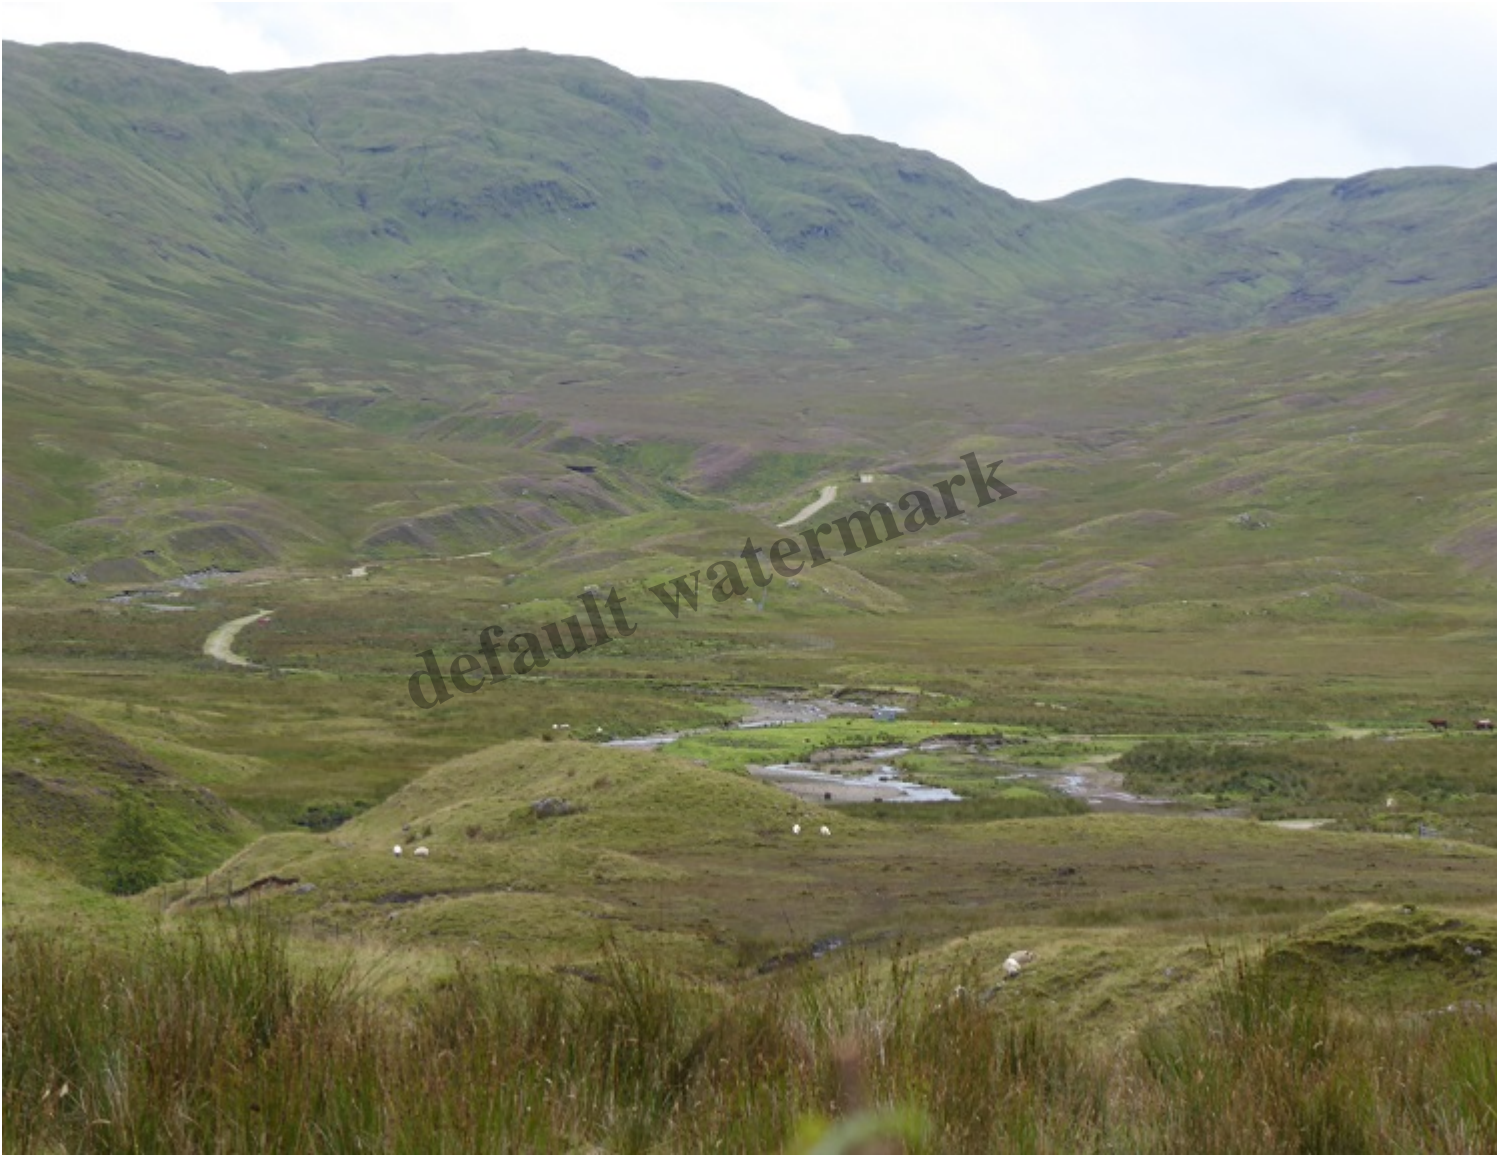
The mid-section of Gleann Dubh is covered by fine hummocky moraine. There are two intakes to the hydro scheme – originally three were planned – and it was agreed a new temporary track should be constructed across the Allt Fathan Glinne to build the first intake:

I can find no subsequent application to retain the track, as happened with the Glen Falloch schemes, and nothing else in the planning papers ([see here](#)) that explains who agreed it should be retained and

why. It now forms a prominent landscape scar in an area that was previously pristine and unmarred by development.

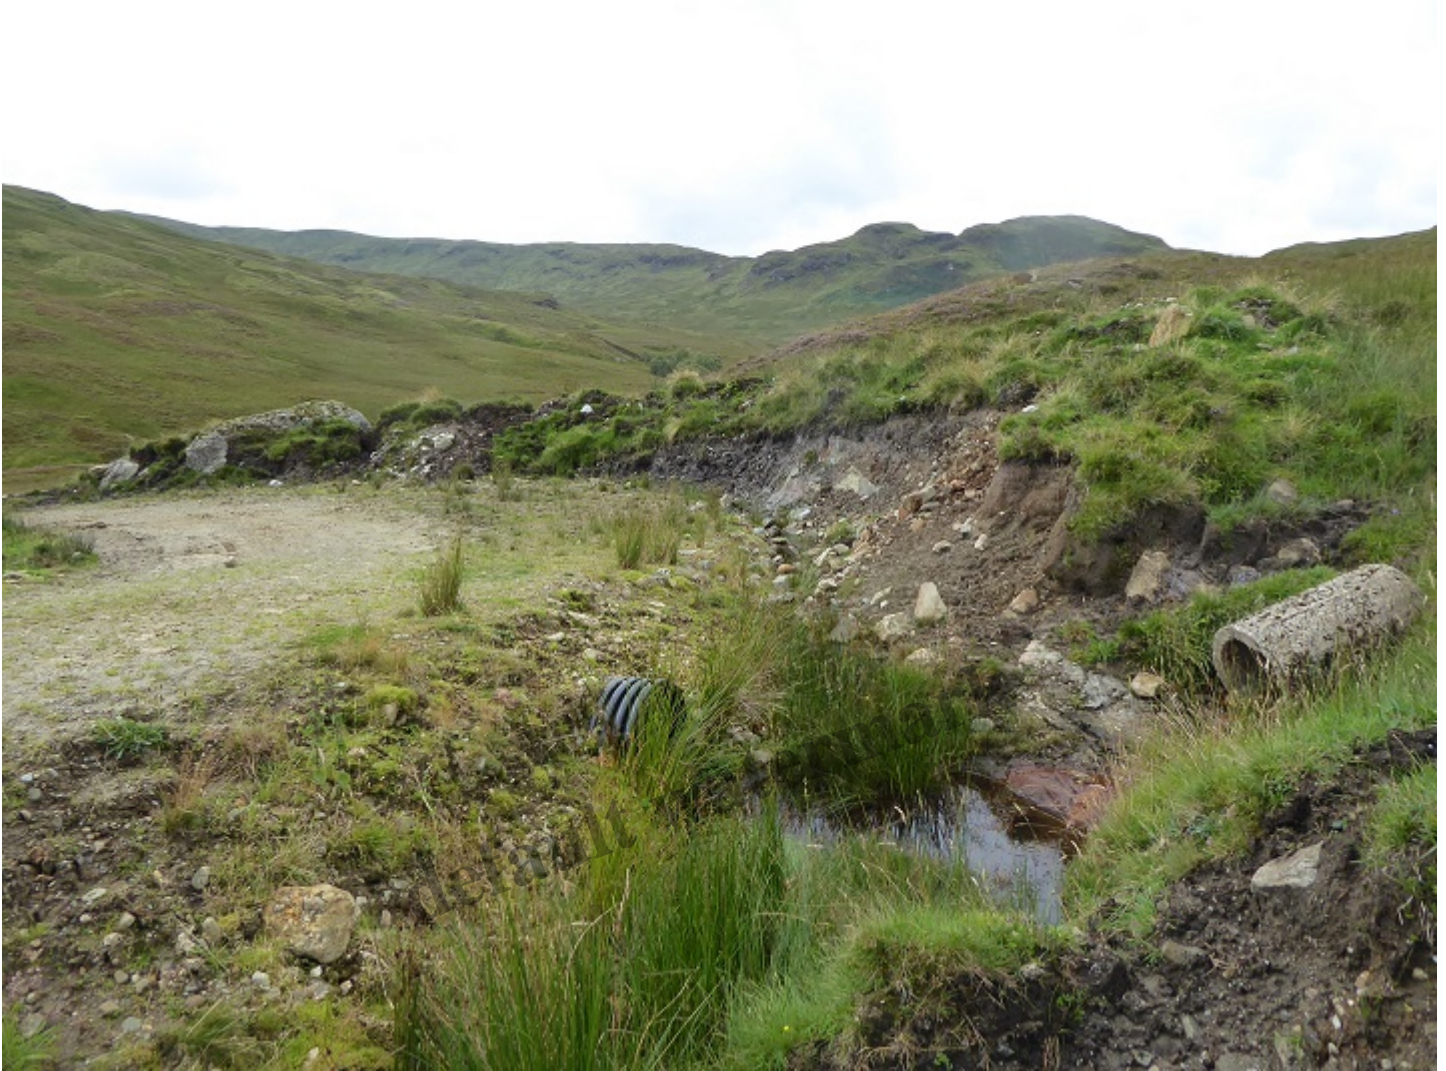
The abandoned concrete pipe indicates that the track reached here before the hydro was constructed but has subsequently been upgraded, with little attempt at restoration, and extended down to the site of the intake on the river.

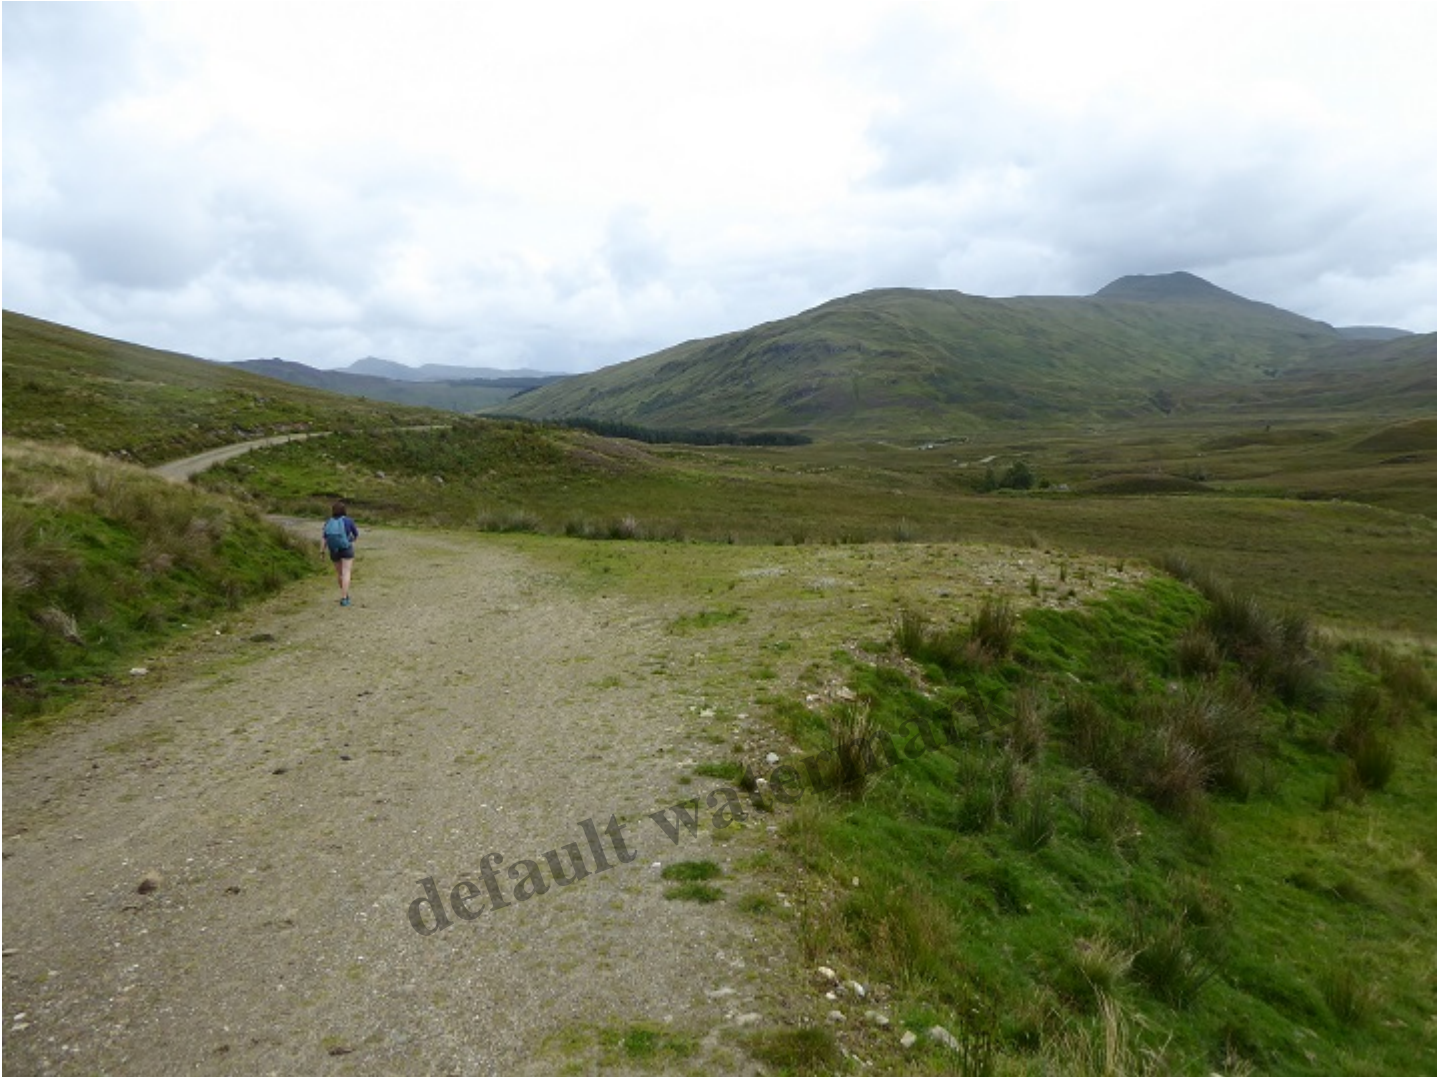
The upgraded track is in many places 4m or more wide, much broader than the LLTNPA's recommended maximum of 2.5m.

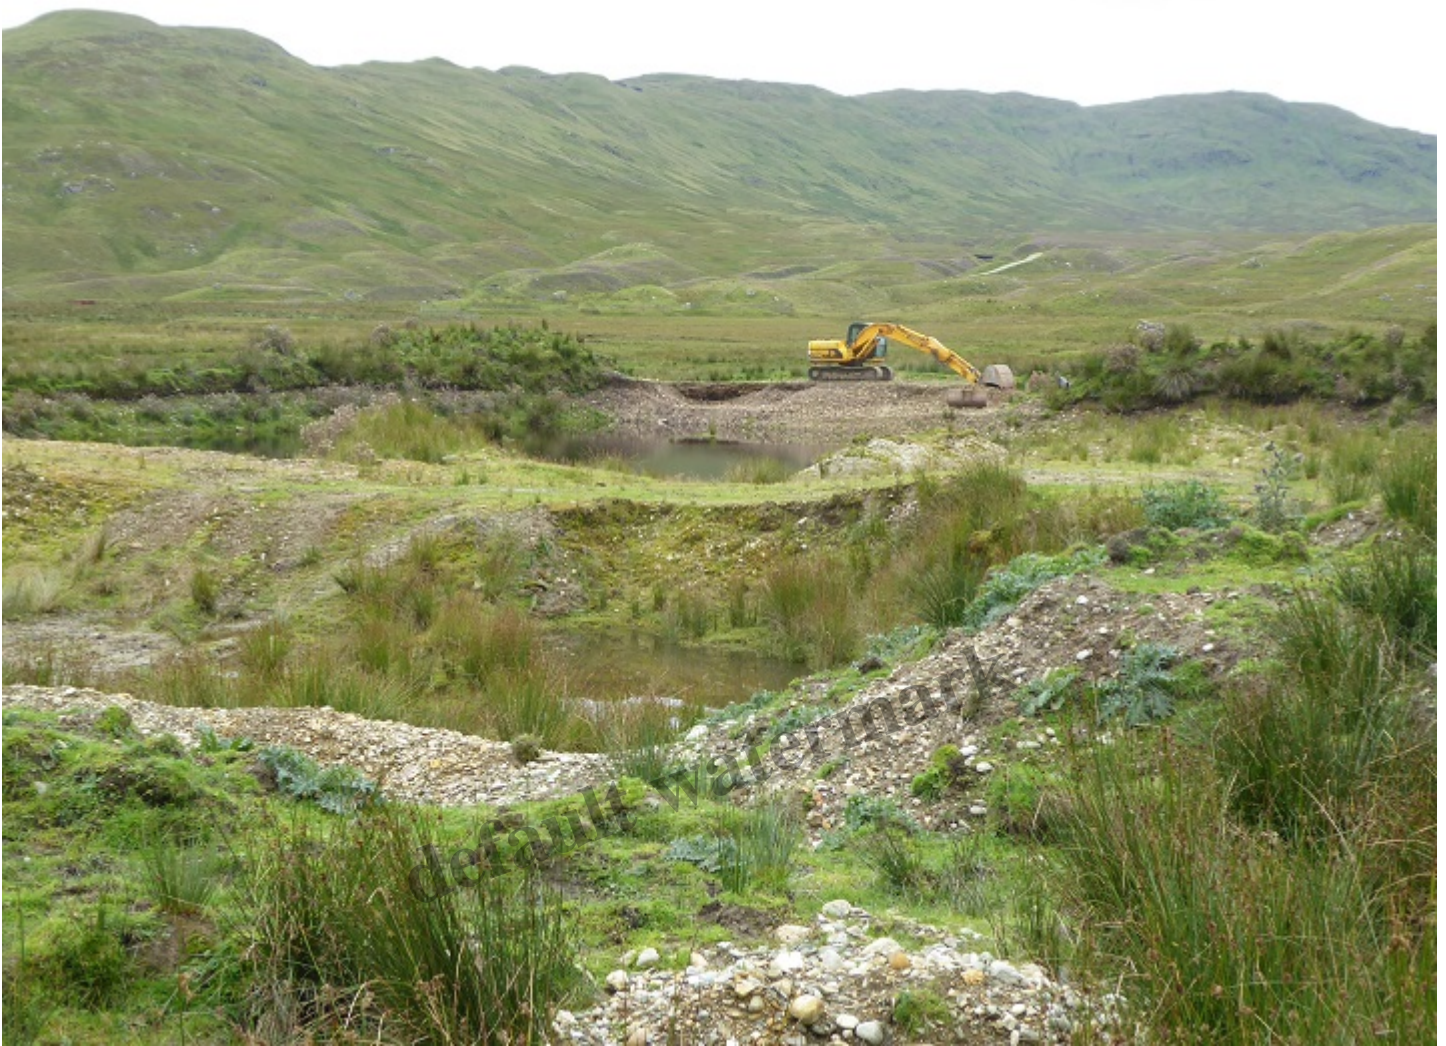
The borrow pits in the moraine still appear to be being worked with no attempt at restoration.

In the past when I have raised issues like this with the LLTNPA they have tended to respond “we were going to address the issues but we have five years to do so”. This scheme was approved in 2015, there is no obvious ongoing restoration work (the digger looks as if it might be adding to the destruction not reducing it) and time now appears to be running out.
