## More National Park hydro planning failures â?? Ballimore and Glen Ample

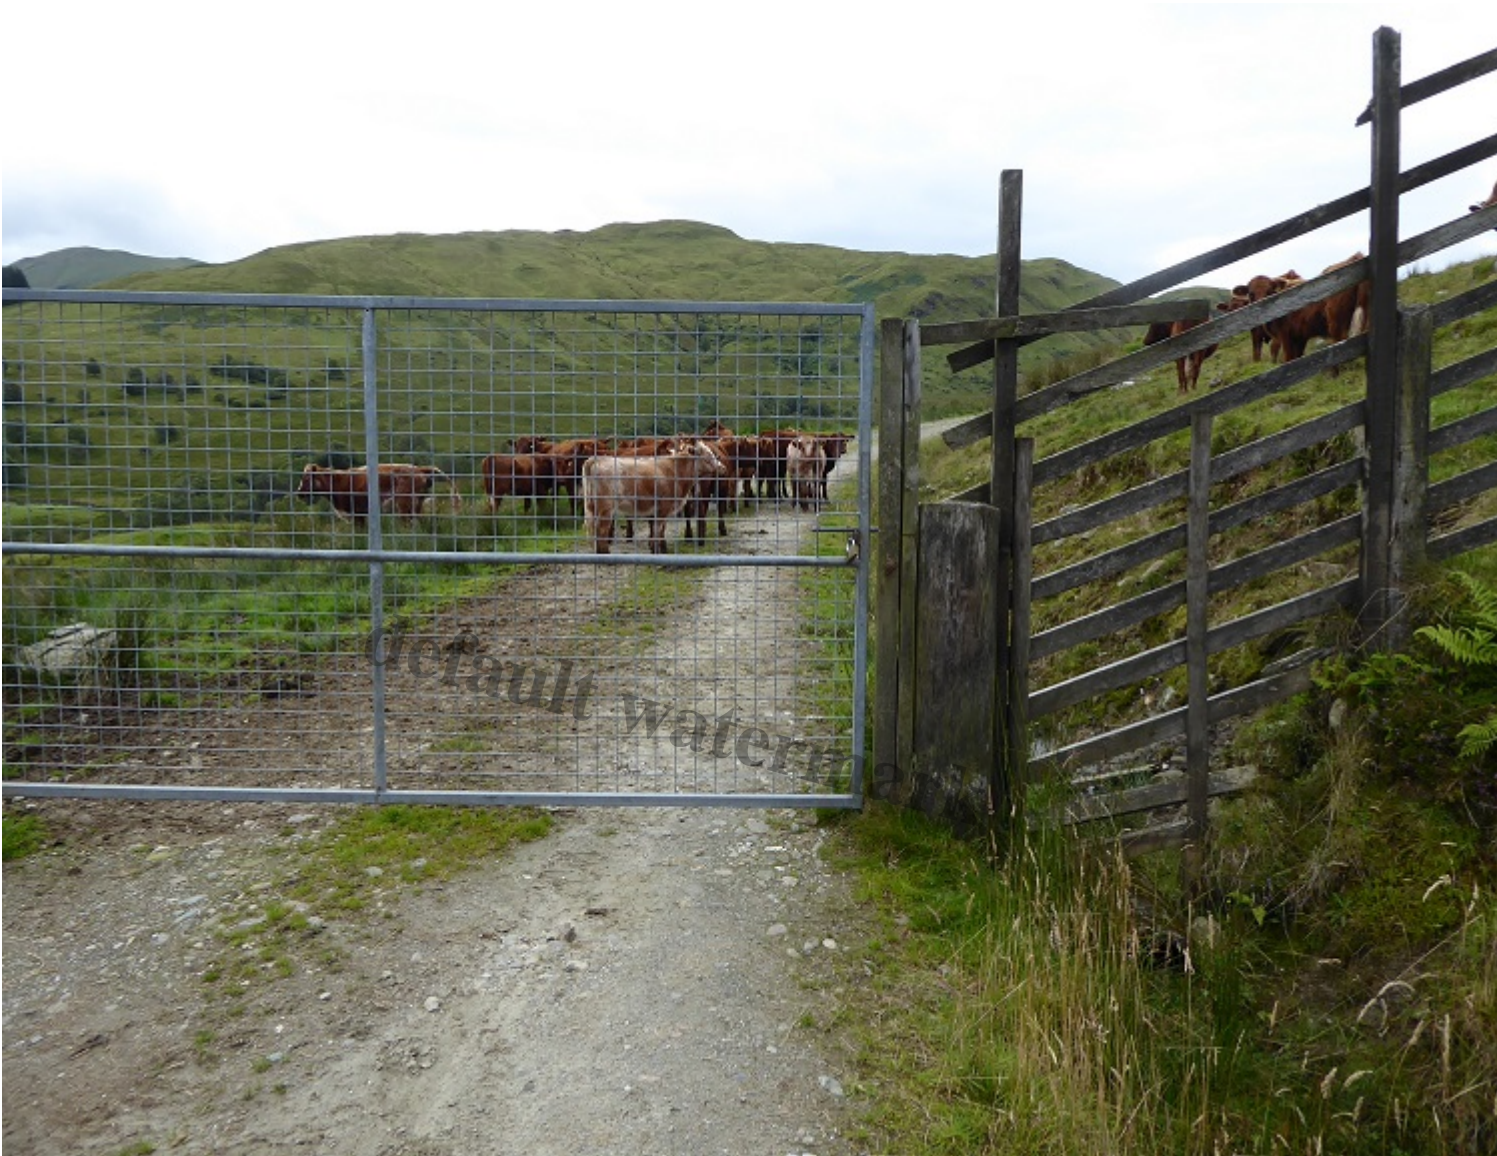
Shortly afterwards we came to a locked gate, the first of four I noted. All are contrary to our access legislation which makes it unlawful to obstruct access and the farm should not have done this. The combination of the locked gate and high deer fencing creates a barrier to access which many people would not be able to get past. In case you are wondering, there were cattle on both sides of the fence so the purpose of the locked gate is not to prevent rustling.

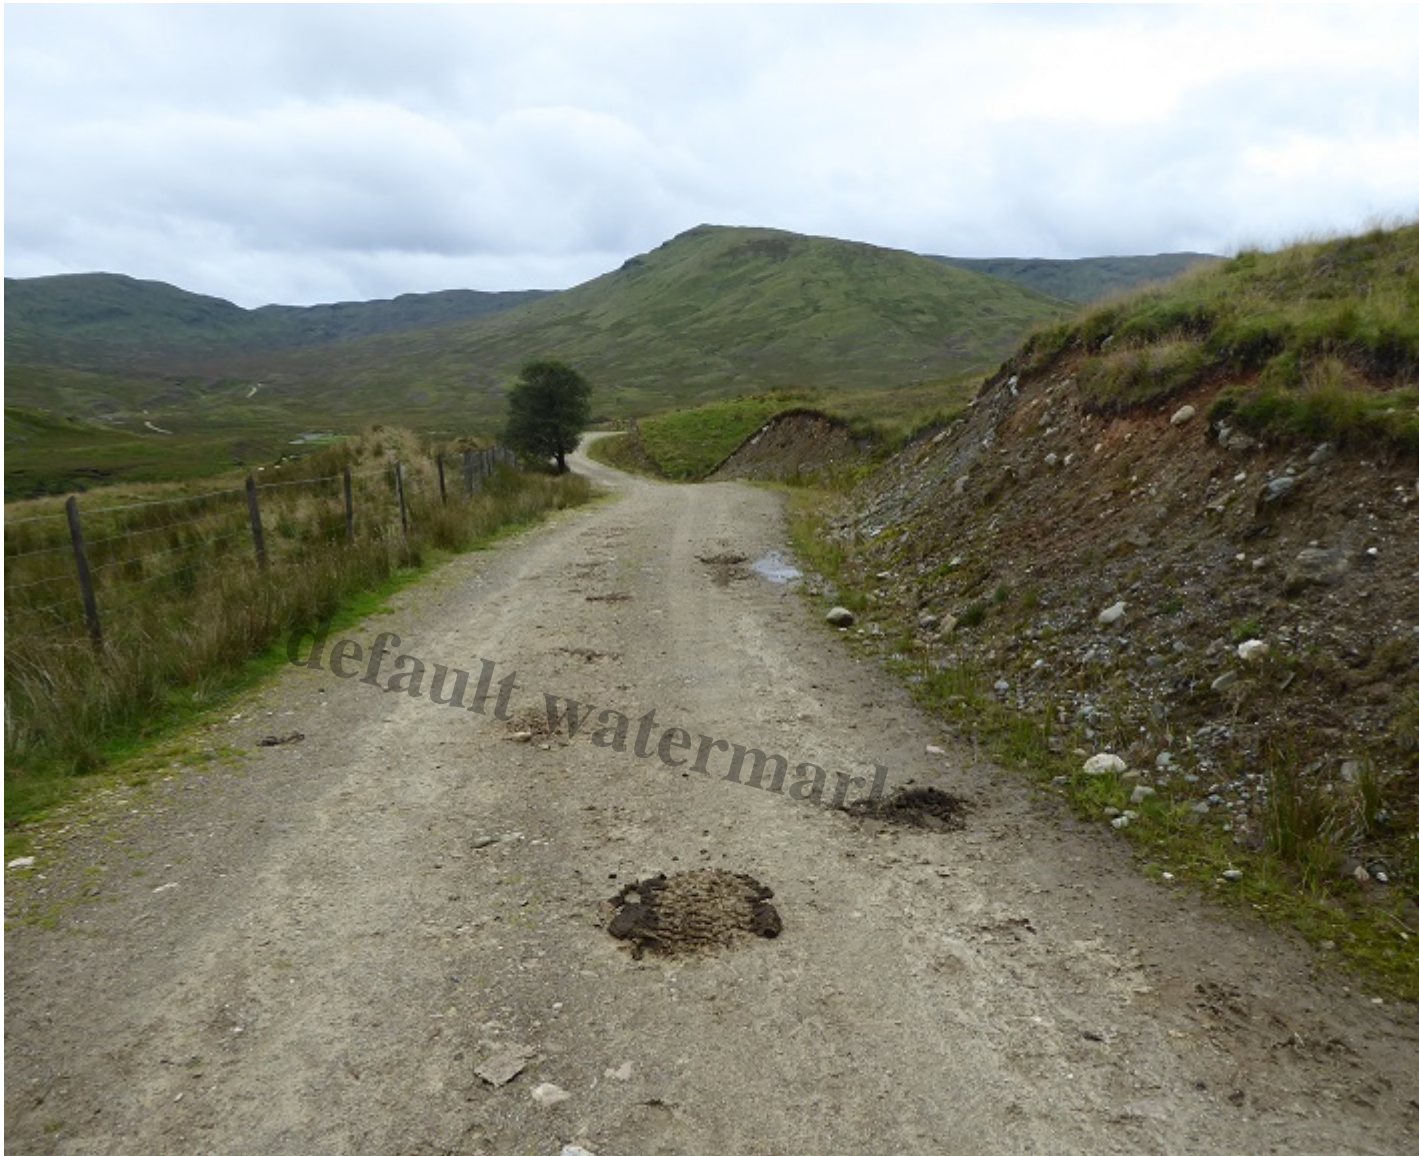
Note new hydro track in distance.

Beyond the second gate the old farm track had been widened for the construction of a hydro scheme, known as the Ballimore hydro, up Gleann Dubh. Its width has not been narrowed subsequently and no attempt has been made to restore the cut banks, all contrary to the LLTNPA good practice guidance on renewables and the Construction Method Statement approved by the planning application:

The Planning Application also contains the usual turf management plan and landscape provisions but all have been ignored.

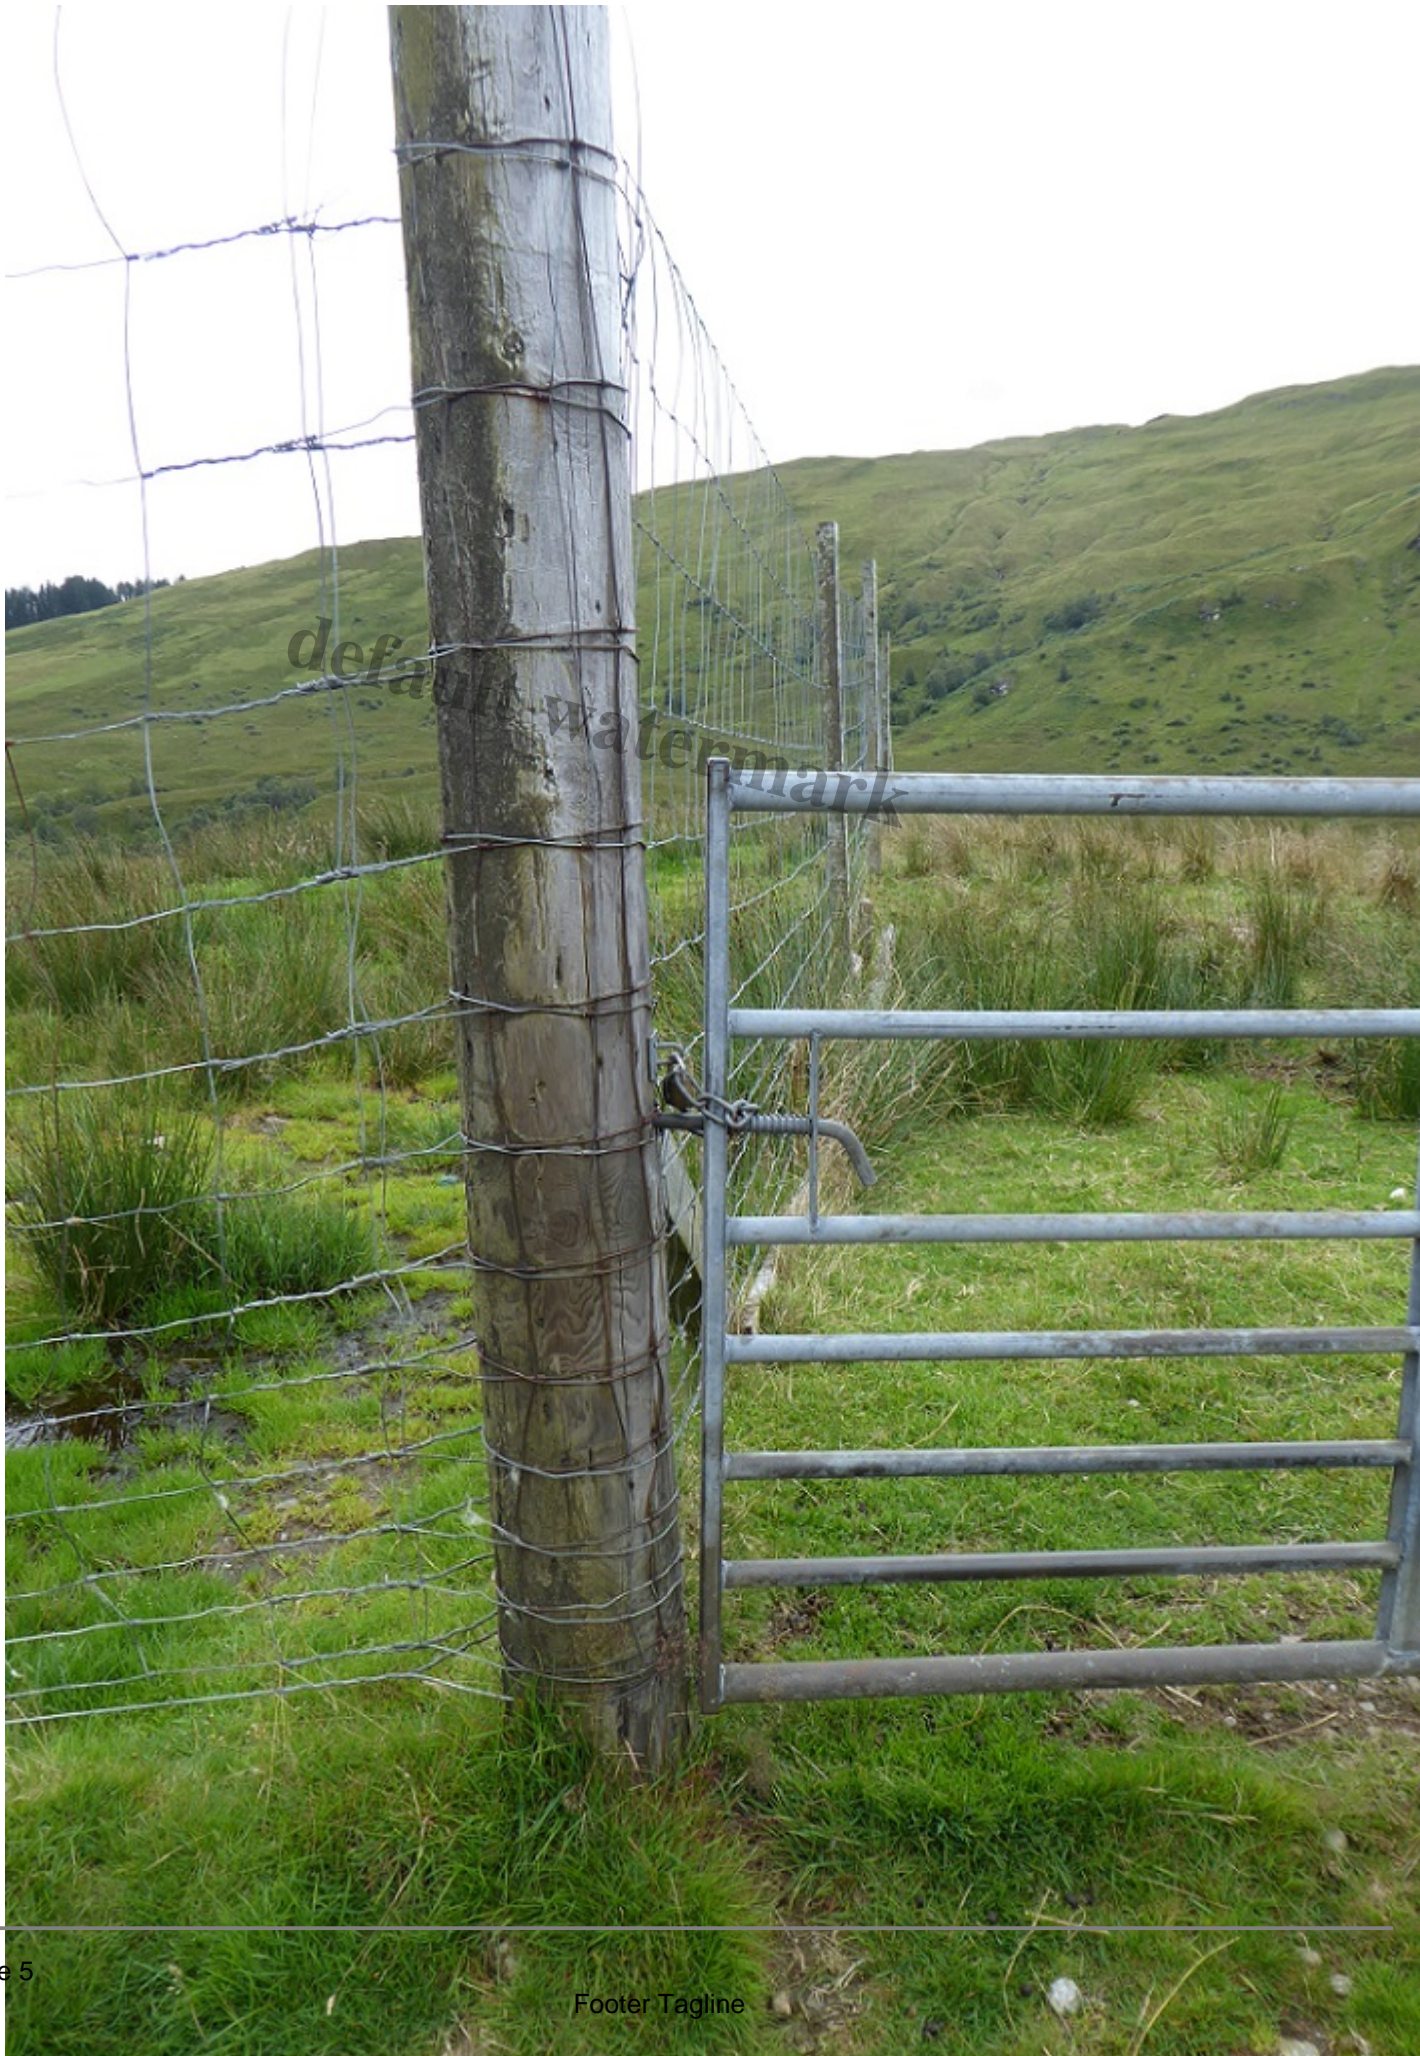
Third locked gate, this one easier to hop over.

The pipeline lies behind the gate and the ground above has, as is usual where hydro schemes are constructed on in-bye land, recovered far better than the track. It is now, however, covered in soft rush which is generally avoided by cattle. Hydro schemes are not without their costs to farmers and food production.

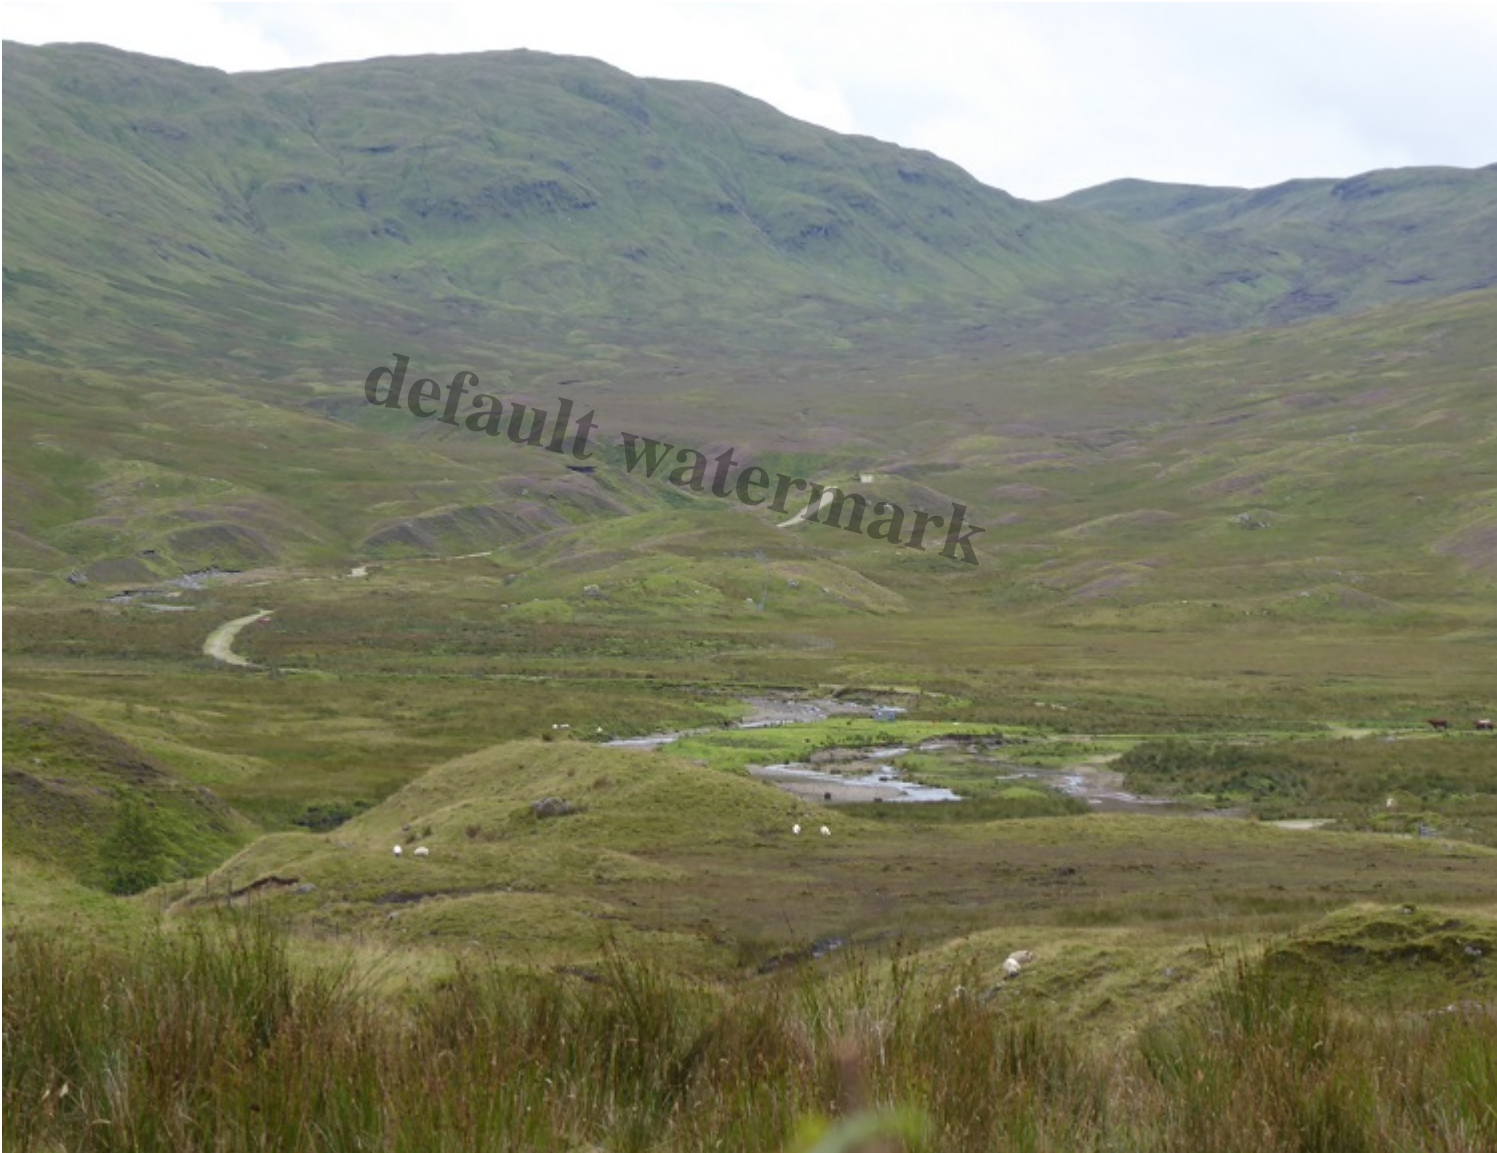
The mid-section of Gleann Dubh is covered by fine hummocky moraine. There are two intakes to the hydro scheme – originally three were planned – and it was agreed a new temporary track should be constructed across the Allt Fathan Glinne to build the first intake:

I can find no subsequent application to retain the track, as happened with the Glen Falloch schemes, and nothing else in the planning papers ([see here](#)) that explains who agreed it should be retained and

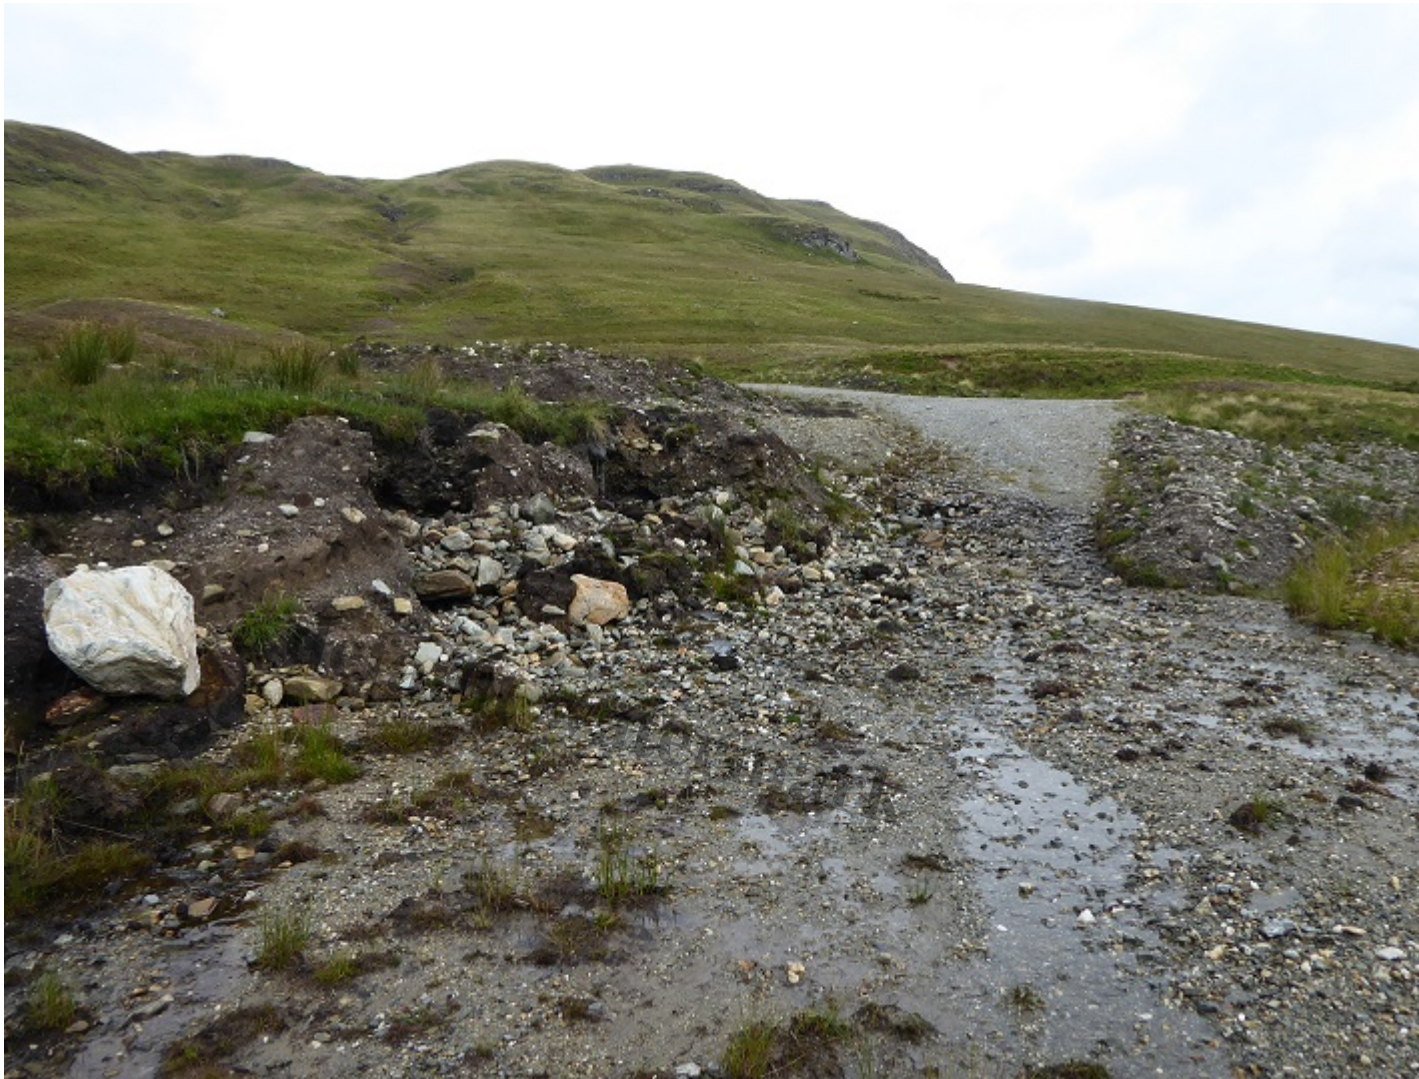
The reason this looks terrible is because in ecological terms it is terrible.

One wonders how any LLTNPA Planning Officer could, for one moment, have thought this was acceptable. What is the point of imposing planning conditions to protect peat (‘‘minimise disturbance and exposure of peat during construction’’) and stop sediment flowing into rivers if they are ignored and this is allowed to happen? But perhaps the LLTNPA Planning Officer was not allowed to visit by their bosses?

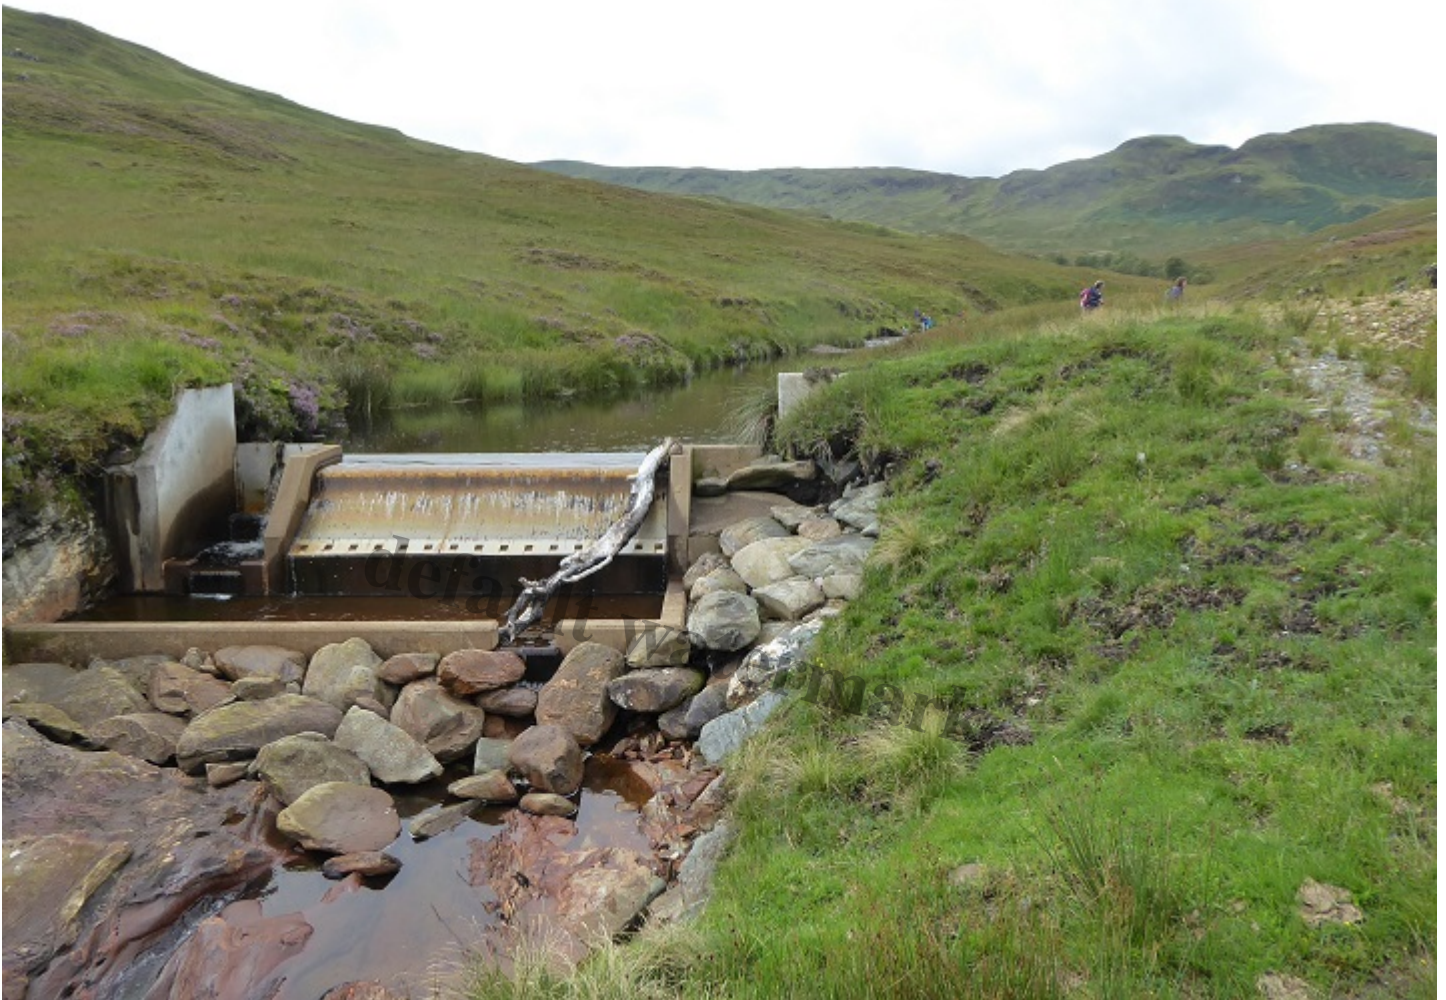
Restoration has taken place on the banks by the intake â?? so why not on the ground above and around the track?

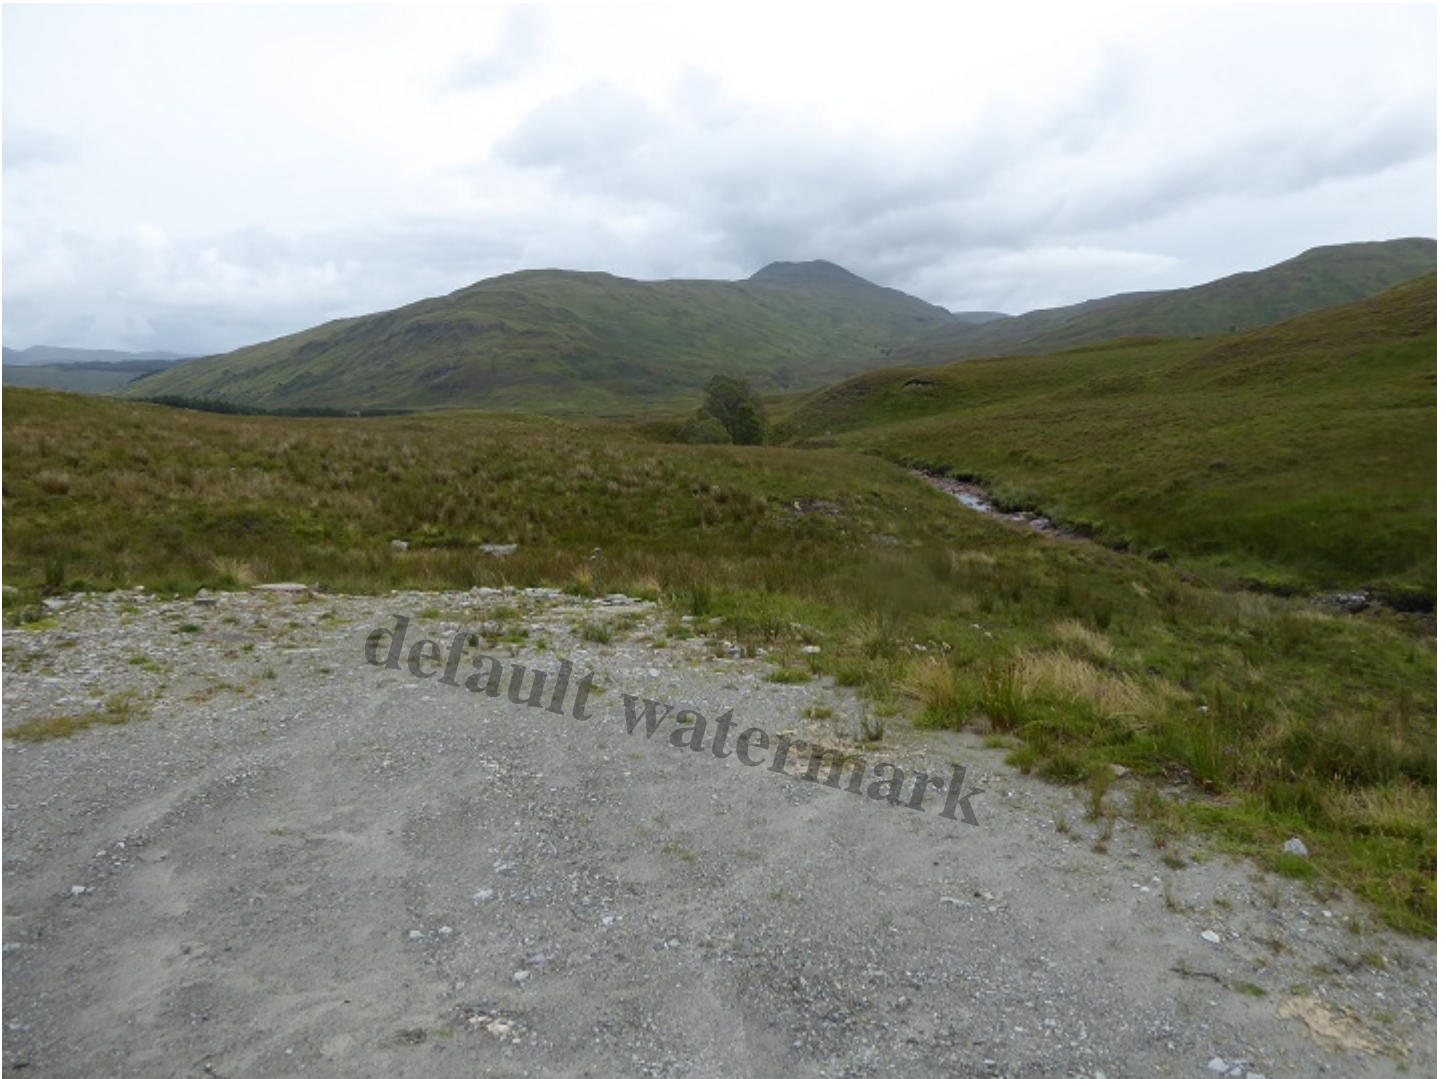
There is no justification for leaving large areas like this used to store materials as turning circles:

But if developers can get away with not doing what they say they will do it adds to their profits (and means less people are employed in the countryside).

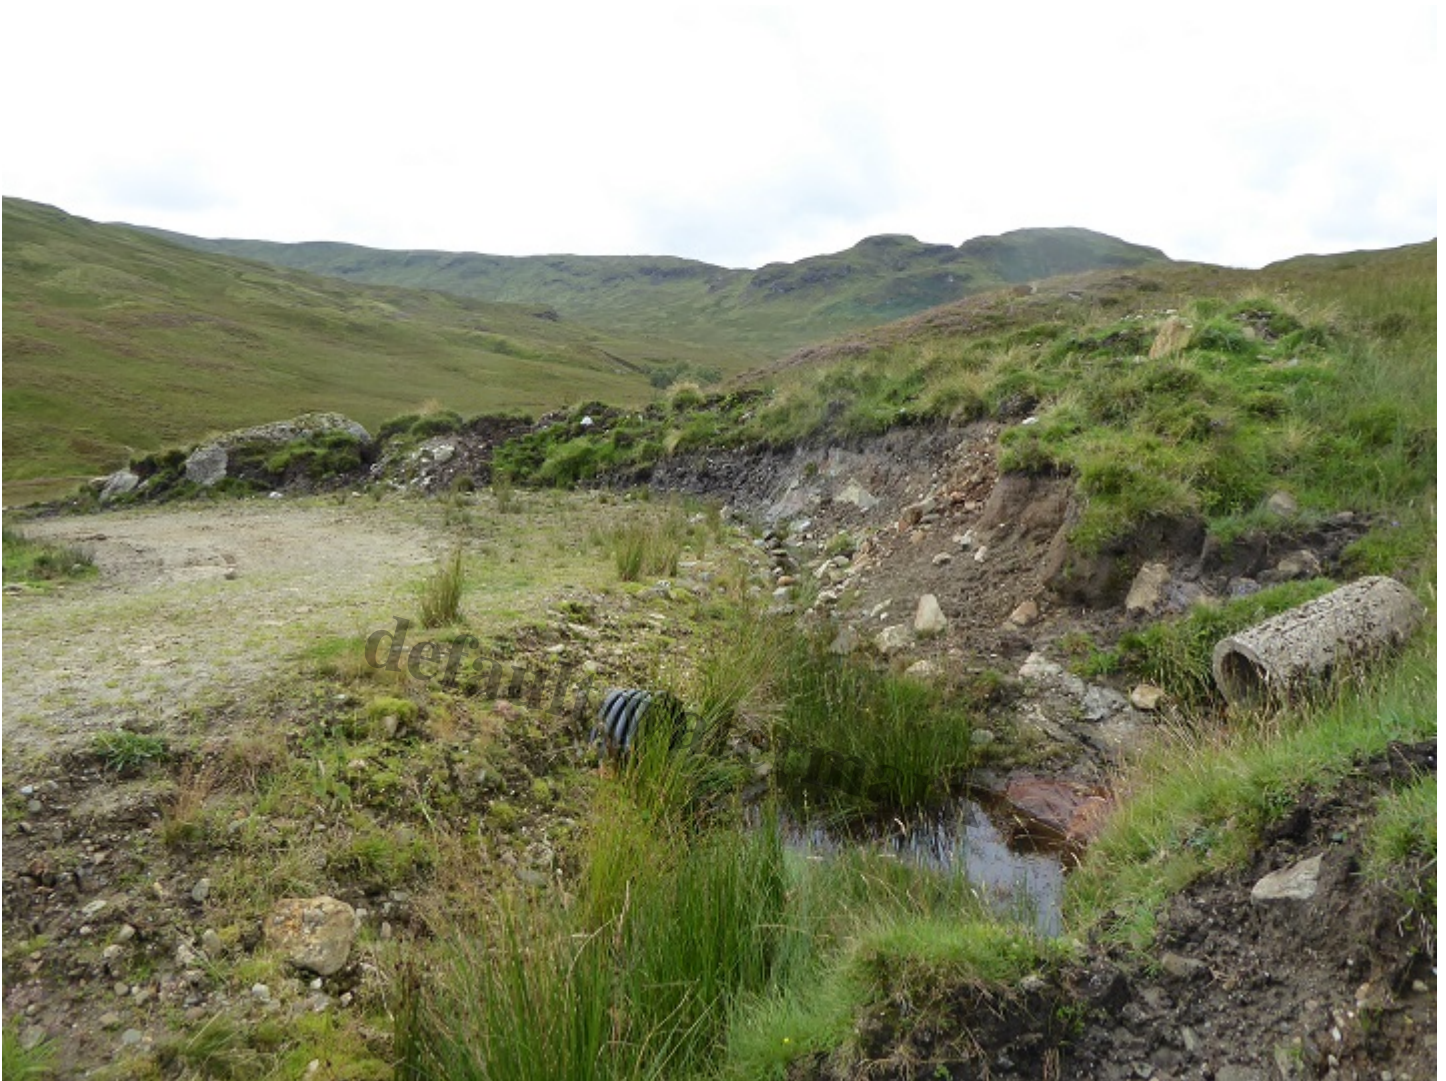
The abandoned concrete pipe indicates that the track reached here before the hydro was constructed but has subsequently been upgraded, with little attempt at restoration, and extended down to the site if the intake on the river.

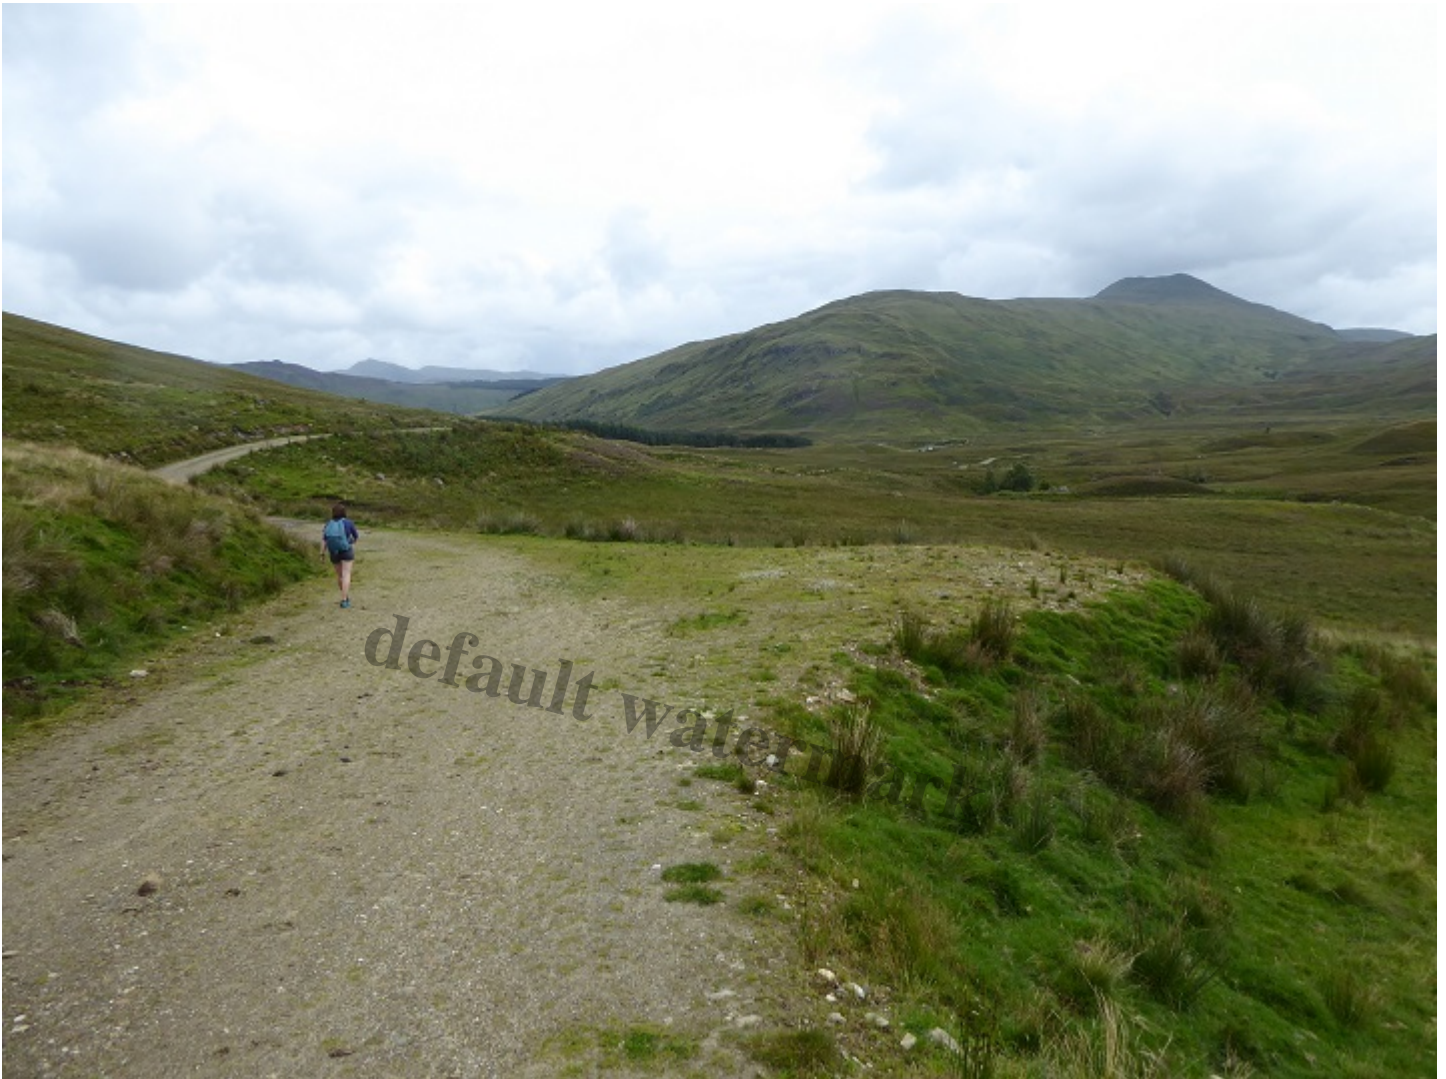
The upgraded track is in many places 4m or more wide, much broader than the LLTNPA's recommended maximum of 2.5m.

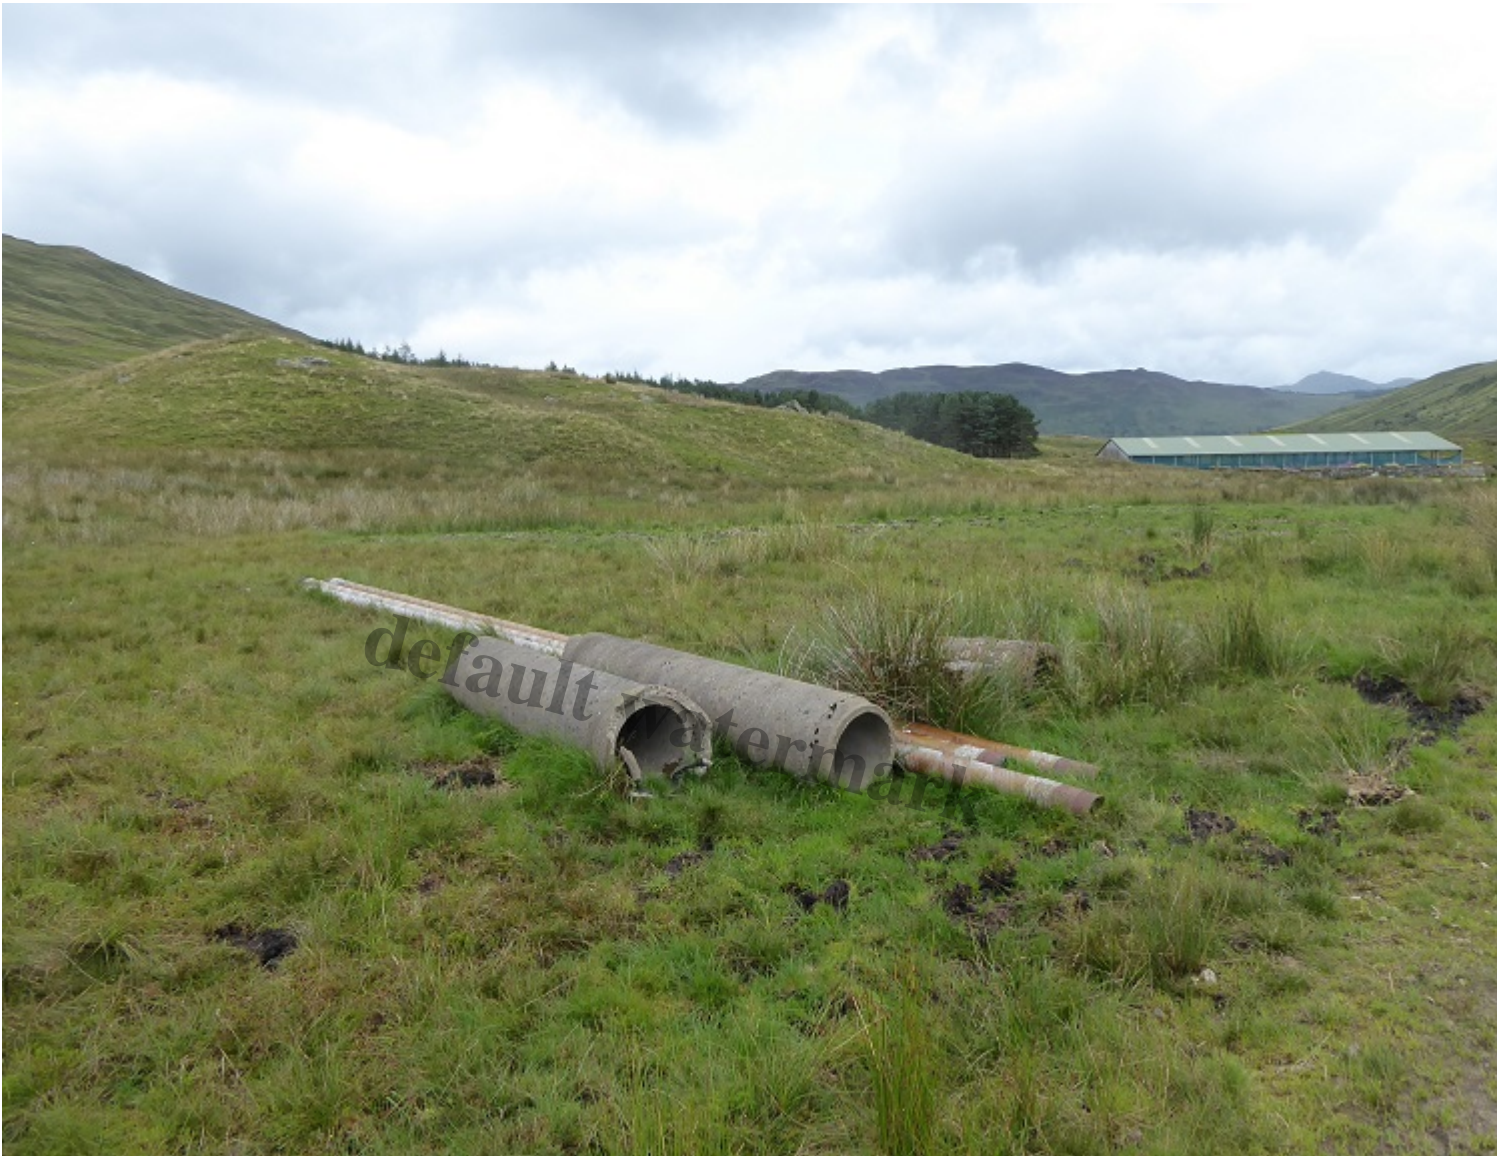
In the vicinity of the large farm building there were two more collections of concrete pipes that appear to have been replaced by plastic ones when the track was widened. What's worse for the environment, concrete or plastic?

The LLTNPA could have used its planning powers to at least ensure that all the detritus created by the hydro scheme was removed. There is so much profit being made out of hydro that developers could easily afford to dispose of waste properly. Ensuring even that, however, seems to be completely beyond the LLTNPA.

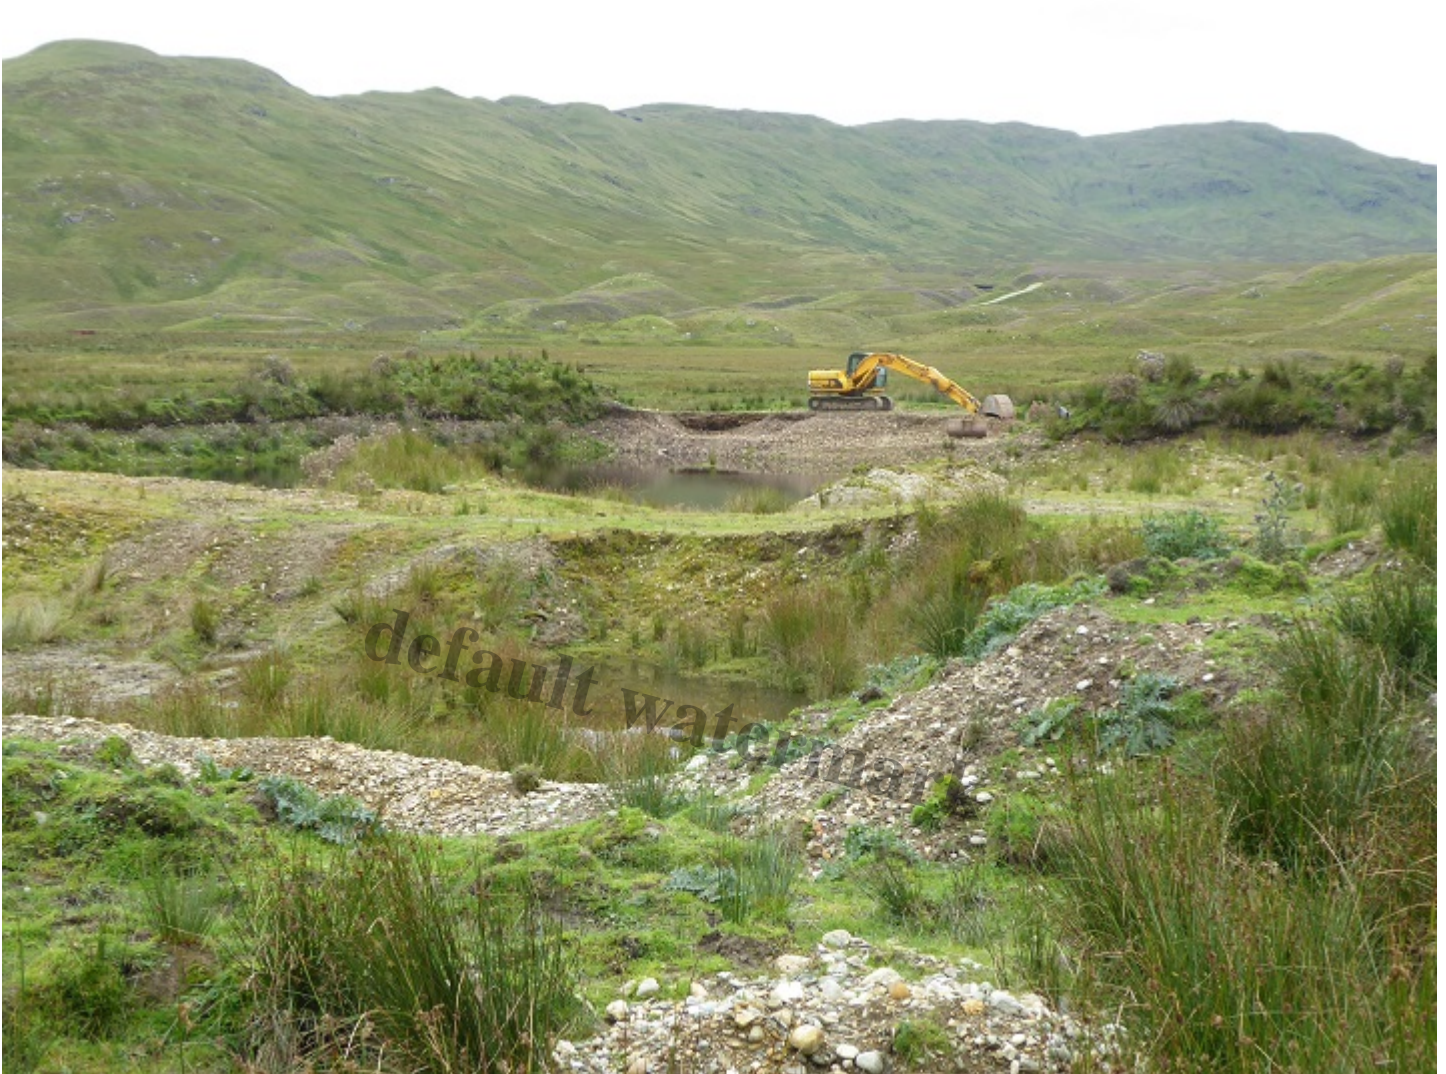
The borrow pits in the moraine still appear to be being worked with no attempt at restoration.

In the past when I have raised issues like this with the LLTNPA they have tended to respond â??we were going to address the issues but we have five years to do soâ??. This scheme was approved in 2015, there is no obvious ongoing restoration work (the digger looks as if it might be adding to the destruction not reducing it) and time now appears to be running out.

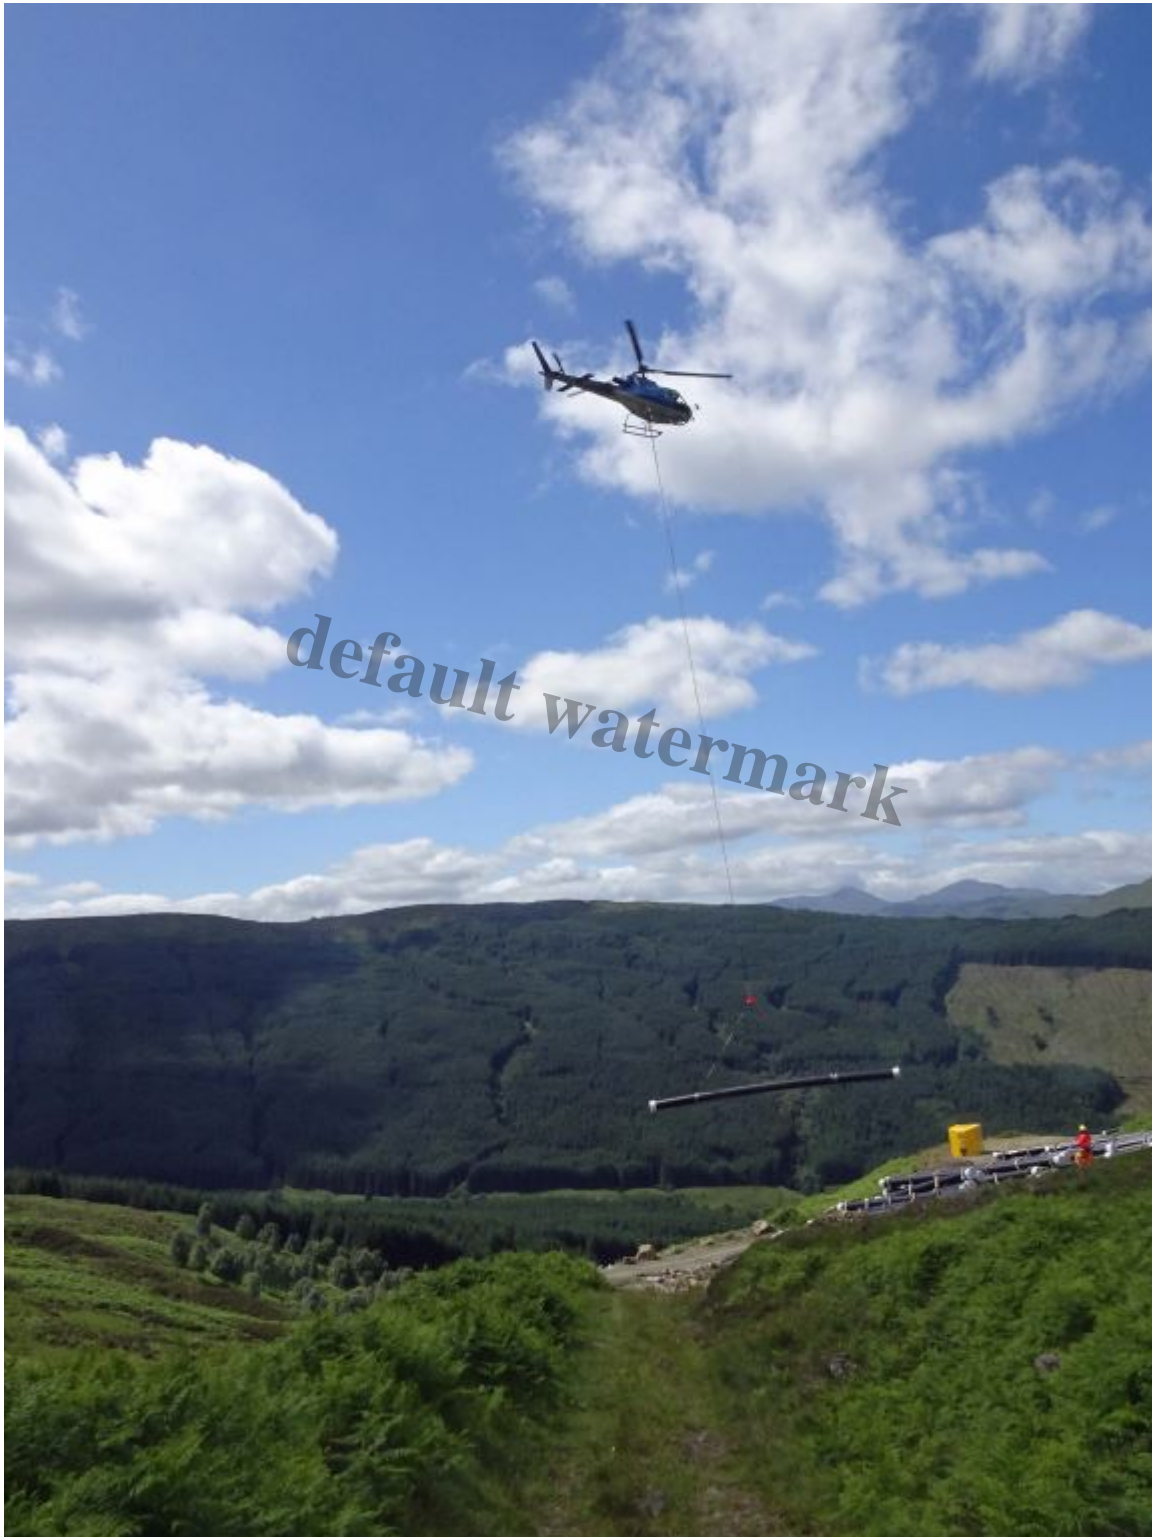
Construction after lockdown. Note the appearance of the track in the foreground. The track down to Glenample Farm used to be pleasant.

On the basis that if you don't complain, the LLTNPA will never address the issues, I have asked the LLTNPA Planners to go and check now whether they are satisfied that their planning conditions are being met for the new hydro scheme in Glen Ample. I was sent some photos from a reader just after lockdown that show that it has already caused serious damage to the landscape and unless the
