## More National Park hydro planning failures â?? Ballimore and Glen Ample

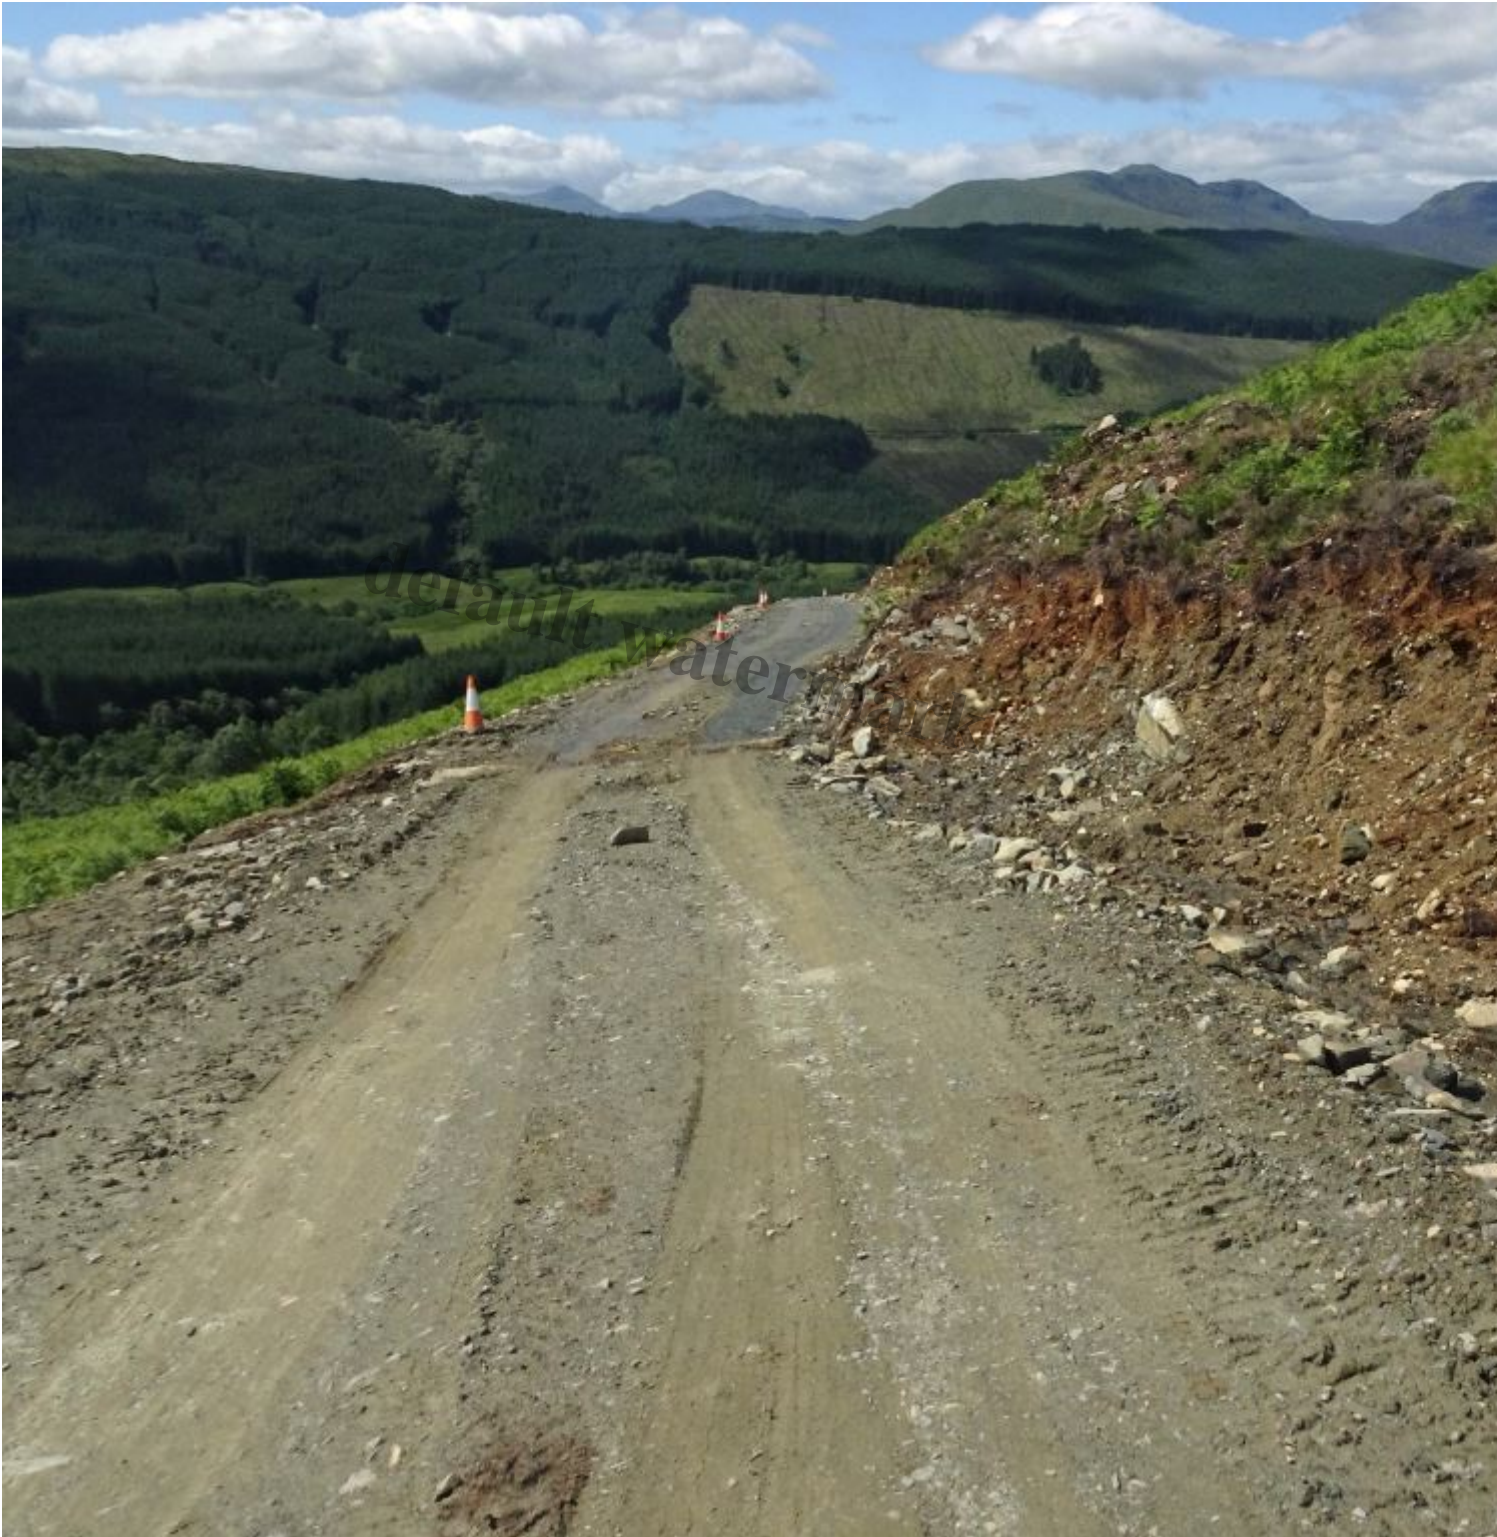
The vertical cutting of the slope has created a bench running across the hillside that is contrary to the Park's best practice guidelines. There is no sign of any of the turf that has been removed to create this and, as a consequence, effective restoration will be even more difficult.
