More National Park hydro planning failures – Ballimore and Glen Ample

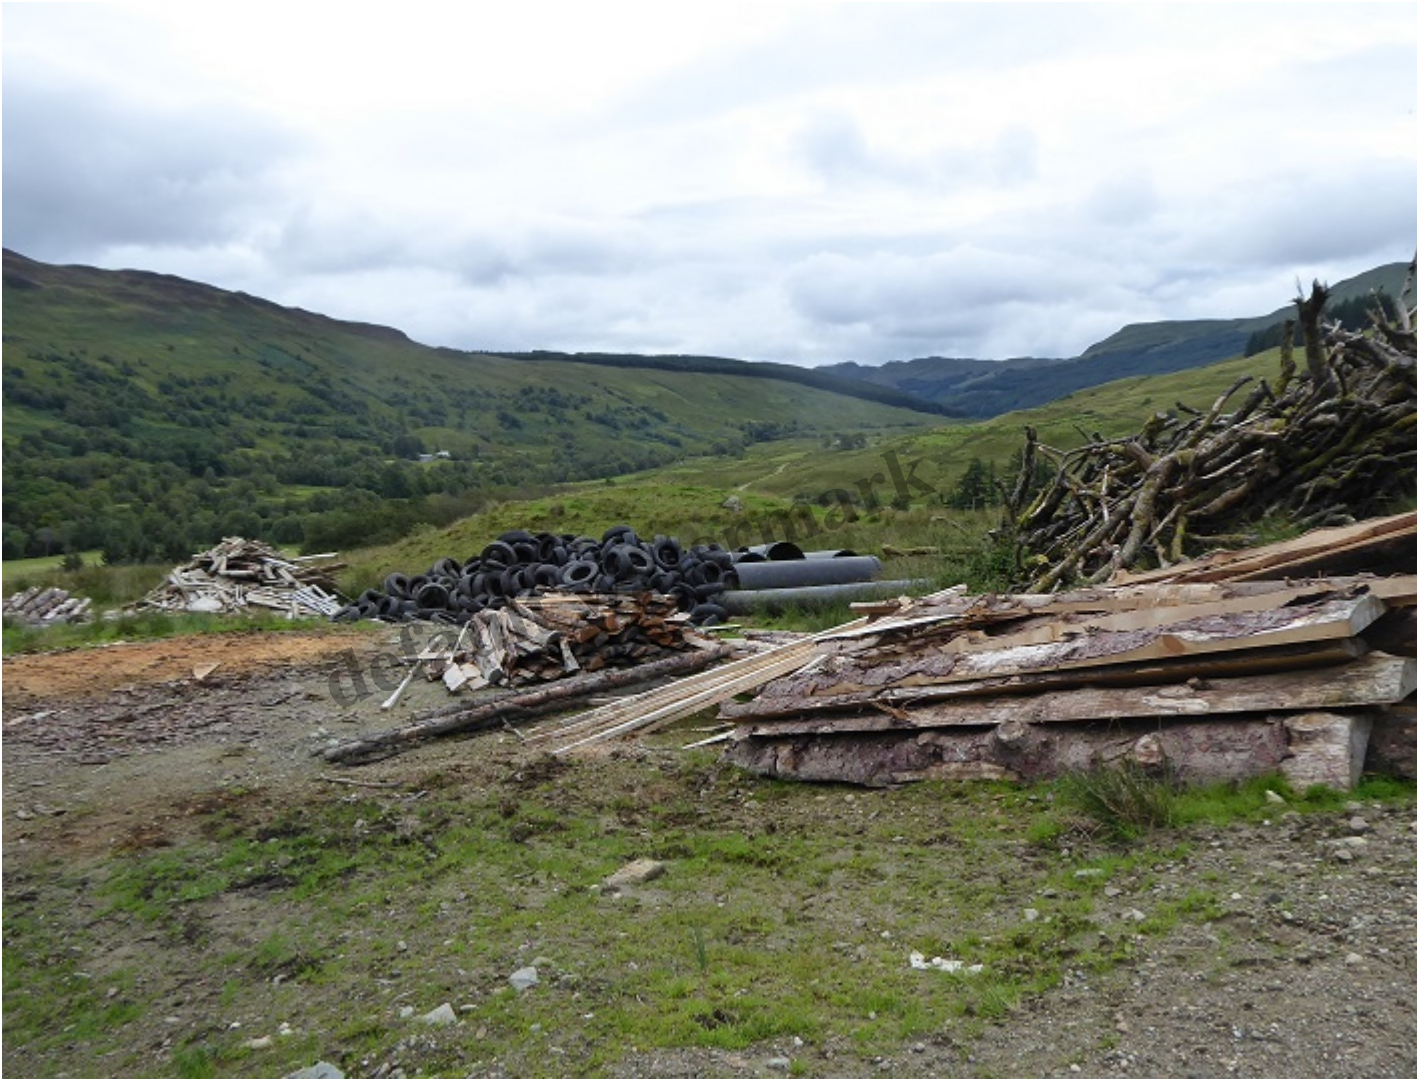
Looking up towards the head of Glen Buckie from a track north of Ballimore Farm. Note the pipes.

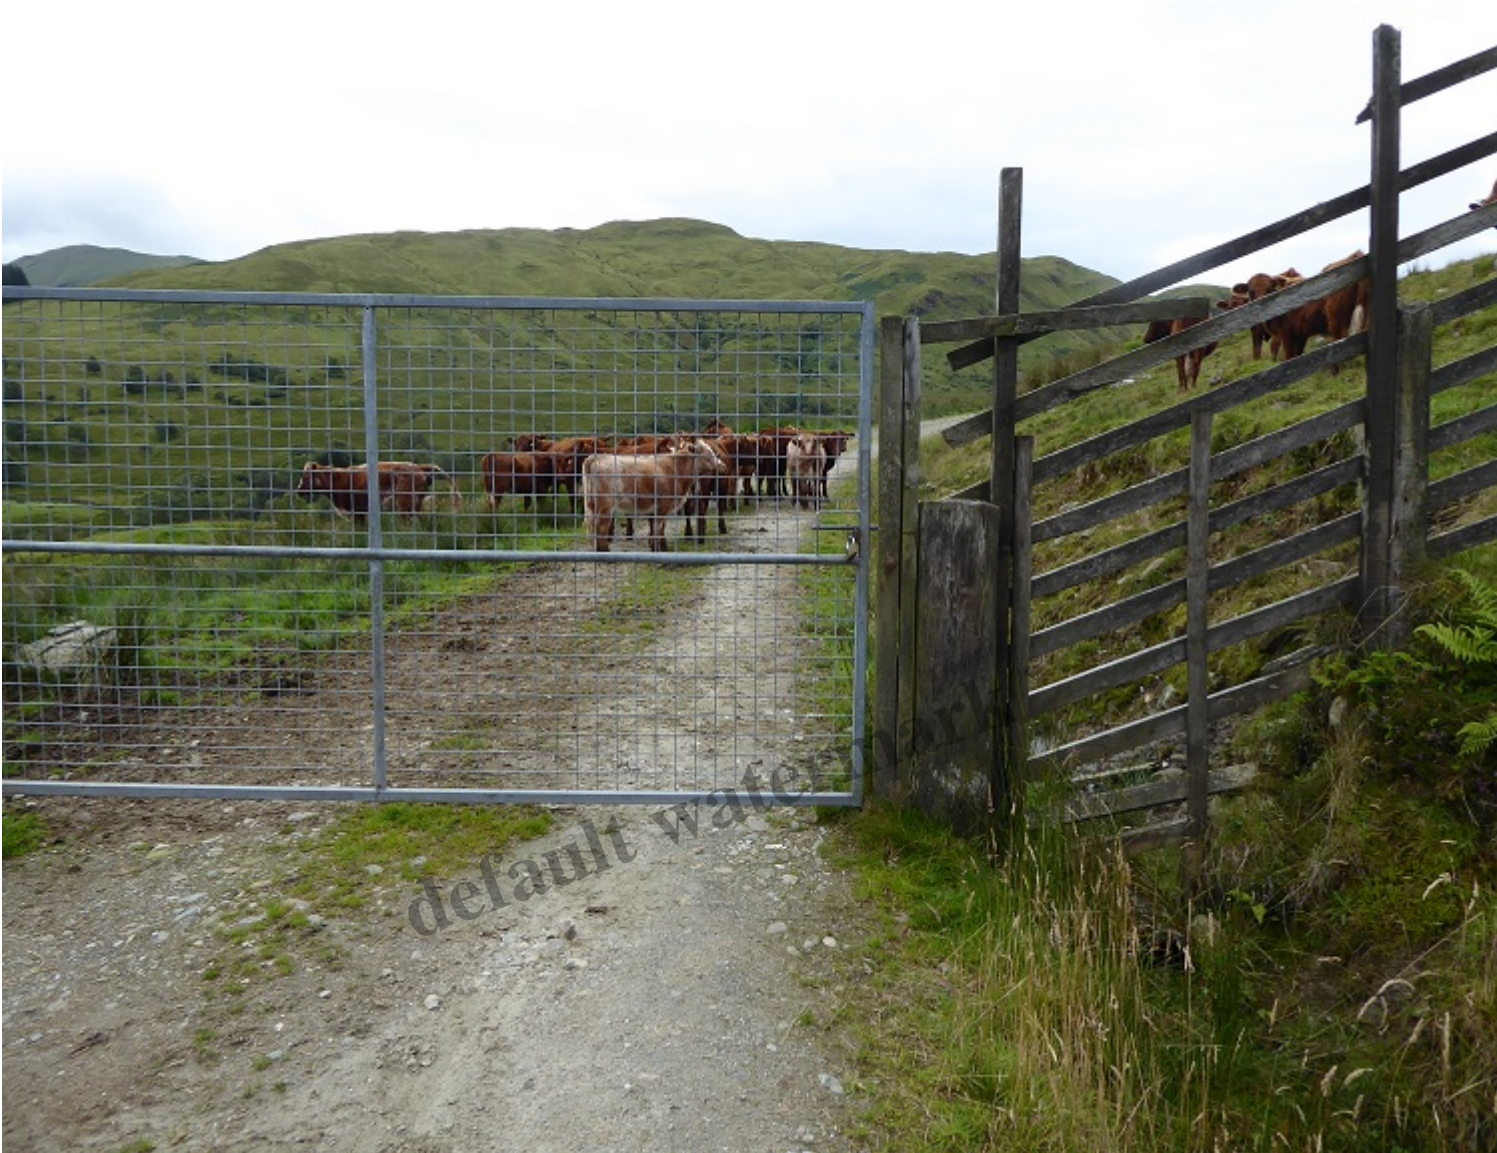
Shortly afterwards we came to a locked gate, the first of four I noted. All are contrary to our access legislation which makes it unlawful to obstruct access and the farm should not have done this. The combination of the locked gate and high deer fencing creates a barrier to access which many people would not be able to get past. In case you are wondering, there were cattle on both sides of the fence so the purpose of the locked gate is not to prevent rustling.

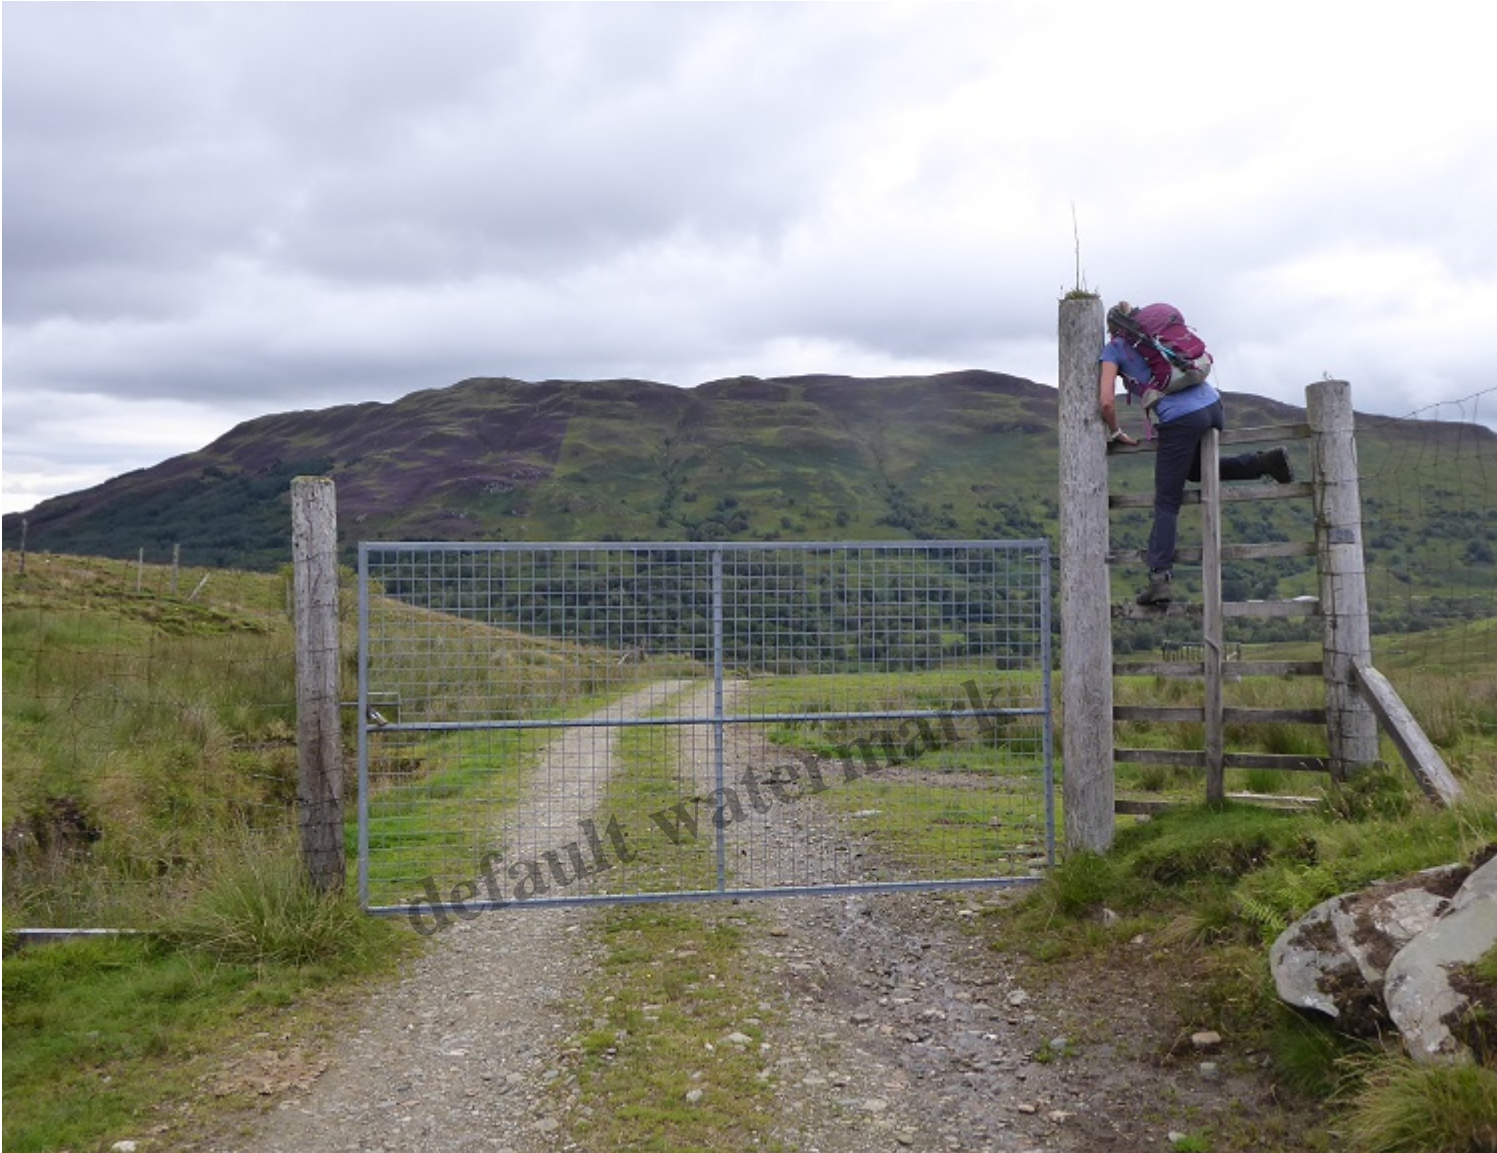
Climbing fences may be ok if you are fit, but people should be able to walk and cycle up this glen – how many members of Loch Lomond and Trossachs National Park Authority could cross the fence with a bike? The LLTNPA as Access Authority has a statutory duty to uphold access rights but is still failing dismally on the ground.

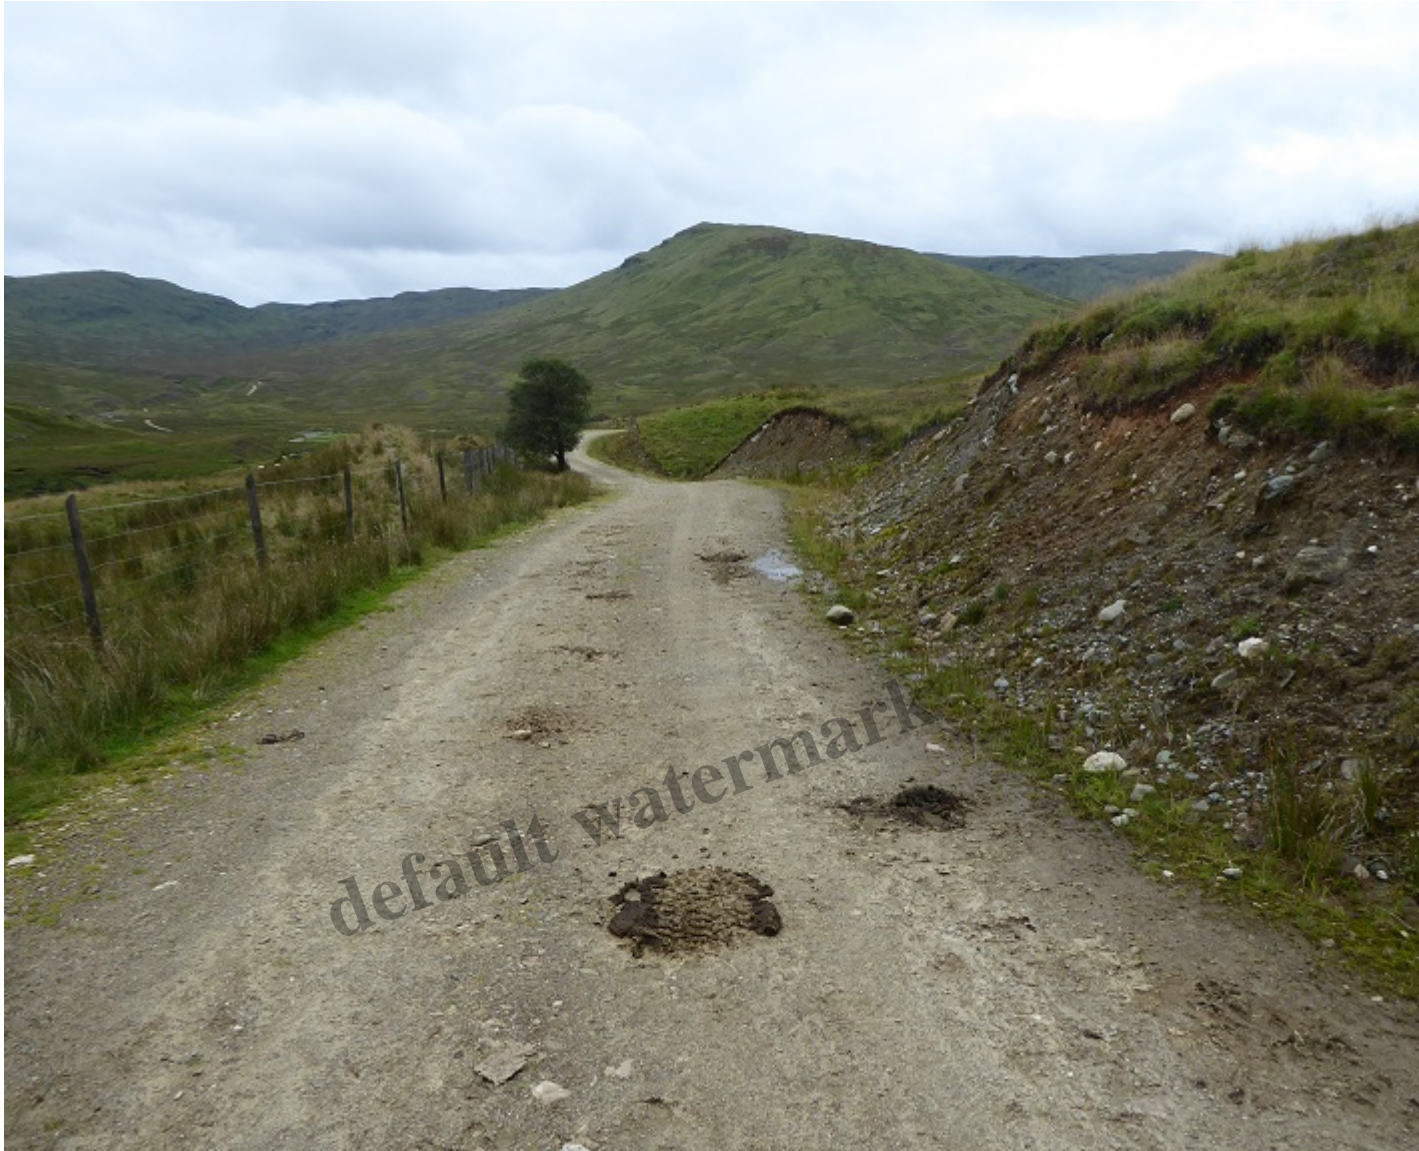
Note new hydro track in distance.

Beyond the second gate the old farm track had been widened for the construction of a hydro scheme, known as the Ballimore hydro, up Gleann Dubh. Its width has not been narrowed subsequently and no attempt has been made to restore the cut banks, all contrary to the LLTNPA good practice guidance on renewables and the Construction Method Statement approved by the planning application:

The Planning Application also contains the usual turf management plan and landscape provisions but all have been ignored.

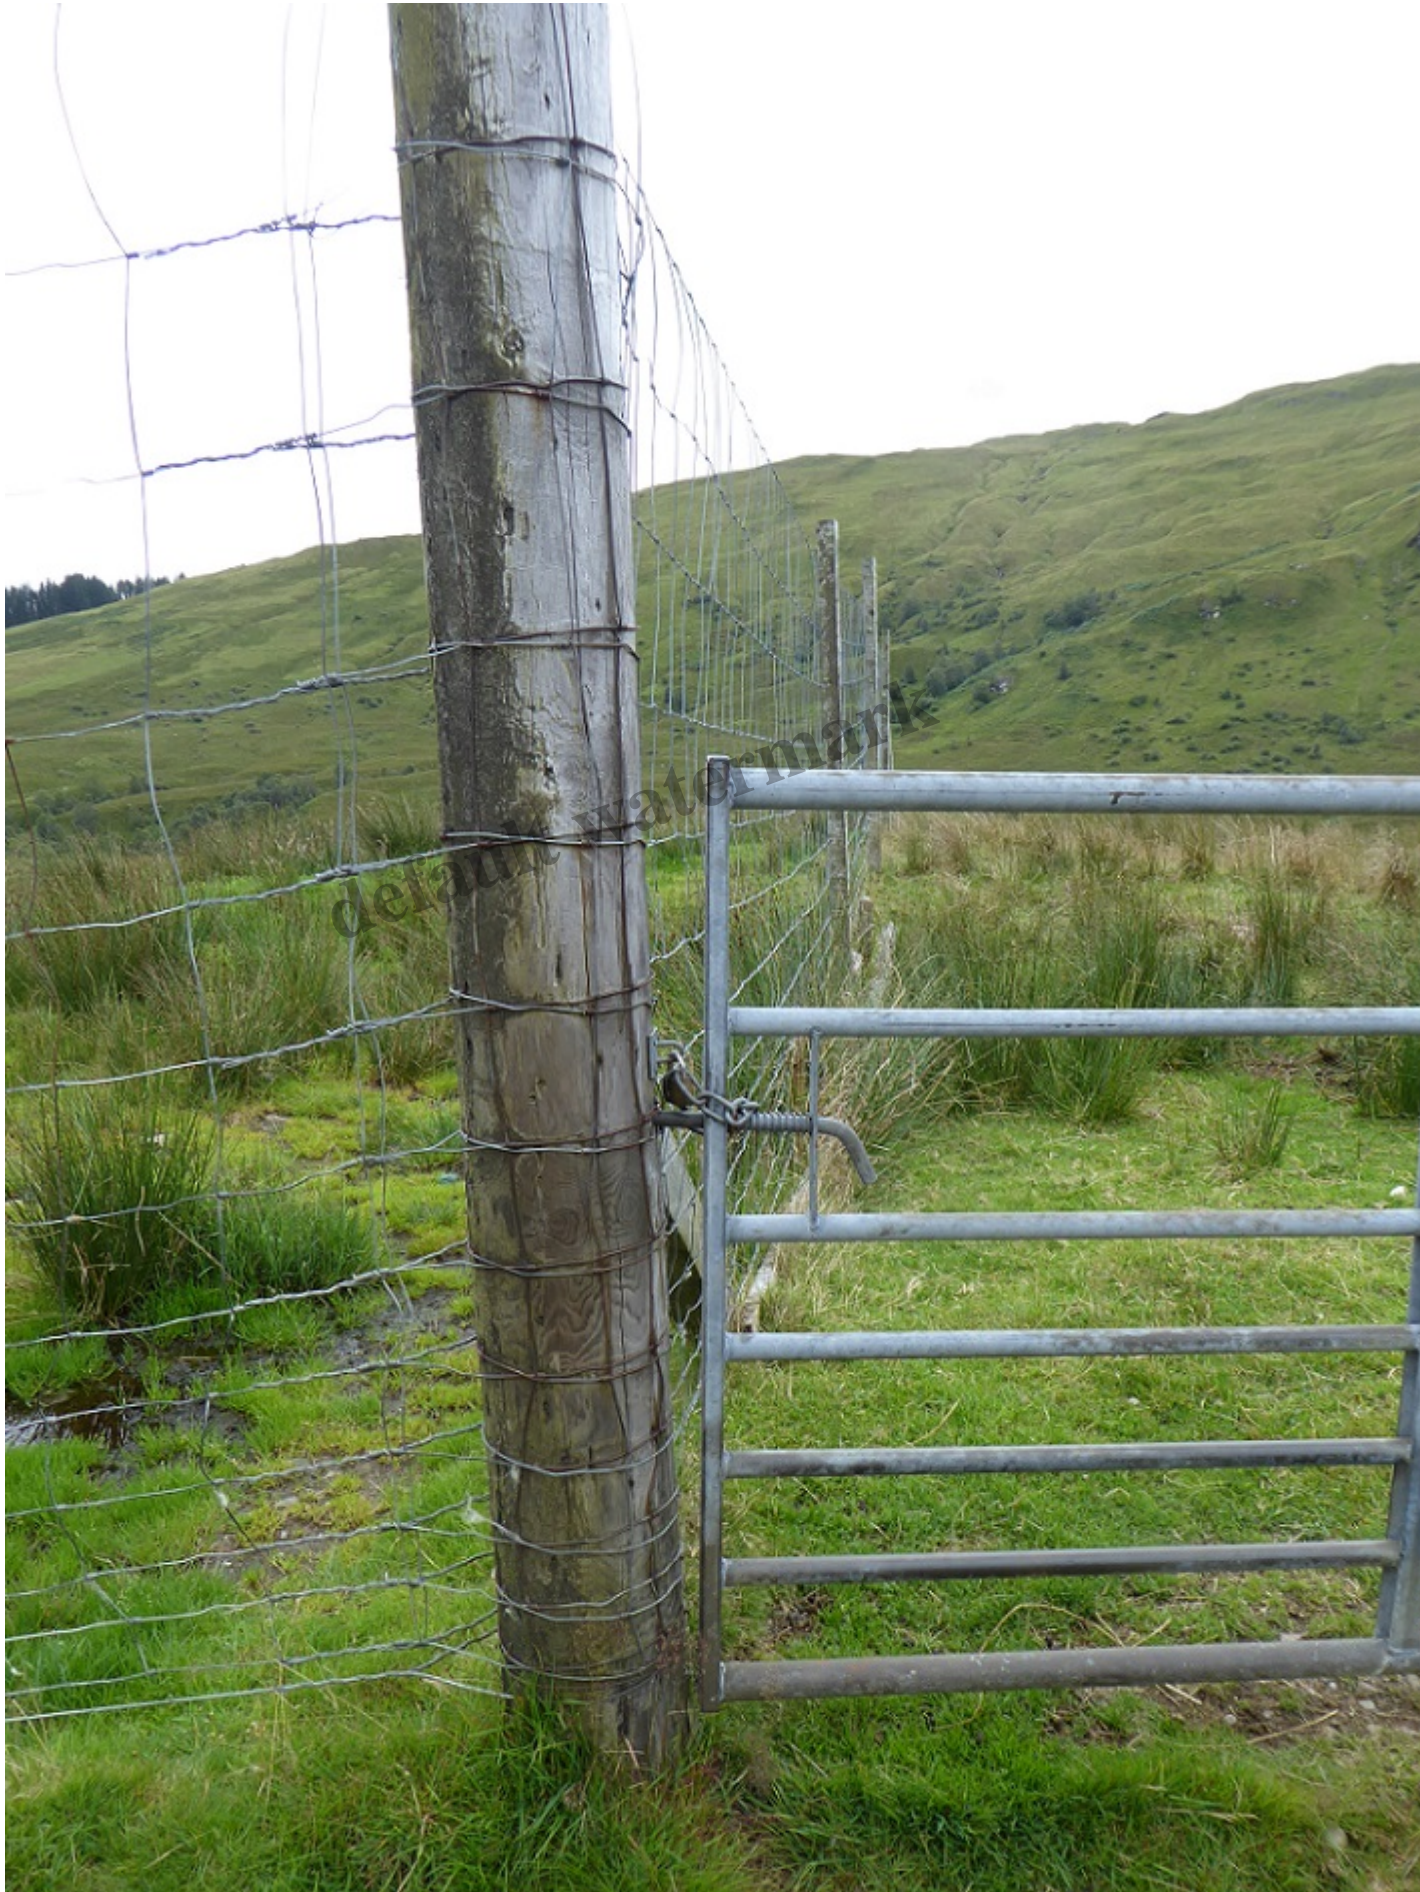
Third locked gate, this one easier to hop over.

The pipeline lies behind the gate and the ground above has, as is usual where hydro schemes are constructed on in-bye land, recovered far better than the track. It is now, however, covered in soft rush which is generally avoided by cattle. Hydro schemes are not without their costs to farmers and food production.

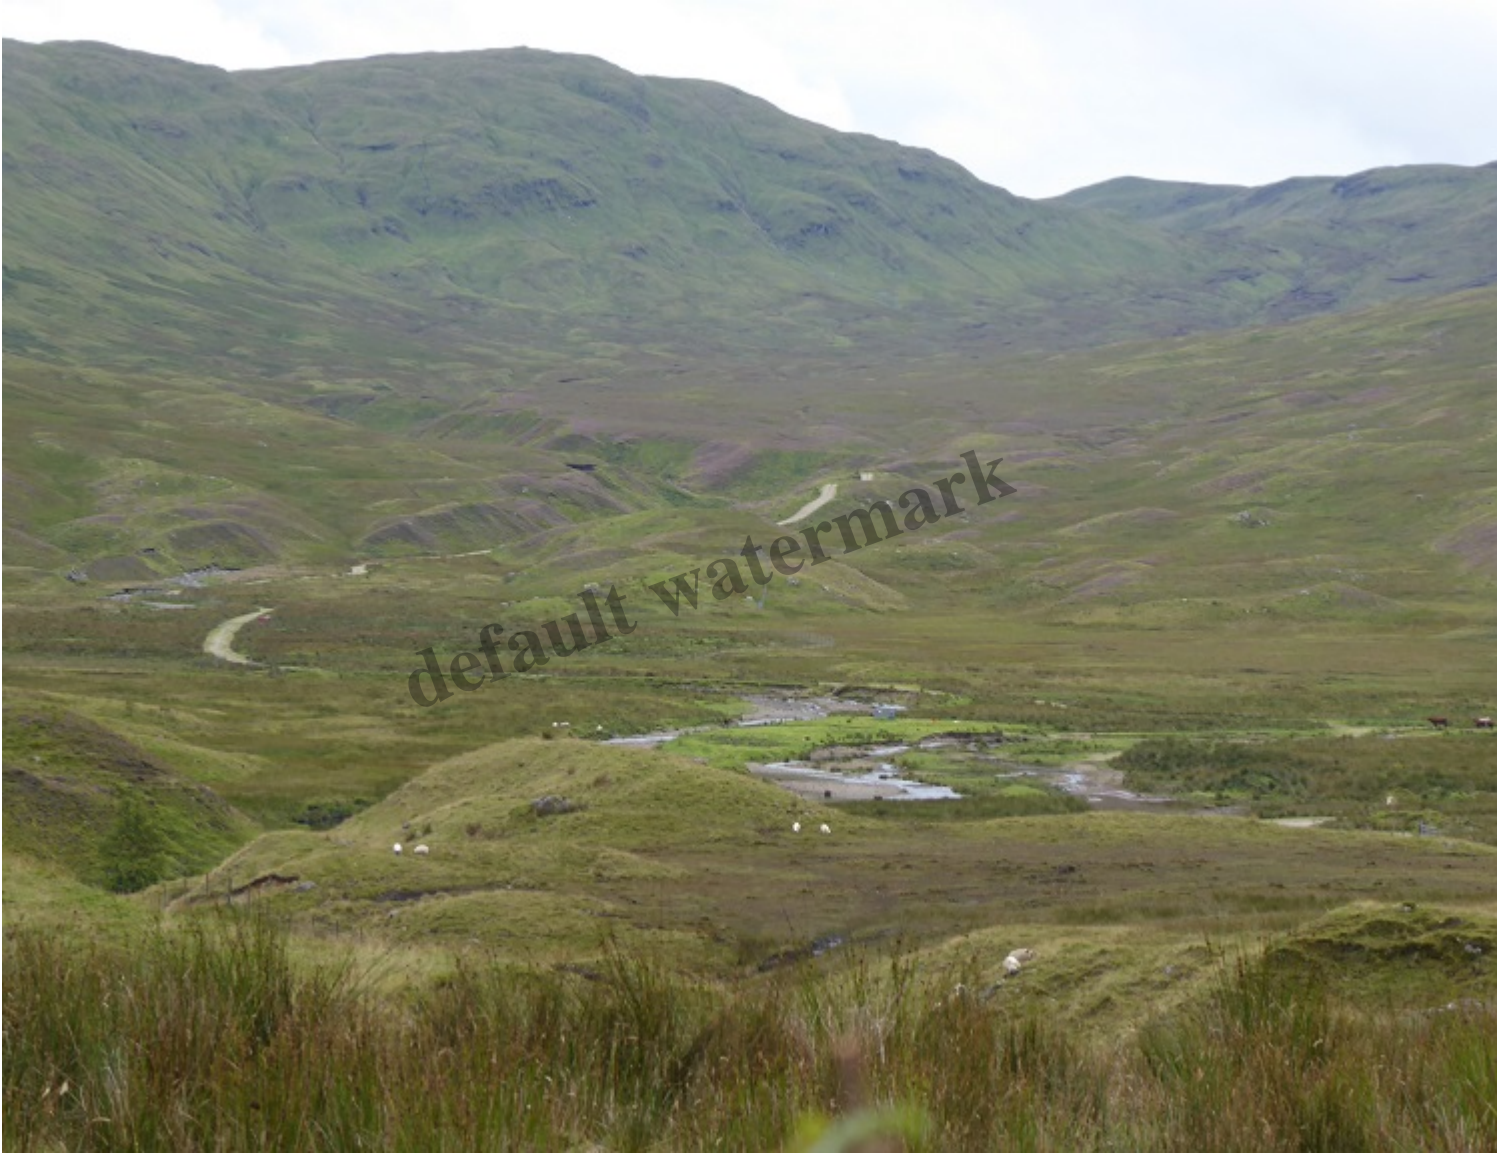
The mid-section of Gleann Dubh is covered by fine hummocky moraine. There are two intakes to the hydro scheme – originally three were planned – and it was agreed a new temporary track should be constructed across the Allt Fathan Glinne to build the first intake:

I can find no subsequent application to retain the track, as happened with the Glen Falloch schemes, and nothing else in the planning papers ([see here](#)) that explains who agreed it should be retained and

why. It now forms a prominent landscape scar in an area that was previously pristine and unmarred by development.

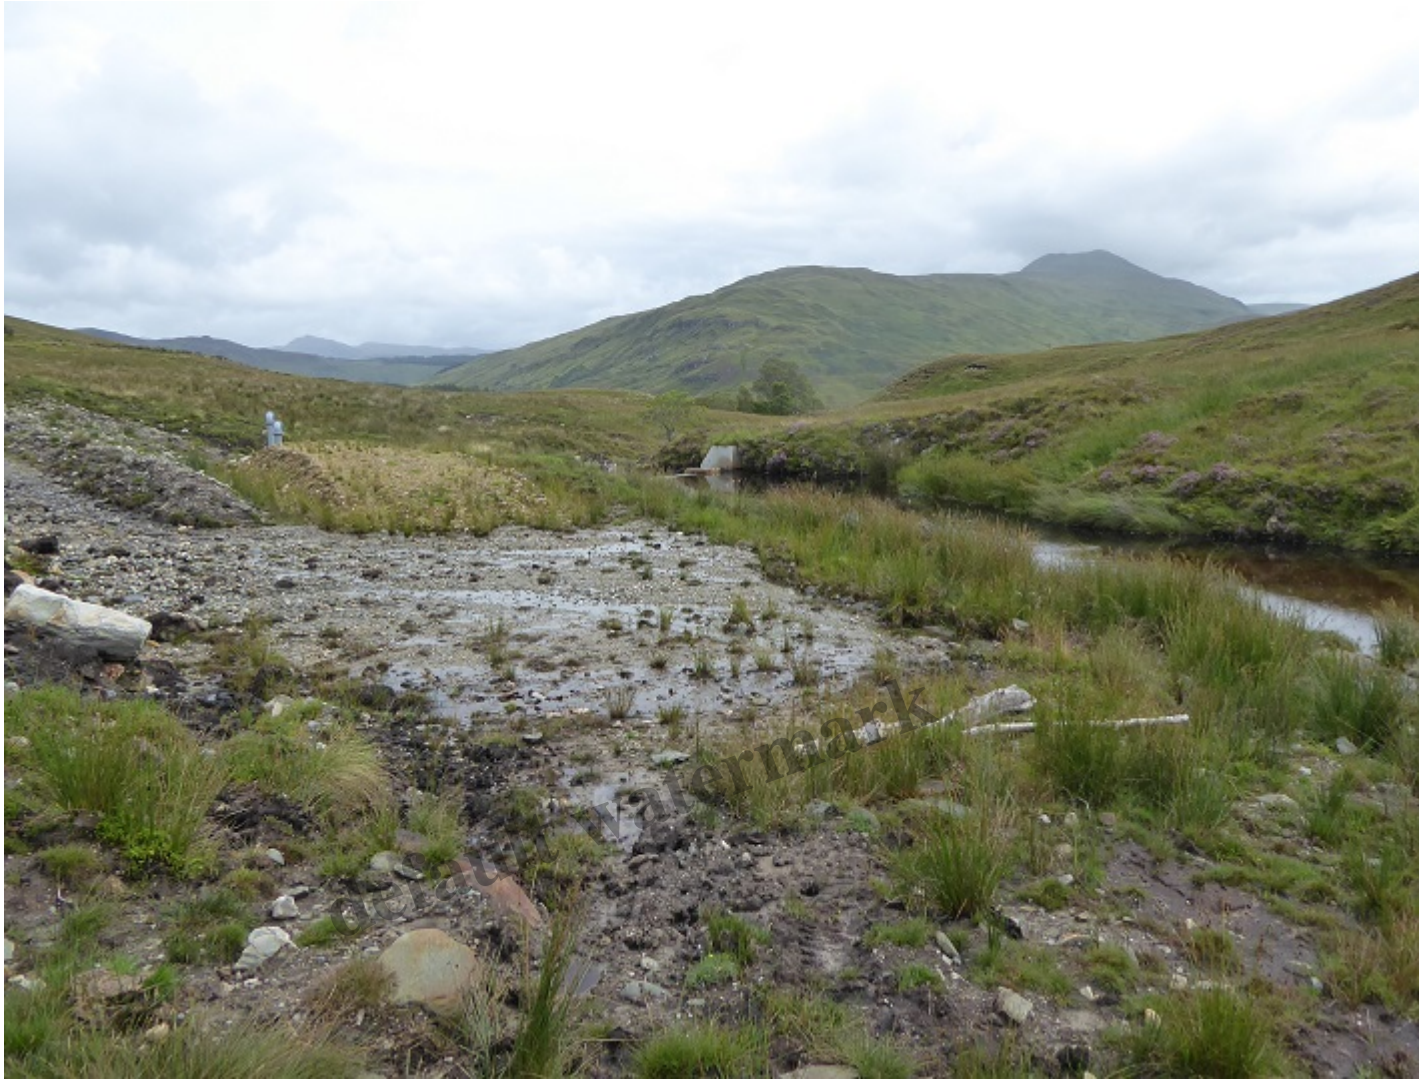
The intake is just visible at the end of the long pool it has created, Ben Vane beyond on right

The documents in the Planning Application describing how the area would be restored are sweet nothings.

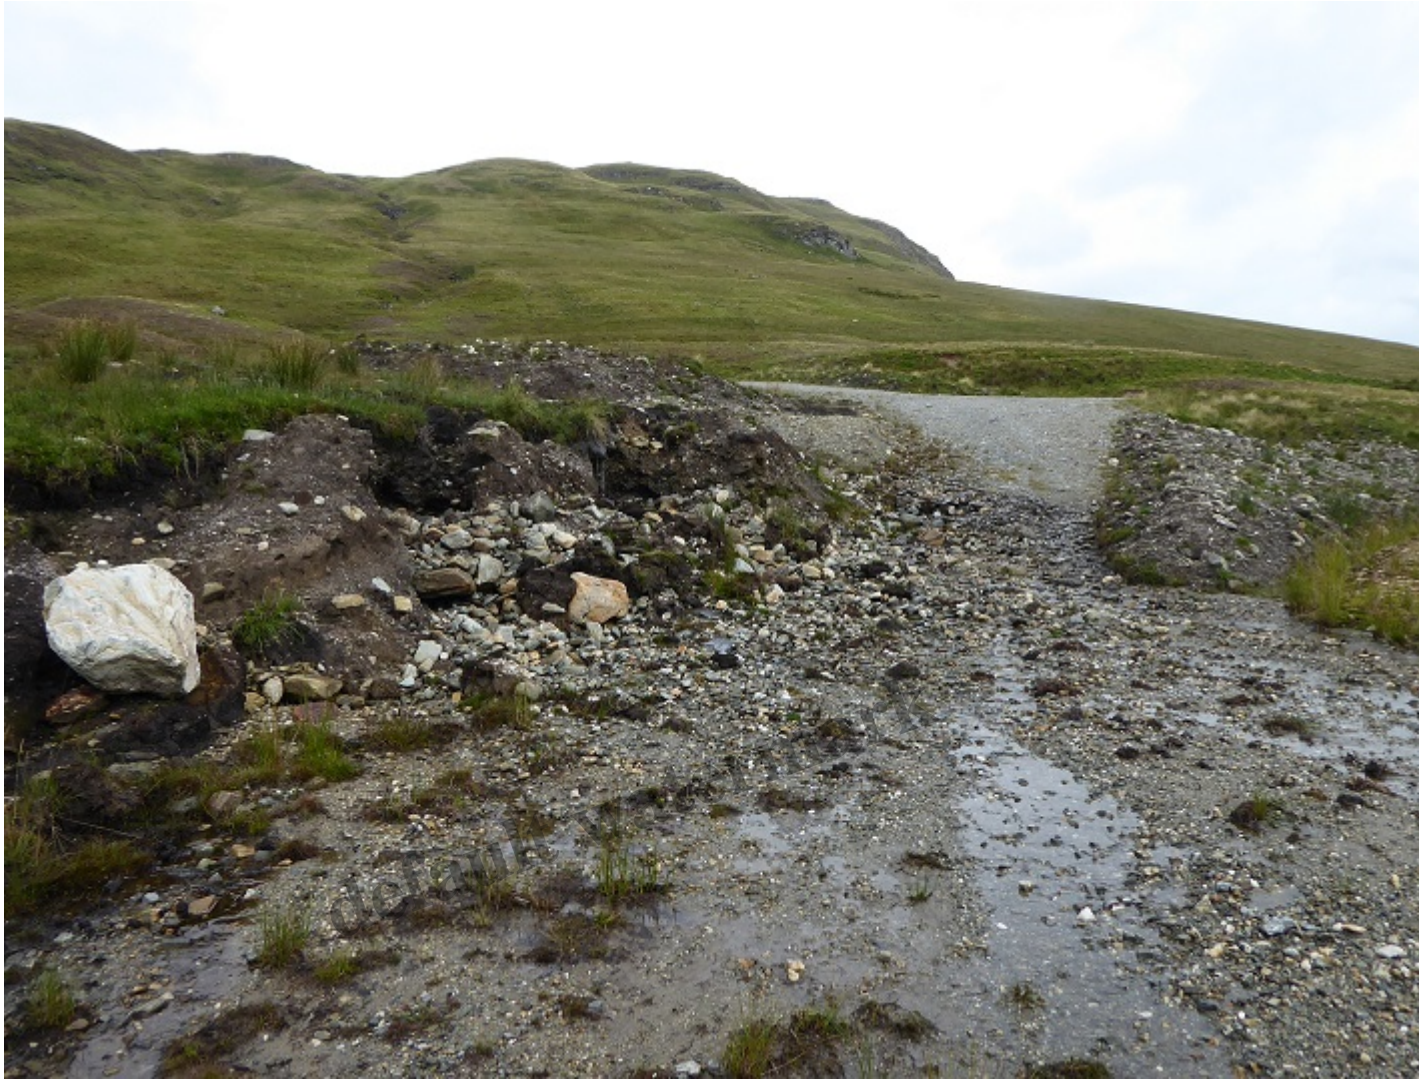
The reason this looks terrible is because in ecological terms it is terrible.

One wonders how any LLTNPA Planning Officer could, for one moment, have thought this was acceptable. What is the point of imposing planning conditions to protect peat (“minimise disturbance and exposure of peat during construction”) and stop sediment flowing into rivers if they are ignored and this is allowed to happen? But perhaps the LLTNPA Planning Officer was not allowed to visit by their bosses?

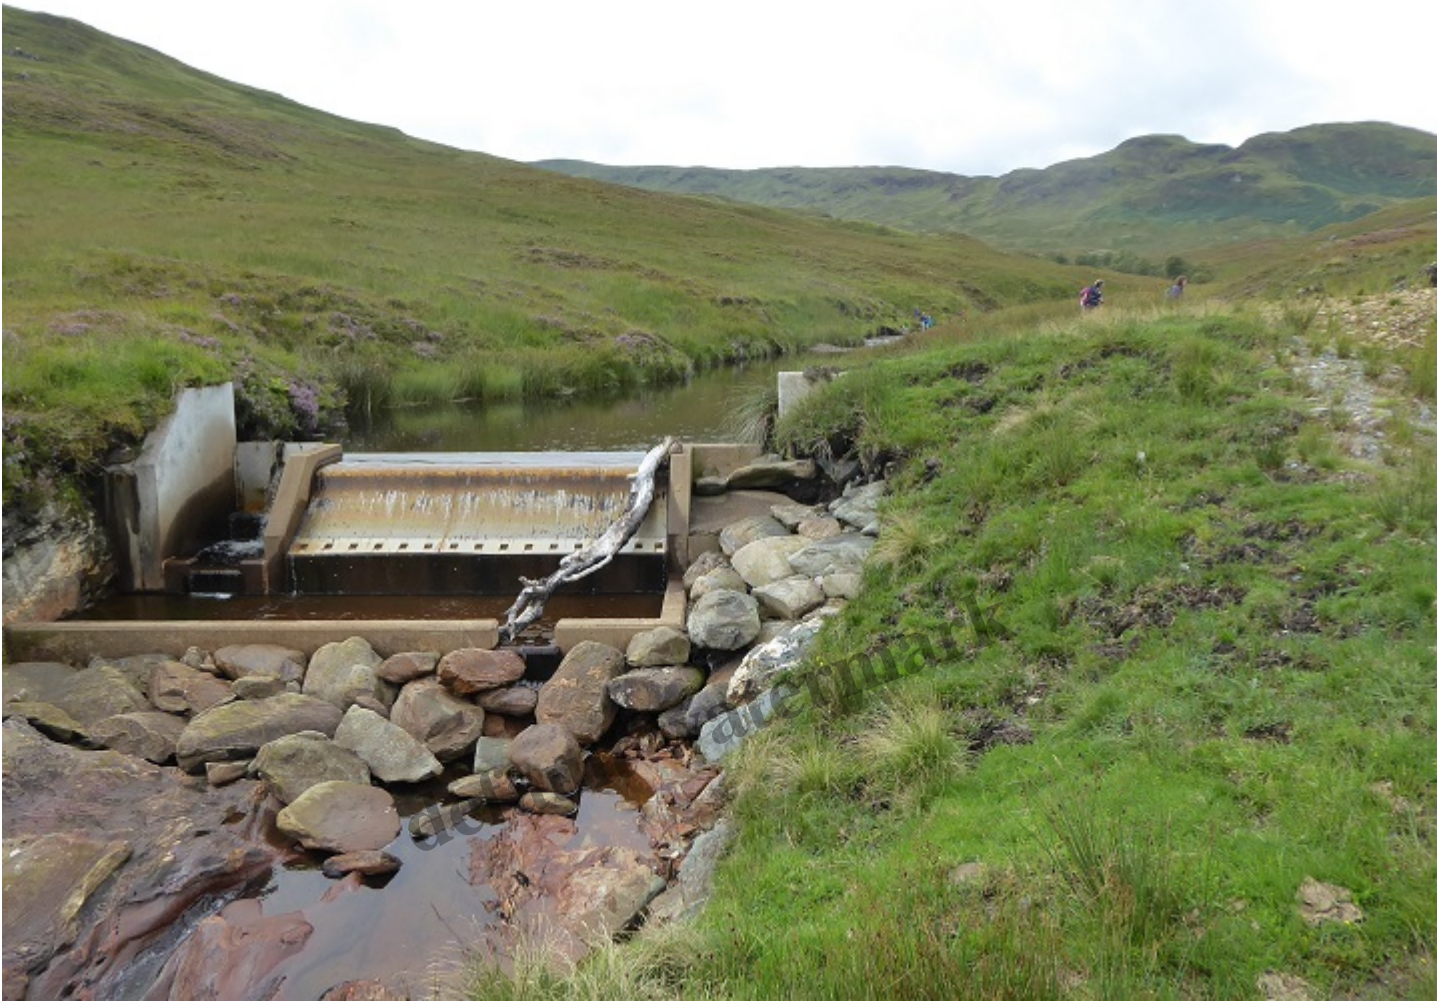
Restoration has taken place on the banks by the intake – so why not on the ground above and around the track?

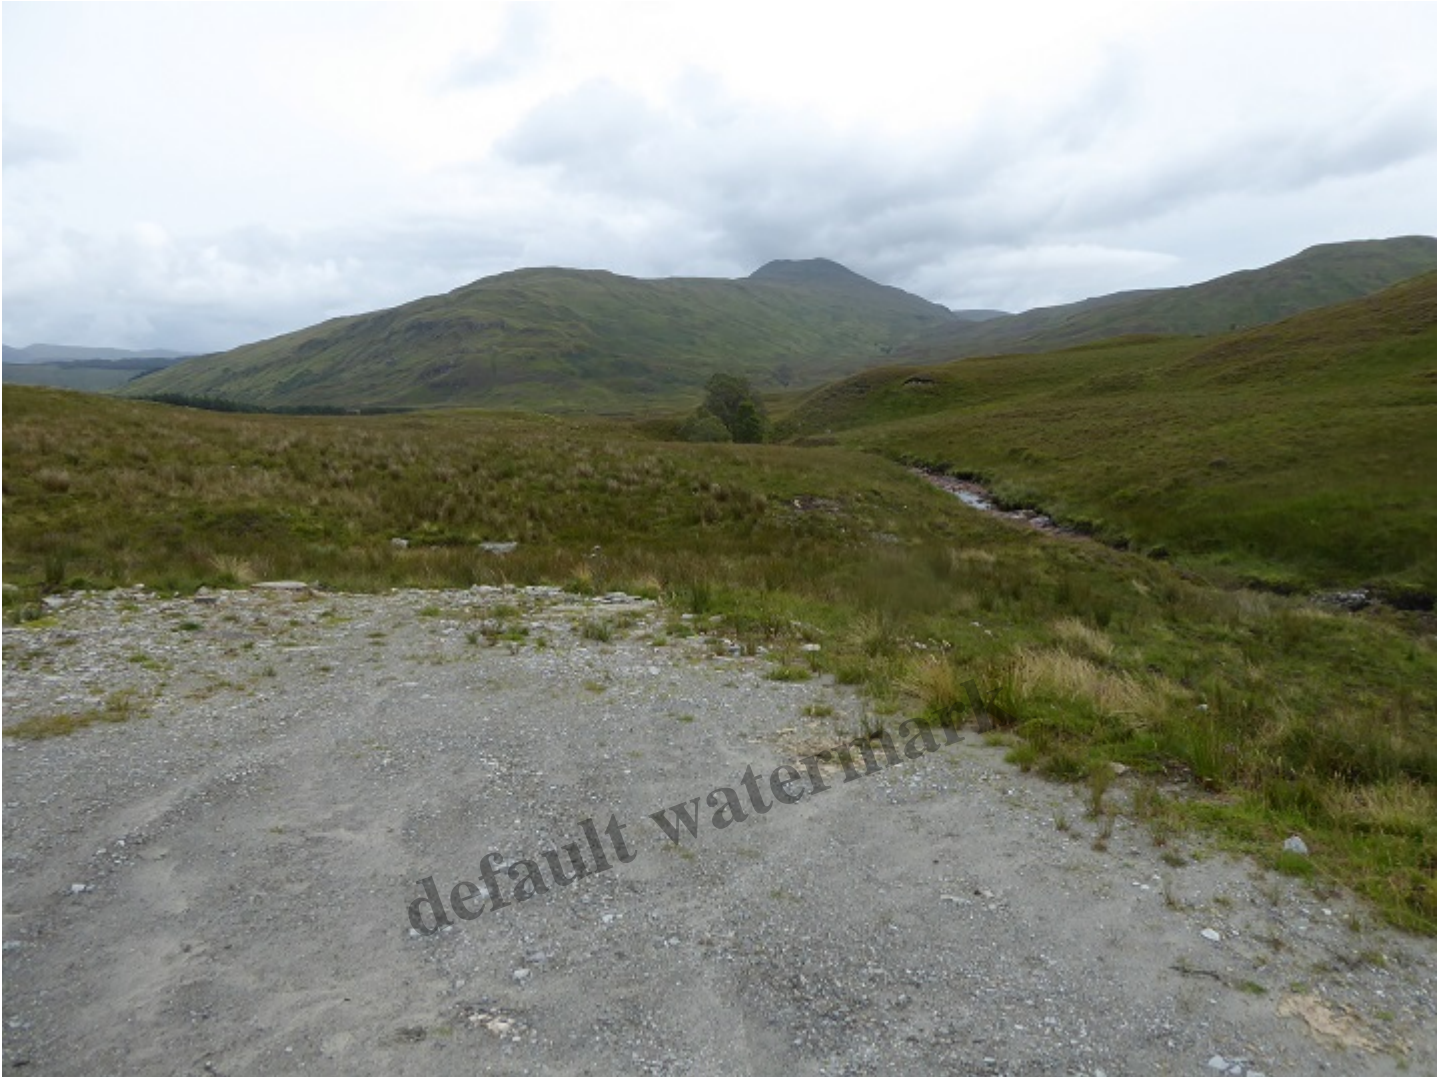
There is no justification for leaving large areas like this used to store materials as turning circles:

“Where tracks are to be narrowed post construction, the down hill side of the road surface will be broken up to relieve compaction and top soil / top peat material stockpiled adjacent to the tracks will be used to narrow the track to the agreed width.” (Extract Construction Method Statement).

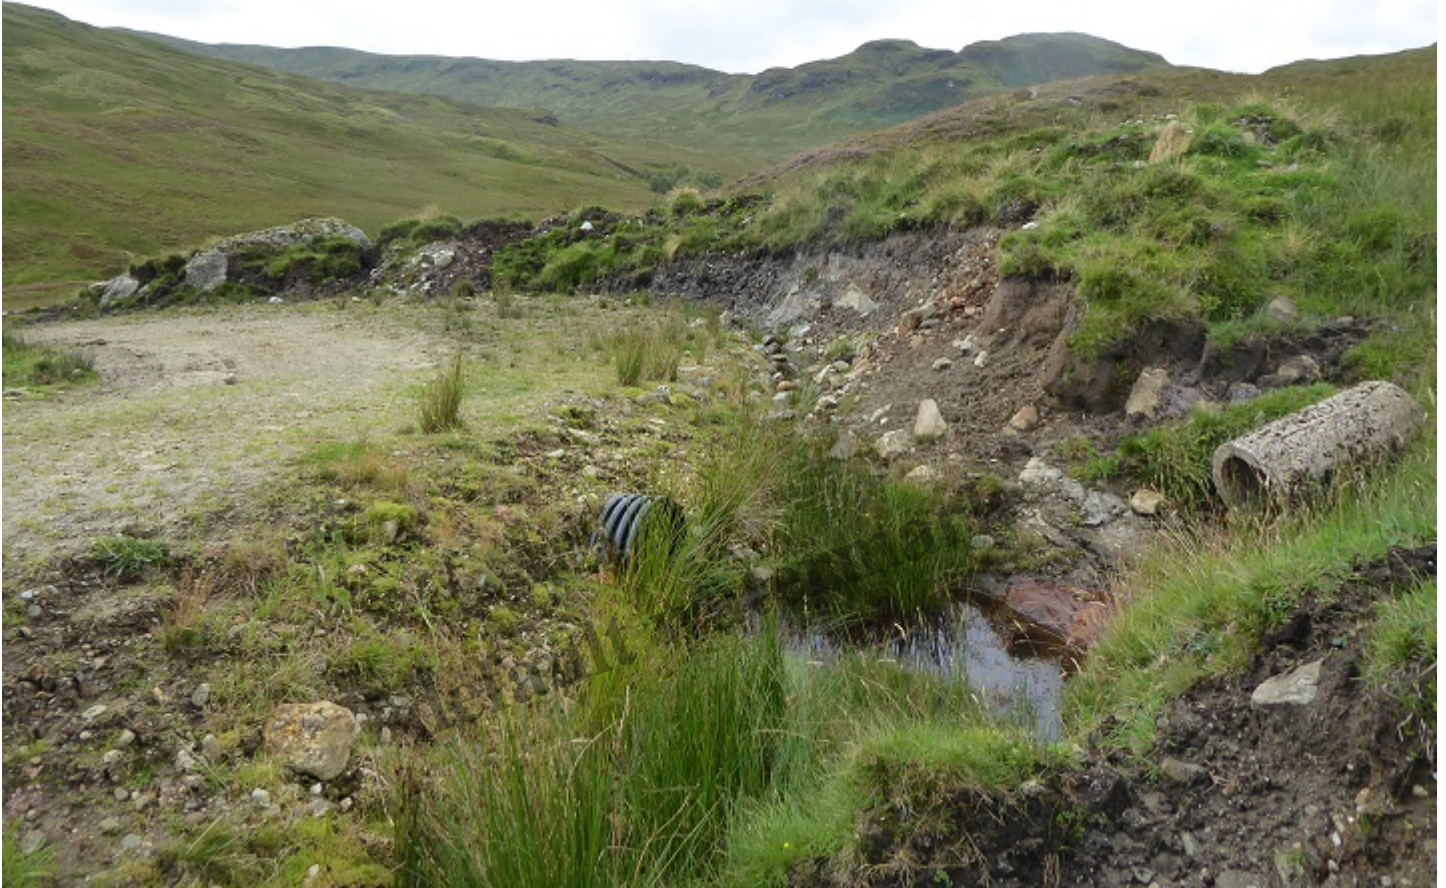
The abandoned concrete pipe indicates that the track reached here before the hydro was constructed but has subsequently been upgraded, with little attempt at restoration, and extended down to the site of the intake on the river.

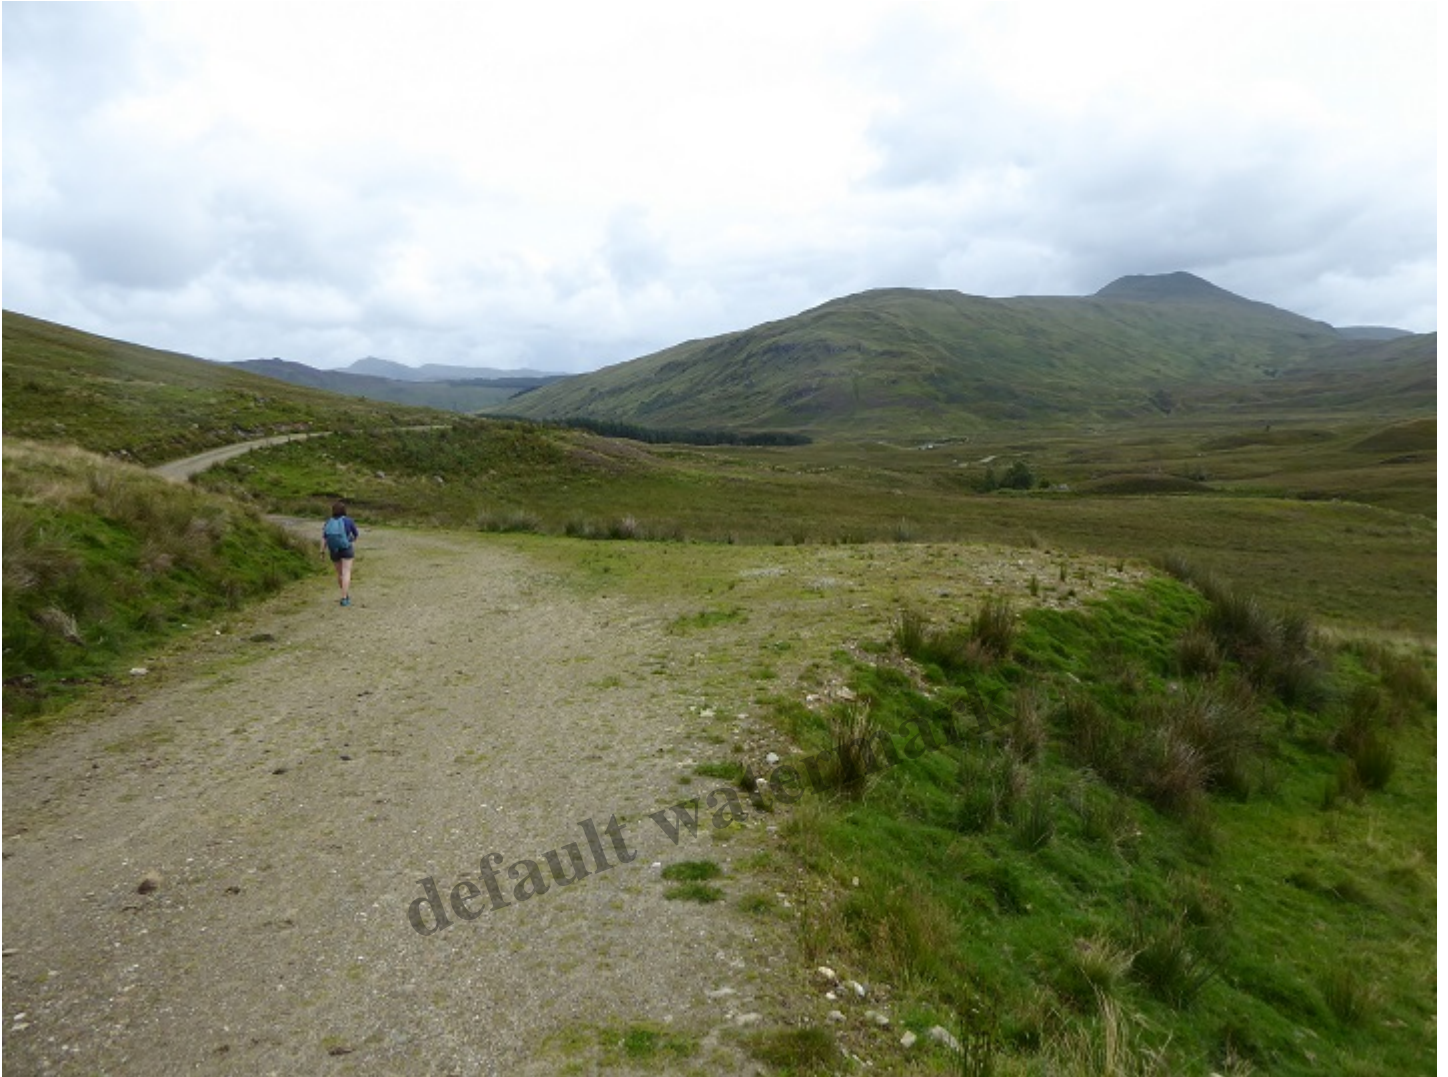
The upgraded track is in many places 4m or more wide, much broader than the LLTNPA's recommended maximum of 2.5m.

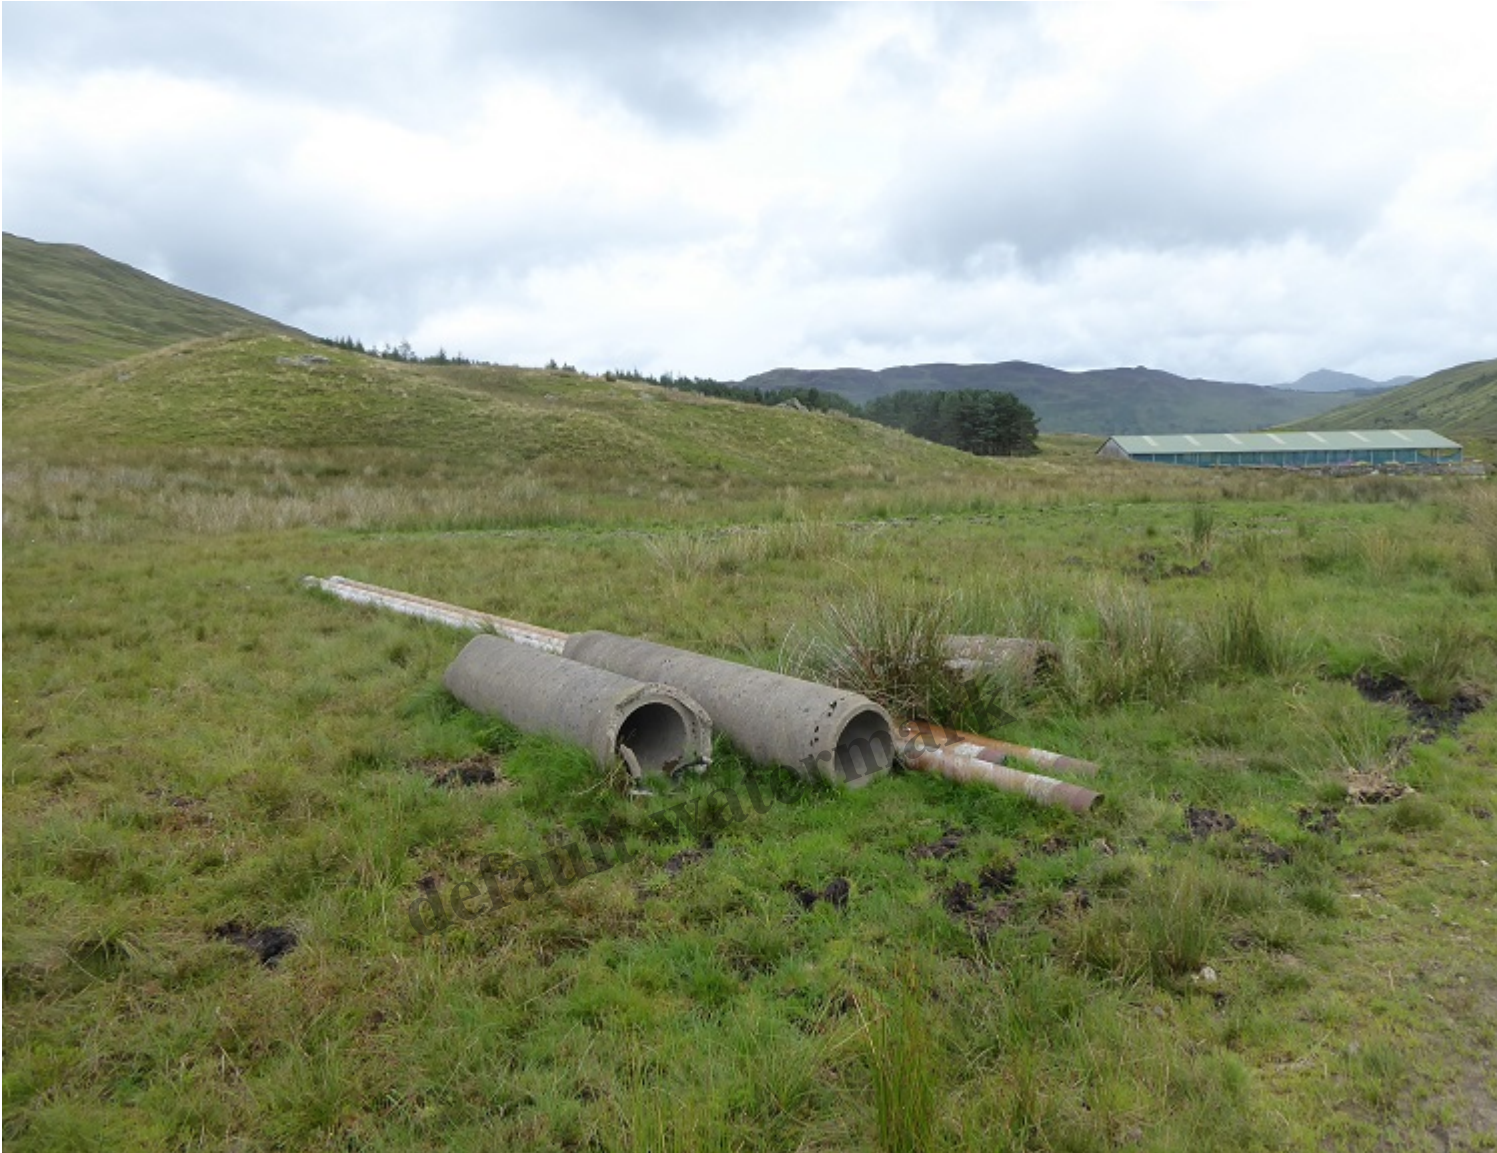
In the vicinity of the large farm building there were two more collections of concrete pipes that appear to have been replaced by plastic ones when the track was widened. What's worse for the environment, concrete or plastic?

The LLTNPA could have used its planning powers to at least ensure that all the detritus created by the hydro scheme was removed. There is so much profit being made out of hydro that developers could easily afford to dispose of waste properly. Ensuring even that, however, seems to be completely beyond the LLTNPA.
