More National Park hydro planning failures – Ballimore and Glen Ample

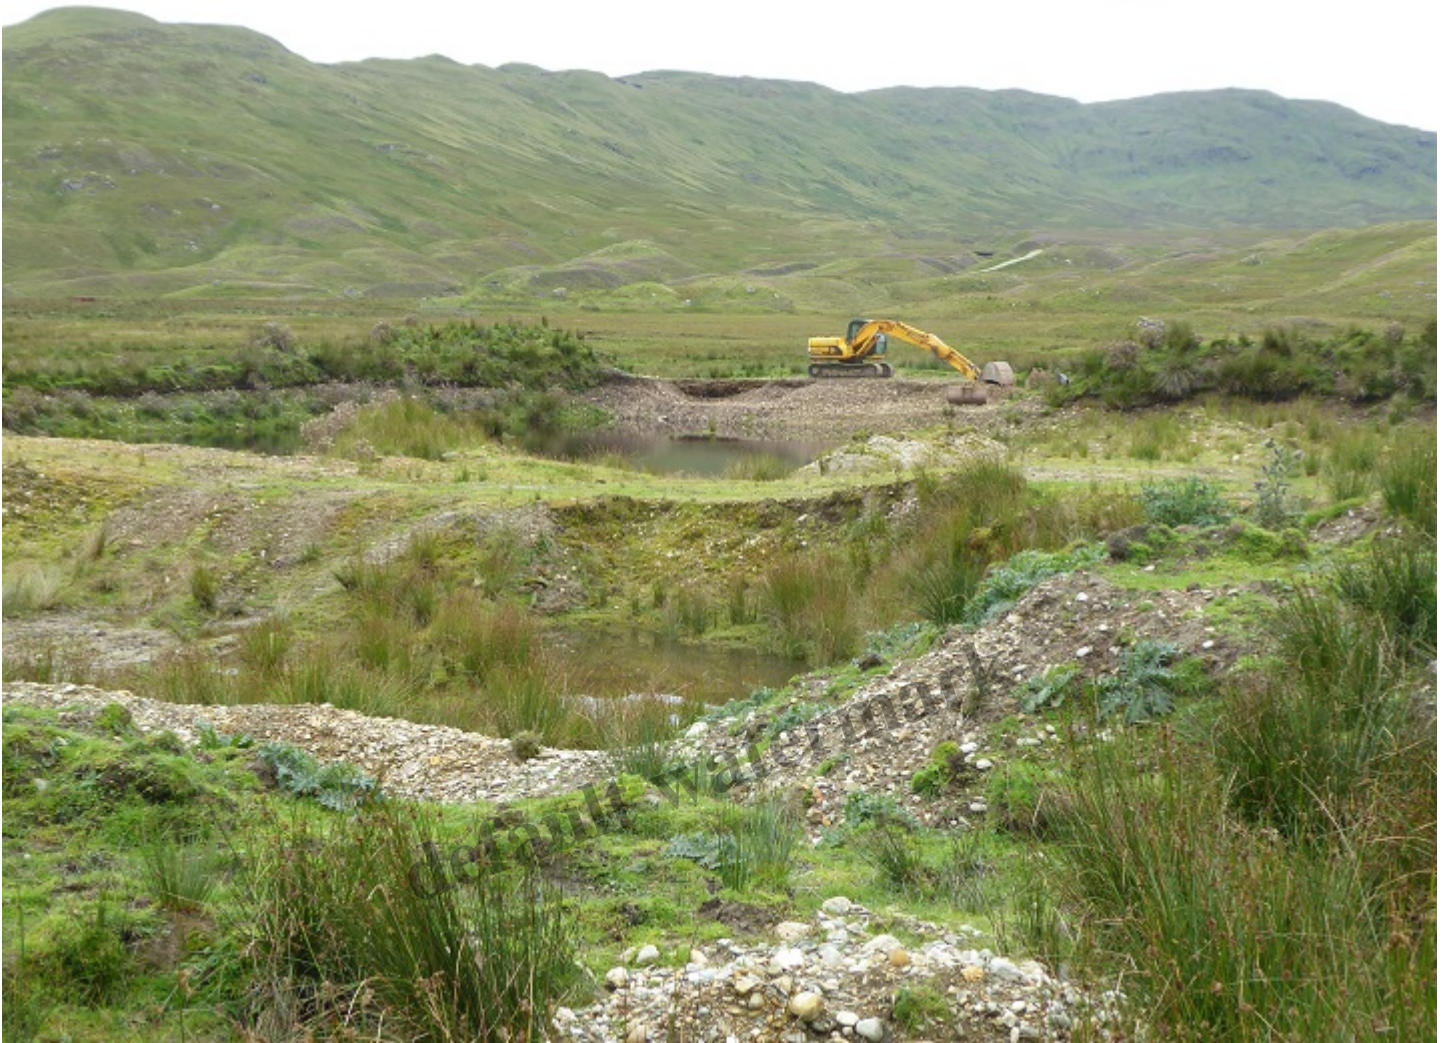
The borrow pits in the moraine still appear to be being worked with no attempt at restoration.

In the past when I have raised issues like this with the LLTNPA they have tended to respond “we were going to address the issues but we have five years to do so”. This scheme was approved in 2015, there is no obvious ongoing restoration work (the digger looks as if it might be adding to the destruction not reducing it) and time now appears to be running out.

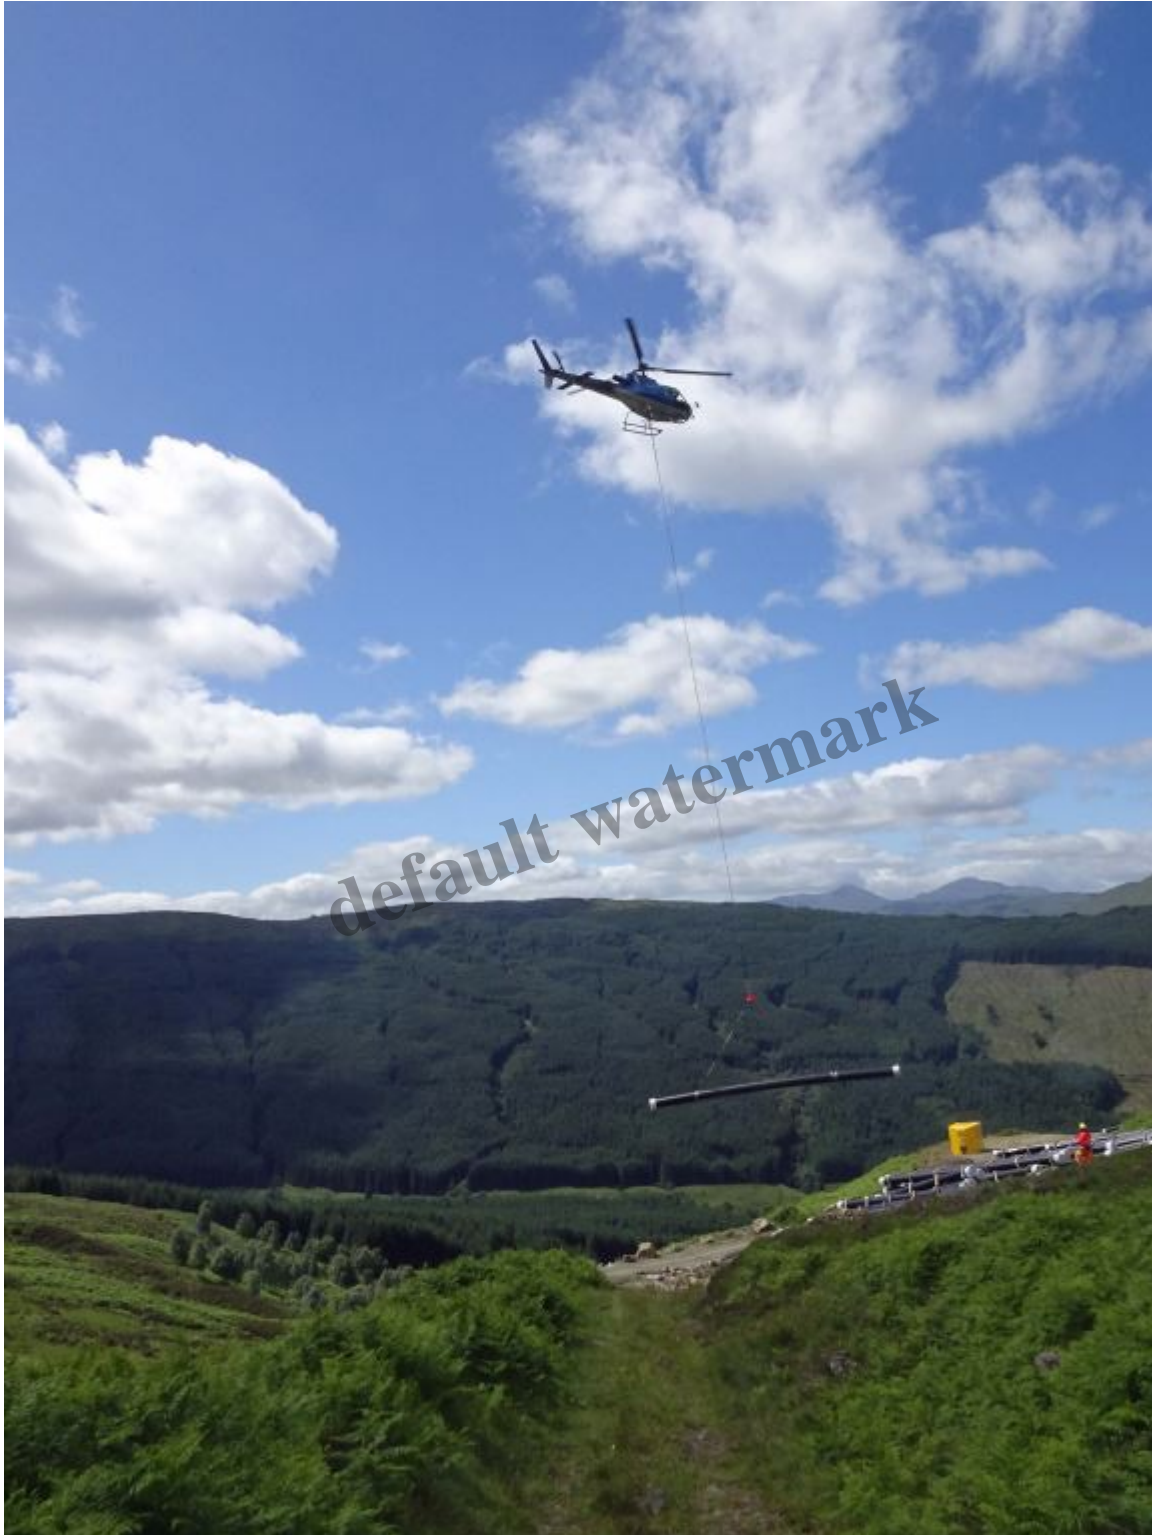
Construction after lockdown. Note the appearance of the track in the foreground. The track down to Glenample Farm used to be pleasant.

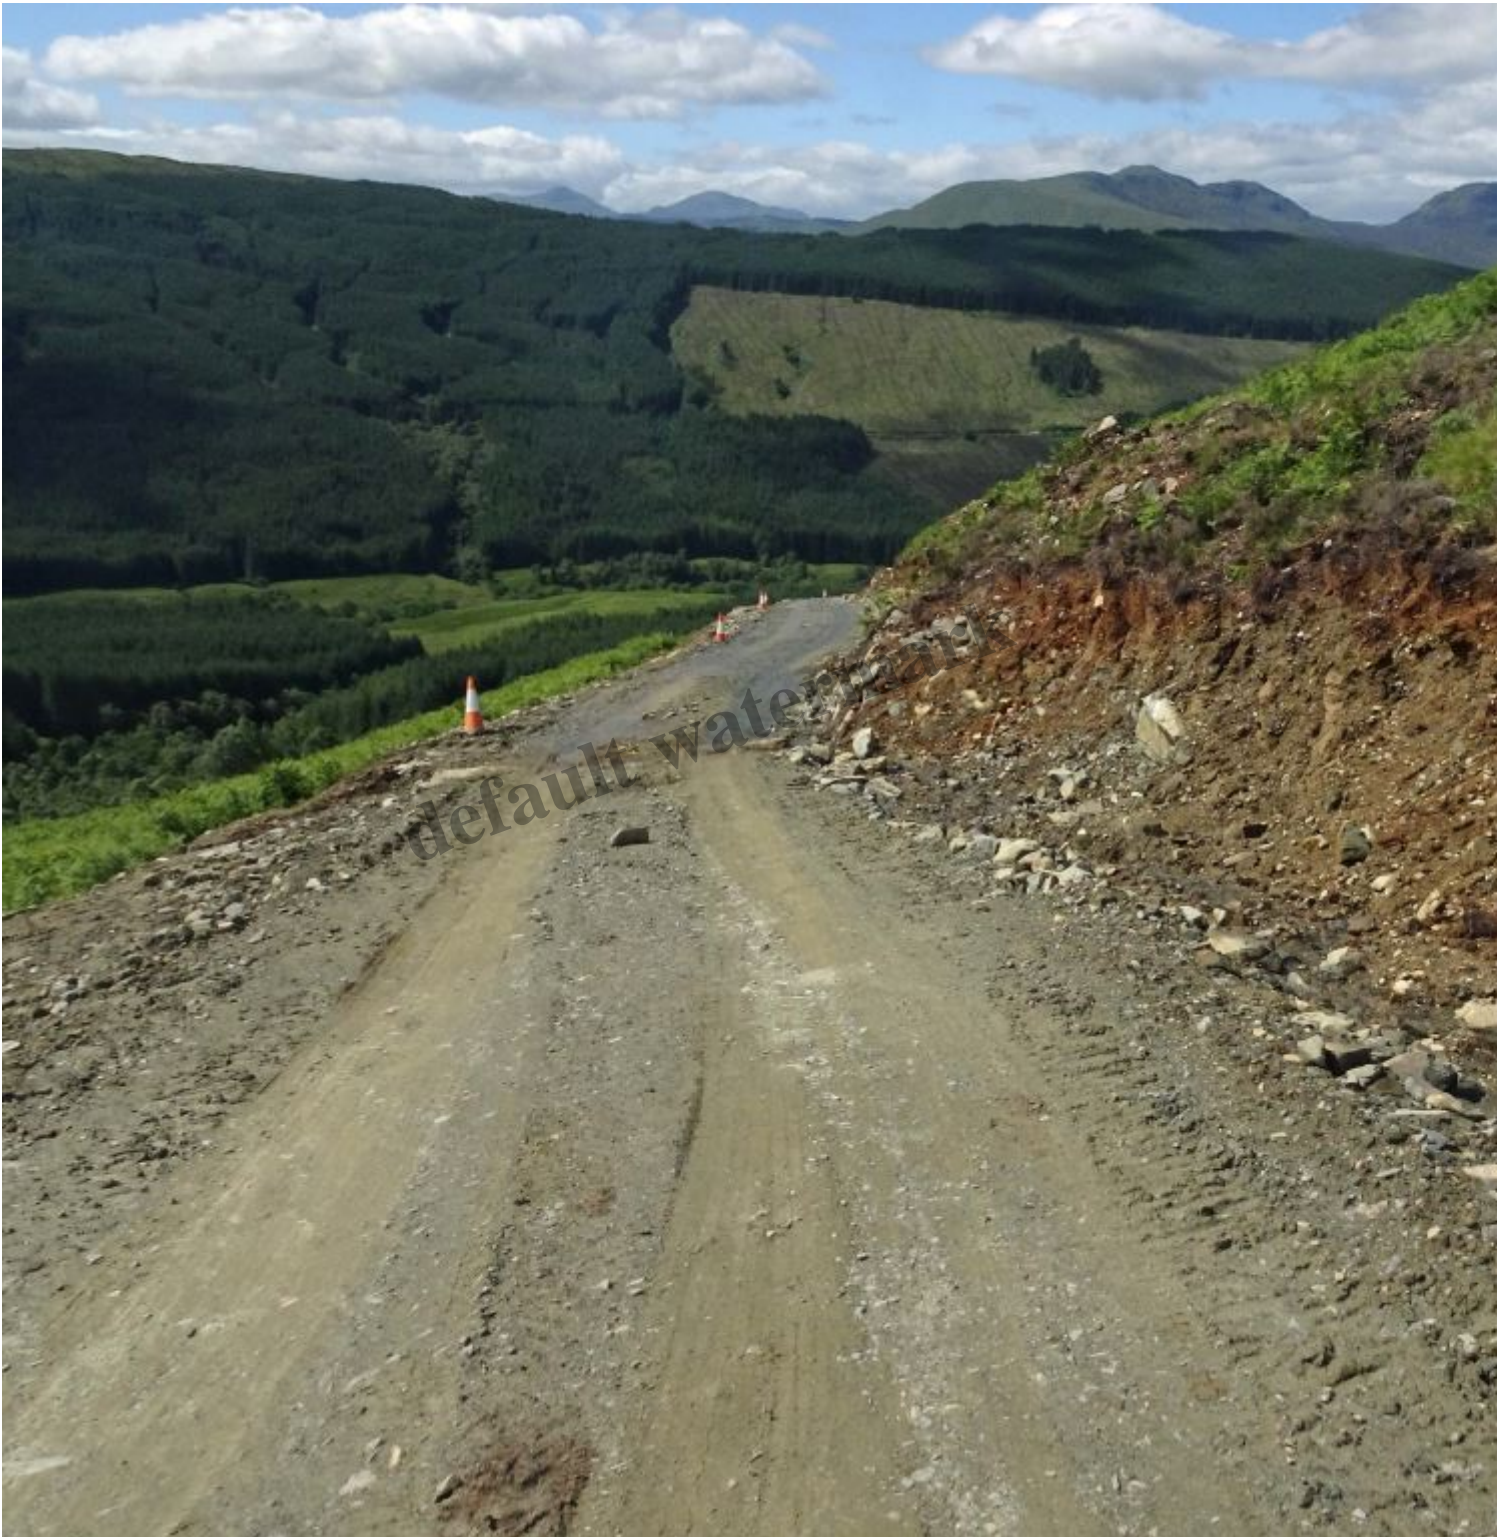
The vertical cutting of the slope has created a bench running across the hillside that is contrary to the Park's best practice guidelines. There is no sign of any of the turf that has been removed to create this and, as a consequence, effective restoration will be even more difficult.

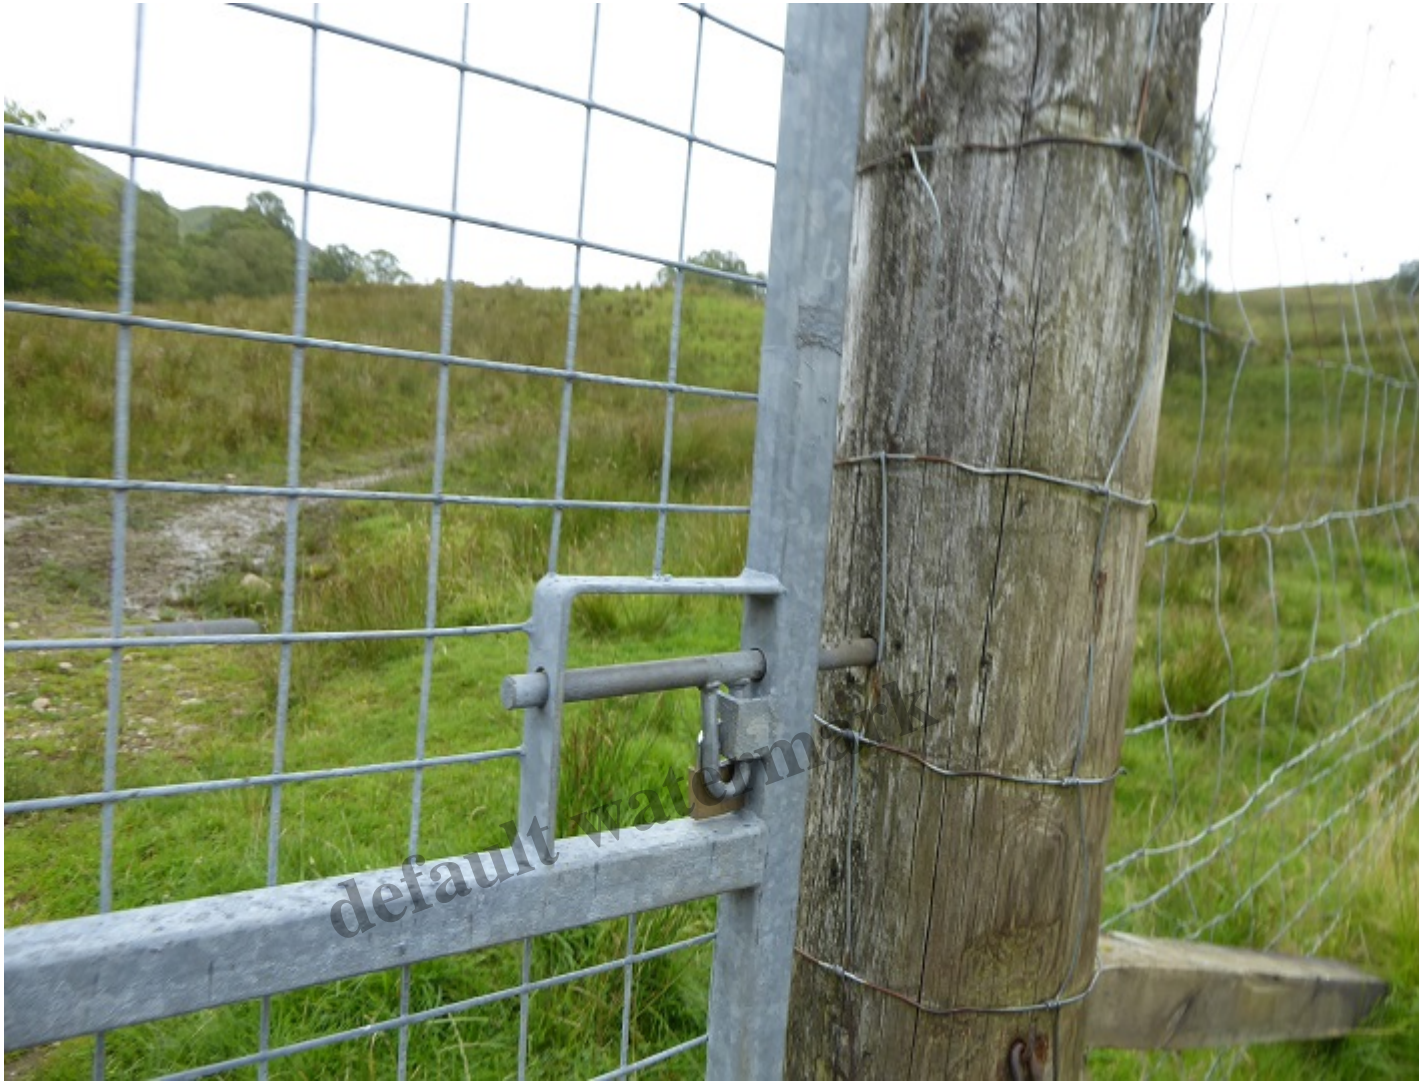
The fourth locked gate
