Unsustainable run of river hydro schemes – Glen Falloch one year on

In August, after the landslides at the Rest and Be Thankful, I visited Glen Falloch to look at what damage had been done to the run of river hydro schemes there by the heavy rainfall. It is three weeks since I blogged about the damage that I had missed seeing in 2019 ([see here](#)). That was caused when the River Falloch was just 30cms higher and prompted a series of posts a year ago on the flood damage (see [here](#), [here](#), [here](#) and [here](#)). While not as dramatic as 2019, the impact that flooding has had on the hydro schemes on the south side of the glen over the last year has nevertheless been extremely significant. This post will consider what has happened to the seven intakes and argue that this raises serious questions about their design, impact and sustainability.

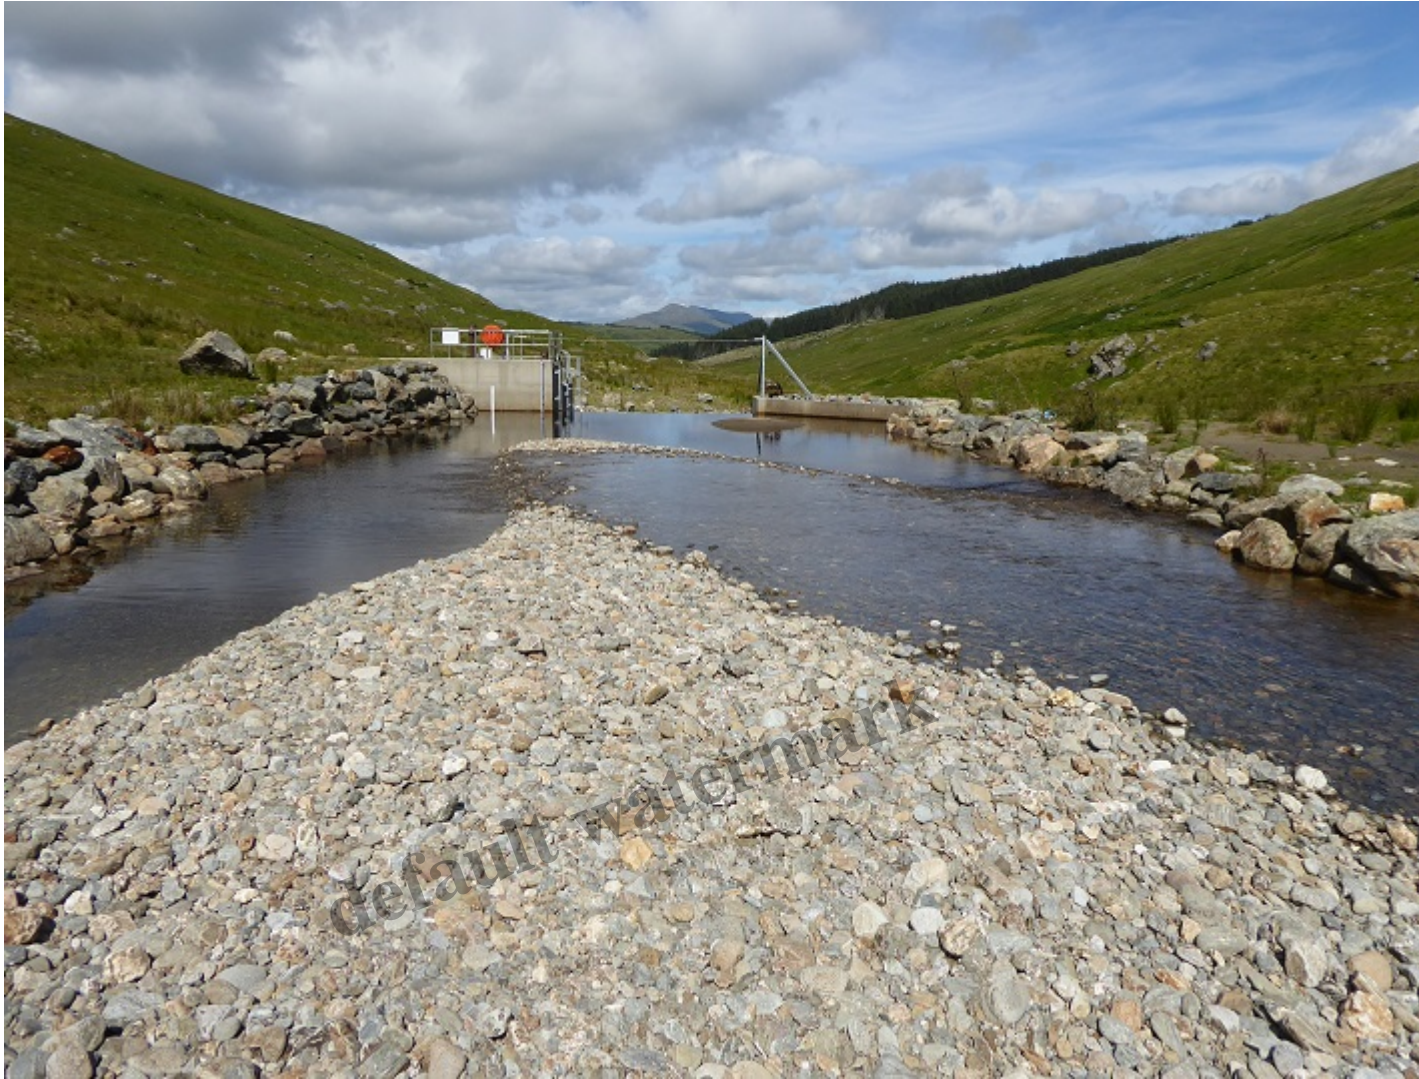
Infilling intake pool August 2020. As the river re-wilds, the hydro is at continuous risk of redundancy

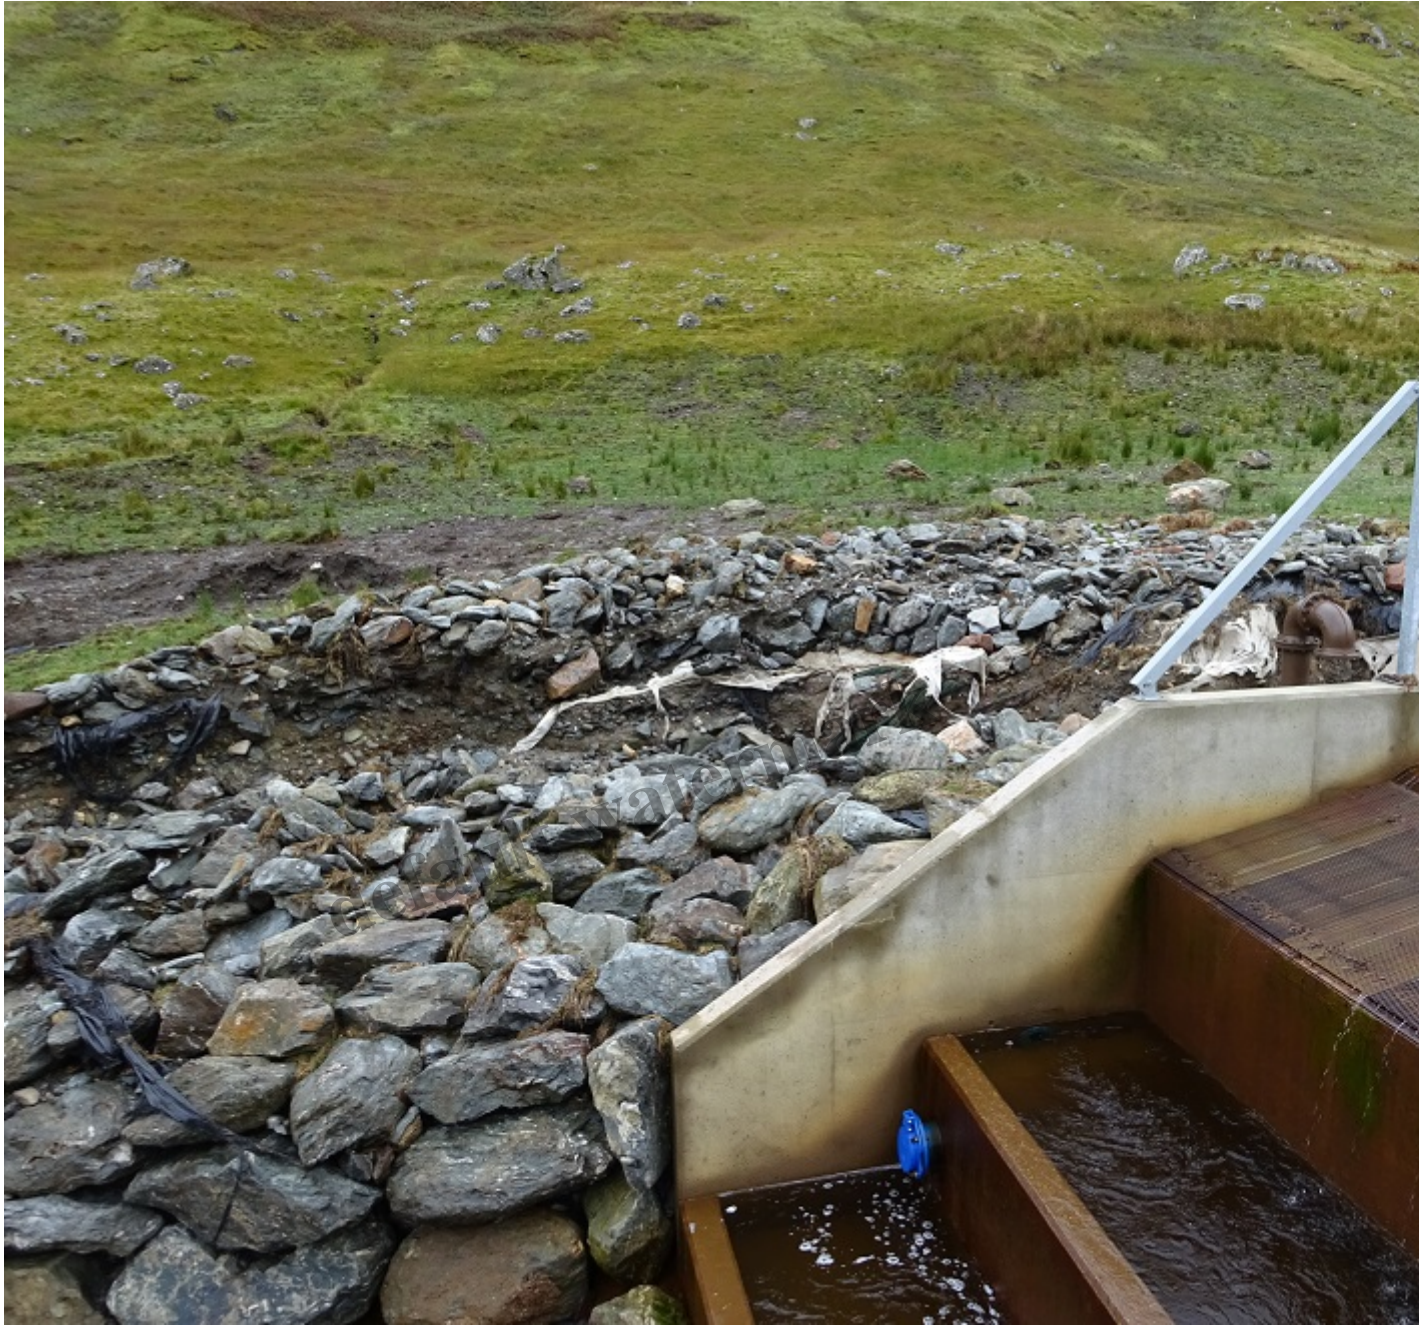
New channel created by overflowing river in August 2019

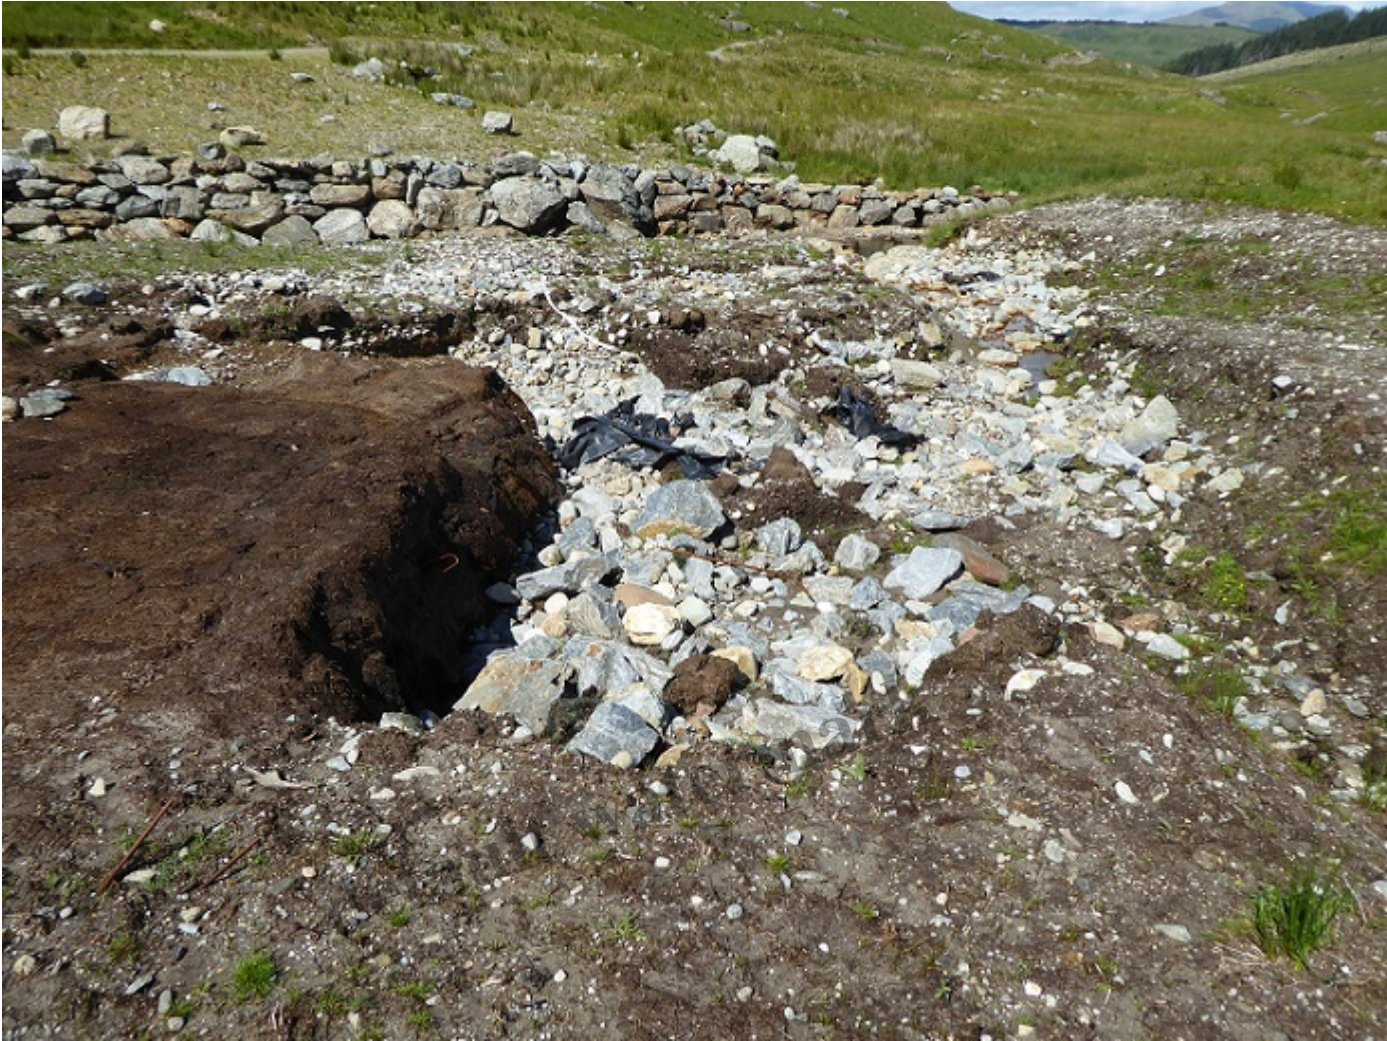
Looking down one of the new channels created by the flood over to far bank of the River Falloch below the intake. A large area of “restored” peat just waiting to be swept away.

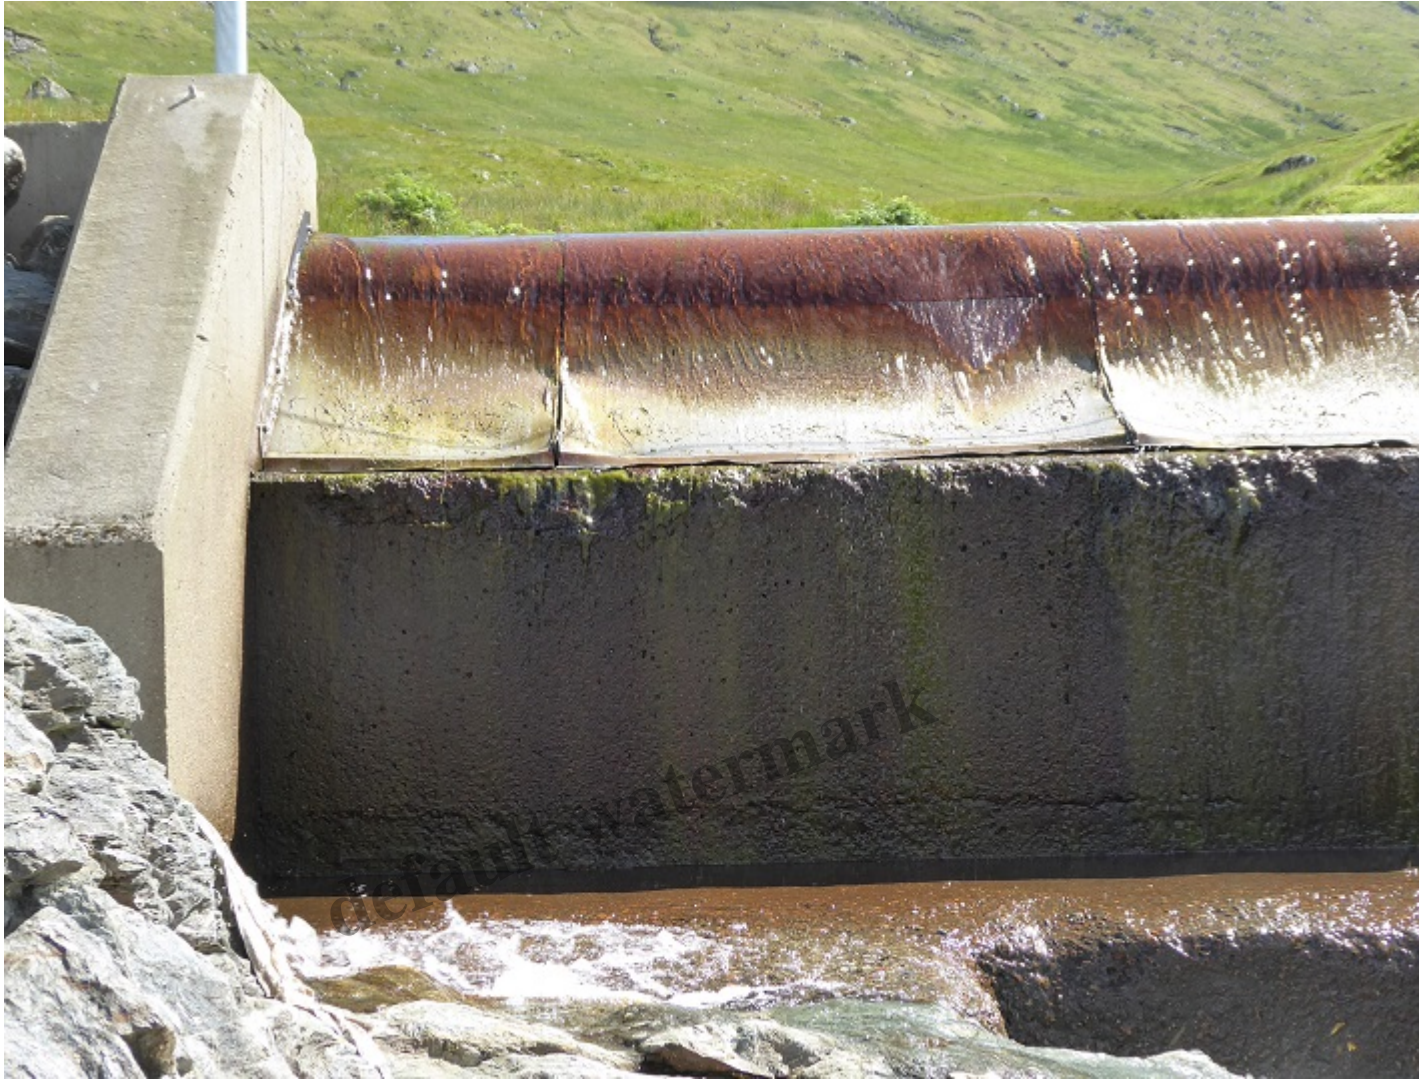
Allt Andoran intake August 2020

The intake itself has become increasingly battered and damaged, illustrating why continual excavation of this pool will be necessary. The narrow mesh Coanda screens are very good at keeping potentially damaging stones and vegetation out of the hydro system but are themselves very vulnerable to damage by boulders and pebbles rolling over them. There are sturdier intake screens, but they let more material into the hydro system, potentially damaging the pipes and turbines.

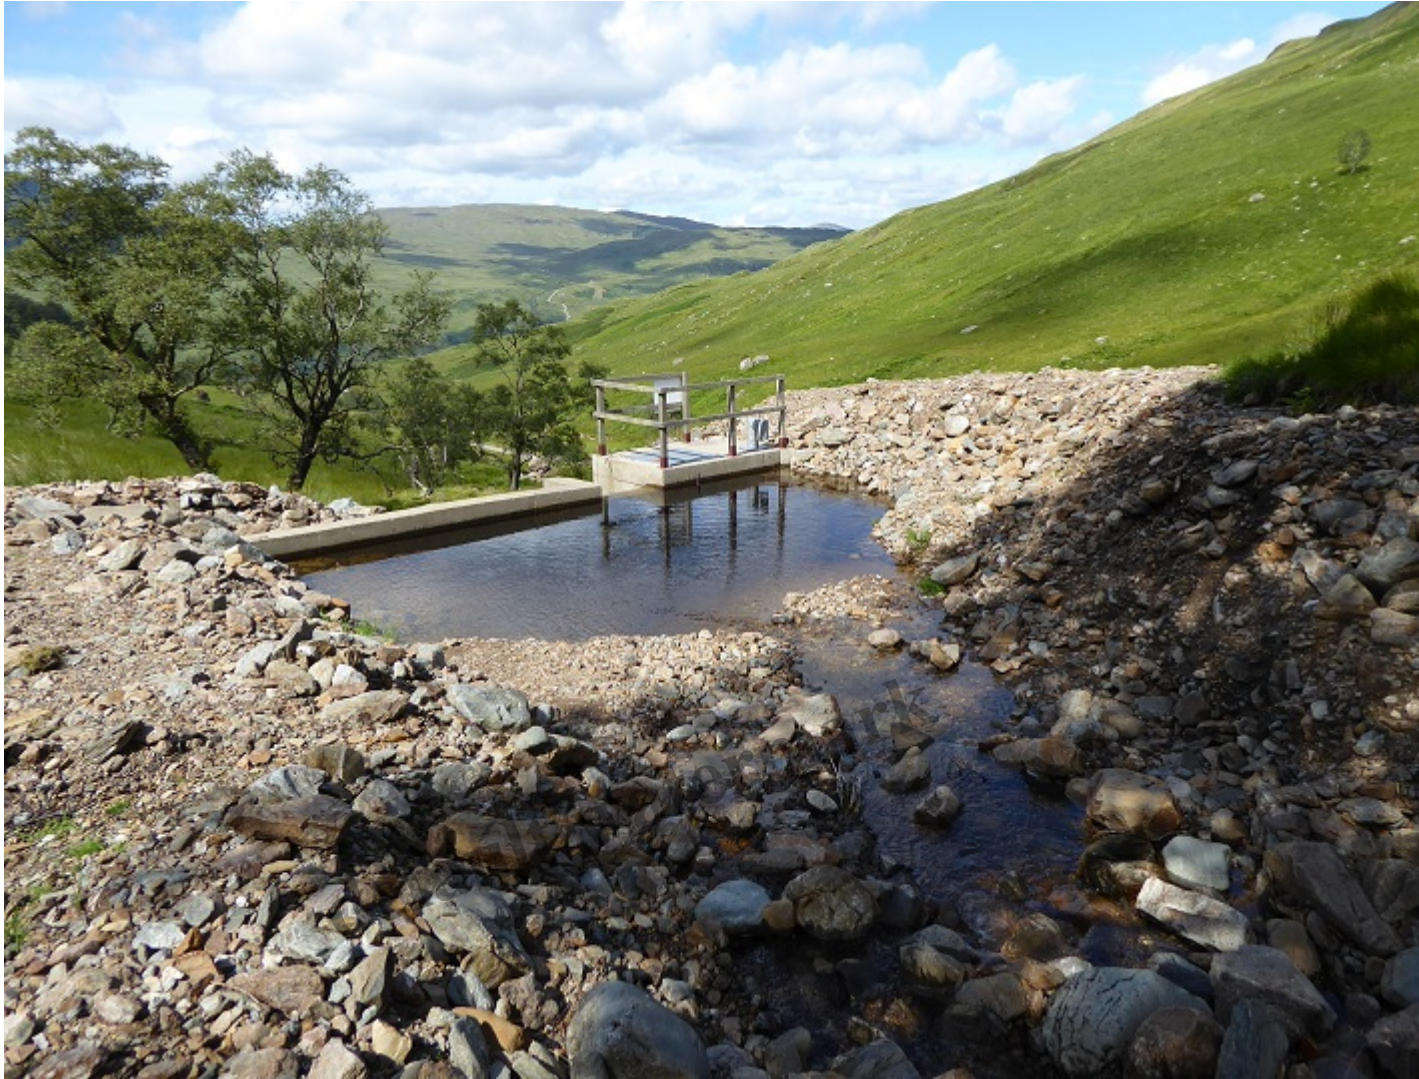
The middle intake with the hydro track by the Allt Chuilinn visible below. August 2020.

There were large rocks around the middle intake in 2018 but they have now been covered with smaller rocks excavated from the river. The pool is not big and, as you can see, is at constant risk of infilling. As soon as debris piles up behind the small intake the burn will divert over the intake wall taking the scheme out of commission. A reasonable guess is it may need to be excavated every couple of years to keep it functional given current levels of rainfall and erosion.

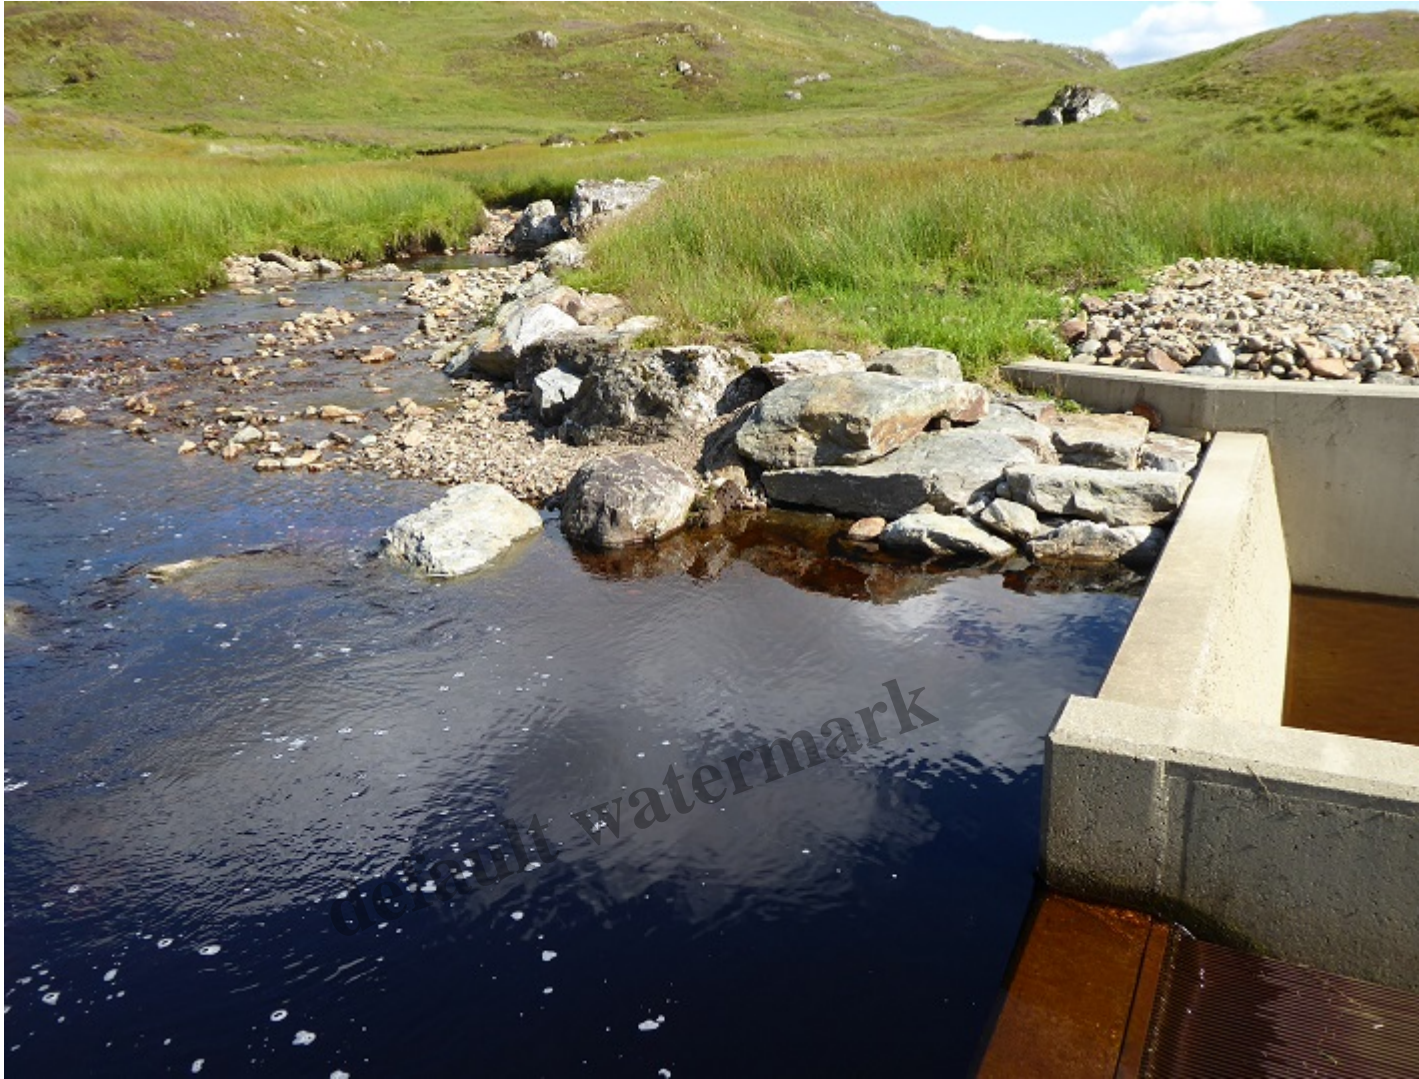
August 2020. Note how the excavated material has been dumped behind the far intake wing wall and the intake screen bottom right, more robust perhaps than a coanda screen but allowing more material through.

This intake has also now been excavated. Judging by the amount of material evident on the bed of the burn above, fairly frequent engineering is likely to be required to keep this scheme going too.

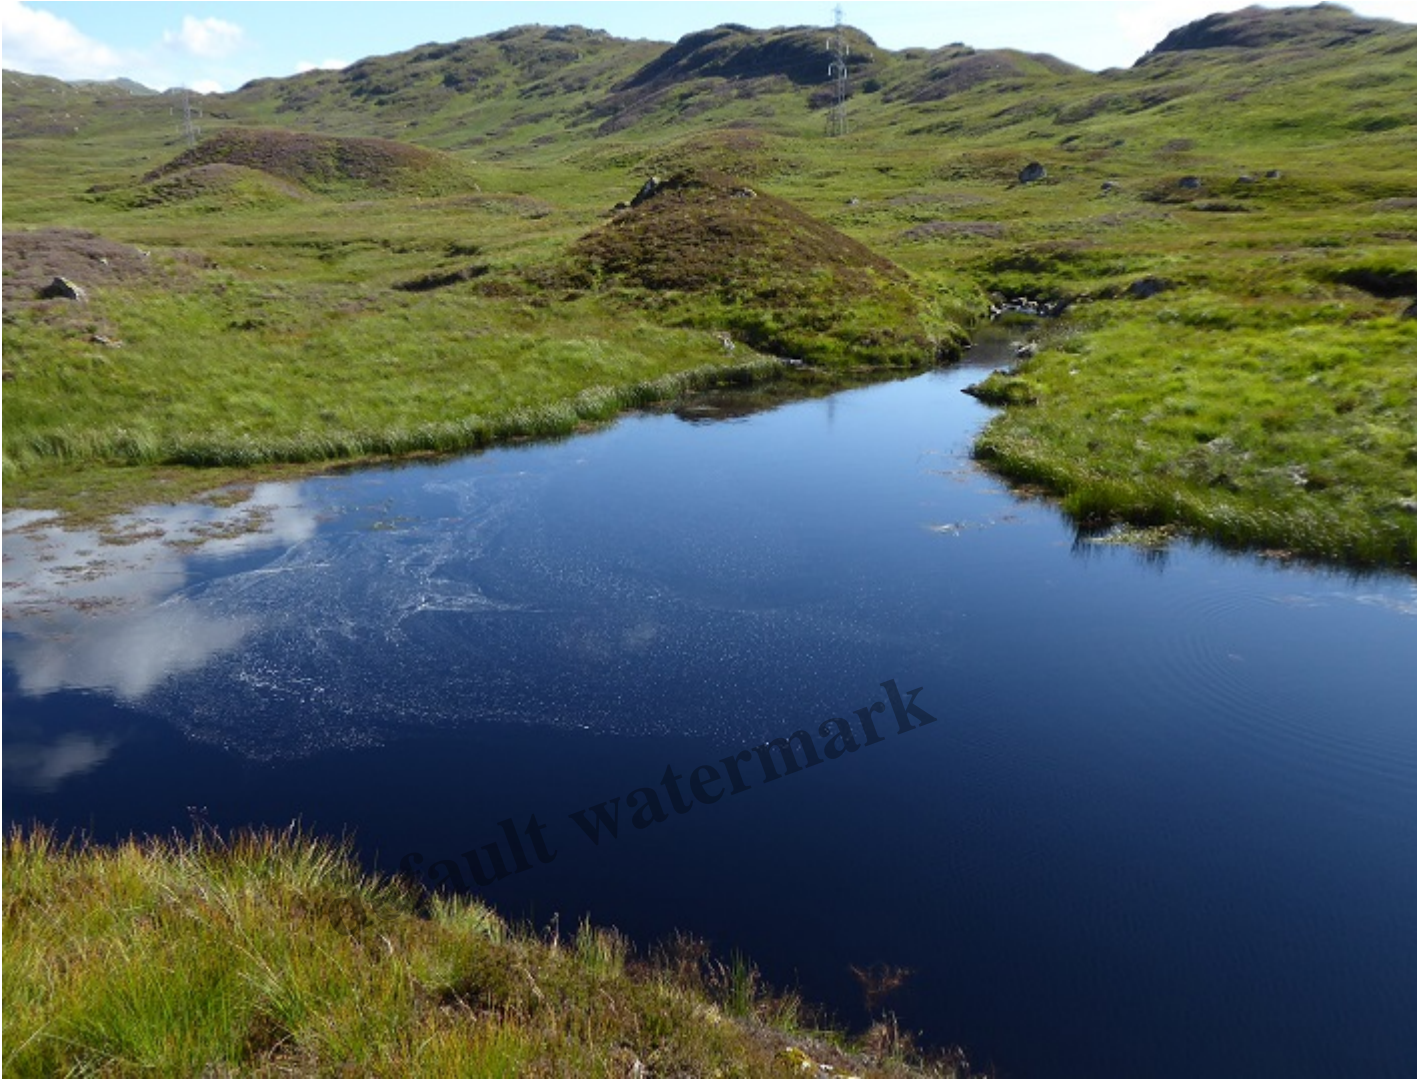
Looking south from the intake – I could see no sign of infilling

Like the Upper Falloch there is a large pool, but this one looks good – almost natural – and isn't infilling. The reasons for this relate to the topography. The burn feeding the pool is not steep and fast flowing but instead wends its way through peat bog. The peat and the vegetation reduce the sediment and rocks that can enter the river system, while the gentle angle means that any material that does enter the burn moves along slowly. Assuming the intake wall has been well constructed, there is unlikely to be any need for further engineering here any time soon, a contrast to the other six intakes on the south side of Glen Falloch. It appears therefore to be the only intake out of the seven that has been well designed and located.
