## Unsustainable run of river hydro schemes – Glen Falloch one year on

### Intake 1 – Upper Glen Falloch

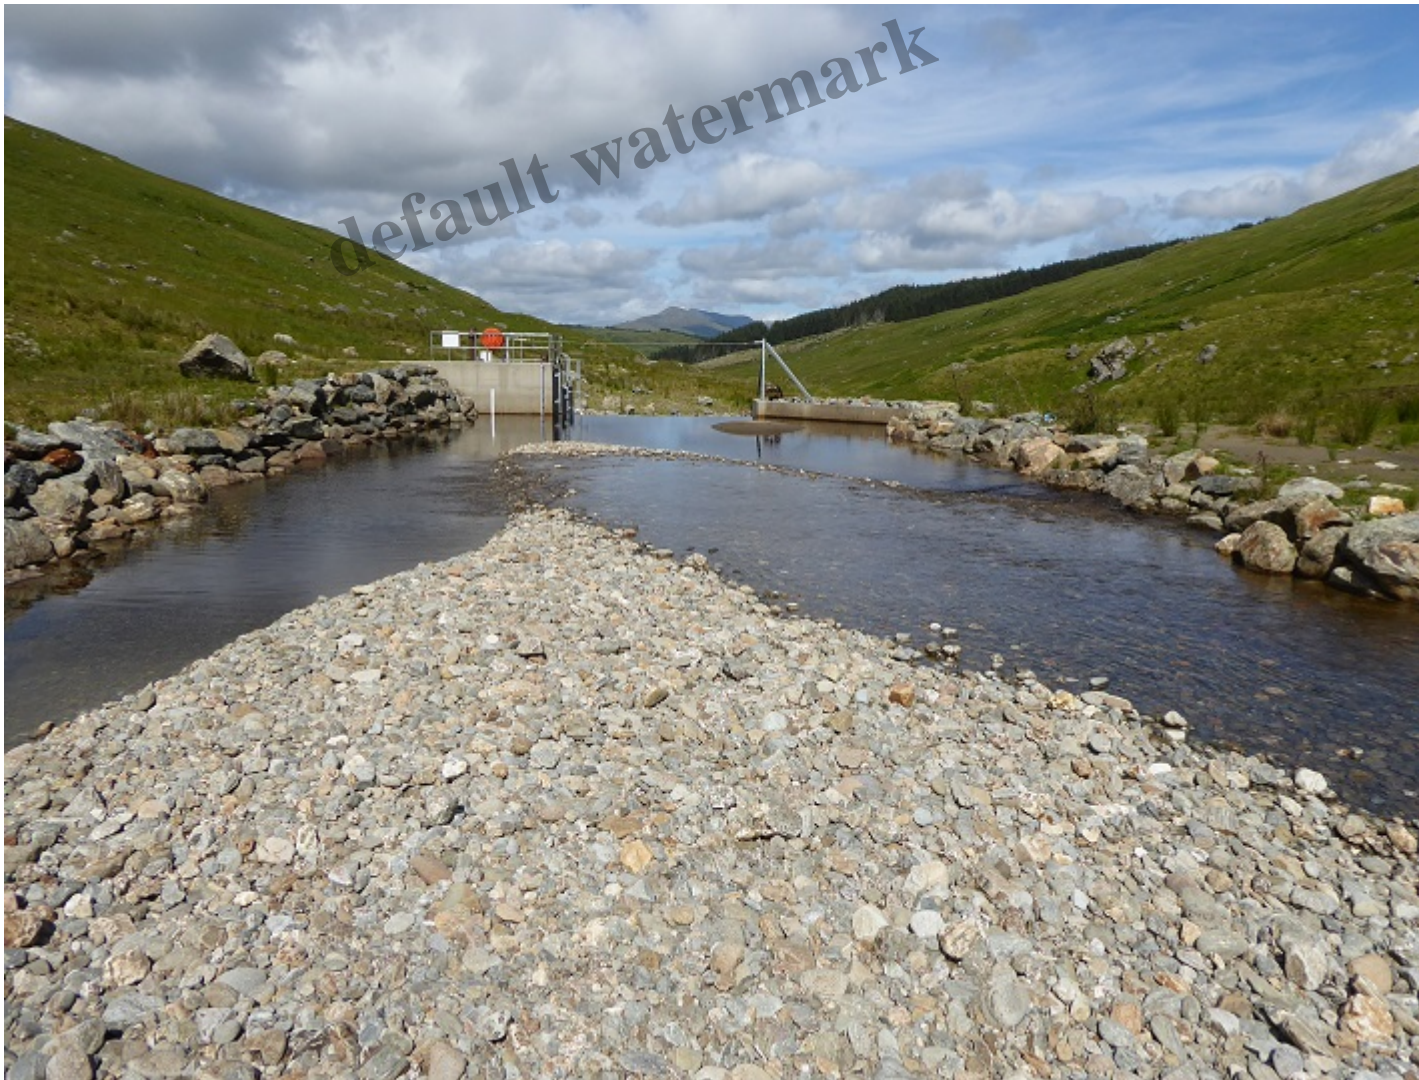
Infilling intake pool August 2020. As the river re-wilds, the hydro is at continuous risk of

redundancy.

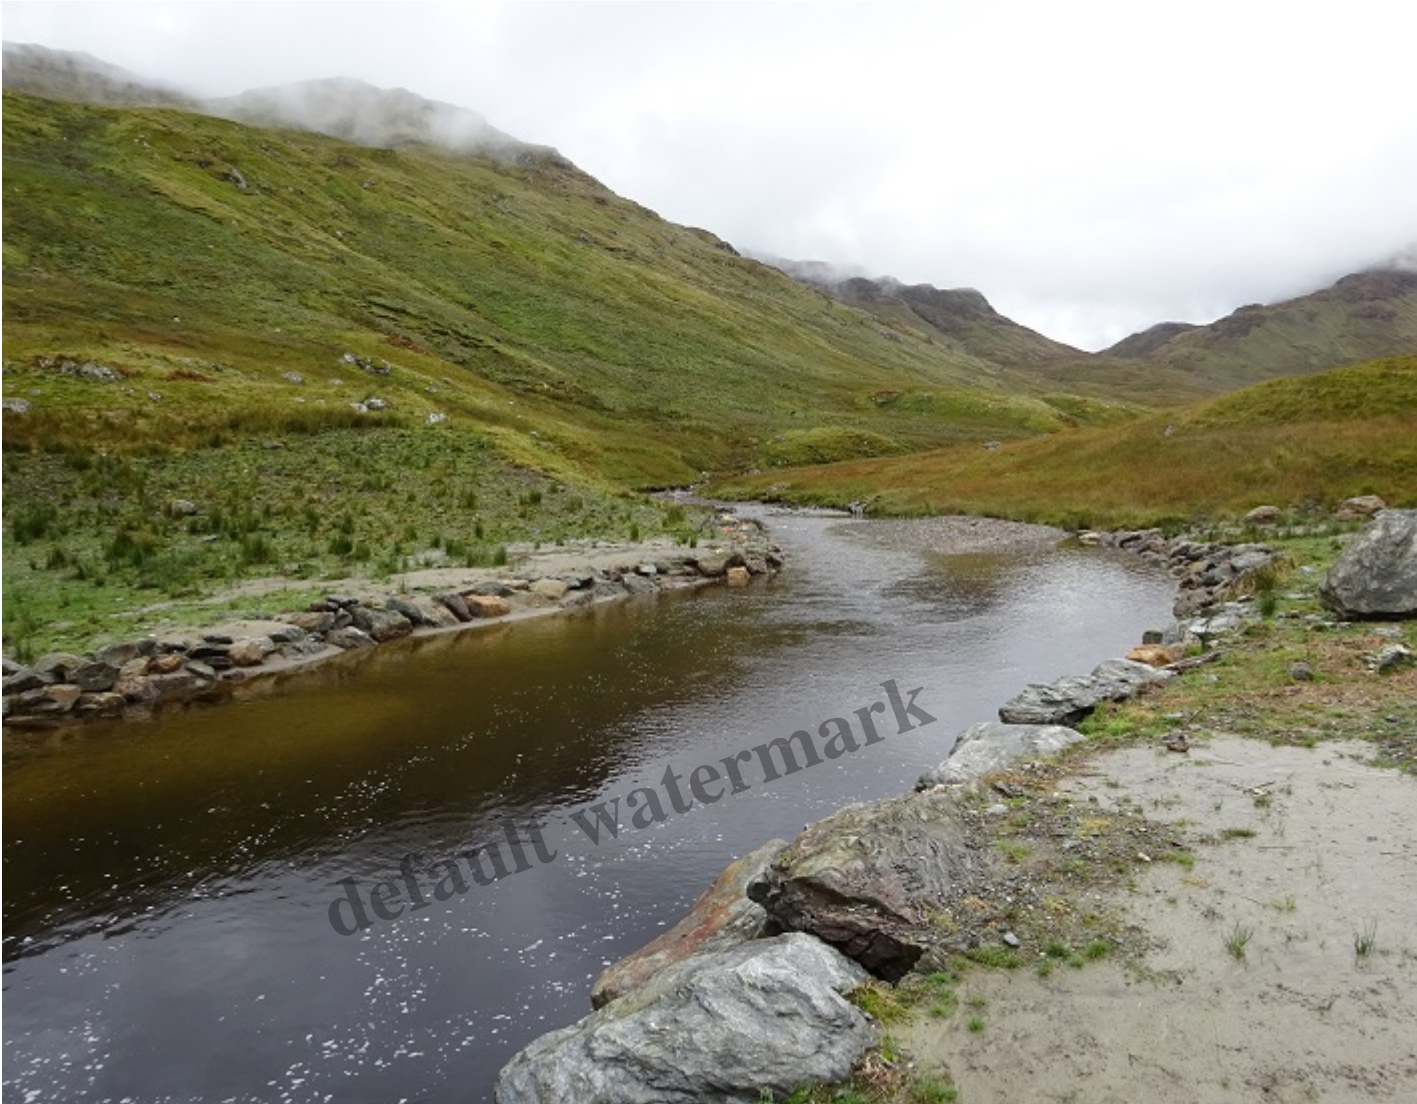
In September 2019, the pool was still there, despite the serious floods the previous month but with signs of additional infilling:

September 2019. Note sandbank on left and shingle bank at top of pool

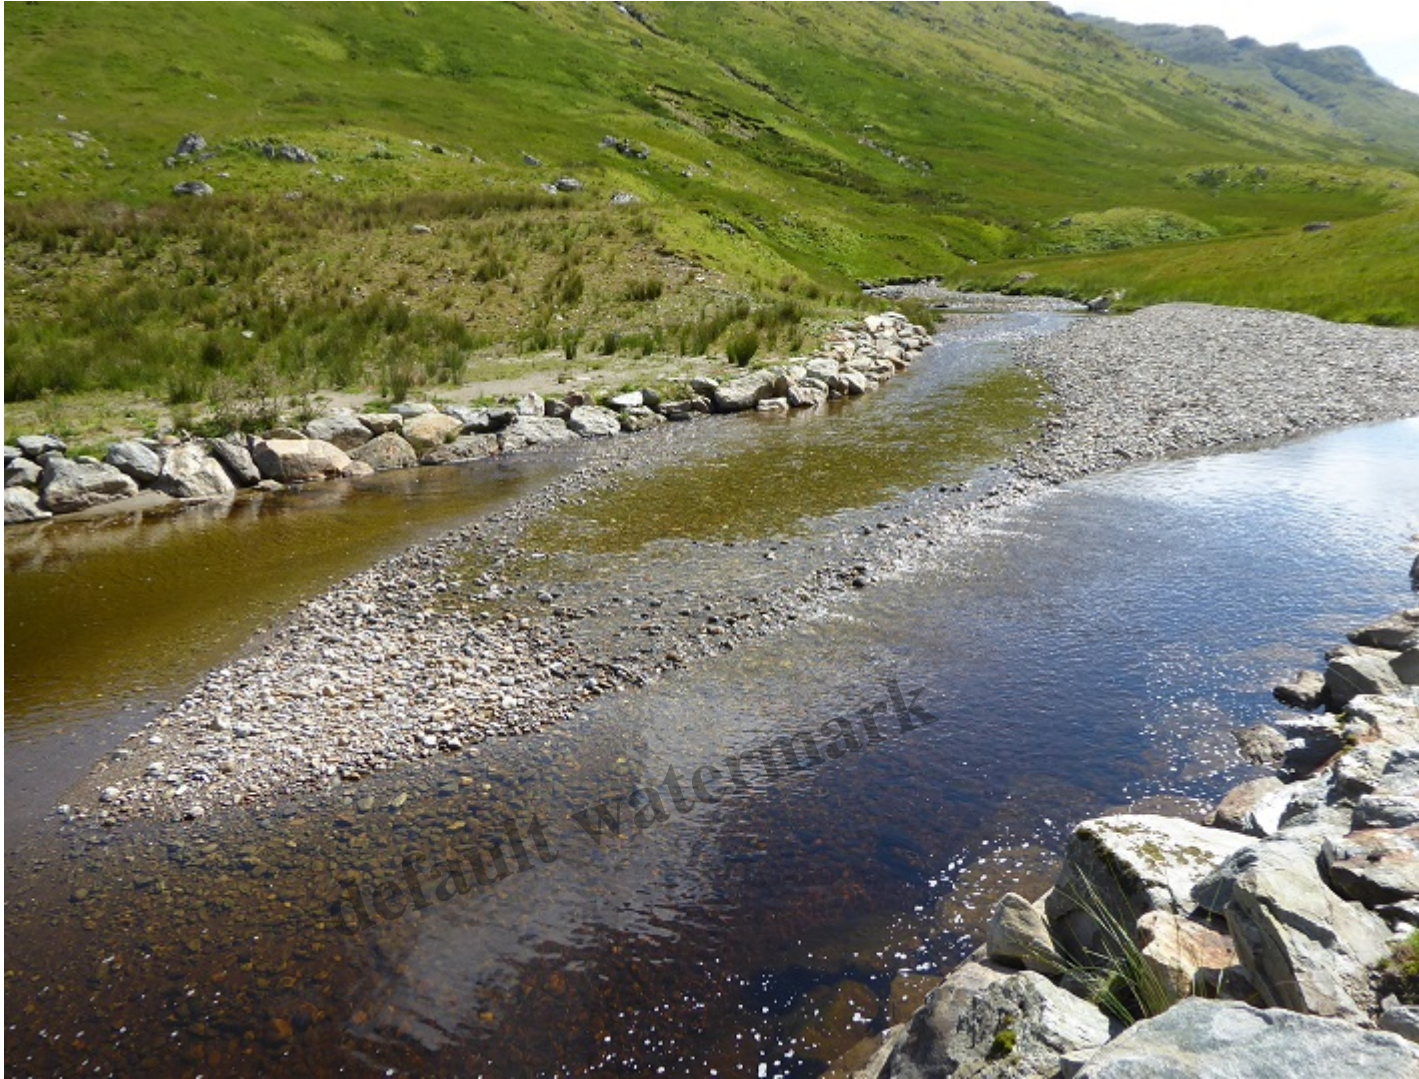
In the year since, the pool has almost completely infilled:

Re-wilding at work.Â Note the extent of the shingle compared to 2017.

The shingle has softened the intake pool with its rip rap bouldering.Â That is out of place in a once wild glen but then nature generally tends to look far better than crude engineering.

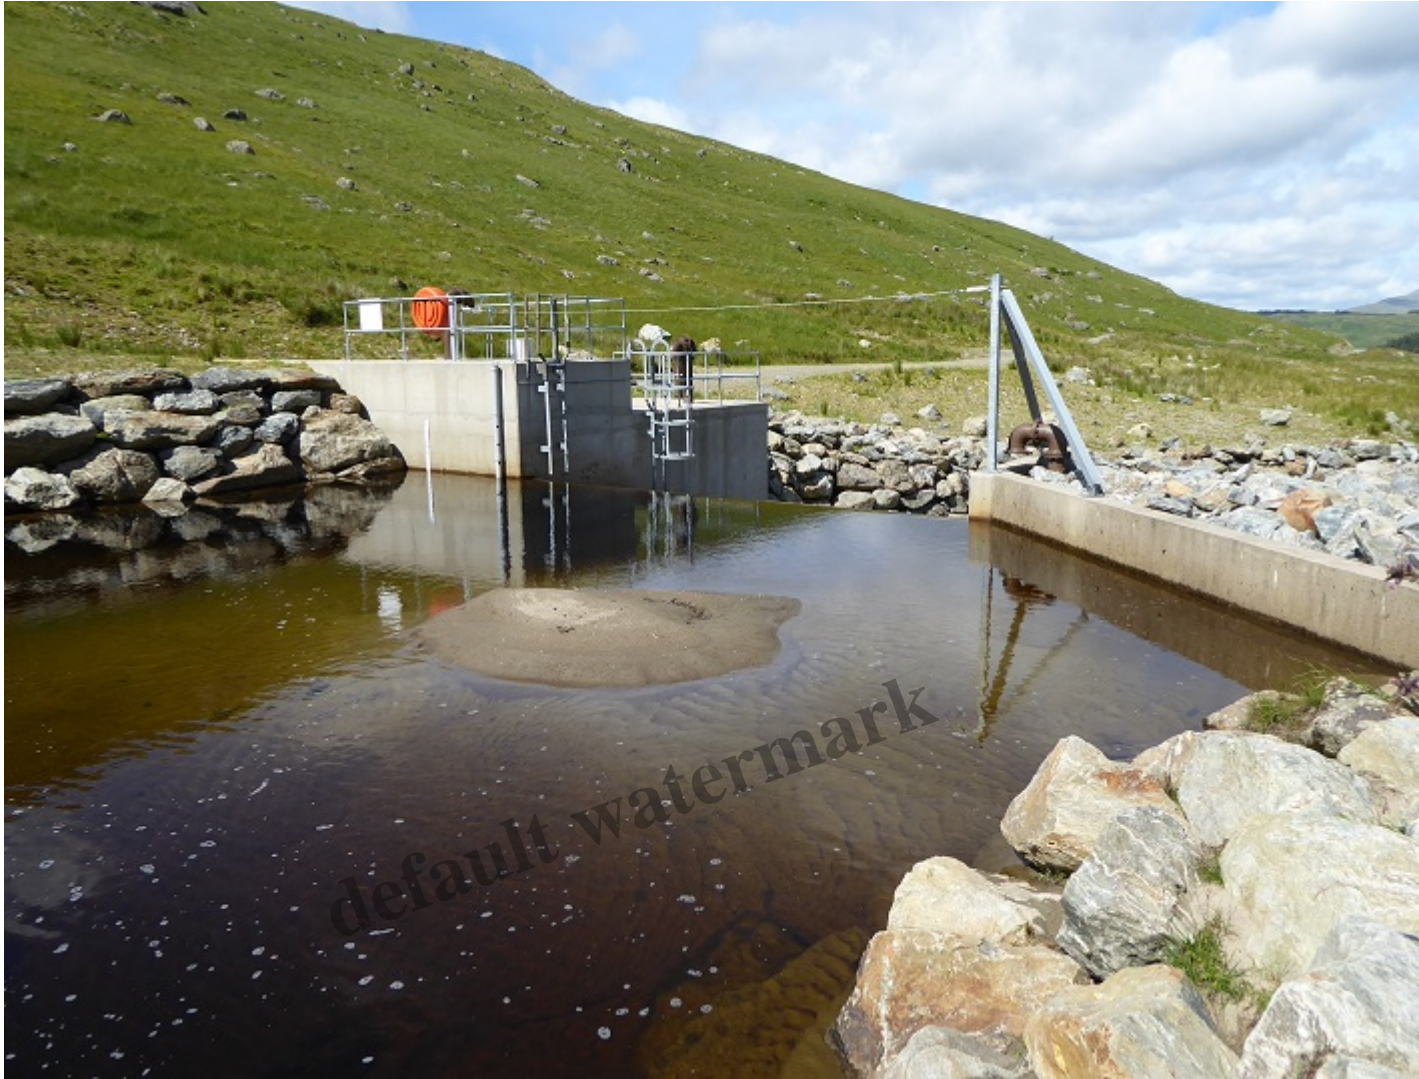
The lifebelt is now redundant!

The intake structure remains for now but it has trapped a large volume of material which now threatens its viability. There are two aspects to this. The first is if the pool infills much further the River Falloch could change its course leaving the hydro intake high and dry, as it almost did in August 2018 ([see here](#)):

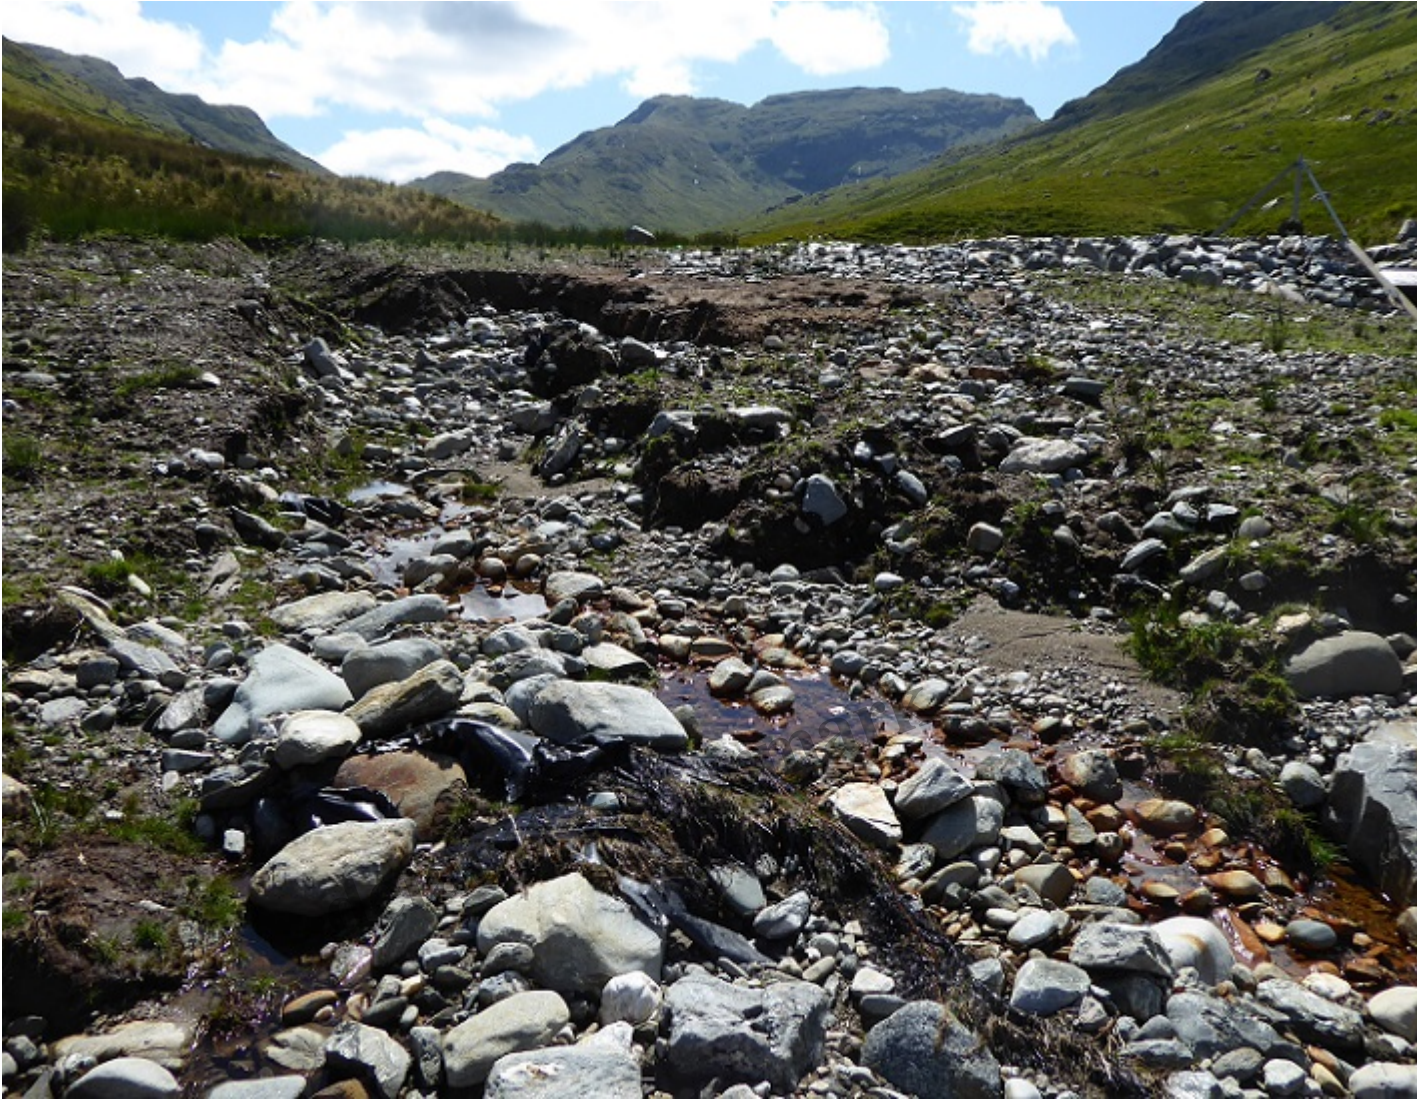
The view up the new channel created in August 2019 one year later.Â Intake on far right, Beinn a Chroin behind.

Leave aside the very poor attempt at restoration, with plastic everywhere and large amounts of peat just waiting to be swept away – poorly situated hydro schemes like this release significant amounts of carbon into the atmosphere – the potential for the river to change course is obvious.Â For this hydro to remain viable constant engineering will be required.

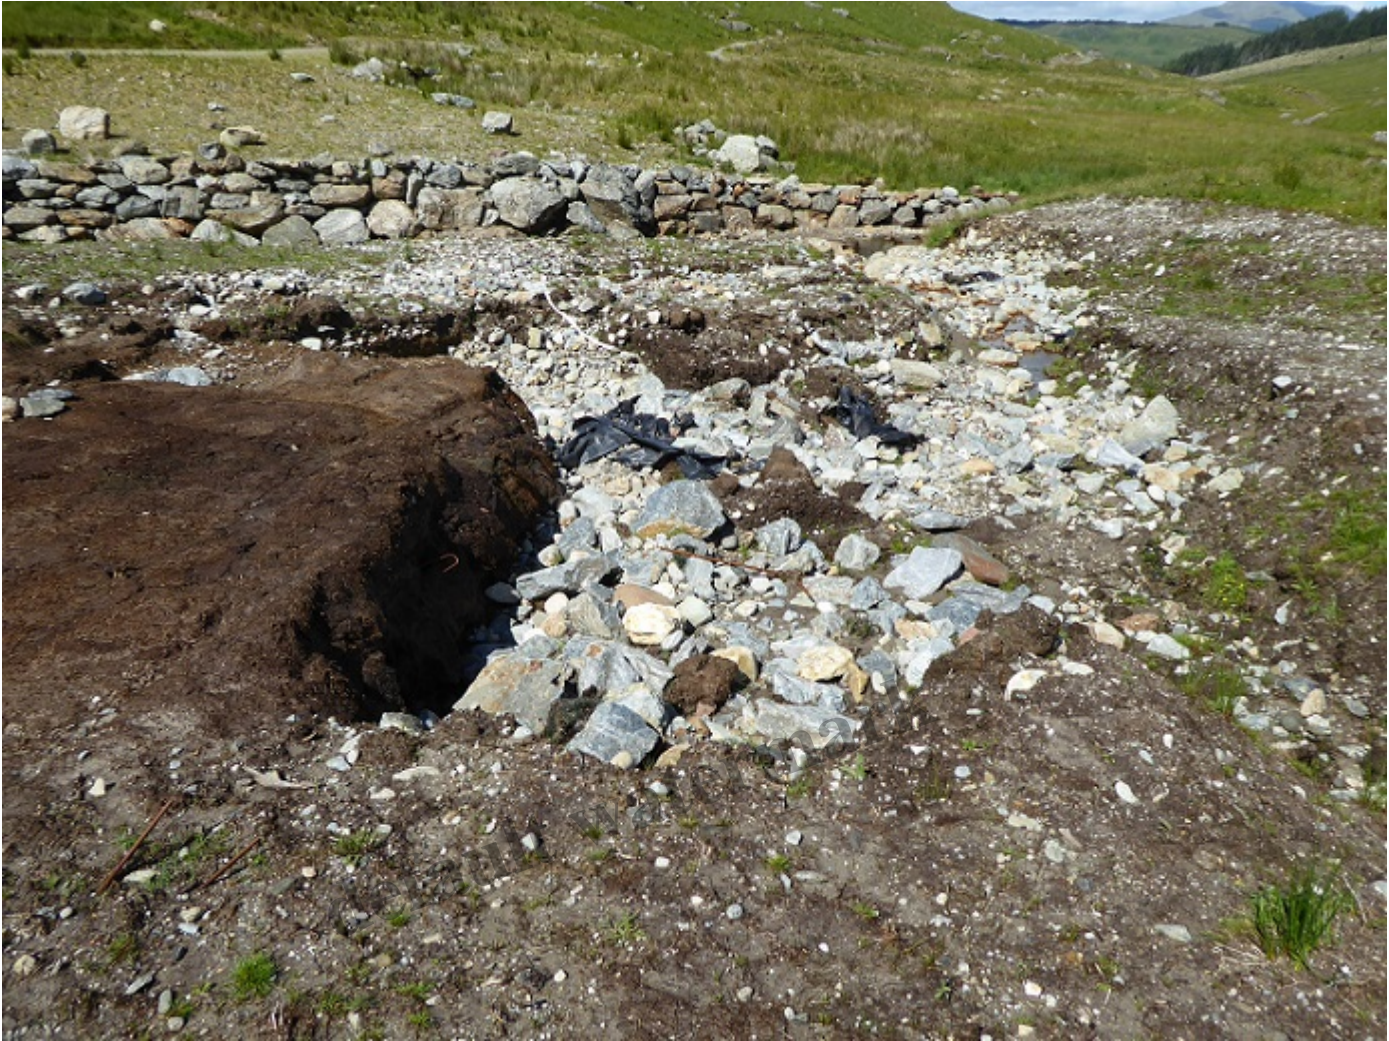
Looking down one of the new channels created by the flood over to far bank of the River Falloch below the intake. A large area of “restored” peat just waiting to be swept away.

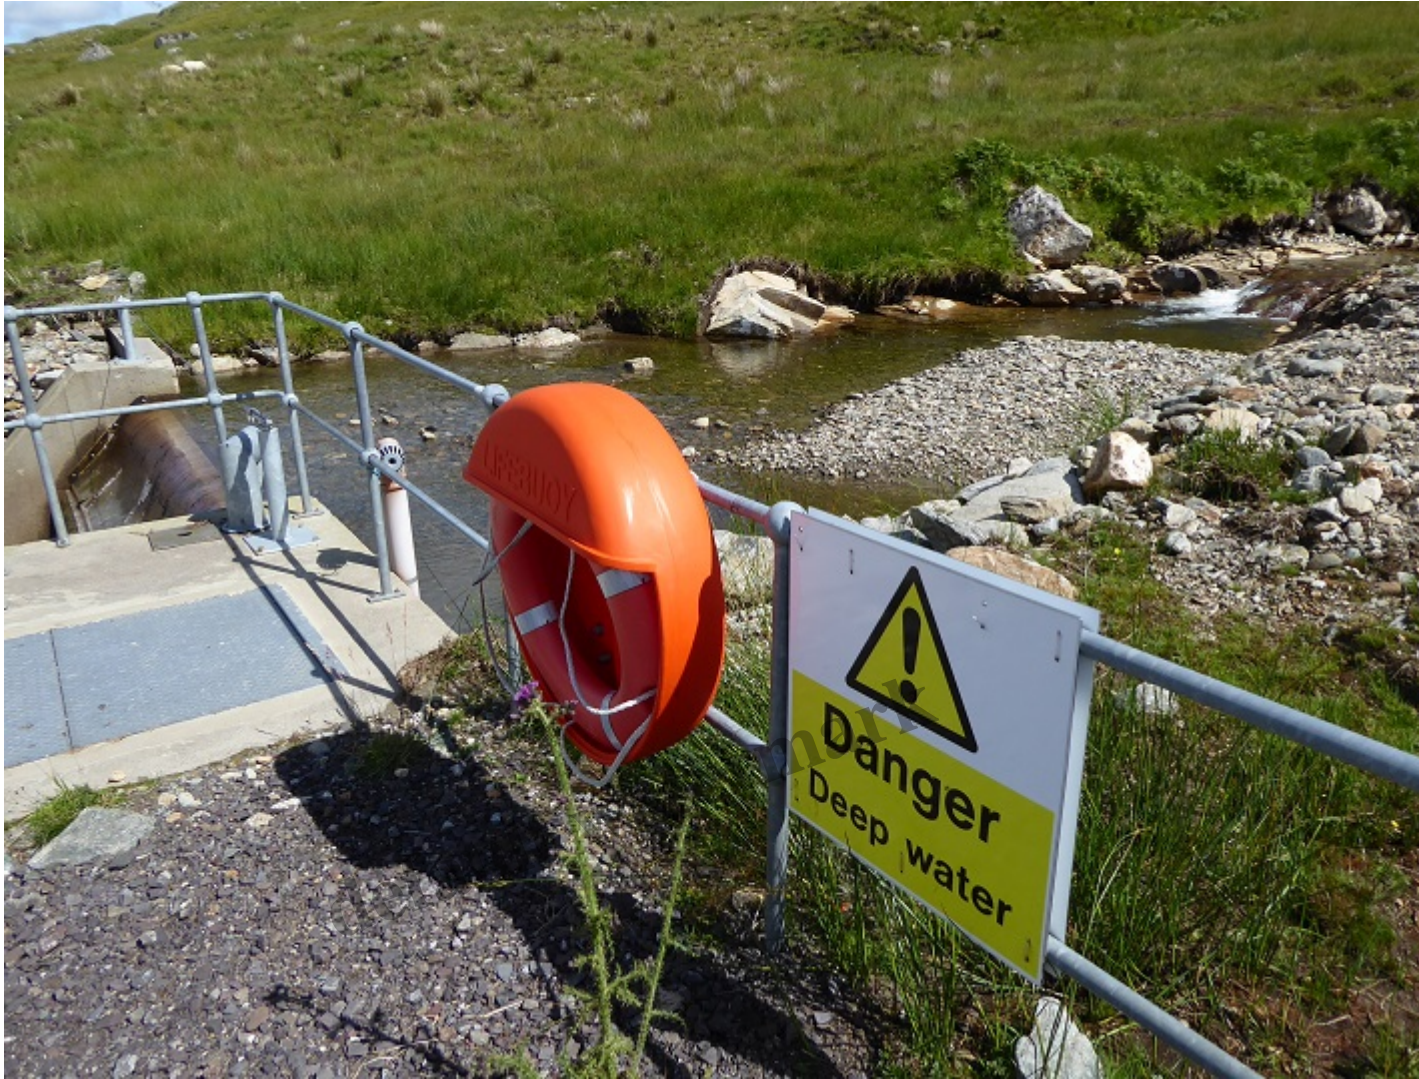
Another deep pool no more.Â August 2020

On the other side of An Caisteal's north ridge lies the Allt Andoran intake.Â It also suffered serious damage large year with some of the rip rap bouldering below the intake swept away (again, [see here](#)).

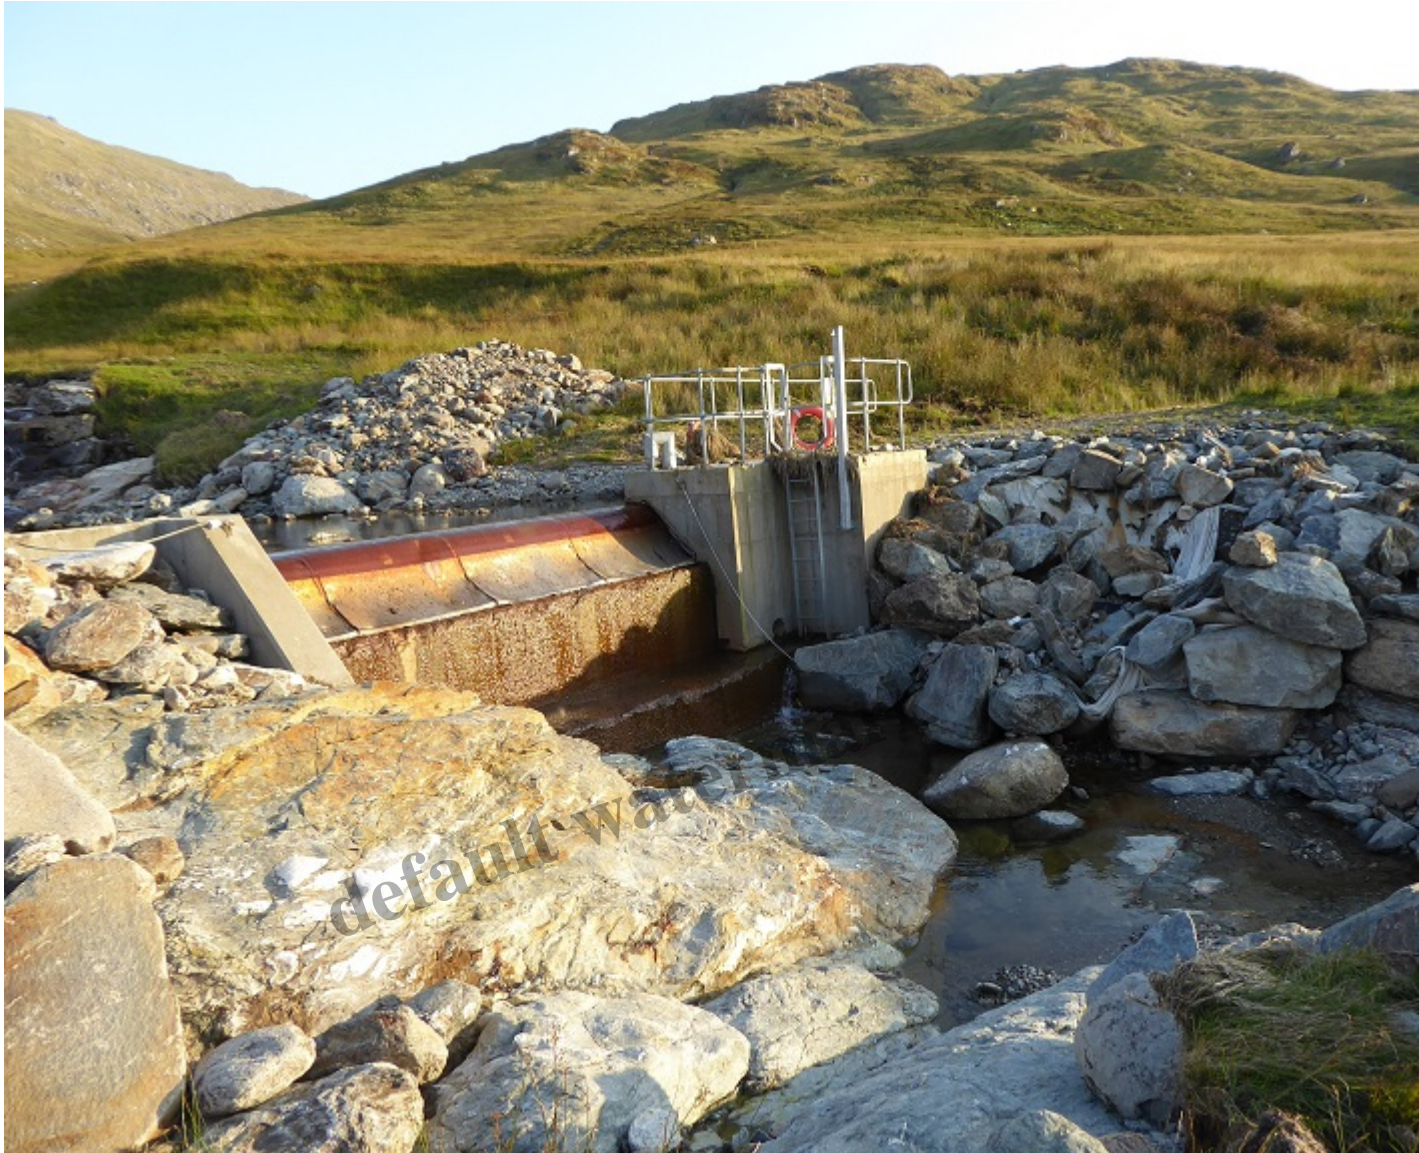
September 2019

A year ago there was a pile of boulders that had been excavated from the pool to get the hydro functioning again:

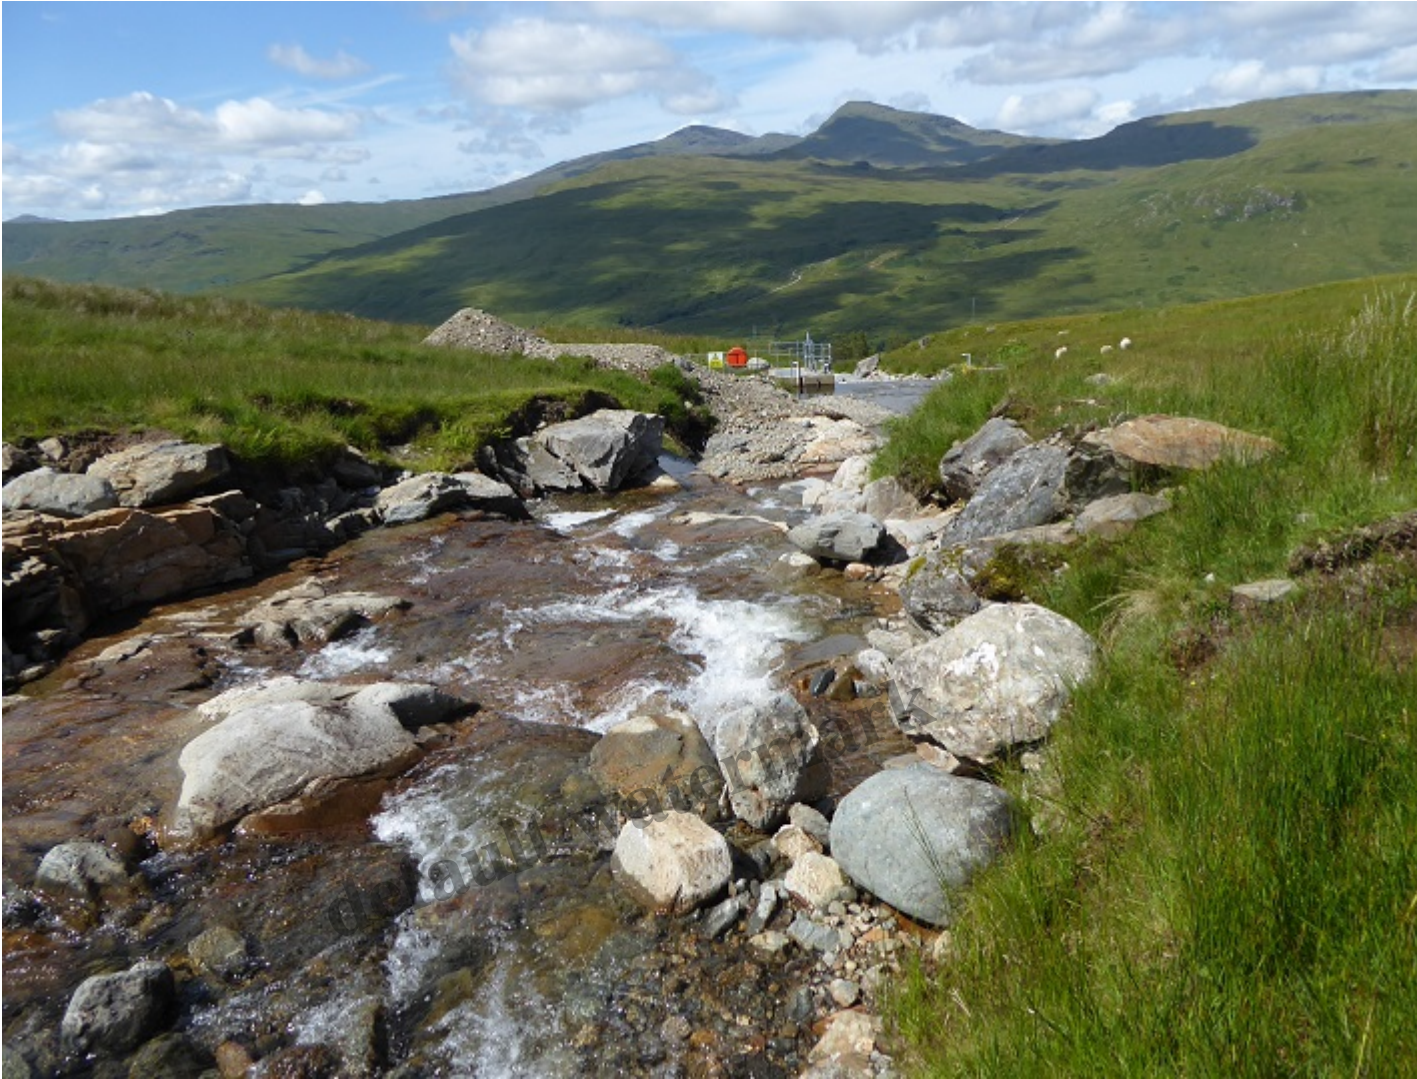
Allt Andoran intake with Ben Oss behind – the flat bit to right of highest part of heap has been created by diggers being driven up onto the heap to drop more stones and boulders.Â August 2020.

We now have river mining in what is supposed to be a National Park.Â It has not had planning permission.Â I have not yet found out whether the Scottish Environment Protection Agency has approved the work – most extraction from rivers requires a license under the Controlled Activities Regulations.

Both SEPA and the LLTNPA should also be concerned about how the extraction of all this material affects the ecology of the river below.Â Shingle and sand provides a home for wildlife but, if it going to be extracted and dumped like this, it can't do that anymore. That will have a knock on effect on fish and birds like dipper and grey wagtail.

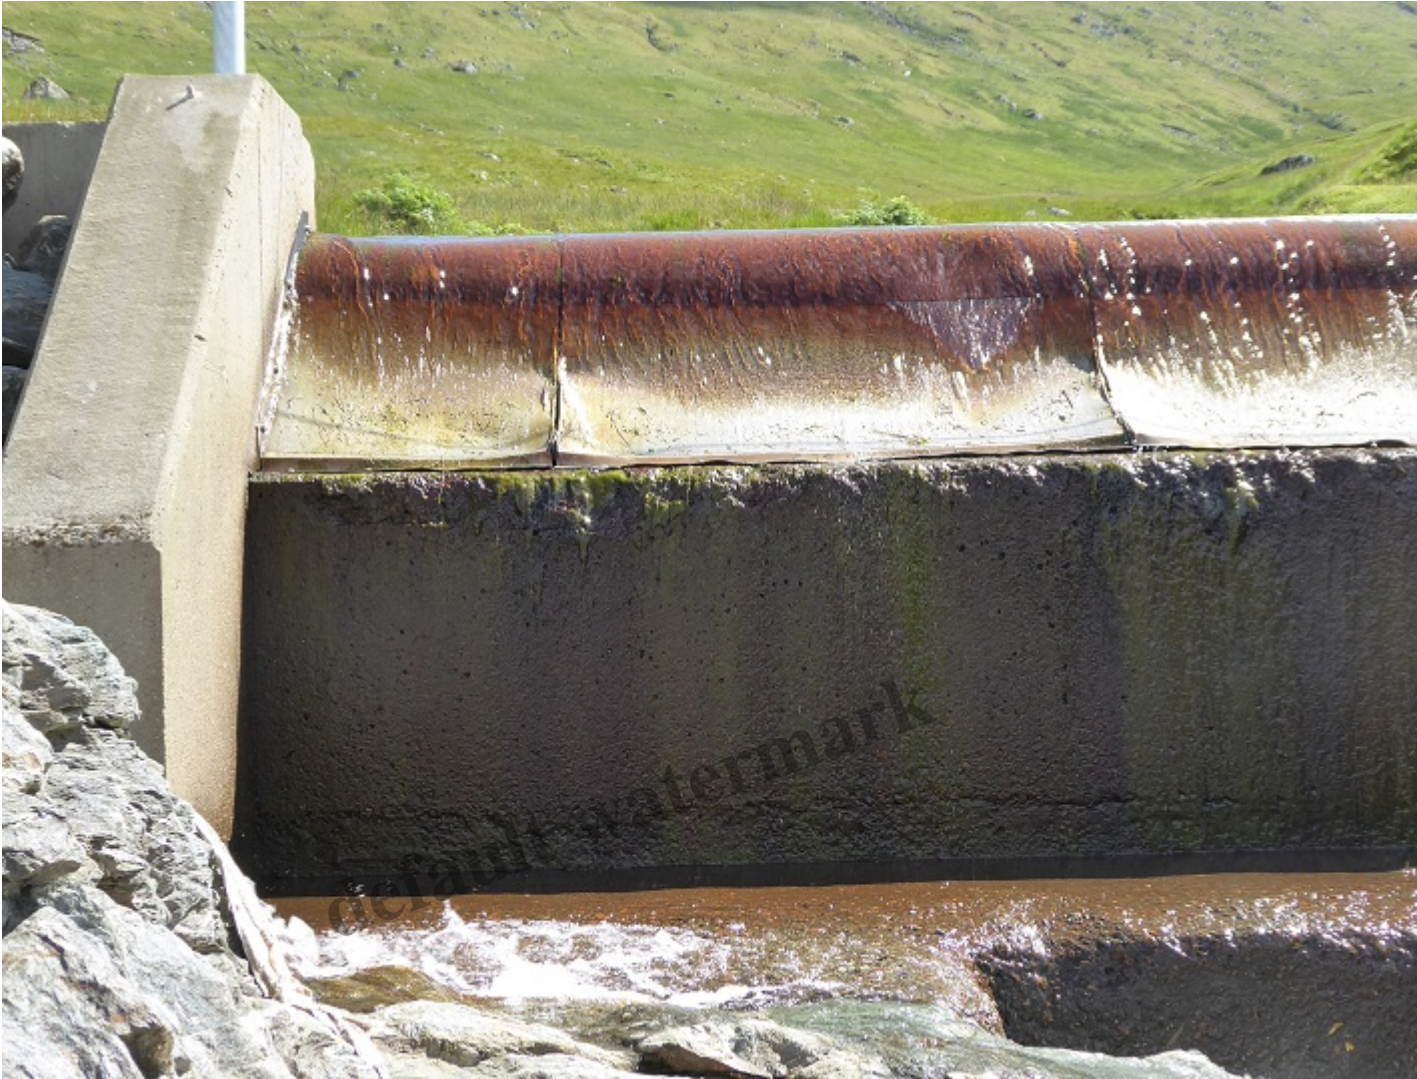
Allt Andoran intake August 2020

The intake itself has become increasingly battered and damaged, illustrating why continual excavation of this pool will be necessary. The narrow mesh Coanda screens are very good at keeping potentially damaging stones and vegetation out of the hydro system but are themselves very vulnerable to damage by boulders and pebbles rolling over them. There are sturdier intake screens, but they let more material into the hydro system, potentially damaging the pipes and turbines.

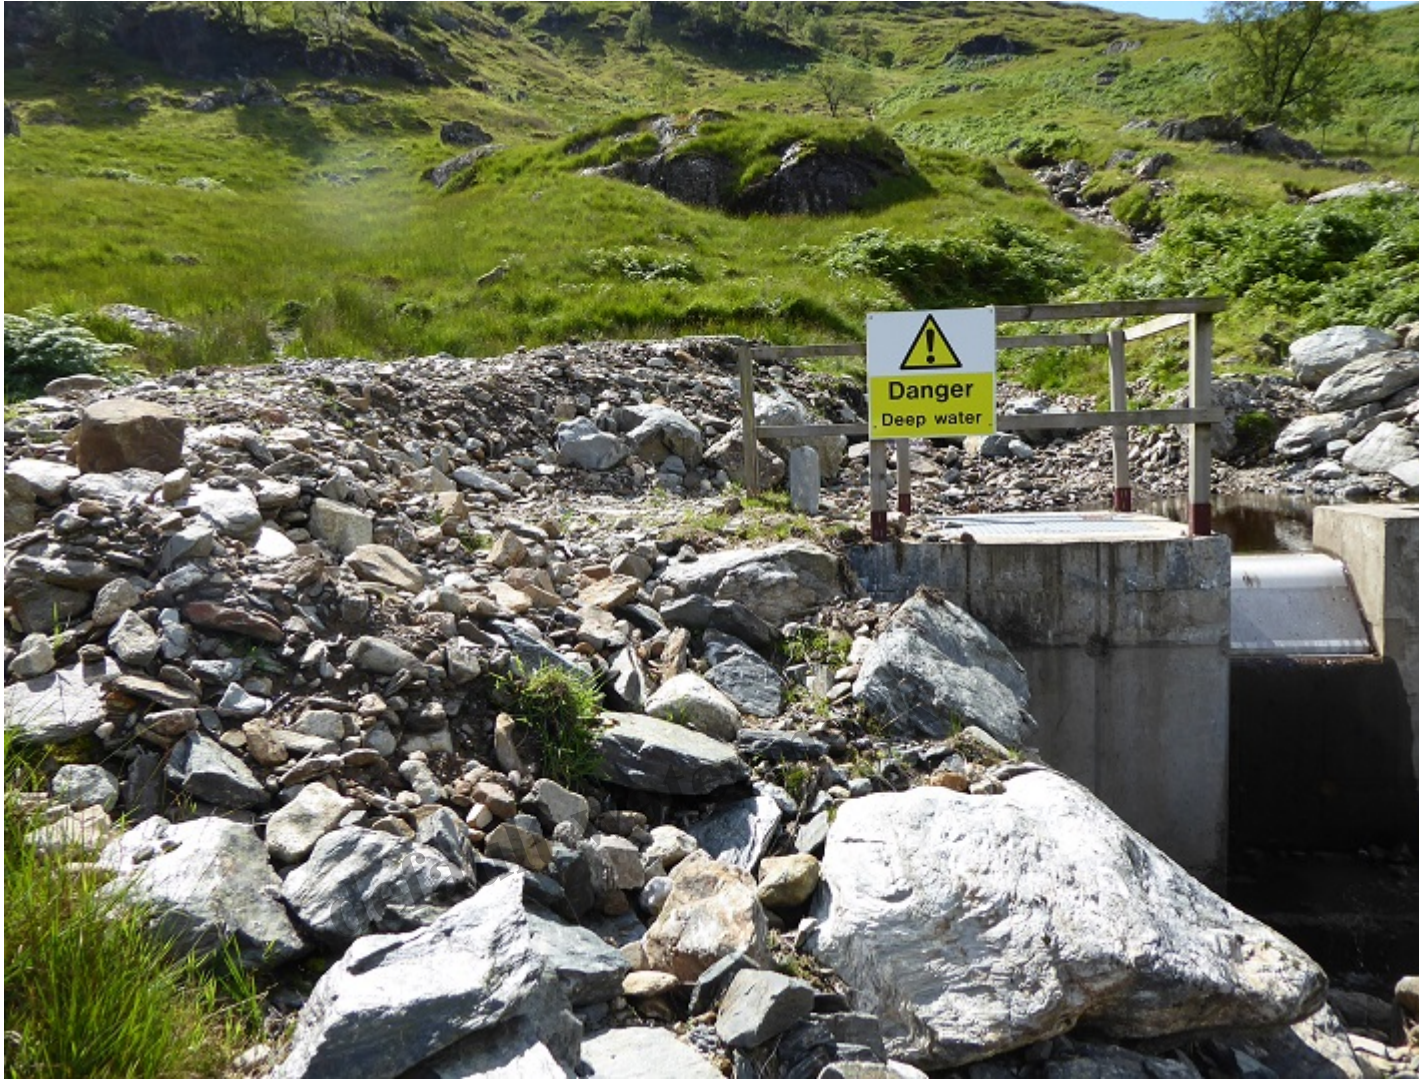
The Allt Chuilinn flows down the next glen to the west and is fed by three intakes. It had suffered the most spectacular damage last year but the smallest intake had been out of commission before that. Poor design and construction had resulted in the burn flowing under the intake leaving what should have been the intake pool high and dry. It has now been fixed:

Being out of commission didn't affect the volume of material that was trapped behind this small intake in just a few years.

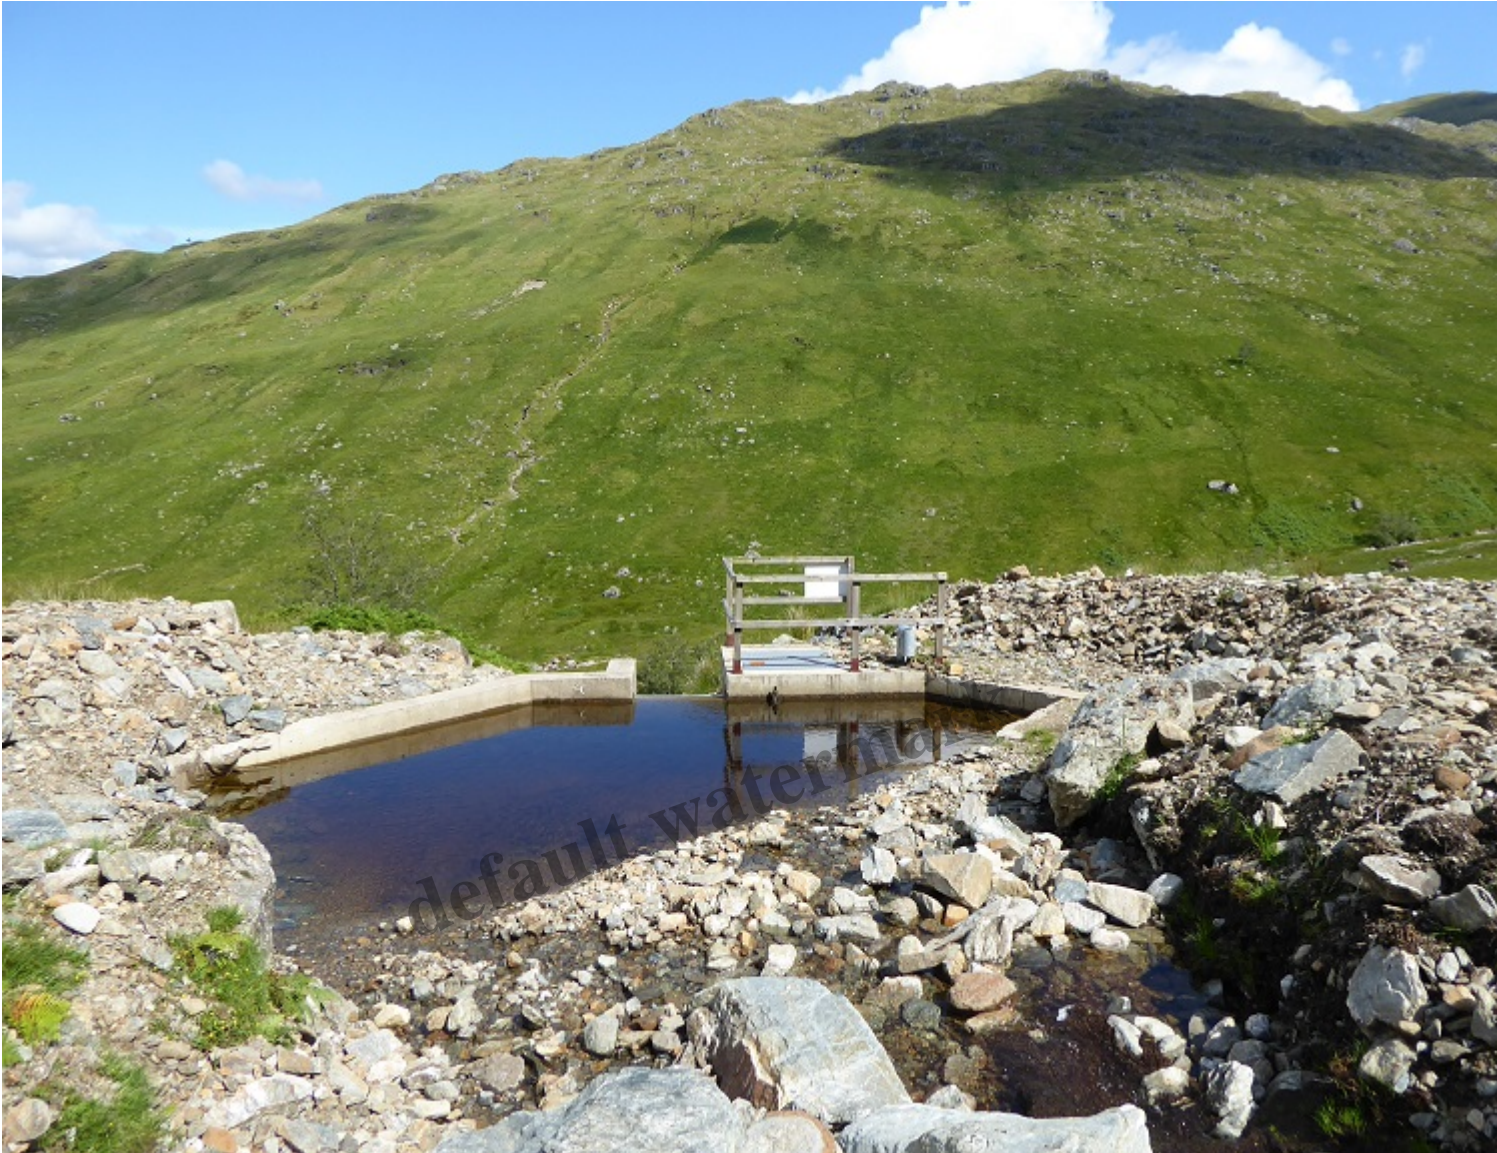
To give Glen Falloch estate credit, a large amount of re-engineering has been undertaken without a new track being put in place and there was very little sign of vehicle damage to the vegetation below. However, the location of this intake means the burn constantly risks changing course, hence the bulldozed bank on the left intended to keep it in its course. Whether that will be enough is not clear. There are signs that this burn might change course higher up.

Again, none of this work has had planning permission. Although hardly visible from the constructed hydro track below, the local landscape impact is significant. It is like coming across one of those mine spoil heaps that litter the Lake District that have taken over a century to mellow.

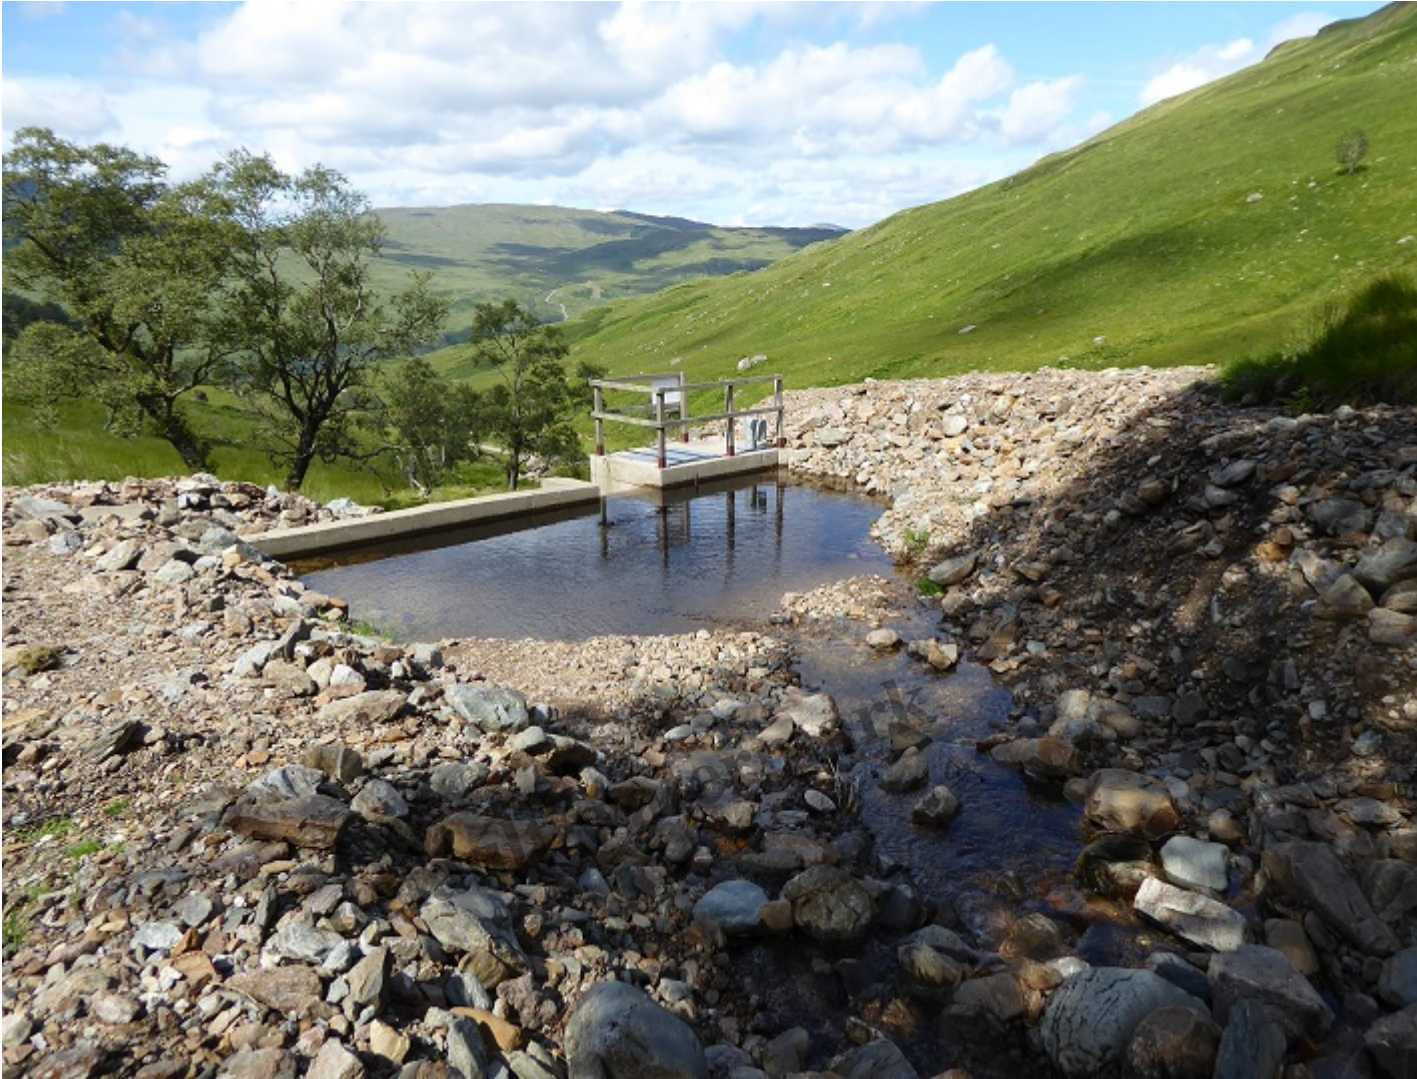
The middle intake with the hydro track by the Allt Chuilinn visible below.Â August 2020.

There were large rocks around the middle intake in 2018 but they have now been covered with smaller rocks excavated from the river.Â The pool is not big and, as you can see, is at constant risk of infilling.Â As soon as debris piles up behind the small intake the burn will divert over the intake wall taking the scheme out of commission.Â A reasonable guess is it may need to be excavated every couple of years to keep it functional given current levels of rainfall and erosion.

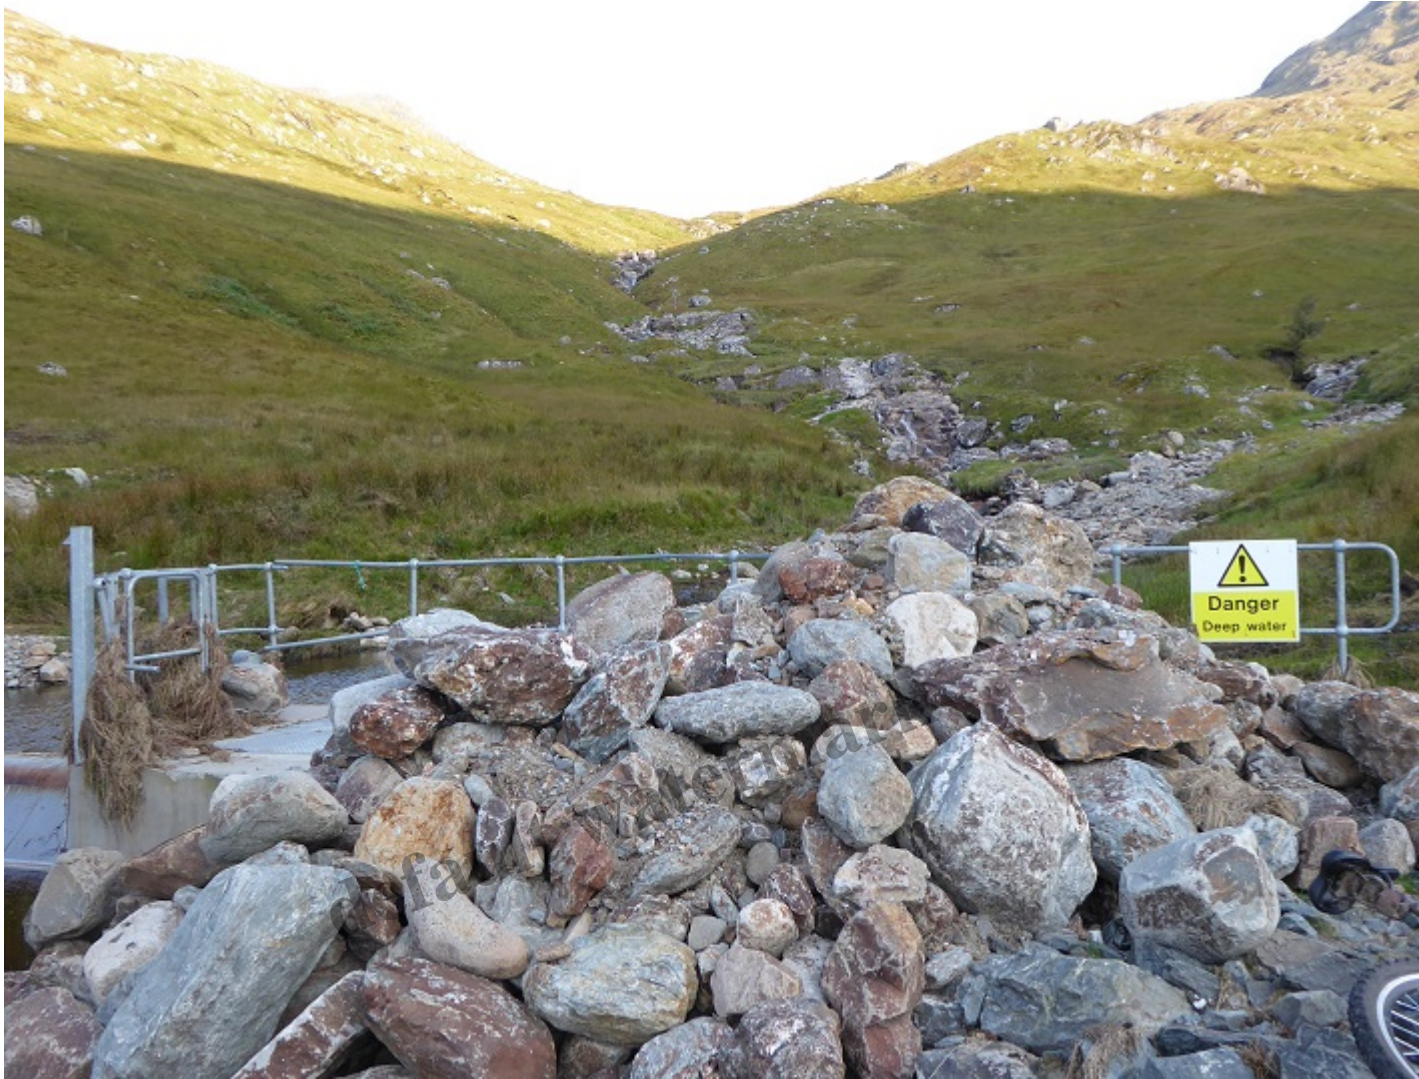
September 2019. A pile of boulders that appeared to have been excavated from the intake pool.
