## Unsustainable run of river hydro schemes – Glen Falloch one year on

### Intake 1 – Upper Glen Falloch

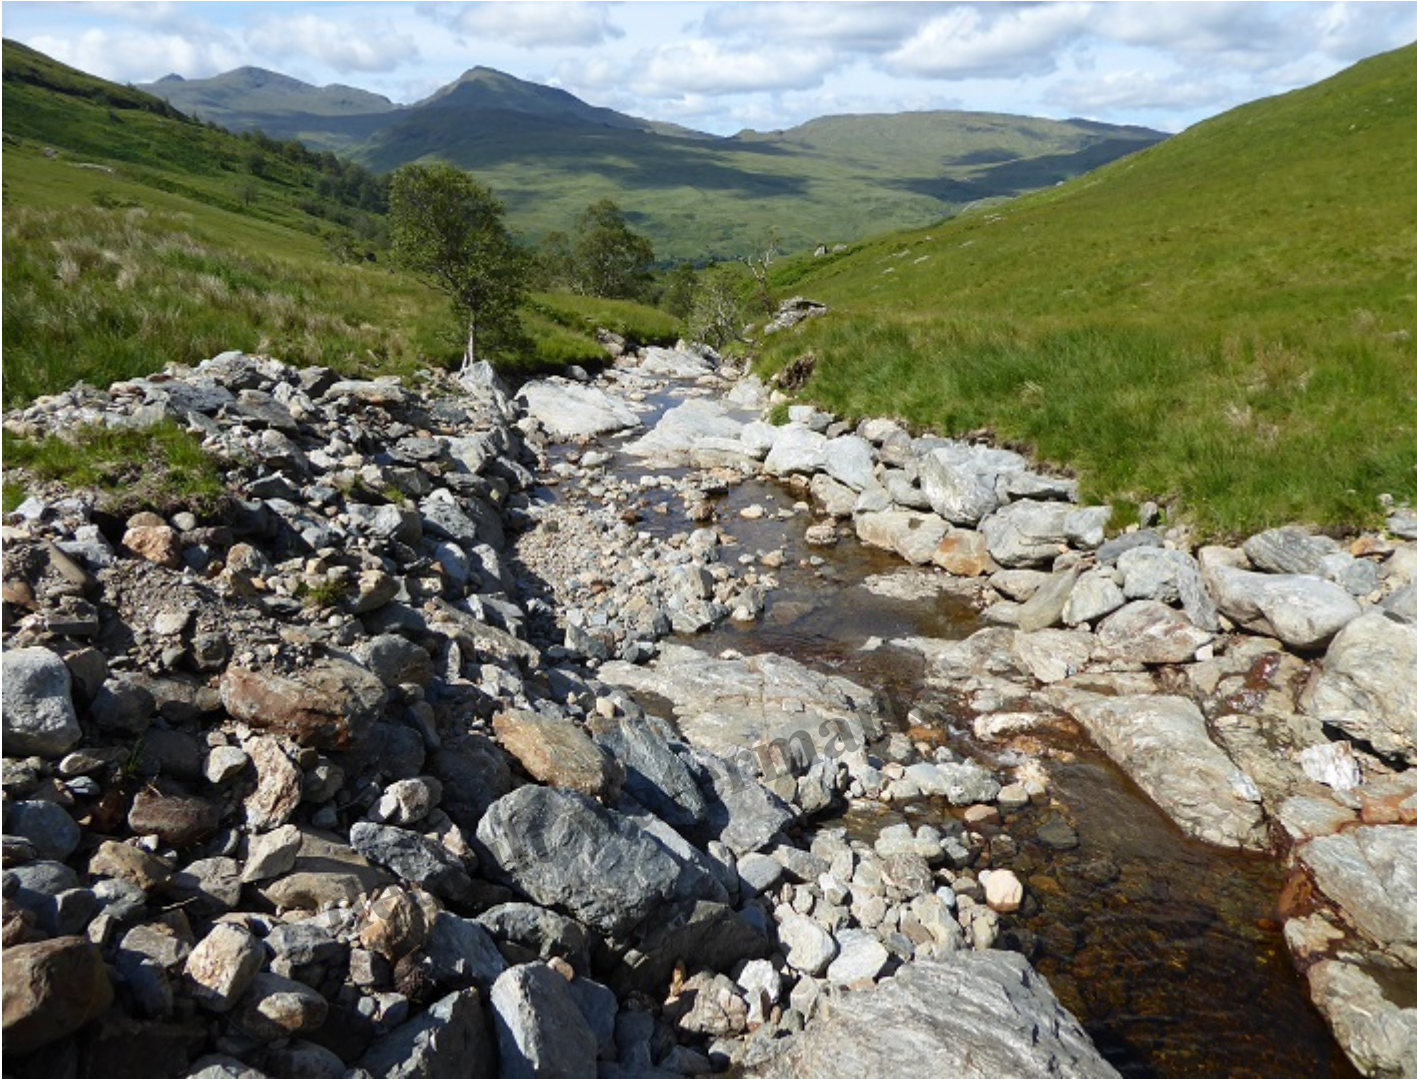
August 2020

The main intake of the Allt Chuilinn was where the worst damage was caused a year ago, with the pool apparently infilled and the rip-rap bouldering along the bank below swept away revealing the hydro pipe.

The restoration, which has again taken place outwith formal planning processes, has again been crude with boulders dumped over the bare pipe. It appears to me that if similar floods to those that occurred in August 2019 were to re-occur much of the “new” left bank would wash away. Both the LLTNPA and SEPA should be concerned about this and involved in trying to find solutions. Unfortunately, instead of admitting to mistakes and addressing the issues, the LLTNPA would prefer to pretend nothing has happened. The convener of the National Park, James Stuart, told me a year ago there is no need for any inquiry into the impact of the flooding on these hydro schemes. In my view he has got this badly wrong.

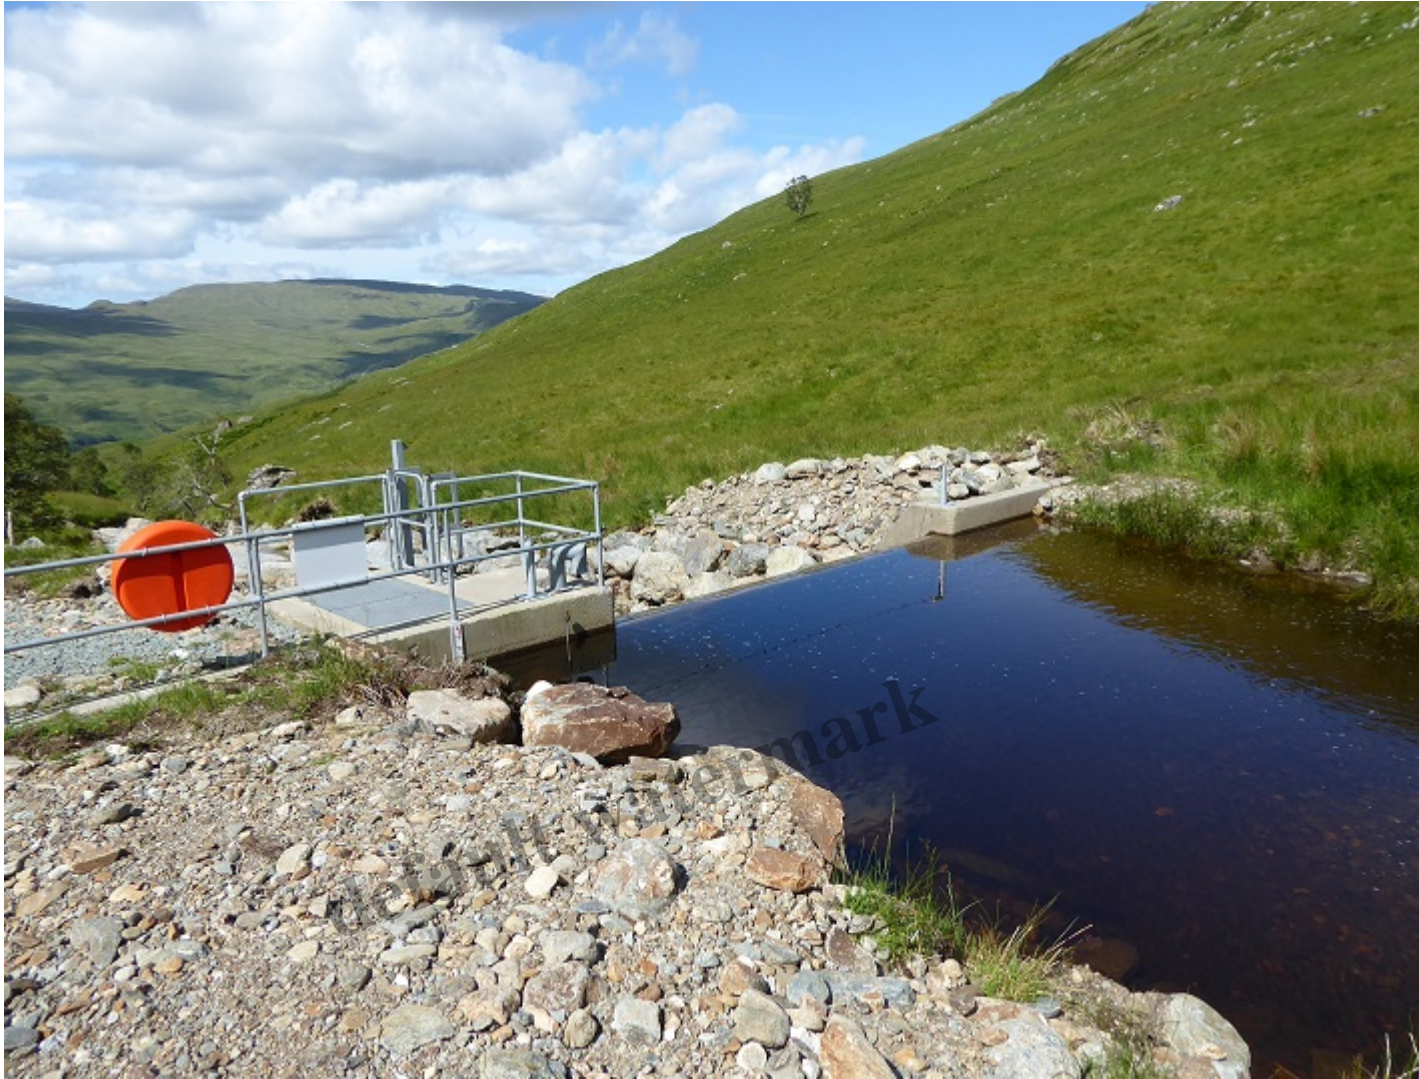
August 2020

A year after being excavated, the main Allt Chuilinn intake pool is still functioning but for how long? If you look carefully you can see how the pool is again gradually infilling. That is nature, you cannot stop these processes, though overgrazing on the hill and increased extreme rain events caused by climate change have increased the rate at which they take place. That has significant implications for the viability of run of river hydro schemes across Scotland.

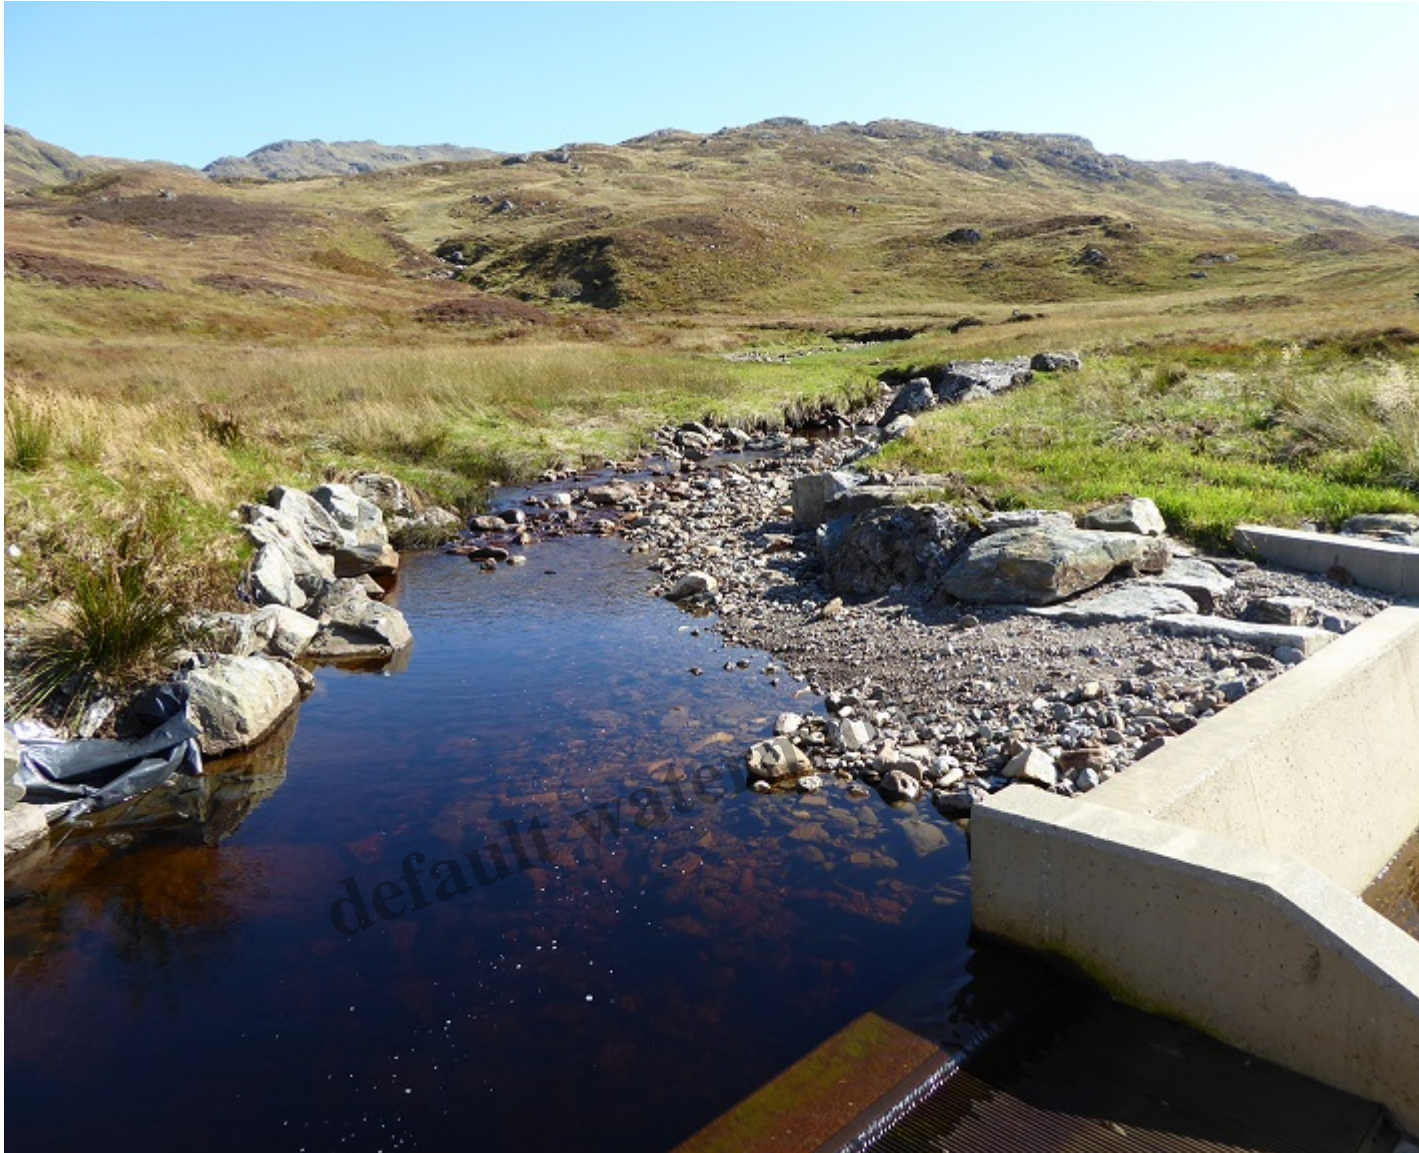
The most popular walkers path up Beinn Chabhair is just to the left of the photo. Note the shingle bank behind the intake and the missing boulder on the left bank. September 2019.

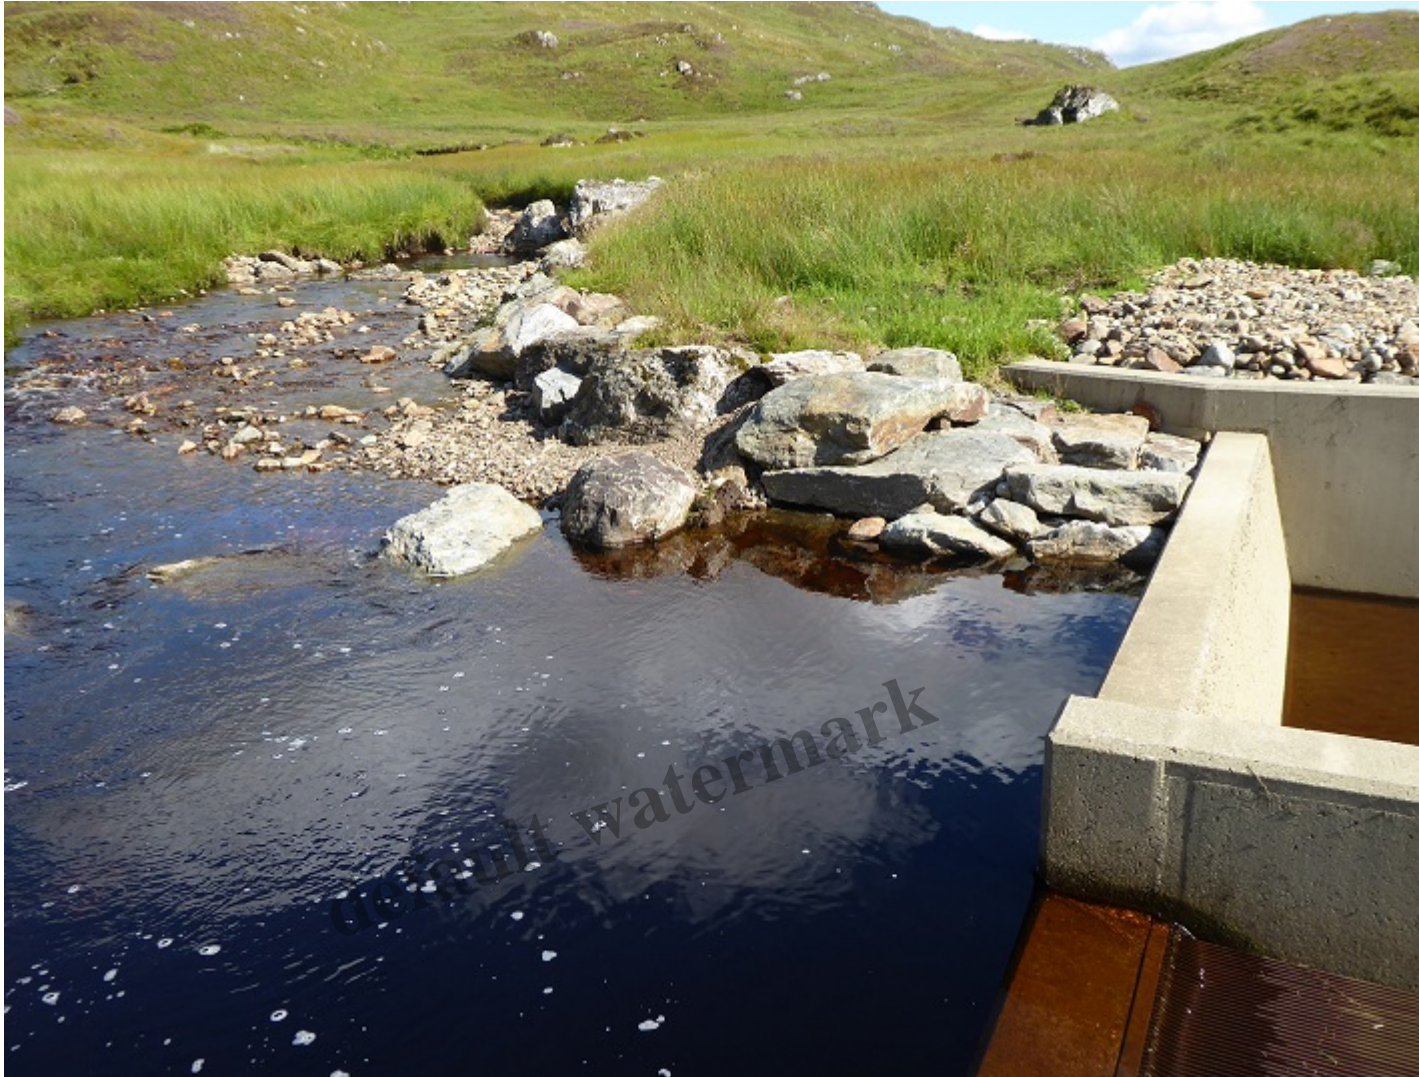
Last year these had been the least affected of all the hydro intakes on the south side of Glen Falloch. Various bits of damage had been done, however, to the higher of the two intakes and it had started to infill.

August 2020. Note how the excavated material has been dumped behind the far intake wing wall and the intake screen bottom right, more robust perhaps than a coanda screen but allowing more material through.

This intake has also now been excavated. Judging by the amount of material evident on the bed of the burn above, fairly frequent engineering is likely to be required to keep this scheme going too.

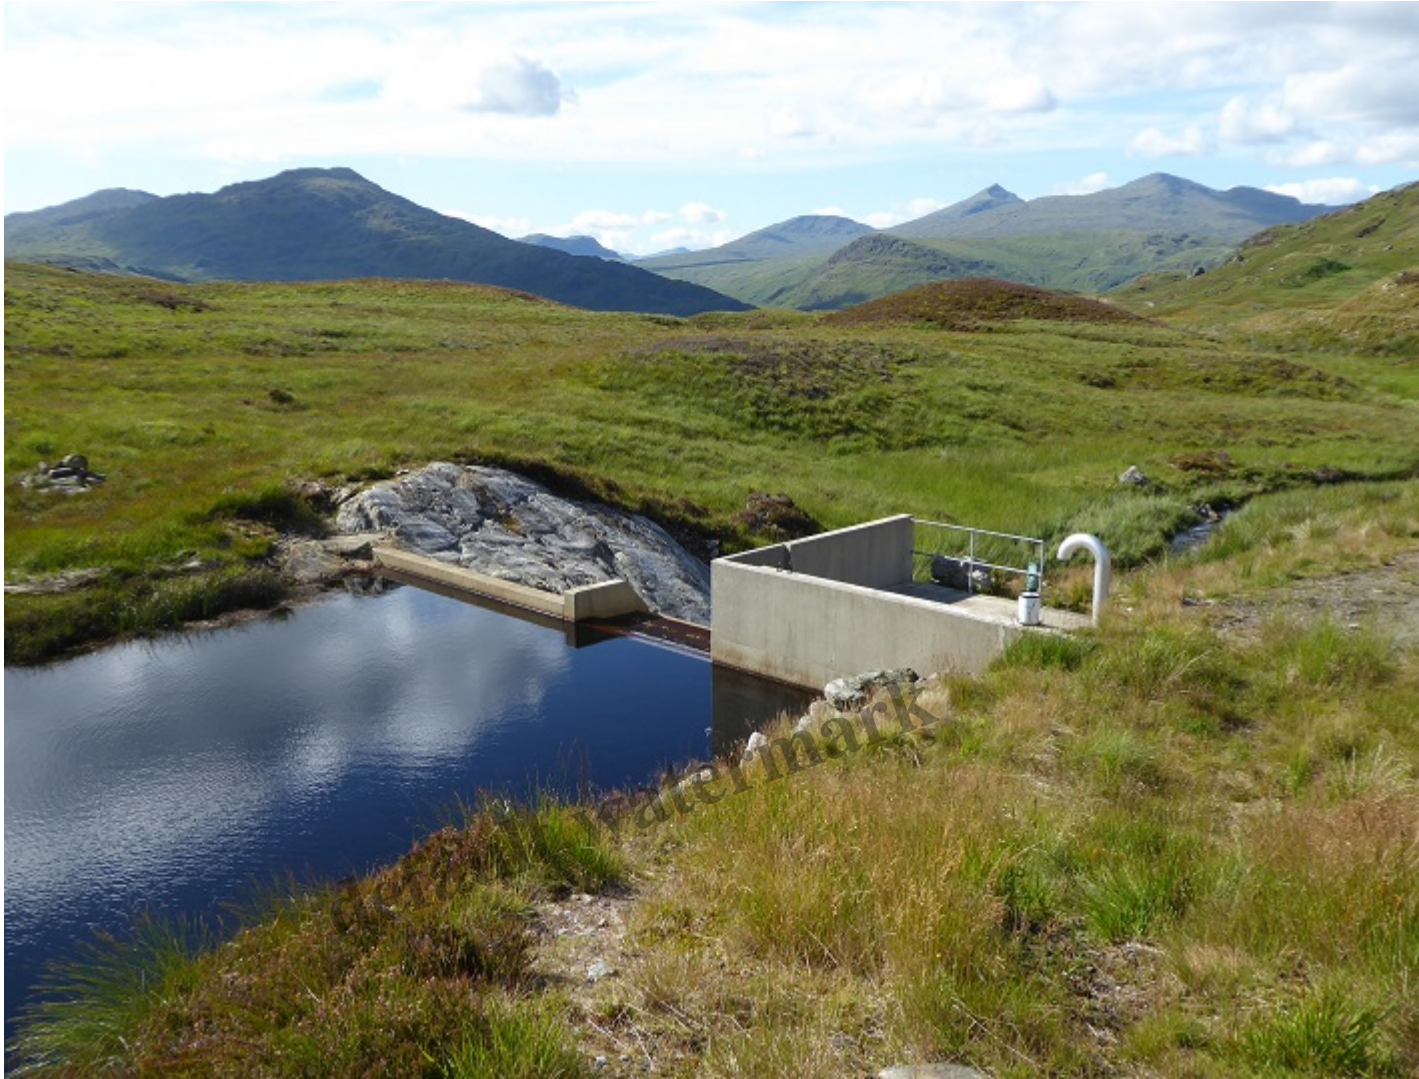
Ben Glas lower intake, Ben Lui in far distance.Â August 2020.

There are reasons for this.Â The intake is built into a slab of rock which is far more resistant to flood damage than rip-rap bouldering.Â Spate water just flows over it while on the near side is a moraine bank.Â This is a burn that is unlikely to change course in the near future.

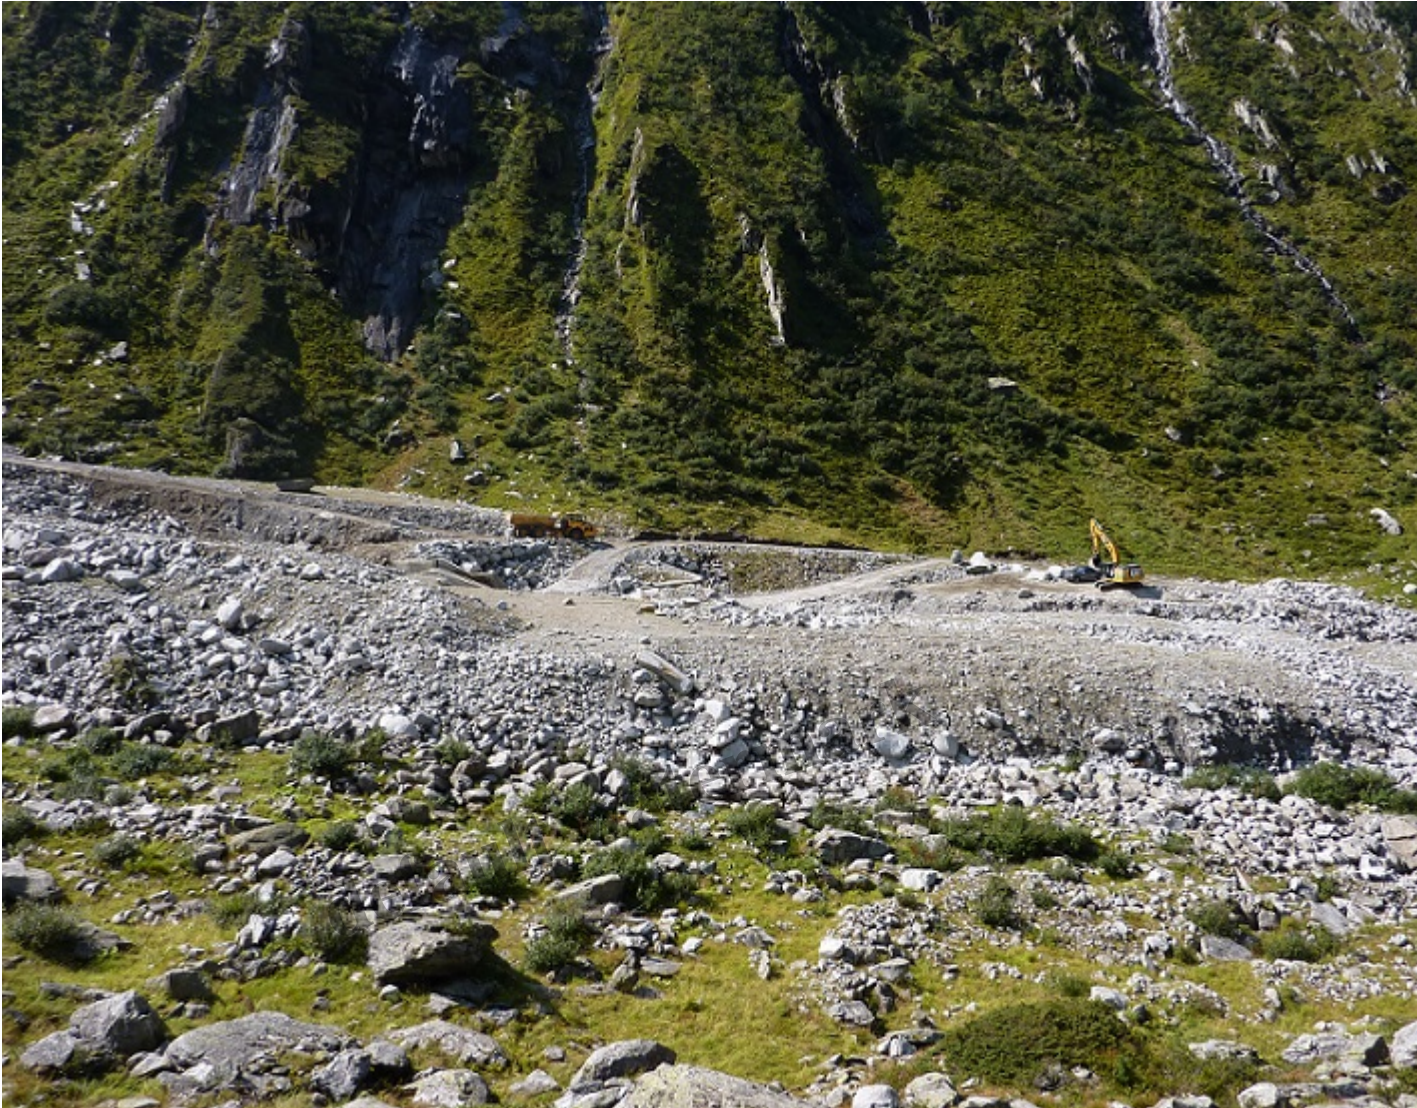
An example from an Austrian National Park – the concrete hydro intake is visible just to the left and forward from the dumper truck

A reader yesterday – see comments – mentioned that infilling and subsequent excavation of intakes was a longstanding issue from older hydro schemes in Scotland and also in the Alps.Â Little consideration appears to have been given to the historical evidence in deciding where to locate run of hydro schemes.
