Unsustainable run of river hydro schemes – Glen Falloch one year on

Intake 1 – Upper Glen Falloch

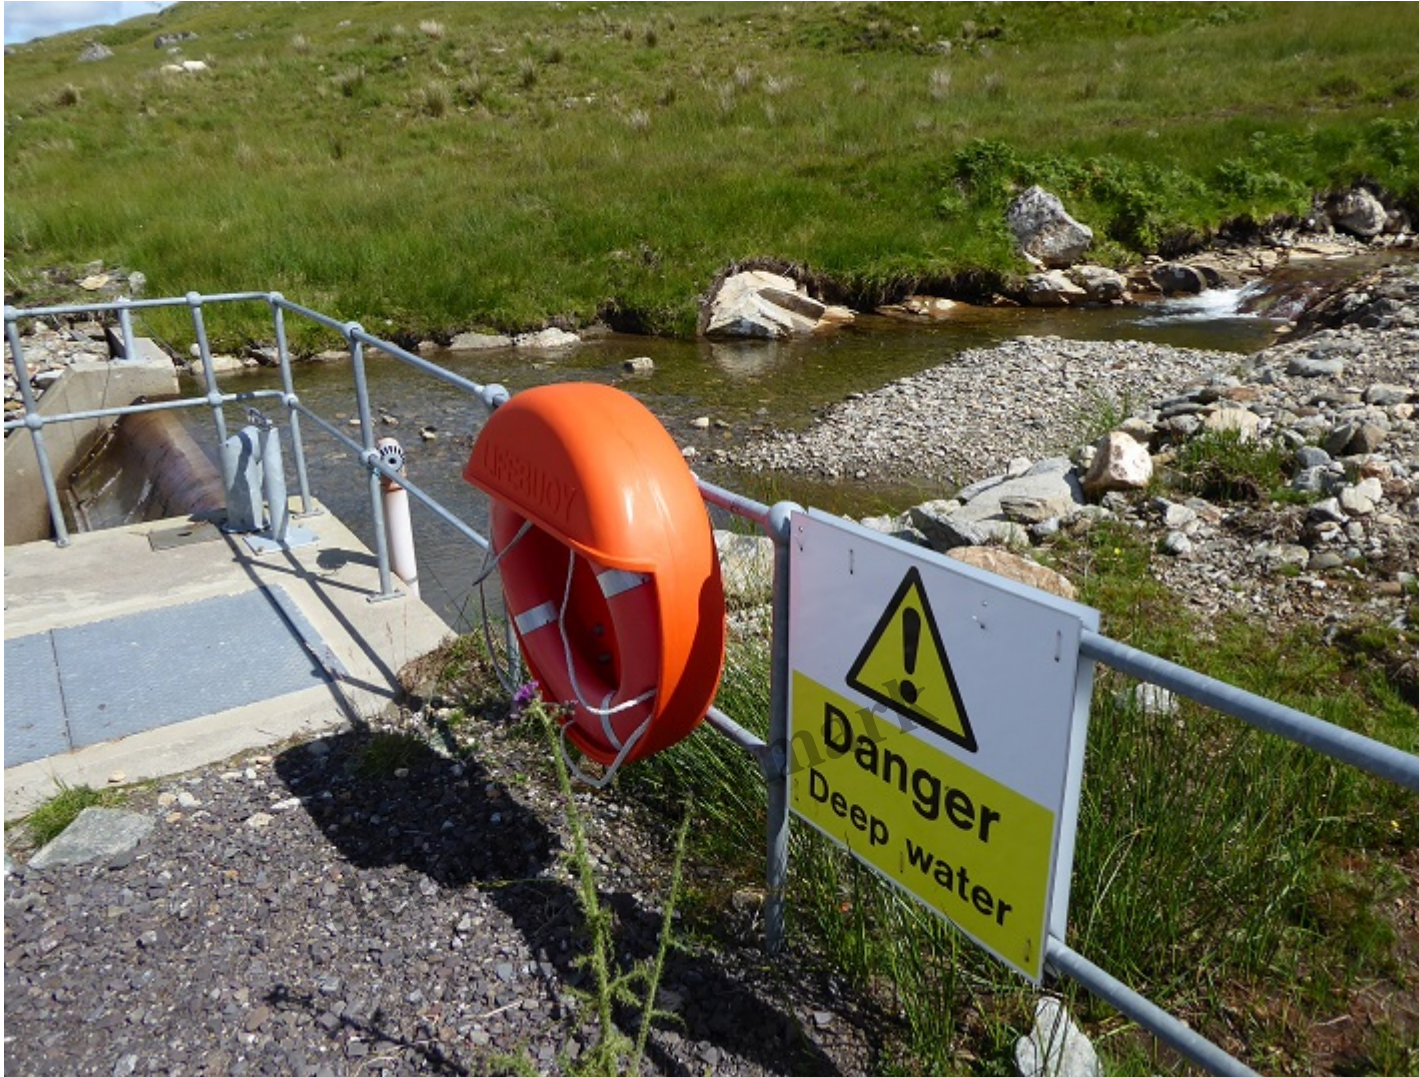
Another deep pool no more. August 2020

On the other side of An Caisteal's north ridge lies the Allt Andoran intake. It also suffered serious damage large year with some of the rip rap bouldering below the intake swept away (again, [see here](#)).

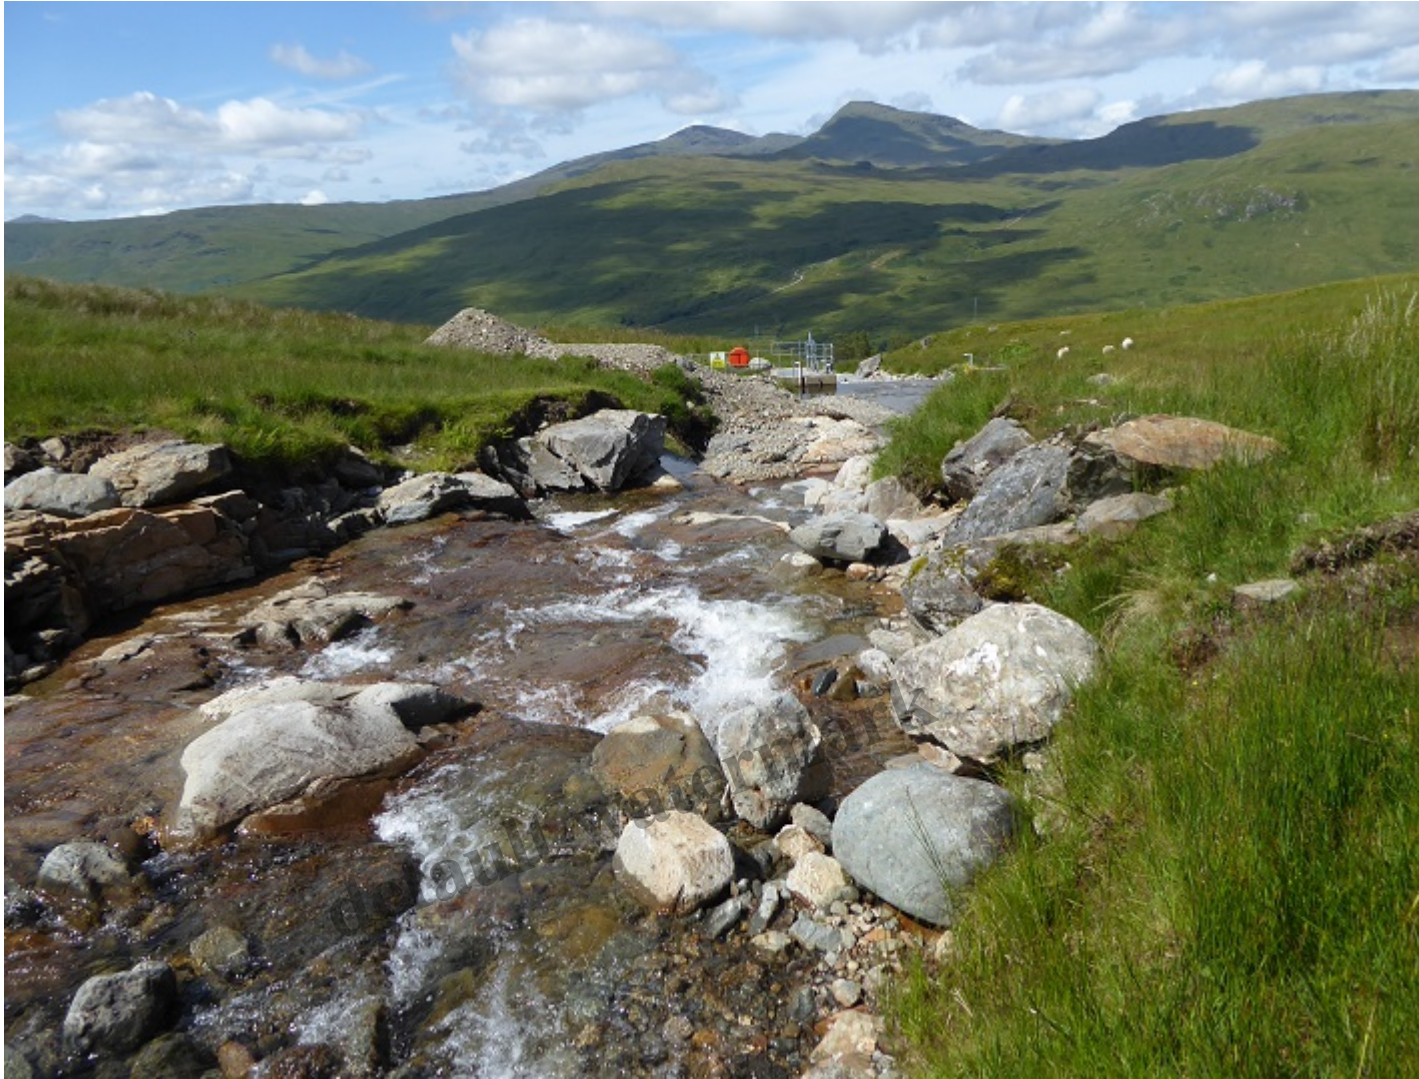
Allt Andoran intake with Ben Oss behind – the flat bit to right of highest part of heap has been created by diggers being driven up onto the heap to drop more stones and boulders. August 2020.

We now have river mining in what is supposed to be a National Park. It has not had planning permission. I have not yet found out whether the Scottish Environment Protection Agency has approved the work – most extraction from rivers requires a license under the Controlled Activities Regulations.
