## Unsustainable run of river hydro schemes â?? Glen Falloch one year on

### Intake 1 â?? Upper Glen Falloch

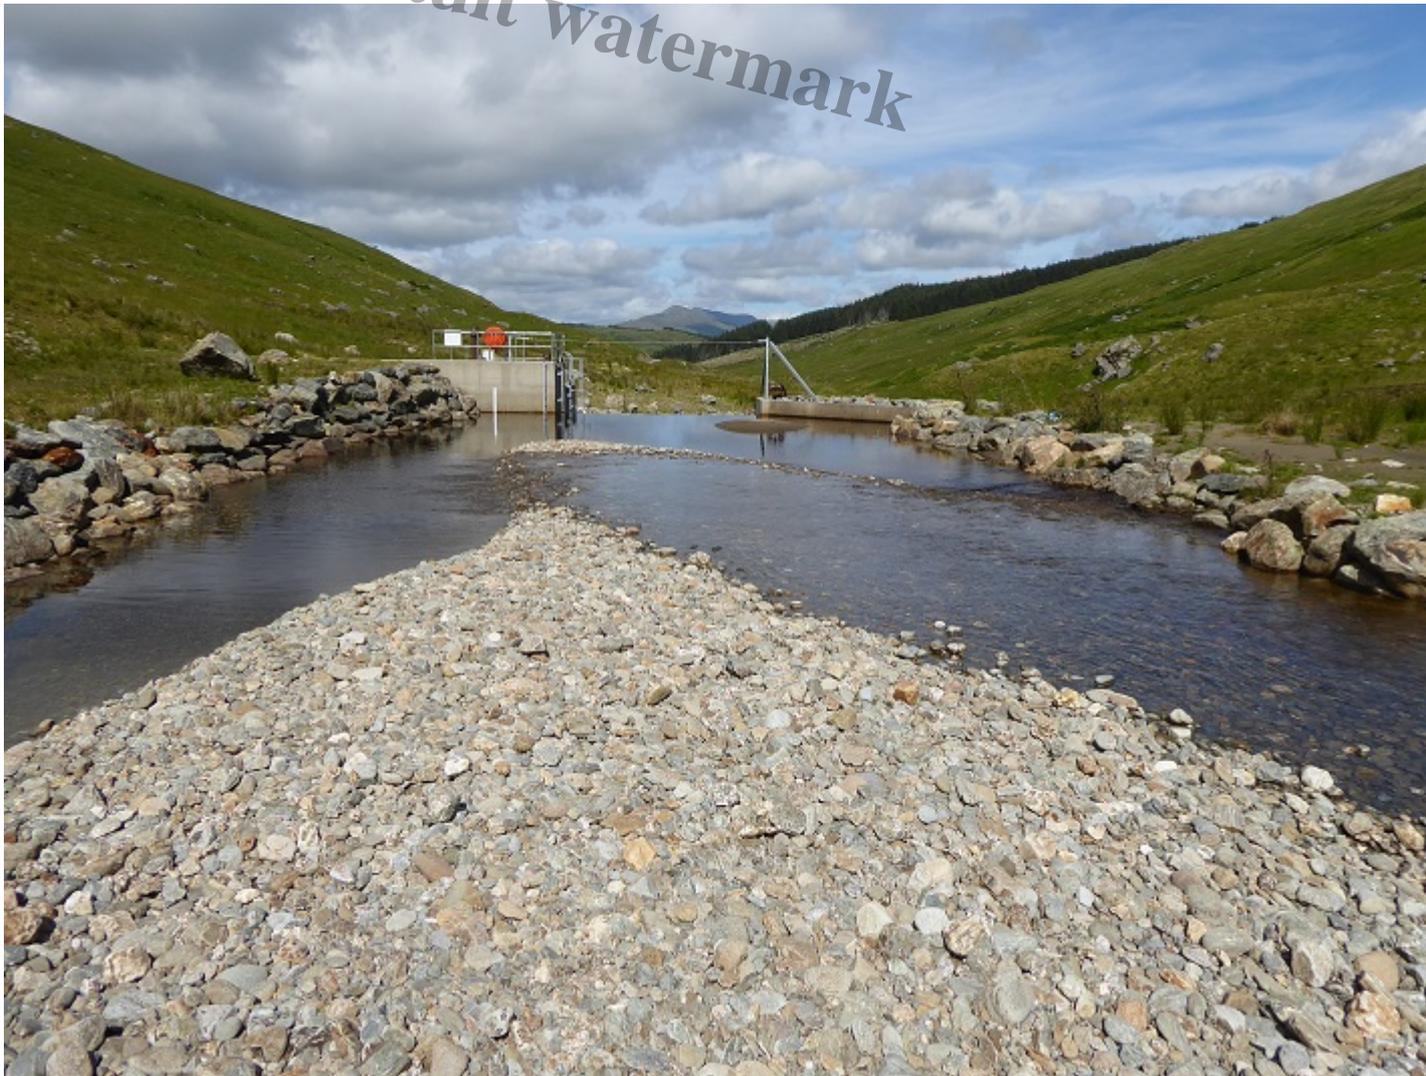
Infilling intake pool August 2020. As the river re-wilds, the hydro is at continuous risk of redundancy

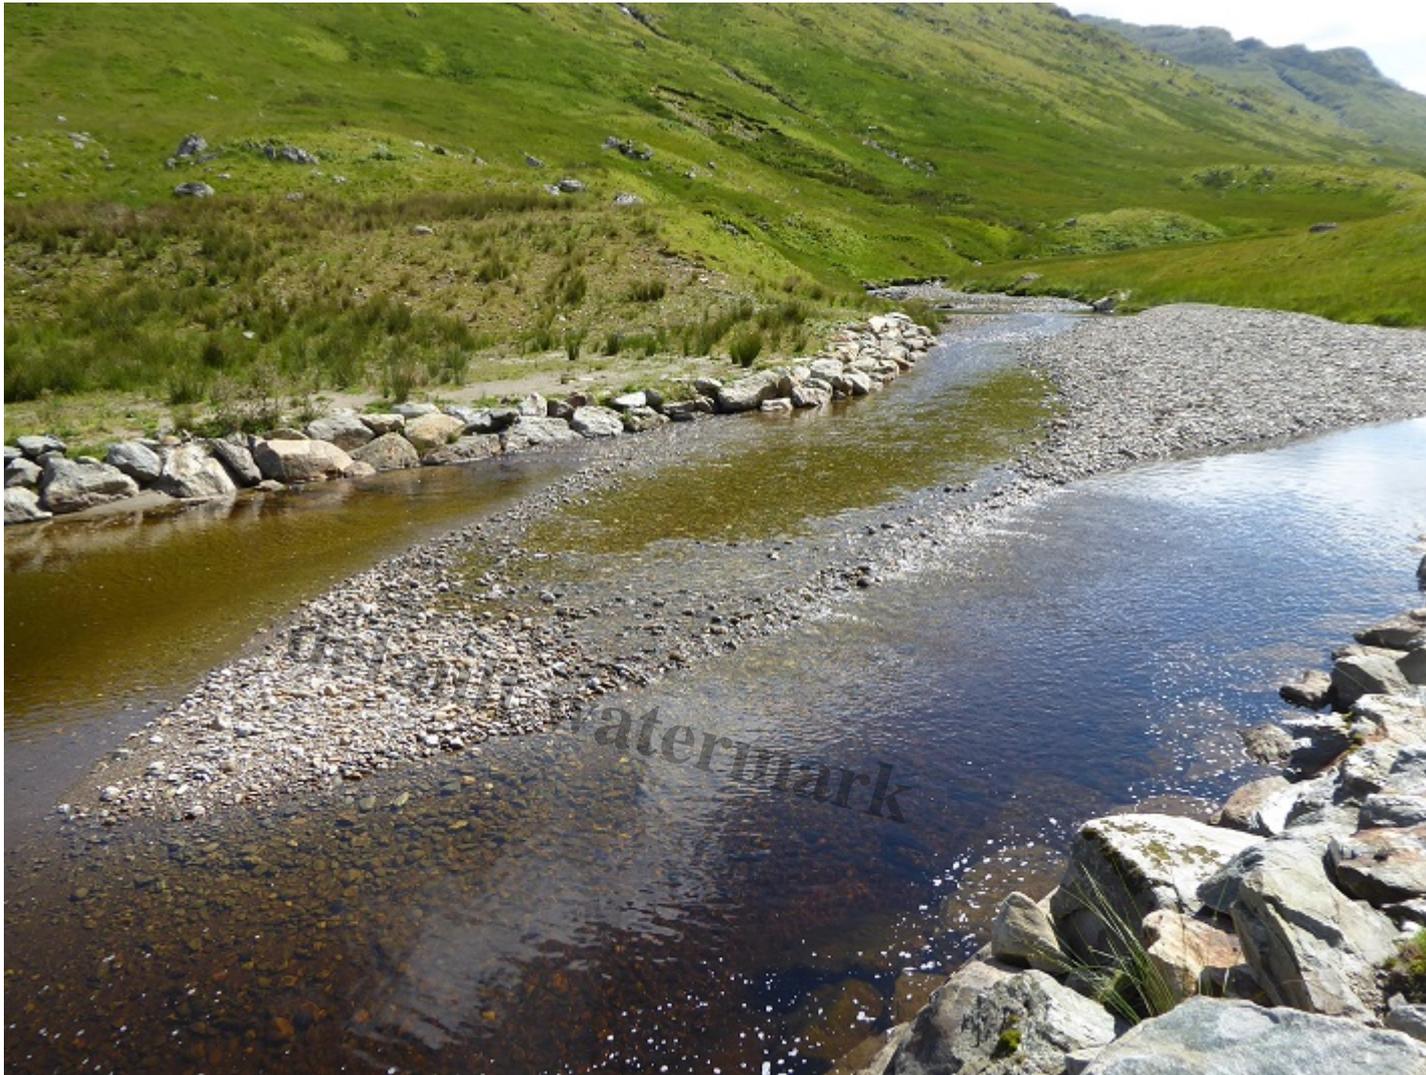
Re-wilding at work. Note the extent of the shingle compared to 2017.

The shingle has softened the intake pool with its rip rap bouldering. That is out of place in a once wild glen but then nature generally tends to look far better than crude engineering.

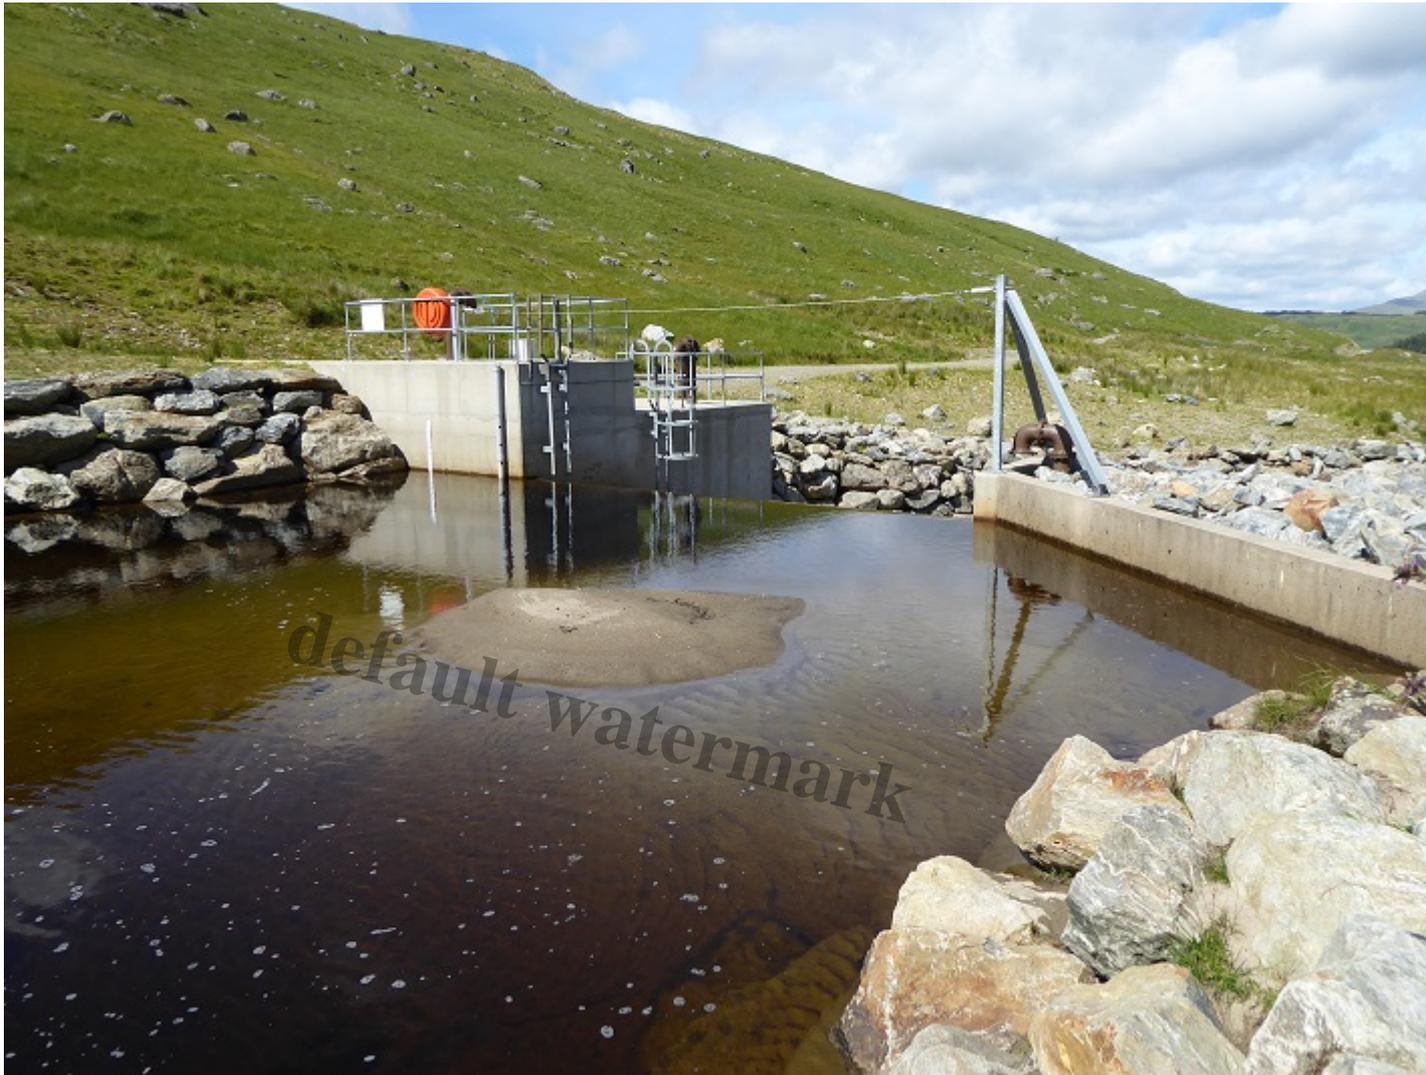
The lifebelt is now redundant!

The intake structure remains for now but it has trapped a large volume of material which now threatens its viability. There are two aspects to this. The first is if the pool infills much further the River Falloch could change its course leaving the hydro intake high and dry, as it almost did in August 2018 ([see here](#)):

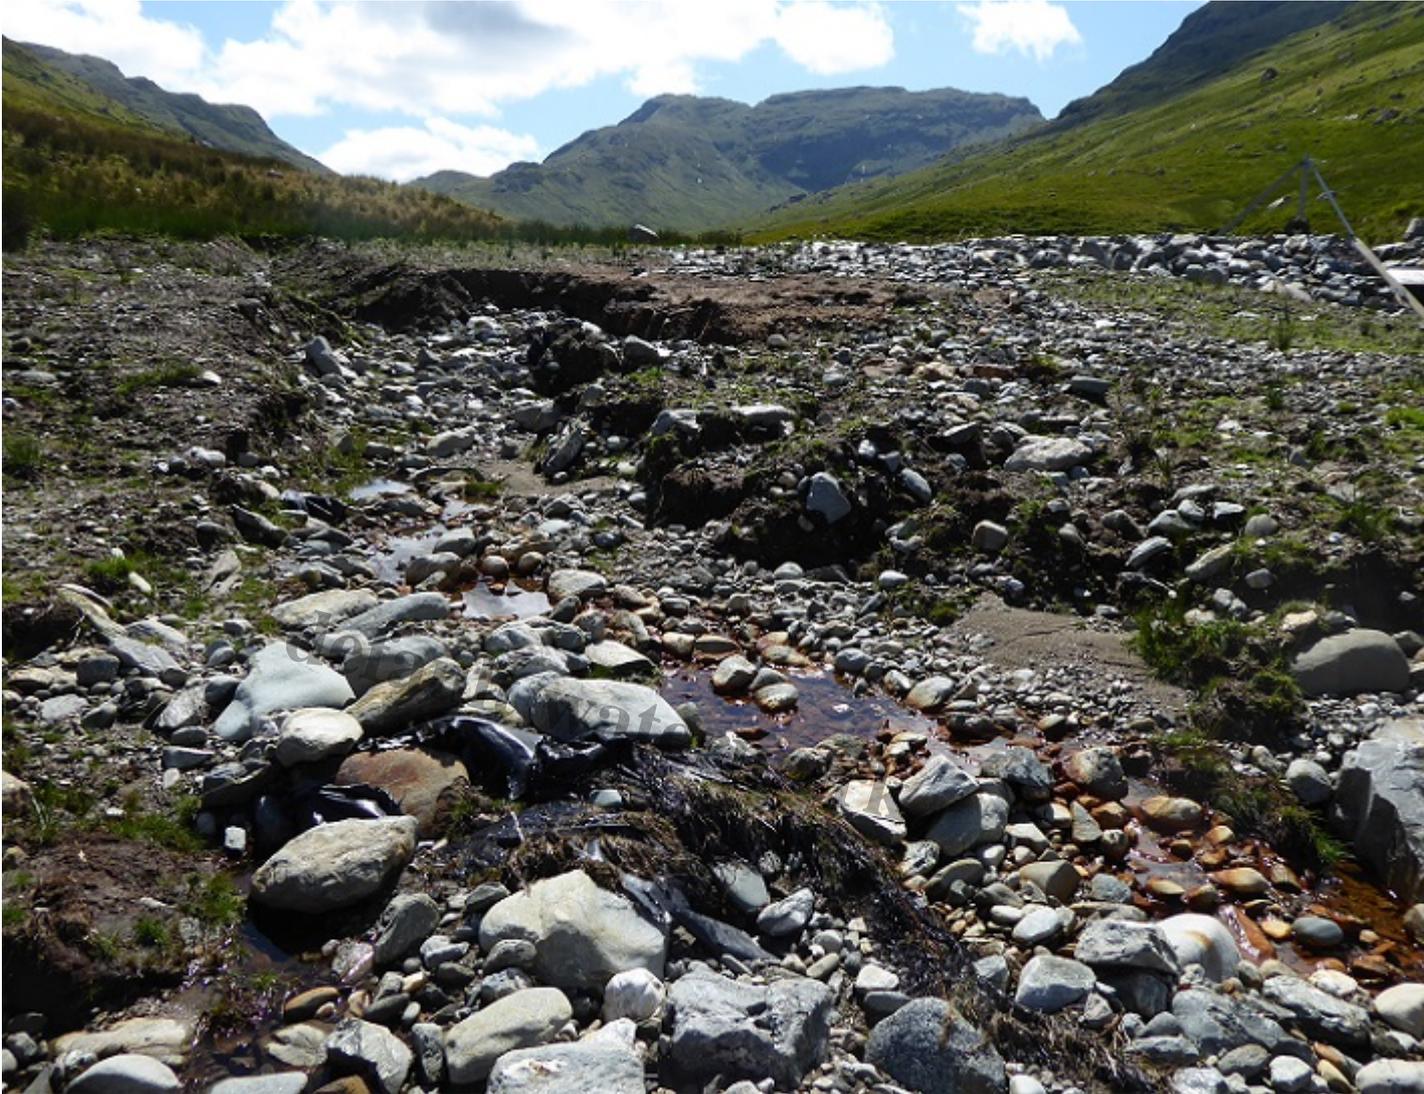
The view up the new channel created in August 2019 one year later. Intake on far right, Beinn a Chroin behind.

Leave aside the very poor attempt at restoration, with plastic everywhere and large amounts of peat just waiting to be swept away – poorly situated hydro schemes like this release significant amounts of carbon into the atmosphere – the potential for the river to change course is obvious. For this hydro to remain viable constant engineering will be required.

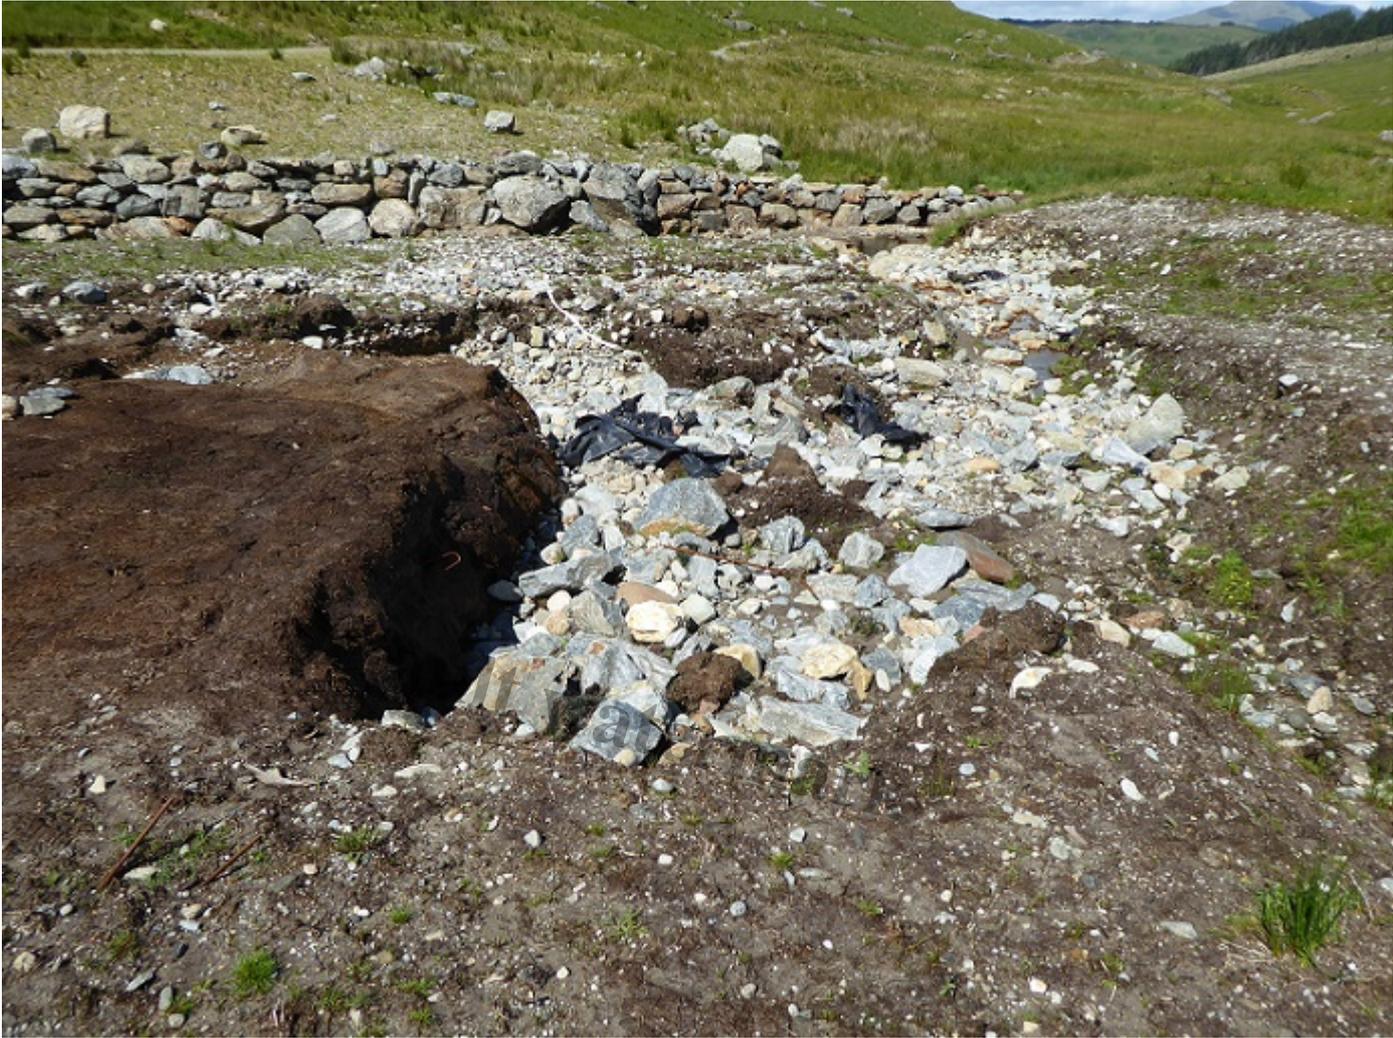
Looking down one of the new channels created by the flood over to far bank of the River Falloch below the intake. A large area of “restored” peat just waiting to be swept away.

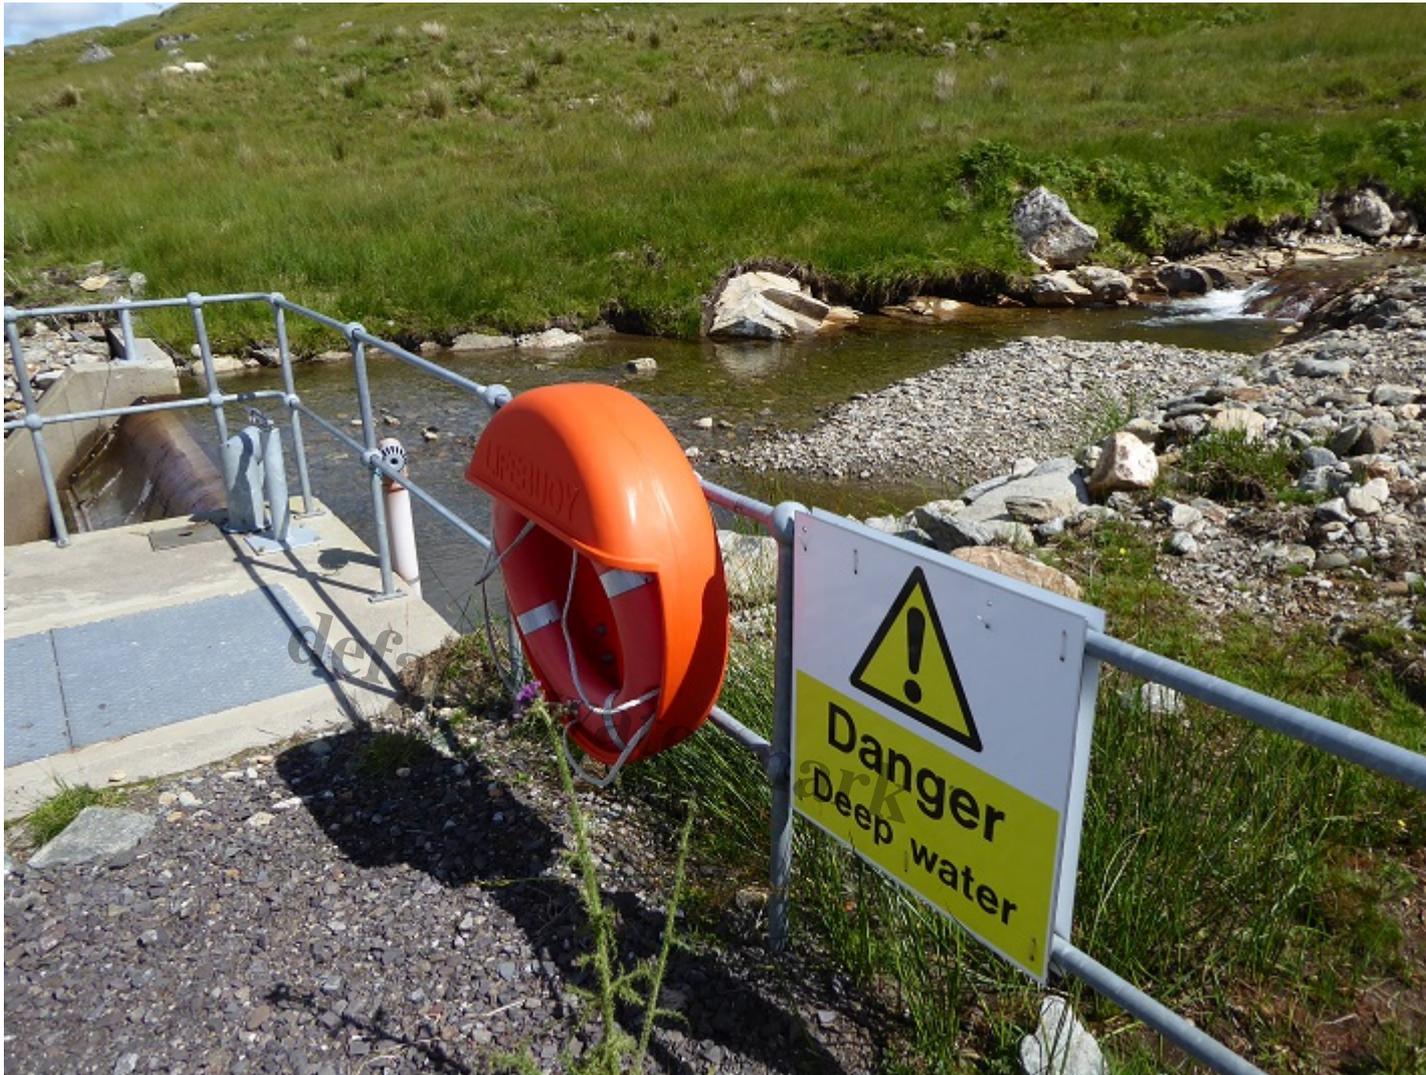
Another deep pool no more. August 2020

On the other side of An Caisteal's north ridge lies the Allt Andoran intake. It also suffered serious damage large year with some of the rip rap bouldering below the intake swept away (again, [see here](#)).

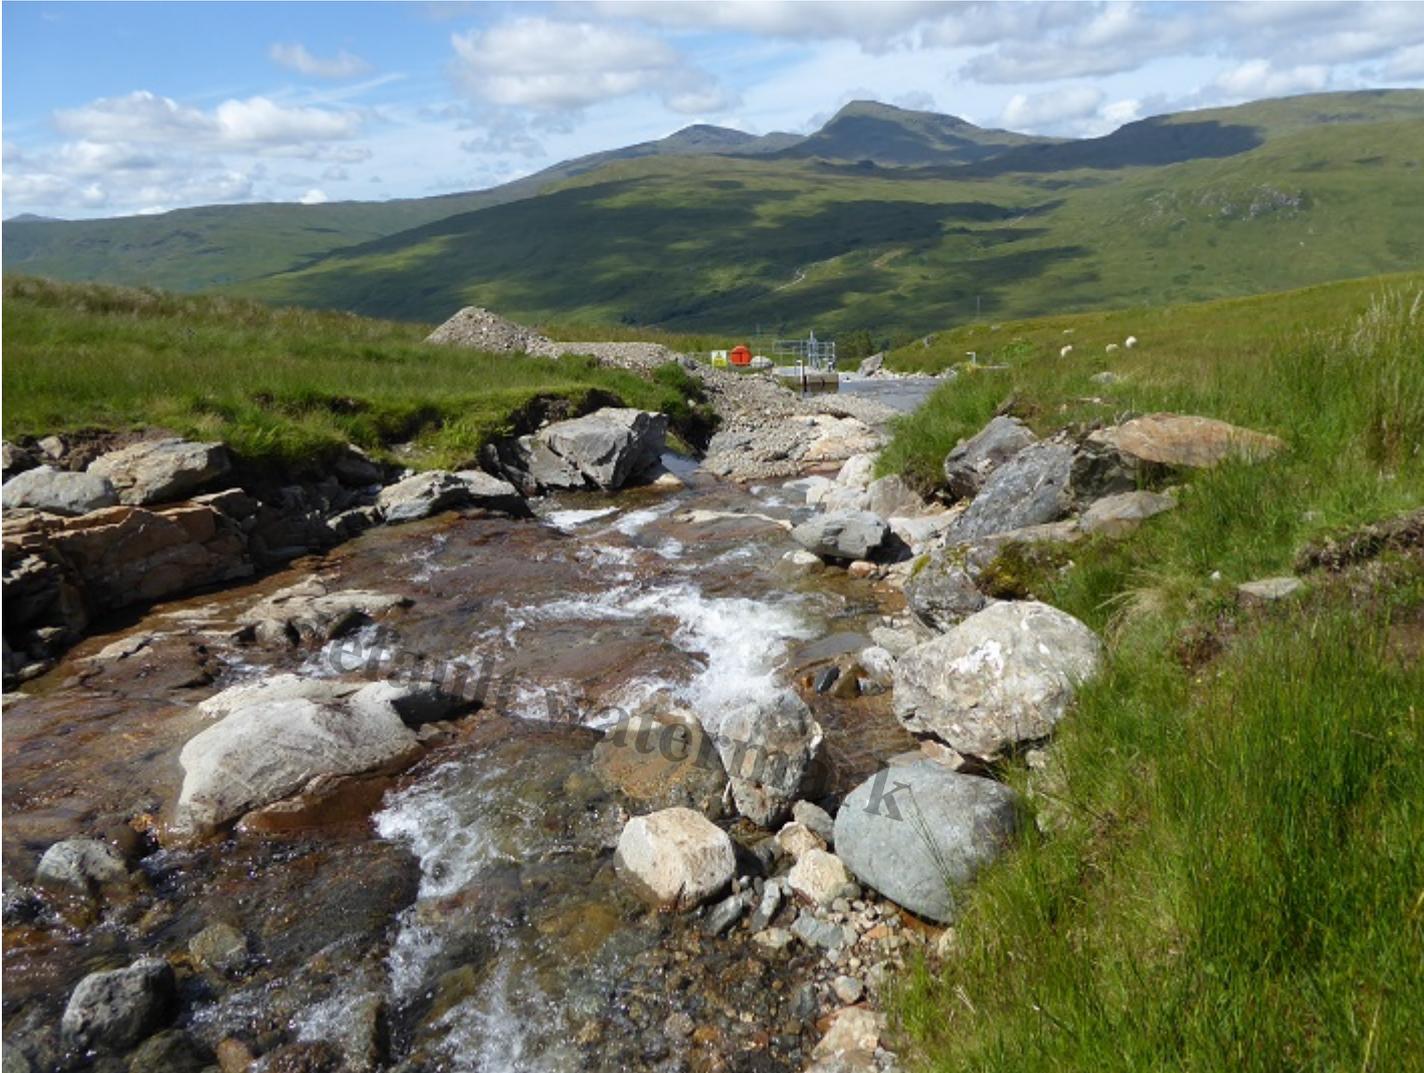
Allt Andoran intake with Ben Oss behind – the flat bit to right of highest part of heap has been created by diggers being driven up onto the heap to drop more stones and boulders. August 2020.

We now have river mining in what is supposed to be a National Park. It has not had planning permission. I have not yet found out whether the Scottish Environment Protection Agency has approved the work – most extraction from rivers requires a license under the Controlled Activities Regulations.

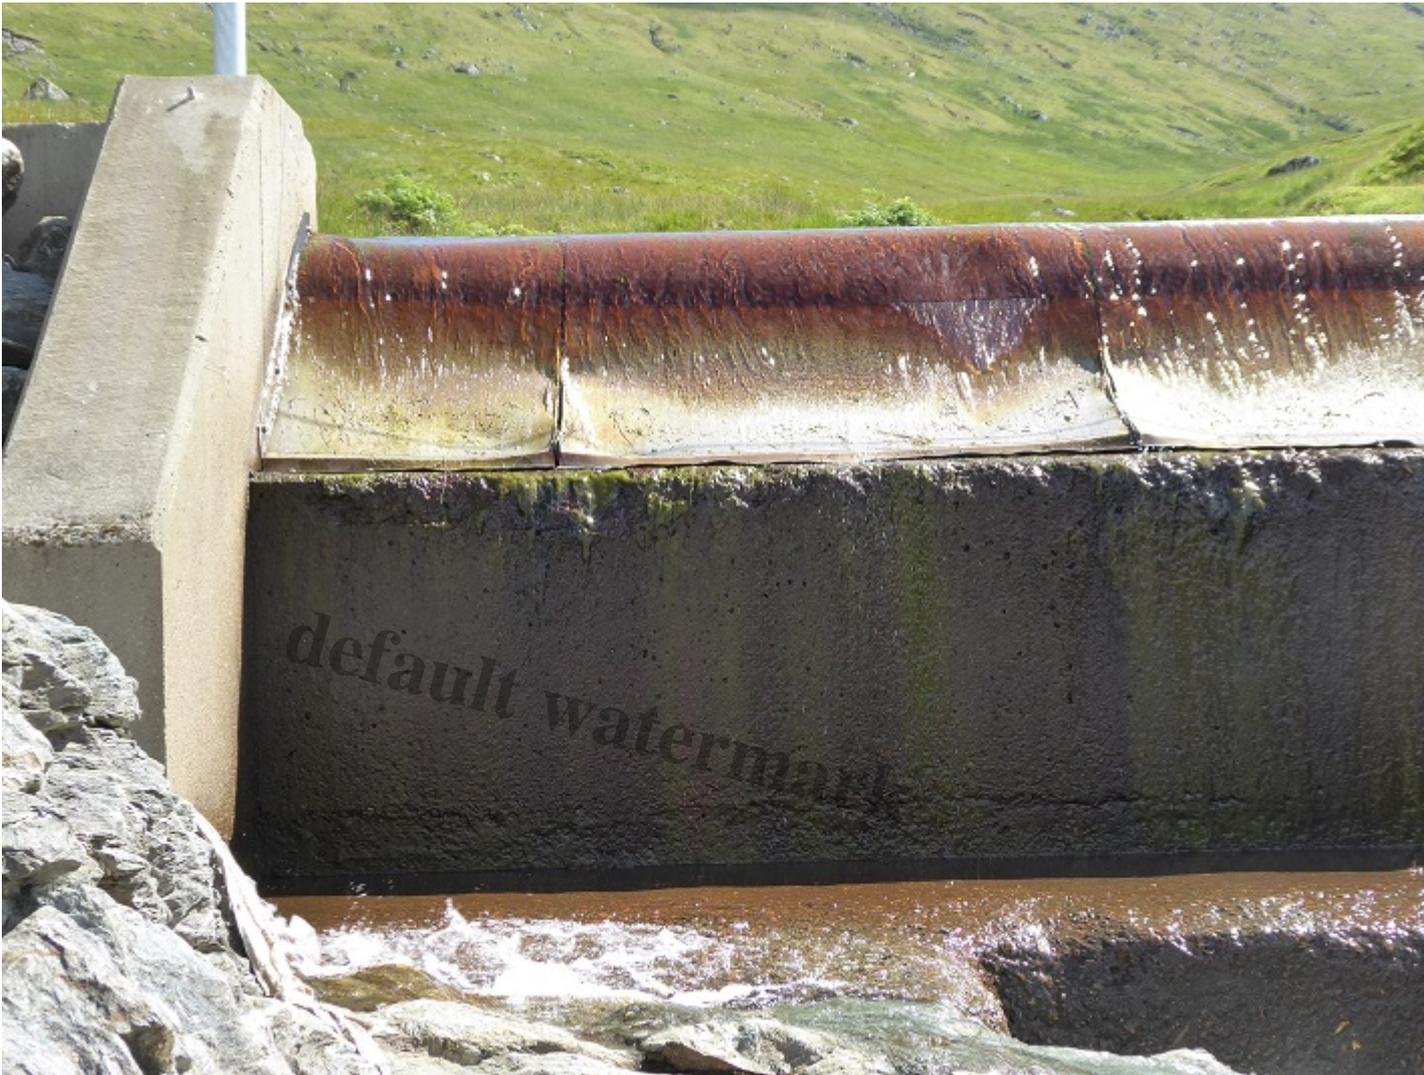
Allt Andoran intake August 2020

The intake itself has become increasingly battered and damaged, illustrating why continual excavation of this pool will be necessary. The narrow mesh Coanda screens are very good at keeping potentially damaging stones and vegetation out of the hydro system but are themselves very vulnerable to damage by boulders and pebbles rolling over them. There are sturdier intake screens, but they let more material into the hydro system, potentially damaging the pipes and turbines.

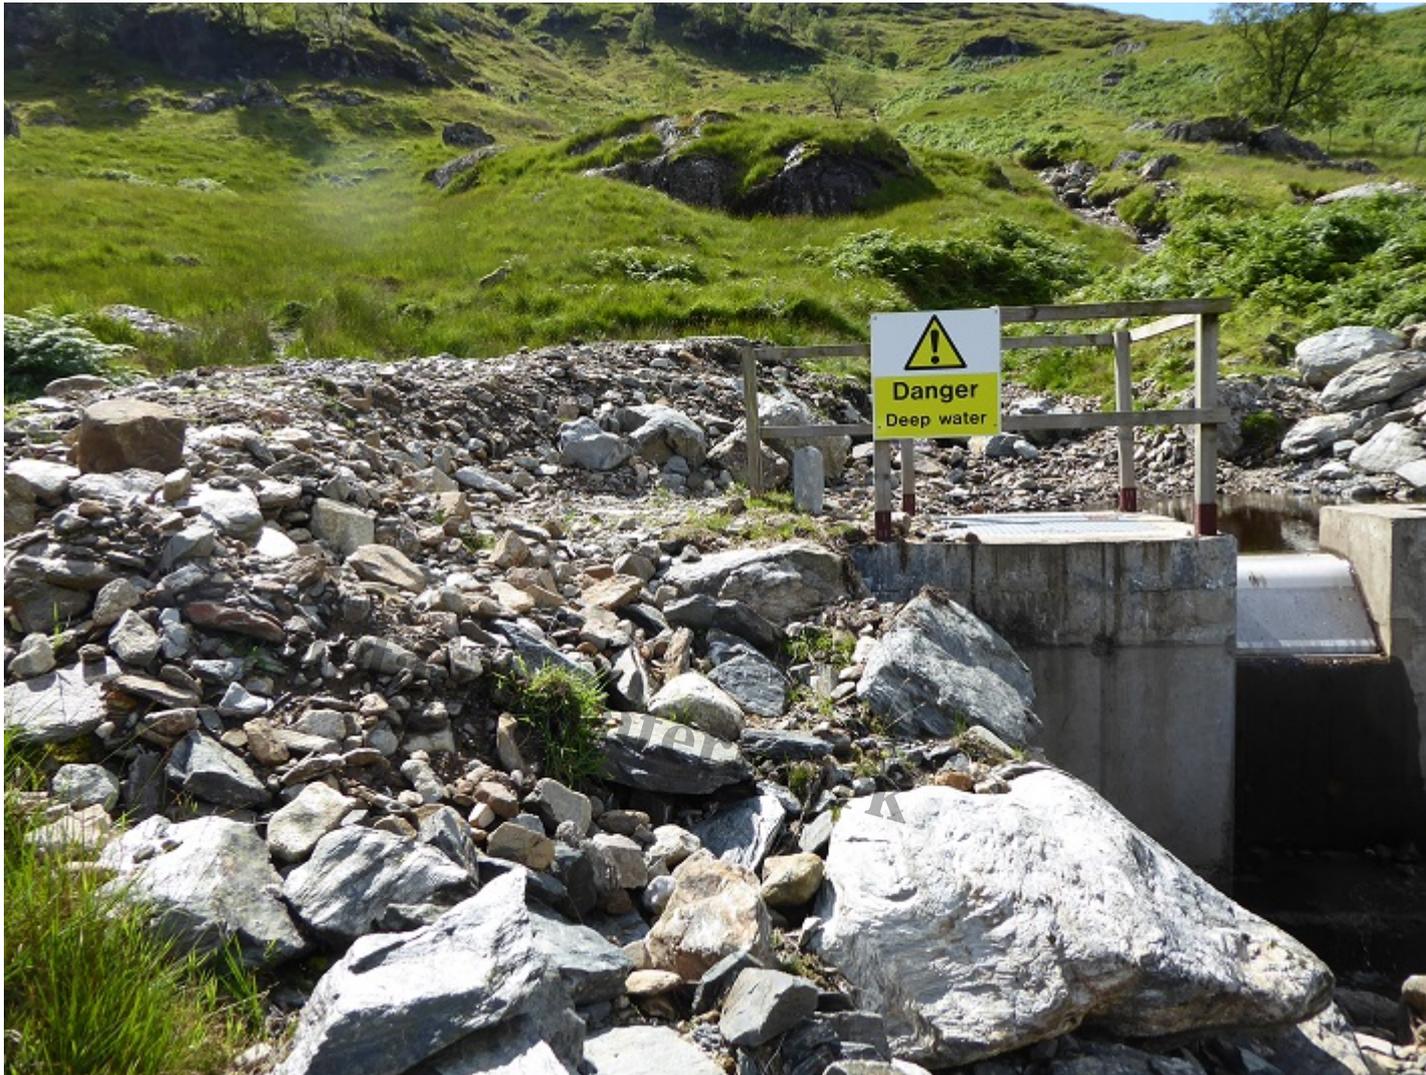
The Allt Chuilinn flows down the next glen to the west and is fed by three intakes. It had suffered the most spectacular damage last year but the smallest intake had been out of commission before that. Poor design and construction had resulted in the burn flowing under the intake leaving what should have been the intake pool high and dry. It has now been fixed:

Being out of commission didn't affect the volume of material that was trapped behind this small intake in just a few years.

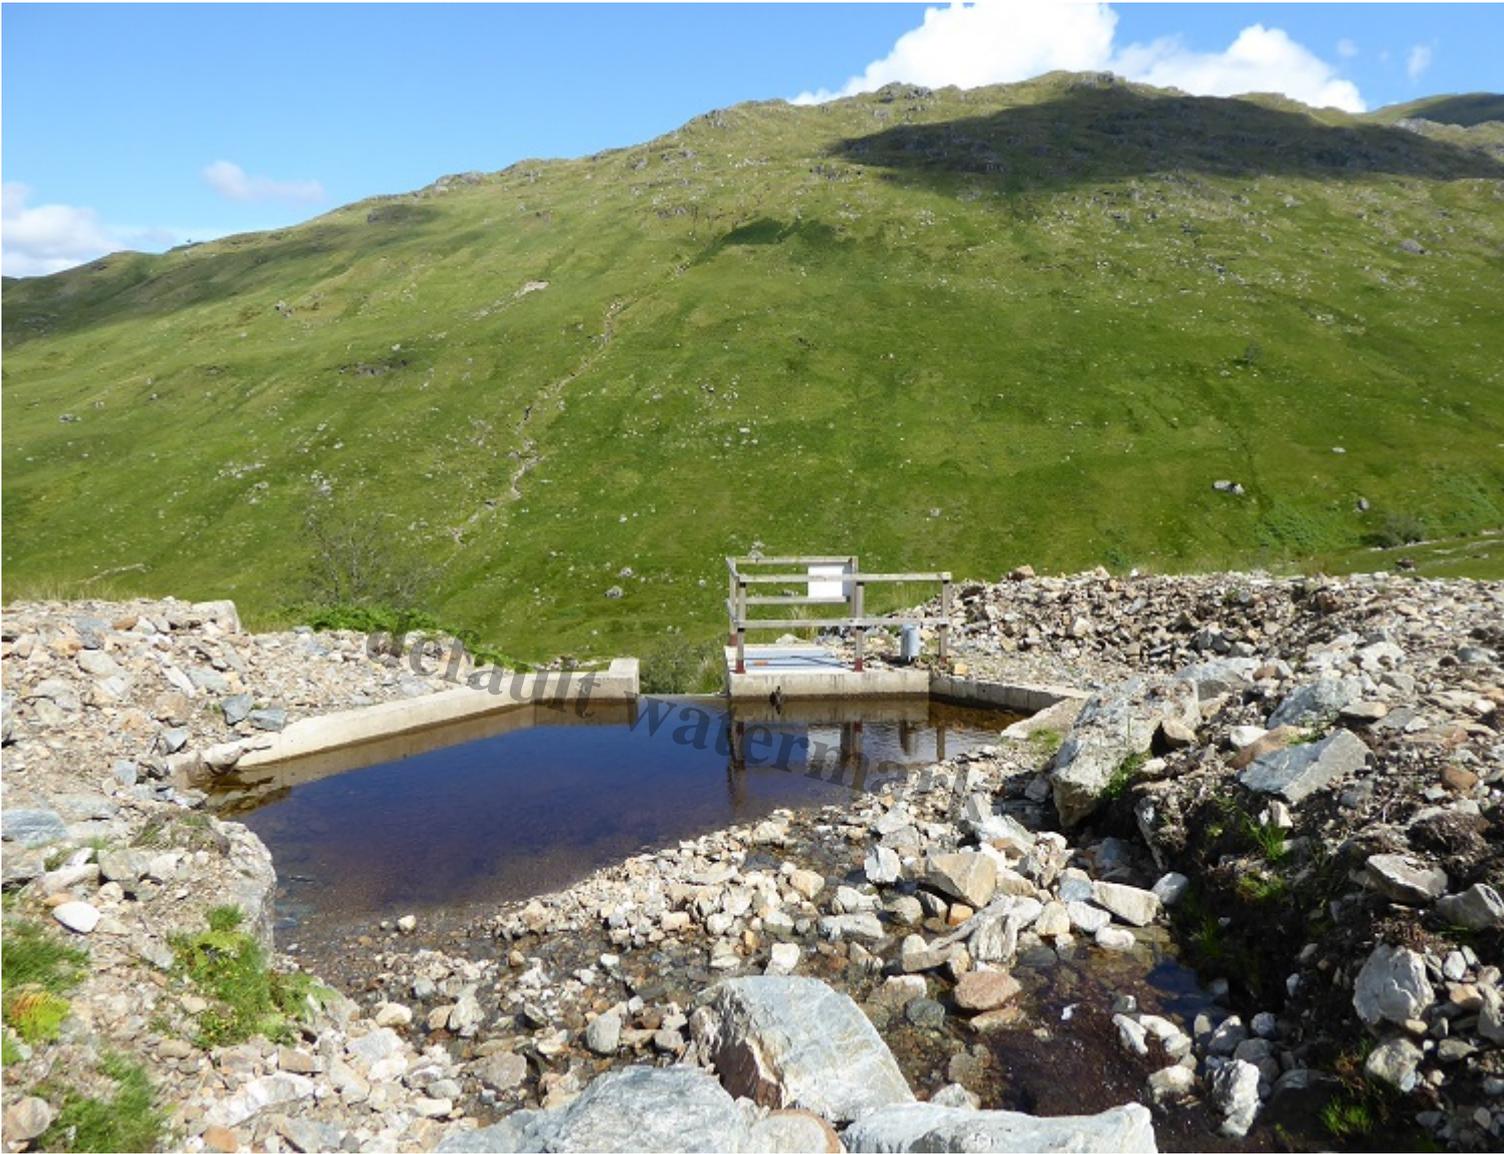
To give Glen Falloch estate credit, a large amount of re-engineering has been undertaken without a new track being put in place and there was very little sign of vehicle damage to the vegetation below. However, the location of this intake means the burn constantly risks changing course, hence the bulldozed bank on the left intended to keep it in its course. Whether that will be enough is not clear. There are signs that this burn might change course higher up.

Again, none of this work has had planning permission. Although hardly visible from the constructed hydro track below, the local landscape impact is significant. It is like coming across one of those mine spoil heaps that litter the Lake District that have taken over a century to mellow.

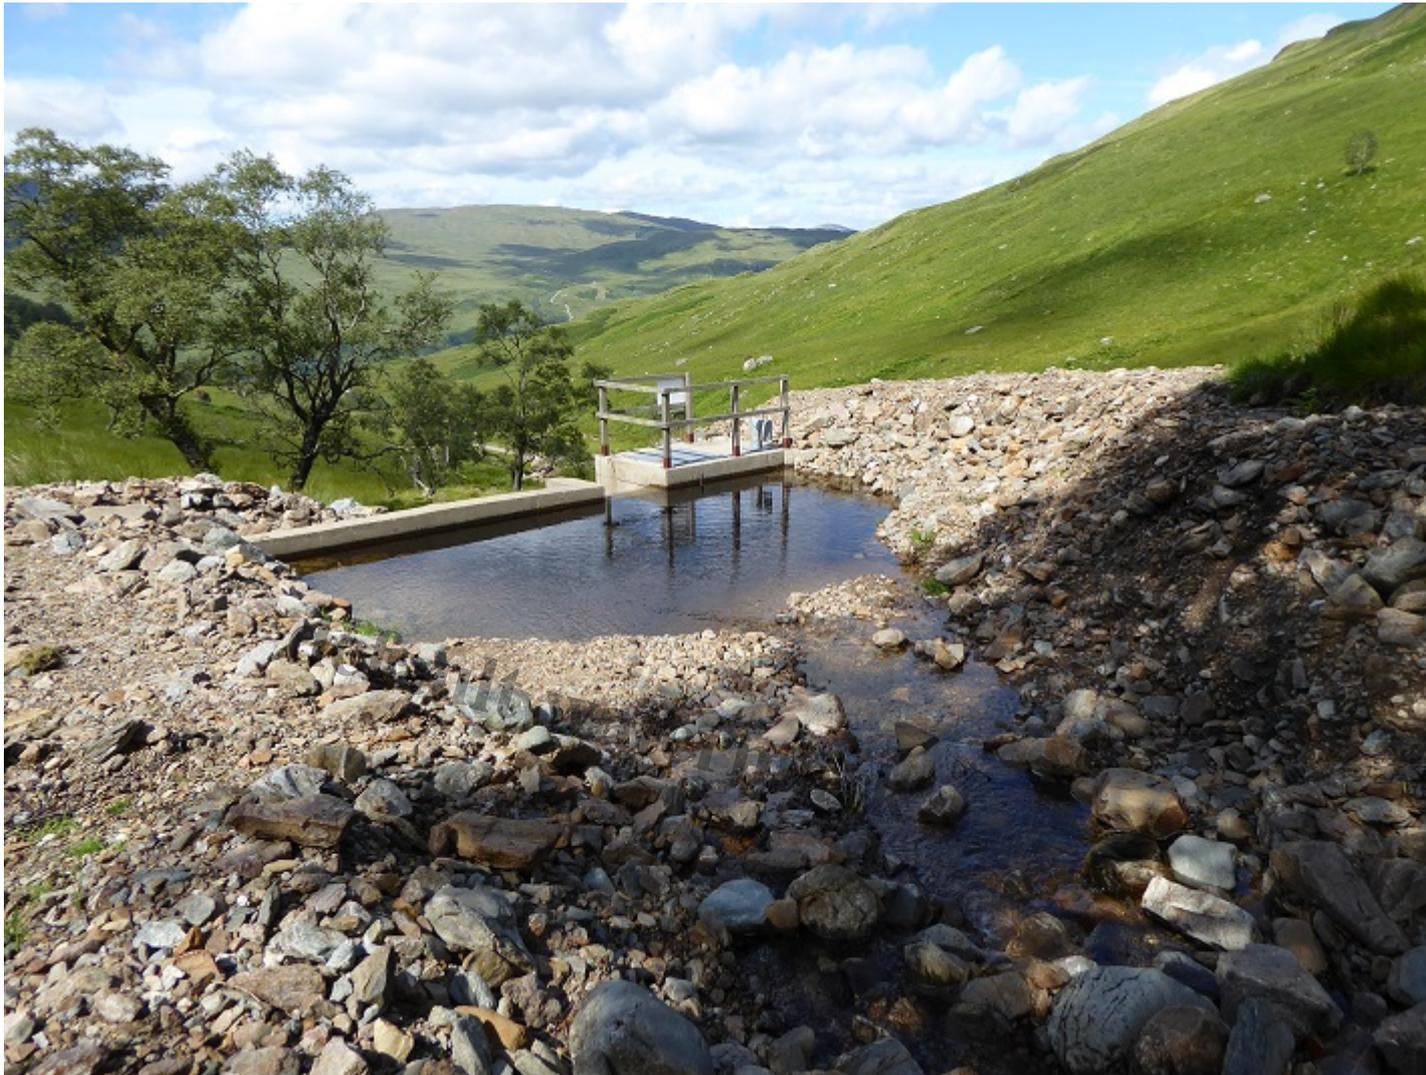
The middle intake with the hydro track by the Allt Chuilinn visible below. August 2020.

There were large rocks around the middle intake in 2018 but they have now been covered with smaller rocks excavated from the river. The pool is not big and, as you can see, is at constant risk of infilling. As soon as debris piles up behind the small intake the burn will divert over the intake wall taking the scheme out of commission. A reasonable guess is it may need to be excavated every couple of years to keep it functional given current levels of rainfall and erosion.

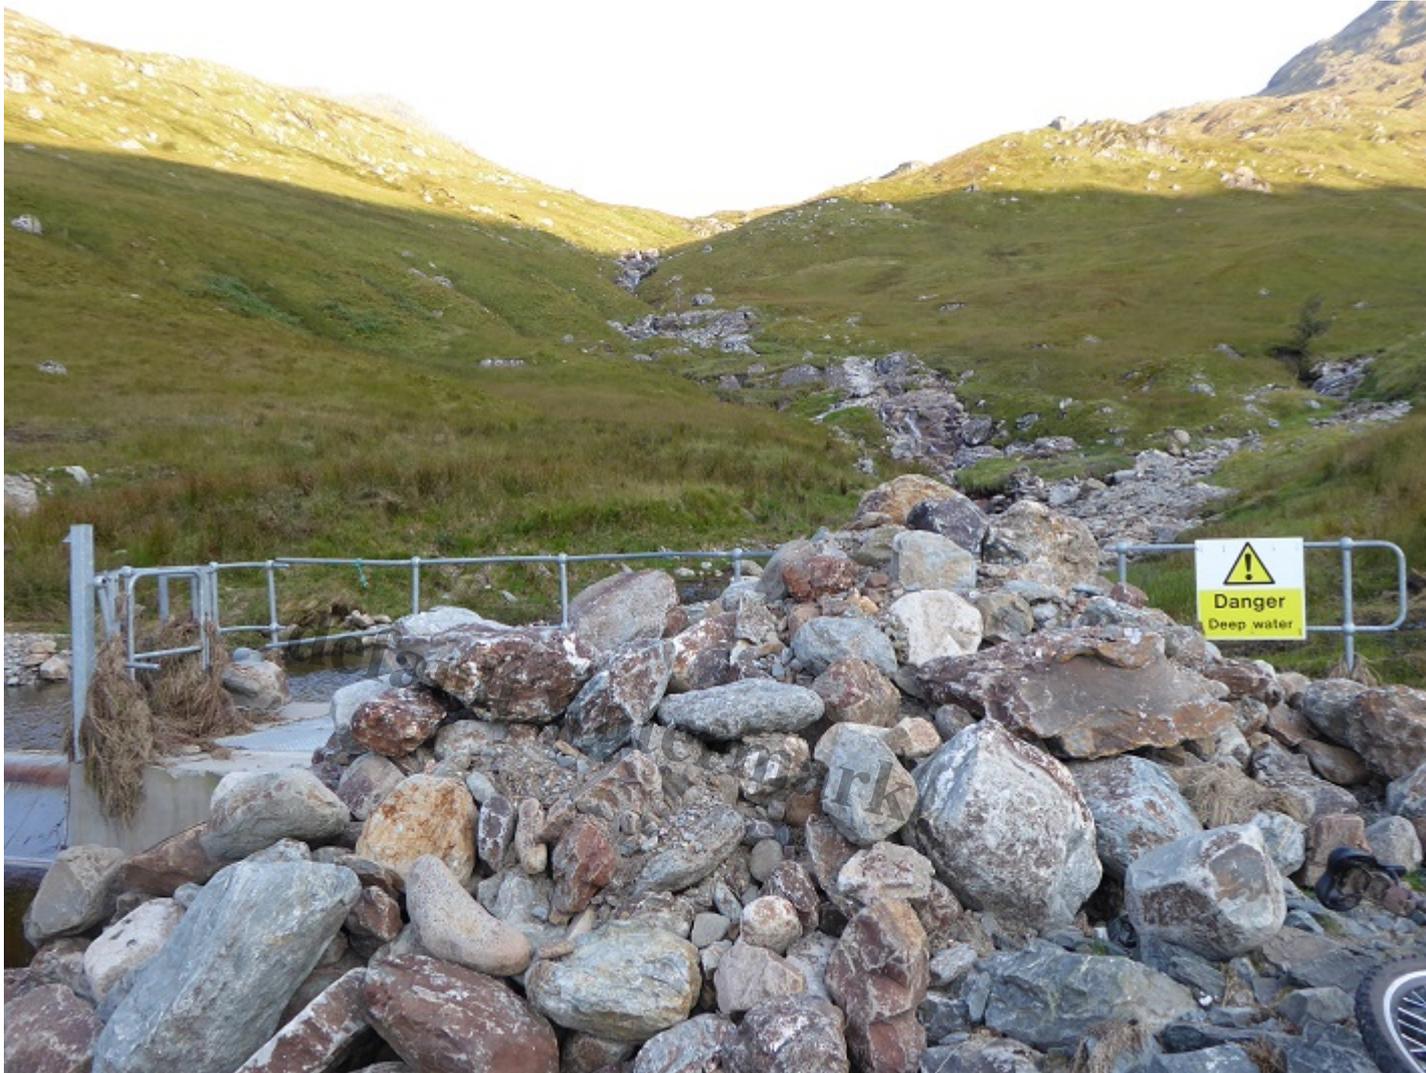
September 2019. A pile of boulders that appeared to have been excavated from the intake pool.

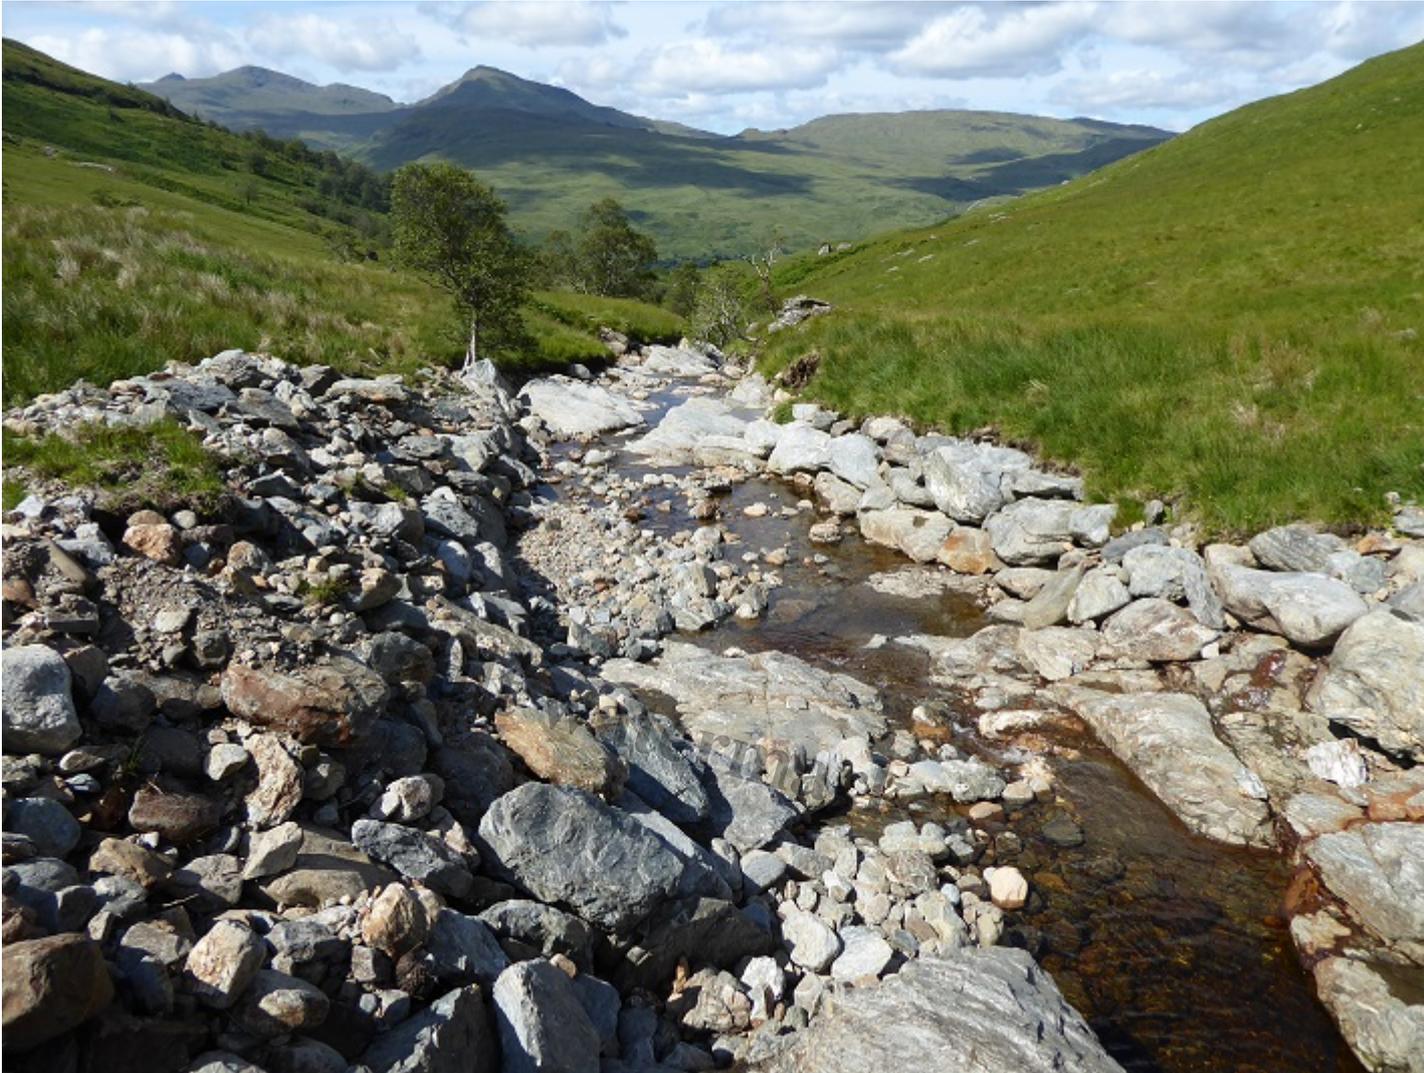
August 2020

The main intake of the Allt Chuilinn was where the worst damage was caused a year ago, with the pool apparently infilled and the rip-rap bouldering along the bank below swept away revealing the hydro pipe.

The restoration, which has again taken place outwith formal planning processes, has again been crude with boulders dumped over the bare pipe. It appears to me that if similar floods to those that occurred in August 2019 were to re-occur much of the “new” left bank would wash away. Both the LLTNPA and SEPA should be concerned about this and involved in trying to find solutions. Unfortunately, instead of admitting to mistakes and addressing the issues, the LLTNPA would prefer to pretend nothing has happened. The convener of the National Park, James Stuart, told me a year ago there is no need for any inquiry into the impact of the flooding on these hydro schemes. In my view he has got this badly wrong.

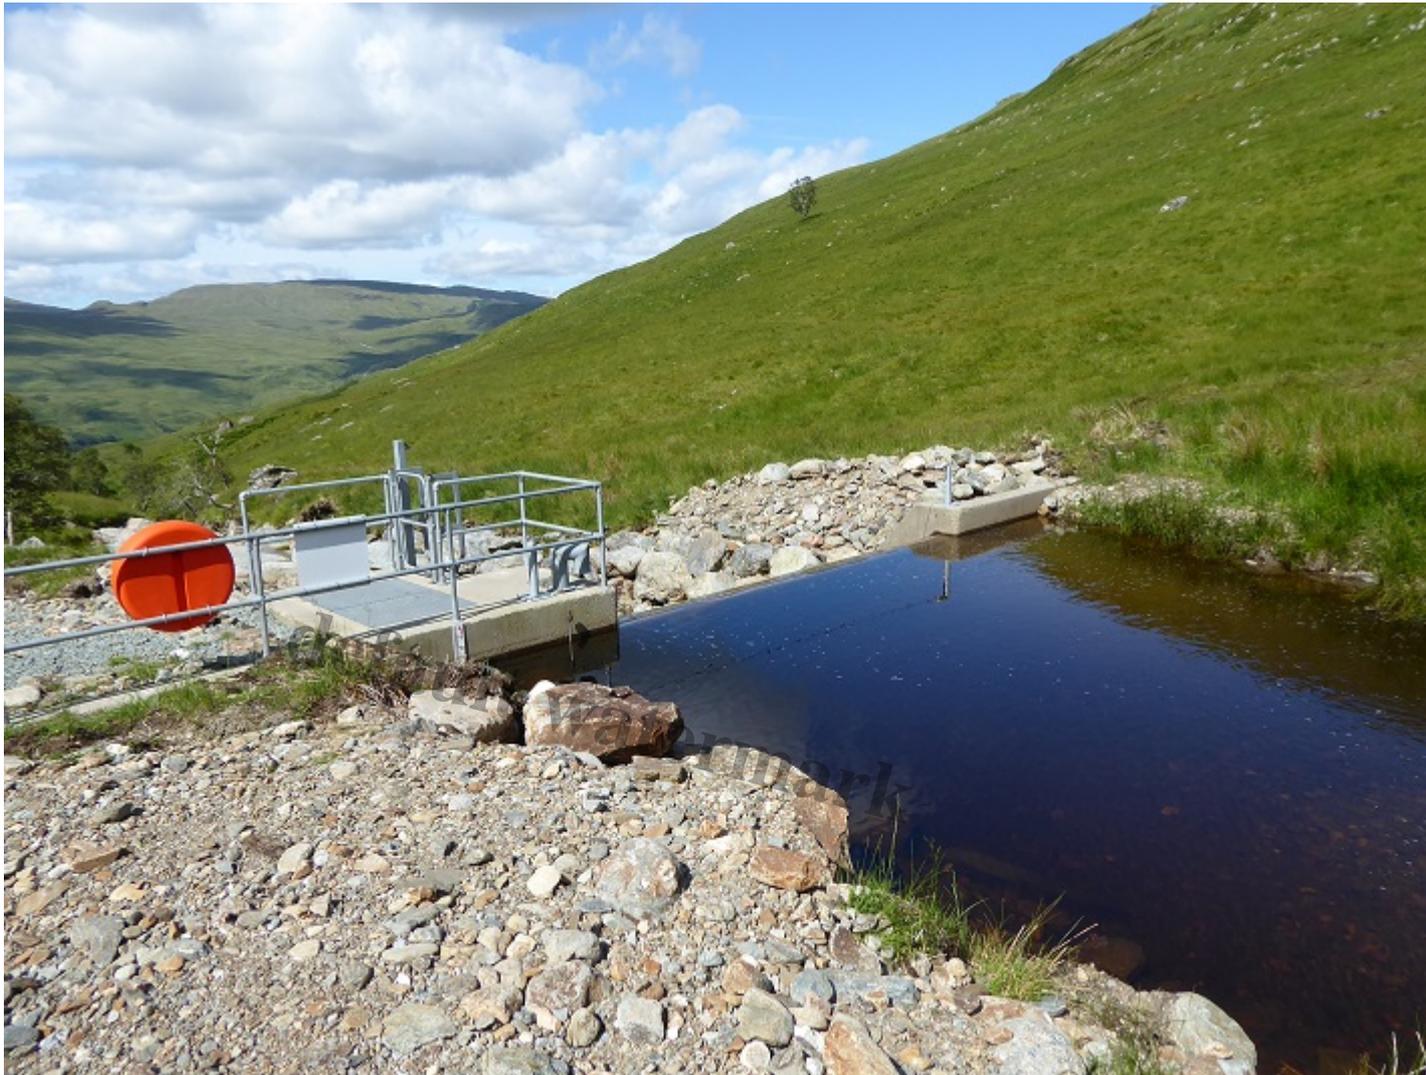
August 2020

A year after being excavated, the main Allt Chuilinn intake pool is still functioning but for how long? If you look carefully you can see how the pool is again gradually infilling. That is nature, you cannot stop these processes, though overgrazing on the hill and increased extreme rain events caused by climate change have increased the rate at which they take place. That has significant implications for the viability of run of river hydro schemes across Scotland.
