## Unsustainable run of river hydro schemes â?? Glen Falloch one year on

### Intake 1 â?? Upper Glen Falloch

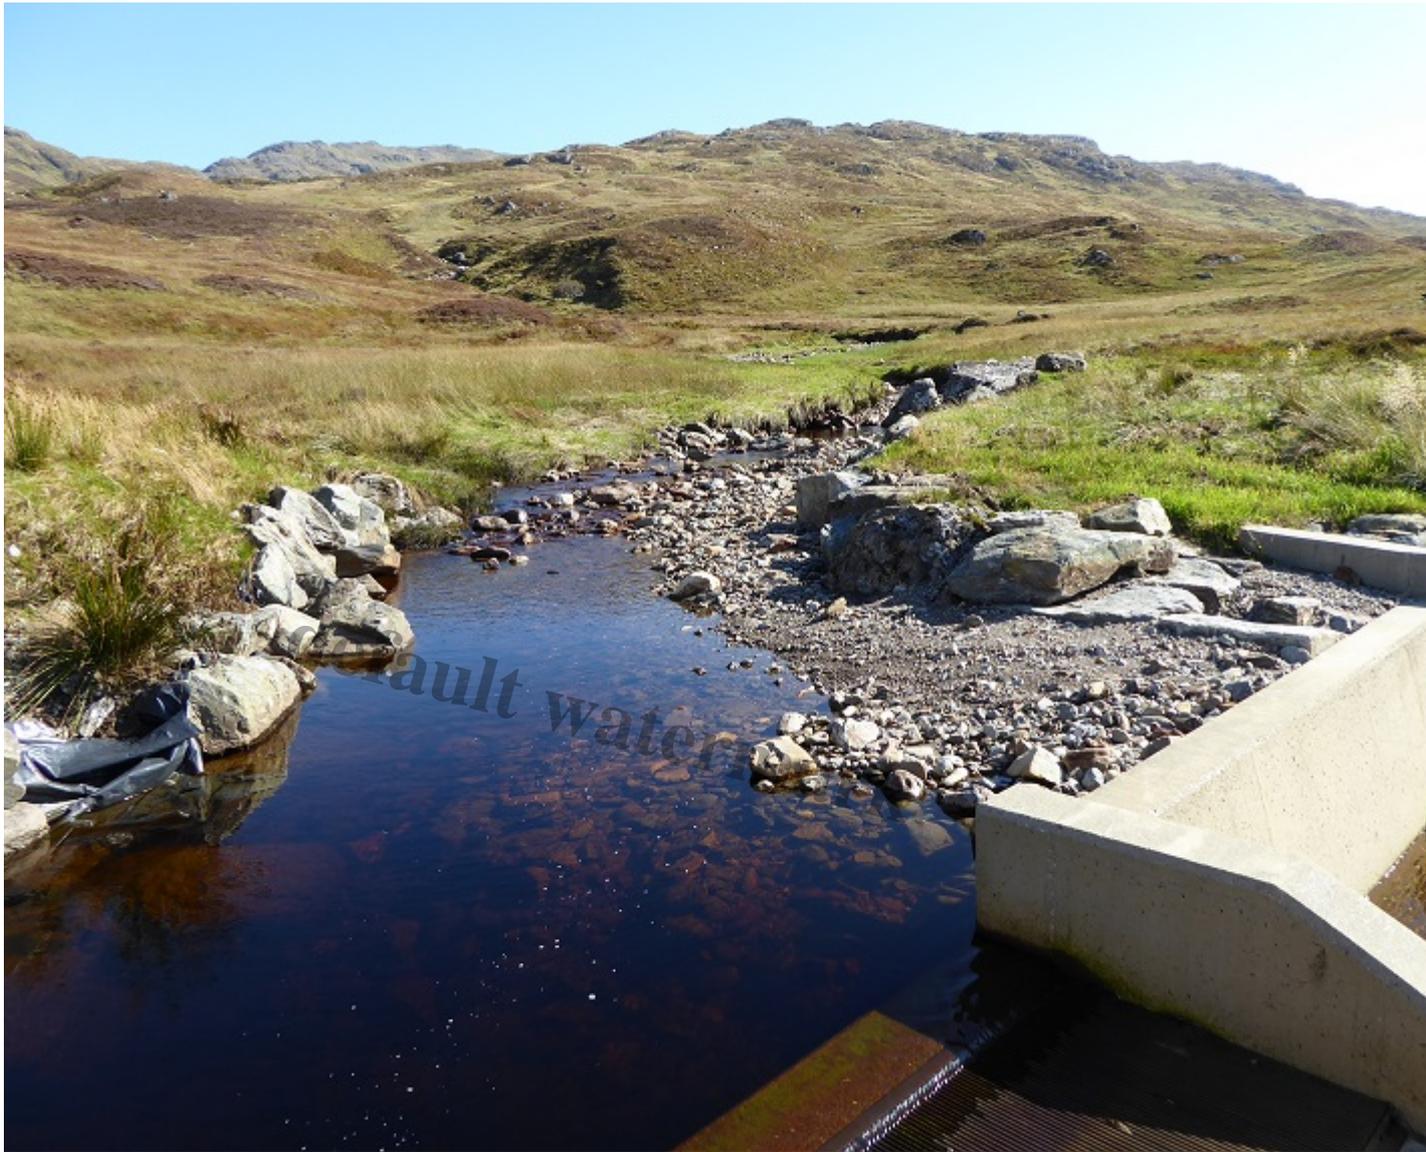
The most popular walkers path up Beinn Chabhair is just to the left of the photo. Note the shingle bar behind the intake and the missing boulder on the left bank. September 2019.

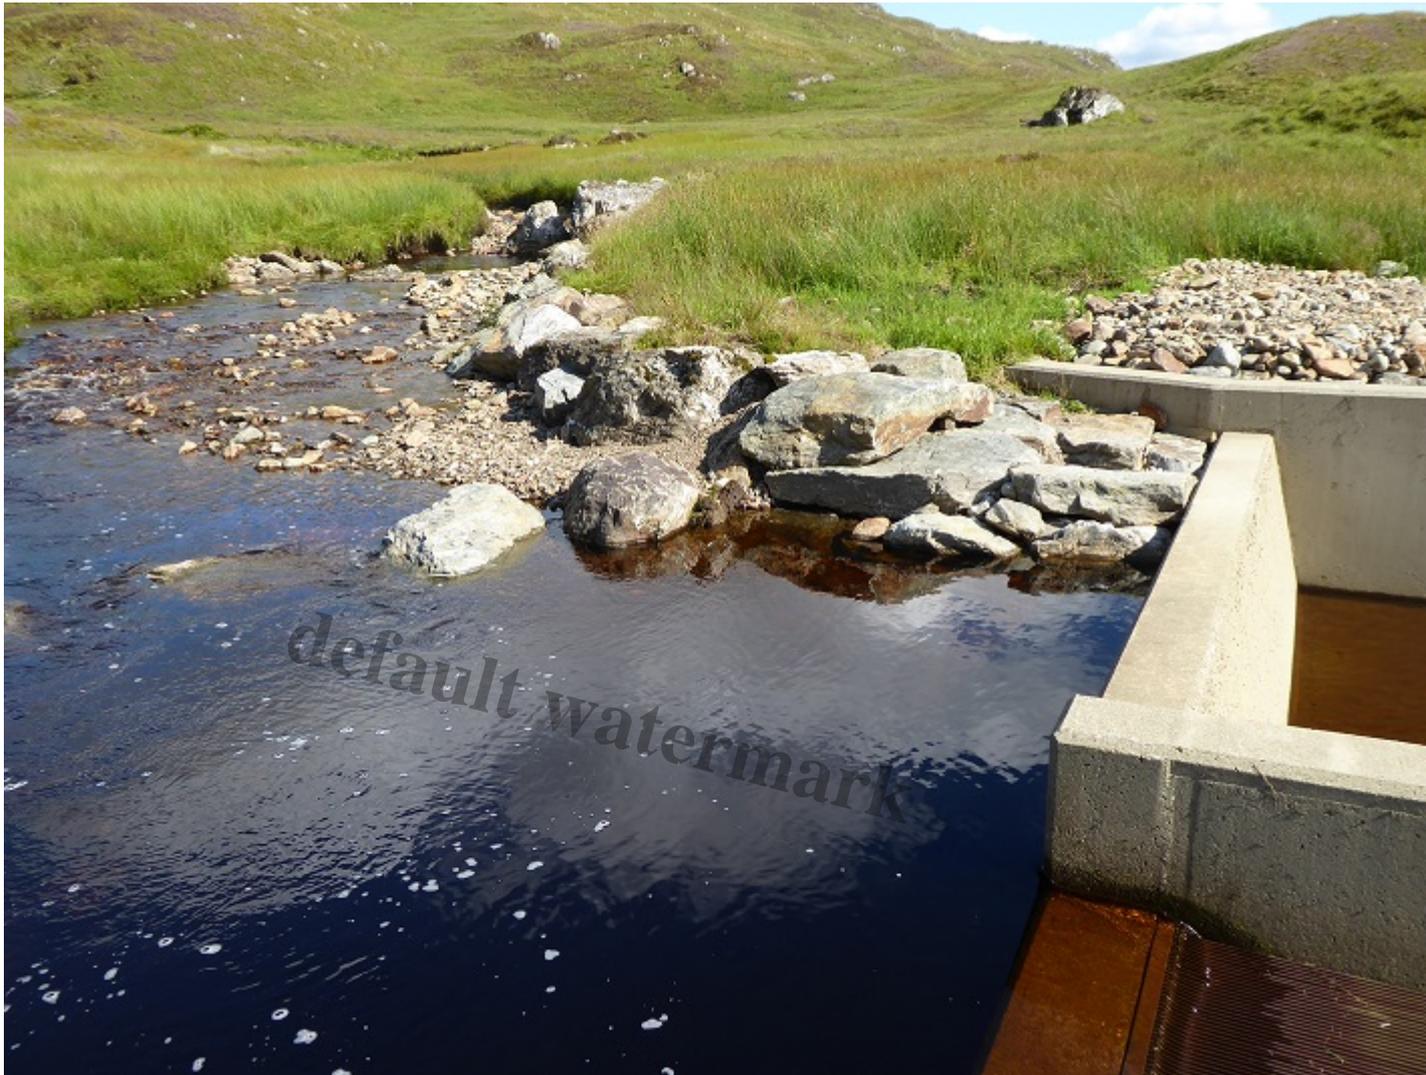
August 2020. Note how the excavated material has been dumped behind the far intake wing wall and the intake screen bottom right, more robust perhaps than a coanda screen but allowing more material through.

This intake has also now been excavated. Judging by the amount of material evident on the bed of the burn above, fairly frequent engineering is likely to be required to keep this scheme going too.

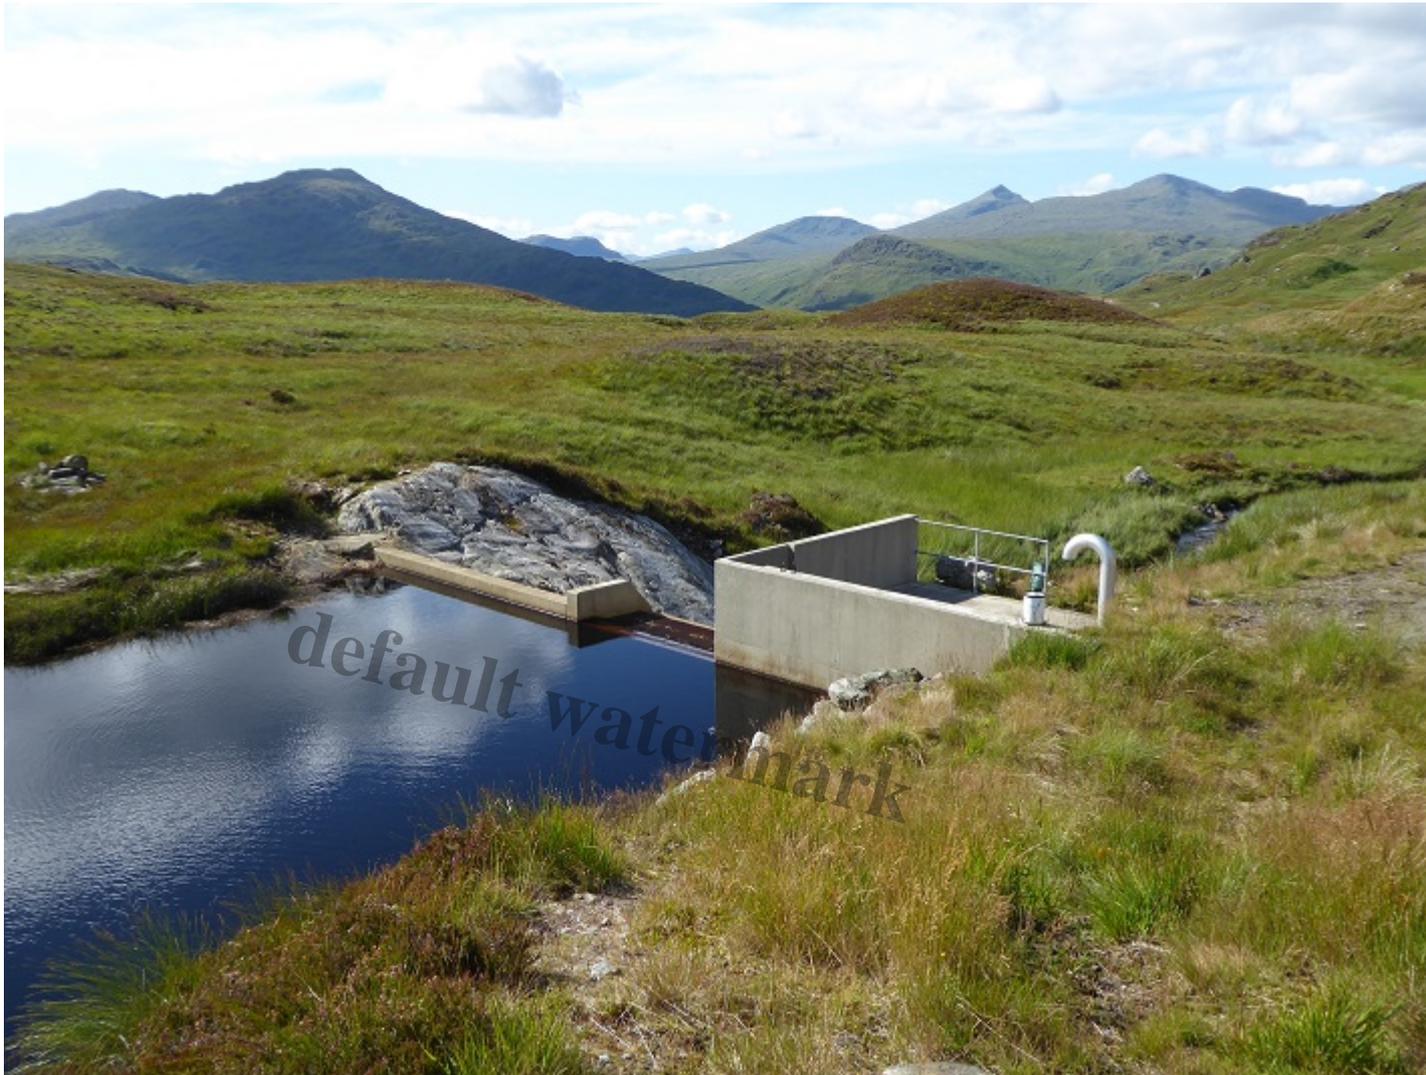
Ben Glas lower intake, Ben Lui in far distance. August 2020.

There are reasons for this. The intake is built into a slab of rock which is far more resistant to flood damage than rip-rap bouldering. Spate water just flows over it while on the near side is a moraine bank. This is a burn that is unlikely to change course in the near future.

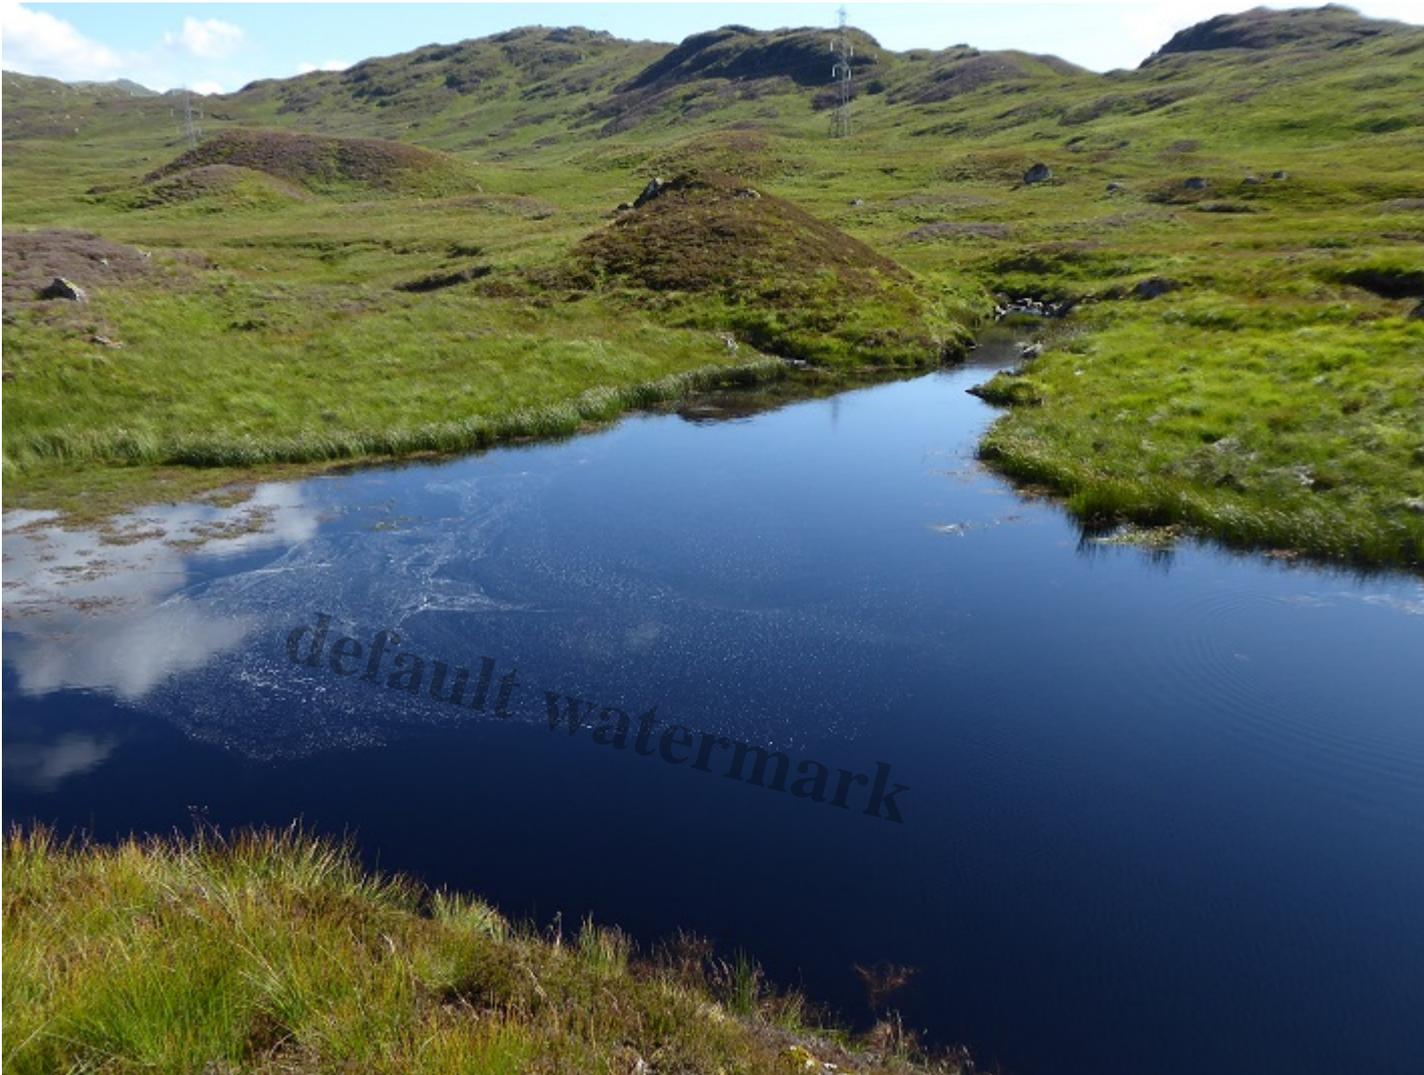
Looking south from the intake â?? I could see no sign of infilling

Like the Upper Falloch there is a large pool, but this one looks good â?? almost natural â?? and isnâ??t infilling. The reasons for this relate to the topography. The burn feeding the pool is not steep and fast flowing but instead wends it way through peat bog. The peat and the vegetation reduce the sediment and rocks that can enter the river system, while the gentle angle means that any material that does enter the burn moves along slowly. Assuming the intake wall has been well constructed, there is unlikely to be any need for further engineering here any time soon, a contrast to the other six intakes on the south side of Glen Falloch. It appears therefore to be the only intake out of the seven that has been well designed and located.
