Hill road upgrades and the planning system – Strone three years on

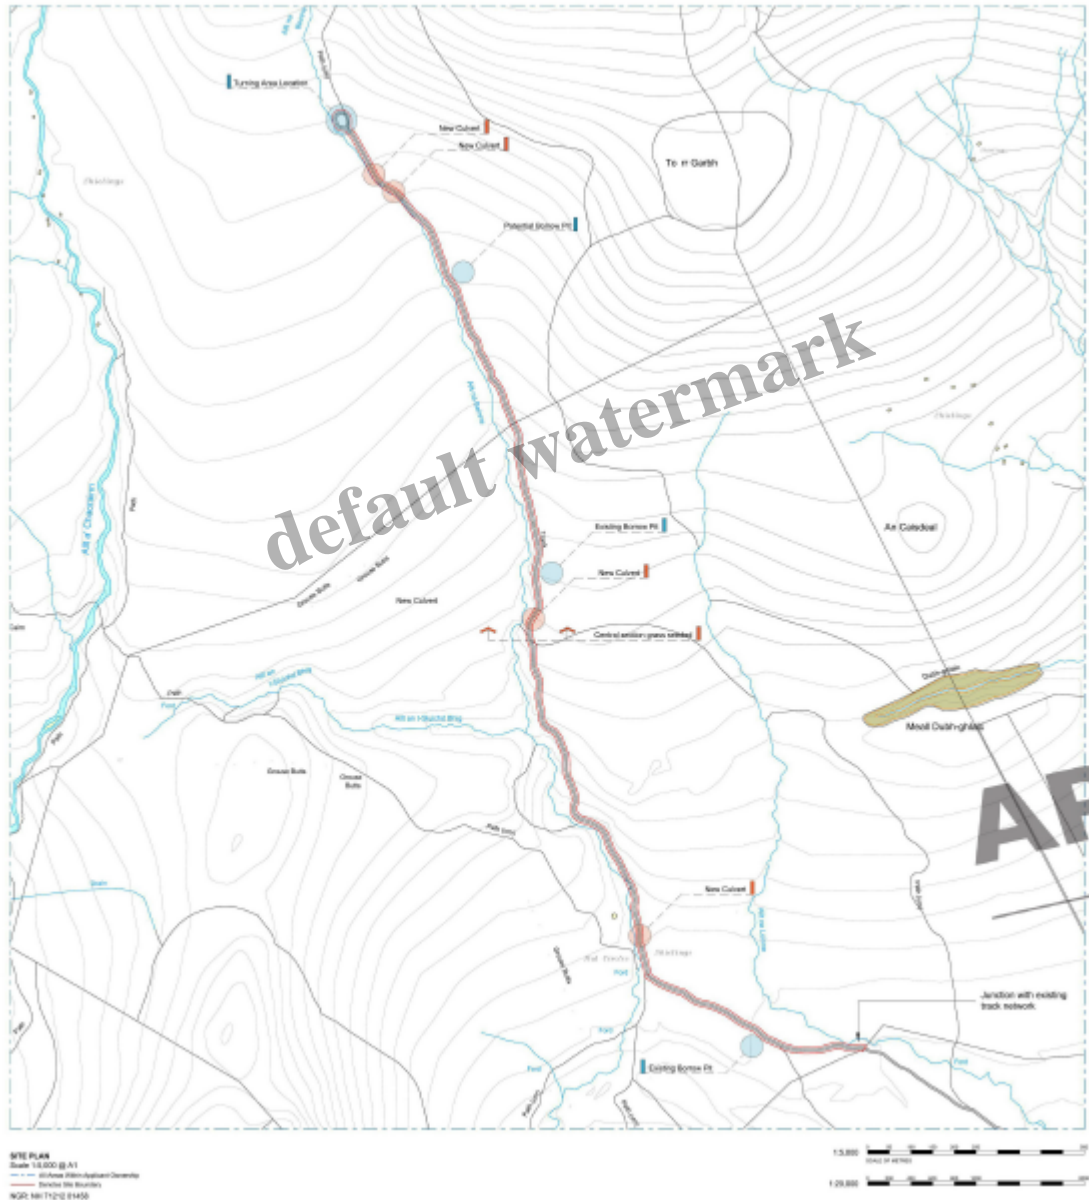
2019/0121/DET CONDITIONS 1 AND 4

Plan of track showing culverts and borrow pits

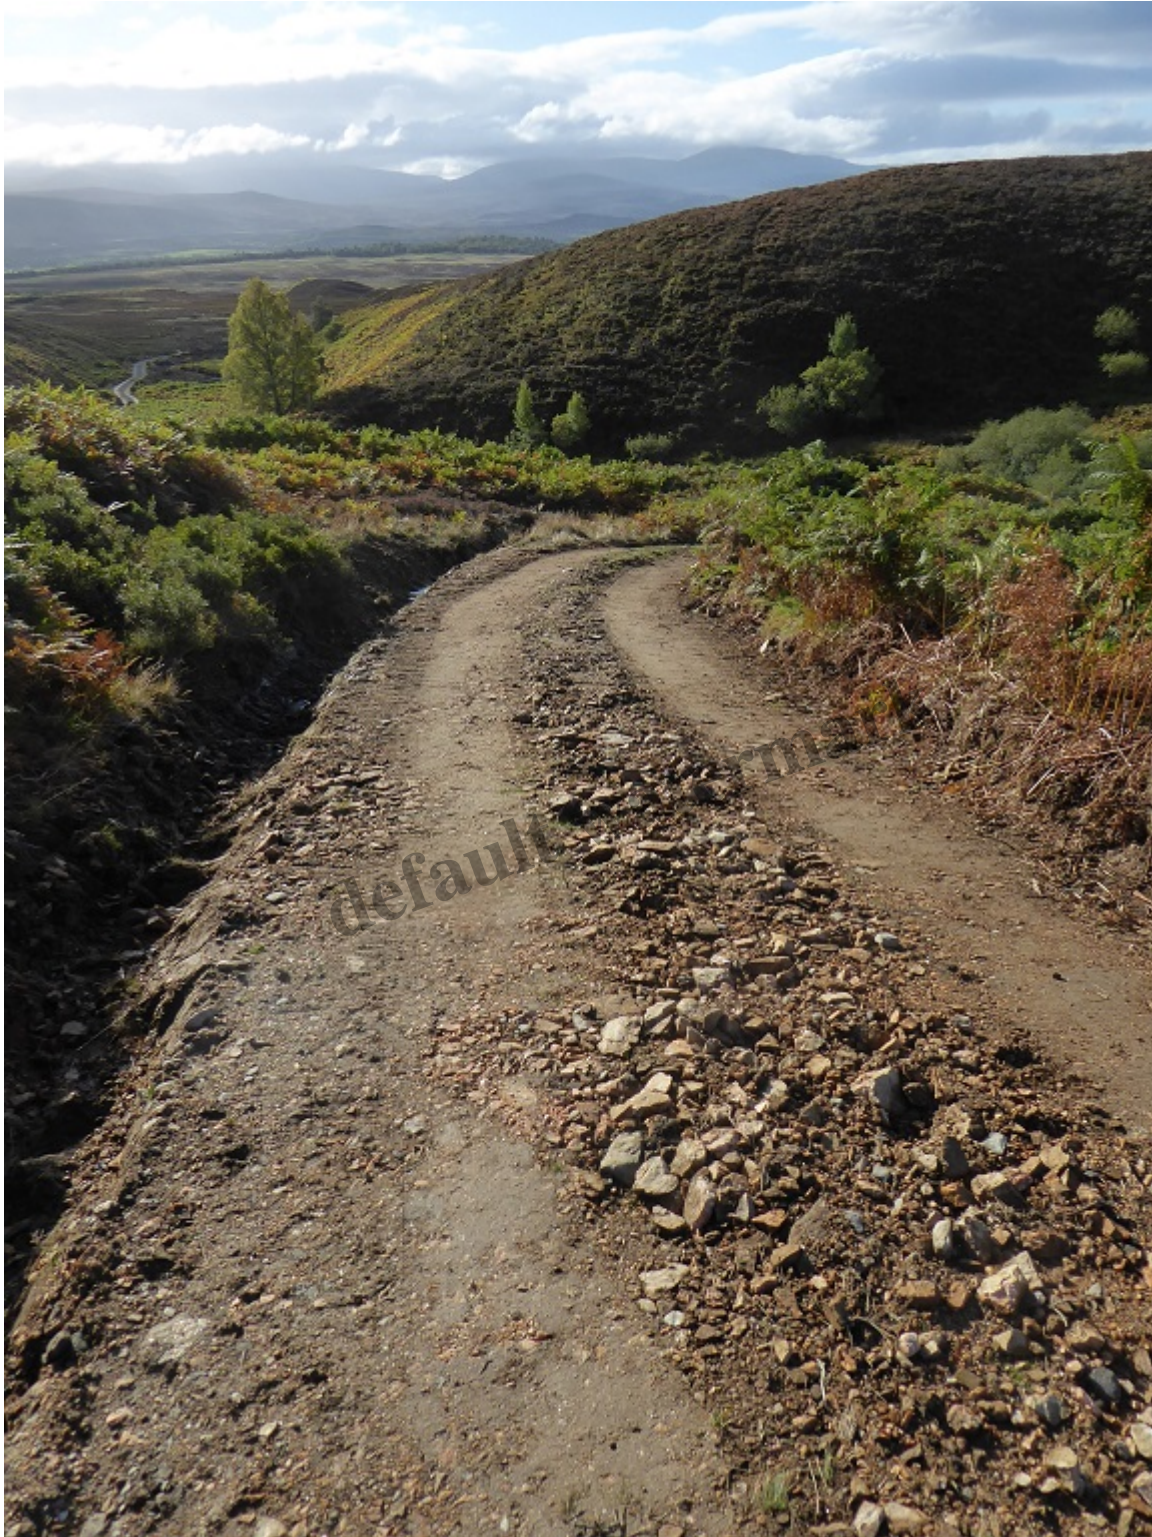
The lowest section of track is quite level and the upgrade work first became obvious where it steepens up by a beautiful wooded area.

It is, however, what happens on the ground that counts. At first sight I was not impressed, with the first steep section of track appearing at risk of serious erosion.

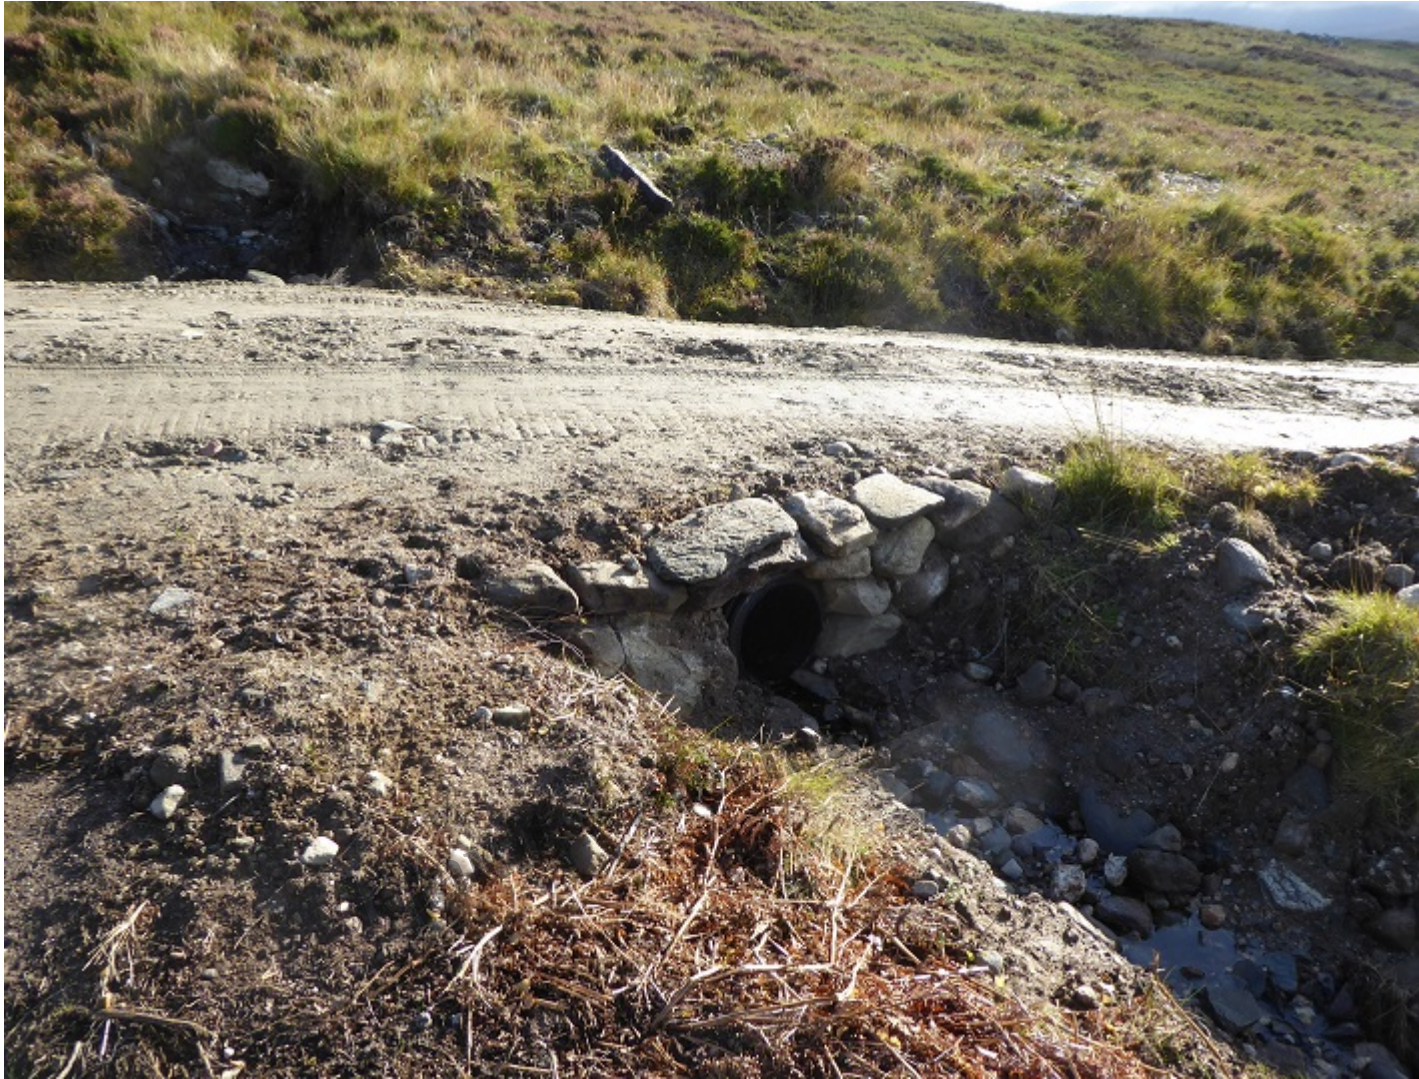
The plastic culverts were not just marked on the plan, they had been concealed and finished, something that happens all too rarely on hill roads.

The basic quality of the work appeared good, .

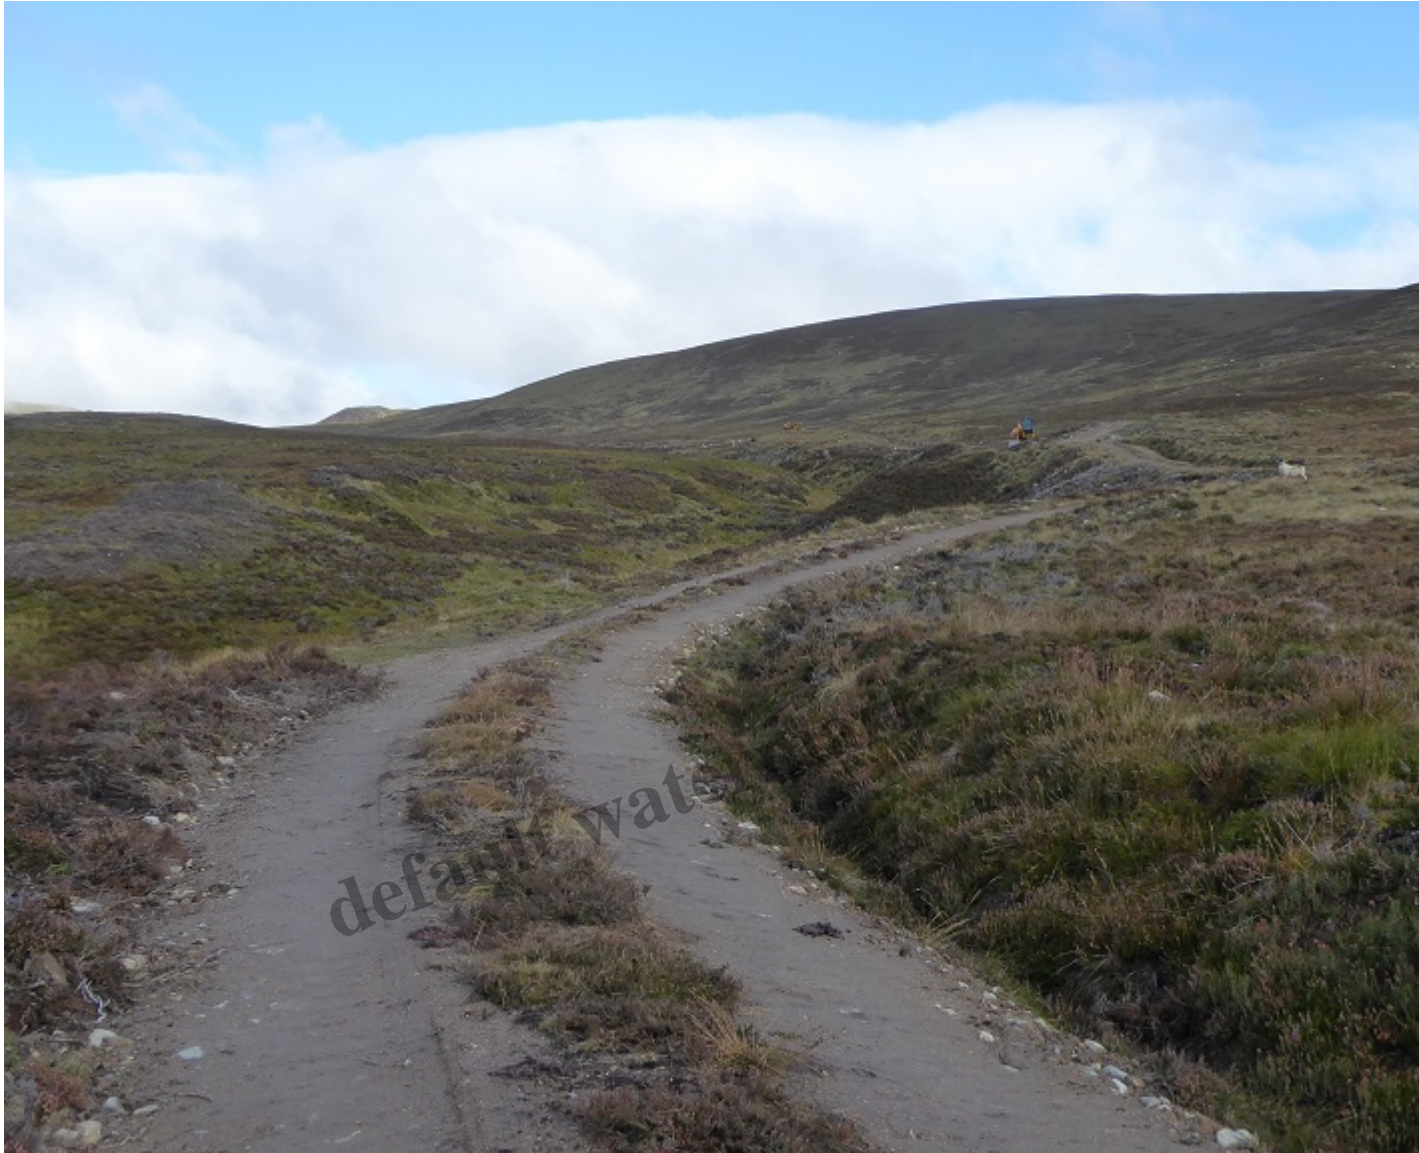
Note not just the vegetated strip but how the banks of the drainage ditch have also been surfaced with vegetation. The vegetation to do this has been “robbed” from either side.

Further up it became clear that the contractors were working from the top down to complete the surface of the track. The specification, which was for a 2.5m road with a 75mm vegetated strip down the middle, has been strictly observed. While arguably the work might have been better done in the Spring, allowing time for the translocated plants to put down roots, if it survives the winter the landscape impact by this time next year should be very little.

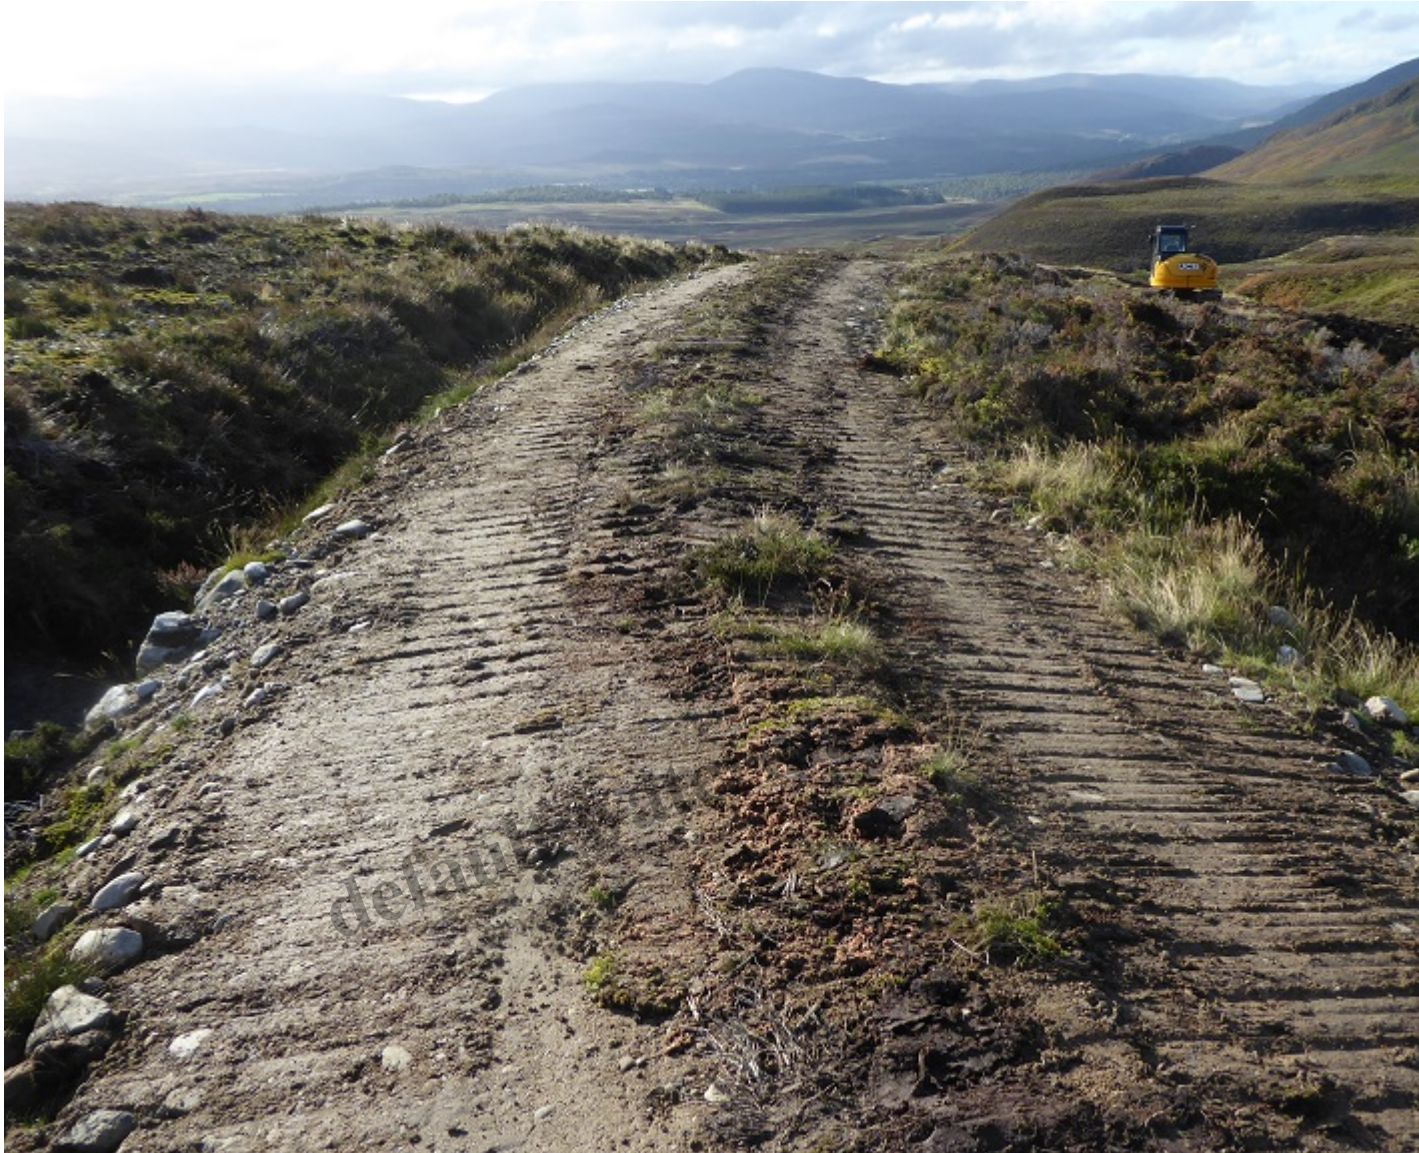
Sphagnum moss, which thrives in bogs, used to cover a short section of the central strip. The erosion on the left of the road appears to have been caused by sheep (see below).

While it is amazing what skilled operators of diggers can do, they do still make mistakes. That is why all work on hill tracks needs to be actively monitored and the workforce advised to change their practice where necessary.

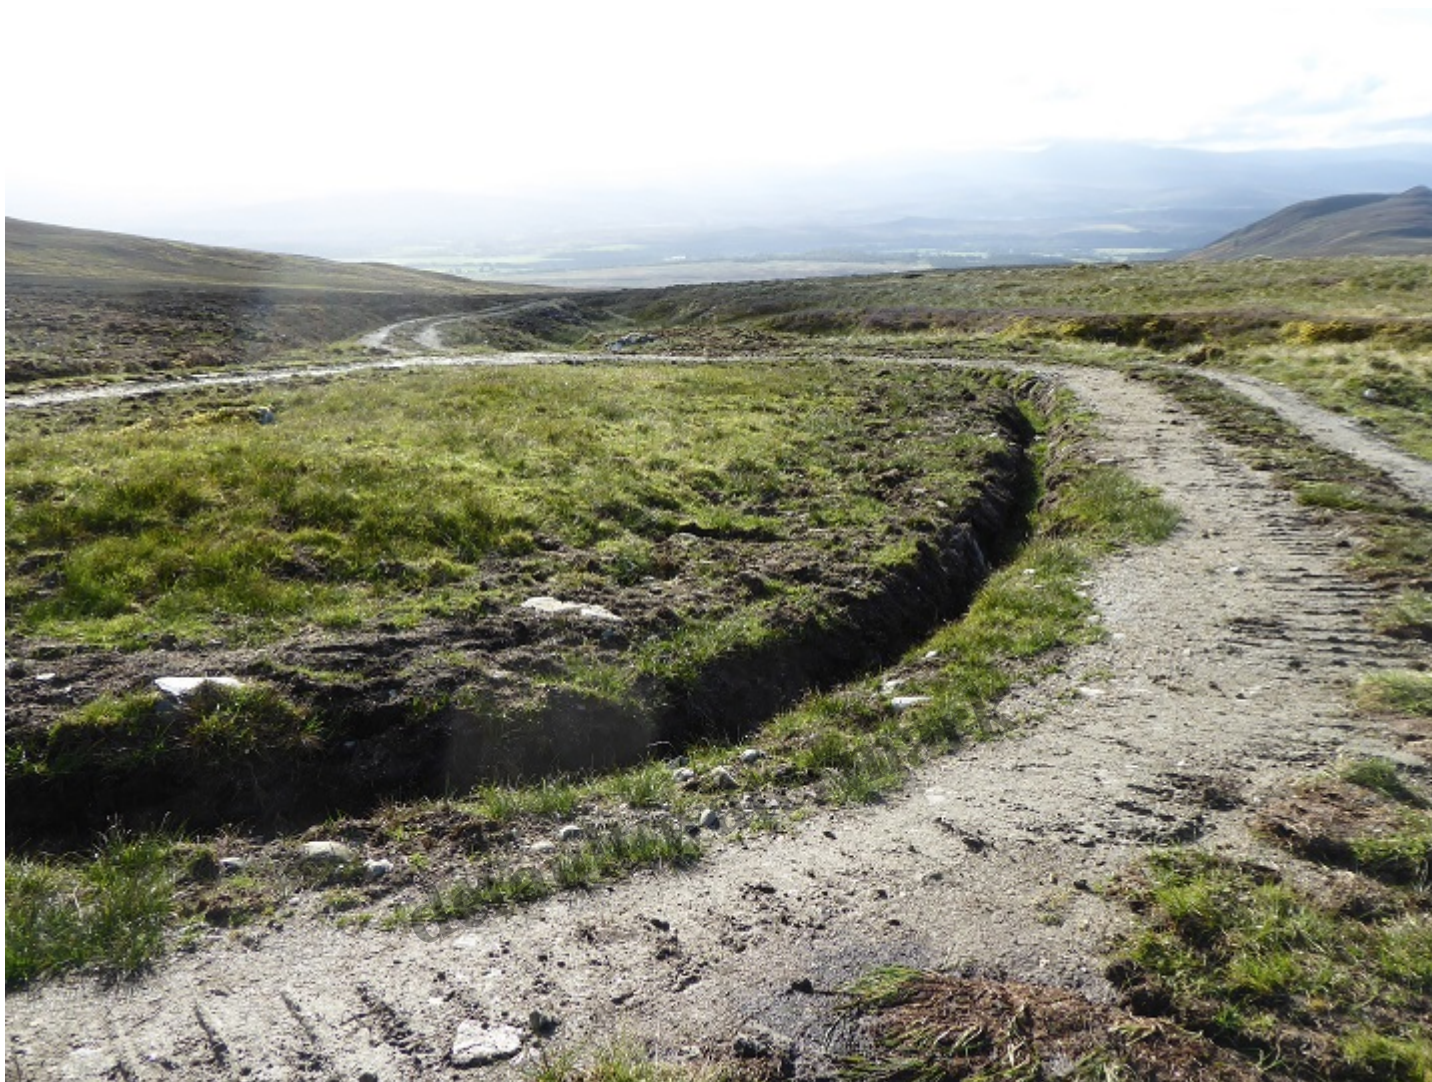
In terms of landscape impact, the line of original road was well chosen and is generally hidden from a afar. I identified two concerns about the design. The first is that a couple of sections exceed 14°, the recommended maximum angle for hill roads. While the addition of vegetation to the raised central strip will help reduce the risk of erosion, it is unlikely to prevent it completely. Future maintenance is therefore likely to be an ongoing issue but any alternative route would have had a much greater landscape impact.

The second is the turning circle at the top of the road. There is no need for it. It significantly increases the landscape impact of the road but has also required the destruction of peat to create the new drainage ditch. This should never have been agreed, particularly when the owner of Glen Banchor is being paid public money to restore damaged peatbog elsewhere on the estate ([see here](#)).

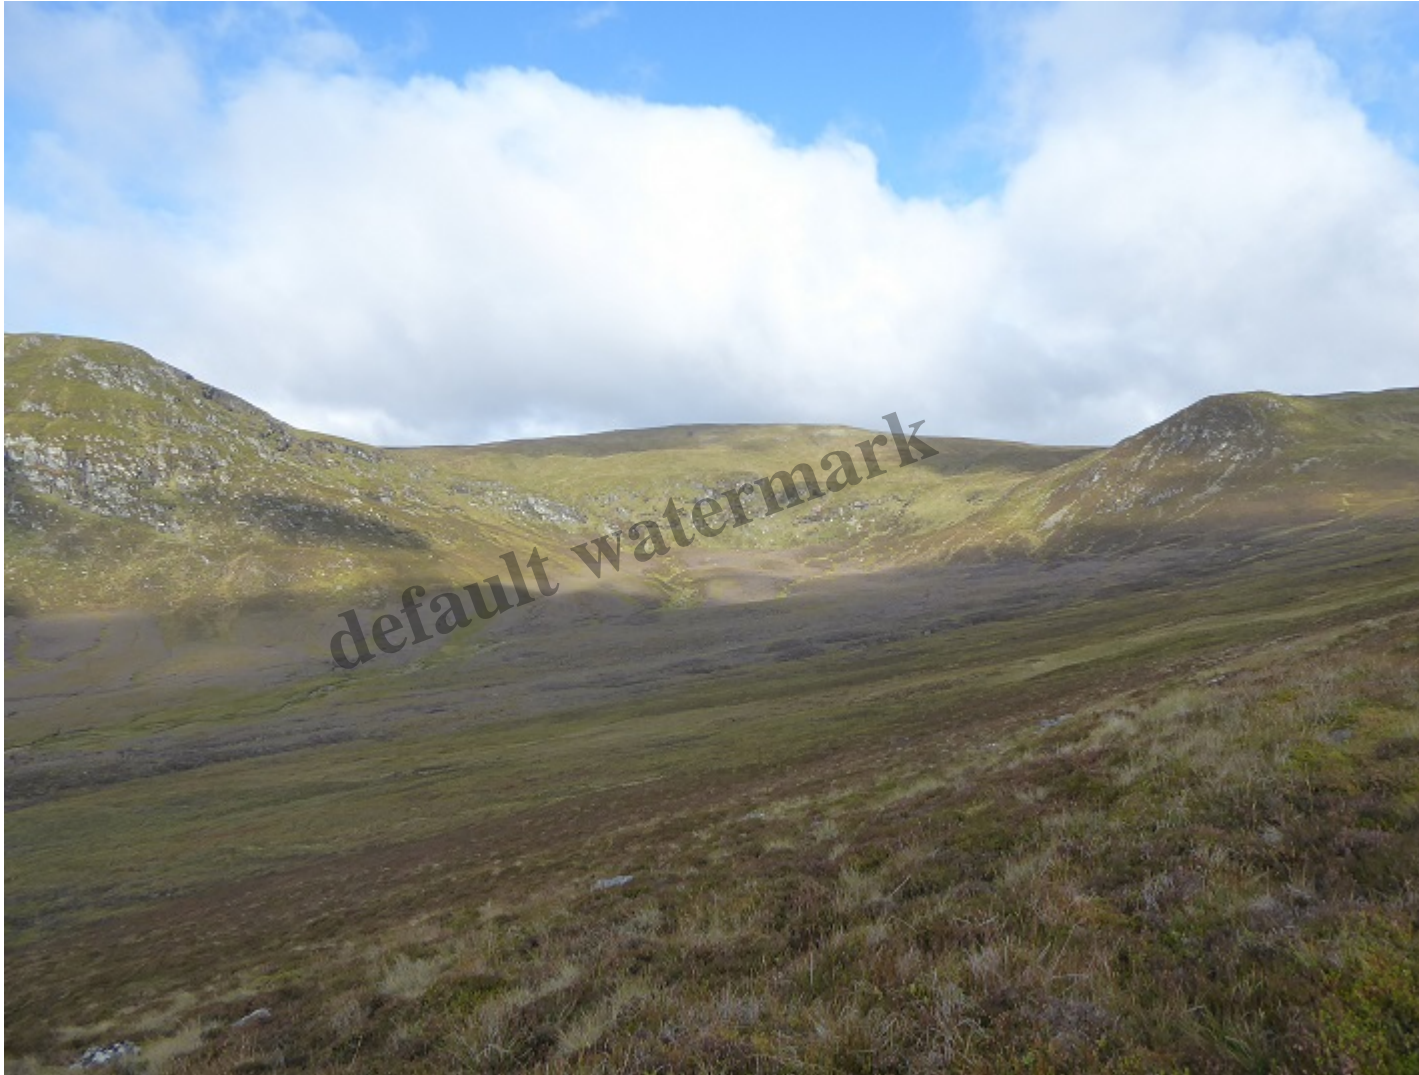
Carn Sgulain centre, A'Chailleach left. The large faint patch in the centre of the photo results from heather dying off, possibly due to old age.
