Hill road upgrades and the planning system – Strone three years on

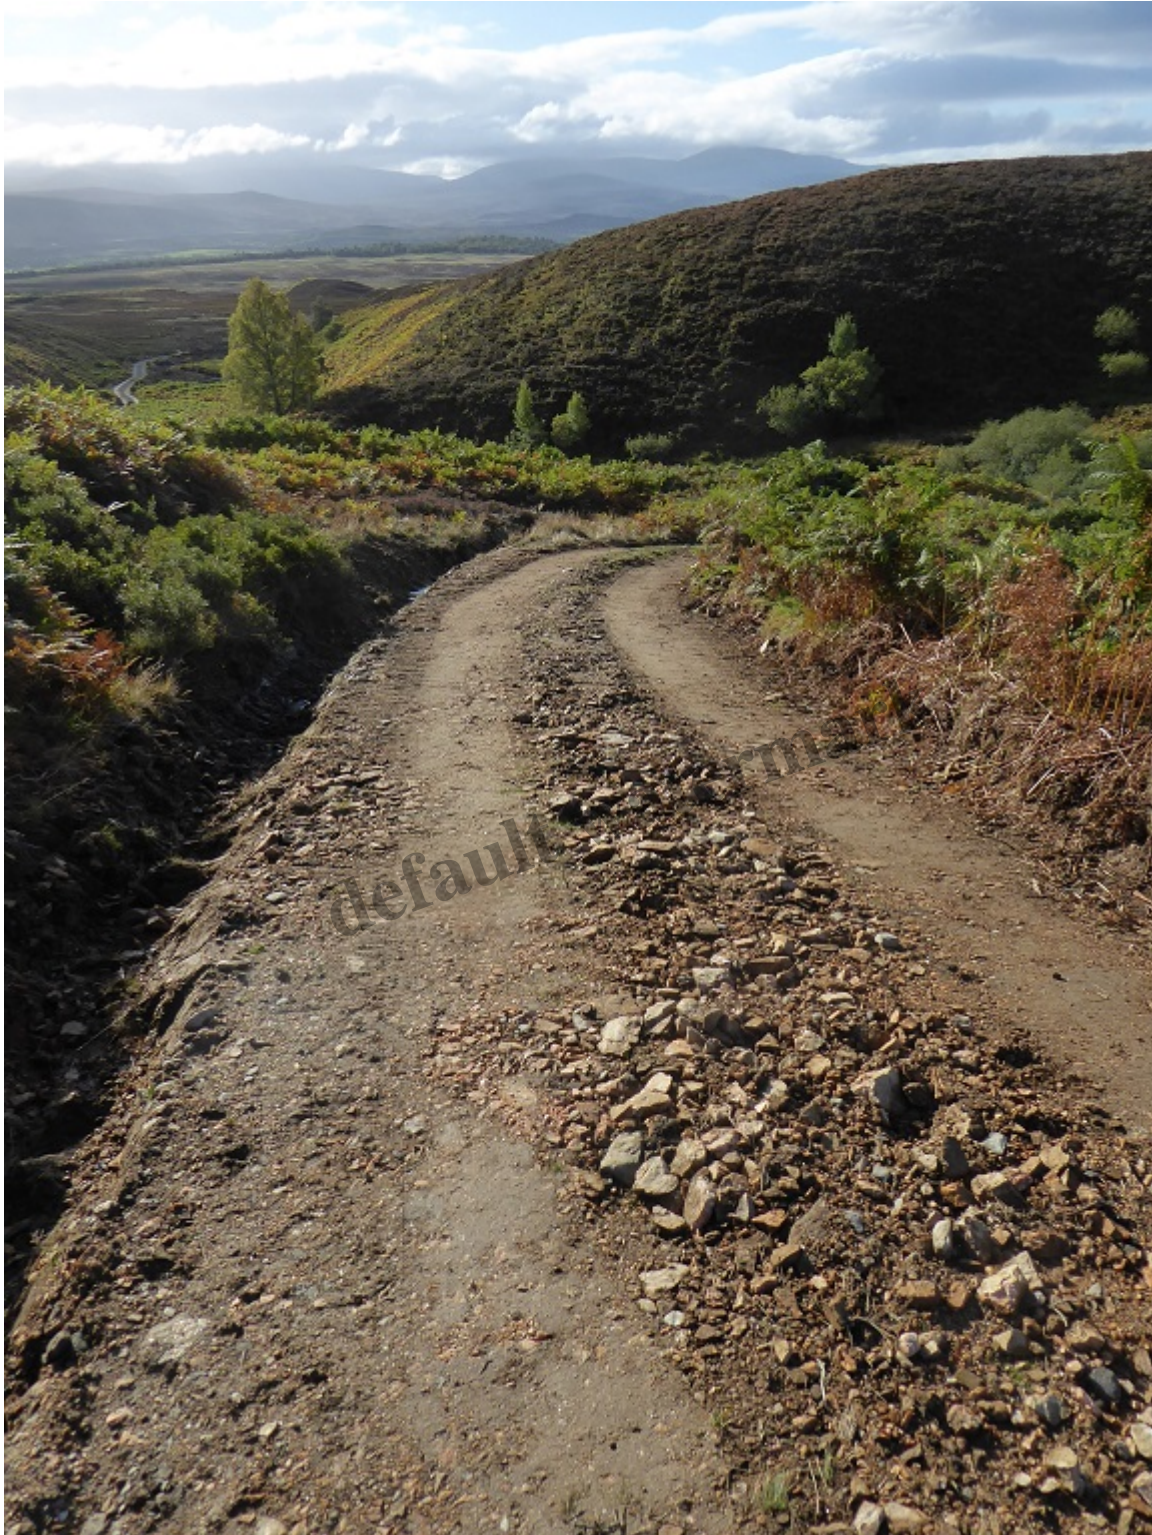
The lowest section of track is quite level and the upgrade work first became obvious where it steepens up by a beautiful wooded area.

It is, however, what happens on the ground that counts. At first sight I was not impressed, with the first steep section of track appearing at risk of serious erosion.

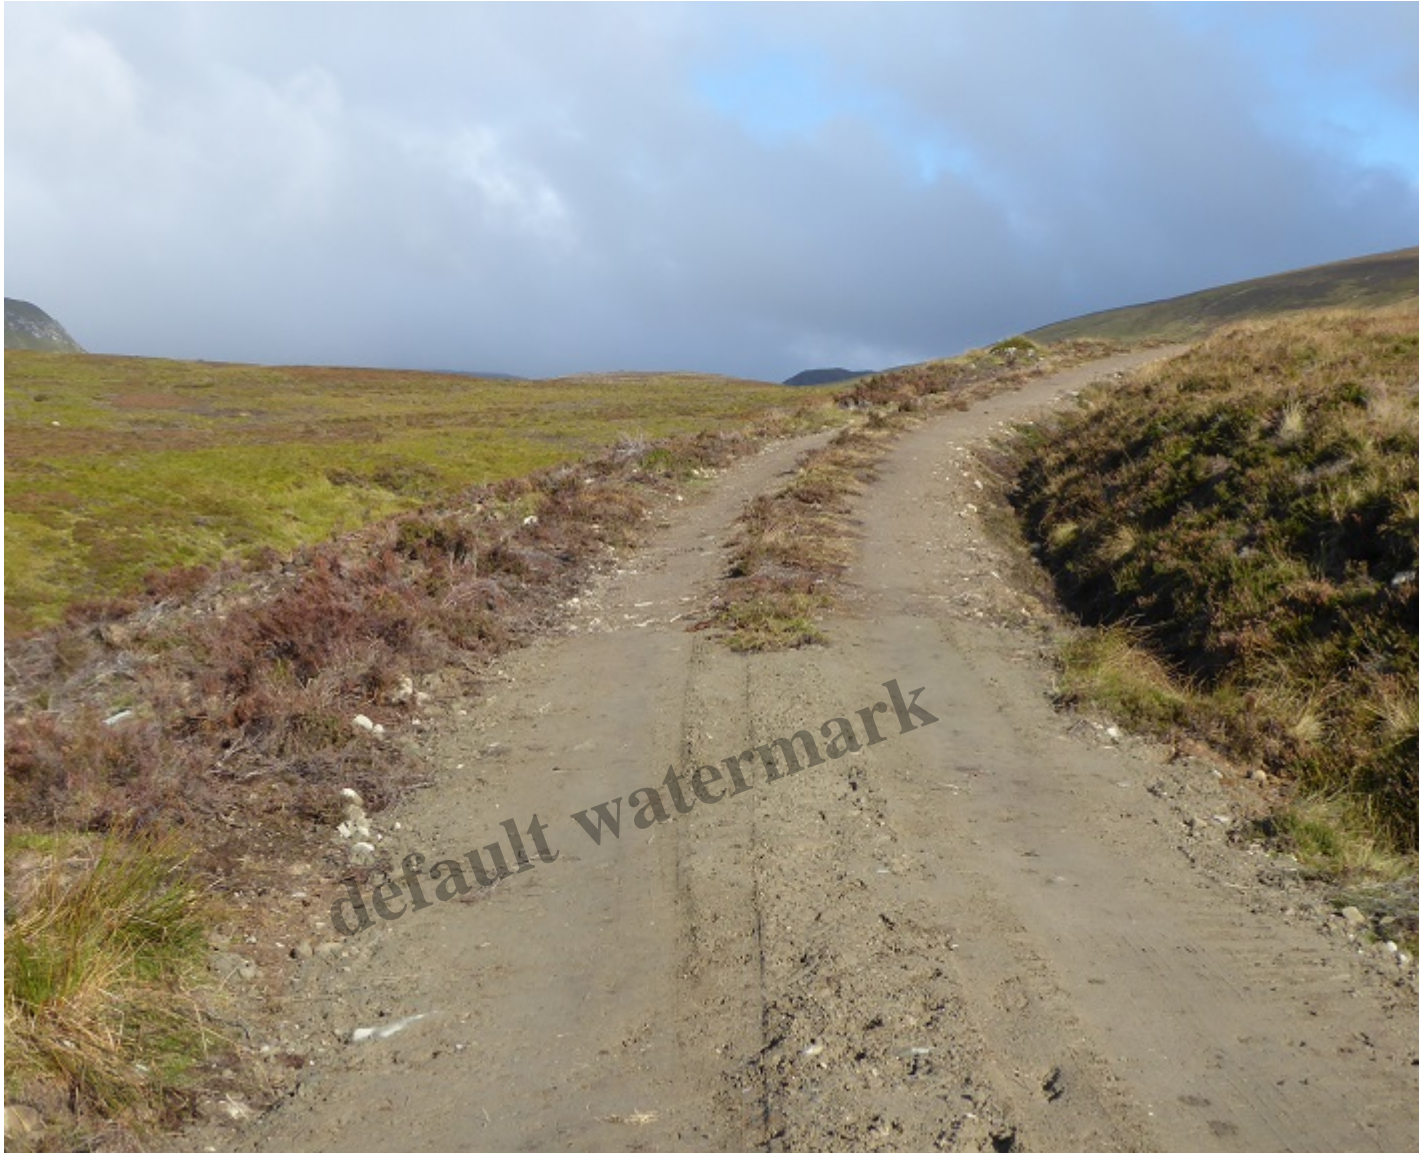
Boundary between finished and unfinished road surface marked by end of central vegetated strip

It was only higher up that it became clear that this was work still in progress. Unfortunately, although the Scottish Planning Portal allows the start and end dates of work on developments granted planning permission to be recorded, neither of our National Parks use this facility. With planning permission lasting three years, this makes it very difficult for any member of the public concerned about a development in a remote area to monitor what is going on. My visit at this stage in the development was pure chance. A lost opportunity for our National Park Authorities, who talk a good game about making more use of volunteers, to empower outdoor recreationists to help monitor developments in our hills.

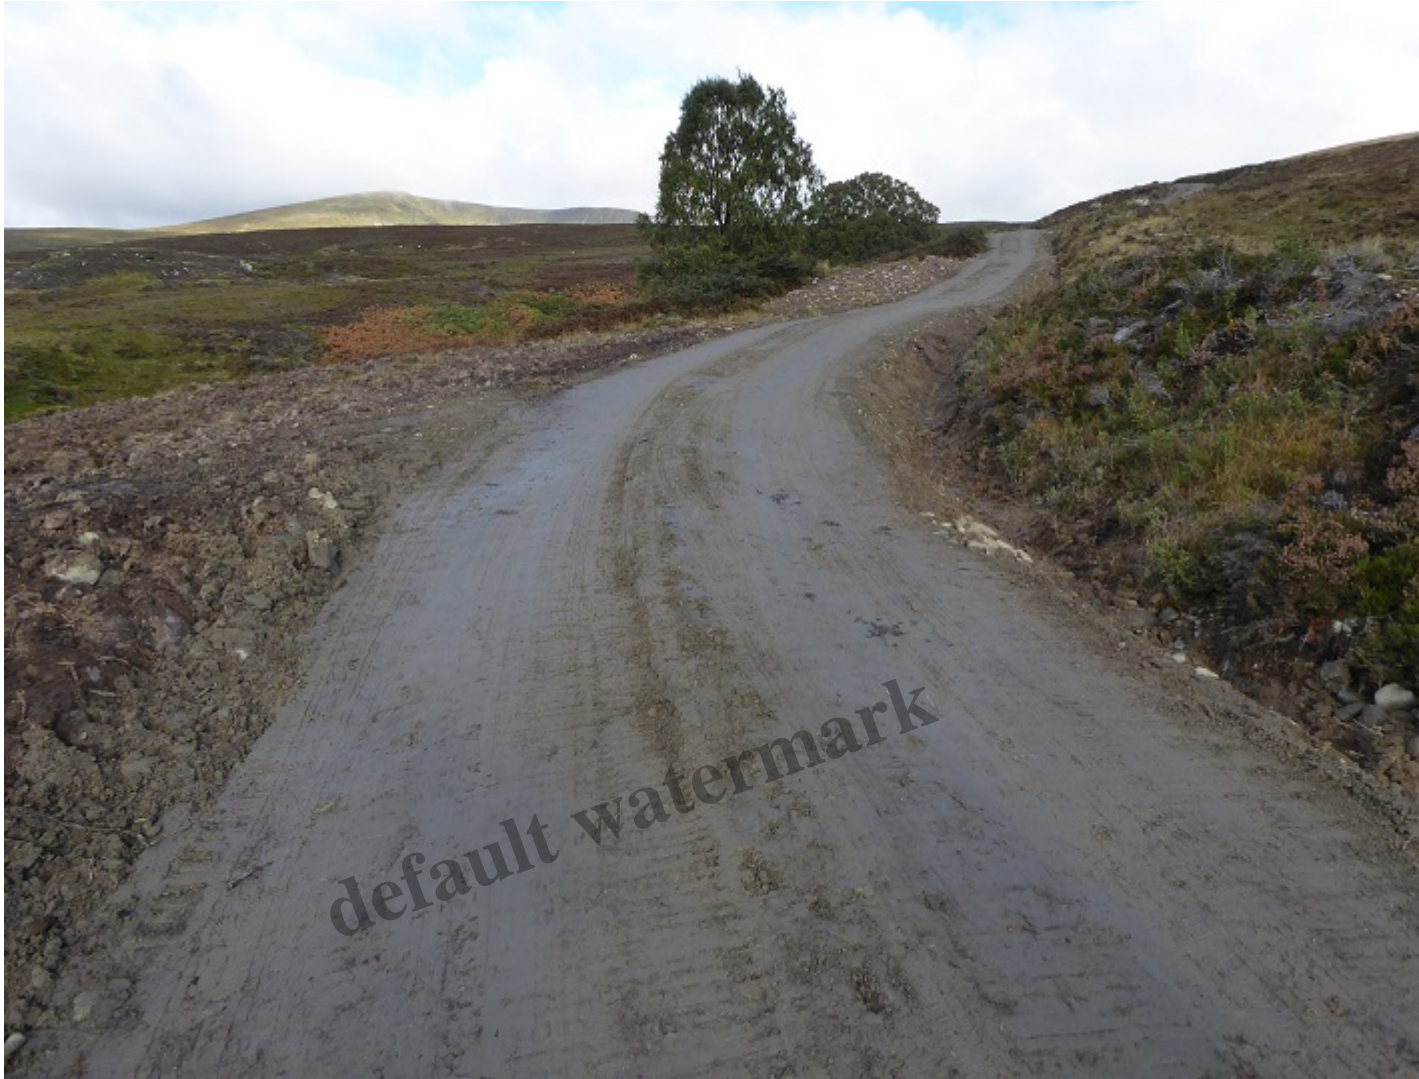
Note how the centre of the road has been raised so that water is shed either side. This prevents the road turning into a watercourse

From where it steepened, a new surface had been added to the road – as per the planning application – and a new drainage ditch excavated, but neither had been finished.

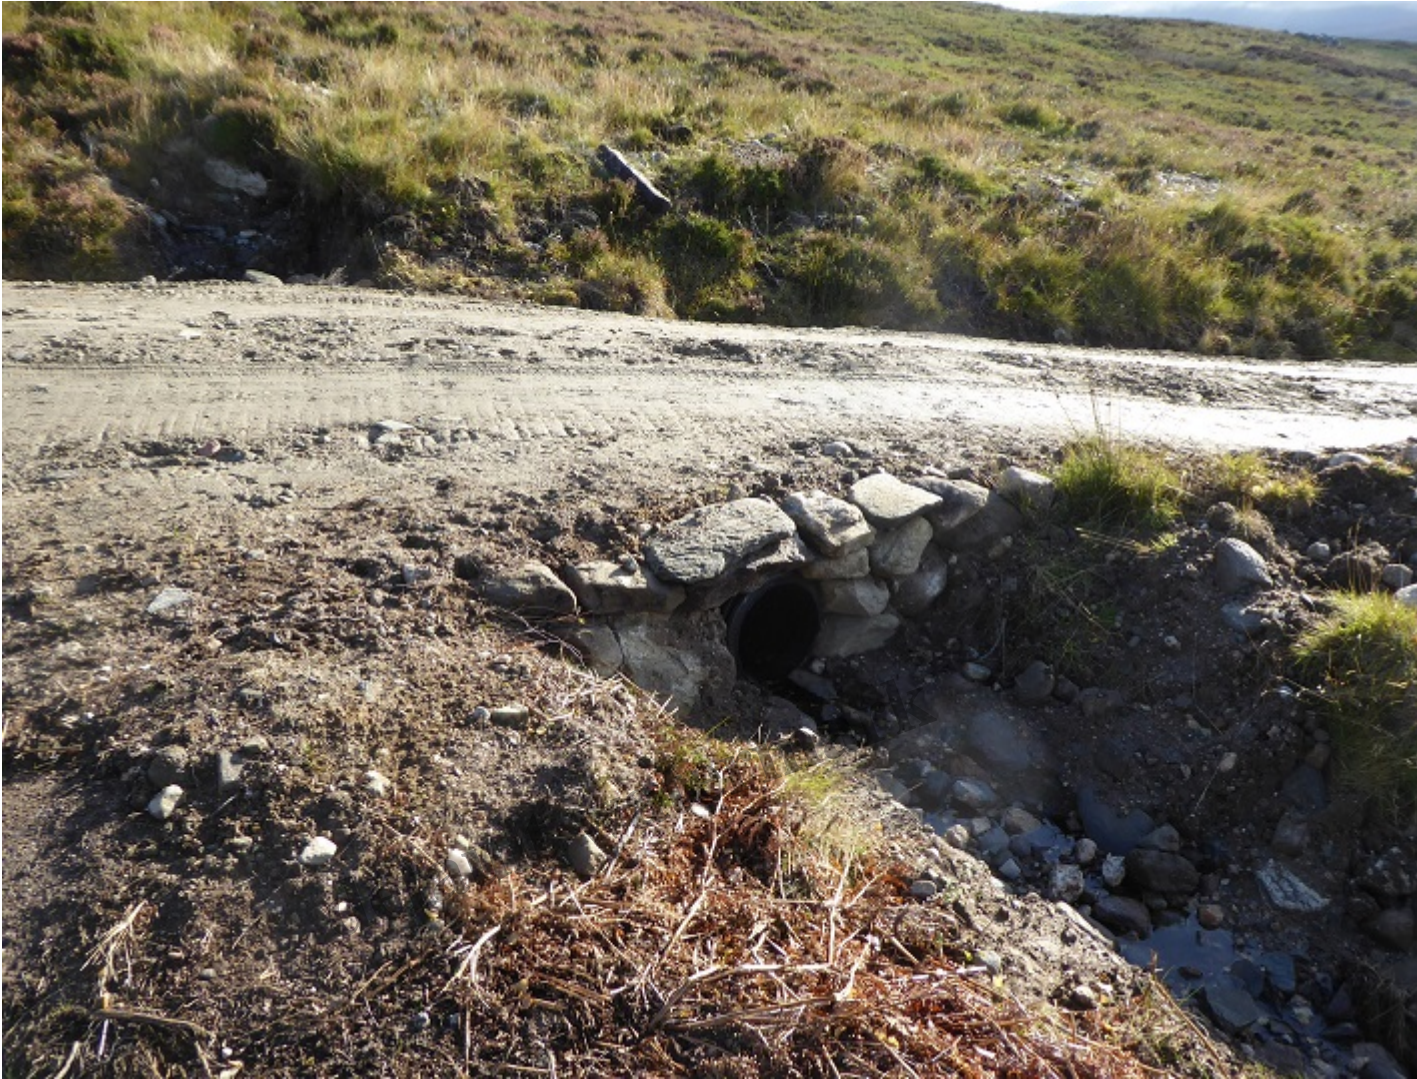
The plastic culverts were not just marked on the plan, they had been concealed and finished, something that happens all too rarely on hill roads.

The basic quality of the work appeared good, .

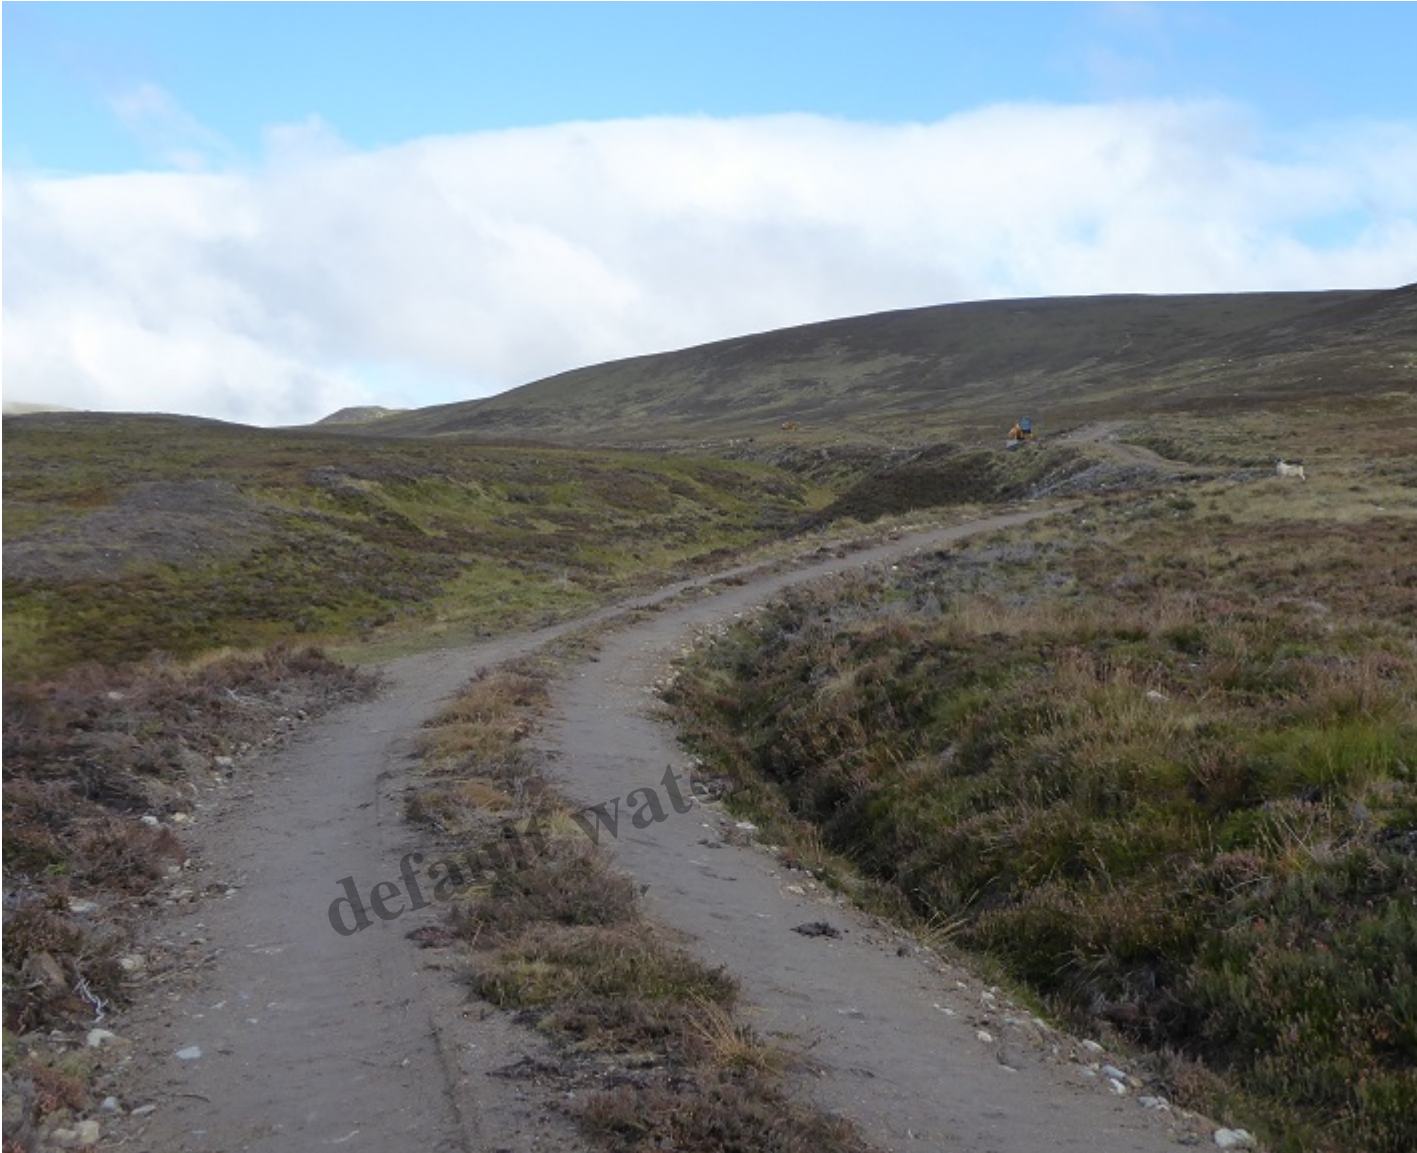
Note not just the vegetated strip but how the banks of the drainage ditch have also been surfaced with vegetation. The vegetation to do this has been “robbed” from either side.

Further up it became clear that the contractors were working from the top down to complete the surface of the track. The specification, which was for a 2.5m road with a 75mm vegetated strip down the middle, has been strictly observed. While arguably the work might have been better done in the Spring, allowing time for the translocated plants to put down roots, if it survives the winter the landscape impact by this time next year should be very little.

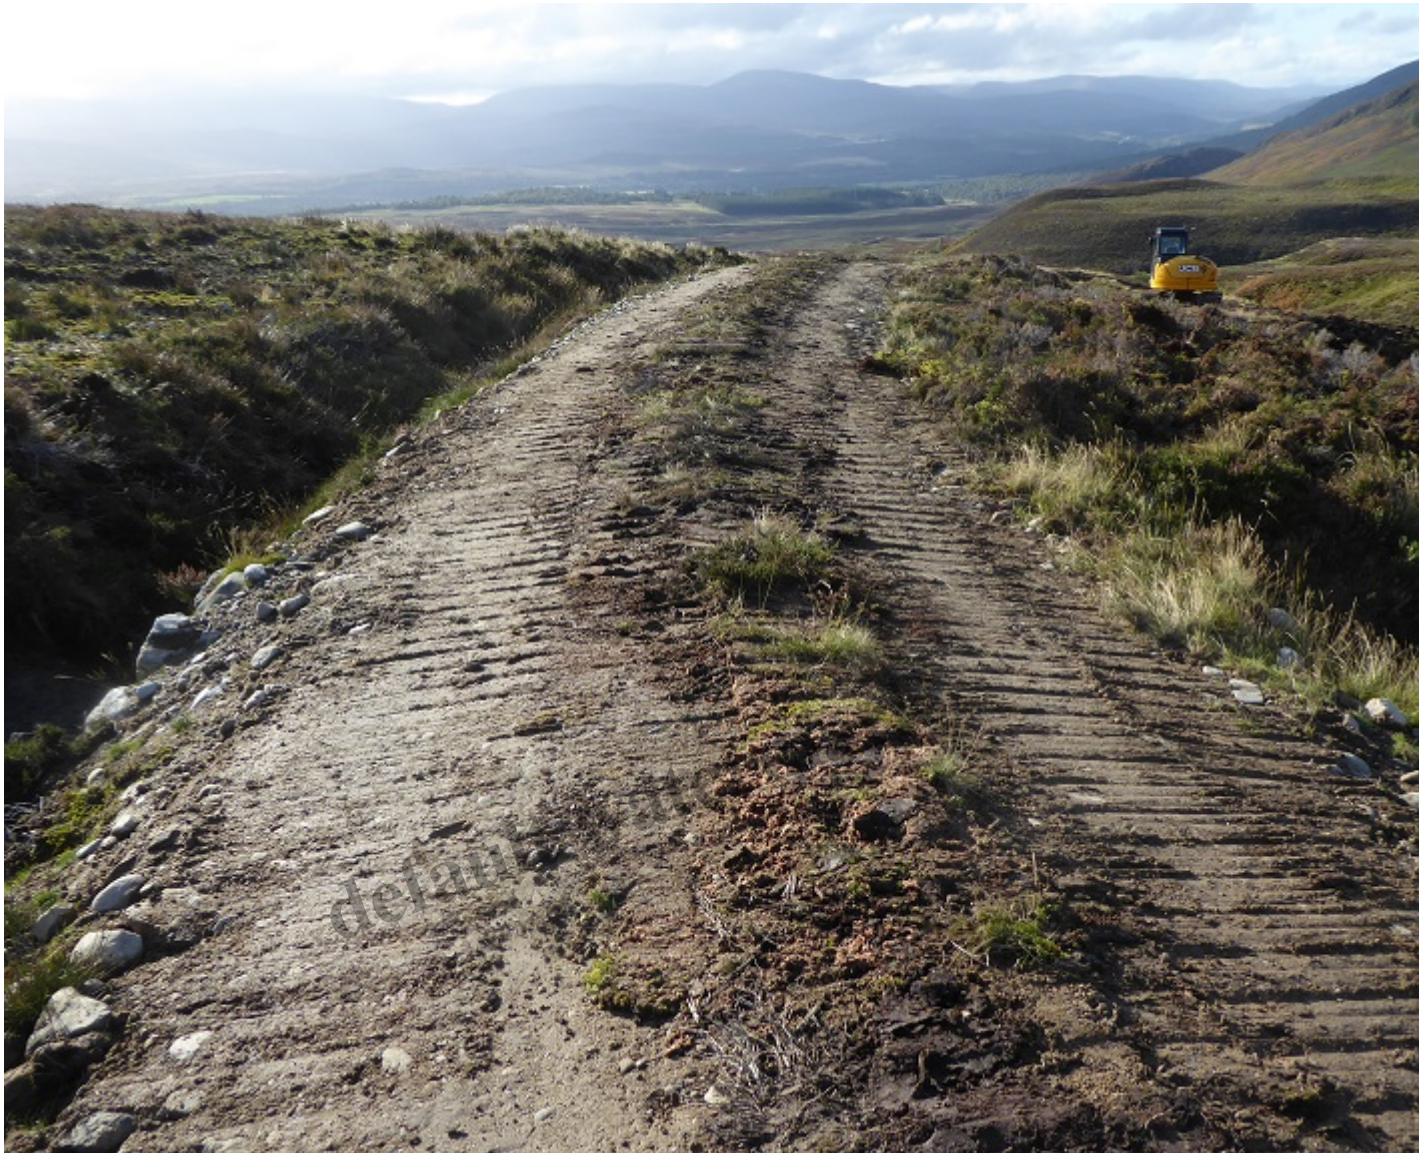
Sphagnum moss, which thrives in bogs, used to cover a short section of the central strip. The erosion on the left of the road appears to have been caused by sheep (see below).

While it is amazing what skilled operators of diggers can do, they do still make mistakes. That is why all work on hill tracks needs to be actively monitored and the workforce advised to change their practice where necessary.

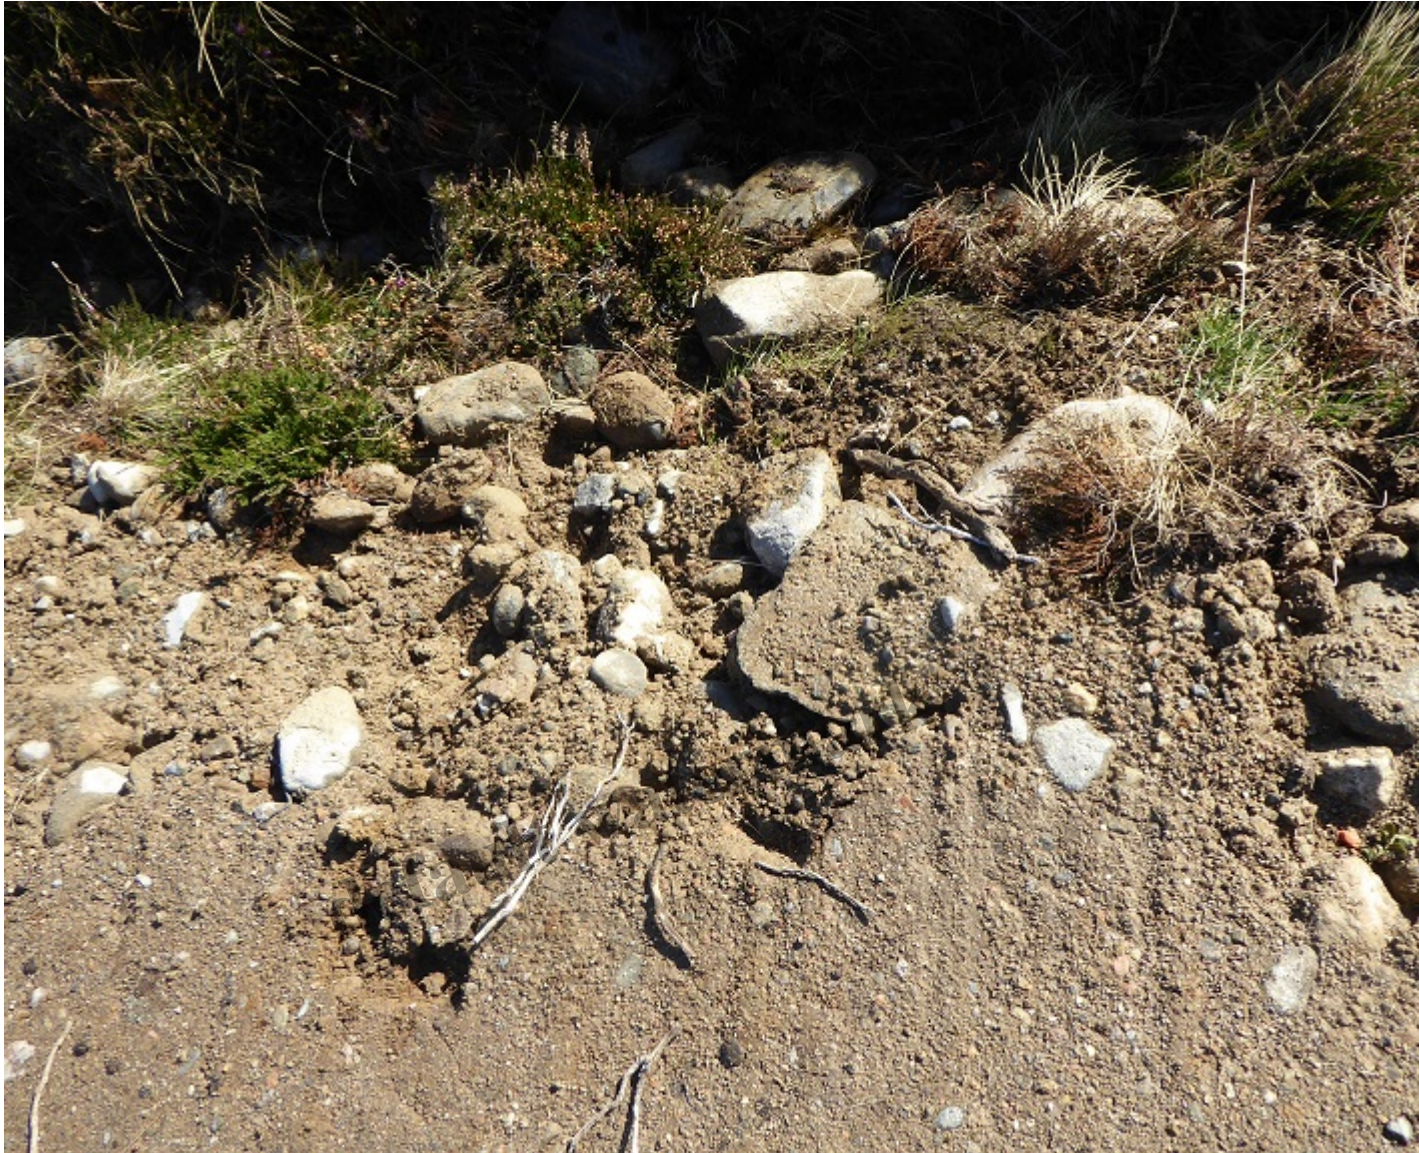
Sheep prints were visible along much of the vegetated edges of the road

A much bigger issue is that grazing animals, primarily sheep, have trampled over much of the vegetated sides of the road helping to break it up and destroy the vegetation before it has taken root. This damage, which is in no-one's interests, could be prevented if planning consents for hill roads included a standard condition requiring farm animals to be removed until vegetation has recovered.

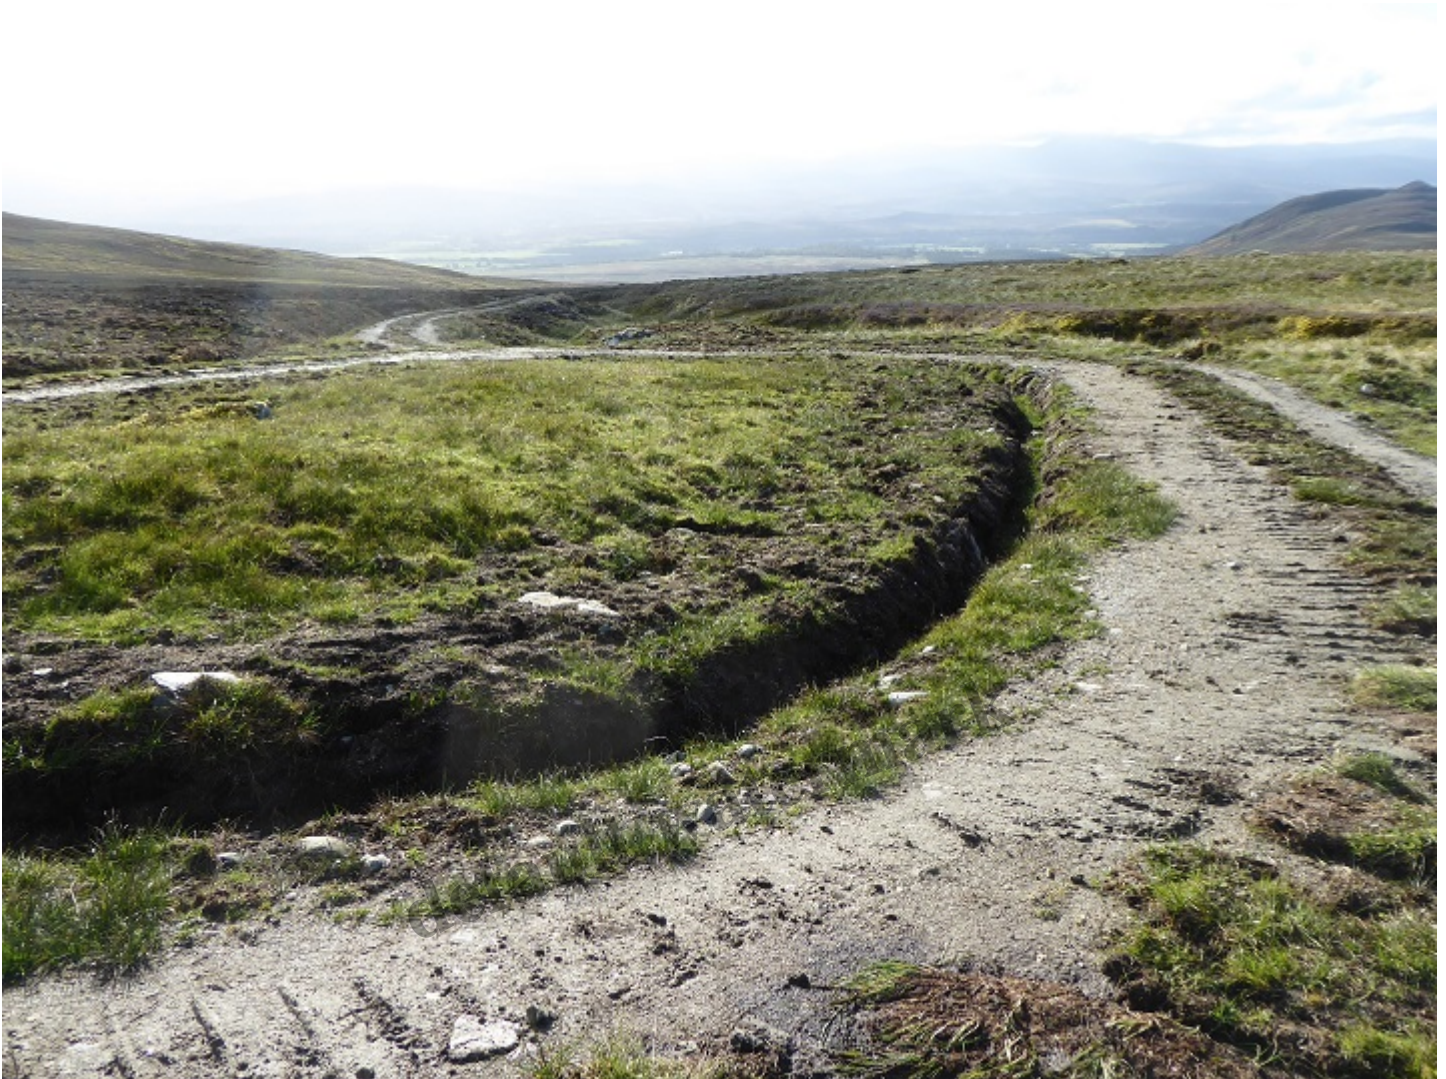
In terms of landscape impact, the line of original road was well chosen and is generally hidden from a afar. I identified two concerns about the design. The first is that a couple of sections exceed 14°, the recommended maximum angle for hill roads. While the addition of vegetation to the raised central strip will help reduce the risk of erosion, it is unlikely to prevent it completely. Future maintenance is therefore likely to be an ongoing issue but any alternative route would have had a much greater landscape impact.

The second is the turning circle at the top of the road. There is no need for it. It significantly increases the landscape impact of the road but has also required the destruction of peat to create the new drainage ditch. This should never have been agreed, particularly when the owner of Glen Banchor is being paid public money to restore damaged peatbog elsewhere on the estate ([see here](#)).
