Hill road upgrades and the planning system â?? Strone three years on

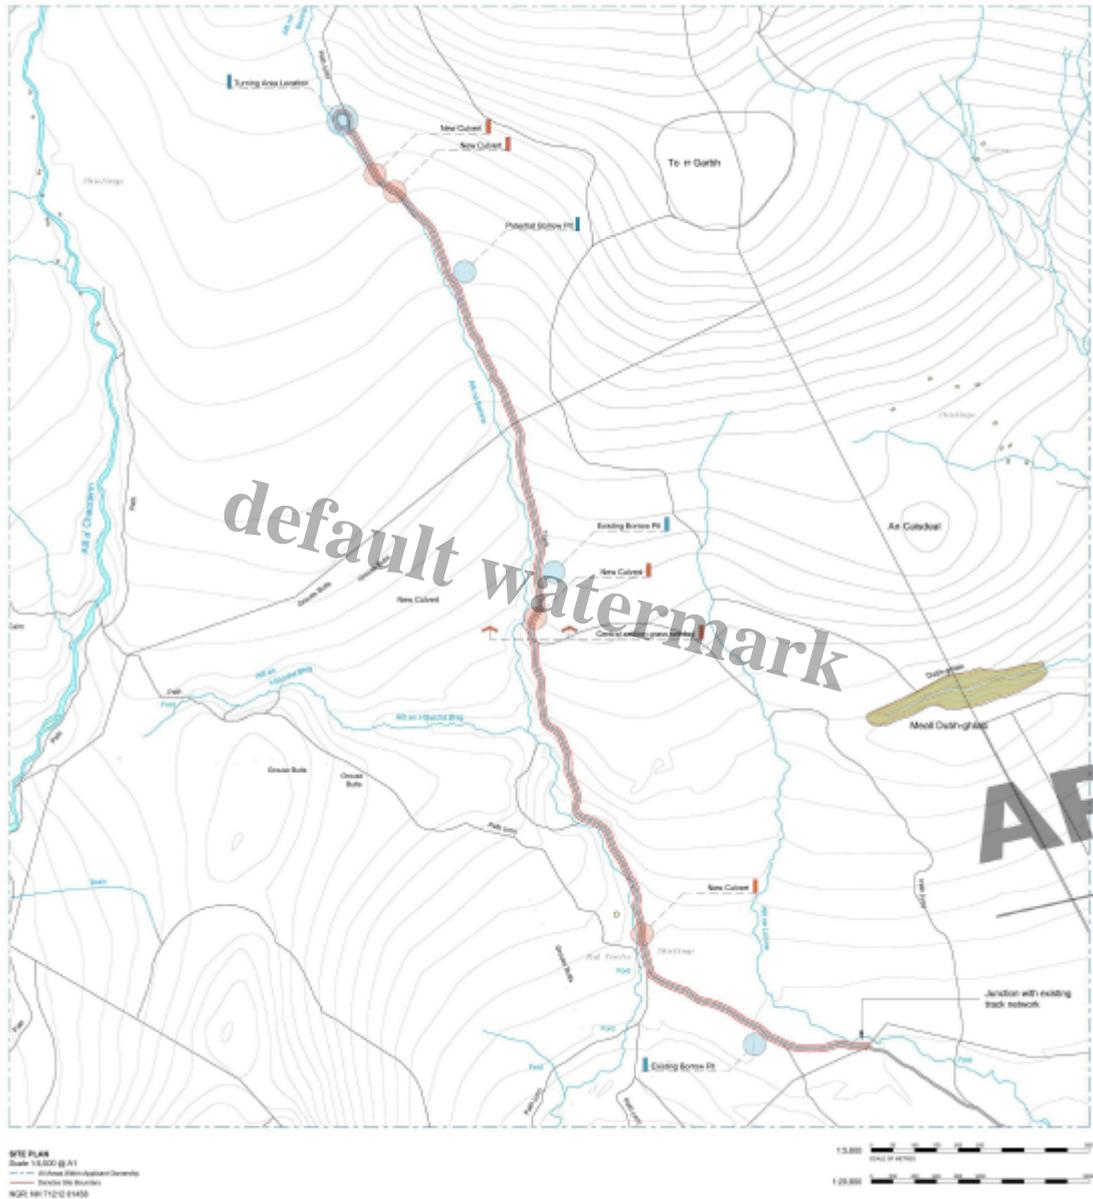
2019/0121/DET CONDITIONS 1 AND 4

Plan of track showing culverts and borrow pits

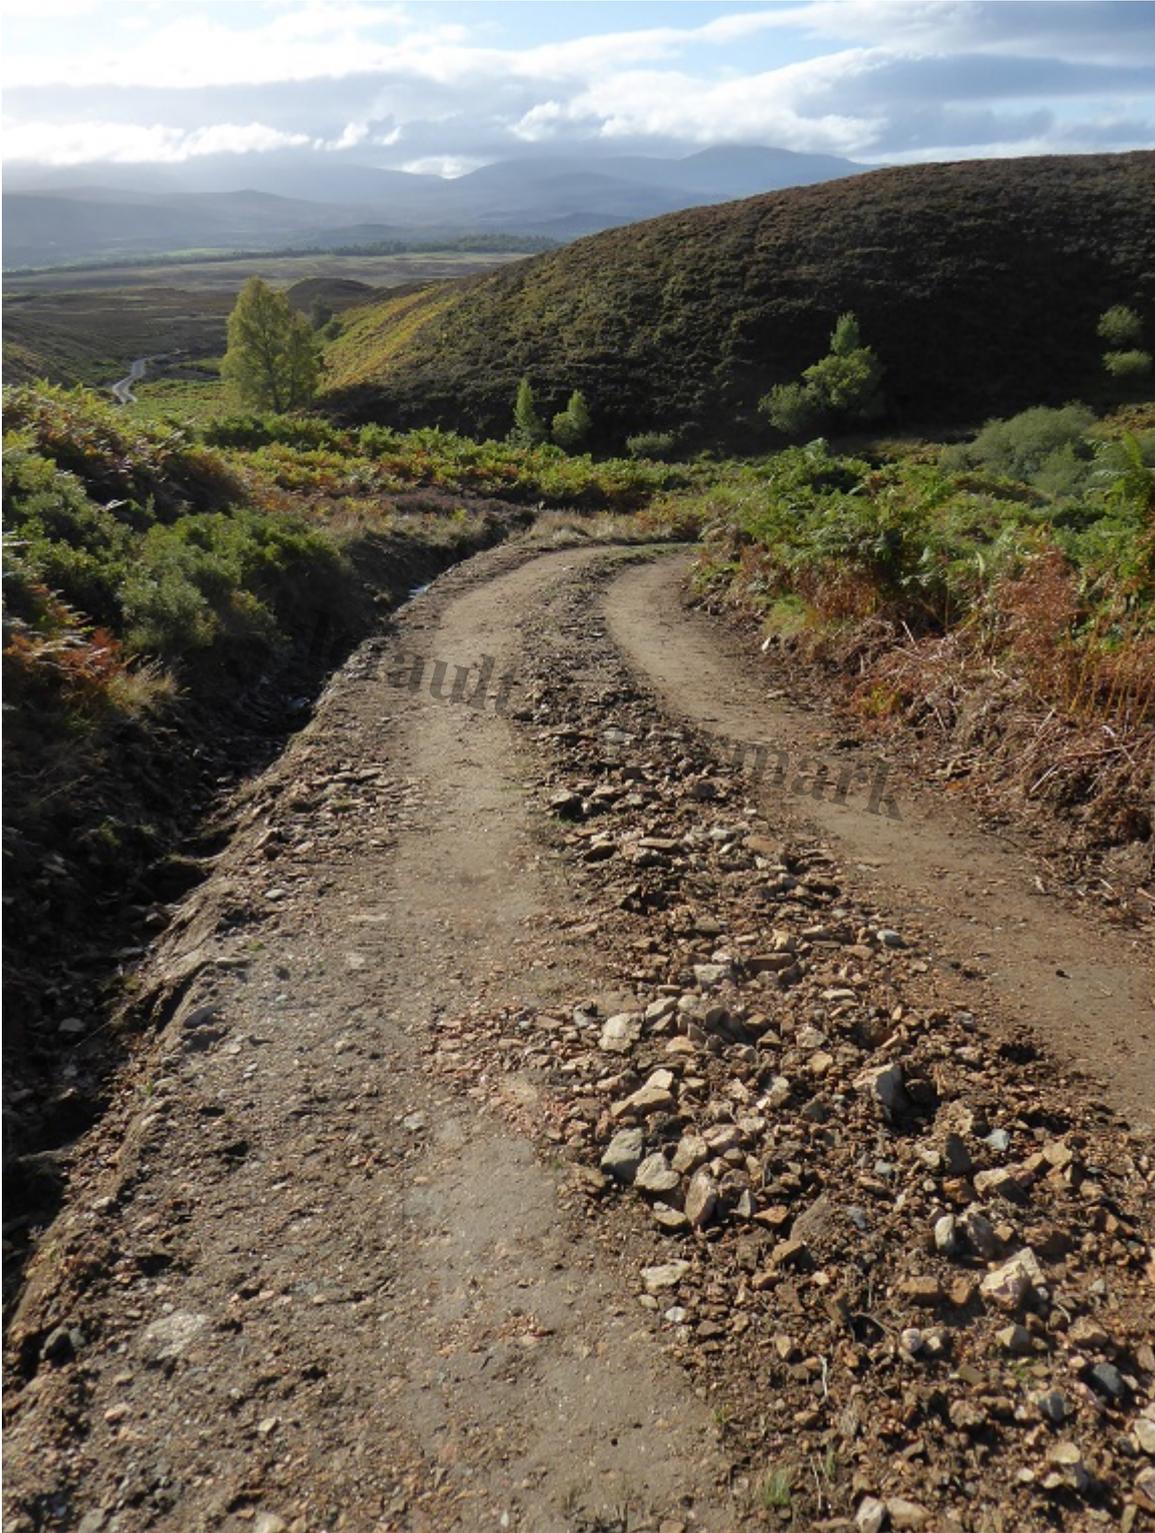
The lowest section of track is quite level and the upgrade work first became obvious where it steepens up by a beautiful wooded area.

It is, however, what happens on the ground that counts. At first sight I was not impressed, with the first steep section of track appearing at risk of serious erosion.

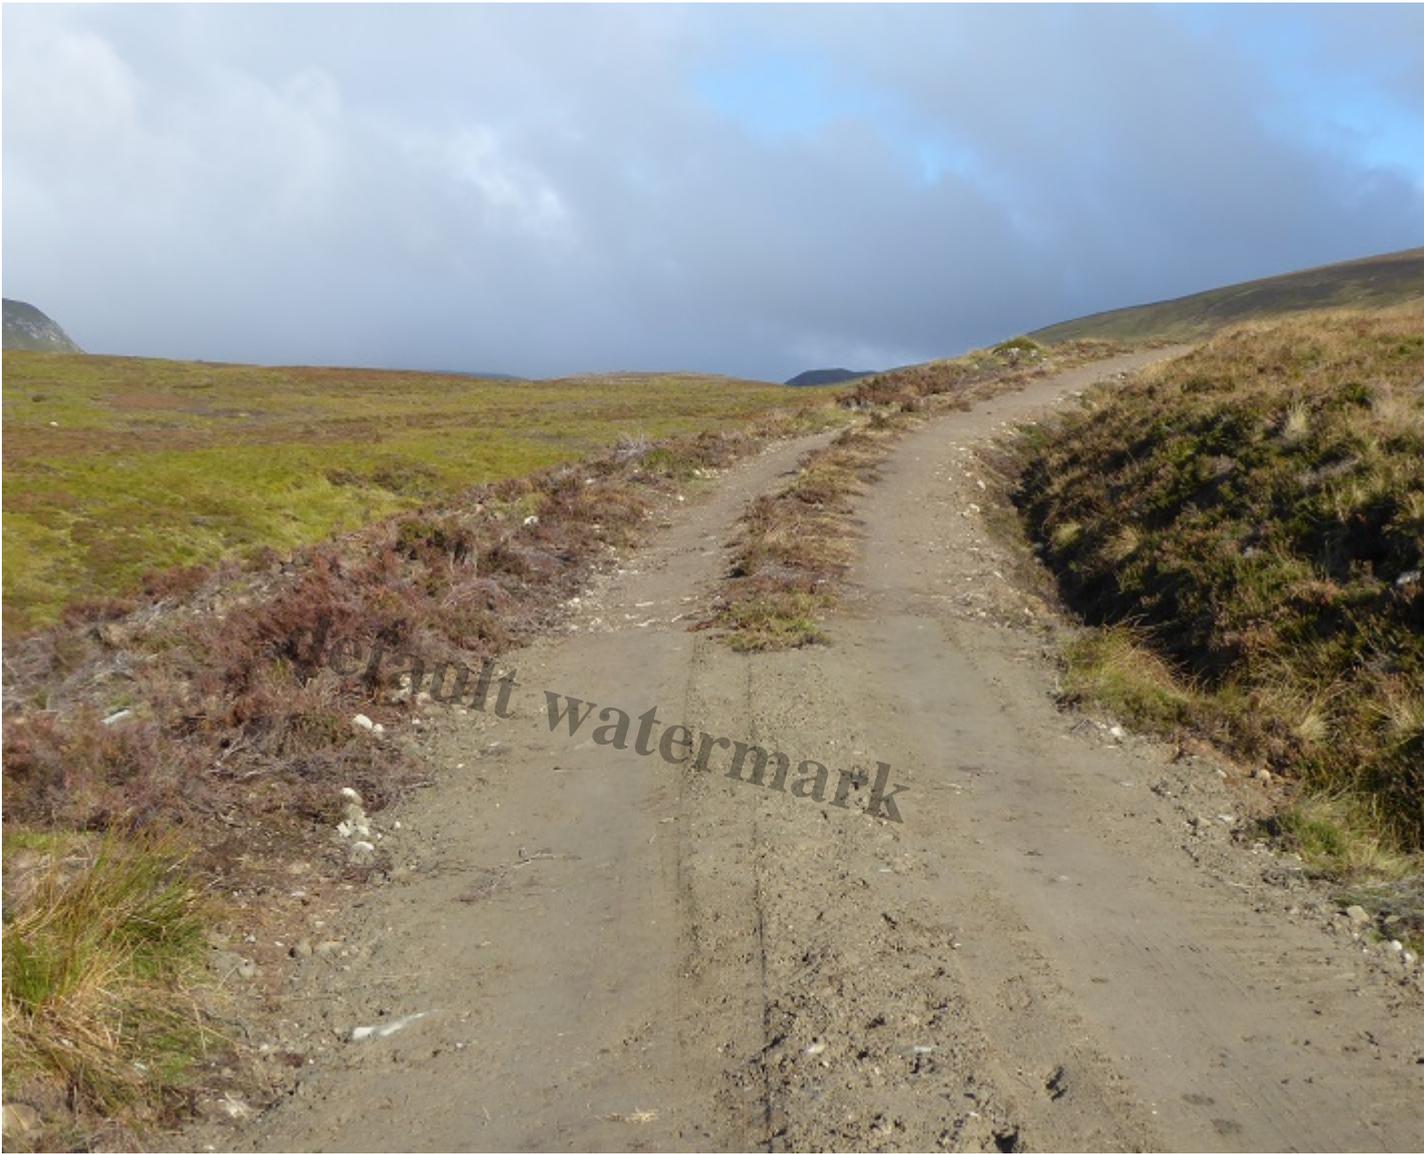
Boundary between finished and unfinished road surface marked by end of central vegetated strip

It was only higher up that it became clear that this was work still in progress. Unfortunately, although the Scottish Planning Portal allows the start and end dates of work on developments granted planning permission to be recorded, neither of our National Parks use this facility. With planning permission lasting three years, this makes it very difficult for any member of the public concerned about a development in a remote area to monitor what is going on. My visit at this stage in the development was pure chance. A lost opportunity for our National Park Authorities, who talk a good game about making more use of volunteers, to empower outdoor recreationists to help monitor developments in our hills.

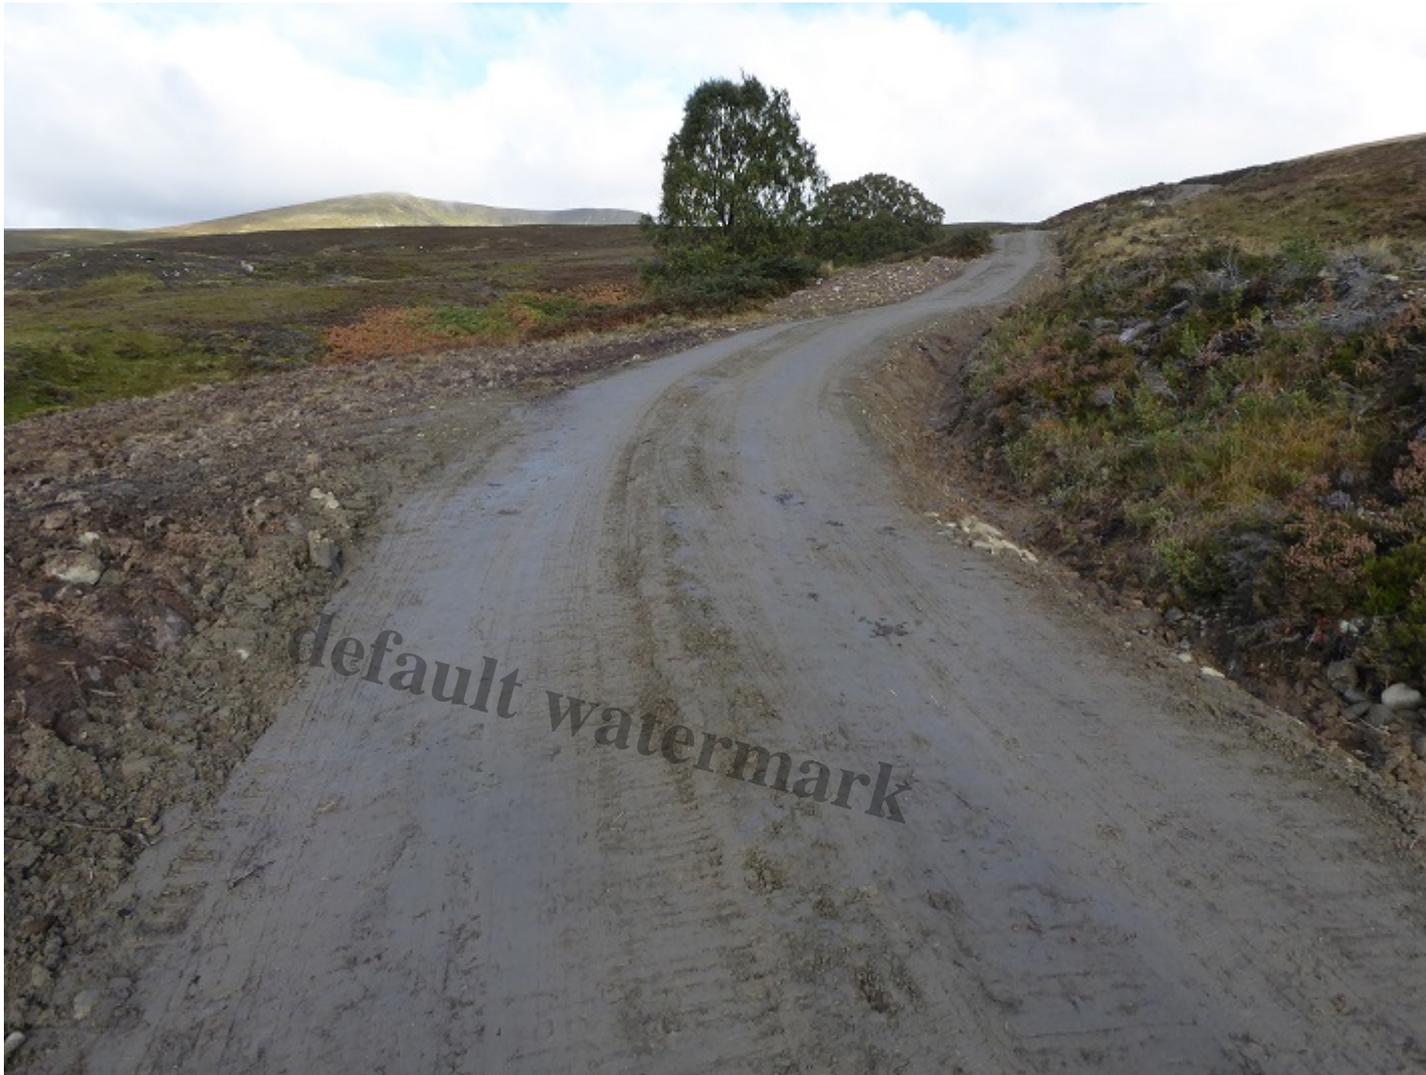
Note how the centre of the road has been raised so that water is shed either side. This prevents the road turning into a watercourse

From where it steepened, a new surface had been added to the road as per the planning application and a new drainage ditch excavated, but neither had been finished.

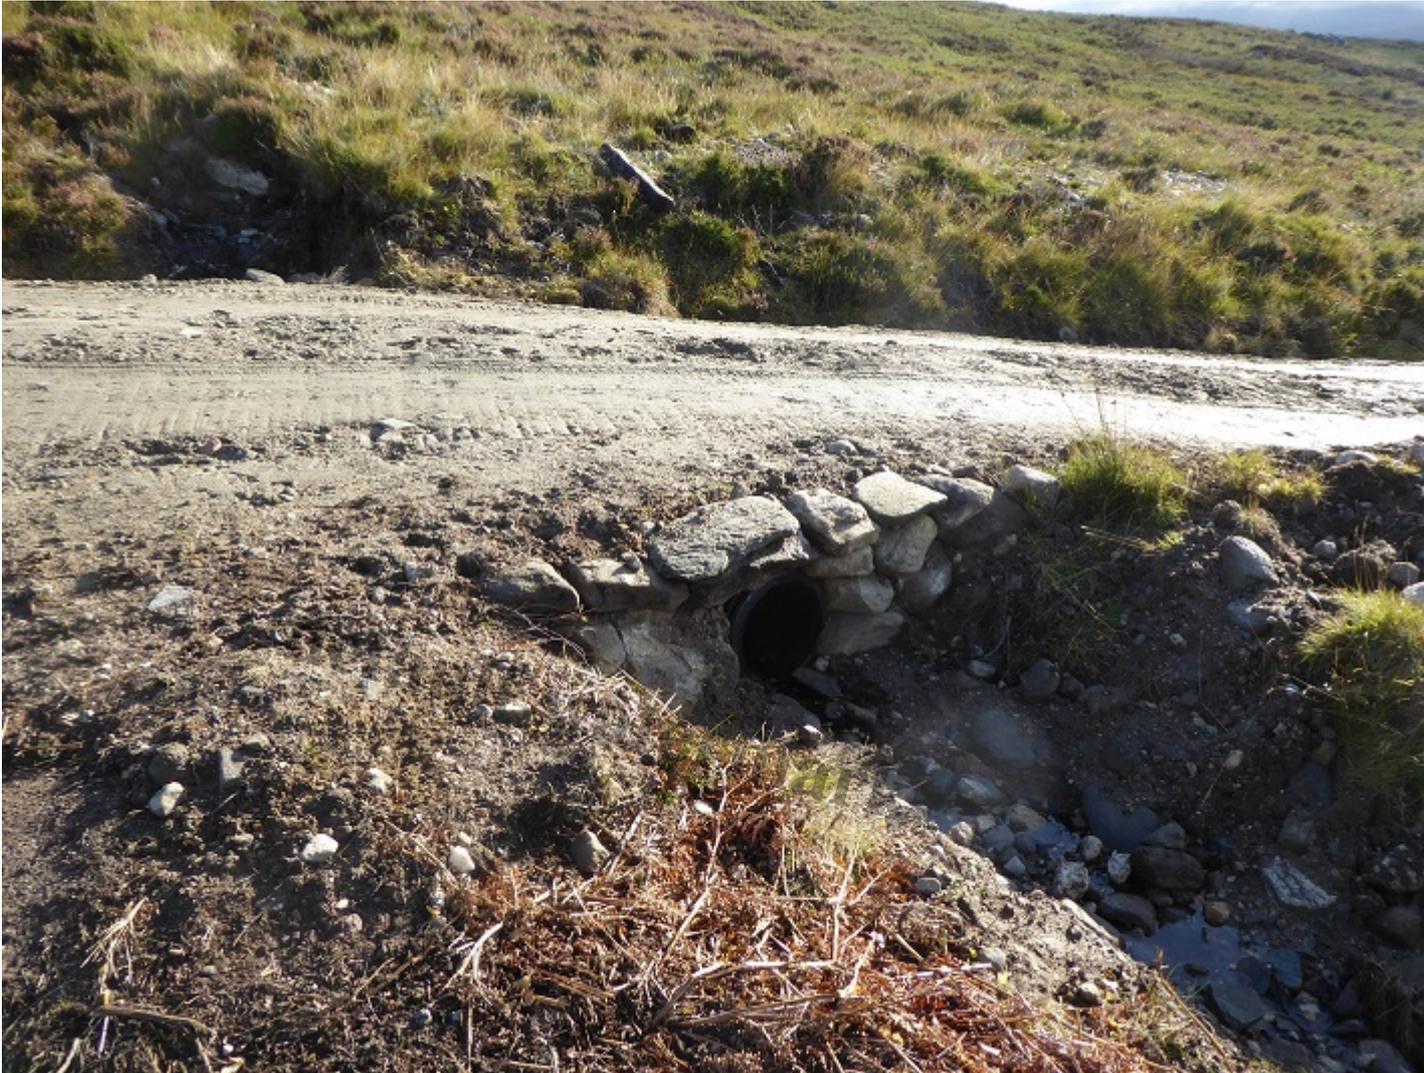
The plastic culverts were not just marked on the plan, they had been concealed and finished, something that happens all too rarely on hill roads.

The basic quality of the work appeared good, .

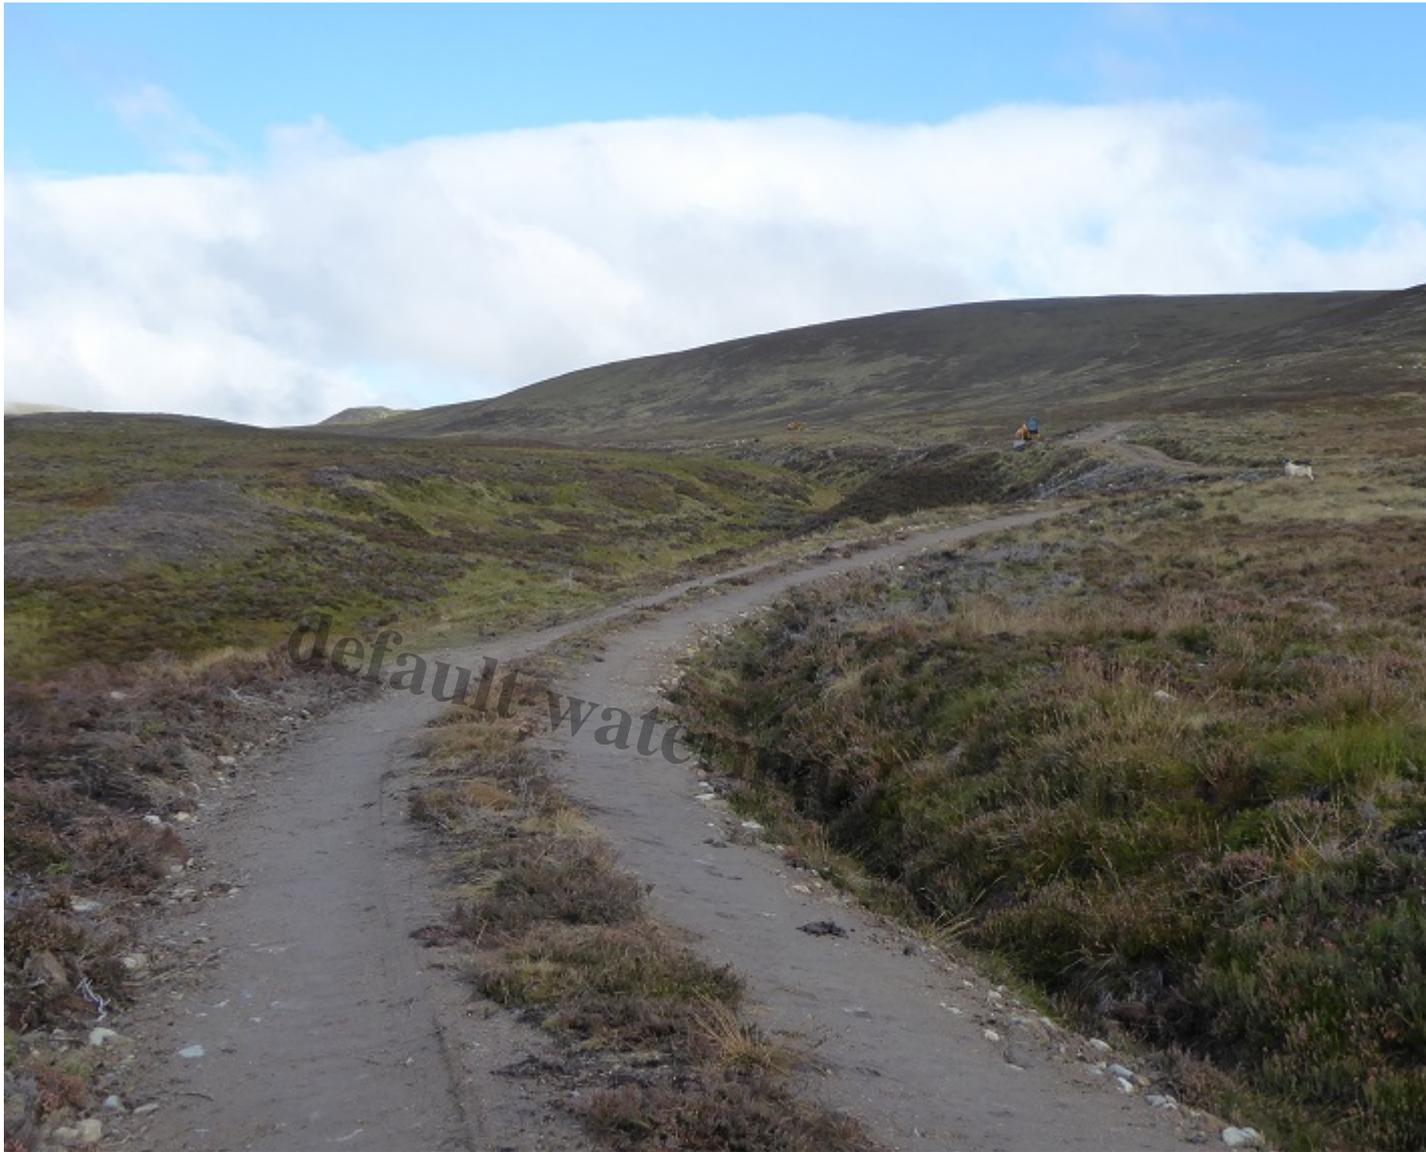
Note not just the vegetated strip but how the banks of the drainage ditch have also been surfaced with vegetation. The vegetation to do this has been “robbed” from either side.

Further up it became clear that the contractors were working from the top down to complete the surface of the track. The specification, which was for a 2.5m road with a 75mm vegetated strip down the middle, has been strictly observed. While arguably the work might have been better done in the Spring, allowing time for the translocated plants to put down roots, if it survives the winter the landscape impact by this time next year should be very little.

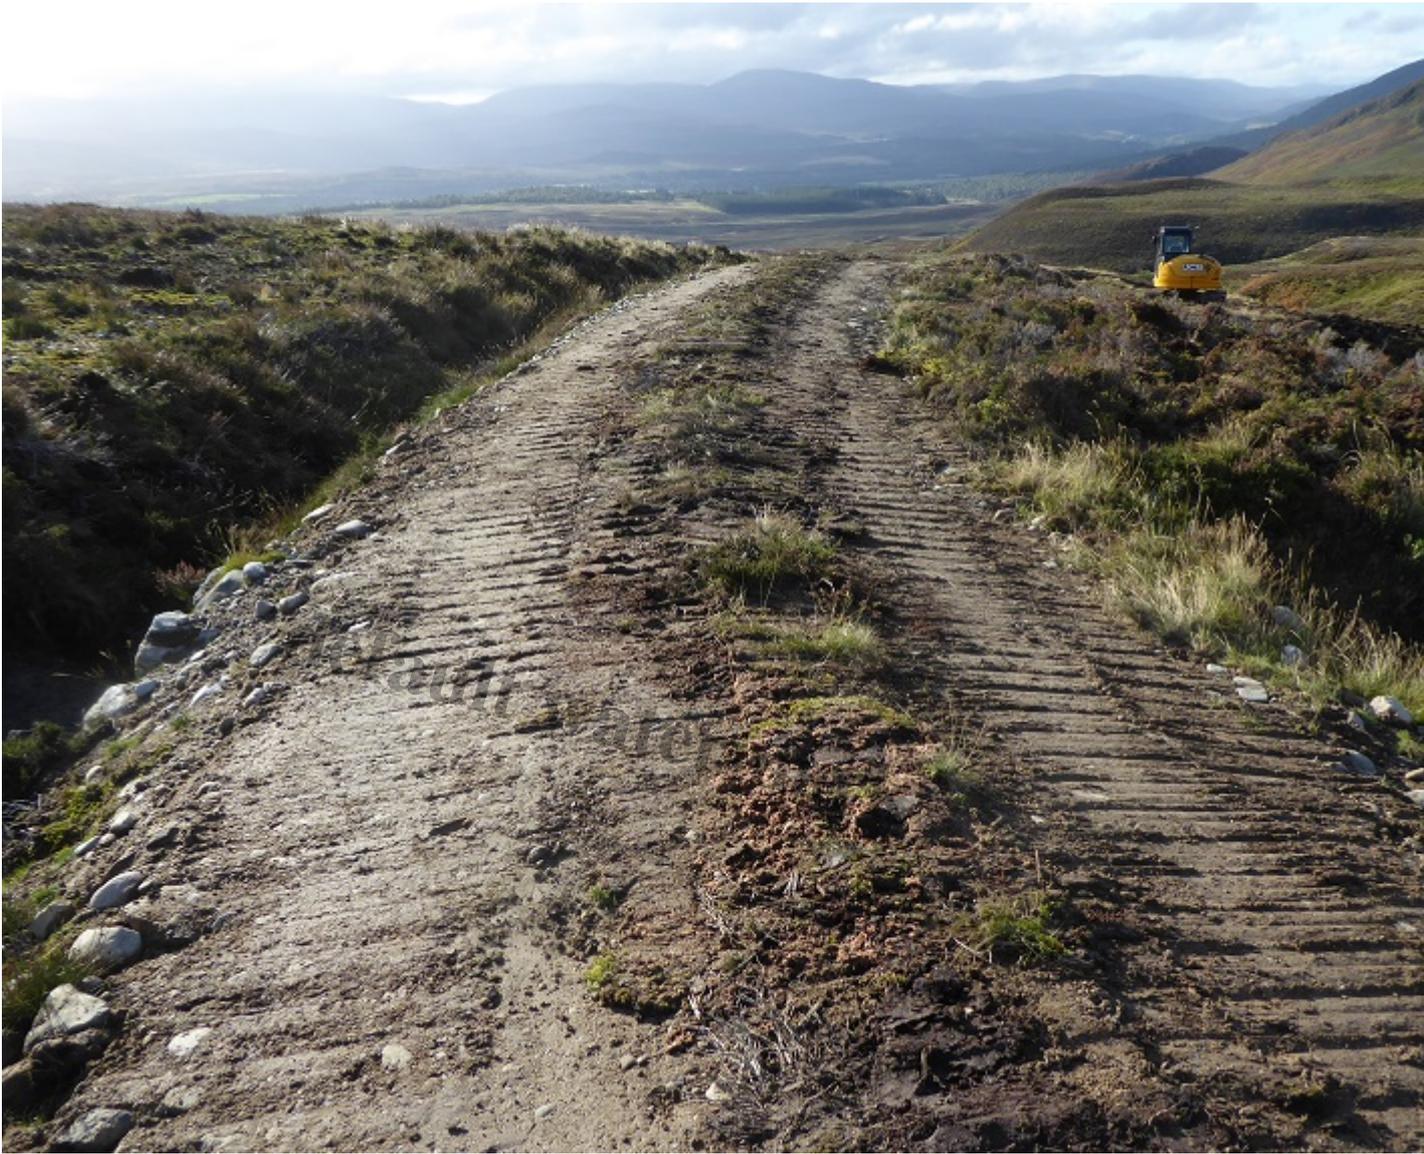
Sphagnum moss, which thrives in bogs, used to cover a short section of the central strip. The erosion on the left of the road appears to have been caused by sheep (see below).

While it is amazing what skilled operators of diggers can do, they do still make mistakes. That is why all work on hill tracks needs to be actively monitored and the workforce advised to change their practice where necessary.

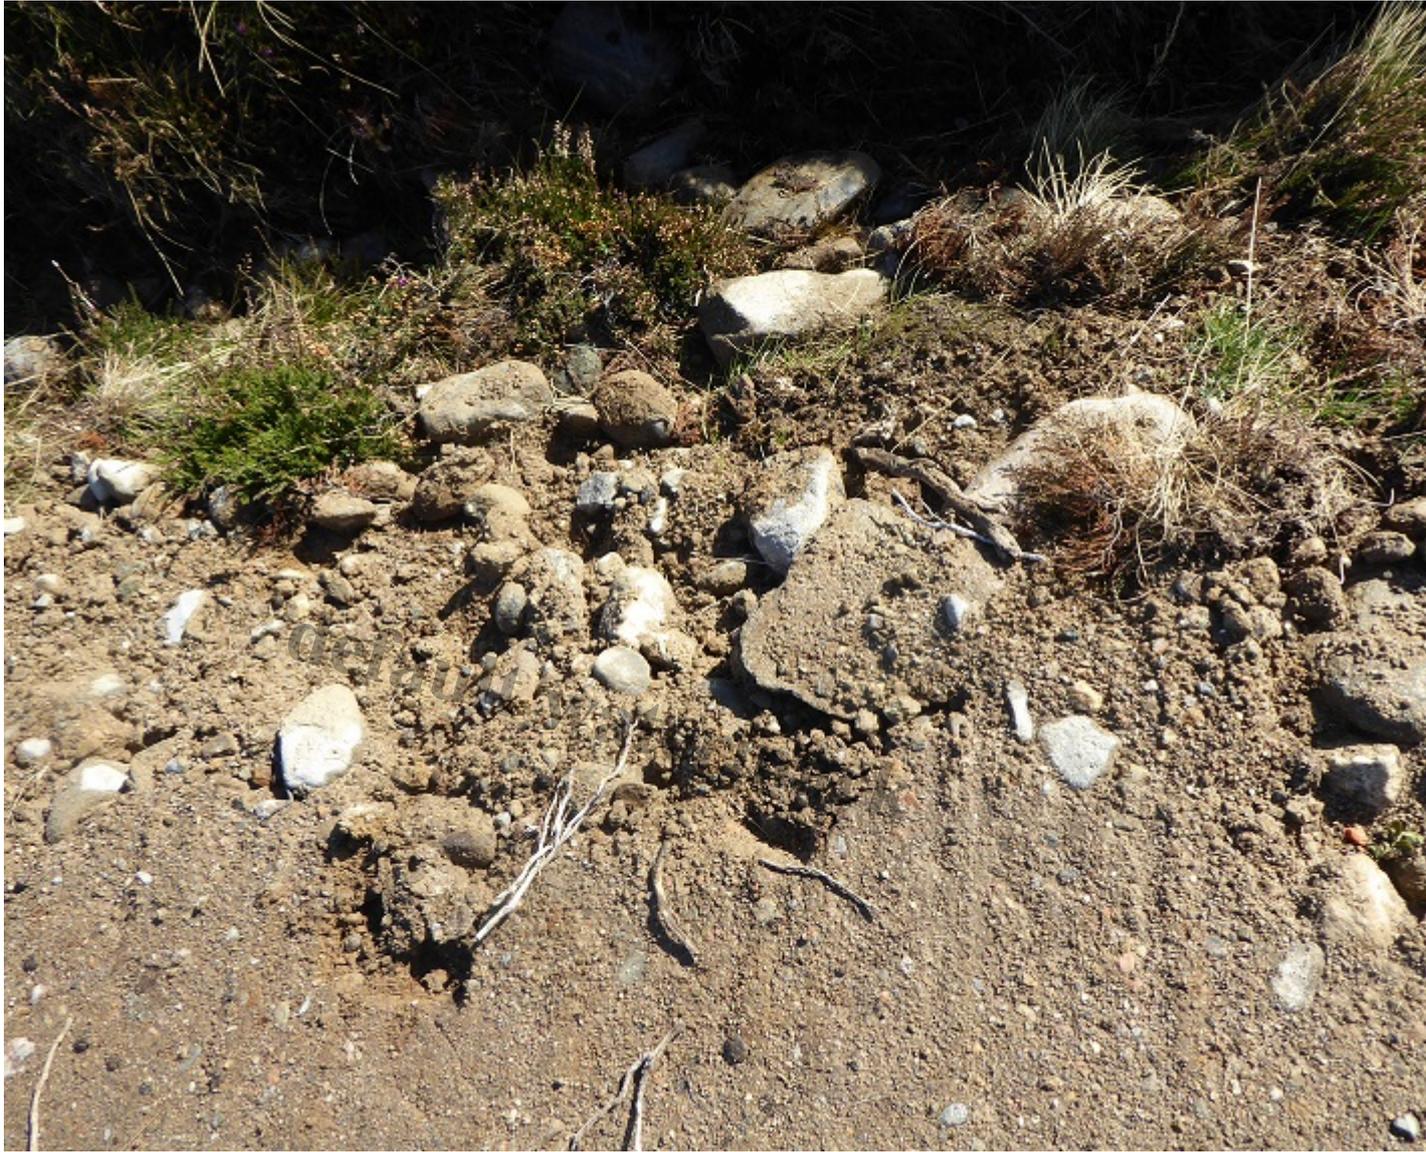
Sheep prints were visible along much of the vegetated edges of the road

A much bigger issue is that grazing animals, primarily sheep, have trampled over much of the vegetated sides of the road helping to break it up and destroy the vegetation before it has taken root. This damage, which is in no-one's interests, could be prevented if planning consents for hill roads included a standard condition requiring farm animals to be removed until vegetation has recovered.

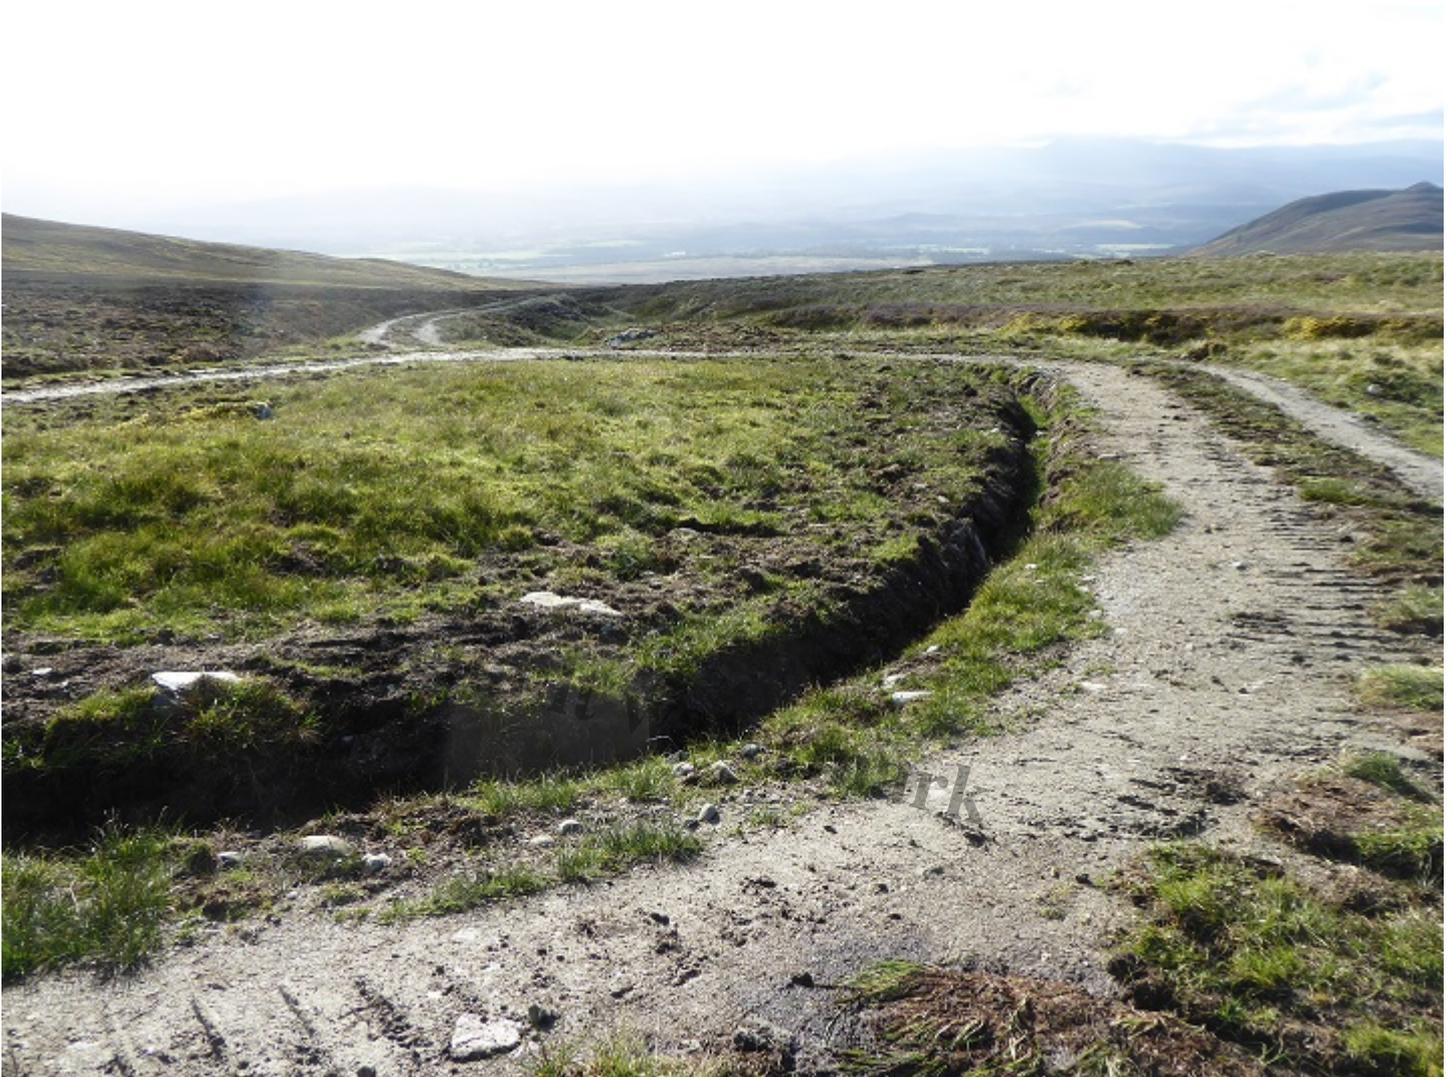
The second is the turning circle at the top of the road. There is no need for it. It significantly increases the landscape impact of the road but has also required the destruction of peat to create the new drainage ditch. This should never have been agreed, particularly when the owner of Glen Banchor is being paid public money to restore damaged peatbog elsewhere on the estate ([see here](#)).

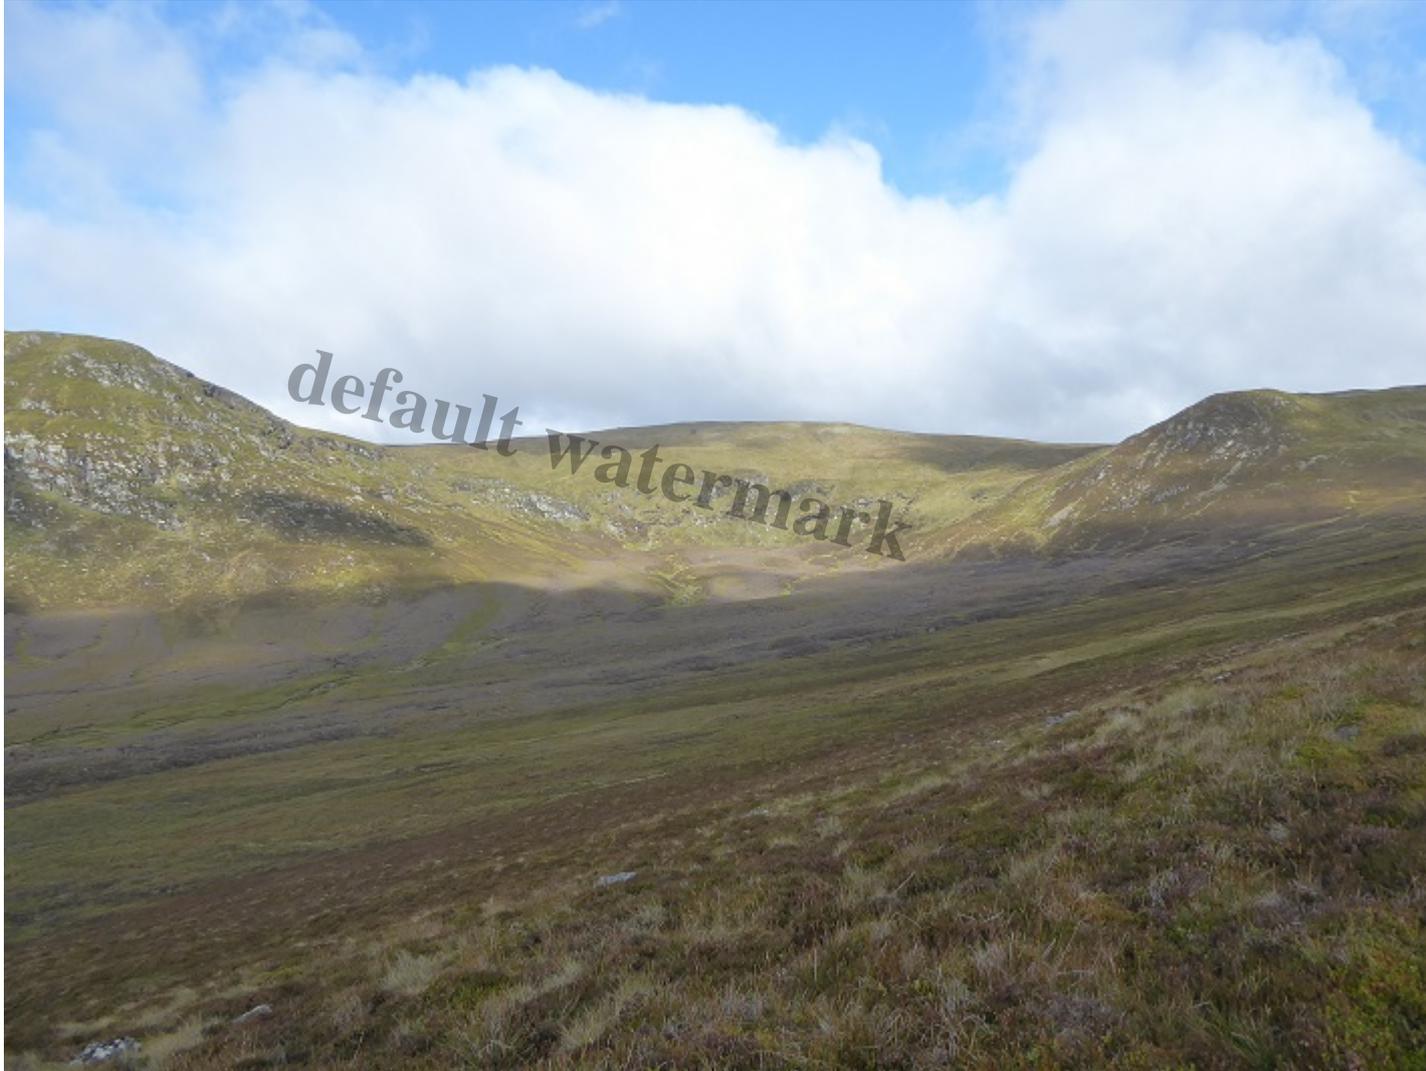
Carn Sgulain centre, Aâ??Chailleach left. The large faint patch in the centre of the photo results from heather dying off, possibly due to old age.
