Will the repair of the Cairngorm Funicular Railway work (1)?

The COWI Cairngorm funicular viaduct appraisal report

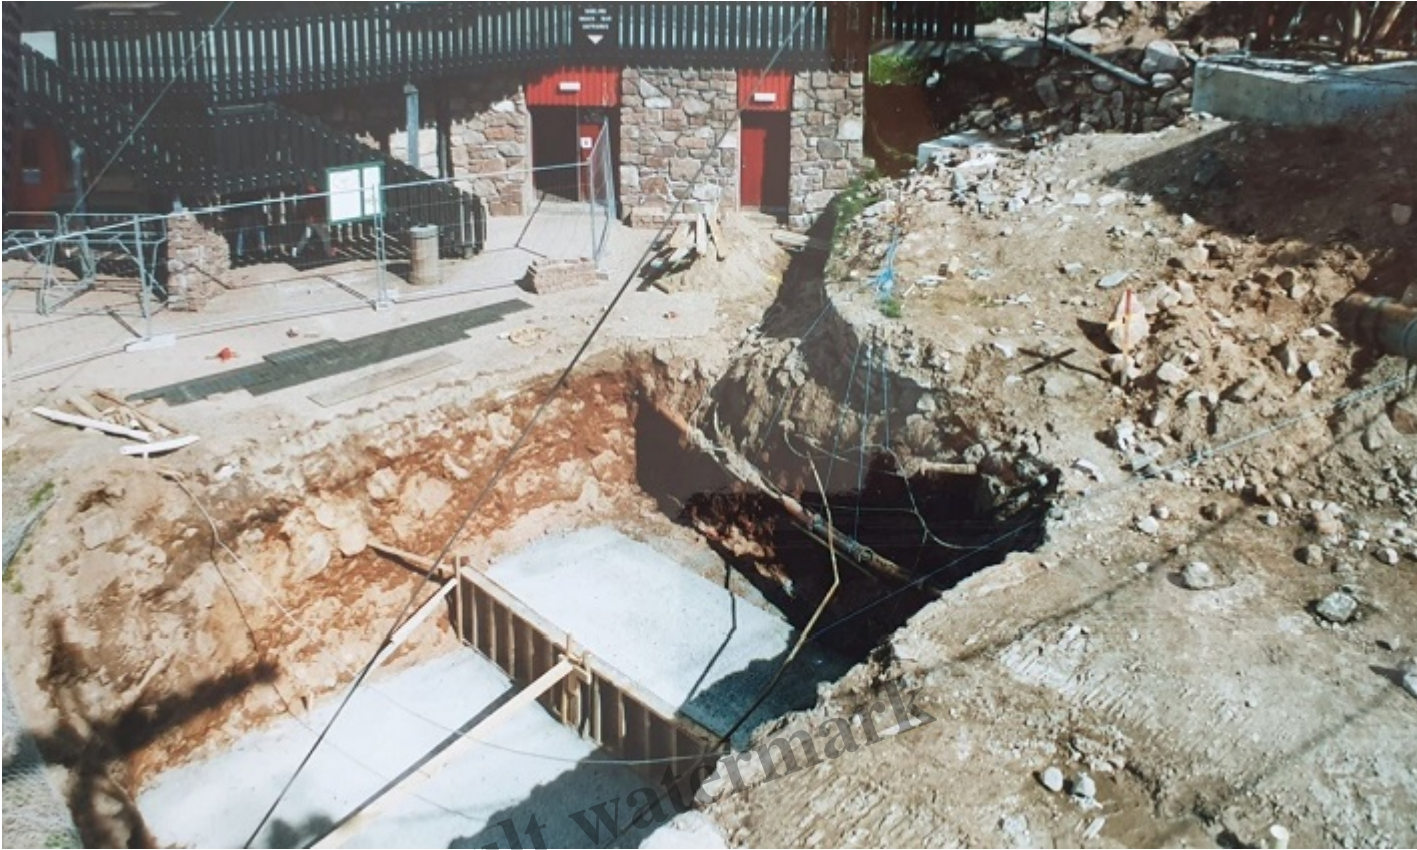
Q1. I am not a civil engineer, so had assumed that foundations would in some way be anchored to the bedrock. But COWI shows that is not the case, except possibly for a few pier bases and anchor blocks, as the bedrock is too deep, up to 5m under the ground. The next picture shows the foundations of a pier near the Shieling during the construction:

As you can see, the foundations are poured onto the mountain sand, gravel, boulder base material with two rafts being formed. The first larger raft is only about 200mm deep and is allowed to harden providing a base for the second pour which forms the base that the piers are connected to. This is known as a cold joint and is referred to in the report.
