Will the repair of the Cairngorm Funicular Railway work (2)?

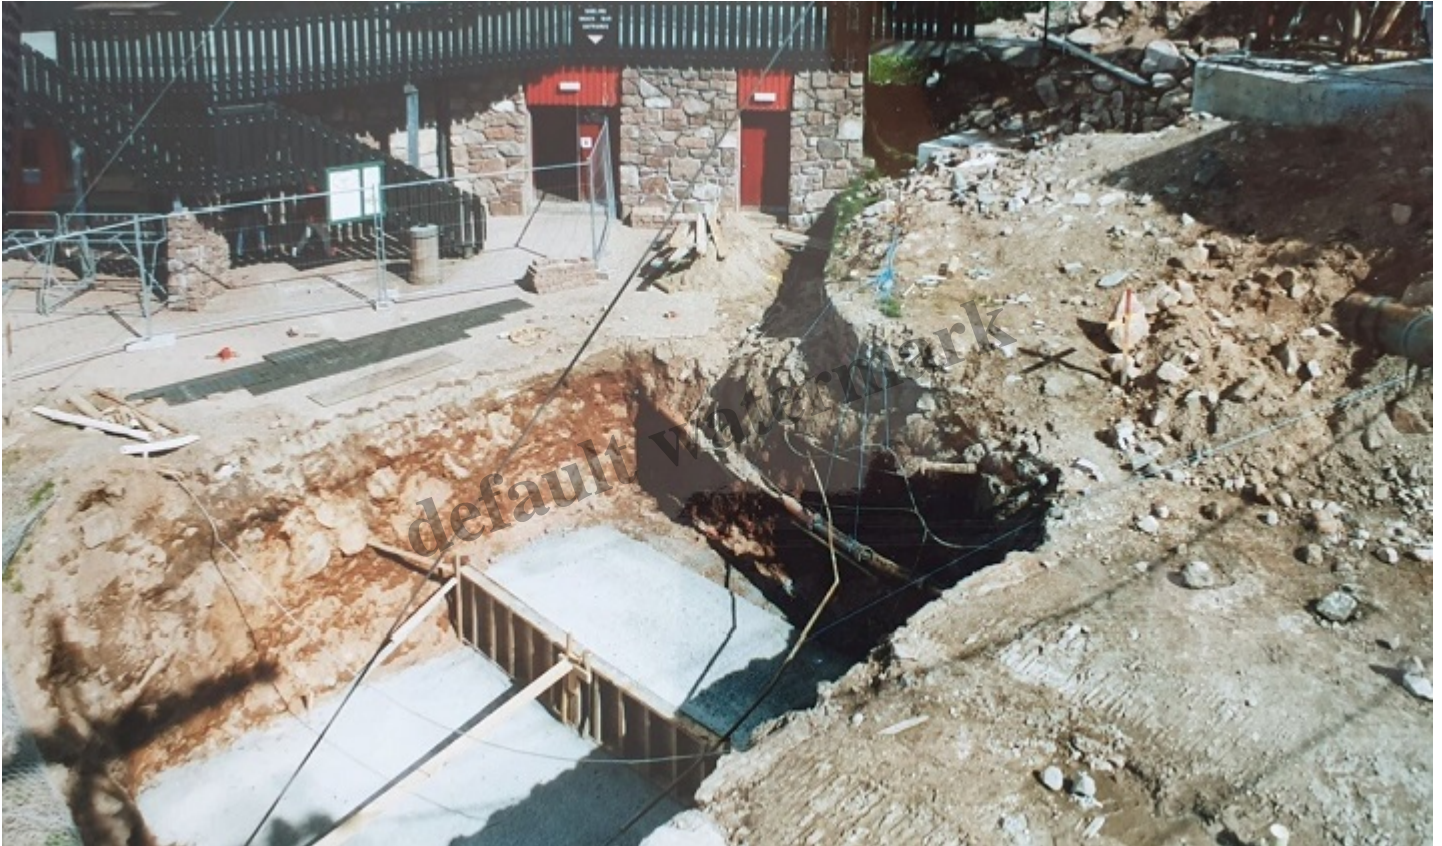
It is now believed to be that of Anchor Block(AB) 48. Notice there are no steel reinforcing rods cast into the foundations on which the Anchor Block would have been constructed. In the COWI report ([see here](#)) it is assumed that the Anchor Blocks are held in place by rock bolts or studs. An example is shown in the next picture:-

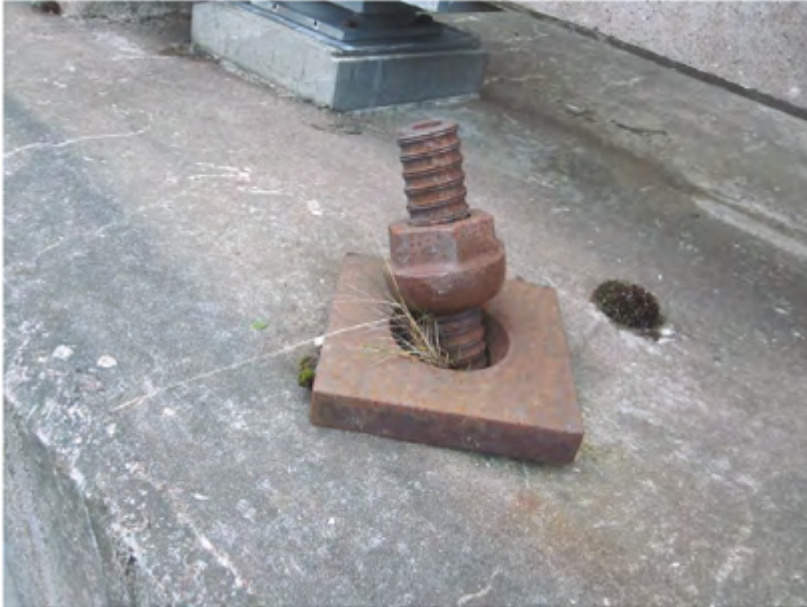
Figure 2-10 Loosened rock bolt in anchor block (refer defect 7)

“Some rock bolts at anchor blocks can be loosened by hand. [New observation by COWI/ADAC, Aug 2018] (Page 11, para 2.2.7). The next picture, courtesy of the COWI report (page 13) is of one of those anchor bolts.

It is not known which of the Anchor Blocks this is, or how many of its securing bolts were loose, but these bolts are there for a reason. These Anchor Blocks take the weight/ strain of the approx. 2 x 300m of uphill concrete beams, which are continually trying to slide downhill under the force of gravity. They should be checked on a regular basis and the nuts torqued to a specific setting. Depending on how many of the bolts on any one Anchor Block were loose, the one below it could have been carrying the full weight of 600m of track! You can see from the corrosion on the rock bolt that the nut has been loose for some time.

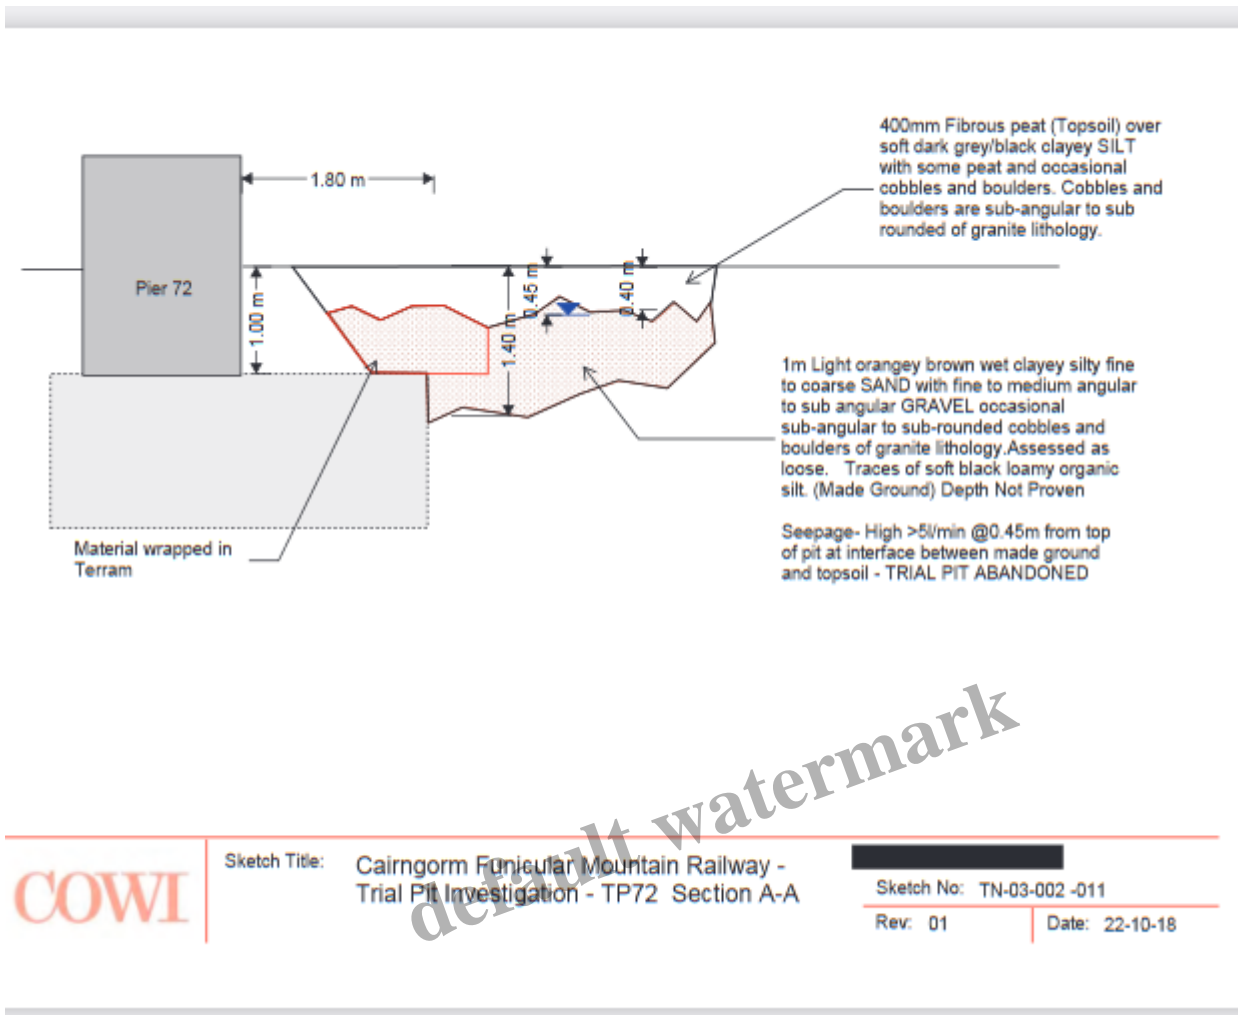
Sketch courtesy of the COWI report Page 201.

Looking at the sketch it shows that the pier is offset on its base. It is not the only one. I would assume that for maximum effect the weight of a pier should be dead centre on its base. Unless the weight is evenly distributed there could be an overturning motion on the base end with the heaviest weight on it which could help explain why they now need propping up.

The COWI report also states that test pit 72 was abandoned due to high water seepage, presumably from the spring above the pier. It is also not the only pier with a natural spring above it, pier 41 is the same.

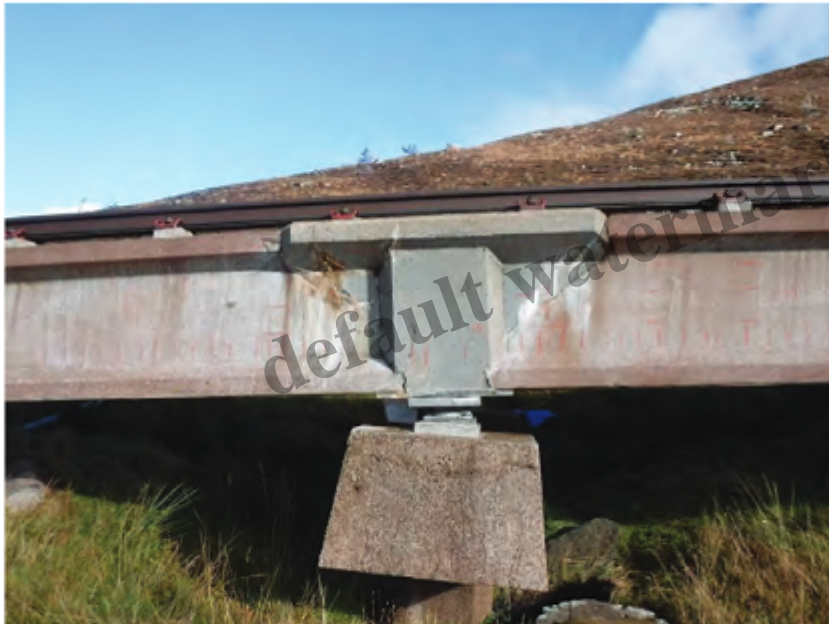
Plate 5 – General view of surface markings to Pier 9 Right Beam up/down.

The next four pictures, again from the COWI report, three from pages 277/8 and the fourth from page 11, show the in situ joint of pier 9 in what appears to be very poor condition with numerous cracks and damage. The first three are from the outside of the structure, the fourth from the inside!
