Will the repair of the Cairngorm Funicular Railway work (2)?

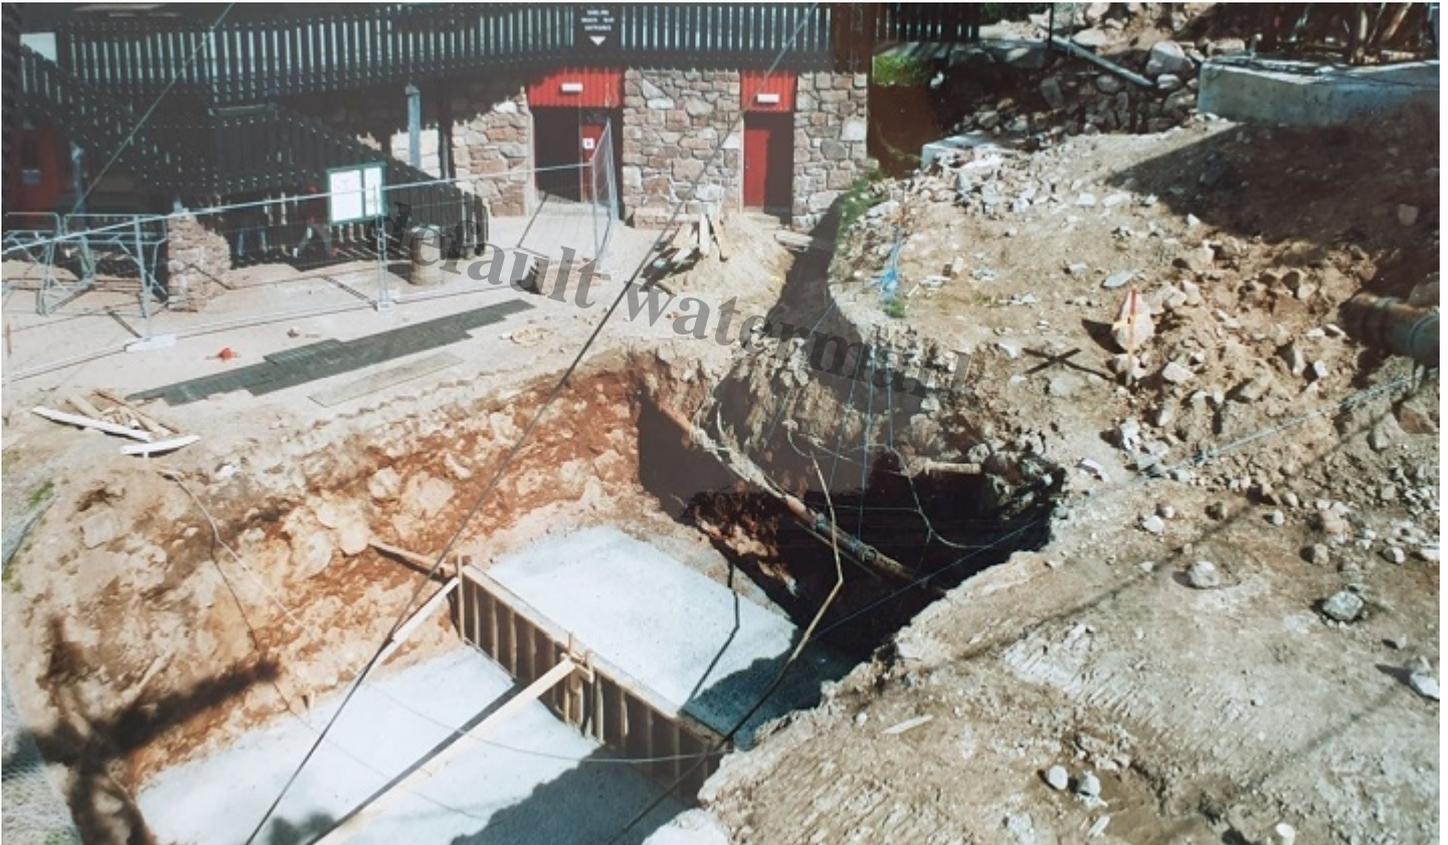
It is now believed to be that of Anchor Block(AB) 48. Notice there are no steel reinforcing rods cast into the foundations on which the Anchor Block would have been constructed. In the COWI report ([see here](#)) it is assumed that the Anchor Blocks are held in place by rock bolts or studs. An example is shown in the next picture:-

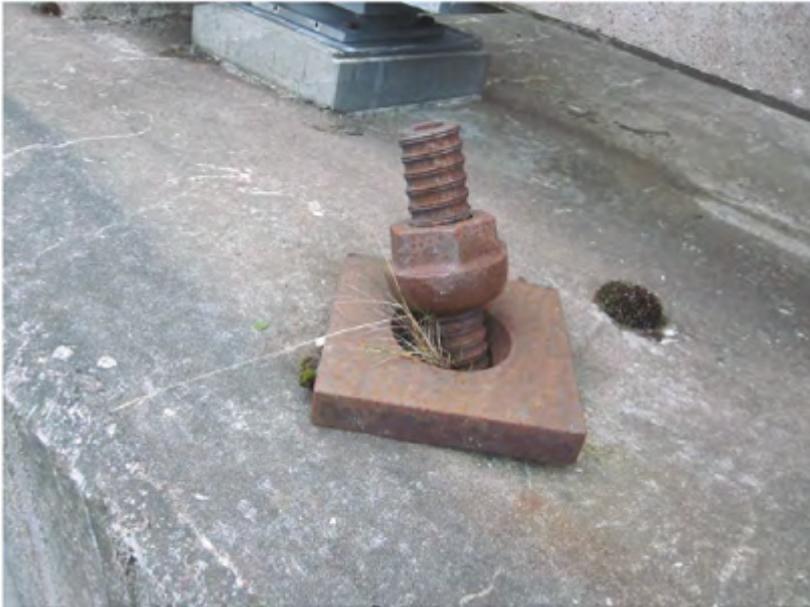
Figure 2-10 Loosened rock bolt in anchor block (refer defect 7)

Some rock bolts at anchor blocks can be loosened by hand. [New observation by COWI/ADAC, Aug 2018] (Page 11, para 2.2.7). The next picture, courtesy of the COWI report (page 13) is of one of those anchor bolts.

It is not known which of the Anchor Blocks this is, or how many of its securing bolts were loose, but these bolts are there for a reason. These Anchor Blocks take the weight/ strain of the approx. 2 x 300m of uphill concrete beams, which are continually trying to slide downhill under the force of gravity. They should be checked on a regular basis and the nuts torqued to a specific setting. Depending on how many of the bolts on any one Anchor Block were loose, the one below it could have been carrying the full weight of 600m of track! You can see from the corrosion on the rock bolt that the nut has been loose for some time.

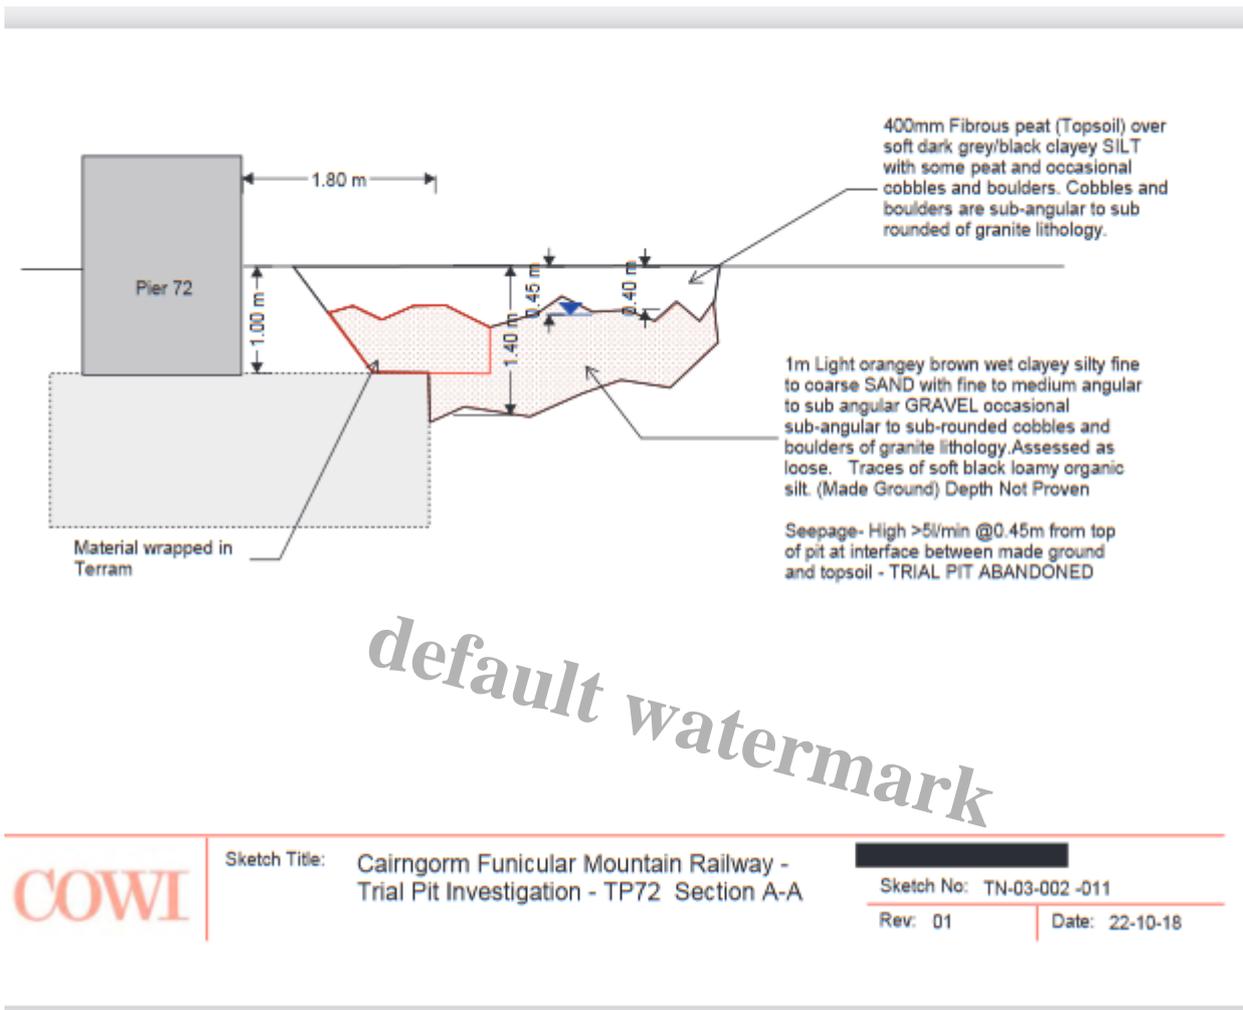
Looking at the sketch it shows that the pier is offset on its base. It is not the only one. I would assume that for maximum effect the weight of a pier should be dead centre on its base. Unless the weight is evenly distributed there could be an overturning motion on the base end with the heaviest weight on it which could help explain why they now need propping up.

The COWI report also states that test pit 72 was abandoned due to high water seepage, presumably from the spring above the pier. It is also not the only pier with a natural spring above it, pier 41 is the same.

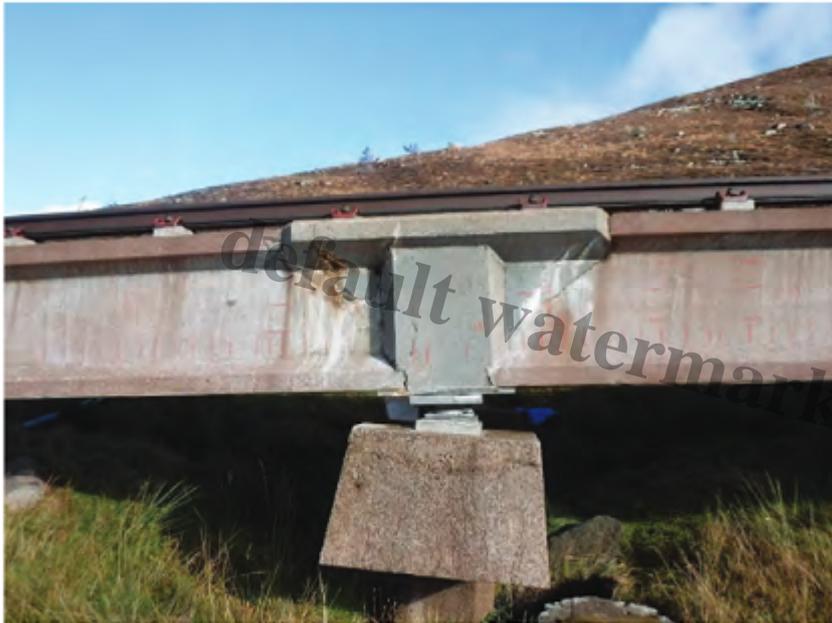
Plate 5 – General view of surface markings to Pier 9 Right Beam up/down.

The next four pictures, again from the COWI report, three from pages 277/8 and the fourth from page 11, show the in situ joint of pier 9 in what appears to be very poor condition with numerous cracks and damage. The first three are from the outside of the structure, the fourth from the inside!

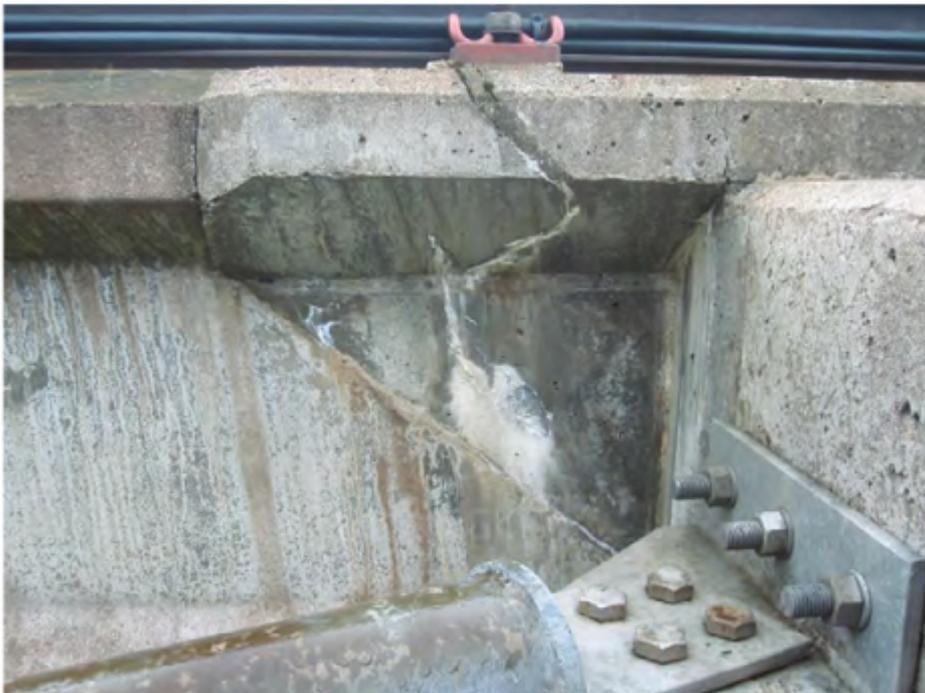
Figure 2-6 Cracking at a pier 9 (refer defect 1)

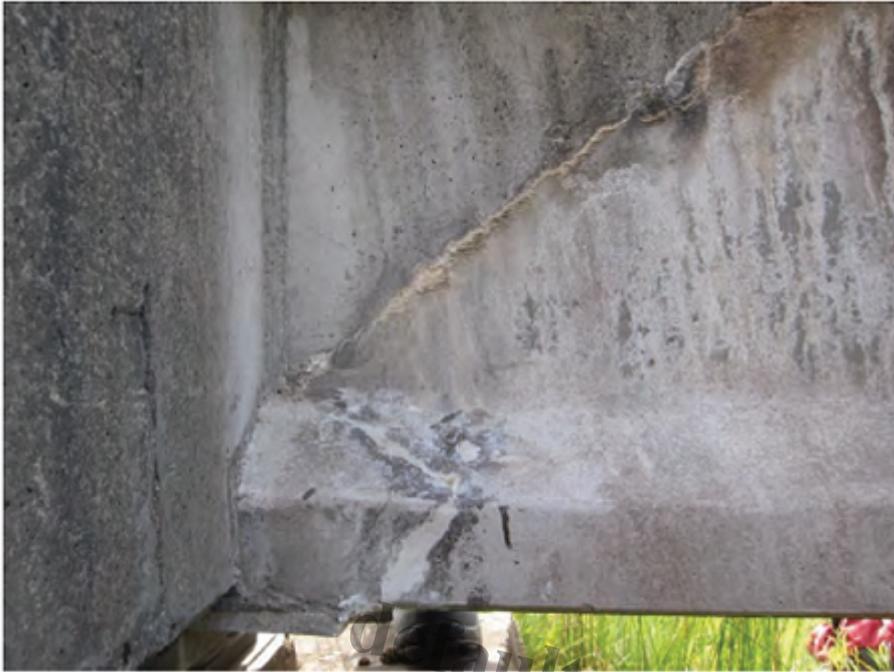
Figure 2-7 Crack repair at pier 9 (refer defect 1)
