Will the repair of the Cairngorm Funicular Railway work (2)?

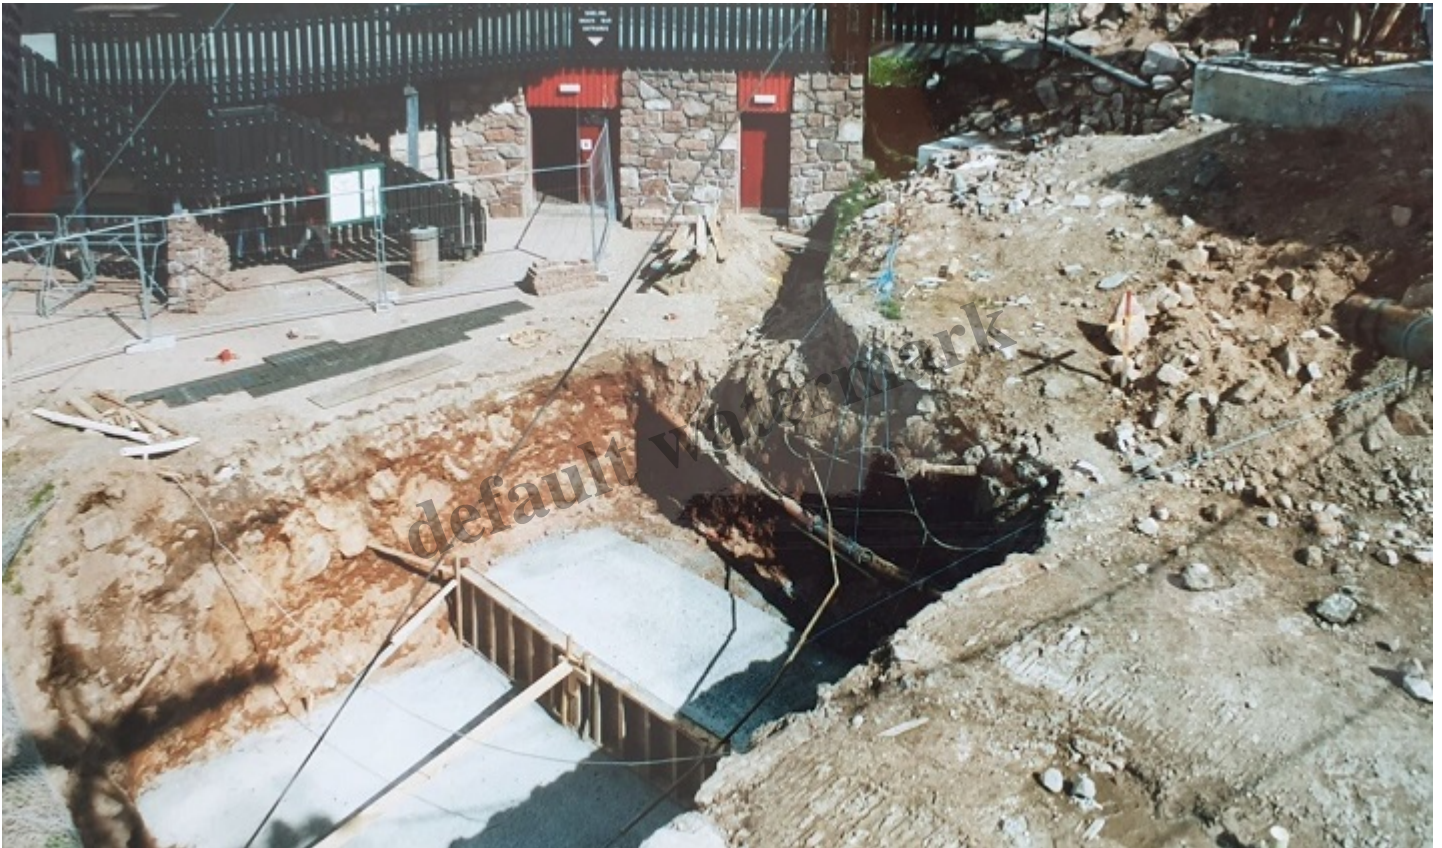
It is now believed to be that of Anchor Block(AB) 48. Notice there are no steel reinforcing rods cast into the foundations on which the Anchor Block would have been constructed. In the COWI report ([see here](#)) it is assumed that the Anchor Blocks are held in place by rock bolts or studs. An example is shown in the next picture:-

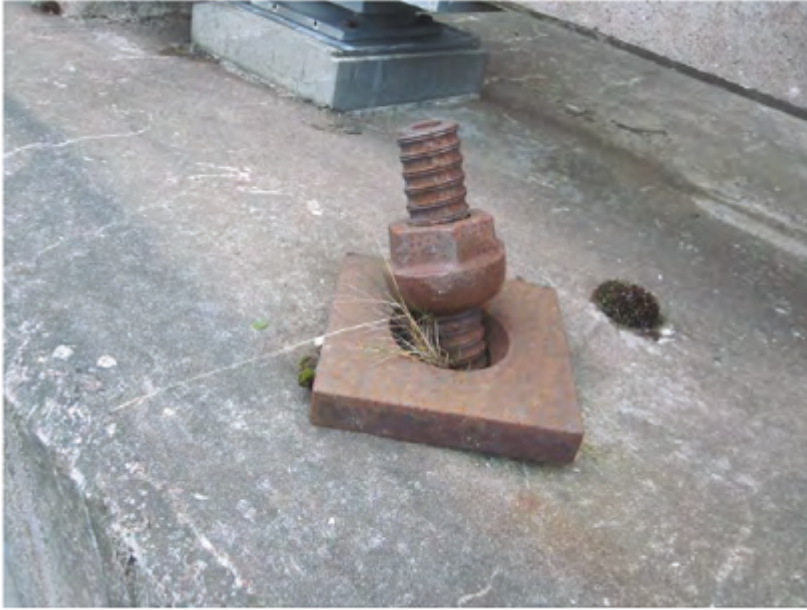
Figure 2-10 Loosened rock bolt in anchor block (refer defect 7)

"Some rock bolts at anchor blocks can be loosened by hand. [New observation by COWI/ADAC, Aug 2018] (Page 11, para 2.2.7). The next picture, courtesy of the COWI report (page 13) is of one of those anchor bolts.

It is not known which of the Anchor Blocks this is, or how many of its securing bolts were loose, but these bolts are there for a reason. These Anchor Blocks take the weight/ strain of the approx. 2 x 300m of uphill concrete beams, which are continually trying to slide downhill under the force of gravity. They should be checked on a regular basis and the nuts torqued to a specific setting. Depending on how many of the bolts on any one Anchor Block were loose, the one below it could have been carrying the full weight of 600m of track! You can see from the corrosion on the rock bolt that the nut has been loose for some time.

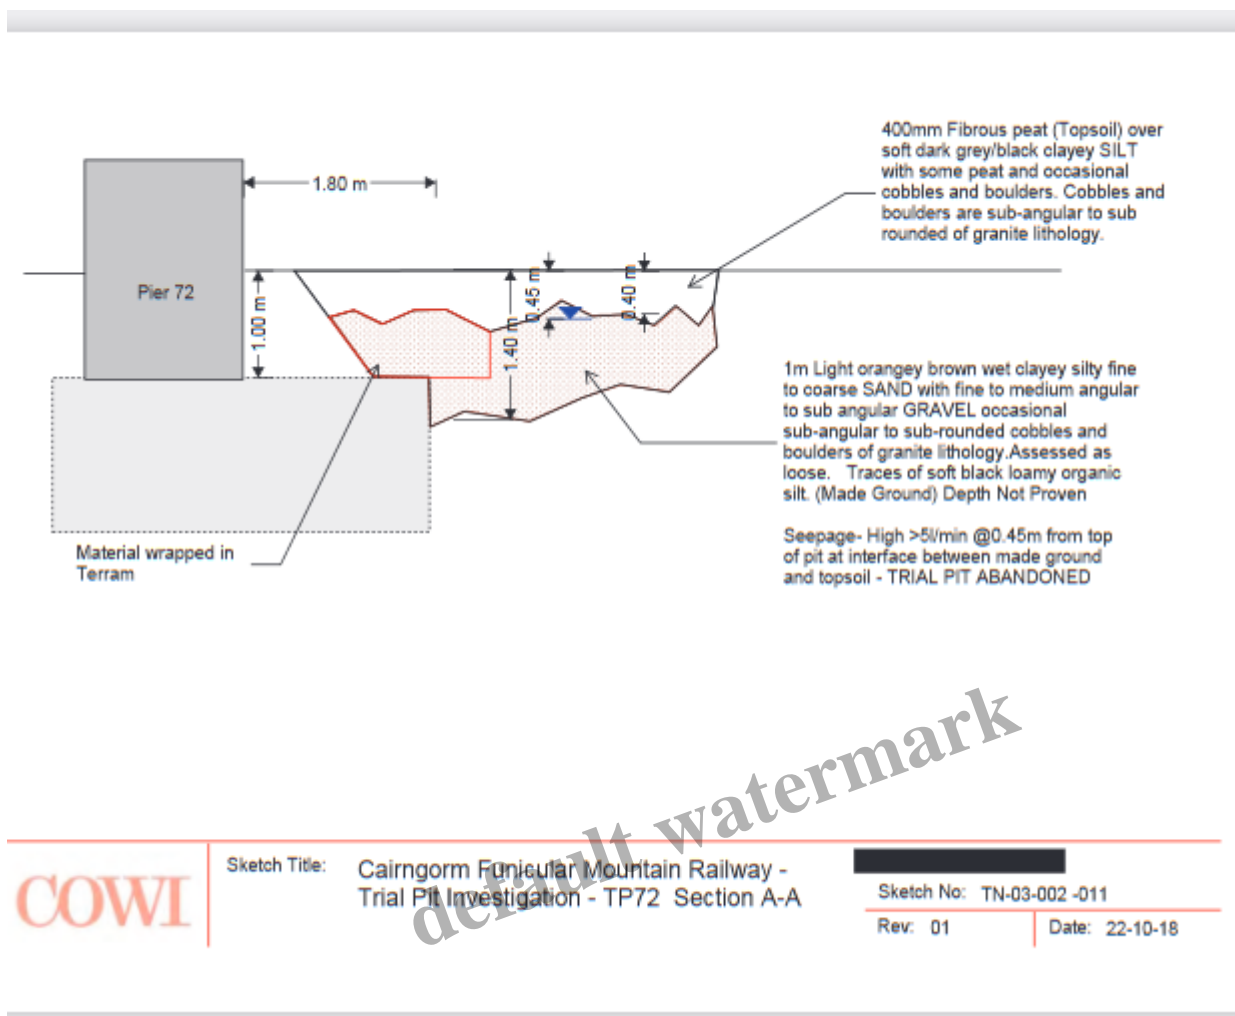
Sketch courtesy of the COWI report Page 201.

Looking at the sketch it shows that the pier is offset on its base. It is not the only one. I would assume that for maximum effect the weight of a pier should be dead centre on its base. Unless the weight is evenly distributed there could be an overturning motion on the base end with the heaviest weight on it which could help explain why they now need propping up.

The COWI report also states that test pit 72 was abandoned due to high water seepage, presumably from the spring above the pier. It is also not the only pier with a natural spring above it, pier 41 is the same.

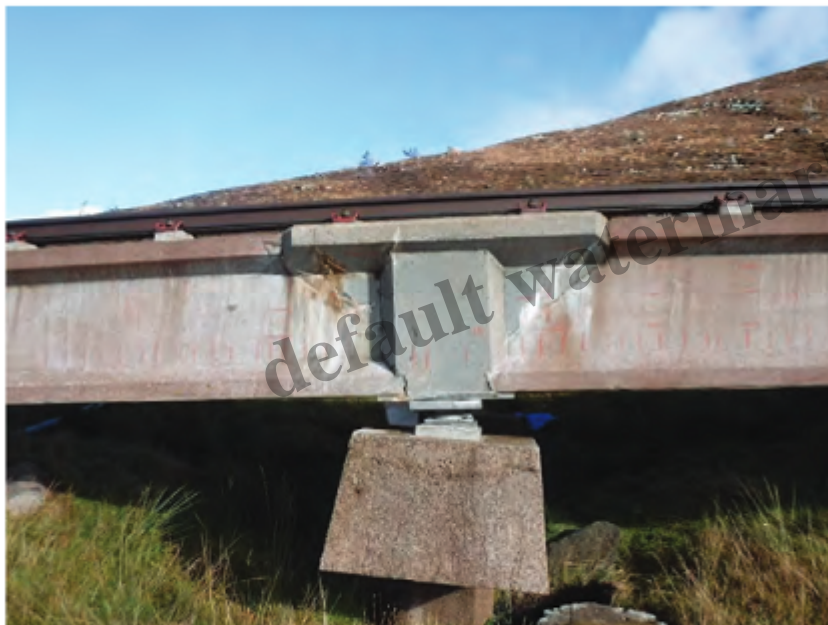
Plate 5 – General view of surface markings to Pier 9 Right Beam up/down.

The next four pictures, again from the COWI report, three from pages 277/8 and the fourth from page 11, show the in situ joint of pier 9 in what appears to be very poor condition with numerous cracks and damage. The first three are from the outside of the structure, the fourth from the inside!

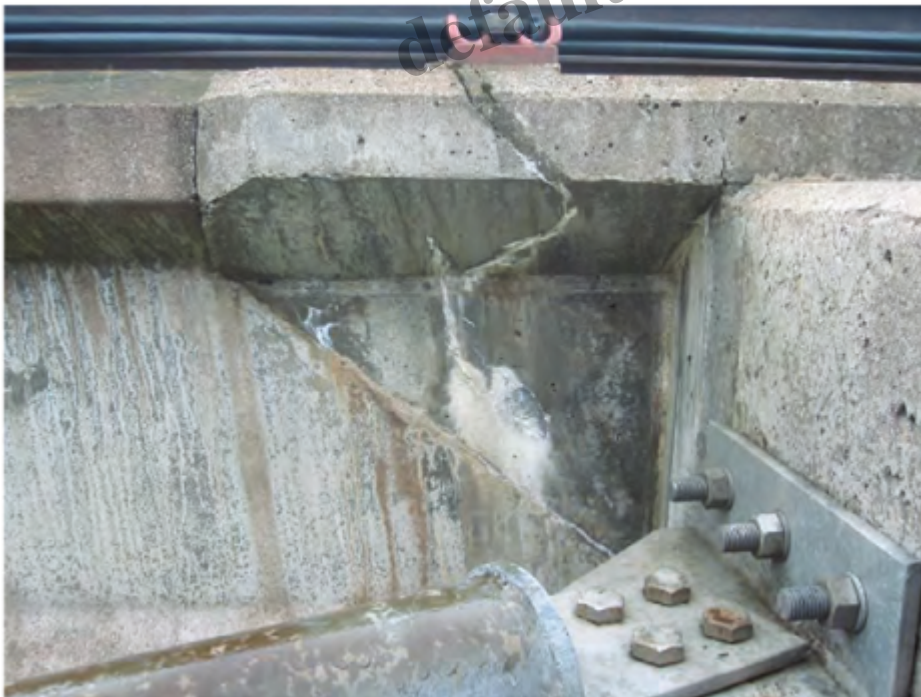
Figure 2-6 Cracking at a pier 9 (refer defect 1)

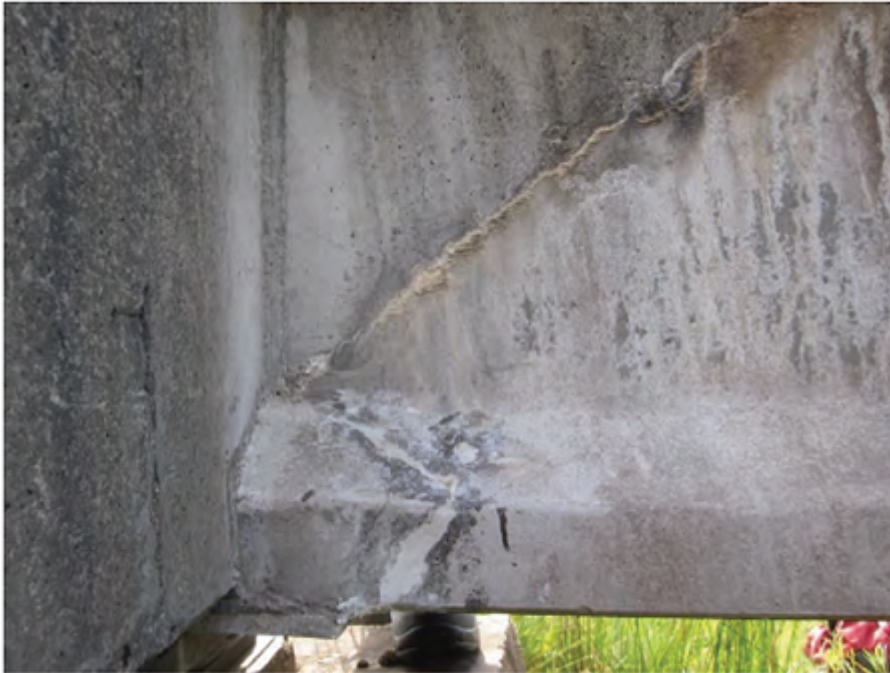
Figure 2-7 Crack repair at pier 9 (refer defect 1)
