Will the repair of the Cairngorm Funicular Railway work (2)?

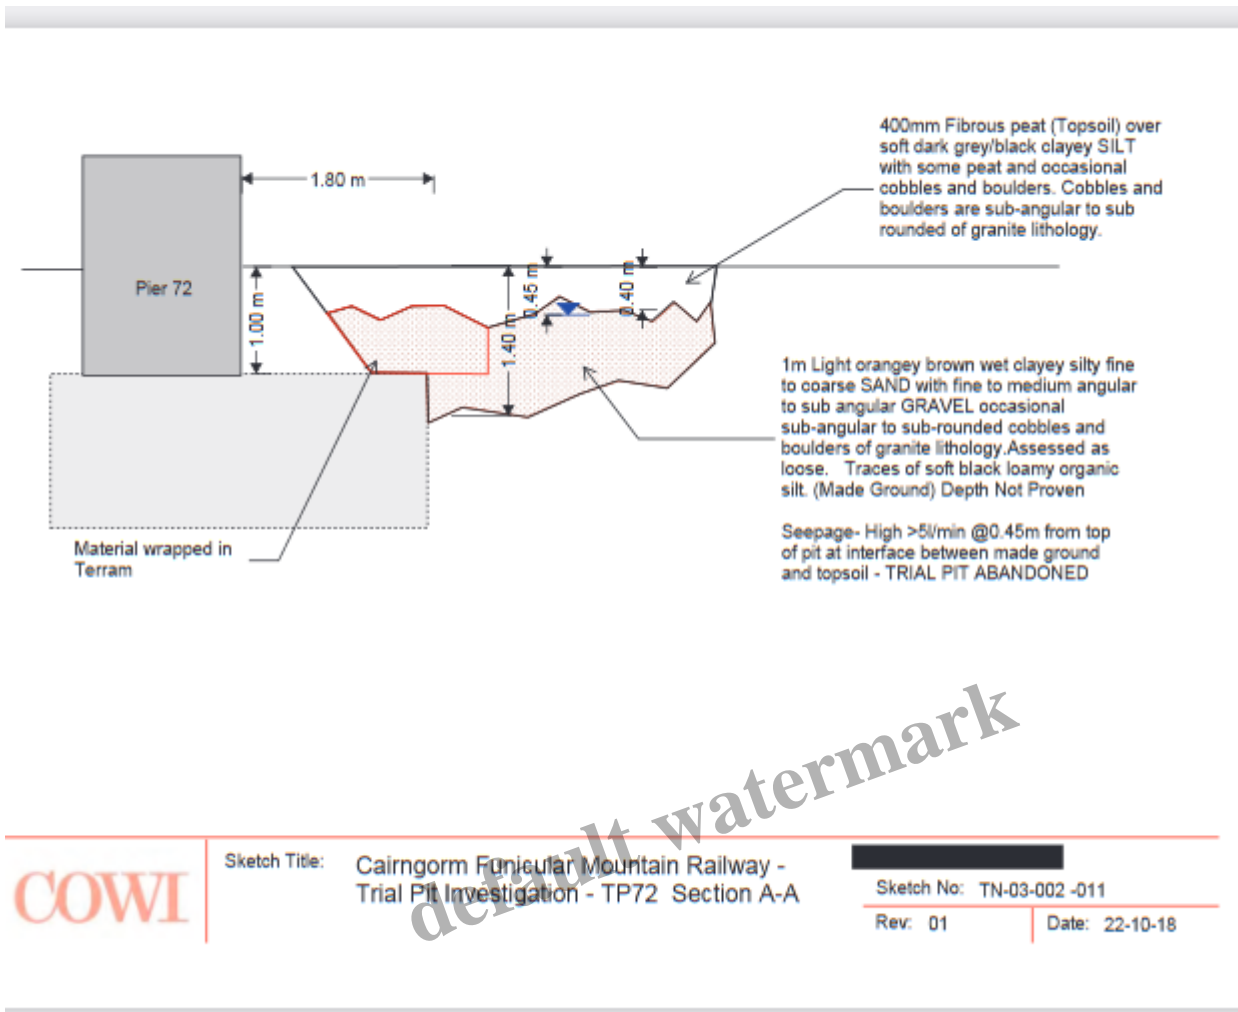
Sketch courtesy of the COWI report Page 201.

Looking at the sketch it shows that the pier is offset on its base. It is not the only one. I would assume that for maximum effect the weight of a pier should be dead centre on its base. Unless the weight is evenly distributed there could be an overturning motion on the base end with the heaviest weight on it which could help explain why they now need propping up.

The COWI report also states that test pit 72 was abandoned due to high water seepage, presumably from the spring above the pier. It is also not the only pier with a natural spring above it, pier 41 is the same.

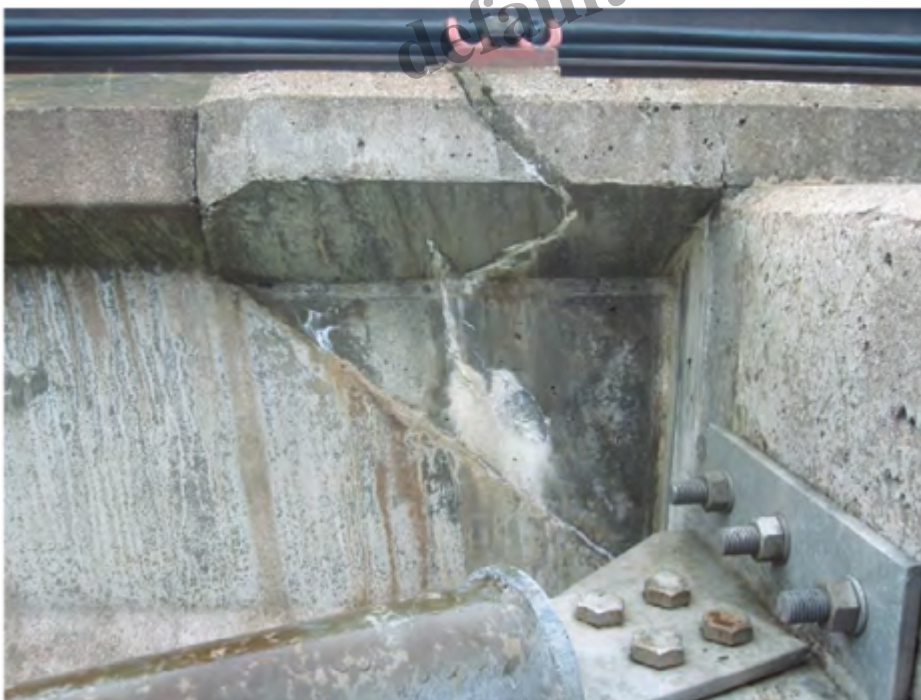
The next four pictures, again from the COWI report, three from pages 277/8 and the fourth from page 11, show the in situ joint of pier 9 in what appears to be very poor condition with numerous cracks and damage. The first three are from the outside of the structure, the fourth from the inside!

Figure 2-6 Cracking at a pier 9 (refer defect 1)
