Will the repair of the Cairngorm Funicular Railway work (3)?

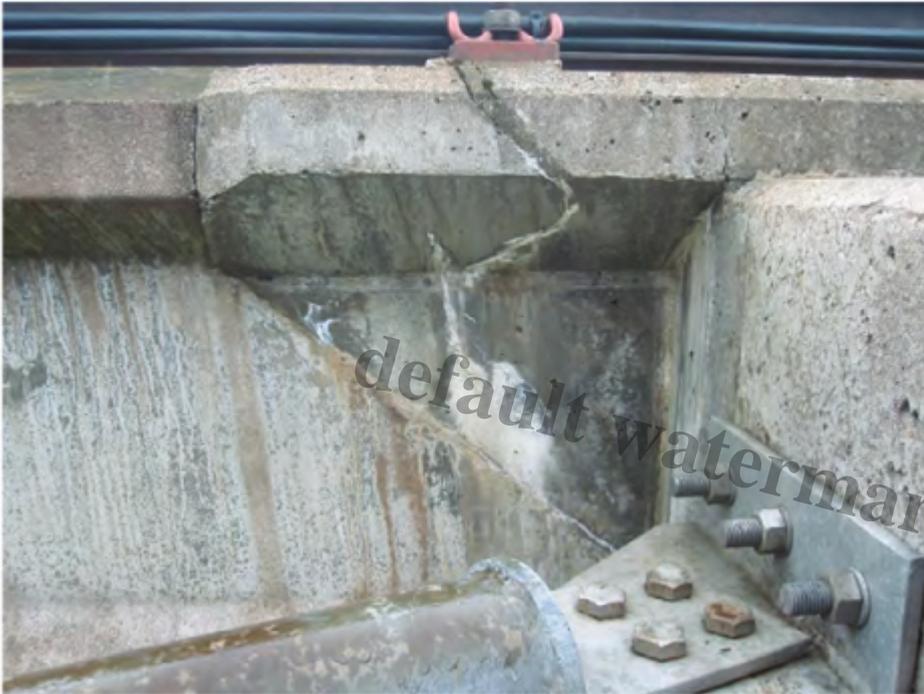
Figure 2-6 Cracking at a pier 9 (refer defect 1)

Unfortunately we are unable to do a site visit at present and have been unable to check from photos if it is the only pier in that section that exhibits damage. If it is, then why is it in such poor condition? Above ground work was not included in the planning application to the Cairngorms National Park Authority and because of that it is not clear what superstructural repairs are include in the Â£16m repair to the funicular. Information about that is important for understanding what has gone wrong and why repairs are needed.

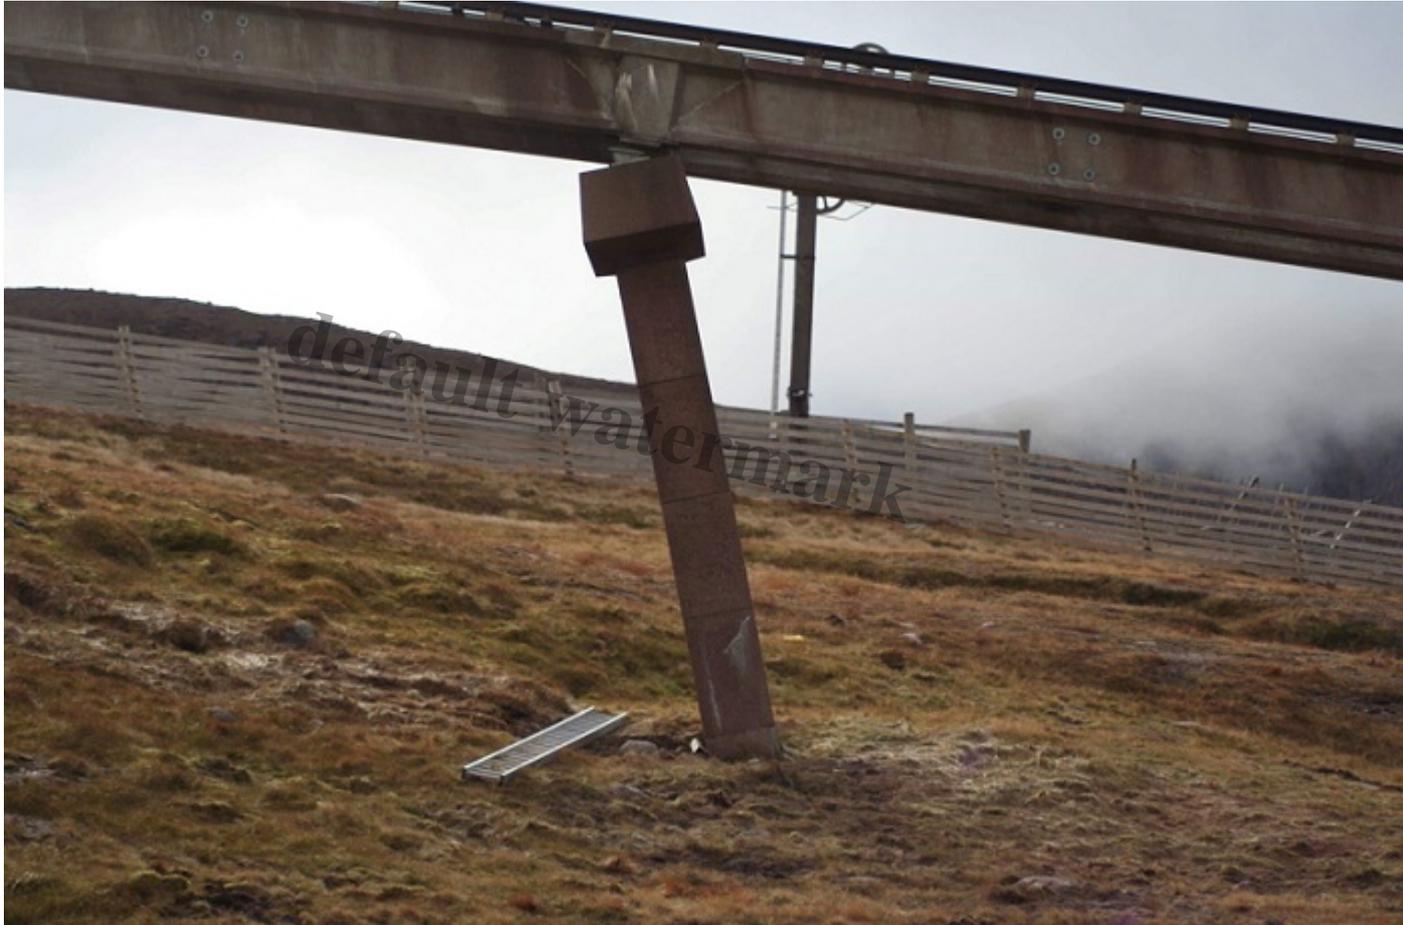
(NB the following photo appears to show the pier leaning more than it is, as you can see from the fence posts behind, but is the only one we have showing a taller pier)

This appears to be Pier 90 or 91

The COWI report says that it is the taller piers that are most affected. Another person who has contacted parkswatch has been a civil engineer and pointed out that a pier of this height should be wider at its base in order to support the weight higher up, that it should taper up to the highest point. But that would have meant that the preformed concrete outer shell at the bottom (no 5) would be larger and contain more re-inforcing than the next one up (No 4) and so on to the top. It could also have meant that the foundations for these taller piers would have to be bigger as well. It was said in the Audit Scotland report of 2009 that, because of the increasing costs, ways were being looked at to try and save money. Was using pre-formed shells of only one size one of the cost saving exercises and did this leave the taller pillars weaker than the short ones placing more stress on the foundations?
