## Will the repair of the Cairngorm Funicular Railway work (3)?

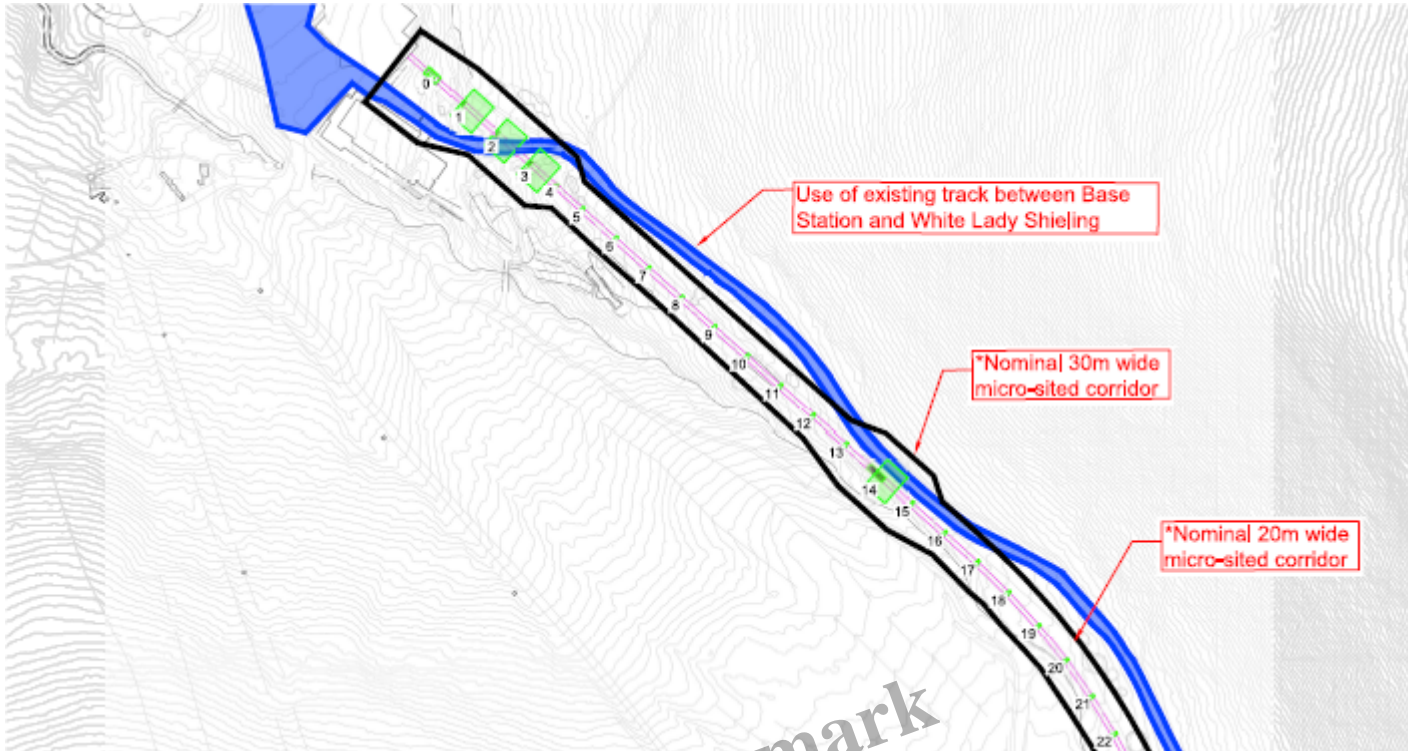
Extract from Planning documents. Green squares indicate work where ground works are planned and include pier 14, an anchor block, but not the ten piers below.

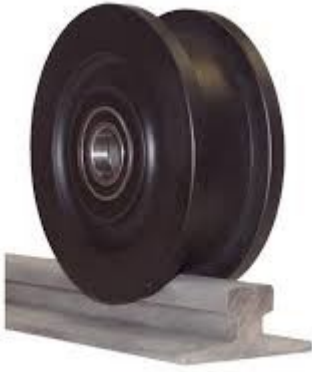
Another problem caused by the wheels is wear and tear on the **sides** of one rail. The wheels on one side of the carriage bogies are double flanged as in the picture below:-

So not only are the wheels on that side wearing the top of the rail, but the sides as well. The funicular could have been not only running on rails which are corrugated on the top, but with wear and tear which would make it rattle from side to side as well! Any vibration and shaking will have been transferred into the piers and bases, and the taller the pier, the worse would be the effect on the foundations.

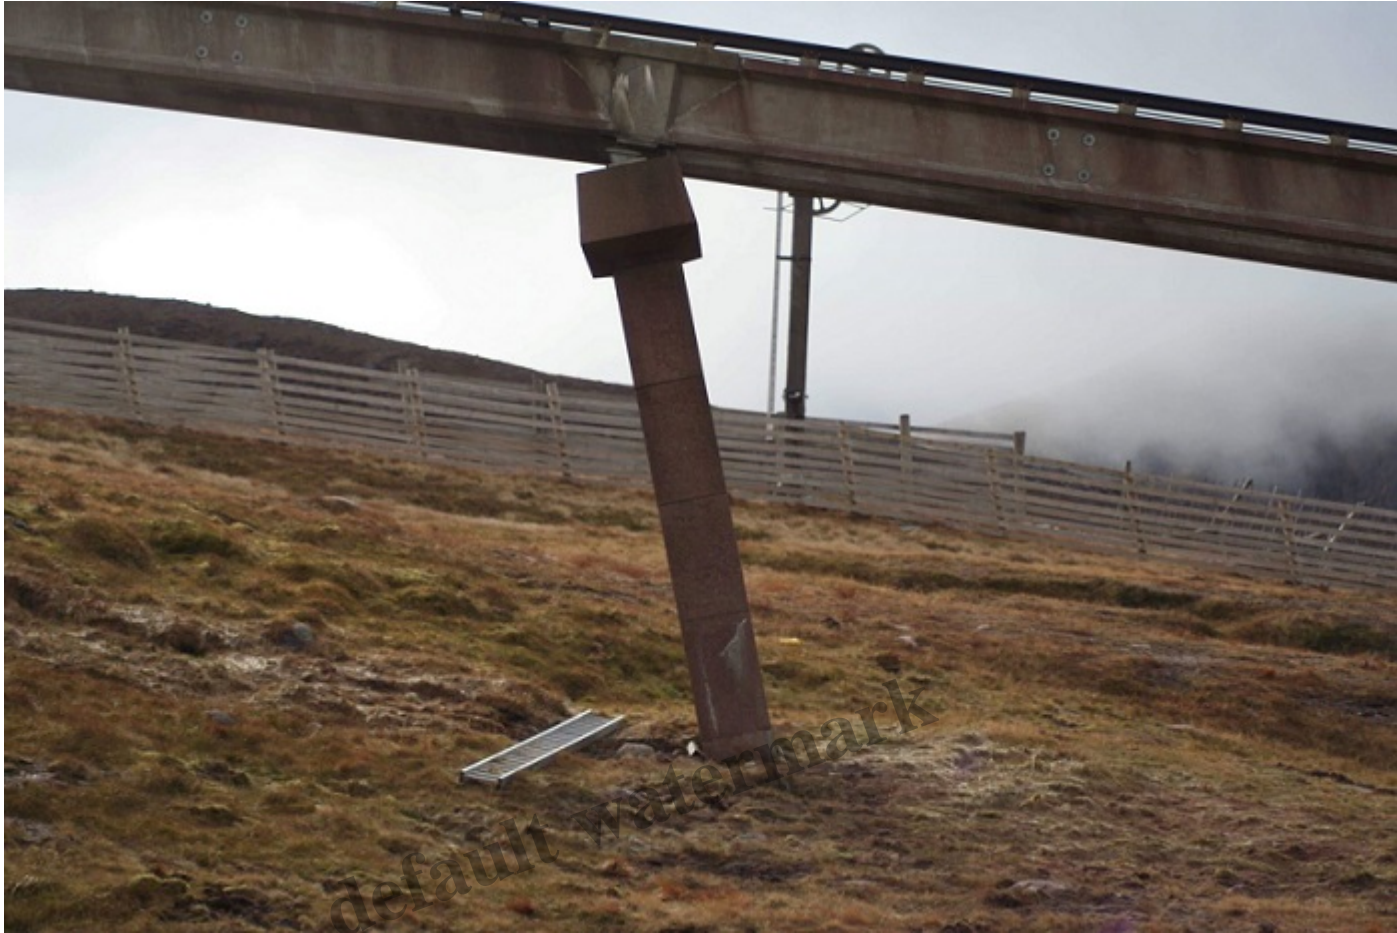
This appears to be Pier 90 or 91

(NB the following photo appears to show the pier leaning more than it is, as you can see from the fence posts behind, but is the only one we have showing a taller pier)

The COWI report says that it is the taller piers that are most affected. Another person who has contacted parkswatch has been a civil engineer and pointed out that a pier of this height should be wider at its base in order to support the weight higher up, that it should taper up to the highest point. But that would have meant that the preformed concrete outer shell at the bottom (no 5) would be larger and contain more re-inforcing than the next one up (No 4) and so on to the top. It could also have meant that the foundations for these taller piers would have to be bigger as well. It was said in the Audit Scotland report of 2009 that, because of the increasing costs, ways were being looked at to try and save money. Was using pre-formed shells of only one size one of the cost saving exercises and did this leave the taller pillars weaker than the short ones placing more stress on the foundations?
