## Will the repair of the Cairngorm Funicular Railway work (3)?

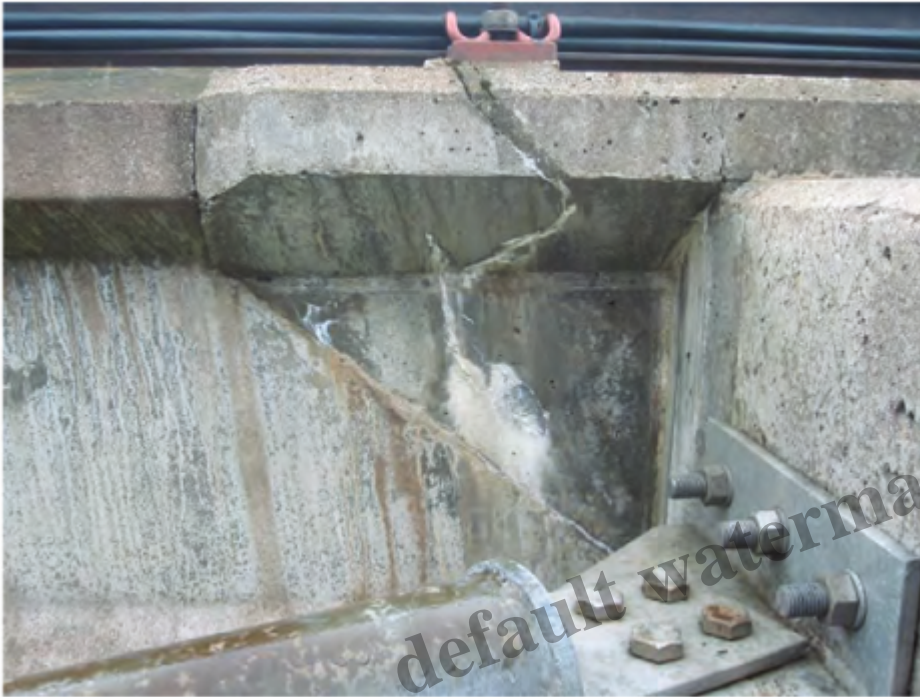
Figure 2-6 Cracking at a pier 9 (refer defect 1)

Unfortunately we are unable to do a site visit at present and have been unable to check from photos if it is the only pier in that section that exhibits damage. If it is, then why is it in such poor condition? Above ground work was not included in the planning application to the Cairngorms National Park Authority and because of that it is not clear what superstructural repairs are include in the £16m repair to the funicular. Information about that is important for understanding what has gone wrong and why repairs are needed.
