## Will the repair of the Cairngorm Funicular Railway work (4)?

Following on from my last post ([see here](#)), which looked at whether vibration from poorly maintained rails could have caused damage to the piers supporting the funicular, this post focuses on the concrete parts of the structure, especially the ends of the “I” support beams and the in-situ blocks. The “I” beams are described as such because of their shape, “I”, when viewed through vertical section while the “in-situ” blocks are so-described because they were poured “in situ” (rather than pre-cast like the “I” beams).

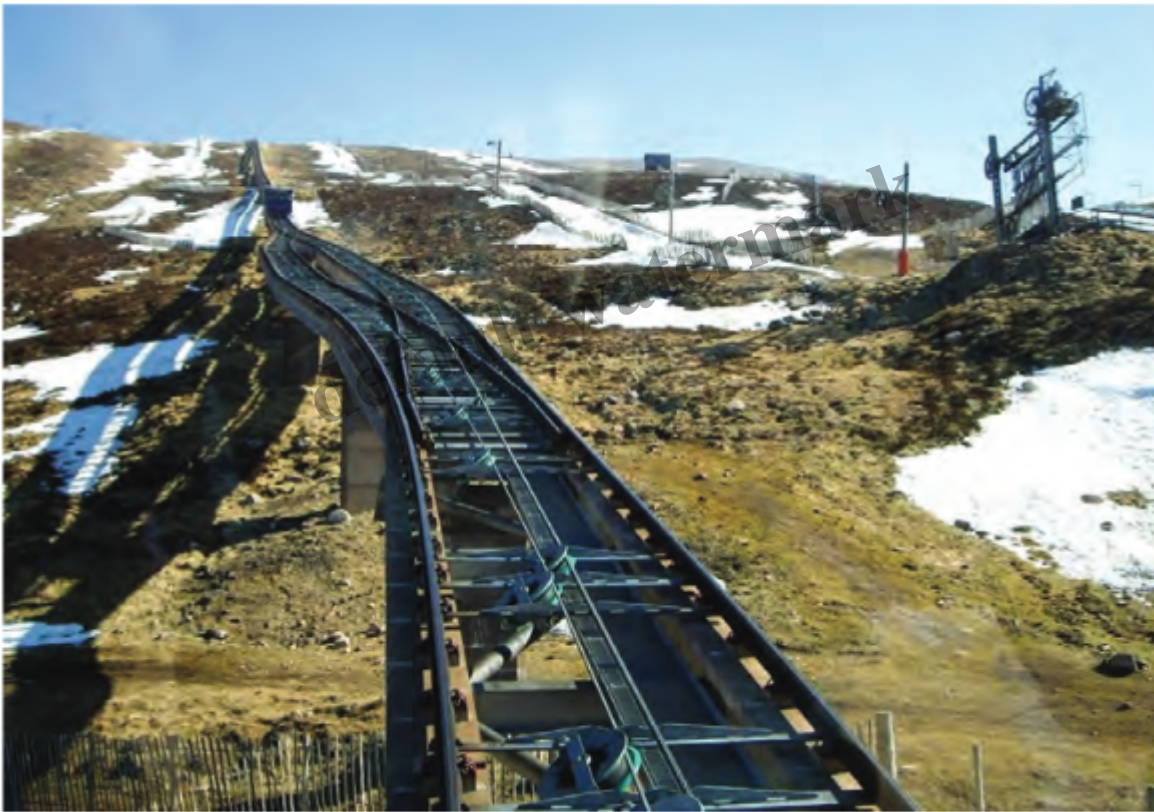
*Figure 2-2 Passing loop*  
Photo credit the COWI report.

The picture above is probably the best one showing the layout of the tracks, including the passing loop, but also shows two piers referred to below. Pier 52 is the one showing to the left of the track with pier 51 just visible between the lower pulley and the next two. The photo also shows how the funicular destroyed Cairn Gorm’s iconic White Lady ski run, one more reason why it should never have been built and should be removed asap.

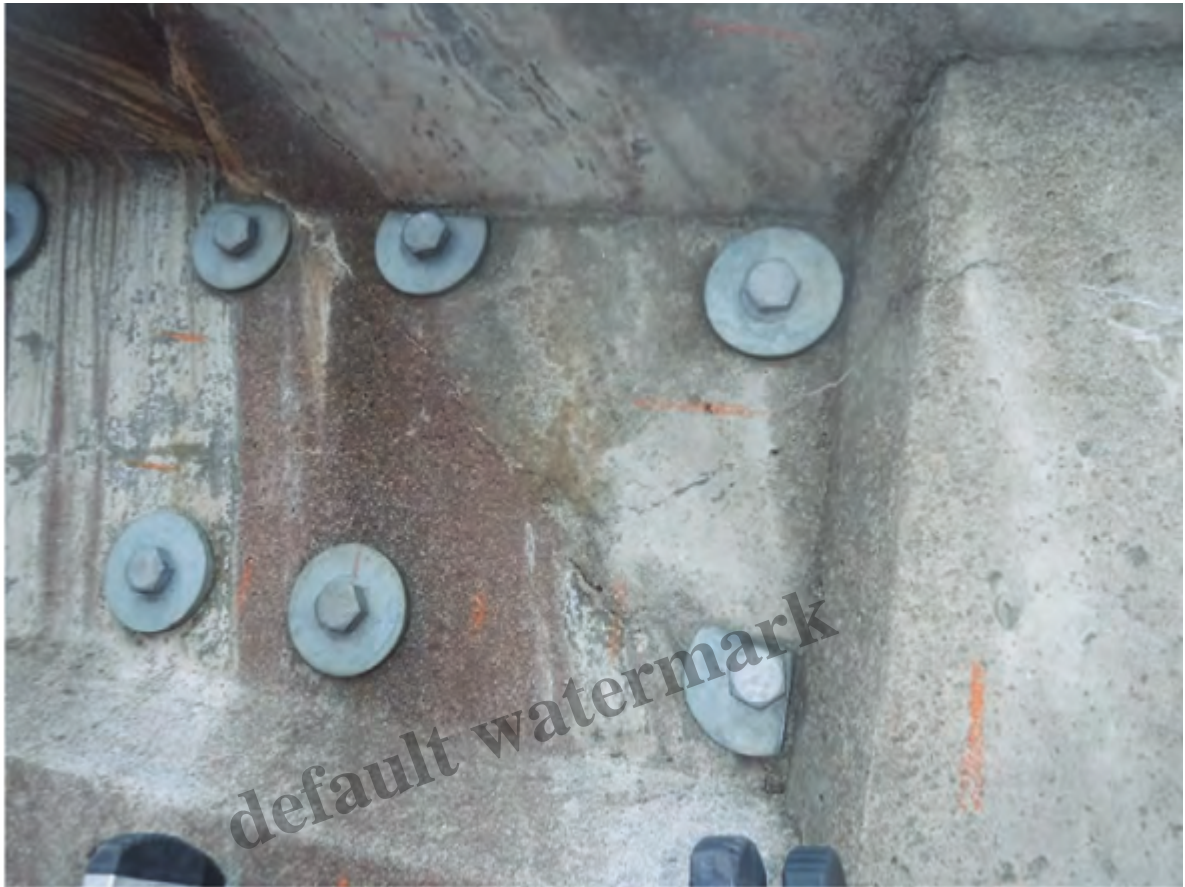
**Plate 18 – General view of surface markings to Pier 51 Left Beam up**

The picture above shows the join between the in-situ block and the left side (looking up the hill) of the concrete “I” beam of Pier 51. Although it is unclear exactly what is going on here as the photo has been taken so close to the pier, it provides ample evidence of the poor workmanship so often referred to in the COWI and ADAC structures reports on the state of the funicular. It looks as though the mould for the concrete joint, which is usually made from plywood and is called “shuttering”, has been poorly constructed. As a result the surface to the right of bolts is sloping, rather than vertical, and appears warped (a consequence of using an old piece of plywood). While some of the concrete may have been patched later, it also appears to have almost covered the bolt holes used to secure the bracing steelwork between the beams (visible in the top photo). At least one washer under the bolt heads has had to be cut with an angle grinder to get it to fit.

There are also several marks showing. Some may be cracks but they could also have been caused by markings on the surface of the plywood when the insitu block was poured!

Apart from the shuttering, there is evidence from the photos in Plates 18 and 24 that not enough care was taken when the concrete was poured to create the in-situ block, as shown by the surface markings. This is easier to see in plate 31:

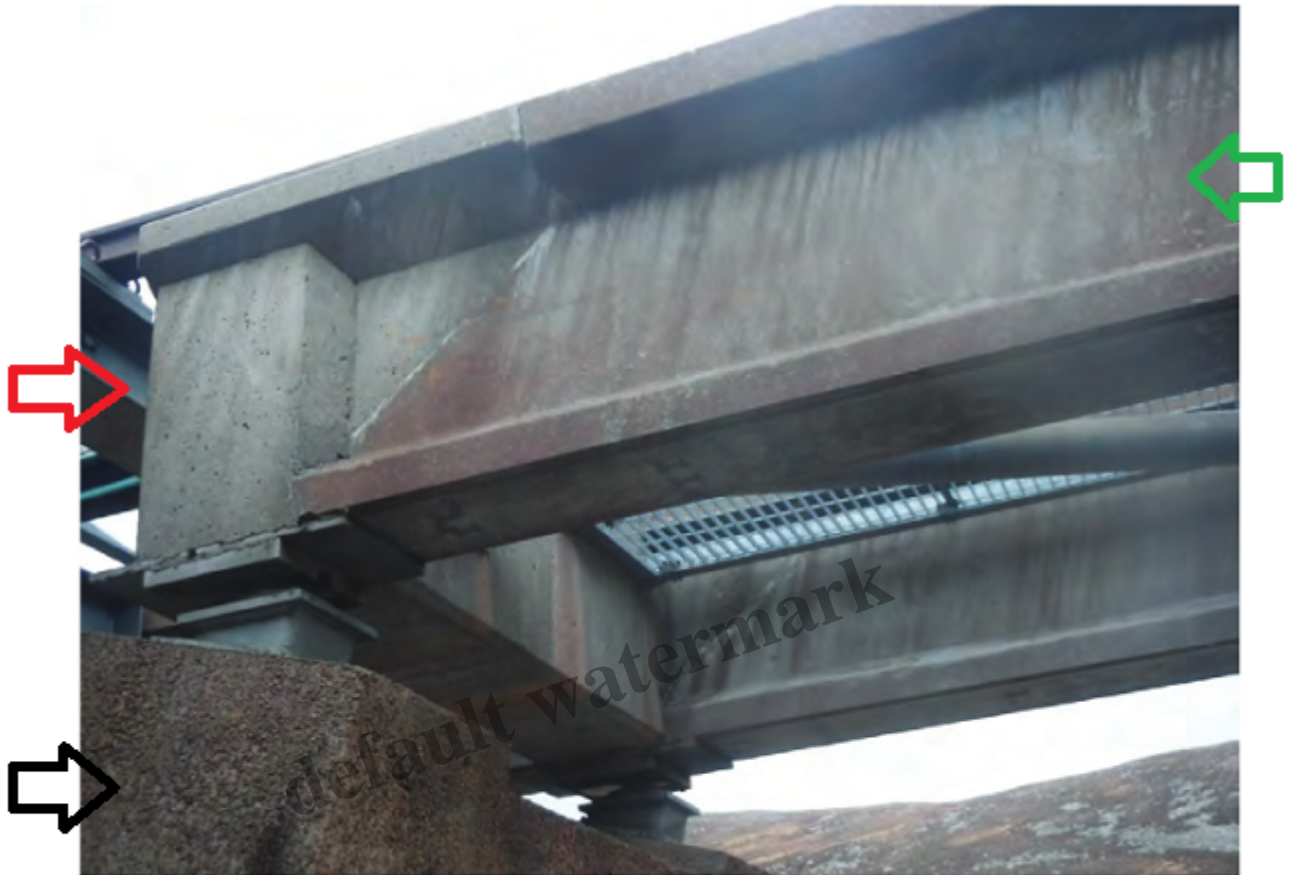
**Plate 24 - General view of surface markings to Pier 53 Right Beam, left support up.**

Green points to “I” beam, red to insitu block and black to crosshead on pier below. . Photo credit COWI report.

Note how the edges in the insitu block are straight and “clean” compared to those shown in plate 18.

Returning to Plate 24, observe that the end of the precast concrete “I” beam is angled, sloping forward from the top edge to the bottom. This gives a much superior joint than a vertical joint. But if you look at the plate which carries the top half of the sliding bearing, that plate only supports the last 50 – 75cms of the end of the “I” beam and, in some cases, due to poor construction, not even that:

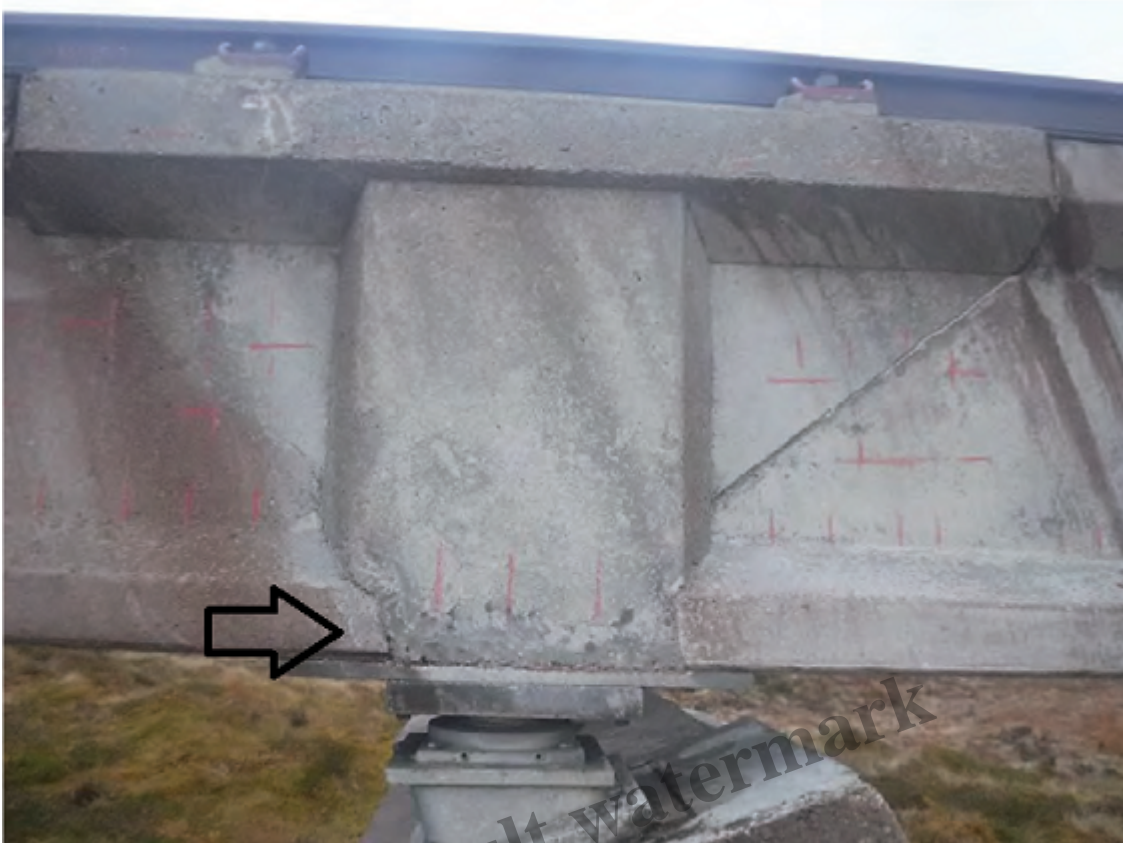
The in-situ concrete used at Cairn Gorm was made in the car park area and then carried by helicopter to where it was needed. This raises another potential issue. There would be times when the helicopter lift would have a shortage or an excess of concrete to fill one of the moulds and an in-situ joint may not have been finished in one pour. This would result in partial setting of the concrete already in place leading to a poor joint. The next picture, especially in the lowest part of the in-situ concrete block, shows what that might look like:-

Photo credit COWI report Page 293, plate 38, pier 69, arrow points to possible earlier pour.

Although this apparent difference in the composition of the concrete, which may have weakened the whole structure, could also be caused by ineffective use of the vibro-poker!

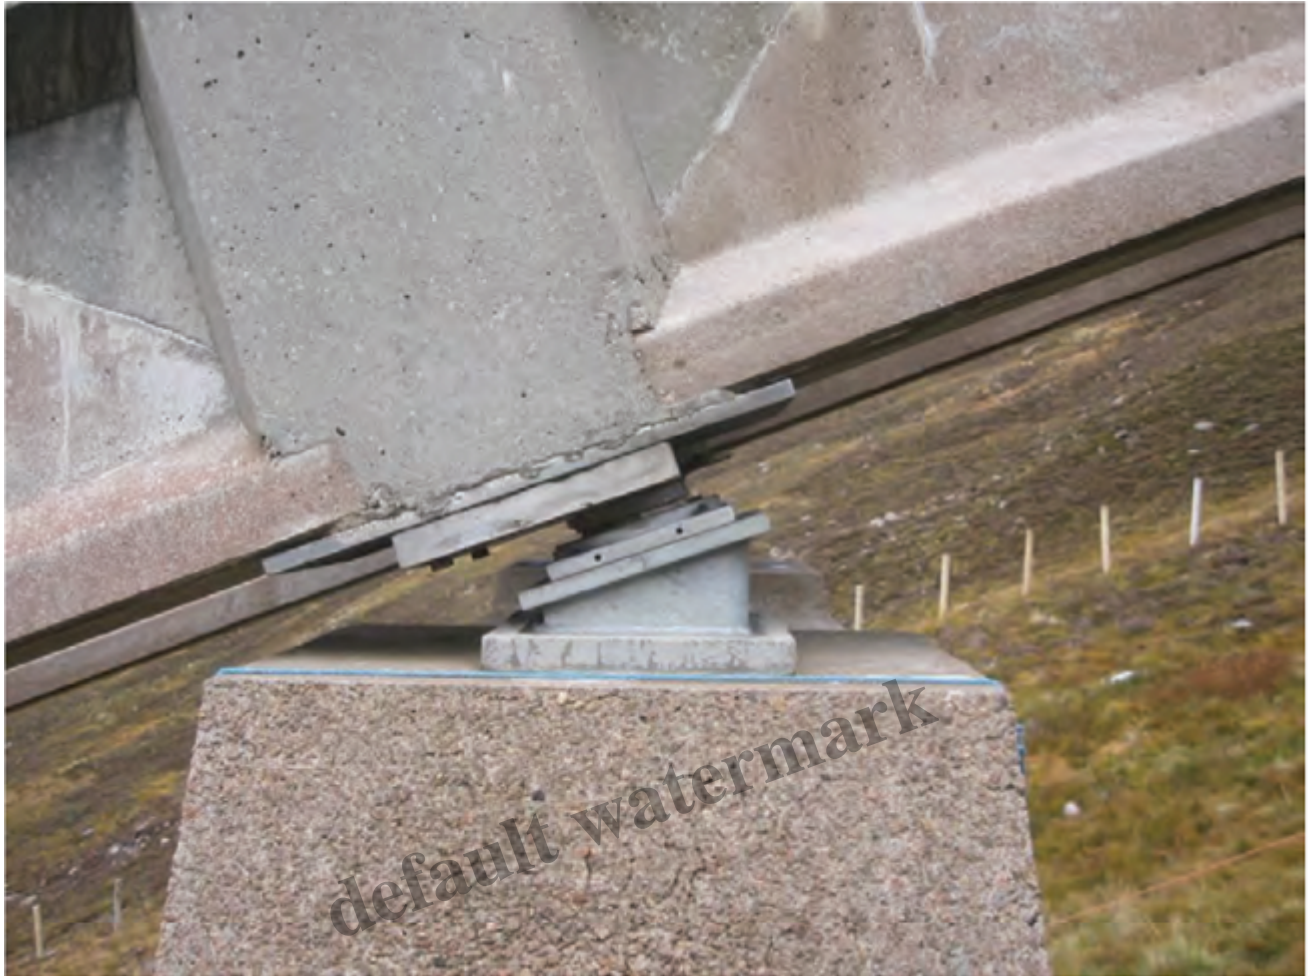
*Figure 2-9 Bearing misalignment (refer defect 5)*

Note the gap between the two beams and the support plate above the ancon bearing. It appears that the concrete poured to form the insitu block above has partly filled the gap.

(1) The plate should have extended far enough to support the “I” beam from the leading edge of the top flange. The lack of support may account for the damage to the lower flanges of the “I” beams, damage that appears at several different piers.

(2) The plates should also have rounded corners and edges to prevent stress points.

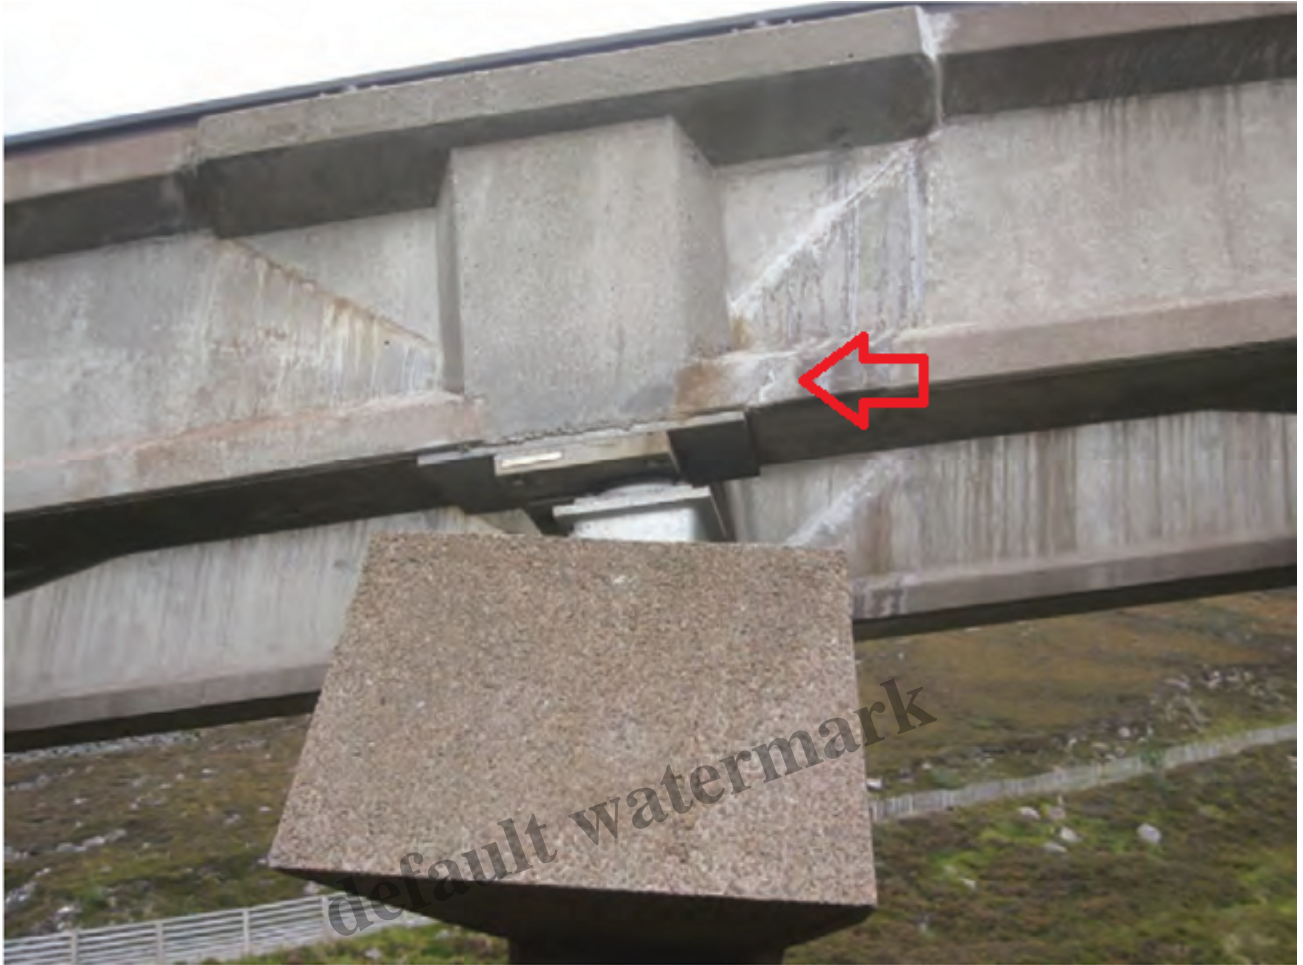
*Figure 2-8 Typical crack leakage and bearing misalignment (refer defects 3 and 5)*

The red arrow marks what appears to be a crack leading diagonally upwards from the edge of the plate, just where you would expect this to happen if too much weight was placed on an inadequate sharp edged support.

The planning application for the funicular stated that replacement of the Ancon bearings below the plates is part of the repair work, so it will be interesting to see if this includes new longer plates. If so, all the in-situ joints will need to be removed as the support plates have concealed vertical sections that project into the concrete above. That could help explain why the cost of the funicular repairs comes to an extraordinary £16.16m.
