Will the repair of the Cairngorm Funicular Railway work (4)?

Following on from my last post ([see here](#)), which looked at whether vibration from poorly maintained rails could have caused damage to the piers supporting the funicular, this post focuses on the concrete parts of the structure, especially the ends of the “I” support beams and the in-situ blocks. The “I” beams are described as such because of their shape, “I”, when viewed through vertical section while the “in-situ” blocks are so-described because they were poured “in situ” (rather than pre-cast like the “I” beams).

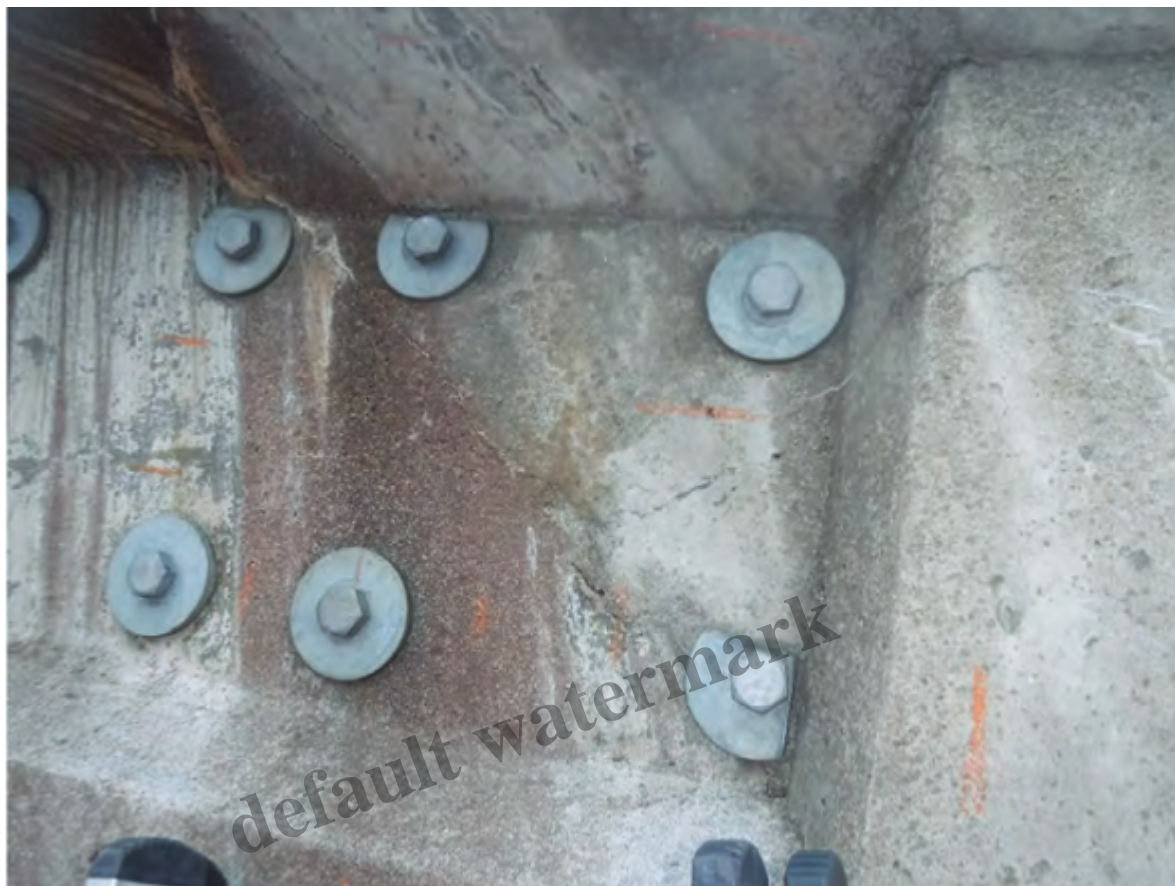
Plate 18 – General view of surface markings to Pier 51 Left Beam up

The picture above shows the join between the in-situ block and the left side (looking up the hill) of the concrete “I” beam of Pier 51. Although it is unclear exactly what is going on here as the photo has been taken so close to the pier, it provides ample evidence of the poor workmanship so often referred to in the COWI and ADAC structures reports on the state of the funicular. It looks as though the mould for the concrete joint, which is usually made from plywood and is called “shuttering”, has been poorly constructed. As a result the surface to the right of bolts is sloping, rather than vertical, and appears warped (a consequence of using an old piece of plywood). While some of the concrete may have been patched later, it also appears to have almost covered the bolt holes used to secure the bracing steelwork between the beams (visible in the top photo). At least one washer under the bolt heads has had to be cut with an angle grinder to get it to fit.

There are also several marks showing. Some may be cracks but they could also have been caused by markings on the surface of the plywood when the insitu block was poured!

Apart from the shuttering, there is evidence from the photos in Plates 18 and 24 that not enough care was taken when the concrete was poured to create the in-situ block, as shown by the surface markings. This is easier to see in plate 31:

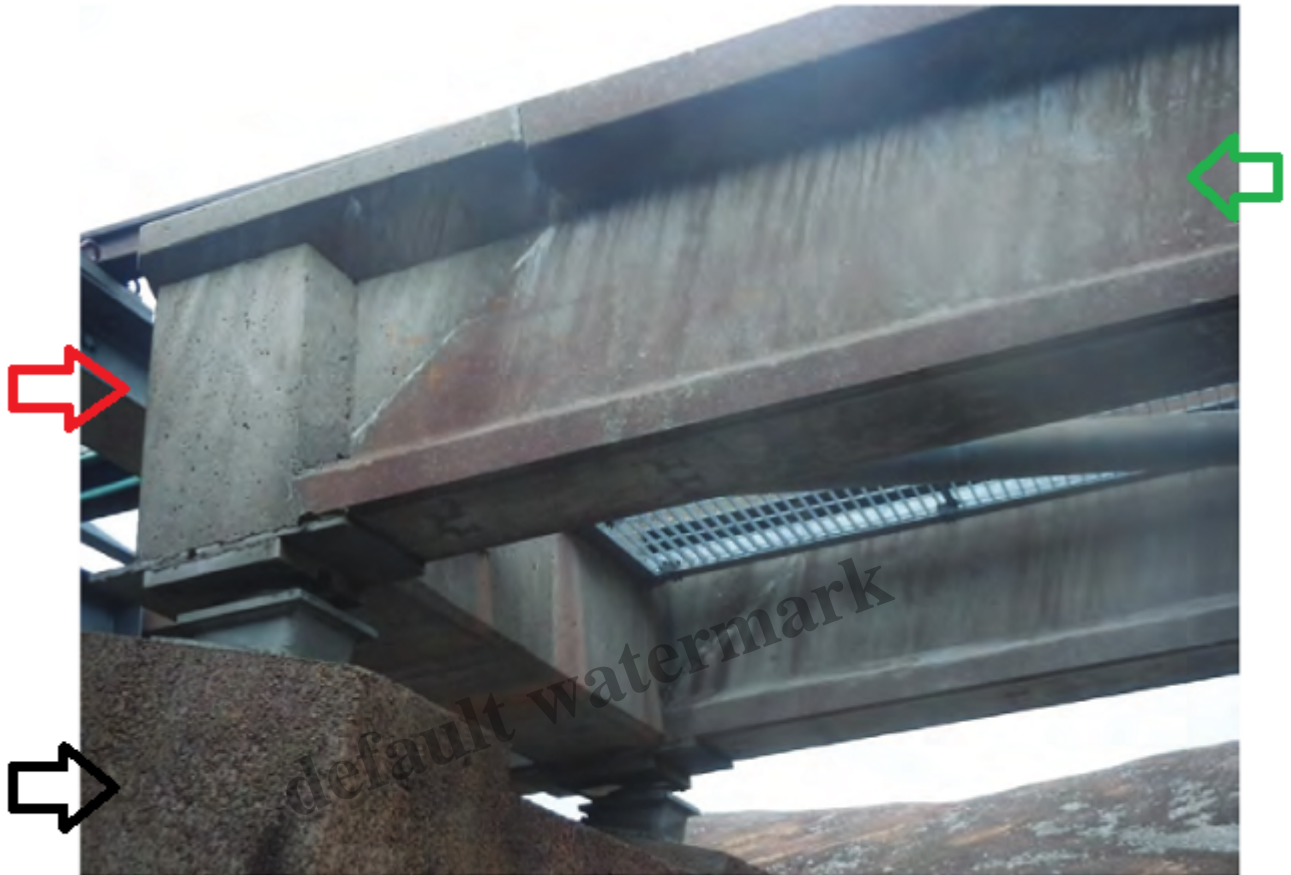
Plate 24 - General view of surface markings to Pier 53 Right Beam, left support up.

Note how the edges in the insitu block are straight and “clean” compared to those shown in plate 18.

Returning to Plate 24, observe that the end of the precast concrete “I” beam is angled, sloping forward from the top edge to the bottom. This gives a much superior join than a vertical joint. But if you look at the plate which carries the top half of the sliding bearing, that plate only supports the last 50 – 75cms of the end of the “I” beam and, in some cases, due to poor construction, not even that:

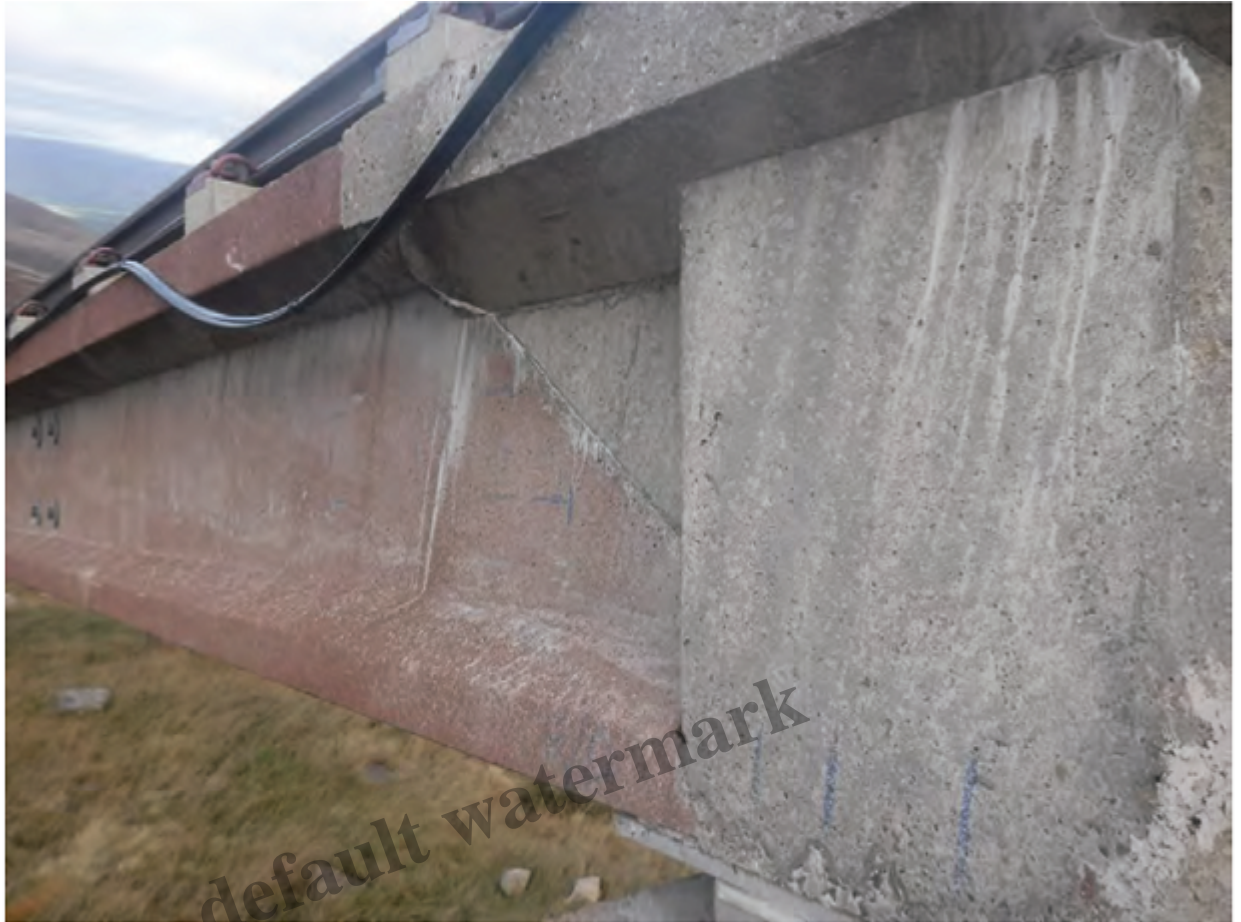
Plate 31 - General view of surface markings to Pier 56 Right Beam down

These could have been caused by the concrete not being vibrated enough with a vibro-rod/ poker or from cold weather.

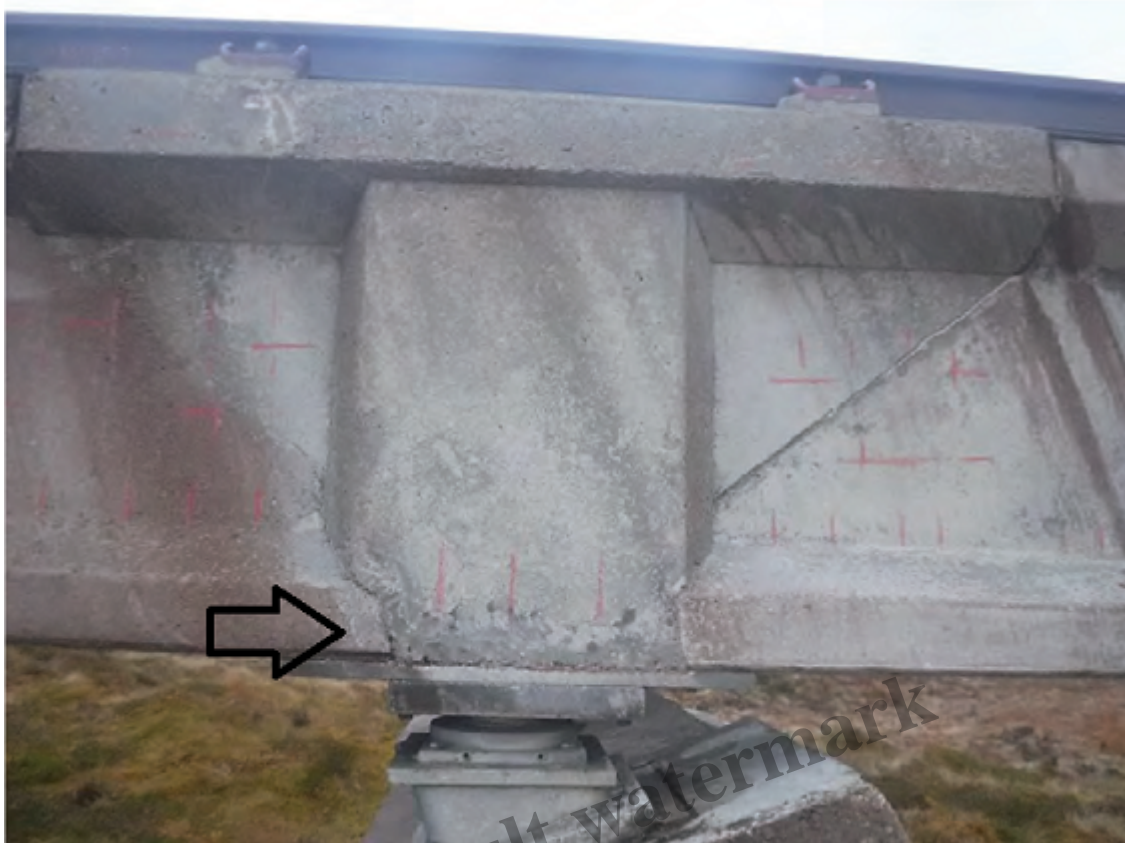
Photo credit COWI report Page 293, plate 38, pier 69, arrow points to possible earlier pour.

Although this apparent difference in the composition of the concrete, which may have weakened the whole structure, could also be caused by ineffective use of the vibro-poker!

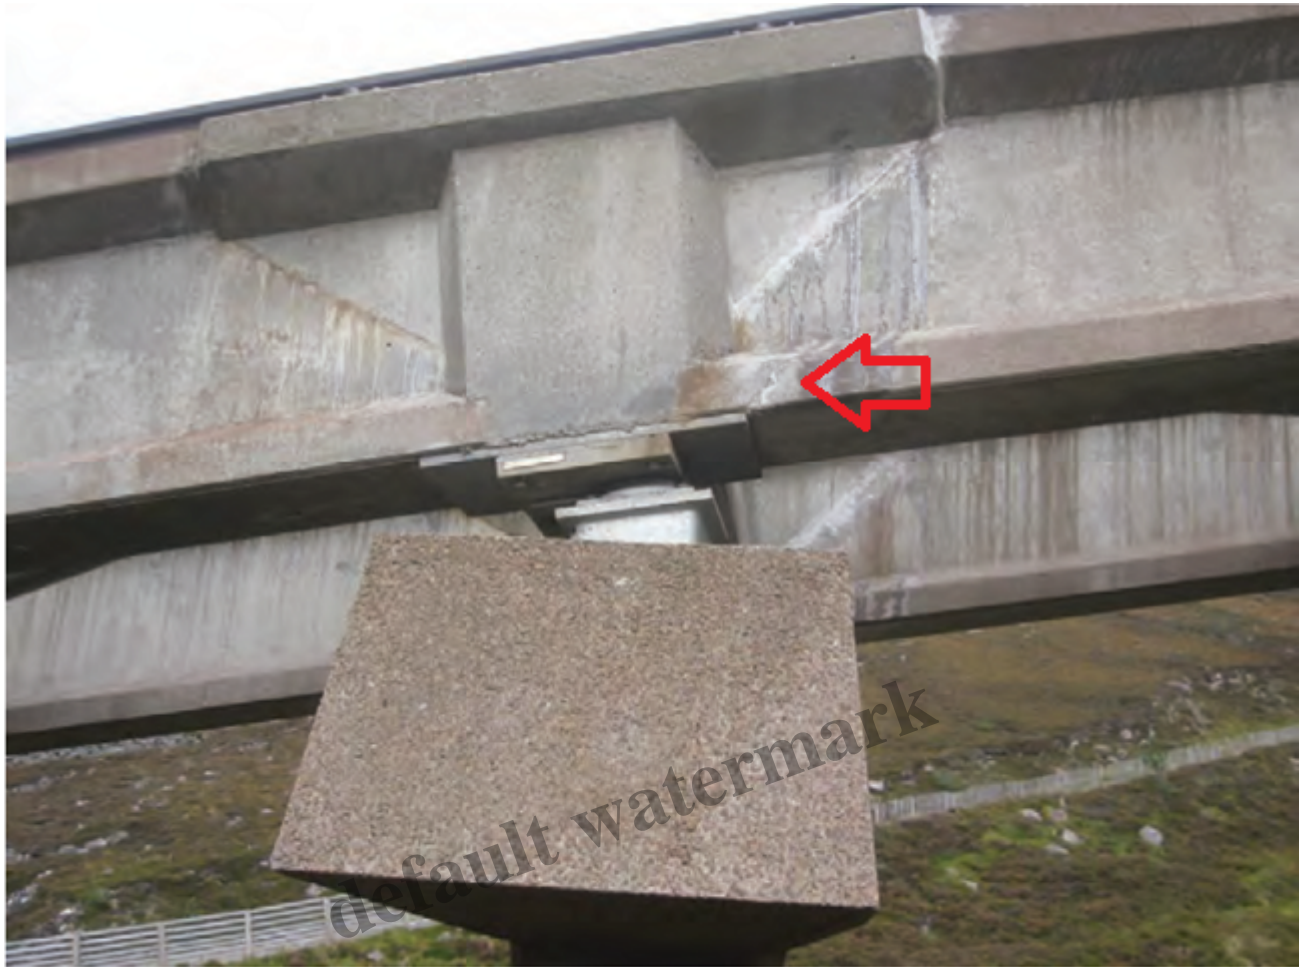
Figure 2-8 Typical crack leakage and bearing misalignment (refer defects 3 and 5)

The red arrow marks what appears to be a crack leading diagonally upwards from the edge of the plate, just where you would expect this to happen if too much weight was placed on an inadequate sharp edged support.

The planning application for the funicular stated that replacement of the Ancon bearings below the plates is part of the repair work, so it will be interesting to see if this includes new longer plates. If so, all the in-situ joints will need to be removed as the support plates have concealed vertical sections that project into the concrete above. That could help explain why the cost of the funicular repairs comes to an extraordinary £16.16m.
