Will the repair of the Cairngorm Funicular Railway work (4)?

Following on from my last post ([see here](#)), which looked at whether vibration from poorly maintained rails could have caused damage to the piers supporting the funicular, this post focuses on the concrete parts of the structure, especially the ends of the “I” support beams and the in-situ blocks. The “I” beams are described as such because of their shape, “I”, when viewed through vertical section while the “in-situ” blocks are so-described because they were poured “in situ” (rather than pre-cast like the “I” beams).

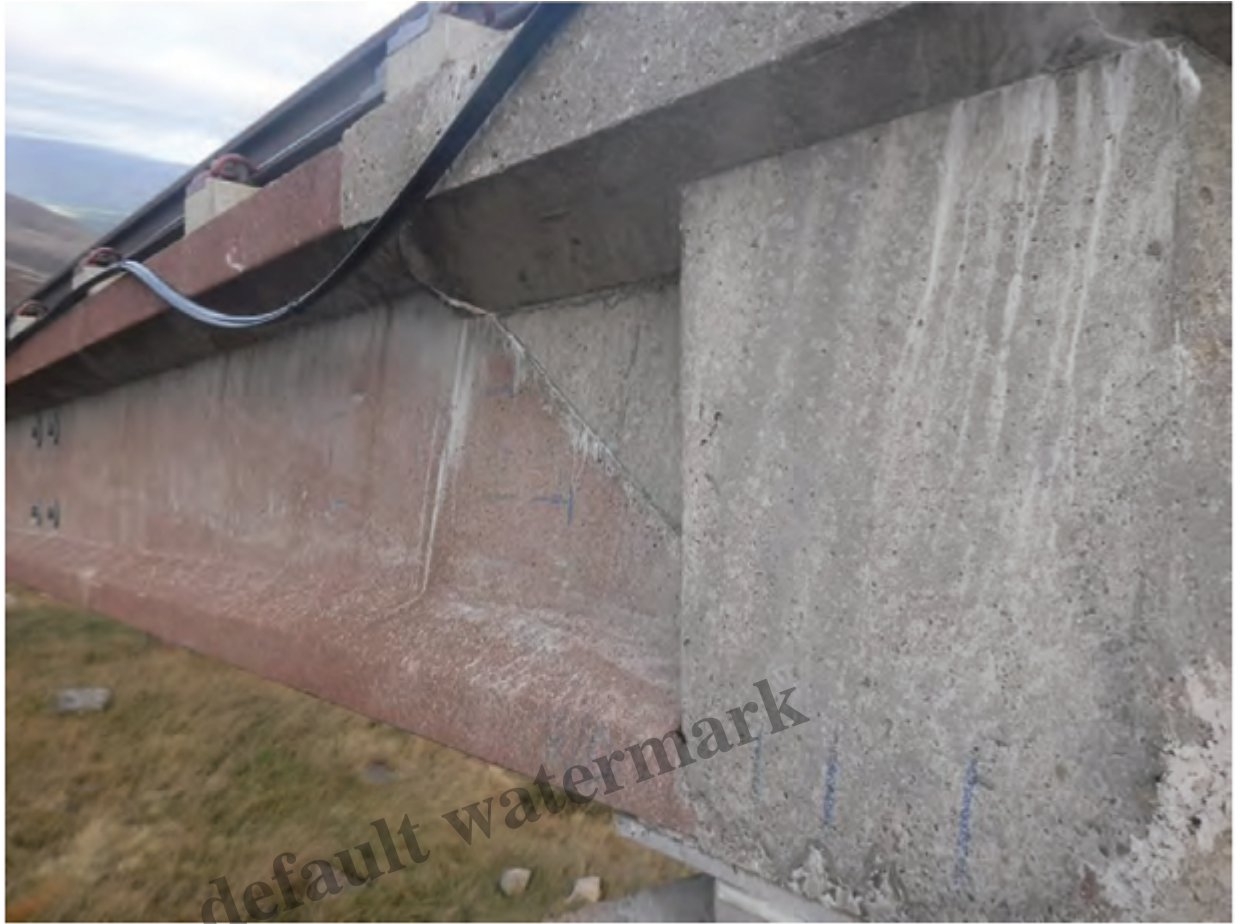
Plate 31 - General view of surface markings to Pier 56 Right Beam down

These could have been caused by the concrete not being vibrated enough with a vibro-rod/ poker or from cold weather.

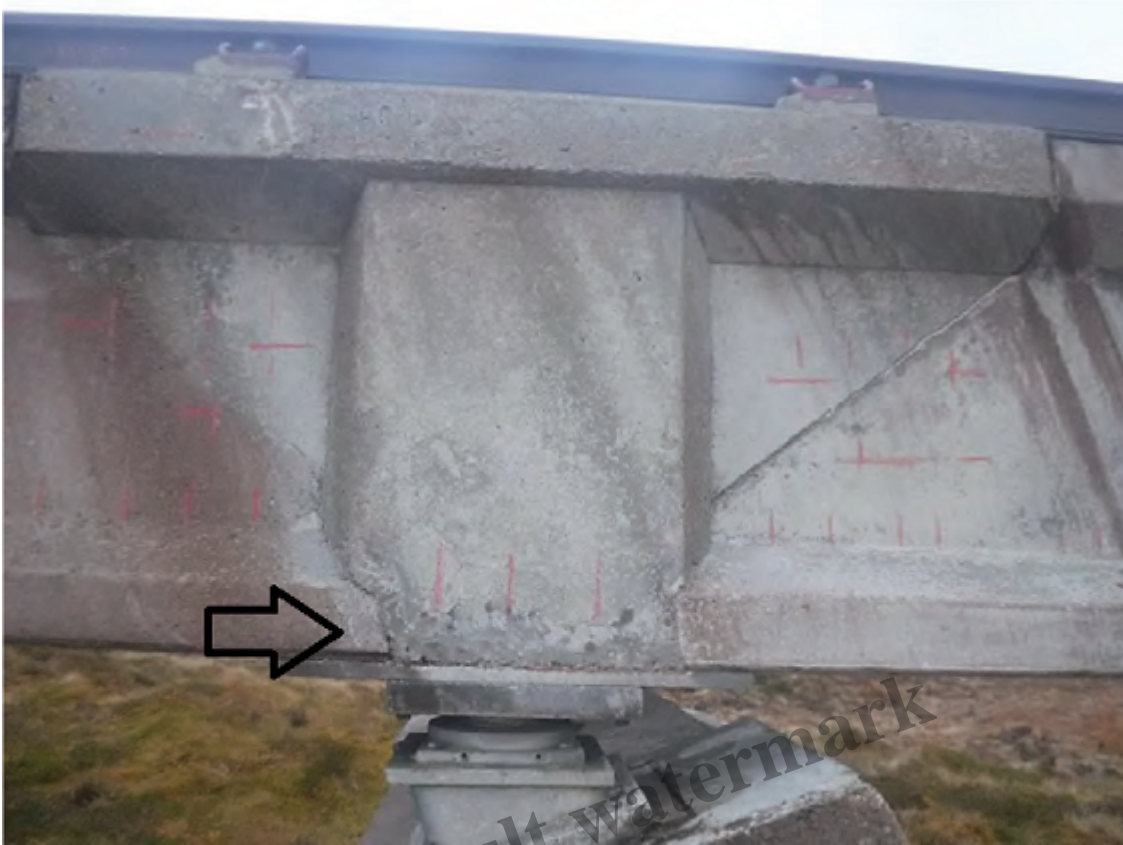
Photo credit COWI report Page 293, plate 38, pier 69, arrow points to possible earlier pour.

Although this apparent difference in the composition of the concrete, which may have weakened the whole structure, could also be caused by ineffective use of the vibro-poker!

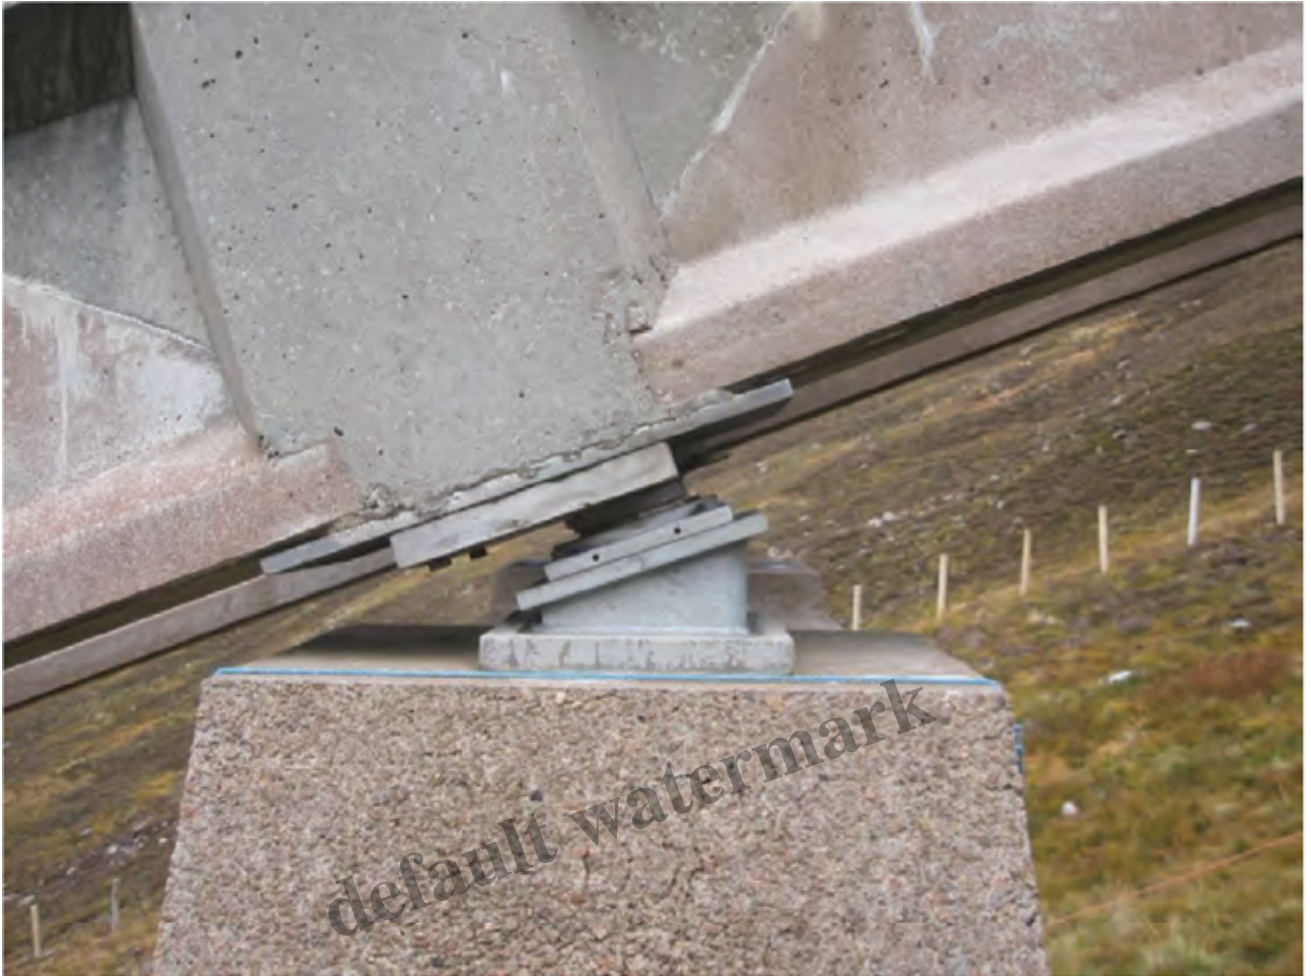
Figure 2-9 Bearing misalignment (refer defect 5)

Note the gap between the two beams and the support plate above the ancon bearing. It appears that the concrete poured to form the insitu block above has partly filled the gap.

(1) The plate should have extended far enough to support the “I” beam from the leading edge of the top flange. The lack of support may account for the damage to the lower flanges of the “I” beams, damage that appears at several different piers.

(2) The plates should also have rounded corners and edges to prevent stress points.
