Will the repair of the Cairngorm Funicular Railway work (4)?

Following on from my last post ([see here](#)), which looked at whether vibration from poorly maintained rails could have caused damage to the piers supporting the funicular, this post focuses on the concrete parts of the structure, especially the ends of the support beams and the in-situ blocks. The beams are described as such because of their shape, "I", when viewed through vertical section while the in-situ blocks are so-described because they were poured in situ (rather than pre-cast like the beams).

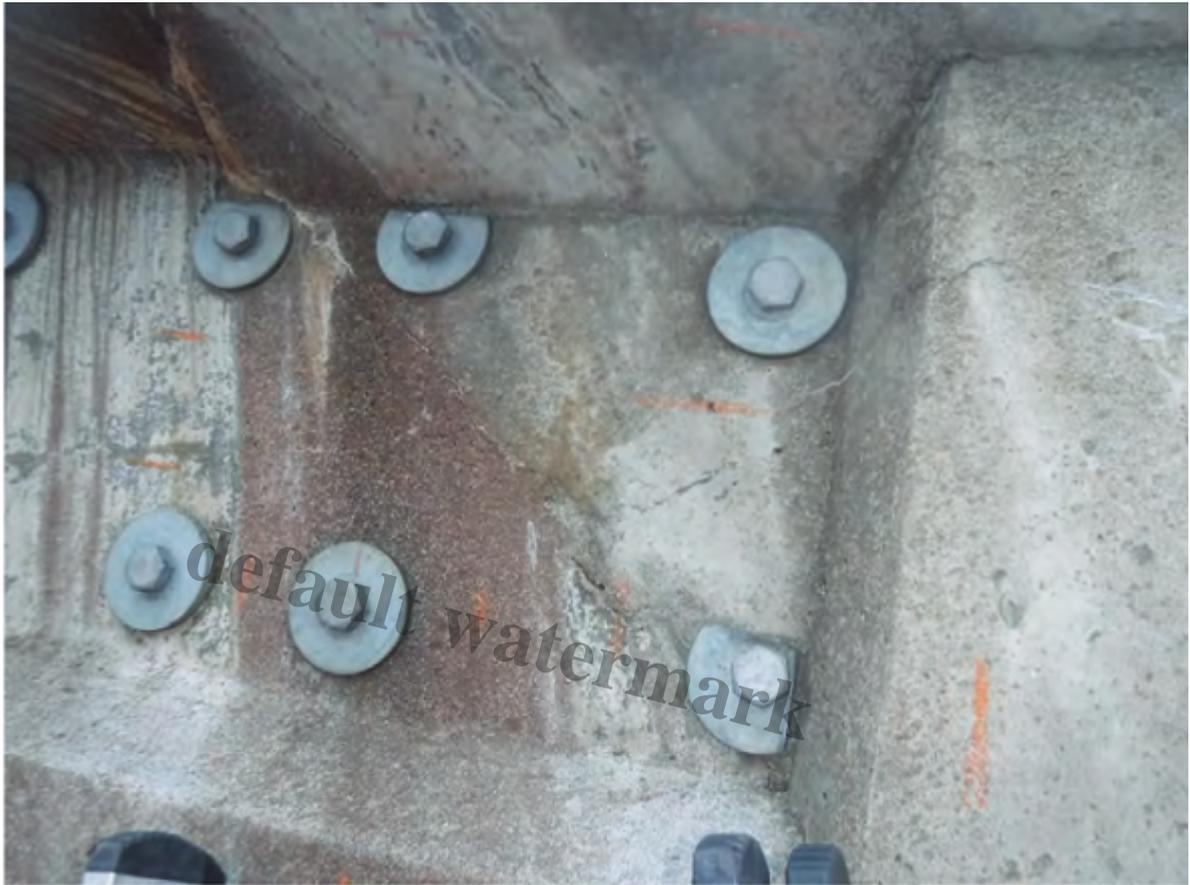
Plate 18 – General view of surface markings to Pier 51 Left Beam up

The picture above shows the join between the in-situ block and the left side (looking up the hill) of the concrete beam of Pier 51. Although it is unclear exactly what is going on here as the photo has been taken so close to the pier, it provides ample evidence of the poor workmanship so often referred to in the COWI and ADAC structures reports on the state of the funicular. It looks as though the mould for the concrete joint, which is usually made from plywood and is called "shuttering", has been poorly constructed. As a result the surface to the right of bolts is sloping, rather than vertical, and appears warped (a consequence of using an old piece of plywood). While some of the concrete may have been patched later, it also appears to have almost covered the bolt holes used to secure the bracing steelwork between the beams (visible in the top photo). At least one washer under the bolt heads has had to be cut with an angle grinder to get it to fit.

There are also several marks showing. Some may be cracks but they could also have been caused by markings on the surface of the plywood when the insitu block was poured!

Apart from the shuttering, there is evidence from the photos in Plates 18 and 24 that not enough care was taken when the concrete was poured to create the in-situ block, as shown by the surface markings. This is easier to see in plate 31:

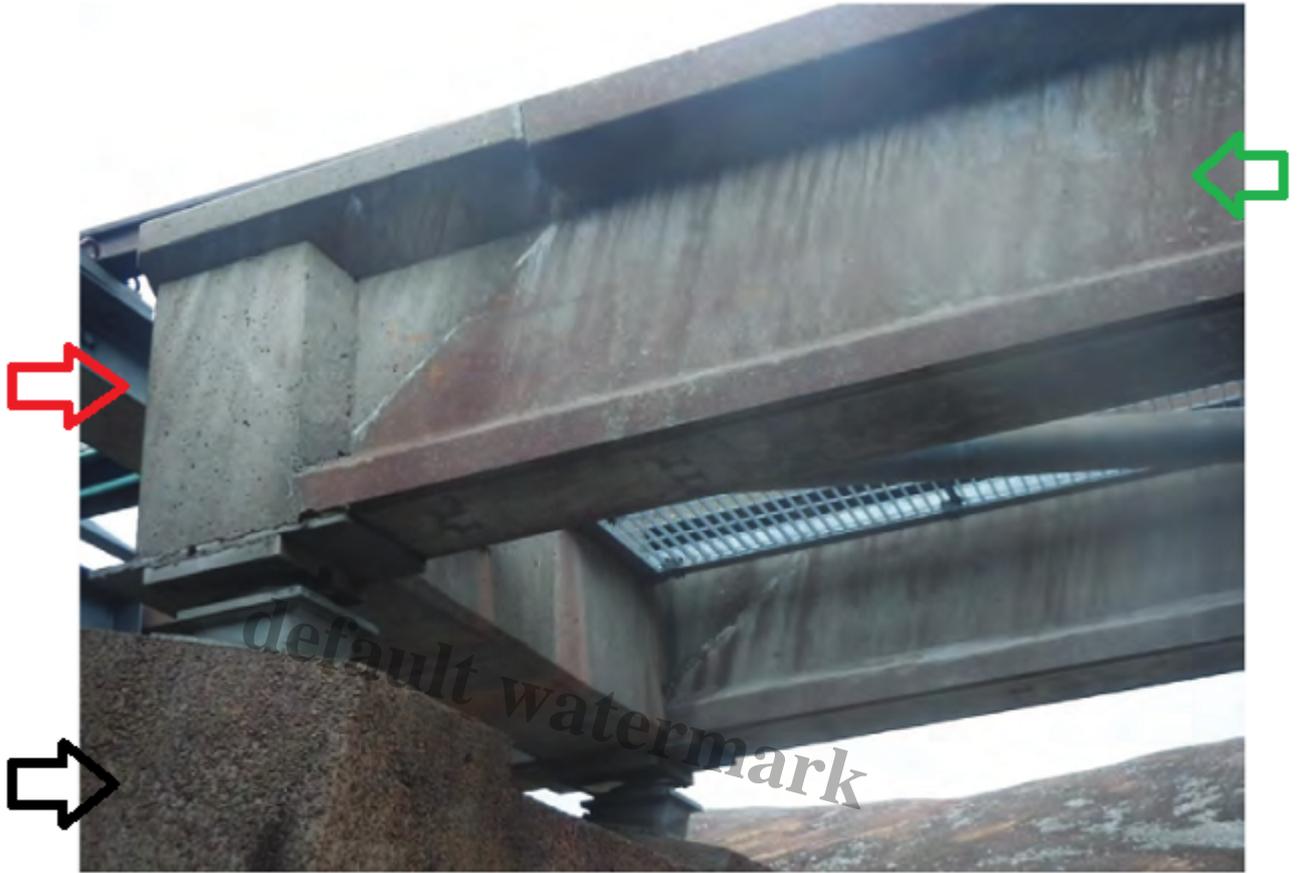
Plate 24 - General view of surface markings to Pier 53 Right Beam, left support up.

Note how the edges in the insitu block are straight and "clean" compared to those shown in plate 18.

Returning to Plate 24, observe that the end of the precast concrete beam is angled, sloping forward from the top edge to the bottom. This gives a much superior joint than a vertical joint. But if you look at the plate which carries the top half of the sliding bearing, that plate only supports the last 50 to 75cms of the end of the beam and, in some cases, due to poor construction, not even that:

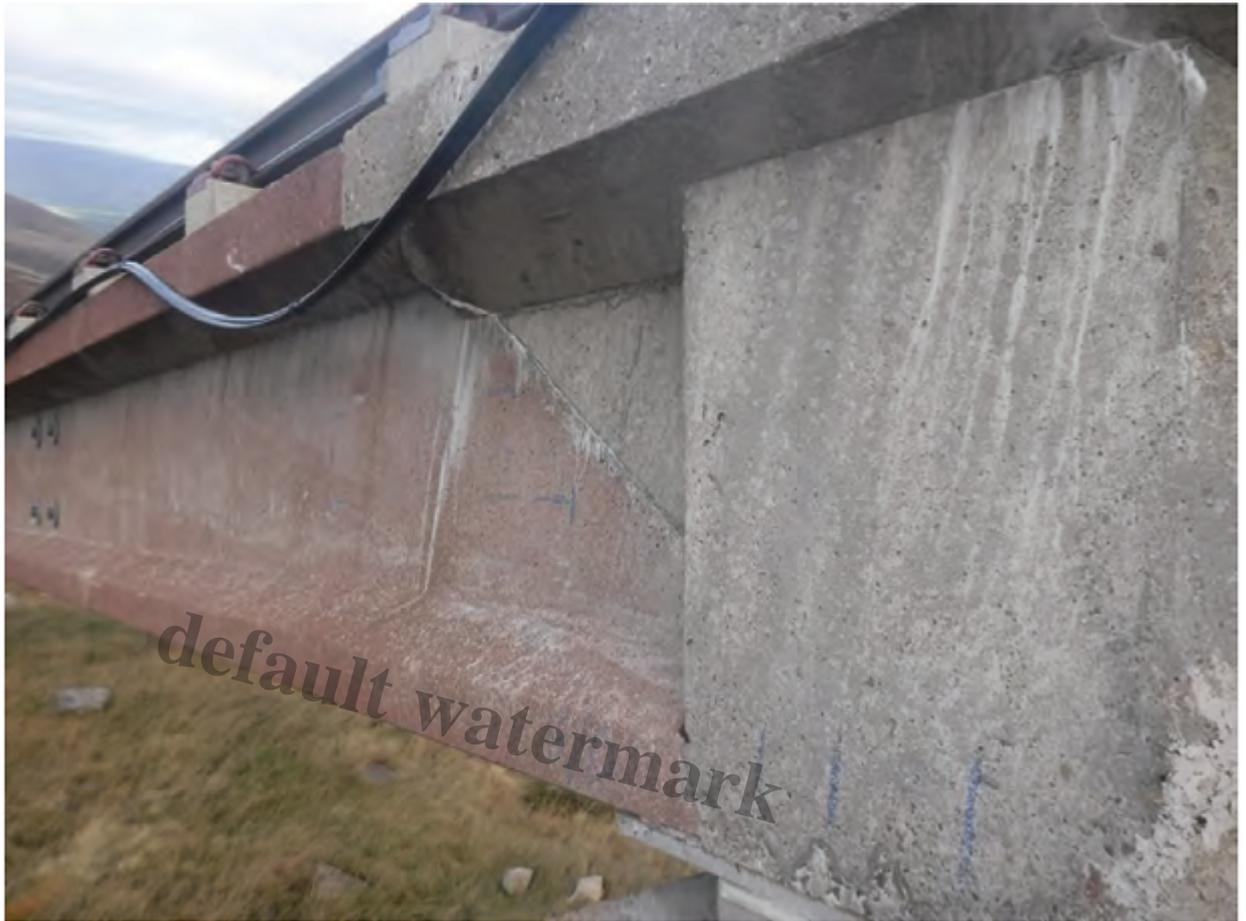
Plate 31 - General view of surface markings to Pier 56 Right Beam down

These could have been caused by the concrete not being vibrated enough with a vibro-rod/ poker or from cold weather.

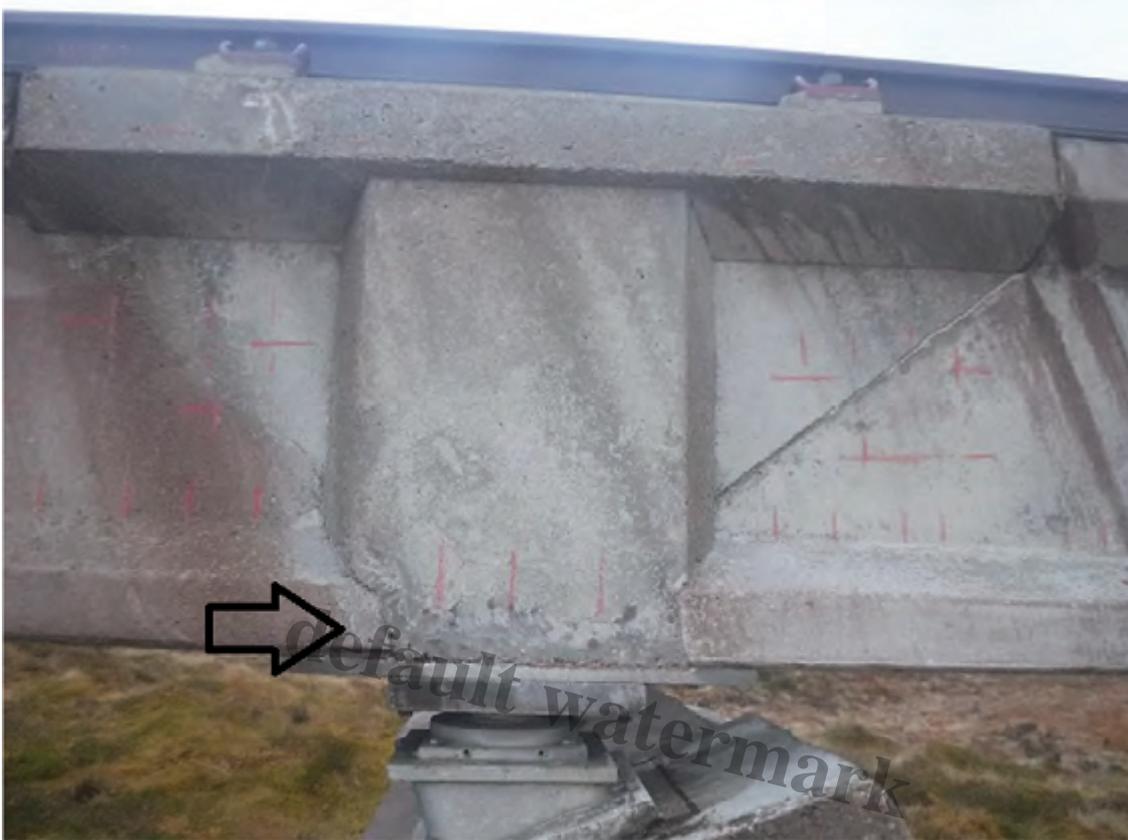
Photo credit COWI report Page 293, plate 38, pier 69, arrow points to possible earlier pour.

Although this apparent difference in the composition of the concrete, which may have weakened the whole structure, could also be caused by ineffective use of the vibro-poker!

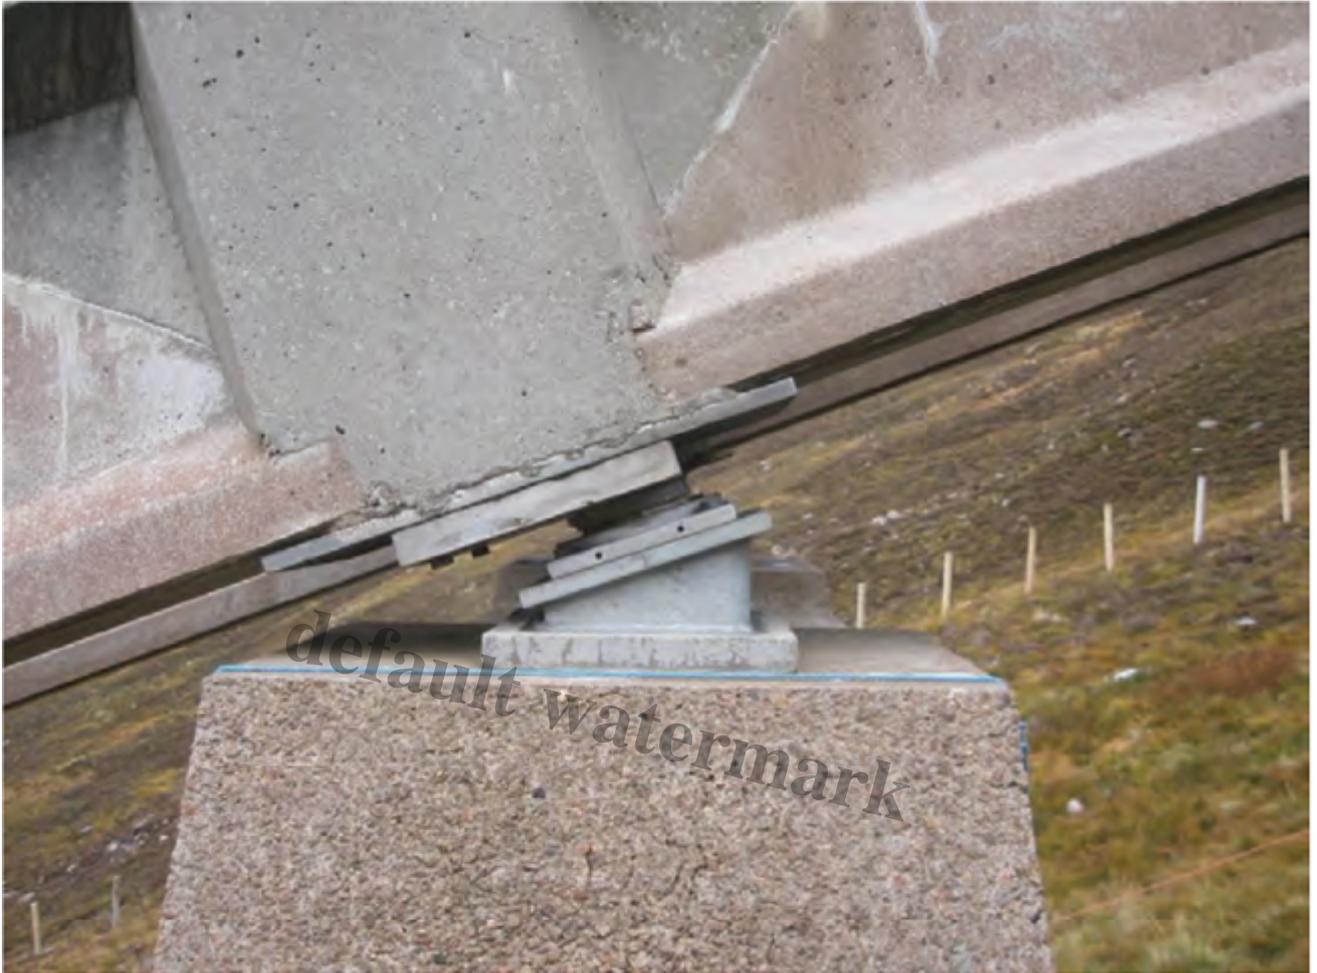
Figure 2-9 Bearing misalignment (refer defect 5)

Note the gap between the two beams and the support plate above the ancon bearing. It appears that the concrete poured to form the insitu block above has partly filled the gap.

(1) The plate should have extended far enough to support the beam from the leading edge of the top flange. The lack of support may account for the damage to the lower flanges of the beams, damage that appears at several different piers.

(2) The plates should also have rounded corners and edges to prevent stress points.

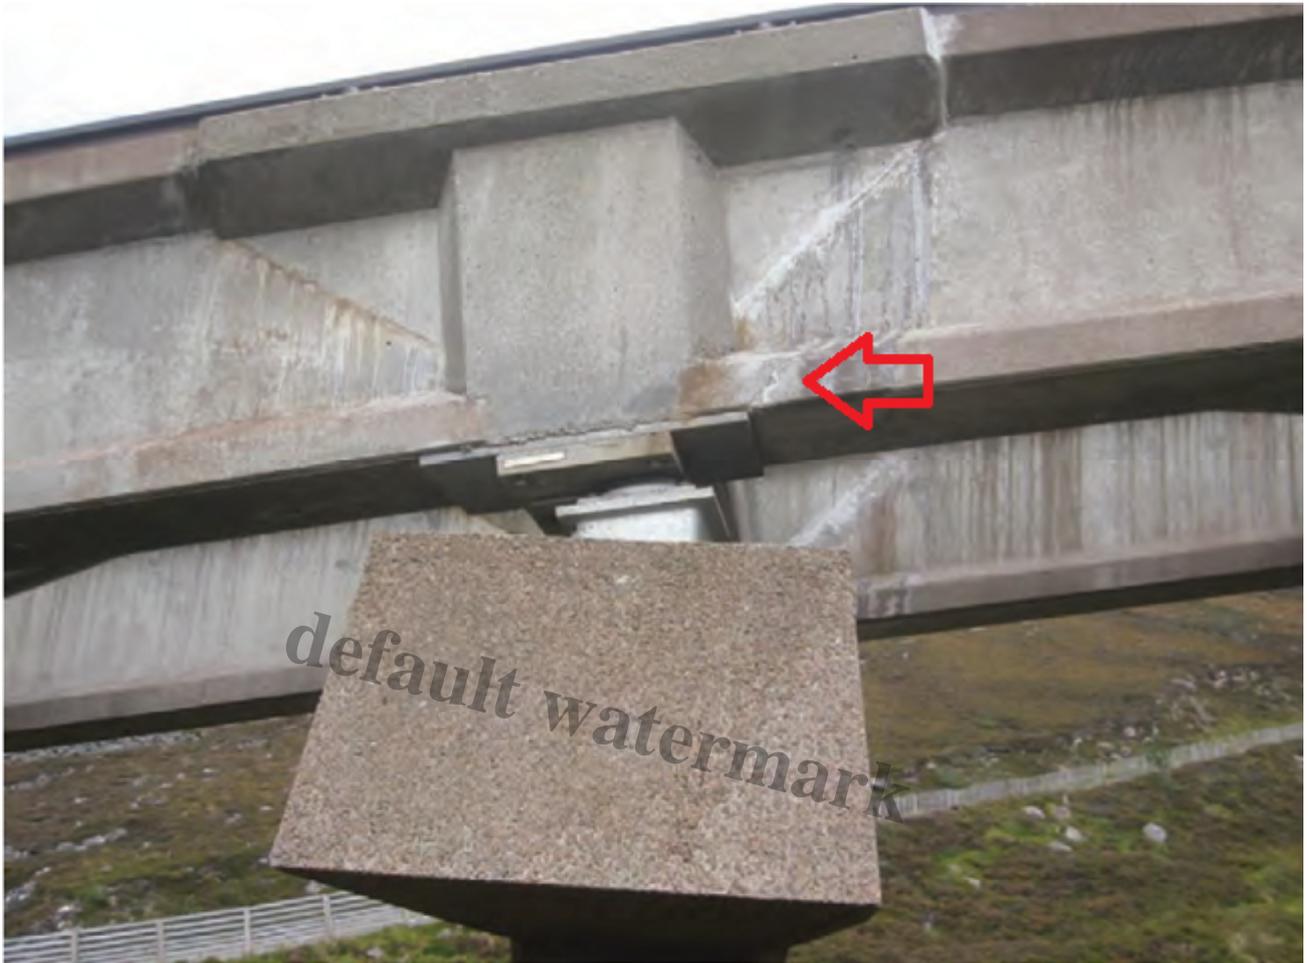
Figure 2-8 Typical crack leakage and bearing misalignment (refer defects 3 and 5)

The red arrow marks what appears to be a crack leading diagonally upwards from the edge of the plate, just where you would expect this to happen if too much weight was placed on an inadequate sharp edged support.

The planning application for the funicular stated that replacement of the Ancon bearings below the plates is part of the repair work, so it will be interesting to see if this includes new longer plates. If so, all the in-situ joints will need to be removed as the support plates have concealed vertical sections that project into the concrete above. That could help explain why the cost of the funicular repairs comes to an extraordinary £16.16m.
