Maintenance and Health and Safety at Cairngorm Mountain (1)

This post takes a further look ([see here](#)) at the ongoing mismanagement of health and safety at Cairn Gorm.

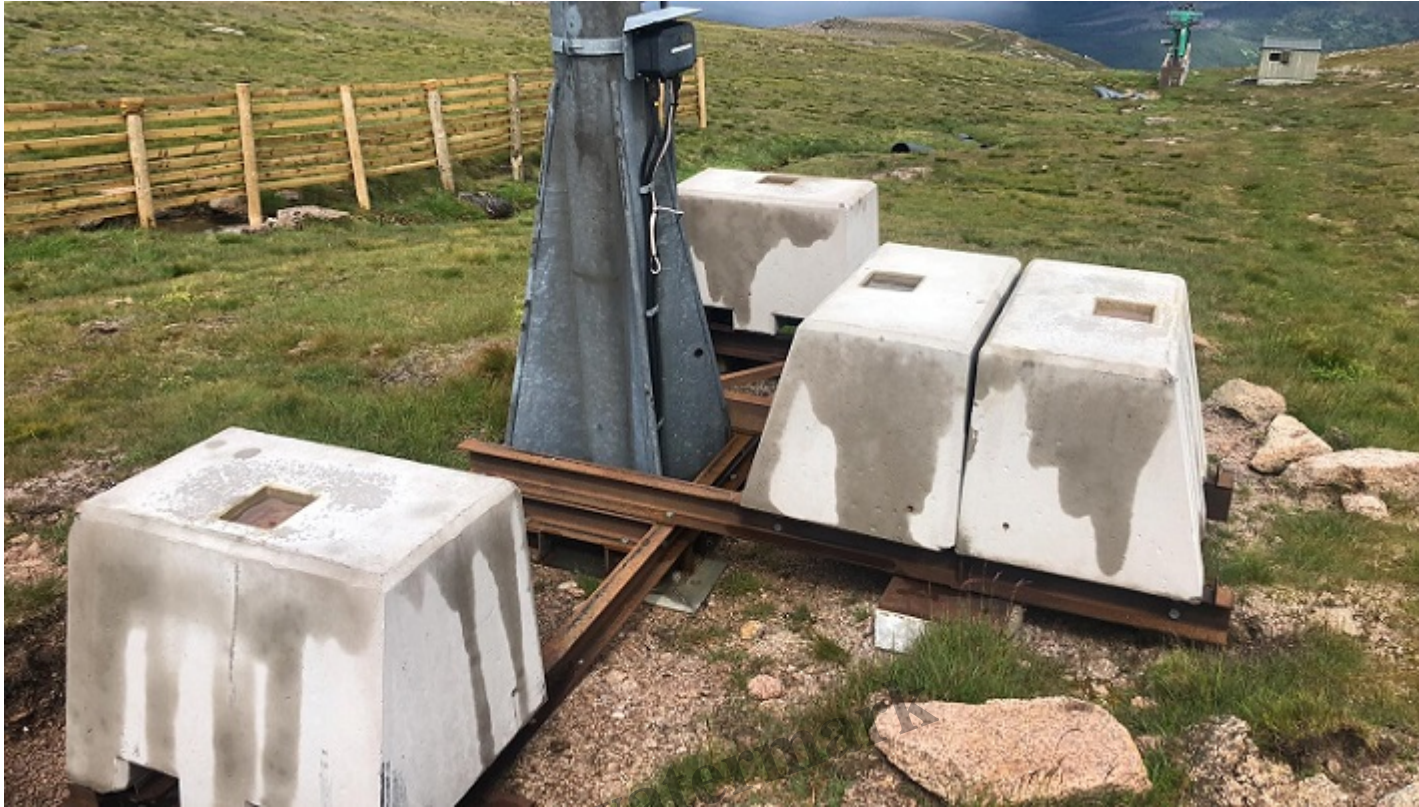
Ptarmigan tow, Pylon 1 with concrete blocks holding it up ? Or are they holding it down as the ropes at this pylon go underneath the pulleys?

It can be seen that this work has just been completed as there is very little water marking and no green algae on the blocks! It also shows poor workmanship in that galvanised steel should have been the preferred option for the framework, but at the very least this could have been painted with a suitable metal paint rather than just left to corrode!

The interesting fact, however, is this particular pylon had previously been mentioned in reports by a firm called ADAC Structures dated 16/11/2015, 22/12/2016 and from 20/07/2017. This comment comes from the last report:

- 4.11.3 Base 1, bolts grade 4. Missing washer on one bolt, so this is ineffective, meaning second bolt has twice the stress, this could fail under load. Action required.

Para 4.11.3. raises the question was this bolt fixed or did it subsequently fail resulting in the remedial work in the first photo?

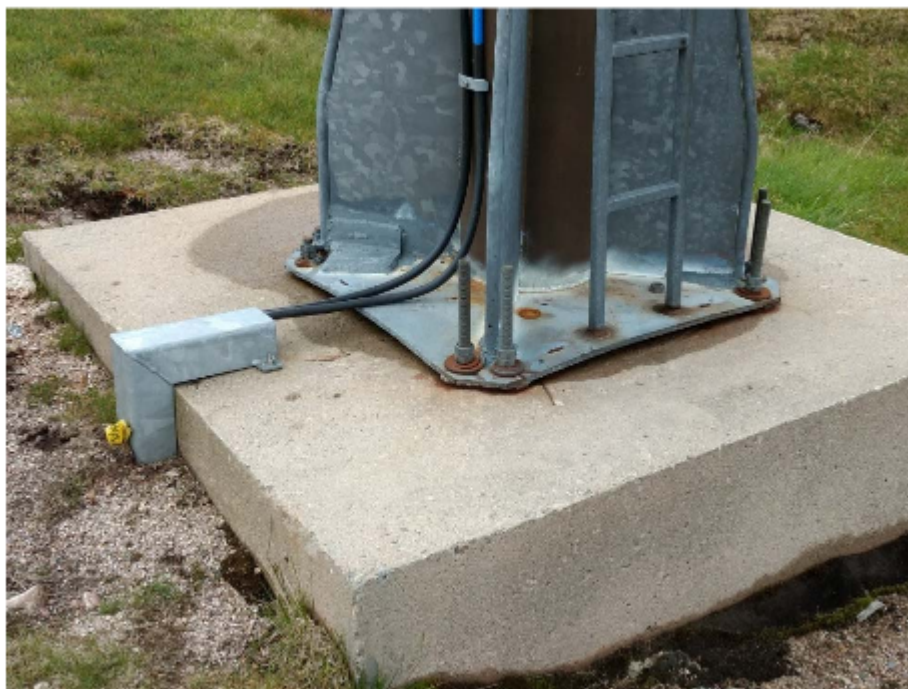
- 4.11.4 Base 2, plate is deformed, presumably due to frost action. It is recommended that all base plates be grouted up. See pic in appendix A.
- 4.11.5 Base 4 is close to being undermined. **Monitor.**

Para 4.11.4. "Base 2, plate is deformed, presumably due to frost action. It is recommended that all base plates are grouted up. See pic. In appendix A"

Photo 1 – base plate deformed by ice action.

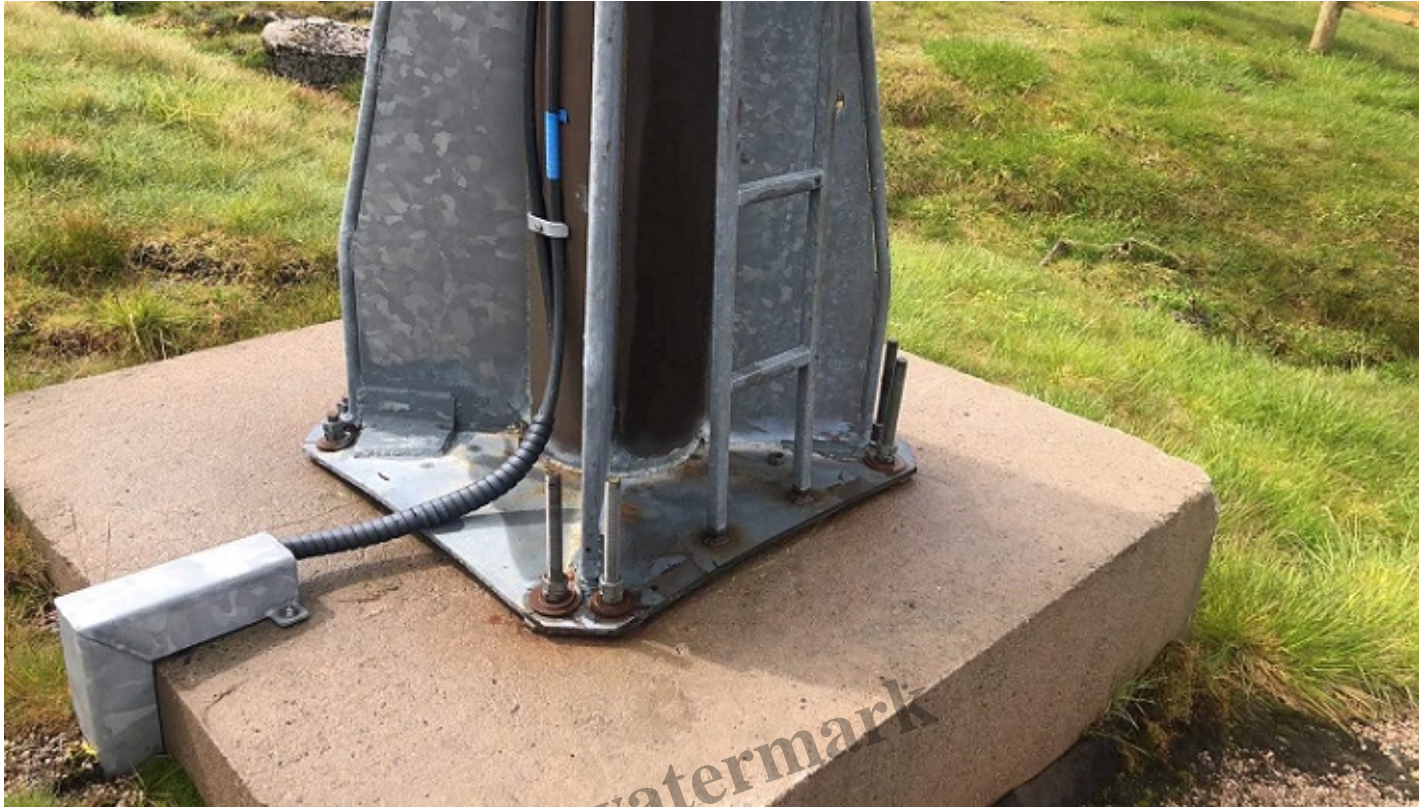
Photo 2 courtesy of a member of the public, summer 2020.

That base plate is clearly in very poor condition judging by the number of welds, the angle iron welded on to an upright and the stains which form when untreated steel rusts! The long lengths of studding left above the double nut arrangement are also a safety risk to anyone working on that pylon!

Because there are no reports in the public domain after 20/07/2017 we do not know whether the work highlighted in red in paras in 4.11.5 and 4.11.6 (above) has been undertaken, but one thing is certain, the Ptarmigan tow is in a very dilapidated state possibly even needing full refurbishment!
