## Maintenance and Health and Safety at Cairngorm Mountain (1)

This post takes a further look ([see here](#)) at the ongoing mismanagement of health and safety at Cairn Gorm.

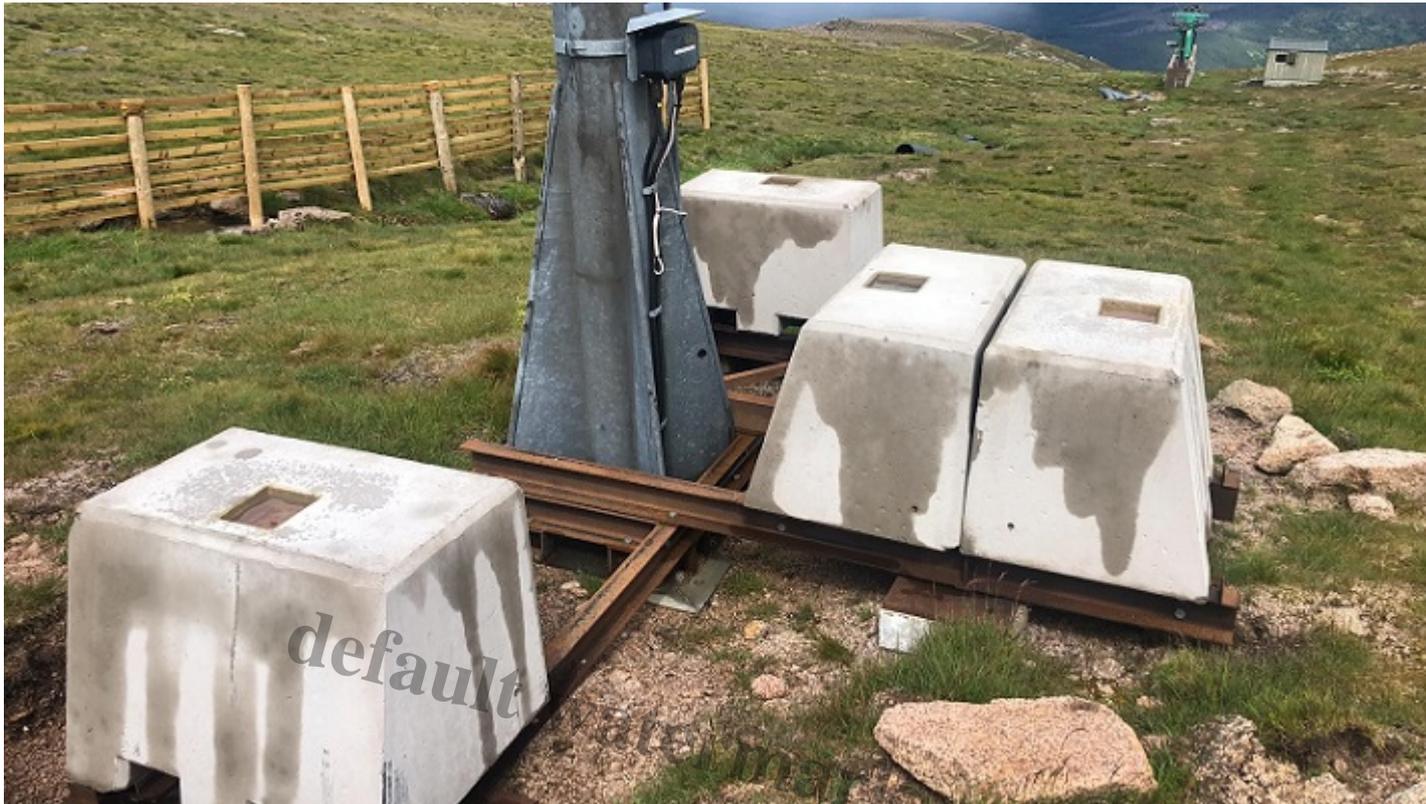
Ptarmigan tow, Pylon 1 with concrete blocks holding it up ? Or are they holding it down as the ropes at this pylon go underneath the pulleys?

It can be seen that this work has just been completed as there is very little water marking and no green algae on the blocks! It also shows poor workmanship in that galvanised steel should have been the preferred option for the framework, but at the very least this could have been painted with a suitable metal paint rather than just left to corrode!

- 4.11.3 Base 1, bolts grade 4. Missing washer on one bolt, so this is ineffective, meaning second bolt has twice the stress, this could fail under load. Action required.

Para 4.11.3. raises the question was this bolt fixed or did it subsequently fail resulting in the remedial work in the first photo?

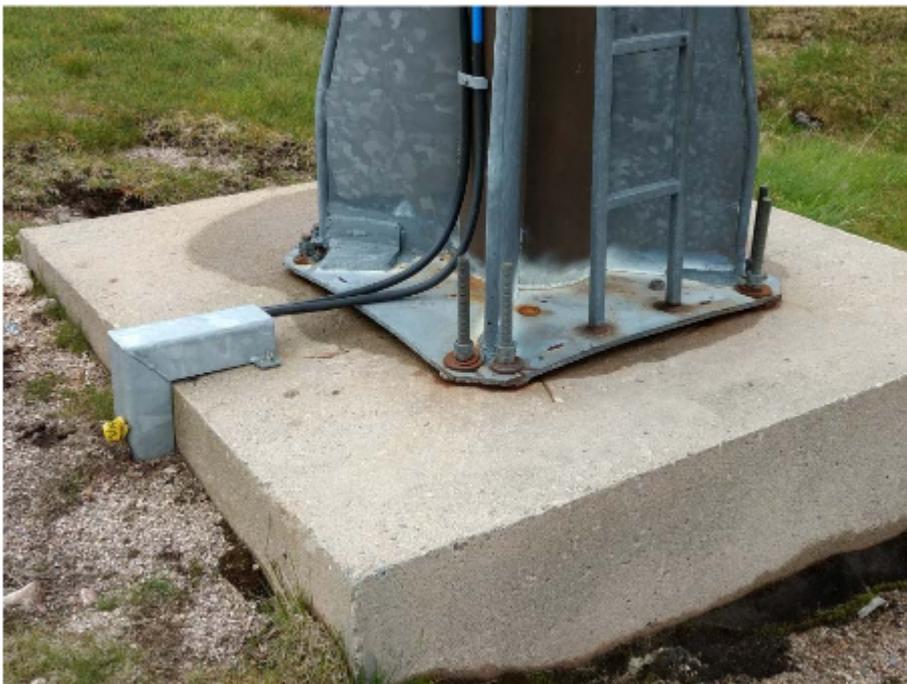
- 4.11.4 Base 2, plate is deformed, presumably due to frost action. It is recommended that all base plates be grouted up. See pic in appendix A.
- 4.11.5 Base 4 is close to being undermined. **Monitor.**

Photo 1 – base plate deformed by ice action.

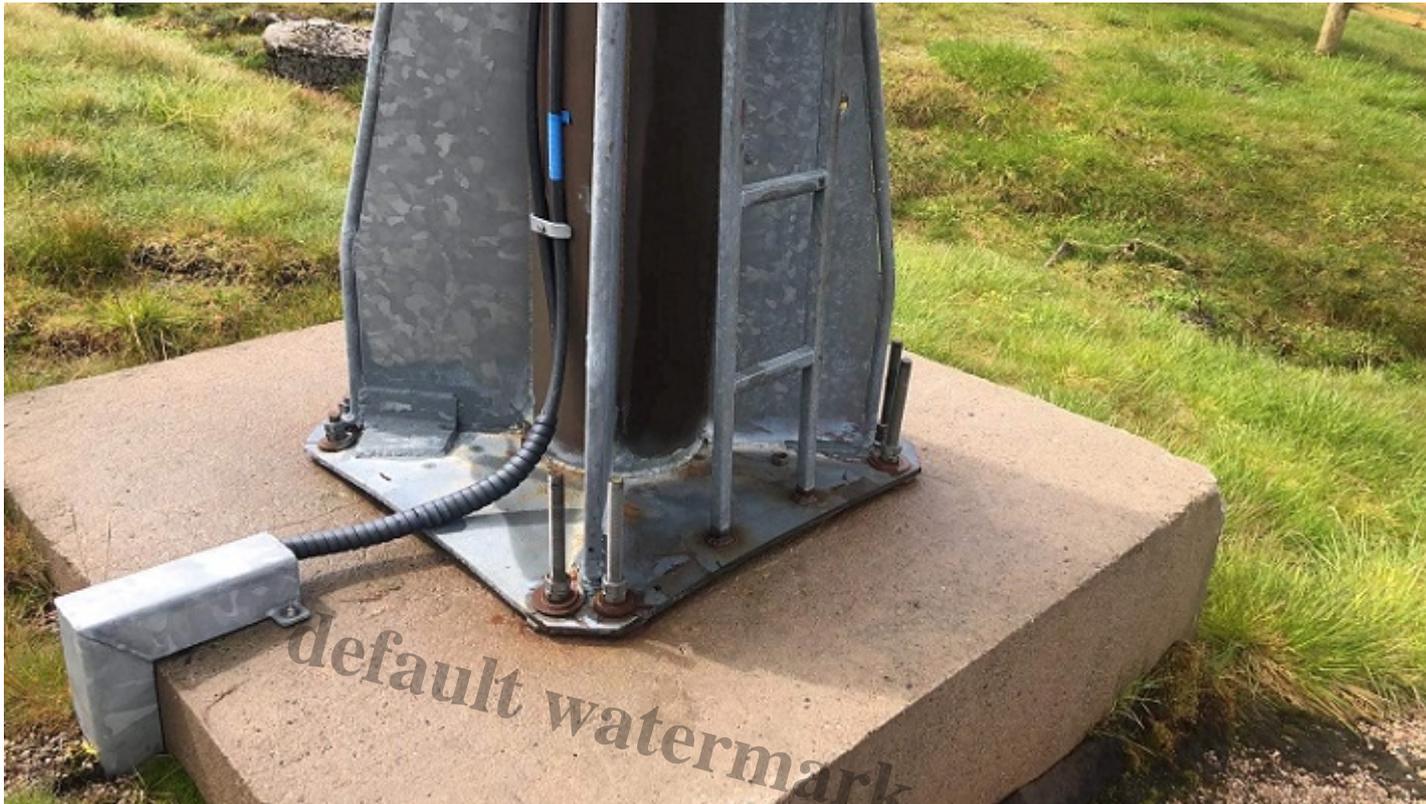
Photo 2 courtesy of a member of the public, summer 2020.

That base plate is clearly in very poor condition judging by the number of welds, the angle iron welded on to an upright and the stains which form when untreated steel rusts! The long lengths of studding left above the double nut arrangement are also a safety risk to anyone working on that pylon!
