Re-engineering ‘run of river hydro schemes’ • Upper Glen Falloch

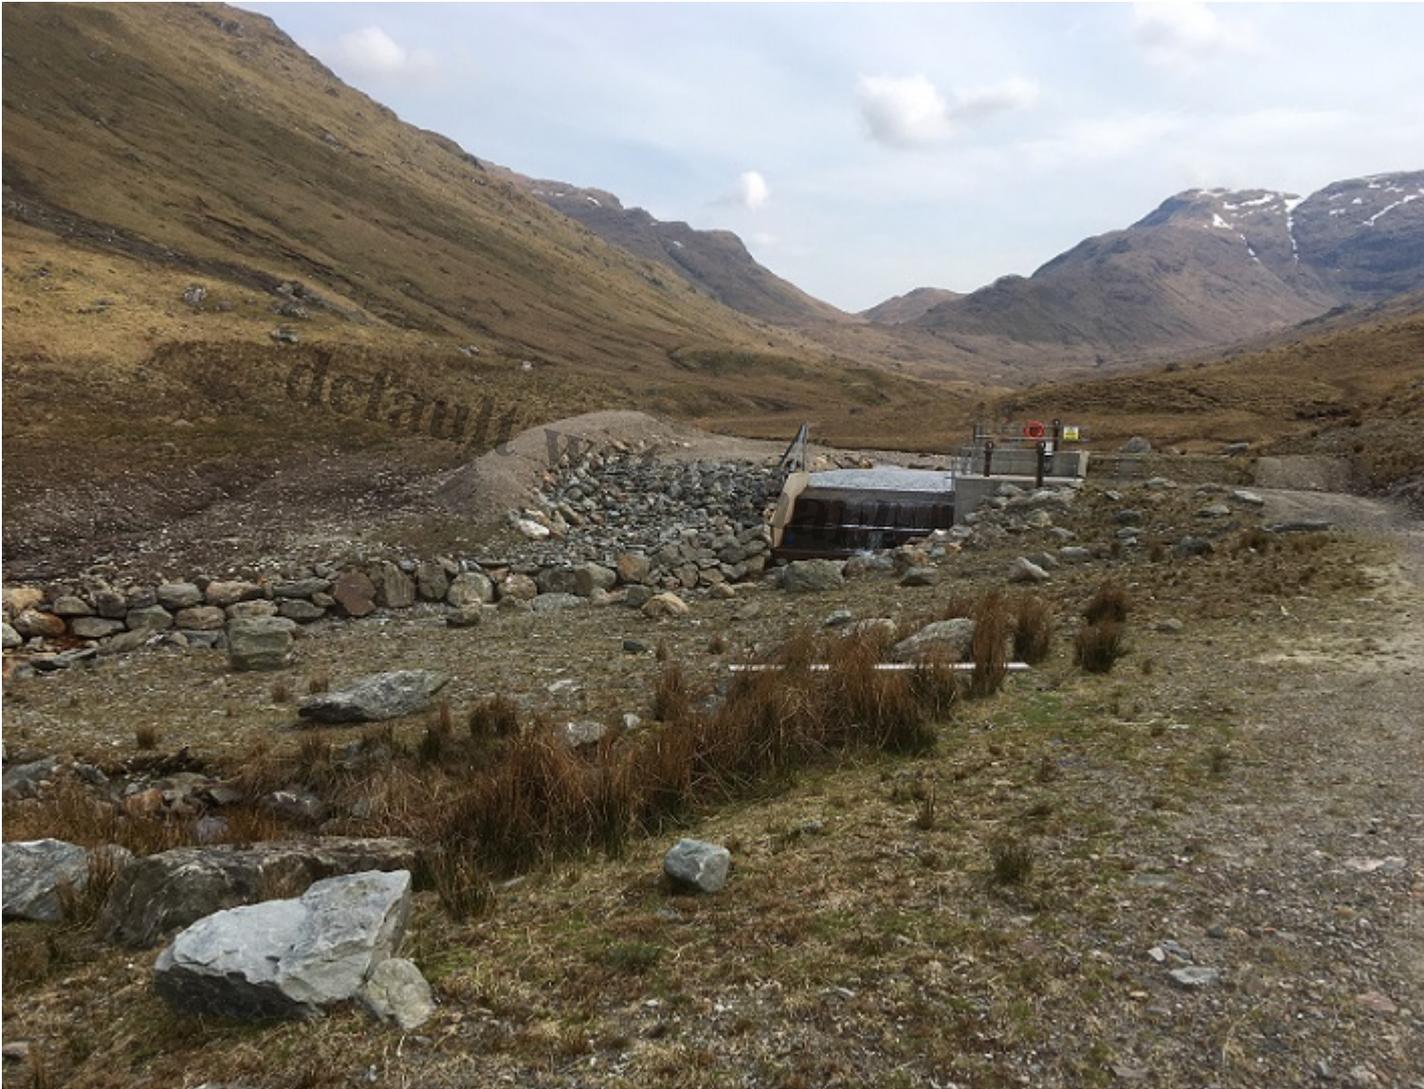
The Upper Glen Falloch hydro intake April 2020, looking in Coire Earb with the popular Munro, Beinn Chroin on the right. Note the new bank, between the area of peat on the left and the boulderly slope to the intake. Photo Credit Helen Todd.

The top photo suggests that, as well as dredging the pool to enable the hydro to operate, the idea behind the creation of the bank was to try and create a defined overflow channel for when the River Falloch floods again and to prevent it diverting round the hydro intake, as almost happened in August 2018:

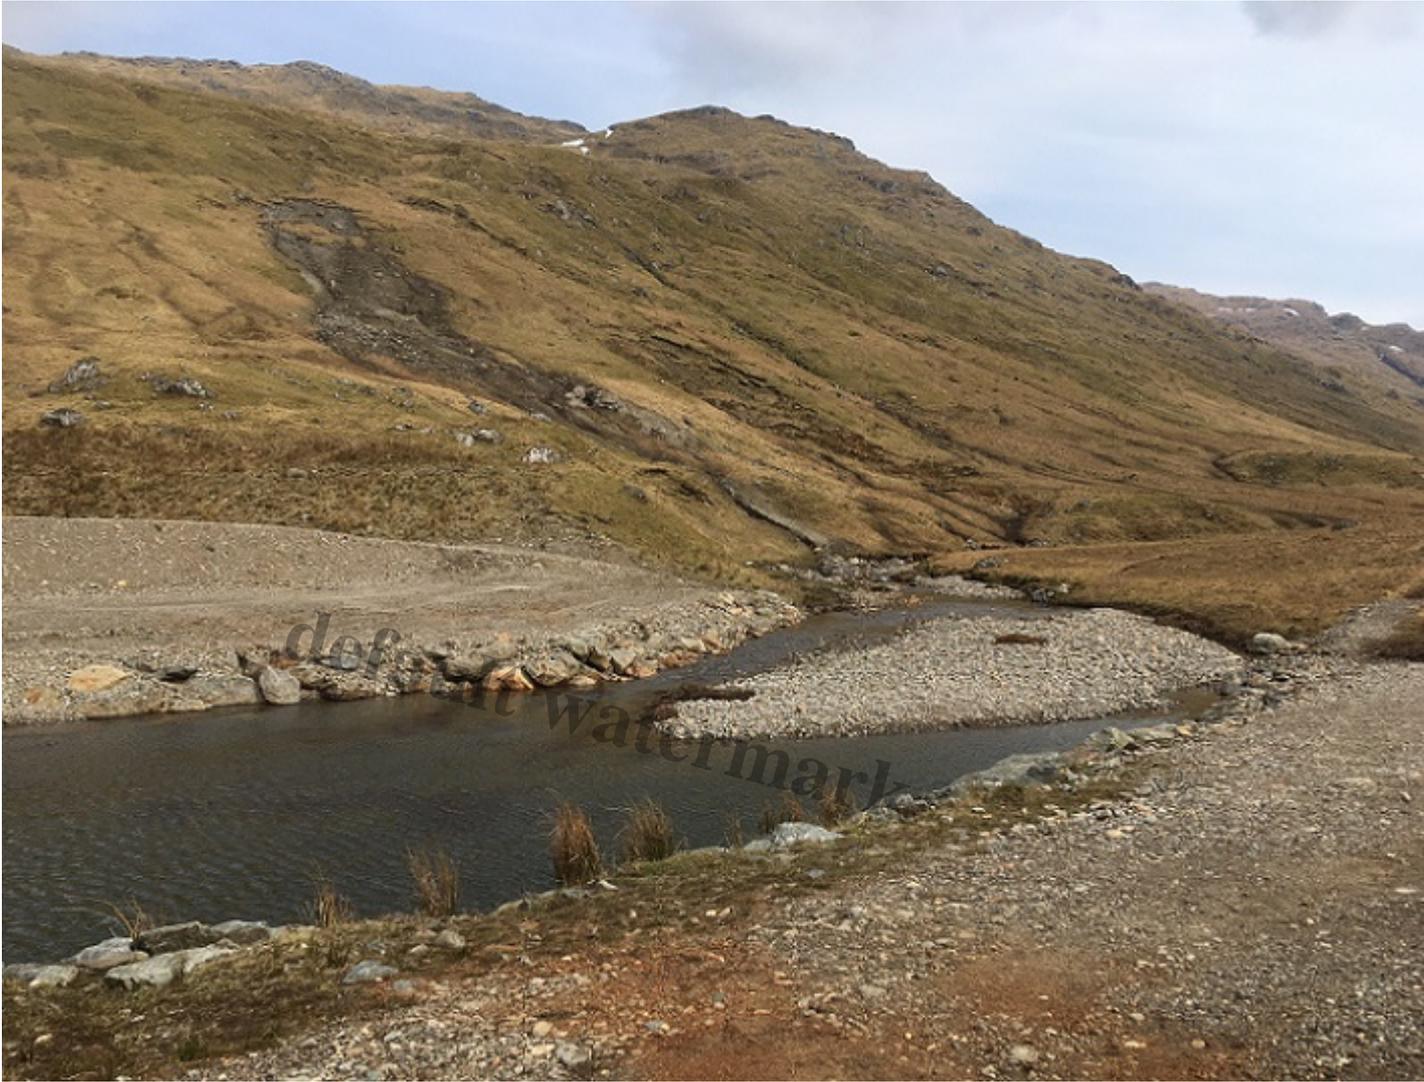
The Upper Glen Falloch intake pool April 2021 Photo Credit Helen Todd

- there has been a major landslip on the hillside just behind the pool (a secondary eroded patch of hillside behind is evident in the August photo but appears to have deteriorated since then);
- much of the shingle bank that had infilled the pool has disappeared; and
- significant quantities of stony material has been laid on the rip rap bouldering on the far side of the pool and used to form a new bank behind.

What appears to have happened is that the hydro intake pool has been dredged and the material then used to re-engineer the far bank. The lack of any sign of debris from the landslip in the pool suggests that the dredging took place after it occurred and was possibly prompted by it. How long to the next one?

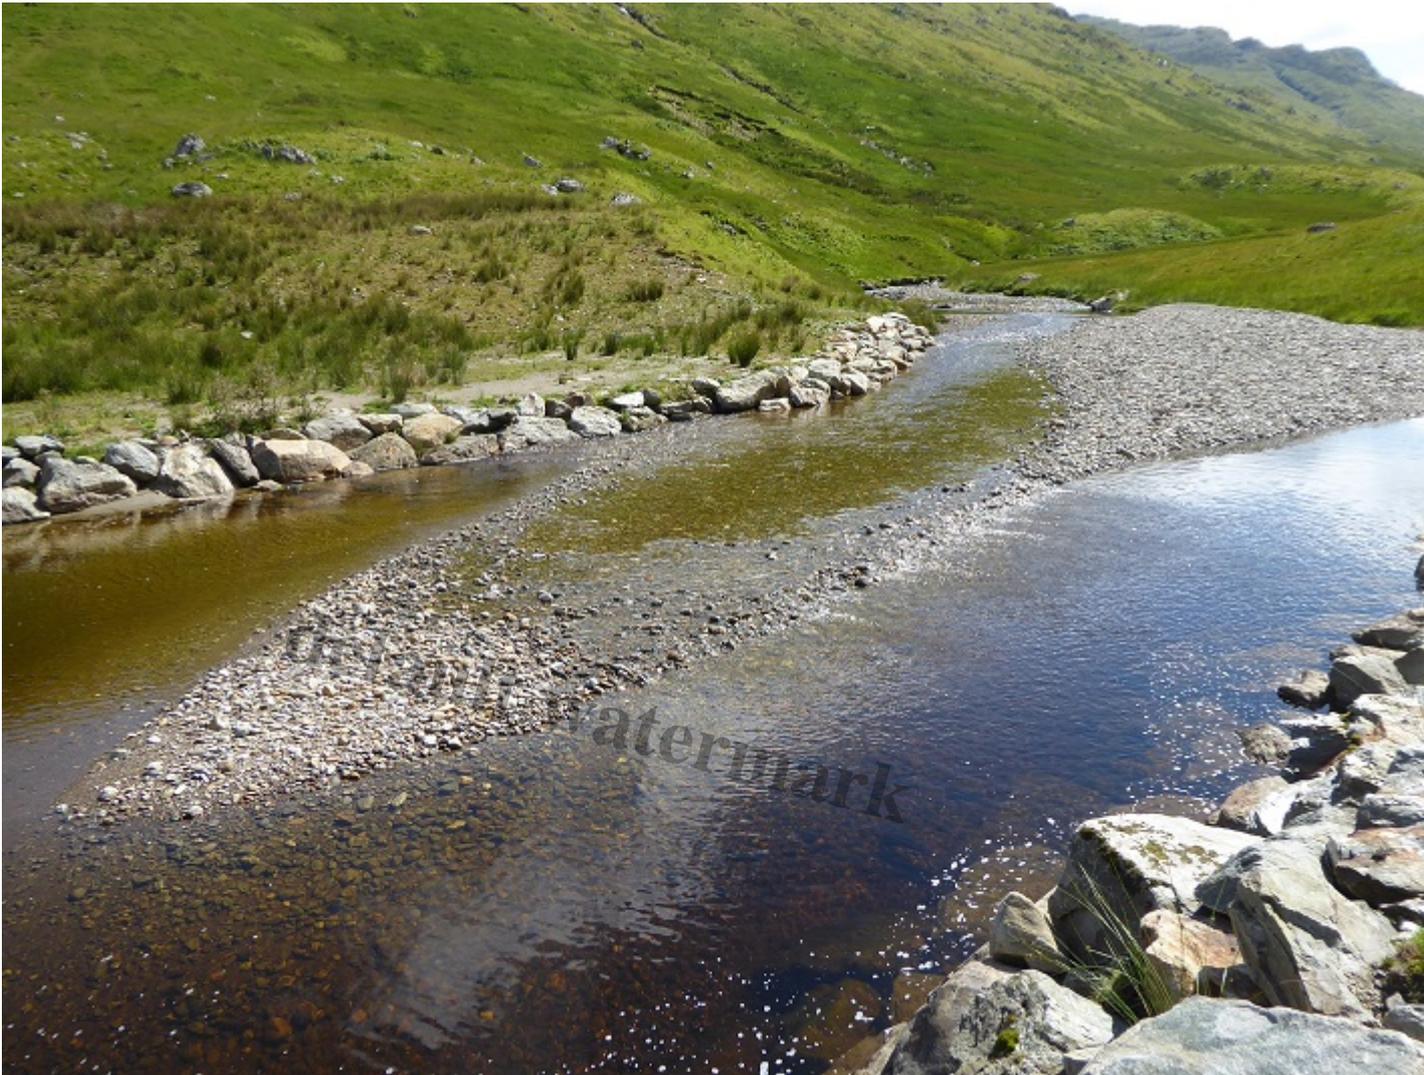
How the upper part of the intake pool appeared in August 2020

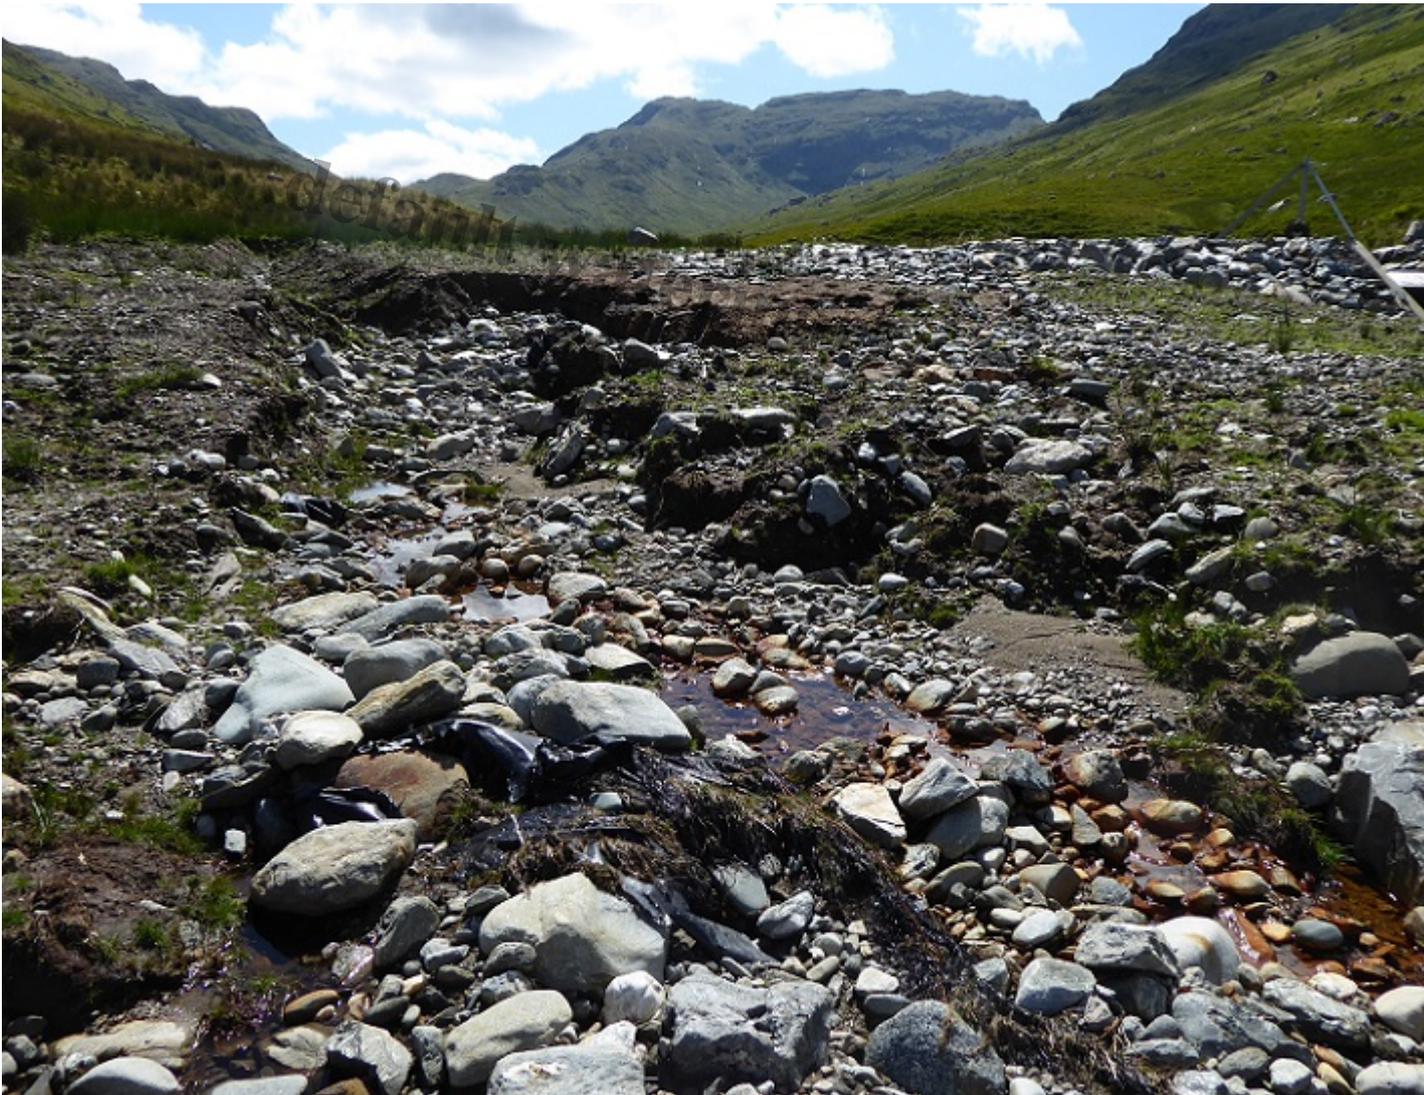
The channel created by the flood has now been "restored" and the peaty area has been separated from the river by the new bank

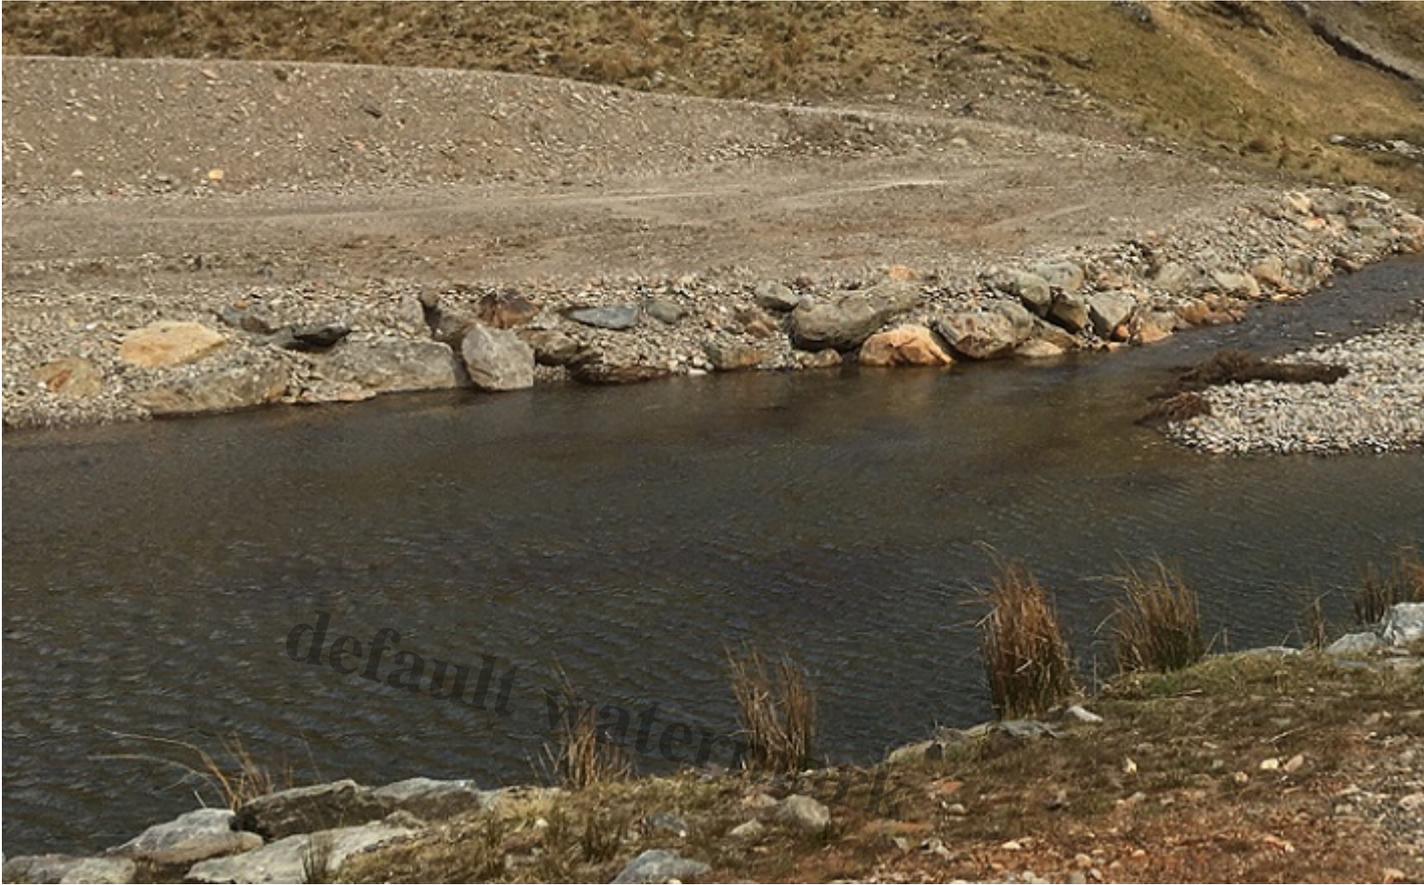
Detail from second photo above, photo credit Helen Todd

It is possible that the shingle that has been placed on top of the rip rap bouldering will enable the edge of the pool to re-vegetate, which would help it resist erosion. But it appears equally possible that the next flood will wash it all back into the pool! Because there is no planning application, it is impossible for the public to know whether this aspect of the work has been based on expert opinion or a wing and a prayer.

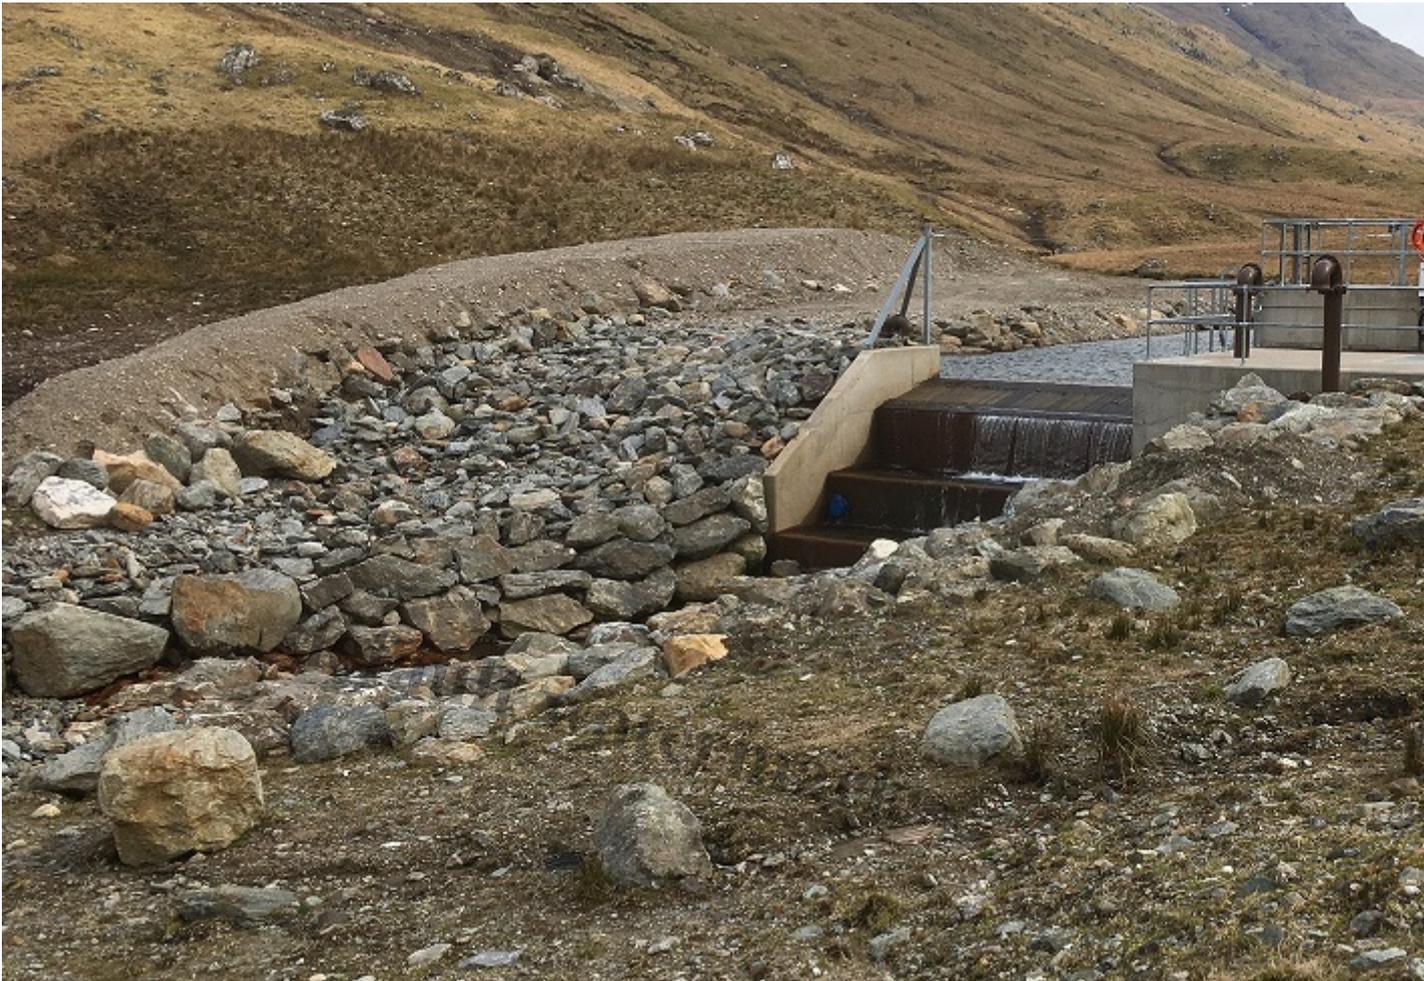
The photo clearly shows how the new bank appears intended to channel overflowing water down be with the boulderly slope (which appears to have been extended) apparently intended to form the bas channel

The new bank and bed of the overflow channel, however, appears completely unfit for purpose if intended to channel flood water. There is direct evidence for this from the River Gynack overflow scheme above Kingussie. There, many of the boulders used to form the base of the channel and the earth banks were so severely eroded at the first flood that the scheme itself has been effectively abandoned ([see here](#)). Unfortunately, the Cairngorms National Park Authority has not acted on my call for an inquiry into what went wrong there. However embarrassing, that might have helped prevent similar mistakes being repeated across the country. That failure does not, however, excuse this: anyone can that the new bank with its sandy sides is at high risk of being swept away.
