Re-engineering “run of river hydro schemes” – Upper Glen Falloch

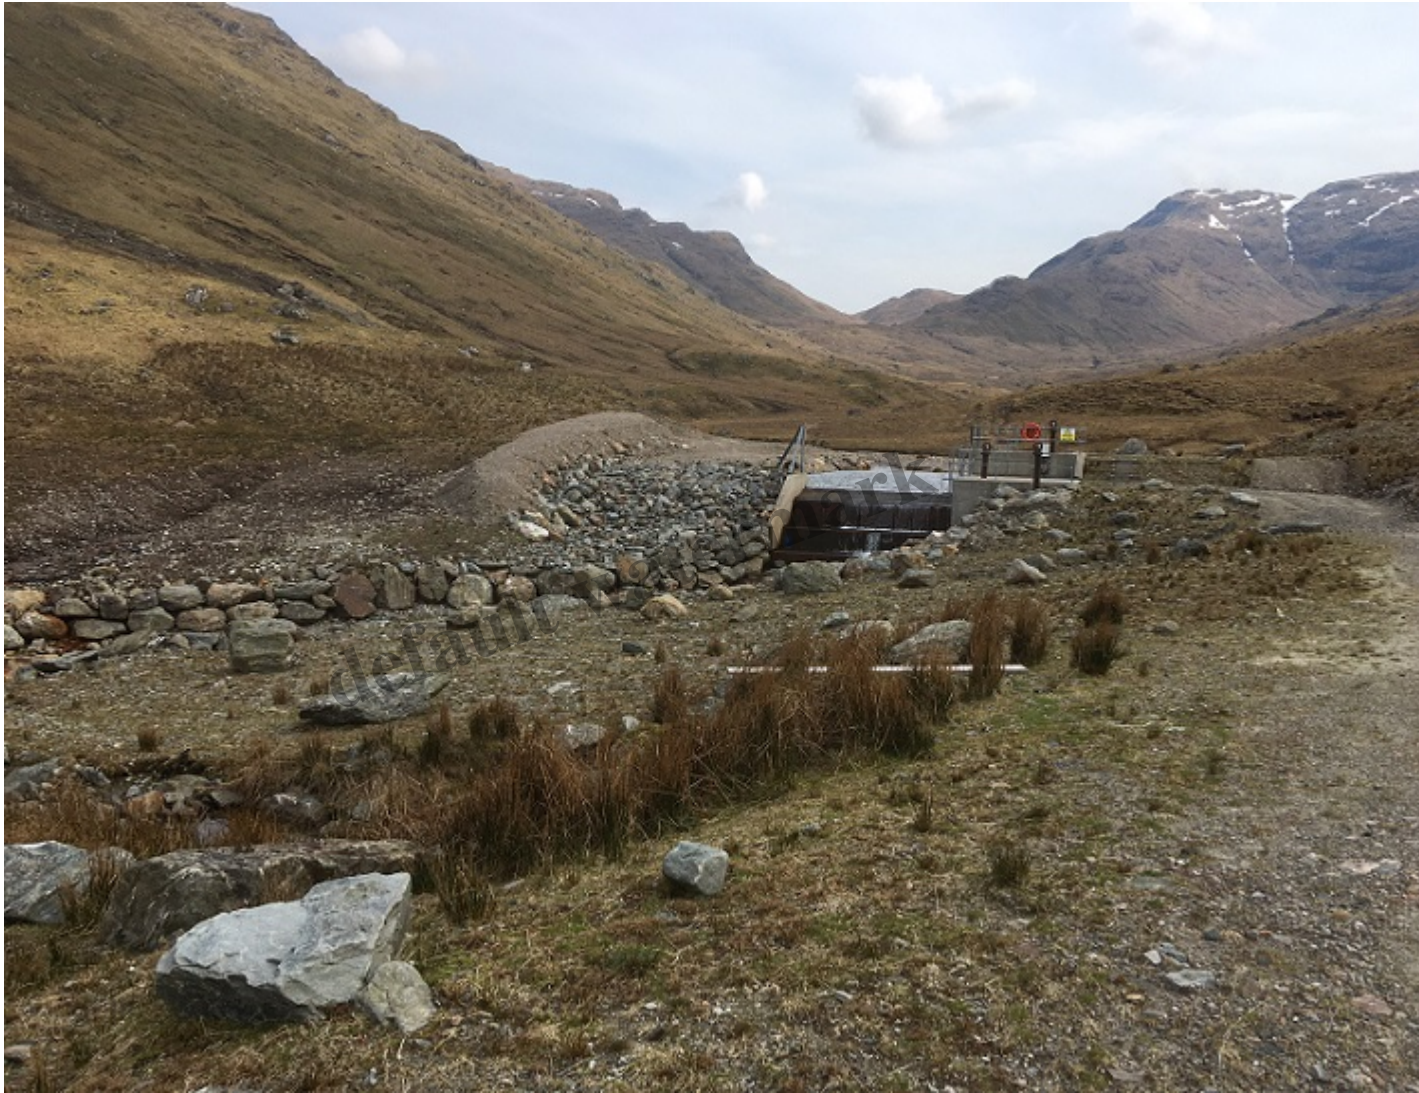
The Upper Glen Falloch hydro intake April 2020, looking in Coire Earb with the popular Munro, Beinn a Chroin on the right. Note the new bank, between the area of peat on the left and the boulderly slope by the intake. Photo Credit Helen Todd.

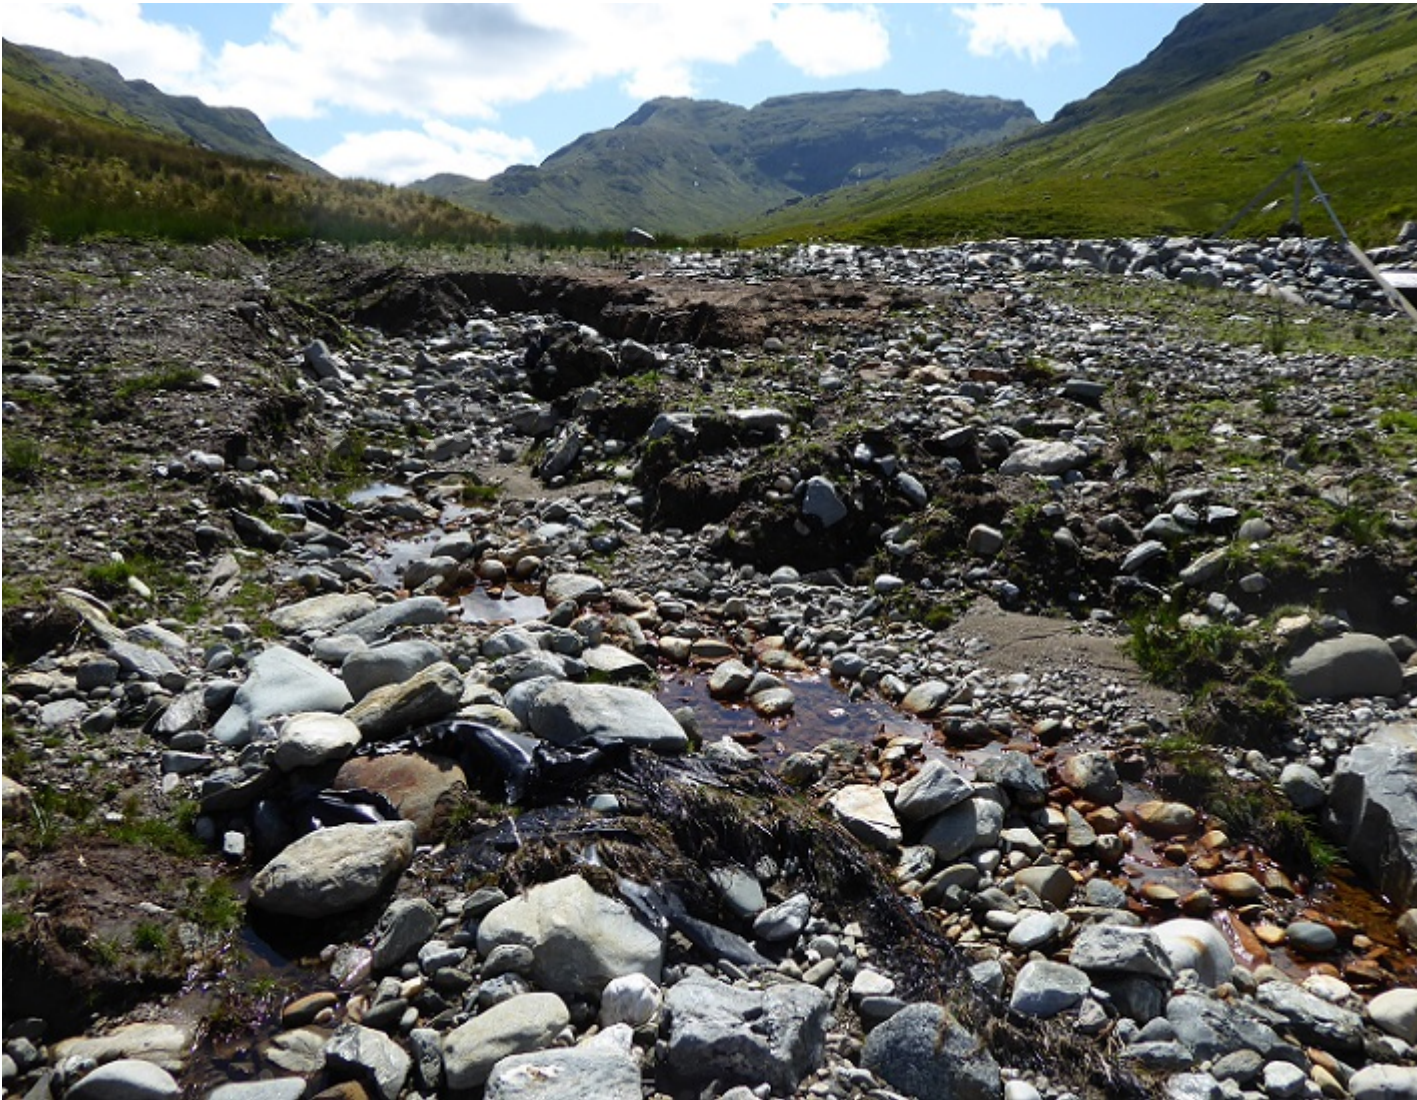
The channel created by the flood has now been “restored” and the peaty area has been separated from the river by the new bank

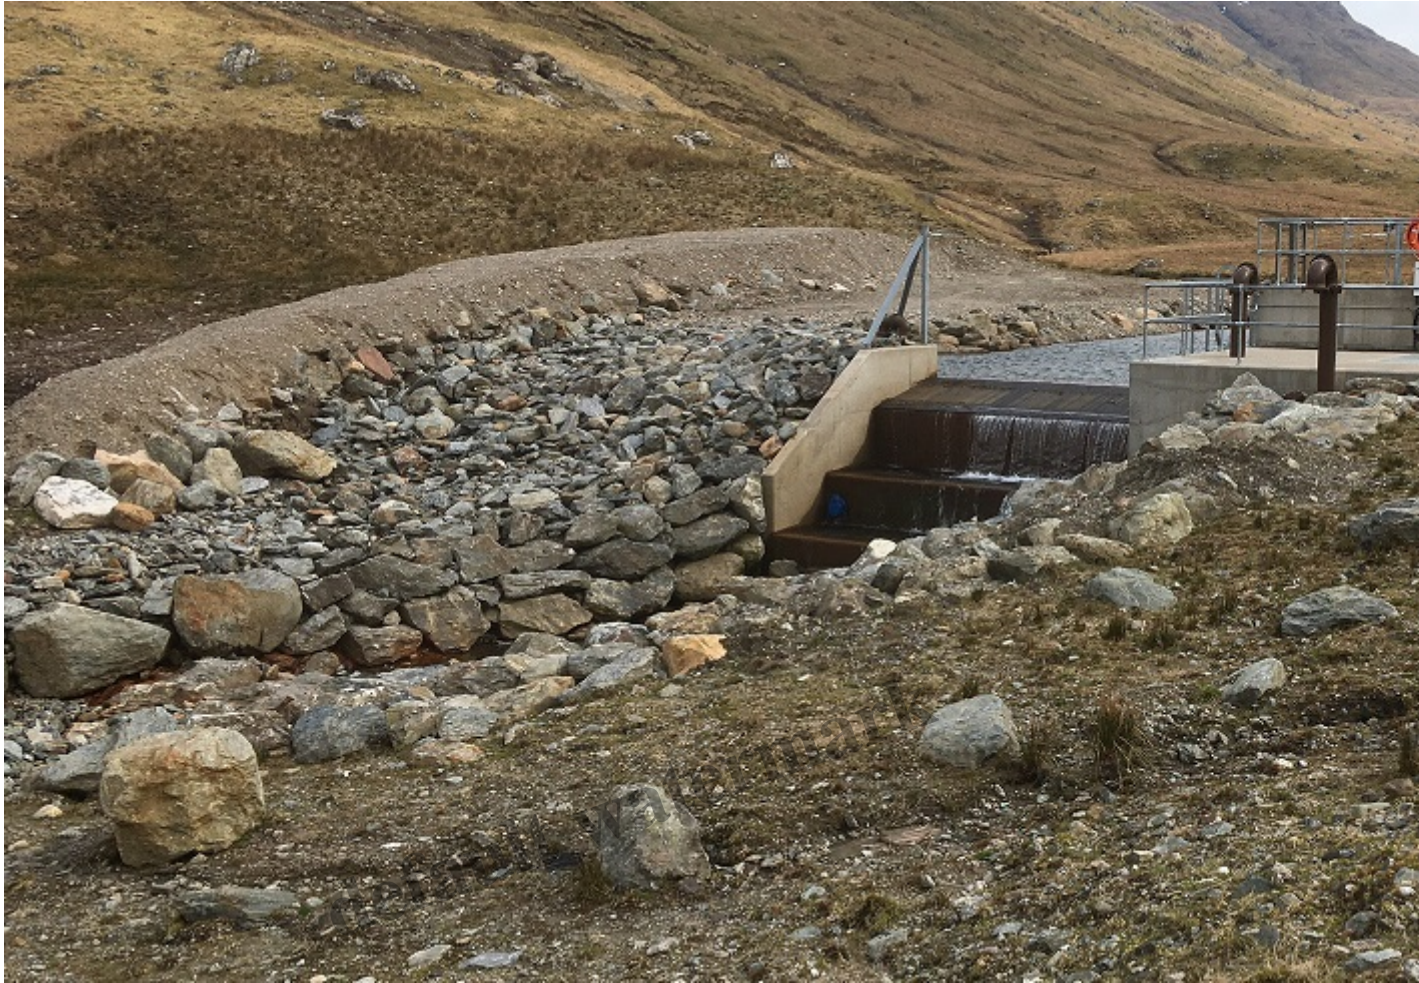
The photo clearly shows how the new bank appears intended to channel overflowing water down be with the boulderly slope (which appears to have been extended) apparently intended to form the base channel

The new bank and bed of the overflow channel, however, appears completely unfit for purpose if intended to channel flood water. There is direct evidence for this from the River Gynack overflow scheme above Kingussie. There, many of the boulders used to form the base of the channel and the earth banks were so severely eroded at the first flood that the scheme itself has been effectively abandoned ([see here](#)). Unfortunately, the Cairngorms National Park Authority has not acted on my call for an inquiry into what went wrong there. However embarrassing, that might have helped prevent similar mistakes being repeated across the country. That failure does not, however, excuse this: anyone can that the new bank with its sandy sides is at high risk of being swept away.
