## Re-engineering “run of river hydro schemes” – Upper Glen Falloch

April 22, 2021

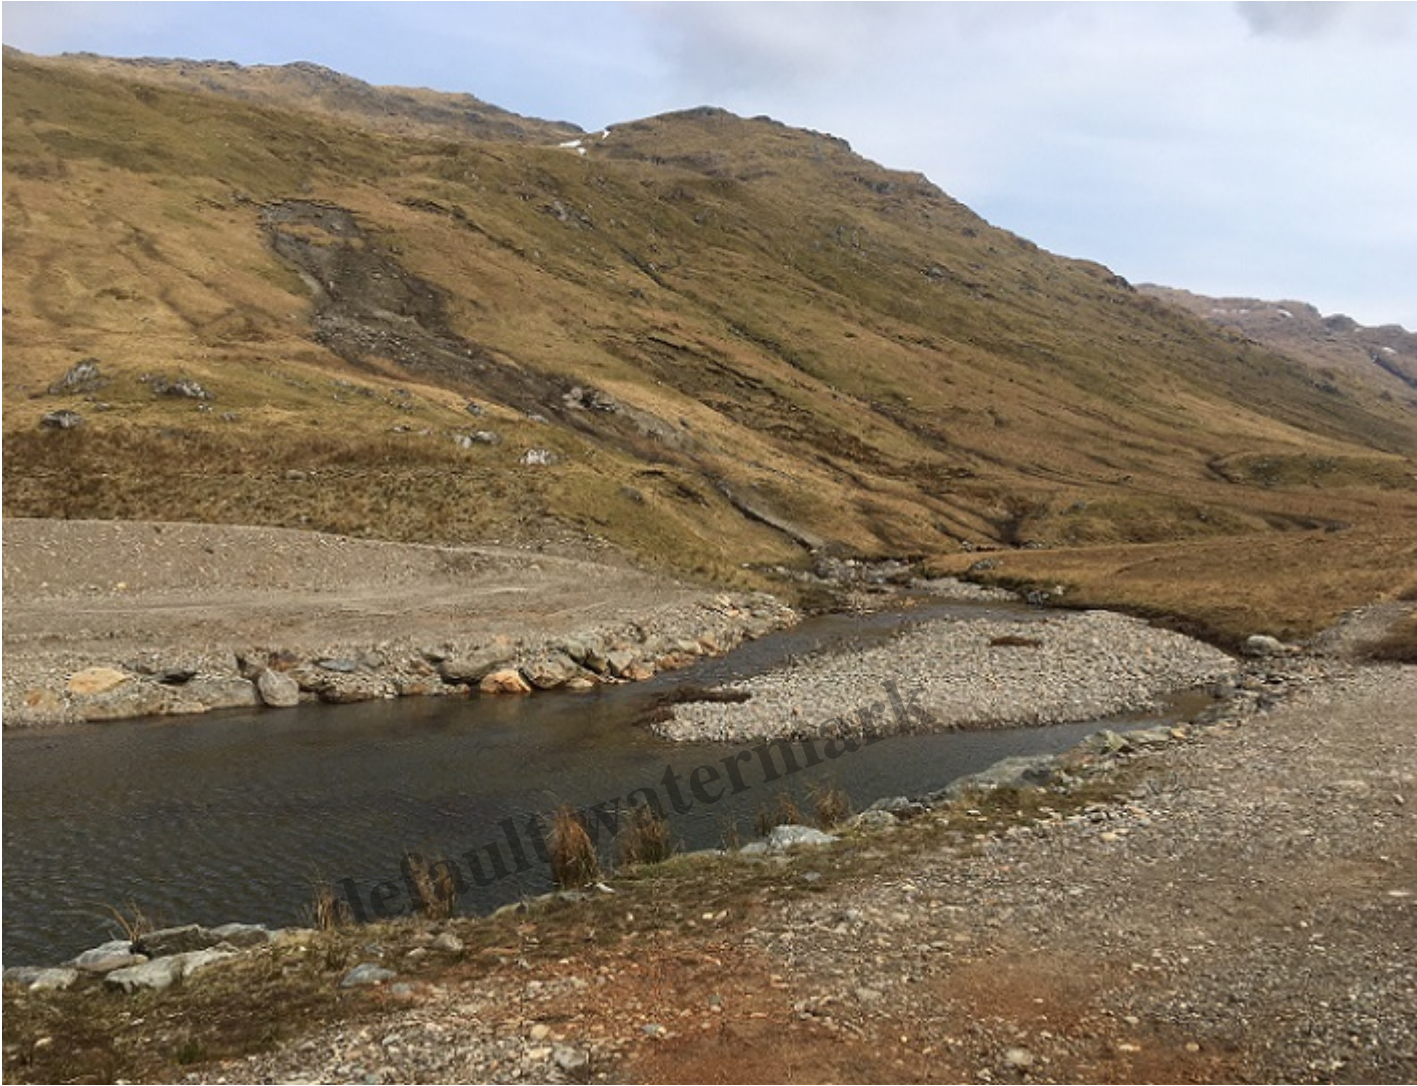
The Upper Glen Falloch intake pool April 2021 Photo Credit Helen Todd

- there has been a major landslip on the hillside just behind the pool (a secondary eroded patch of hillside behind is evident in the August photo but appears to have deteriorated since then);
- much of the shingle bank that had infilled the pool has disappeared; and
- significant quantities of stony material has been laid on the rip rap bouldering on the far side of the pool and used to form a new bank behind.

What appears to have happened is that the hydro intake pool has been dredged and the material then used to re-engineer the far bank. The lack of any sign of debris from the landslip in the pool suggests that the dredging took place after it occurred and was possibly prompted by it. How long to the next one?

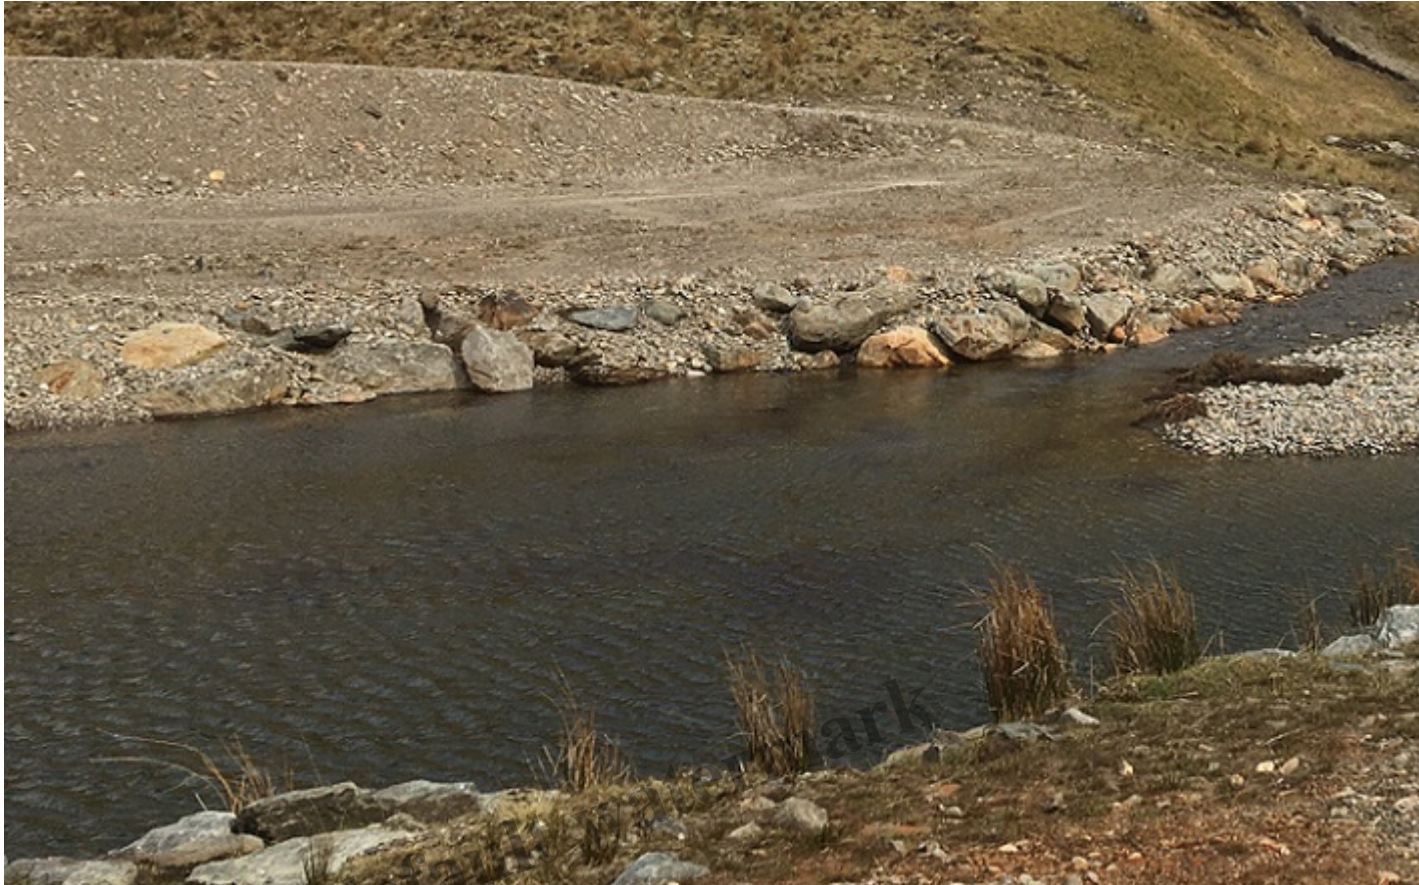
Detail from second photo above, photo credit Helen Todd

It is possible that the shingle that has been placed on top of the rip rap bouldering will enable the edge of the pool to re-vegetate, which would help it resist erosion. But it appears equally possible that the next flood will wash it all back into the pool! Because there is no planning application, it is impossible for the public to know whether this aspect of the work has been based on expert opinion or a wing and a prayer.

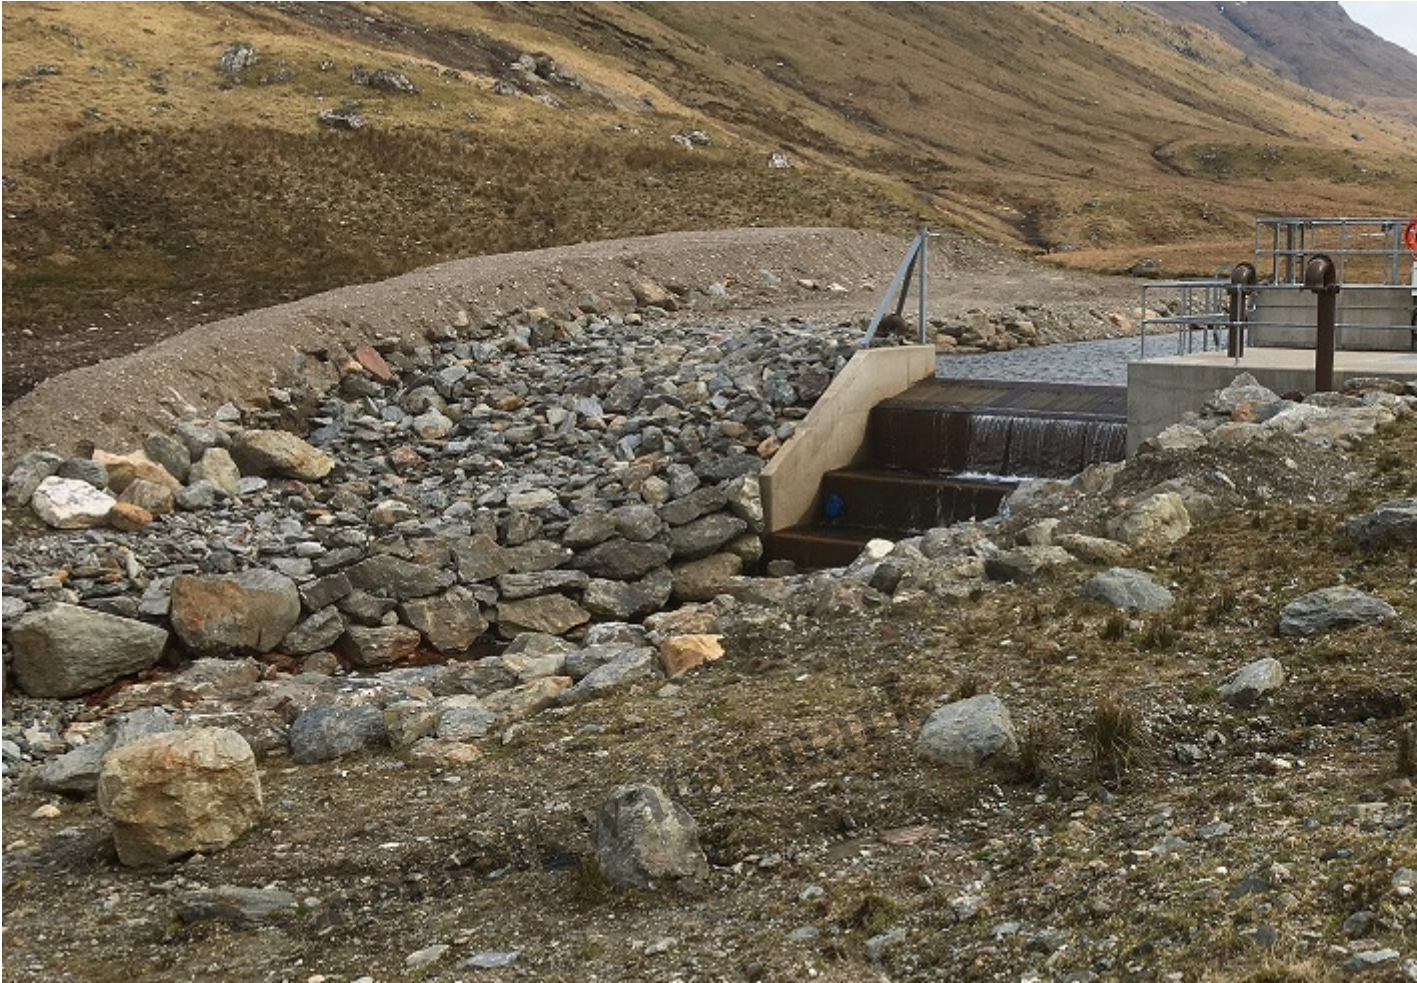
The photo clearly shows how the new bank appears intended to channel overflowing water down be with the boulderly slope (which appears to have been extended) apparently intended to form the bas channel

The new bank and bed of the overflow channel, however, appears completely unfit for purpose if intended to channel flood water. There is direct evidence for this from the River Gynack overflow scheme above Kingussie. There, many of the boulders used to form the base of the channel and the earth banks were so severely eroded at the first flood that the scheme itself has been effectively abandoned ([see here](#)). Unfortunately, the Cairngorms National Park Authority has not acted on my call for an inquiry into what went wrong there. However embarrassing, that might have helped prevent similar mistakes being repeated across the country. That failure does not, however, excuse this: anyone can that the new bank with its sandy sides is at high risk of being swept away.
