## Cairn Gorm – the construction site at the heart of the National Park (2)

## Changes to the repair plans

## What's happening on the ground

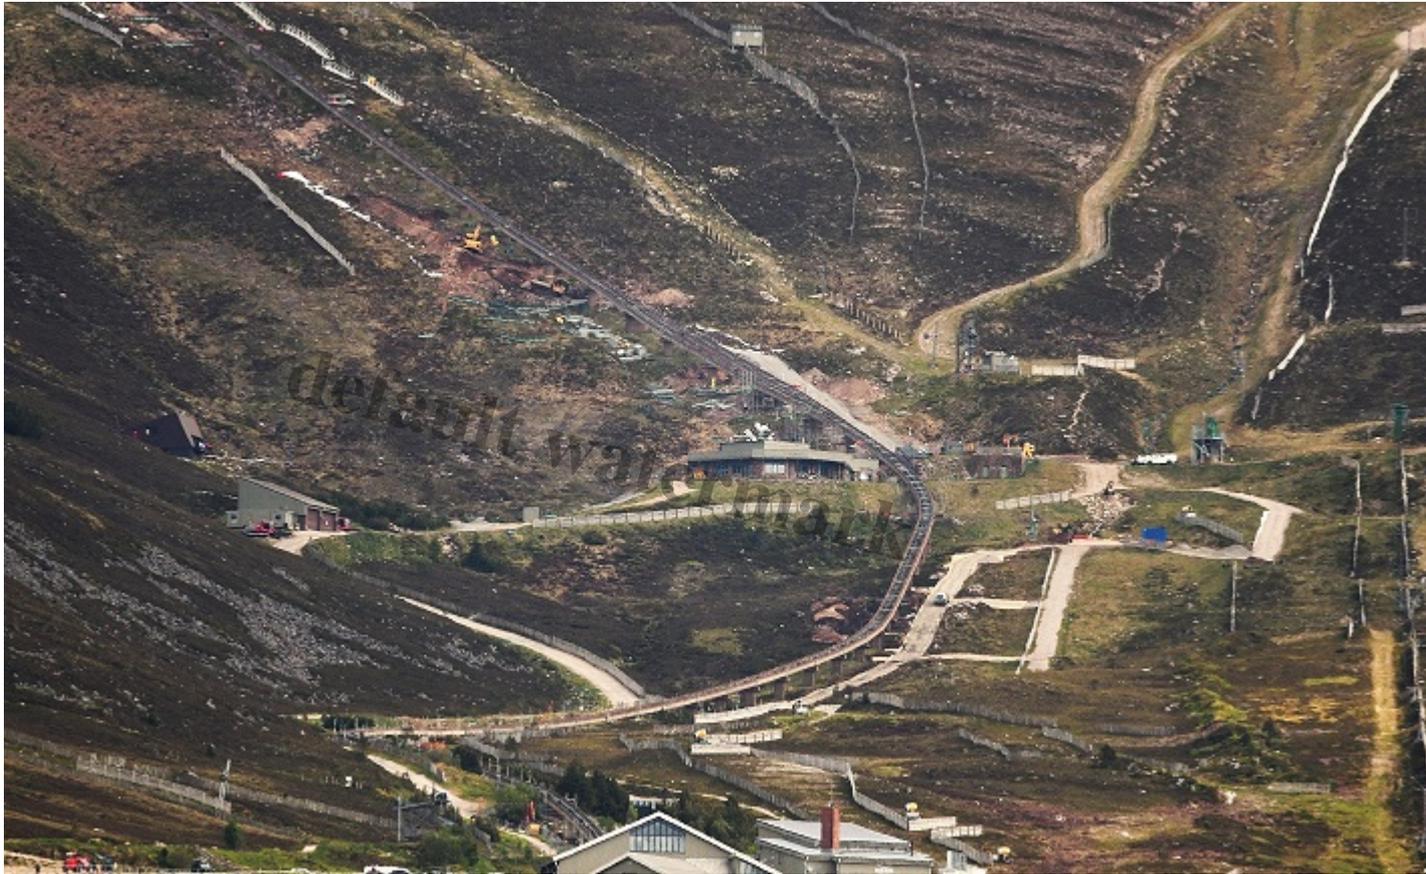
View of middle section of funicular repair work showing temporary access tracks on righthand side of track and extensive earthworks by and above the mid-station. Photo credit George Paton mid-June

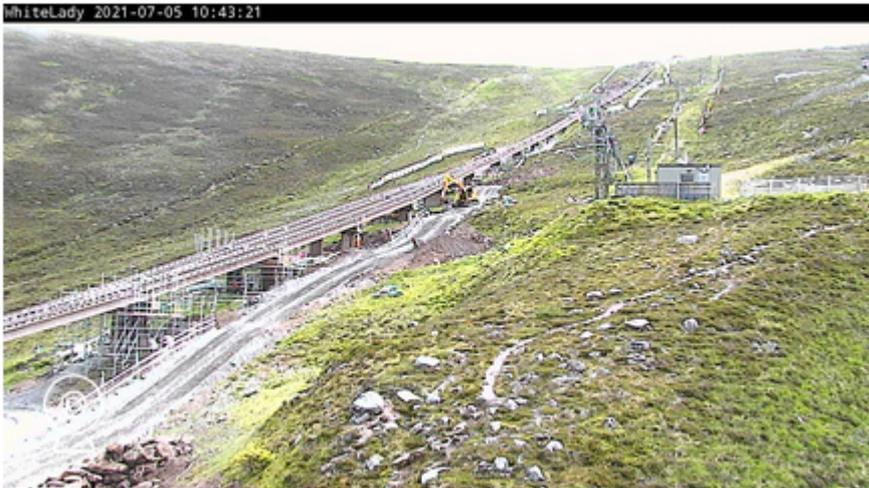
The minor earth works at the passing area earlier today

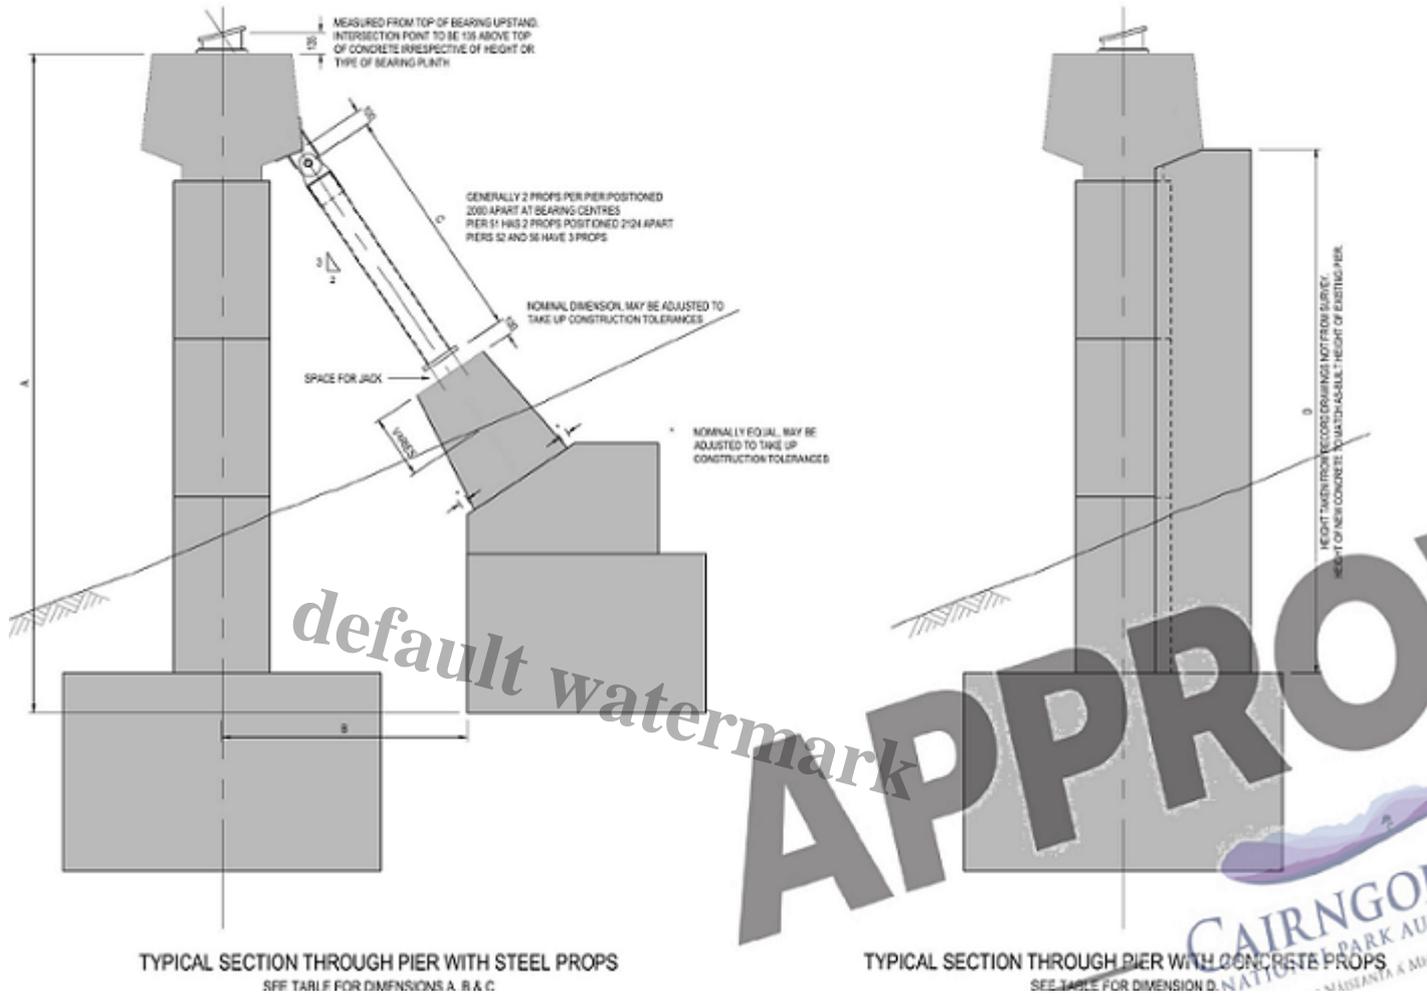
Extract from the new plans. The left hand diagram appeared in the CNPA Planning Papers, the right hand one is new!

What the documents do show that is instead of adding props supported by new foundations to all 63 piers, the plan now is to reinforce 19 of the piers with additional concrete supports, as in the diagram on the right and, in three cases, to strengthen the piers with short concrete jackets.

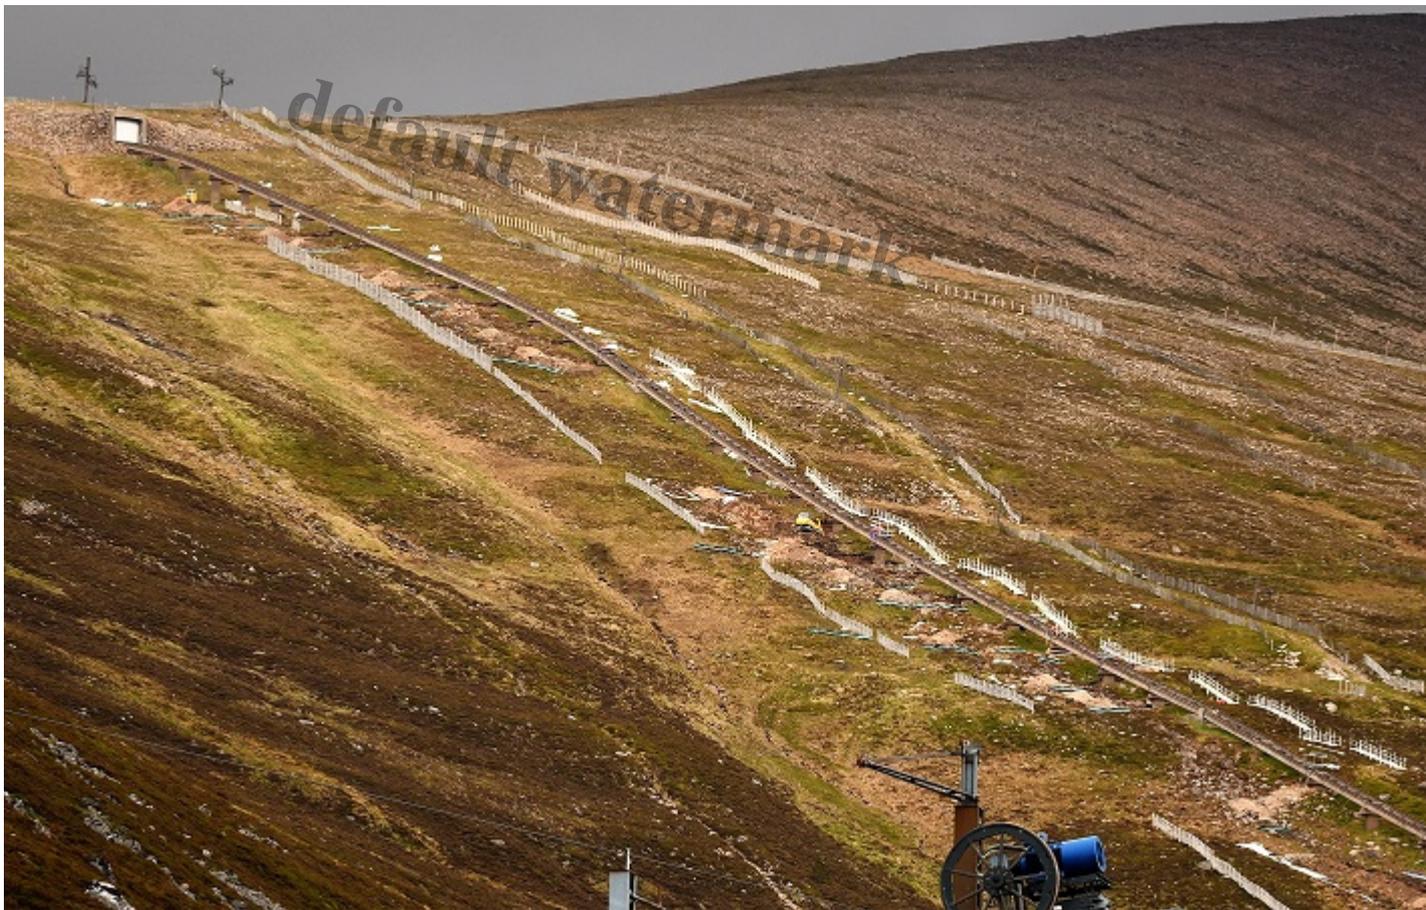
View of repair work above the mid-station to the funicular tunnel, top left, with sections of walkway in the far side of the funicular. Diggers are visible top left and centre. Photo credit George Paton mid-J

The section of the funicular where the repairs are having least impact at present is above the mid-station on the steeper ground. Above pier 62 materials are being flown in by helicopter and there is no sign of temporary construction tracks (though these were mentioned in the planning documents). A pedestrian walkway has been installed to prevent ground damage. The CNPA will be pleased.

However, the piles of excavated material will have a significant impact on ground vegetation. The latest plans state that for the foundations supporting the steel props *any surplus excavated material may*

*be spread locally or stockpiled*? Where the stockpile will be taken and how the ground beneath it will be restored is still not clear. What should be obvious though is that any material spread locally will be simply be washed downhill.

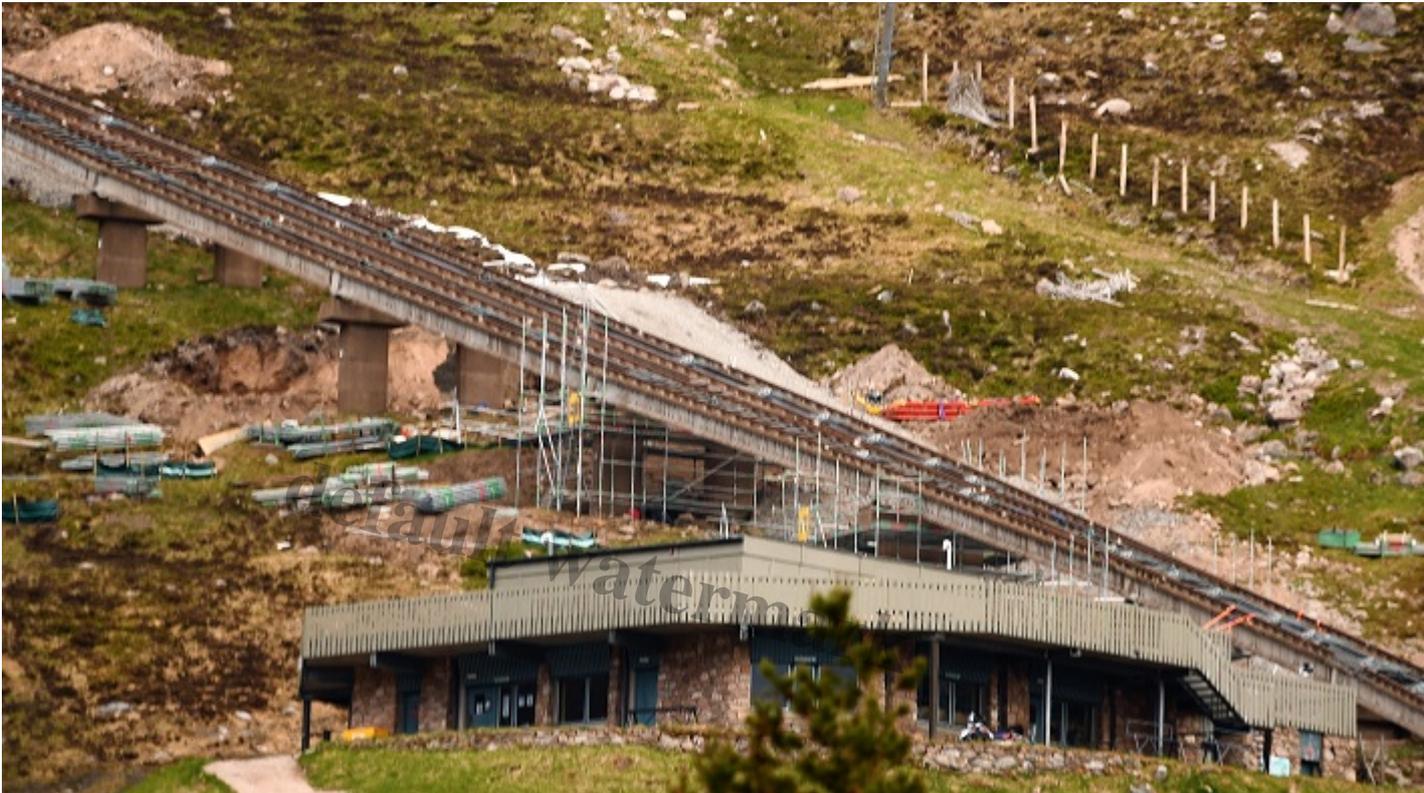
George apologises for the slightly blurry photo but it helps show the extent of the "minor earthworks" approved by the CNPA! Photo Credit George Paton

The area around the double track passing place and loading station appears far worse: huge holes, a large excavated "temporary" access track (on the far side) and piles of excavated material.

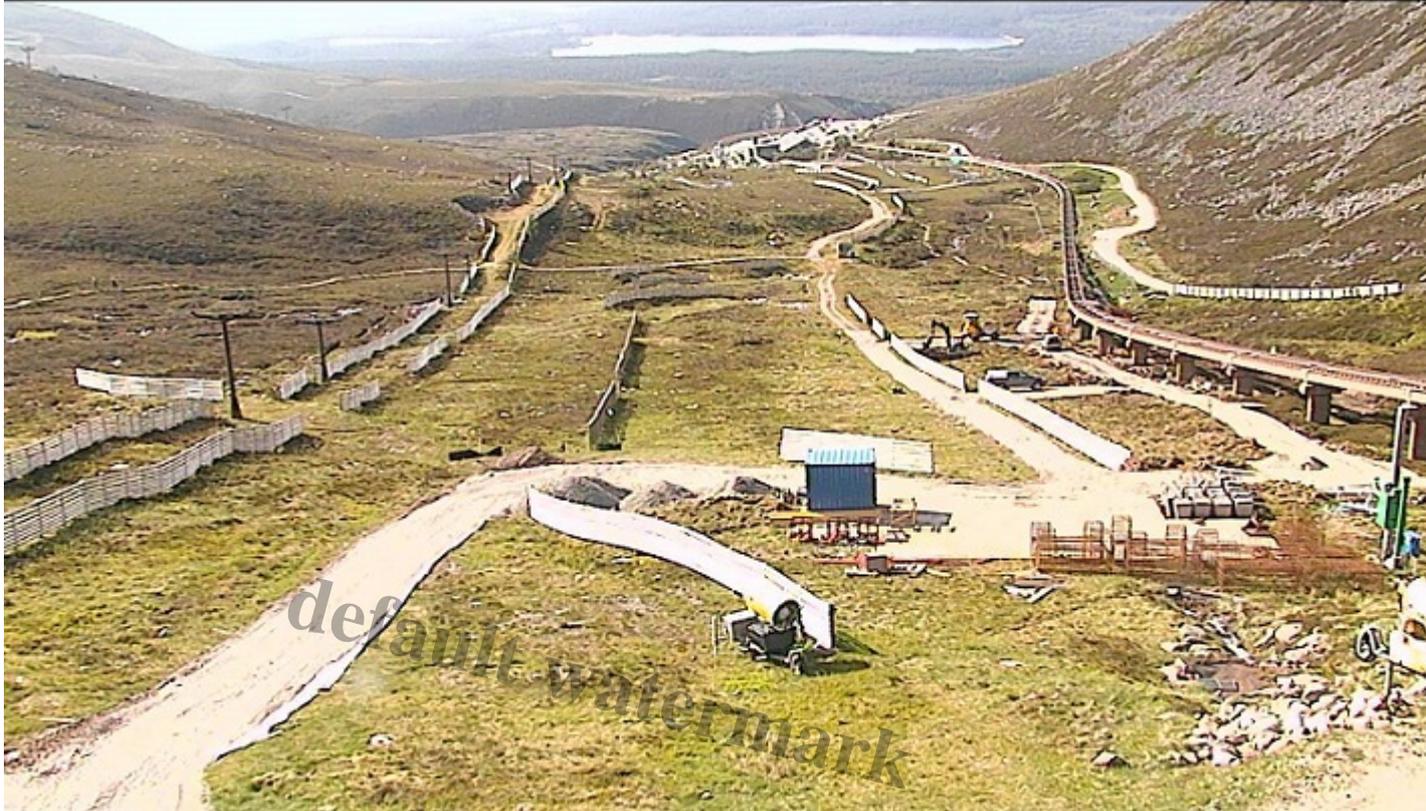
Looking down the Shieling â??SunKidâ?• Rope tow. Photo credit CMSL webcam

The track on the left was constructed unlawfully as part of the installation of the SunKid tow ([see here](#)) but then granted retrospective planning permission by the CNPA. It has now been â??temporarilyâ?• upgraded and a further new temporary track created parallel to the funicular to provide access for the repair work. A geotextile, visible on the left of the screenshot, has been placed below the new surface. This appears to follow a recommendation from SEPA that *â??all temporary tracks where peat would otherwise be excavated comprise of geotextile or plastic track matting unless there is a significant technical reason why this is not feasible.â?•*

While the ground by the funicular is very peaty, any peat under the sunkid track was destroyed during its construction (see link above for photos). All the geotextile matting will do therefore is kill the vegetation below. Where the track needed to be widened temporarily it would have been far less damaging to have excavated and saved the surface vegetation and then replaced this. The photos provide no evidence that such protection and restoration techniques are happening at Cairn Gorm, whether on the temporary access tracks or around the pits that have been excavated for the new piers. My guess is that is far too expensive and instead HIE will re-seed the damaged areas in due course.
