## Cairn Gorm – the construction site at the heart of the National Park (2)

### Who was responsible for the funicular design failure?

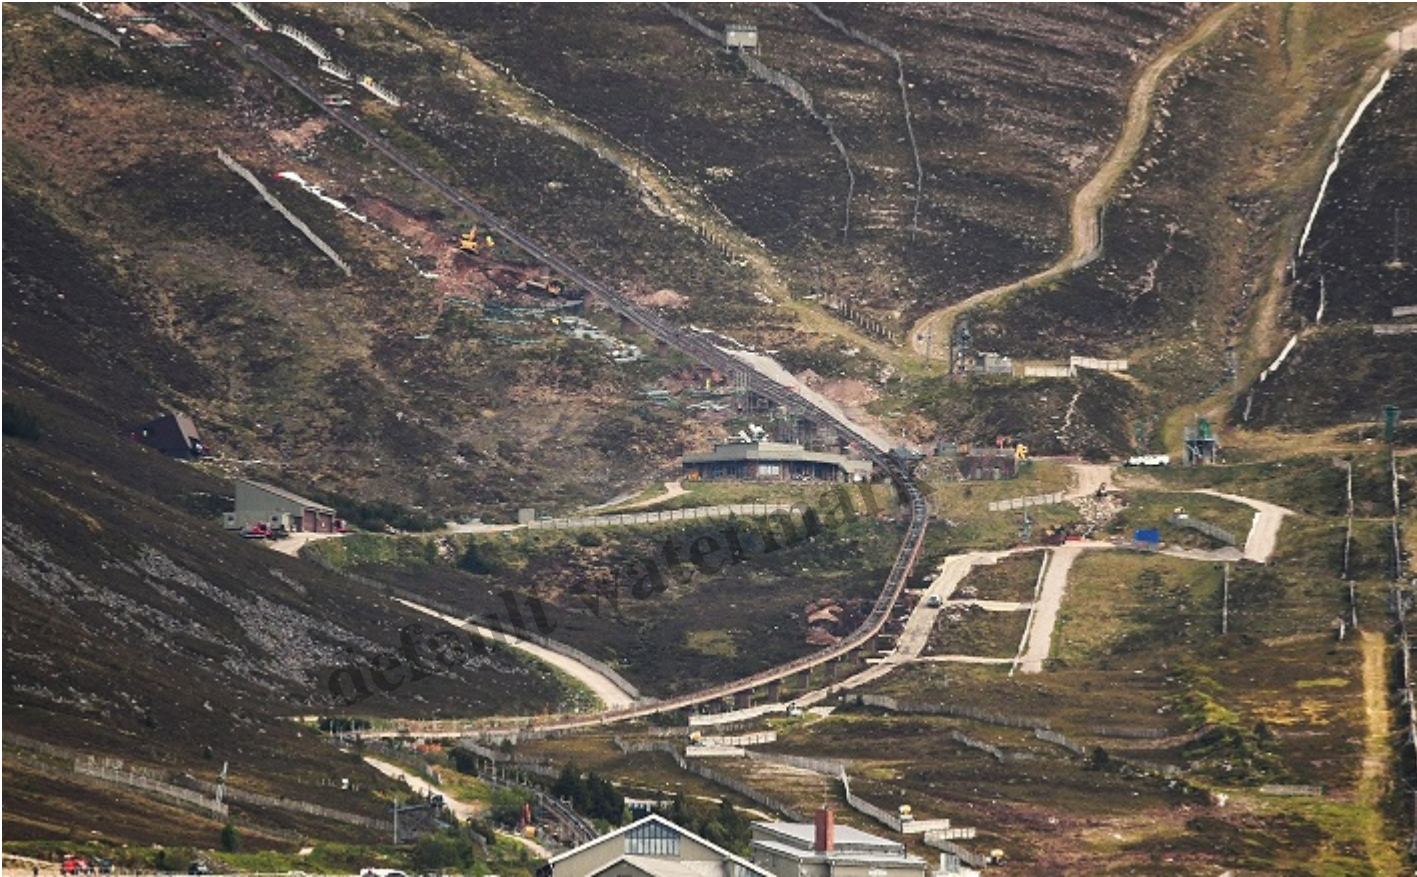
View of middle section of funicular repair work showing temporary access tracks on righthand side of track and extensive earthworks by and above the mid-station. Photo credit George Paton mid-June

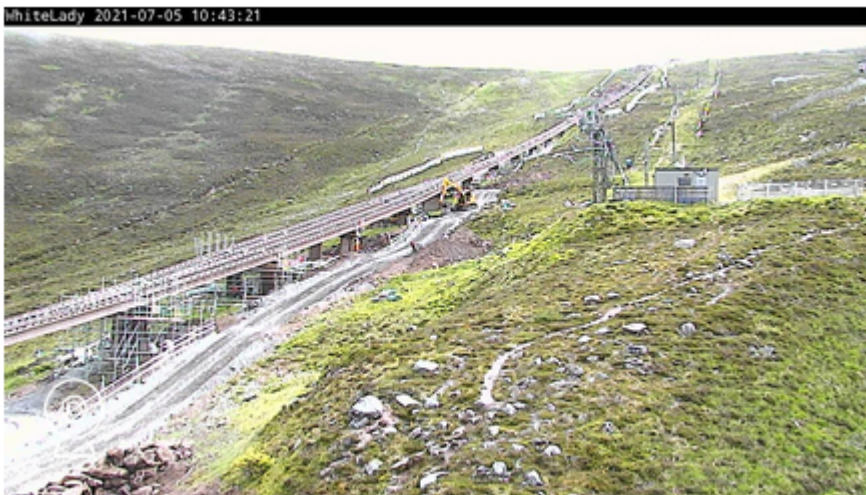
The minor earth works at the passing area earlier today

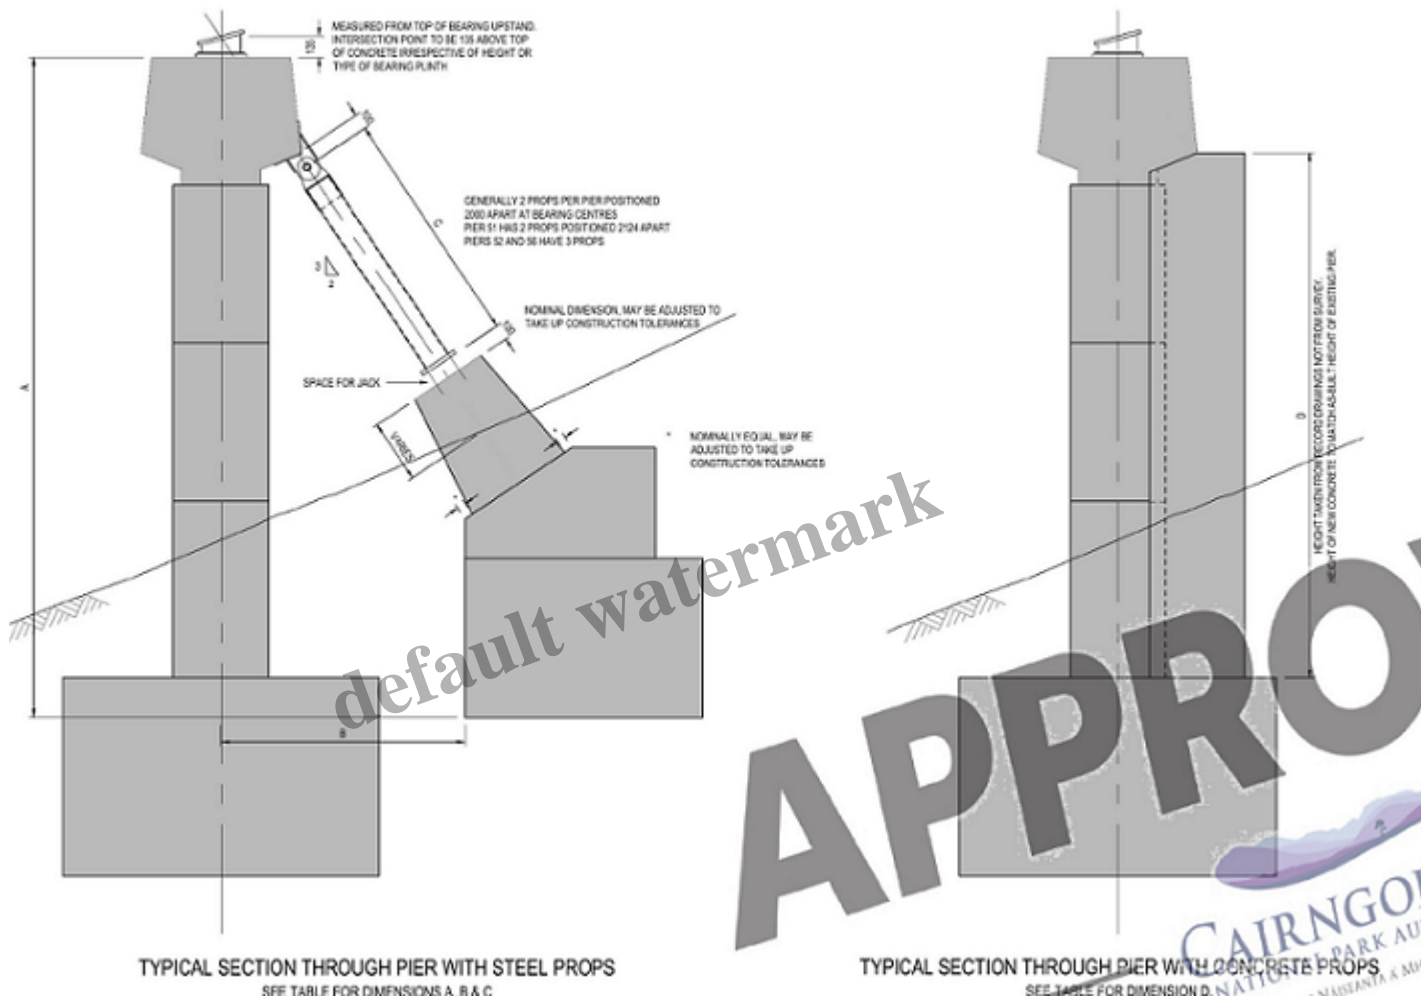
Extract from the new plans. The left hand diagram appeared in the CNPA Planning Papers, the right hand one is new!

What the documents do show that is instead of adding props supported by new foundations to all 63 piers, the plan now is to reinforce 19 of the piers with additional concrete supports, as in the diagram on the right and, in three cases, to strength the piers with short concrete jackets.

The revised proposal to install 22 concrete props/jackets suggests that in these cases the problem has not been that the piers are tilting, but rather they are not strong enough to support the viaduct above.

Given that the other piers appear to be tilting and need propping up due to inadequate foundations, one wonders at the wisdom of adding a lot more weight to the foundations of these 22 piers. How does Liff know that the new concrete props won't make the foundations tilt or slide?

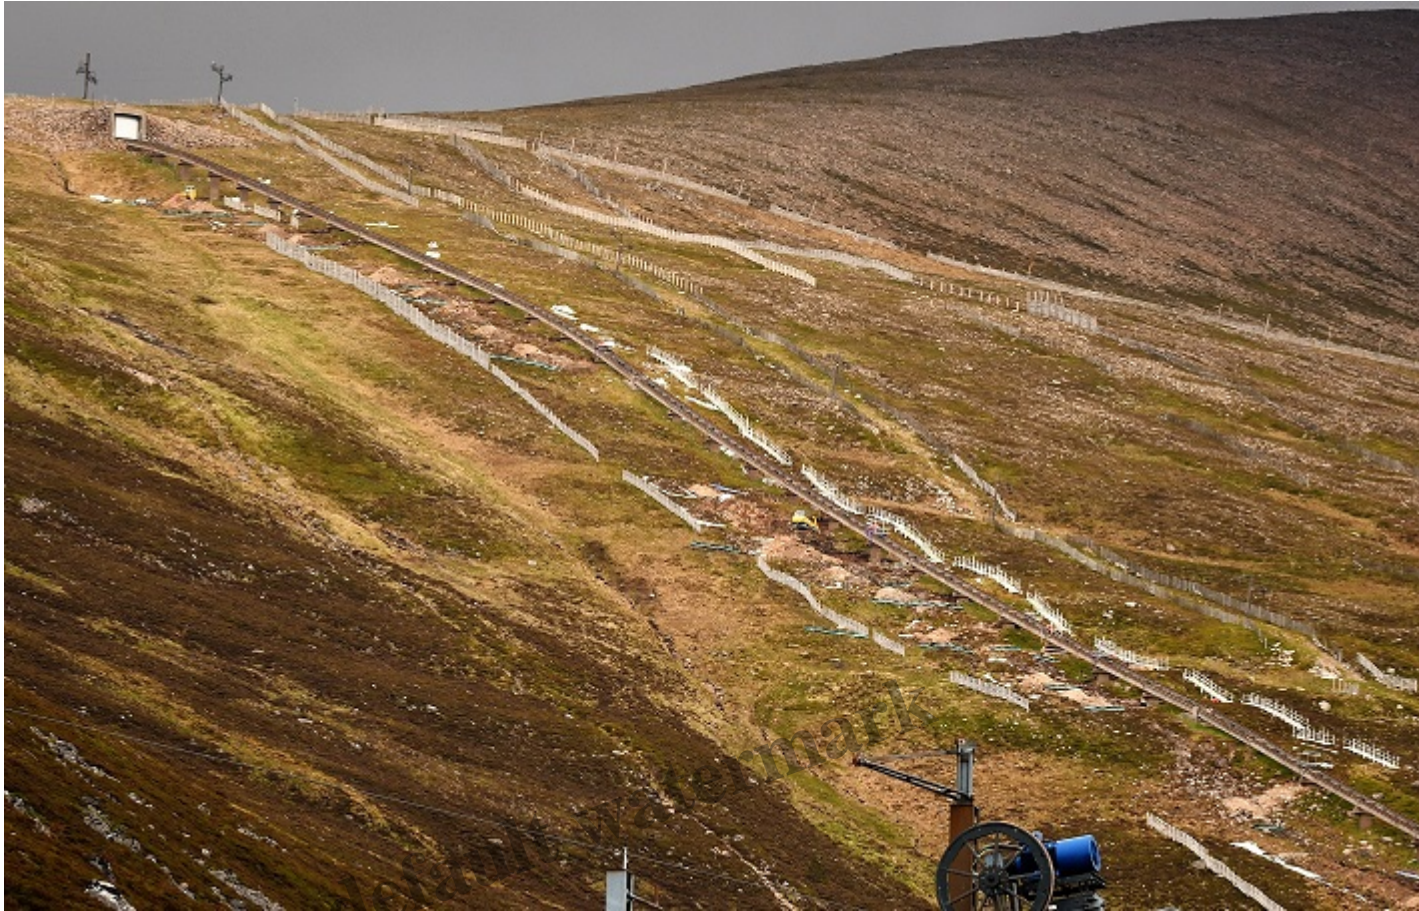
View of repair work above the mid-station to the funicular tunnel, top left, with sections of walkway in place on the far side of the funicular. Diggers are visible top left and centre. Photo credit George Paton m

The section of the funicular where the repairs are having least impact at present is above the mid-station on the steeper ground. Above pier 62 materials are being flown in by helicopter and there is no sign of temporary construction tracks (though these were mentioned in the planning documents). A pedestrian walkway has been installed to prevent ground damage. The CNPA will be pleased.

However, the piles of excavated material will have a significant impact on ground vegetation. The latest plans state that for the foundations supporting the steel props *“any surplus excavated material may be spread locally or stockpiled”*. Where the stockpile will be taken and how the ground beneath it will be restored is still not clear. What should be obvious though is that any material “spread locally” will be simply be washed downhill.

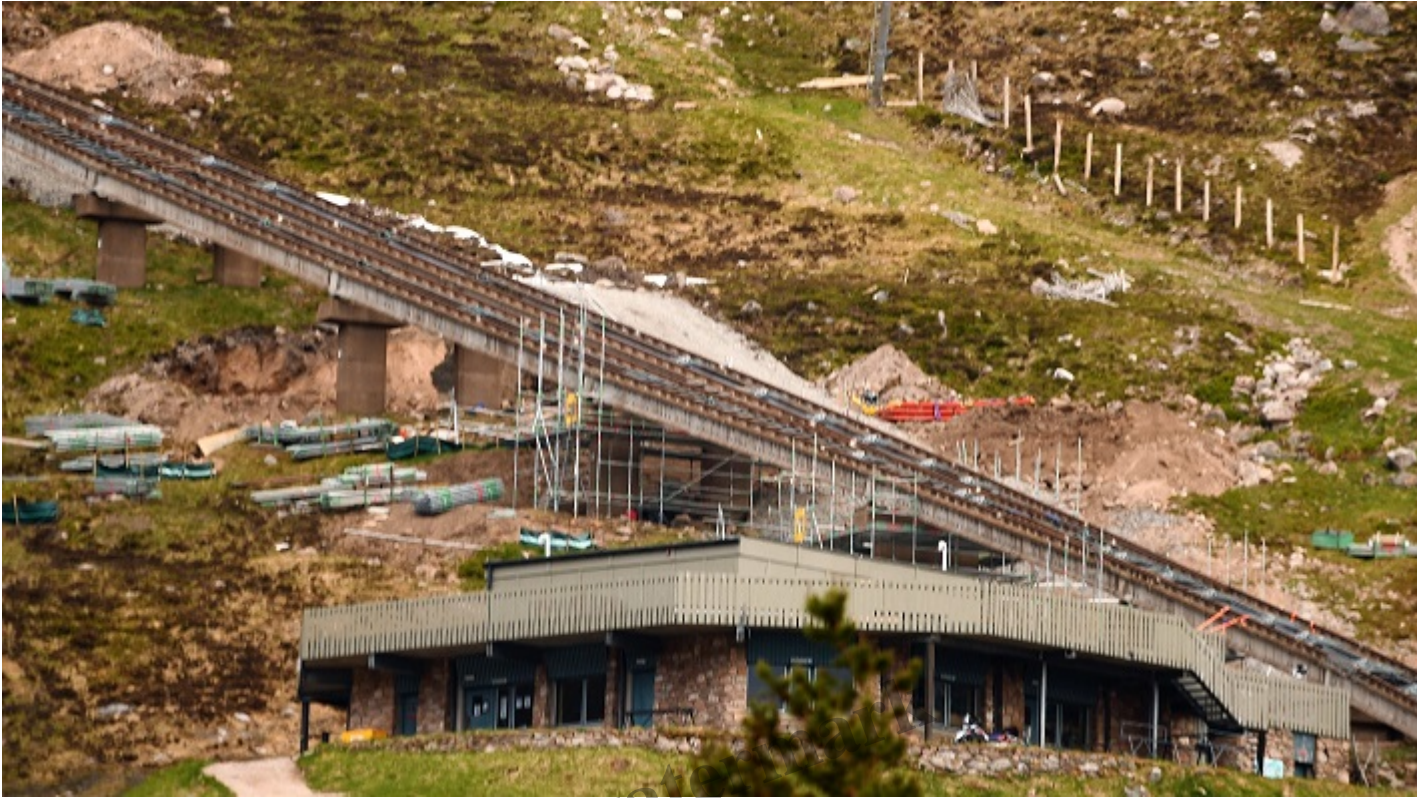
George apologises for the slightly blurry photo but it helps show the extent of the “minor earthworks” approved by the CNPA! Photo Credit George Paton

The area around the double track passing place and loading station appears far worse: huge holes, a large excavated “temporary” access track (on the far side) and piles of excavated material.

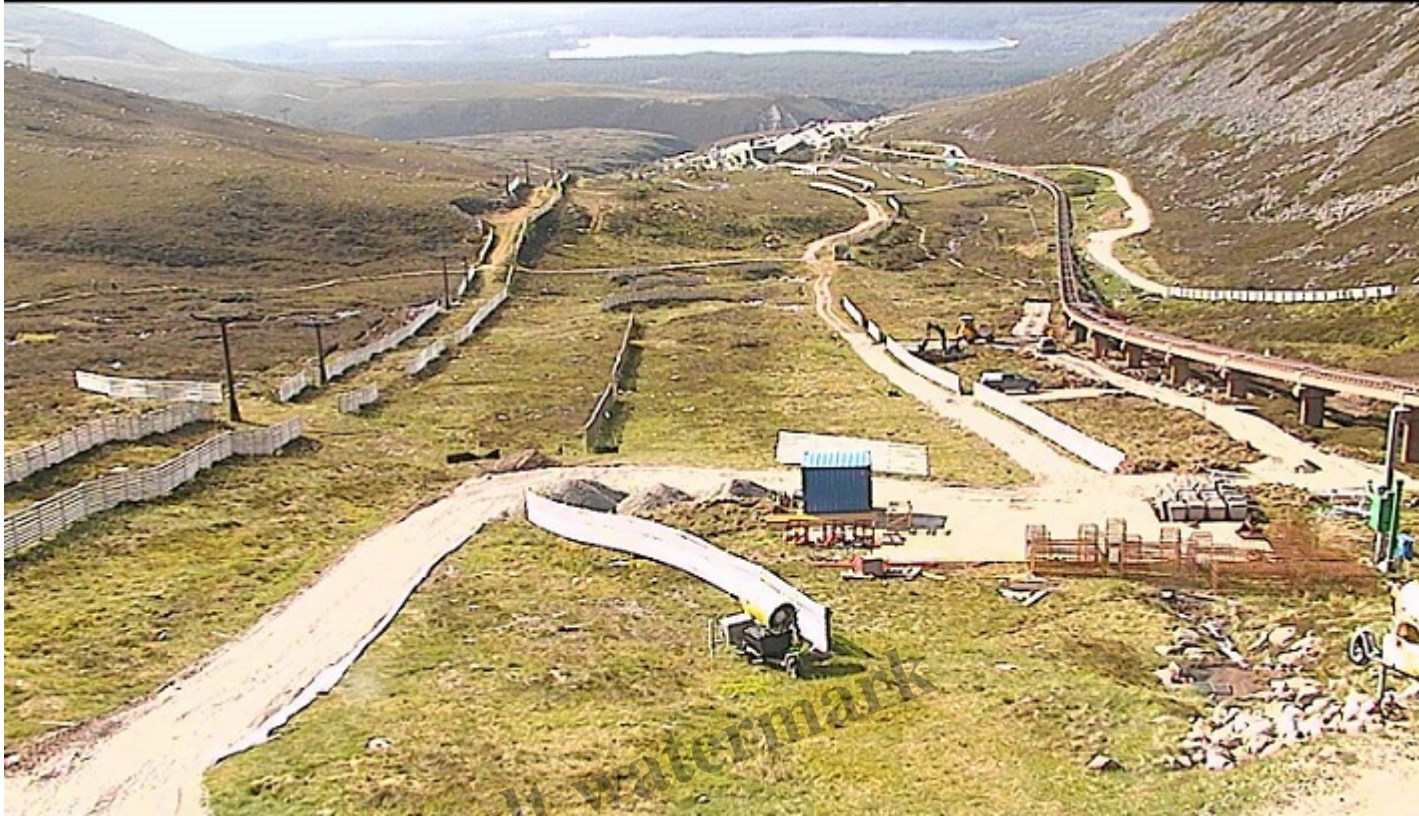
Looking down the Shieling "SunKid" Rope tow. Photo credit CMSL webcam

The track on the left was constructed unlawfully as part of the installation of the SunKid tow ([see here](#)) but then granted retrospective planning permission by the CNPA. It has now been "temporarily" upgraded and a further new temporary track created parallel to the funicular to provide access for the repair work. A geotextile, visible on the left of the screenshot, has been placed below the new surface. This appears to follow a recommendation from SEPA that *"all temporary tracks where peat would otherwise be excavated comprise of geotextile or plastic track matting unless there is a significant technical reason why this is not feasible."*

While the ground by the funicular is very peaty, any peat under the sunkid track was destroyed during its construction (see link above for photos). All the geotextile matting will do therefore is kill the vegetation below. Where the track needed to be widened temporarily it would have been far less damaging to have excavated and saved the surface vegetation and then replaced this. The photos provide no evidence that such protection and restoration techniques are happening at Cairn Gorm, whether on the temporary access tracks or around the pits that have been excavated for the new piers. My guess is that is far too expensive and instead HIE will re-seed the damaged areas in due course.
