Further photos of the hydro destruction in Glen Etive – the Allt Chaorainn

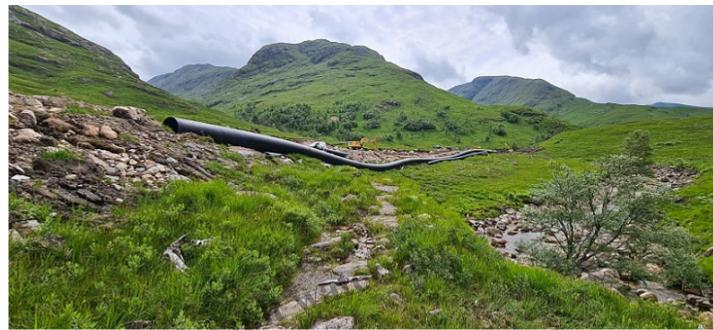
View along footpath from below the construction corridor. All photo credits, anon, parkswatchscotland.

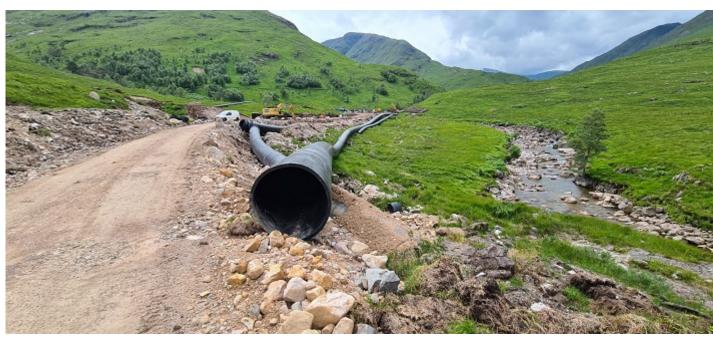
View along the construction corridor up to the intakes with excavated peat on right

Approaching the two intakes on the Allt Chaorainn the road has been excavated not just through peat but granite slabs will can never be restored. Note too the bare patch in the woodland on the hillside above. This does not appear to be a natural landslip – what caused that?

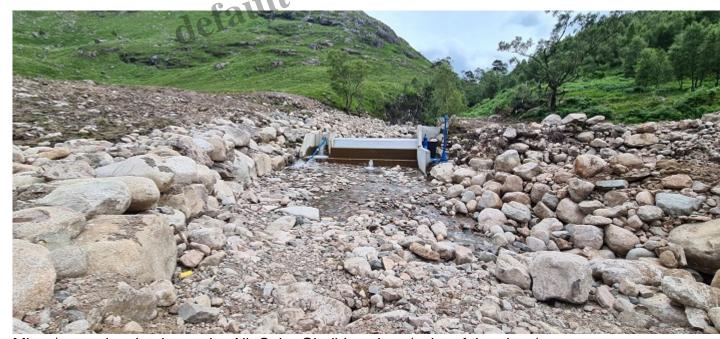
Minor/secondary intake on the Allt Coire Ghuibhsachan (coire of the pines).

The area of ground affected by the construction is extensive and has wrecked the approach to what was once a beautiful gorge. The work is not yet finished but at present the bed of the re-engineered watercourse appears at high risk of being washed away as happened with the Gynack overflow above Kingussie (see here), a problem that has still not been solved five years later.

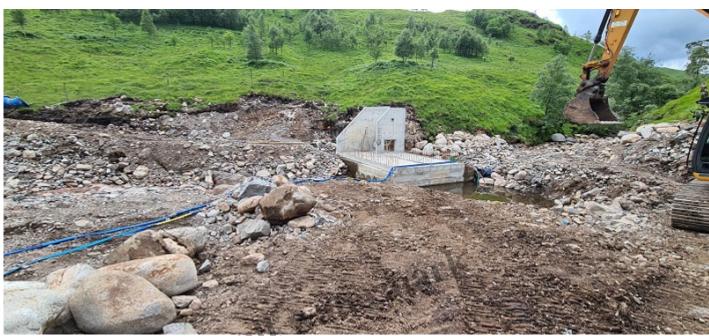
The main/primary intake

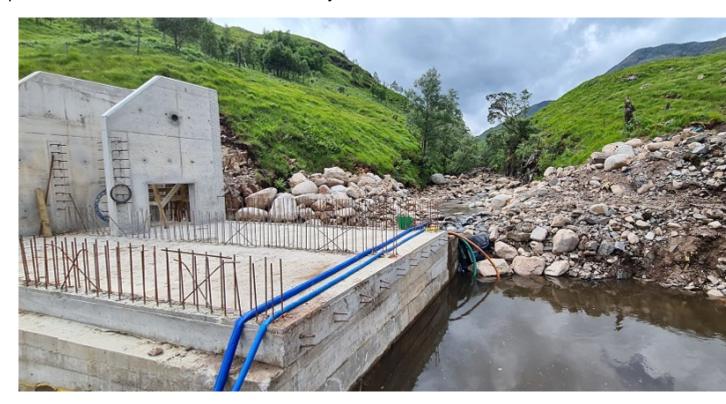
The main intake from closer up

"They said that the water levels will reach as high as the re-bar on the wall, roughly where the circle is cut out. Roughly, to give you an idea."

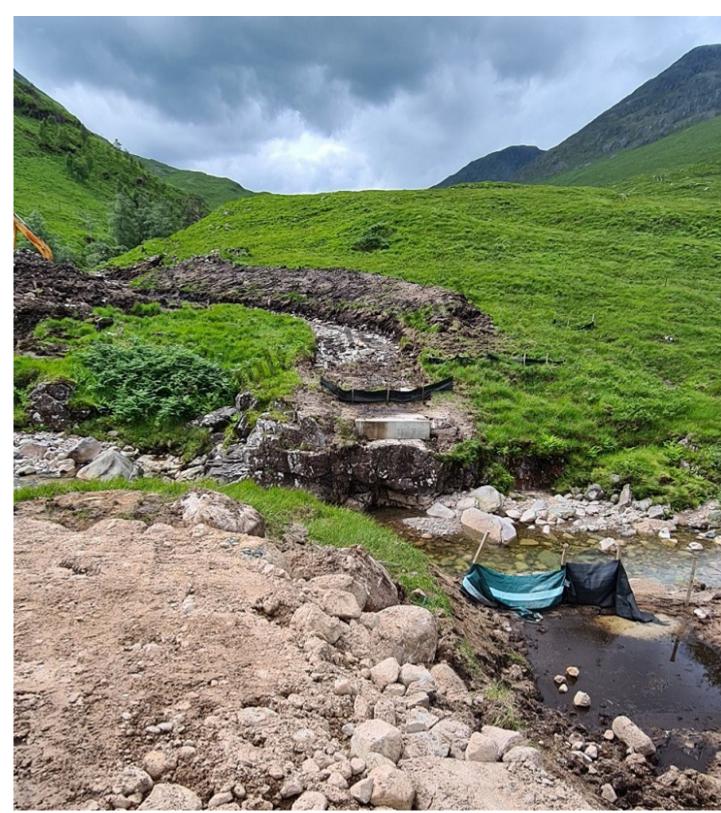
Construction track through peat to the intake with concrete foundation for bridge

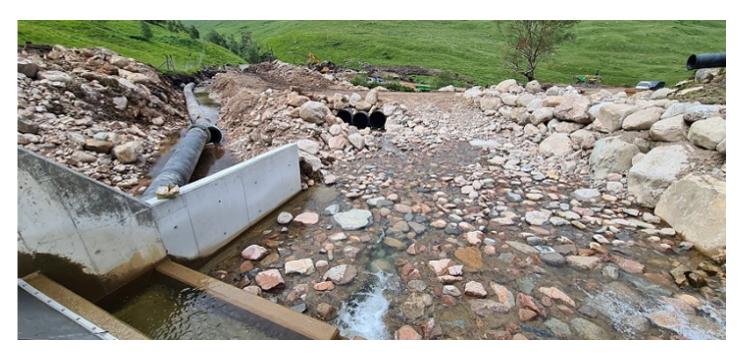
"The minor extraction point. Water flows over the 'weir' into the capture and down through the black pipe to the main extraction, then down hill to the station. There are temporary works still in place and will be removed when the pipes are connected."

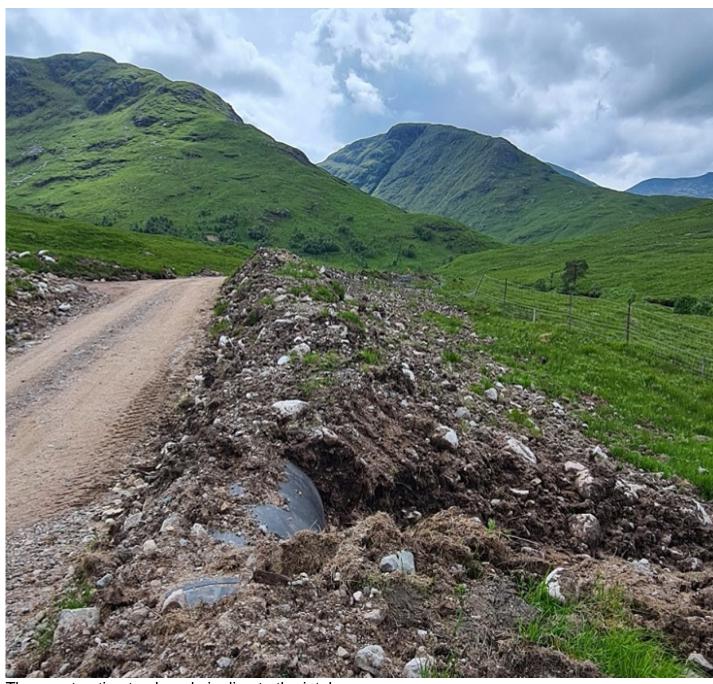
The construction track and pipeline to the intakes.

According to the planning consent issued by Highland Council the trenches for the pipes are supposed to open for only a short-time to promote effective restoration of the ground while the construction tracks are to be removed entirely..

The short section of exposed pipe in this photo illustrates that sections of the pipeline have not been buried deep enough. Because of this the line of the pipe will form a new ridge across the landscape while its smooth surface is likely to shed any turf and vegetation placed on top (as in the photo). The result is likely to be a highly visible half buried pipeline, worse than a properly buried pipeline and probably worse than leaving it in the open air on a less conspicuous line (see here).

Moreover since material that was lifted from above the line of the track appears to have been used to

cover the pipe there looks like a shortage of vegetation to cover up the new road.
