Further photos of the hydro destruction in Glen Etive â?? the Allt Chaorainn

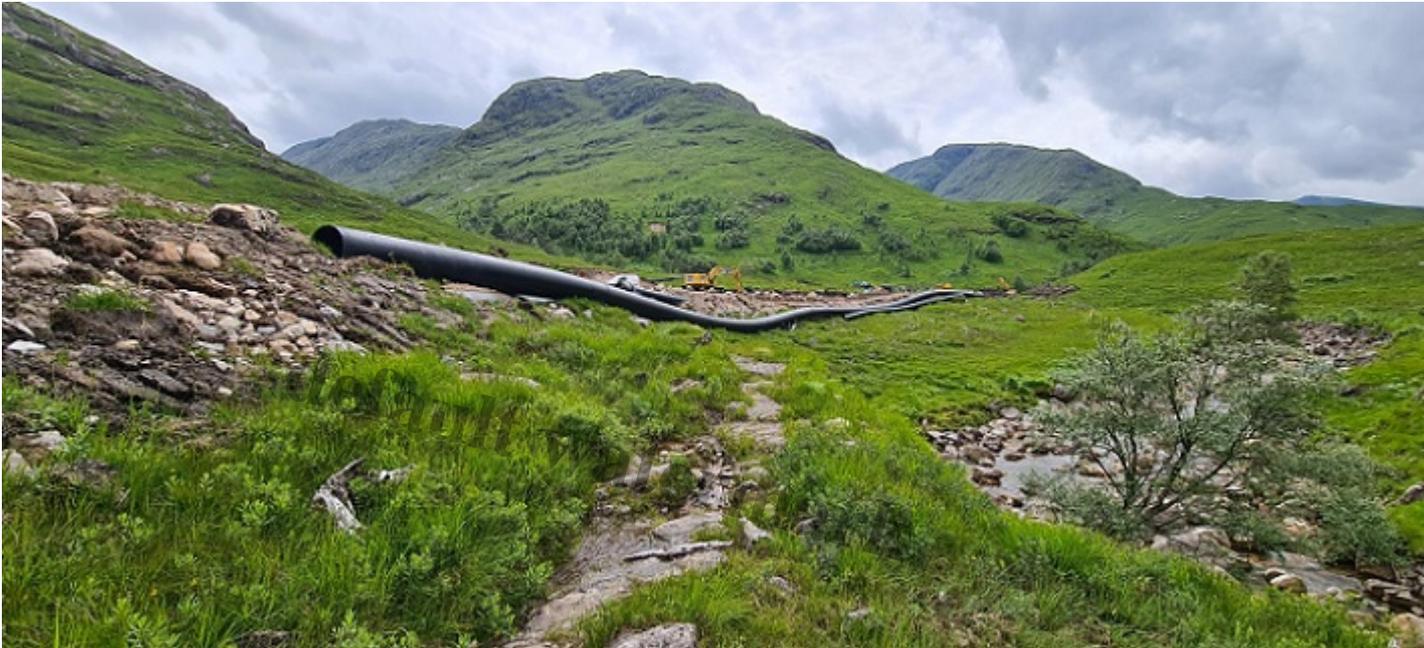
View along footpath from below the construction corridor. All photo credits, anon, parkswatchscotland.

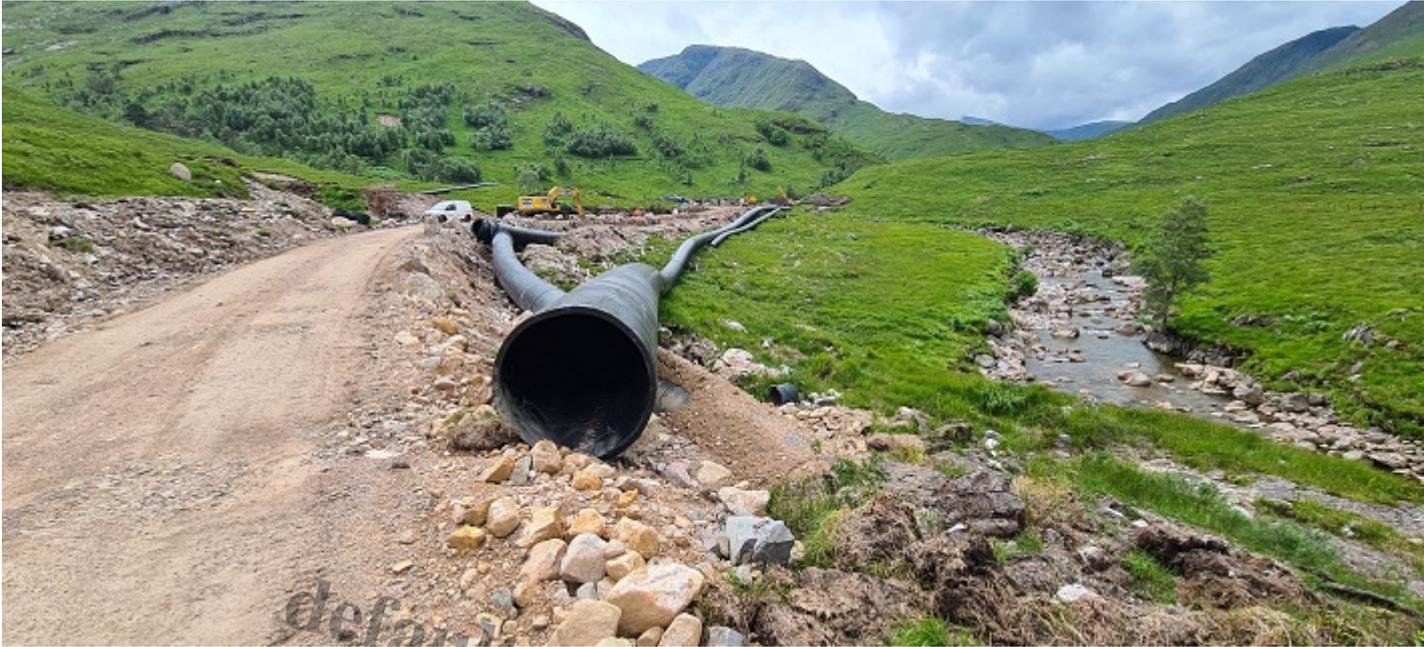
View along the construction corridor up to the intakes with excavated peat on right

Approaching the two intakes on the Allt Chaorainn the road has been excavated not just through peat but granite slabs will can never be restored. Note too the bare patch in the woodland on the hillside above. This does not appear to be a natural landslip â?? what caused that?

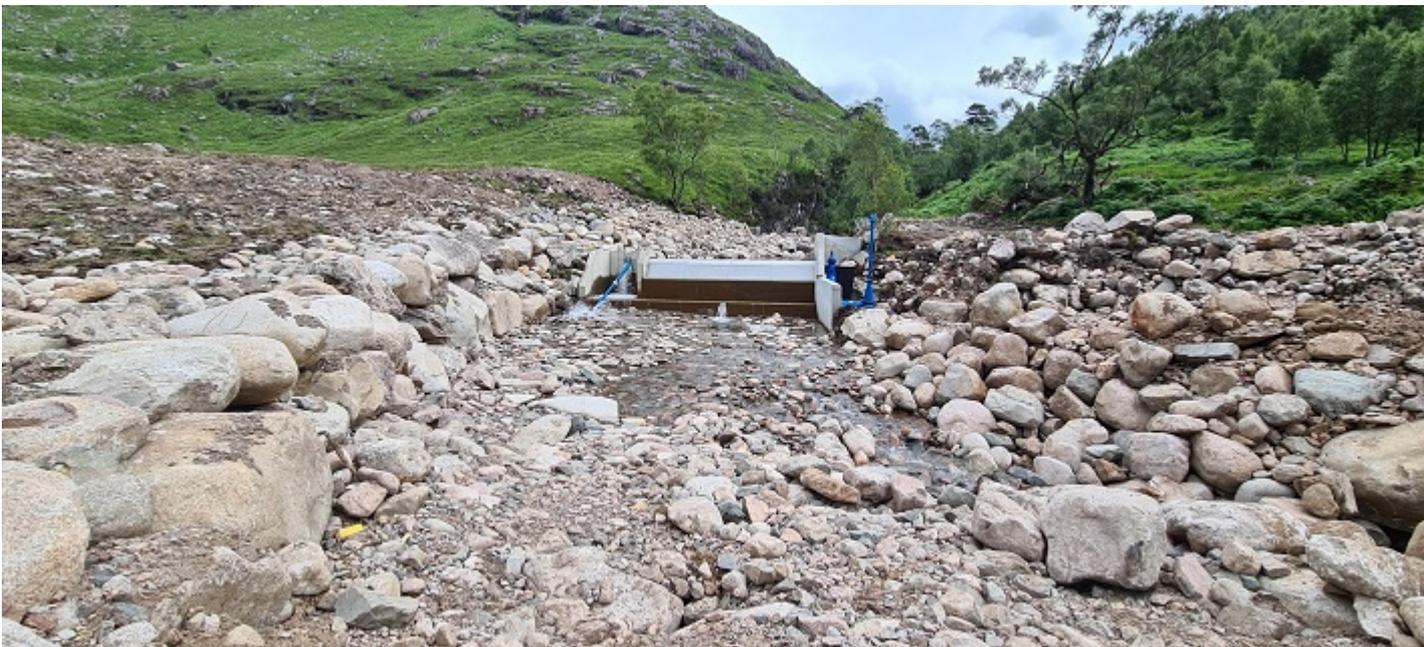
Minor/secondary intake on the Allt Coire Ghuibhsachan (coire of the pines).

The area of ground affected by the construction is extensive and has wrecked the approach to what was once a beautiful gorge. The work is not yet finished but at present the bed of the re-engineered watercourse appears at high risk of being washed away as happened with the Gynack overflow above Kingussie ([see here](#)), a problem that has still not been solved five years later.

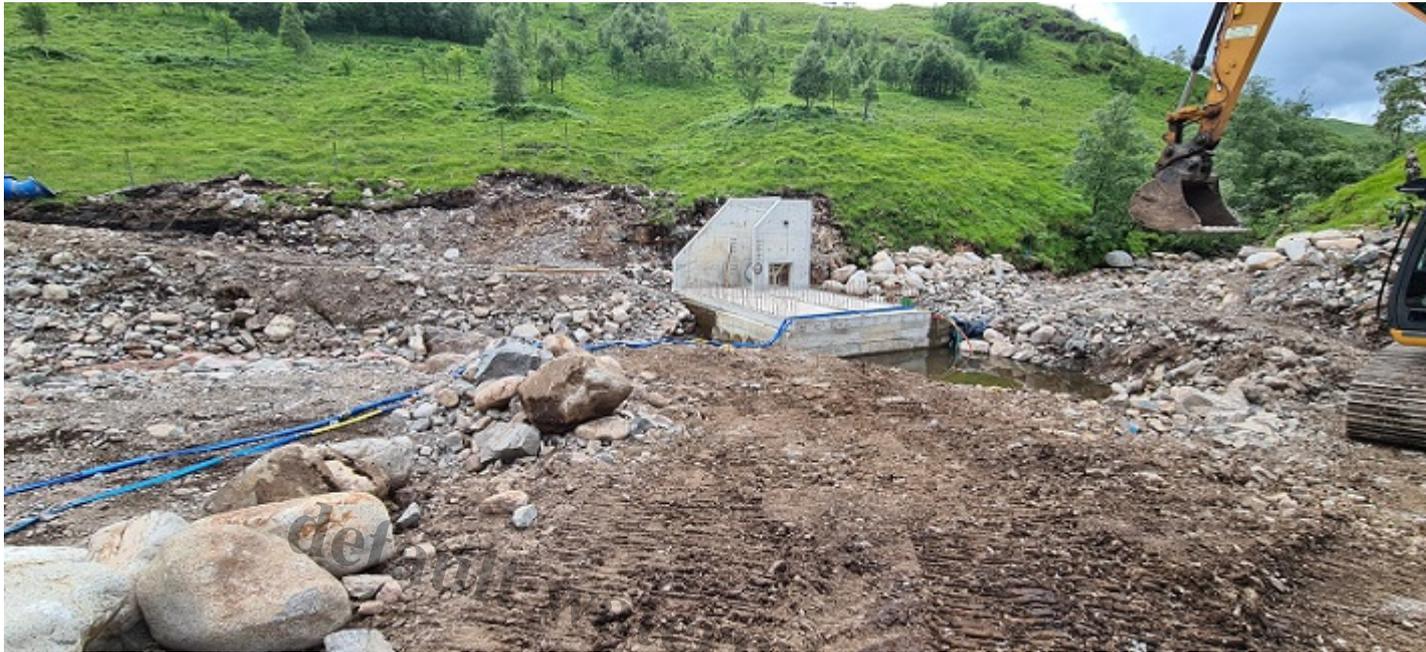
The main/primary intake

â??They had said that the works were due to finish mid August, however they are well behind and completion could well be some more months away.â?•

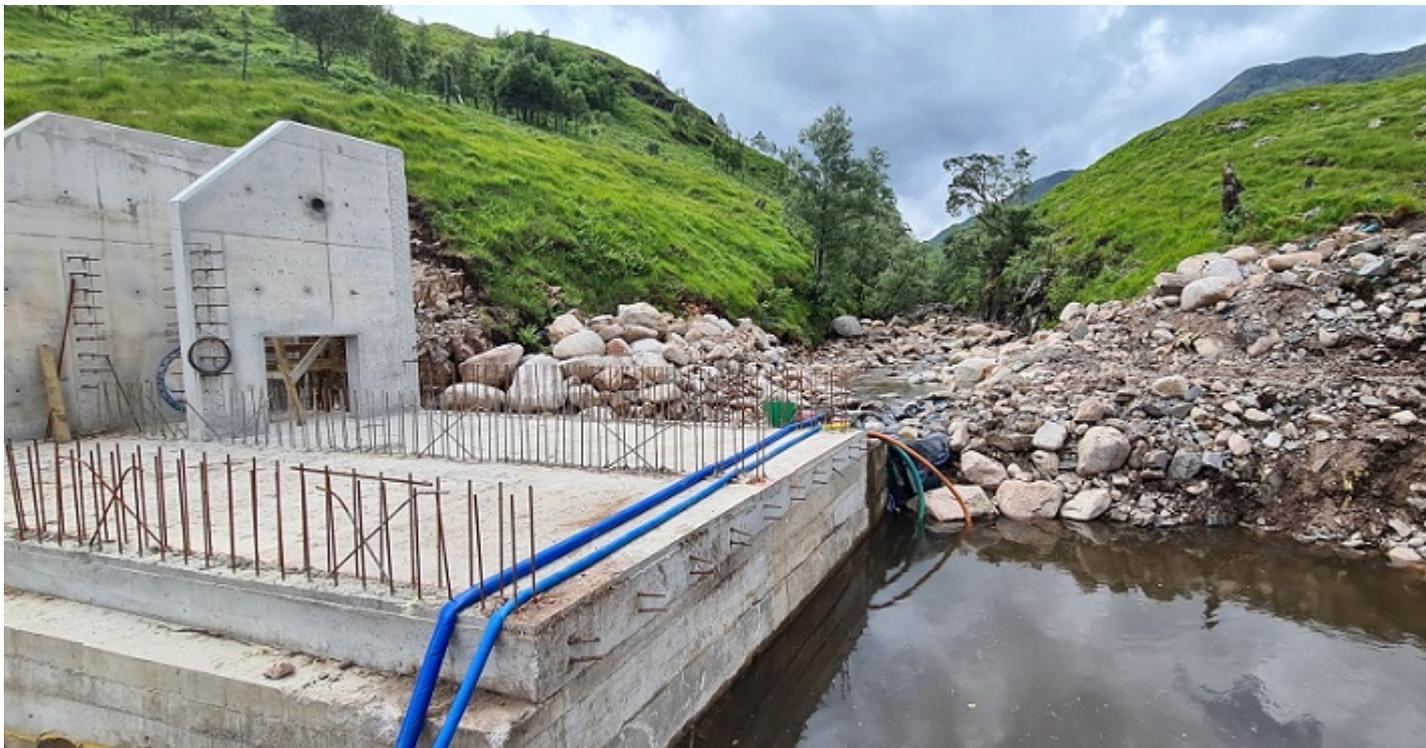
The main intake from closer up

â??They said that the water levels will reach as high as the re-bar on the wall, roughly where the circle is cut out. Roughly, to give you an idea.â??•

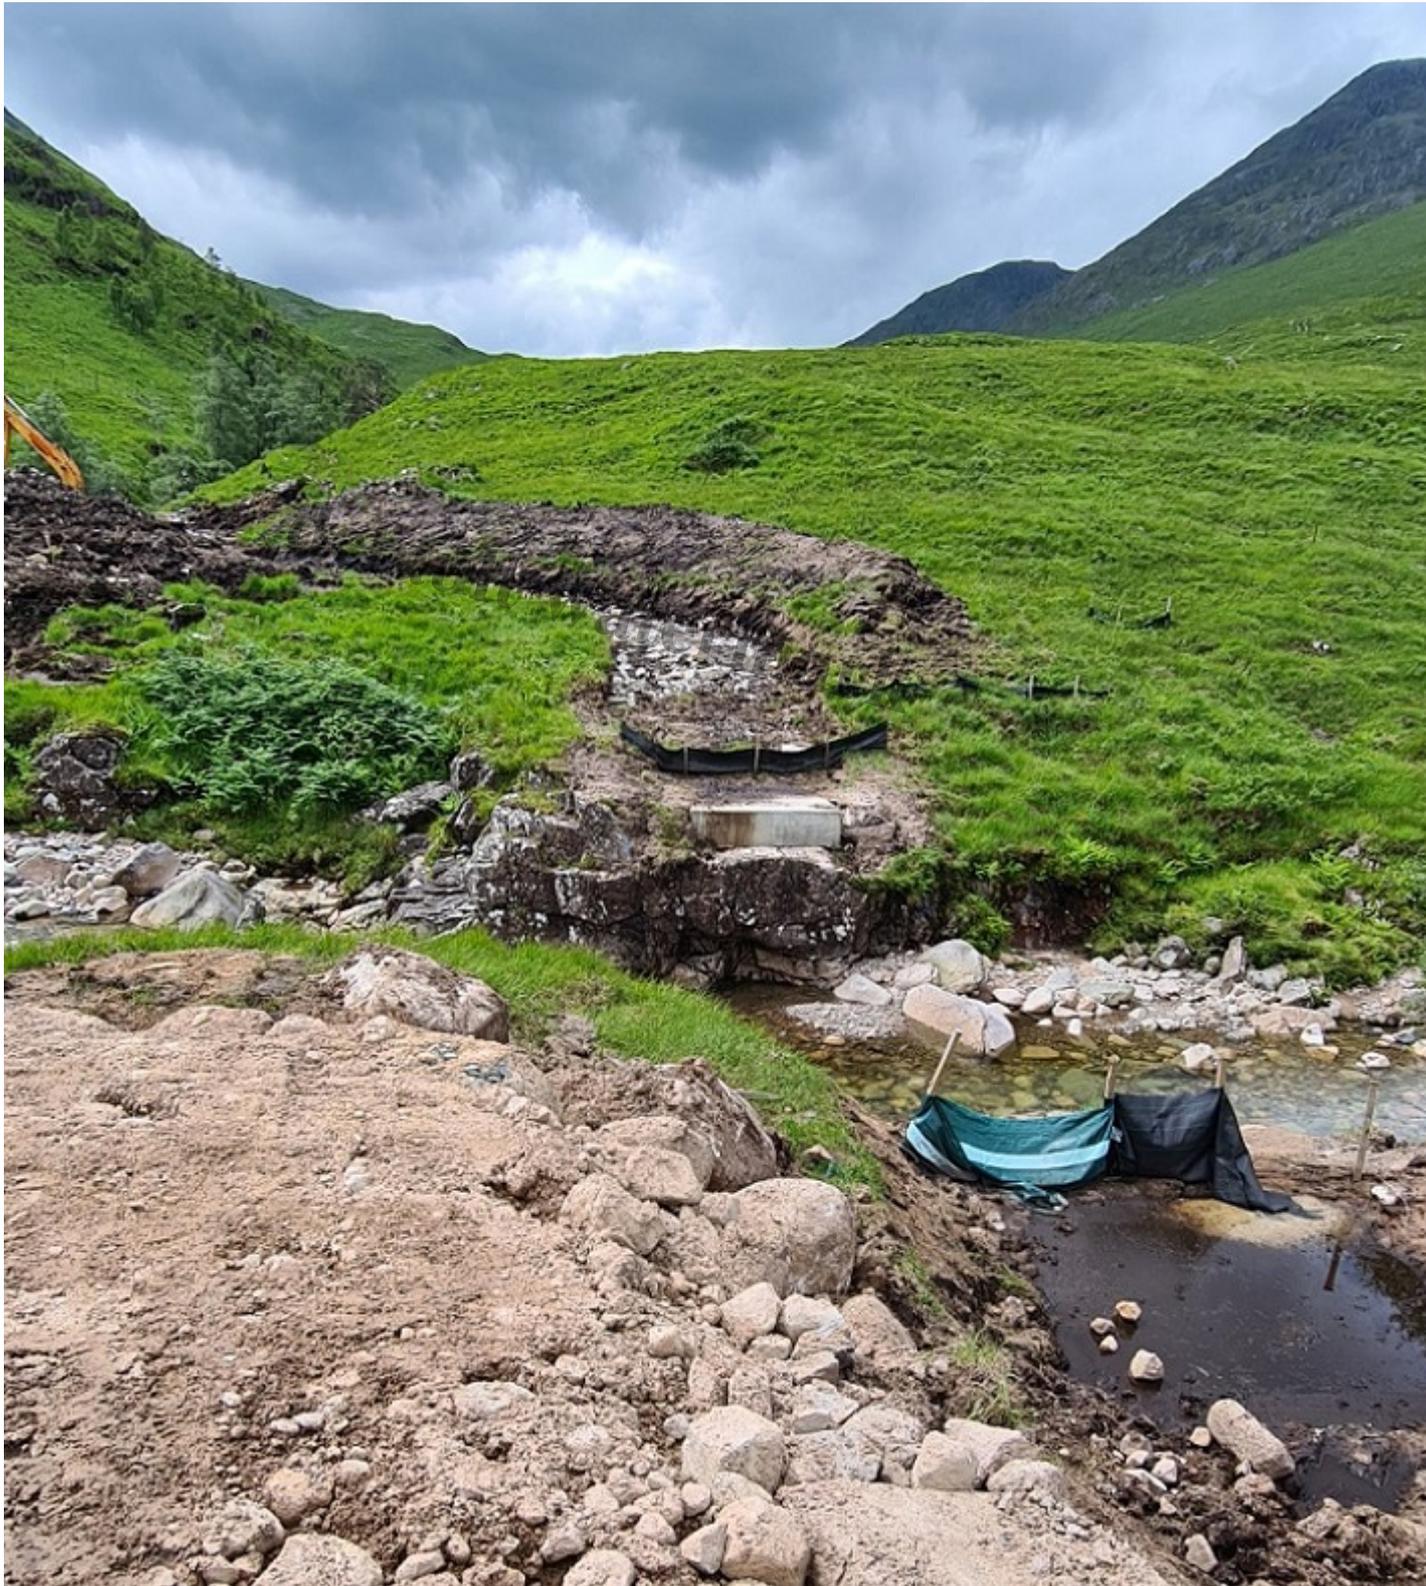
Construction track through peat to the intake with concrete foundation for bridge

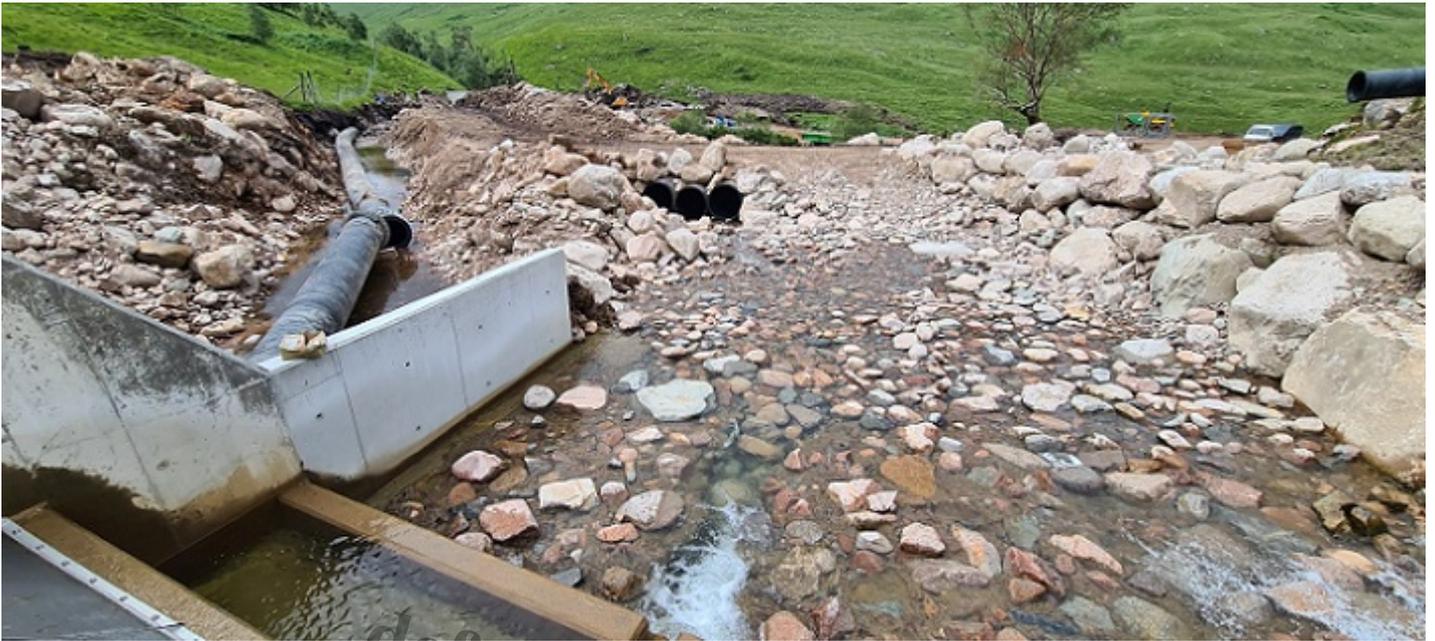
• The minor extraction point. Water flows over the weir into the capture and down through the black pipe to the main extraction, then down hill to the station. There are temporary works still in place and will be removed when the pipes are connected. •

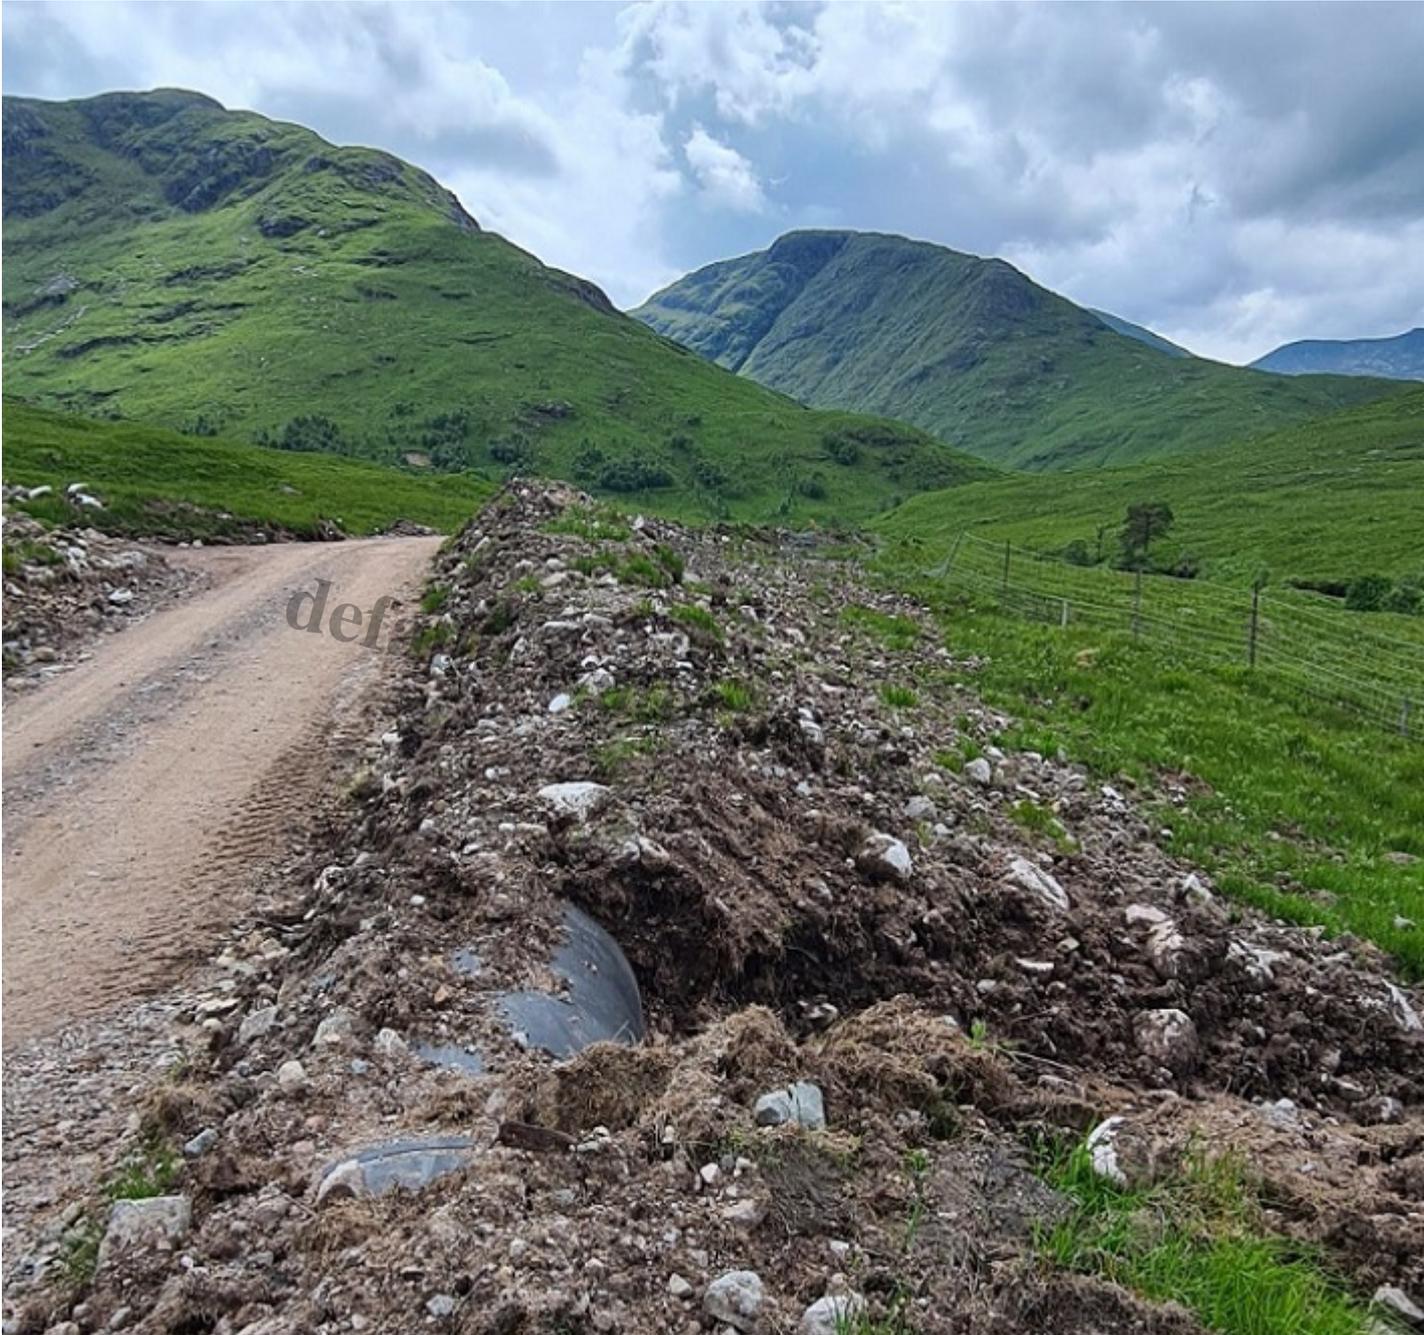
The construction track and pipeline to the intakes.

According to the planning consent issued by Highland Council the trenches for the pipes are supposed to open for only a short-time to promote effective restoration of the ground while the construction tracks are to be removed entirely..

The short section of exposed pipe in this photo illustrates that sections of the pipeline have not been buried deep enough. Because of this the line of the pipe will form a new ridge across the landscape while its smooth surface is likely to shed any turf and vegetation placed on top (as in the photo). The result is likely to be a highly visible half buried pipeline, worse than a properly buried pipeline and probably worse than leaving it in the open air on a less conspicuous line ([see here](#)).

Moreover since material that was lifted from above the line of the track appears to have been used to cover the pipe there looks like a shortage of vegetation to cover up the new road.
