## Further photos of the hydro destruction in Glen Etive – the Allt Chaorainn

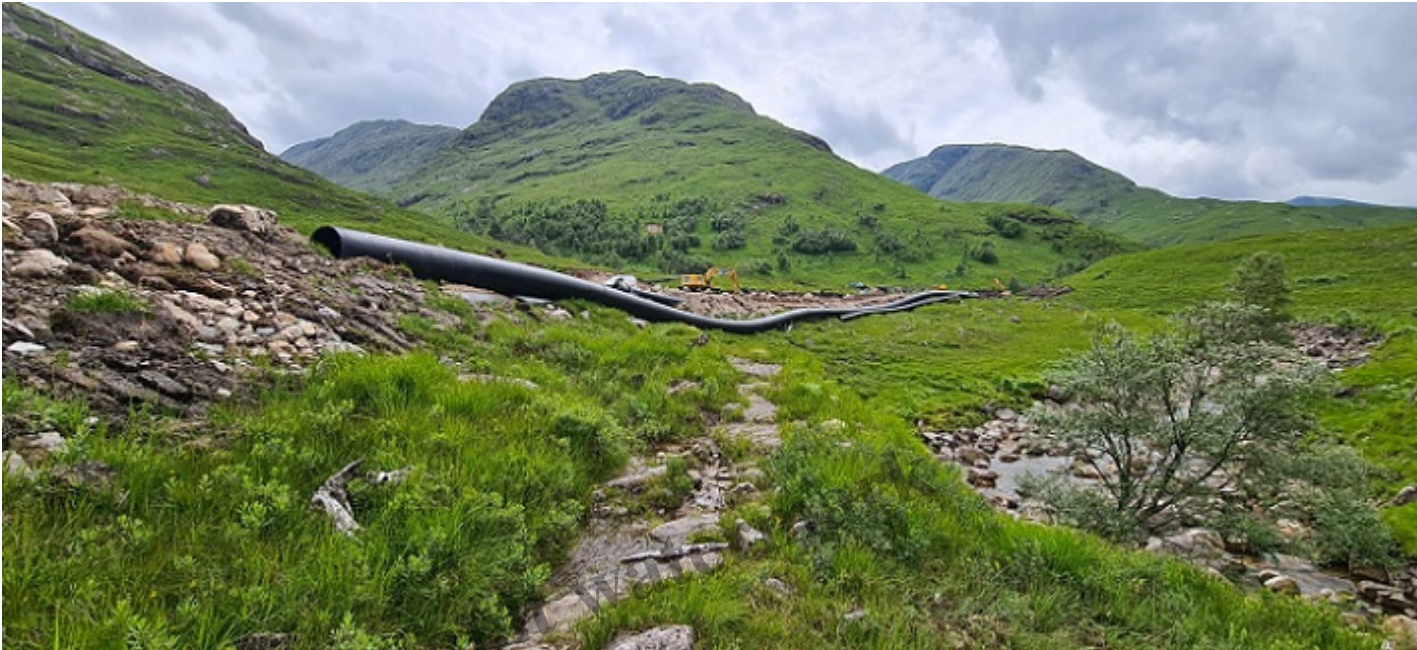
View along footpath from below the construction corridor. All photo credits, anon, parkswatchscotland.

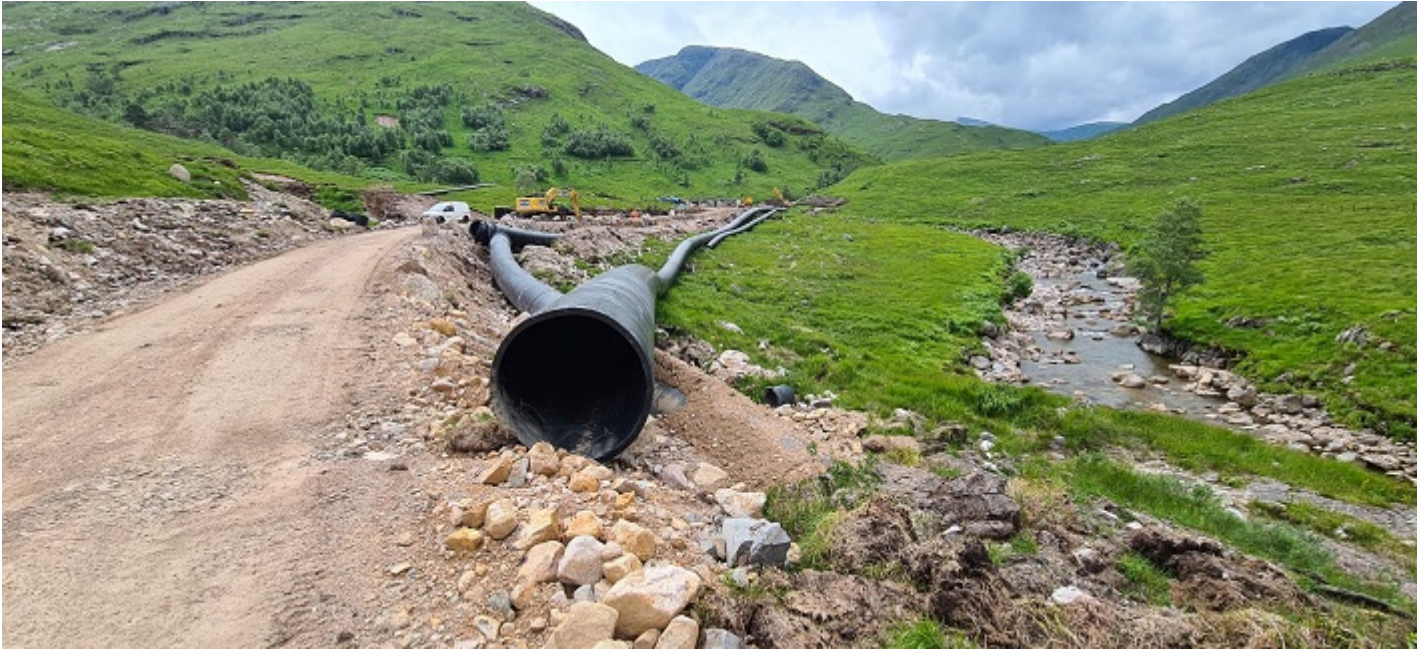
View along the construction corridor up to the intakes with excavated peat on right

Approaching the two intakes on the Allt Chaorainn the road has been excavated not just through peat but granite slabs will can never be restored. Note too the bare patch in the woodland on the hillside above. This does not appear to be a natural landslip – what caused that?

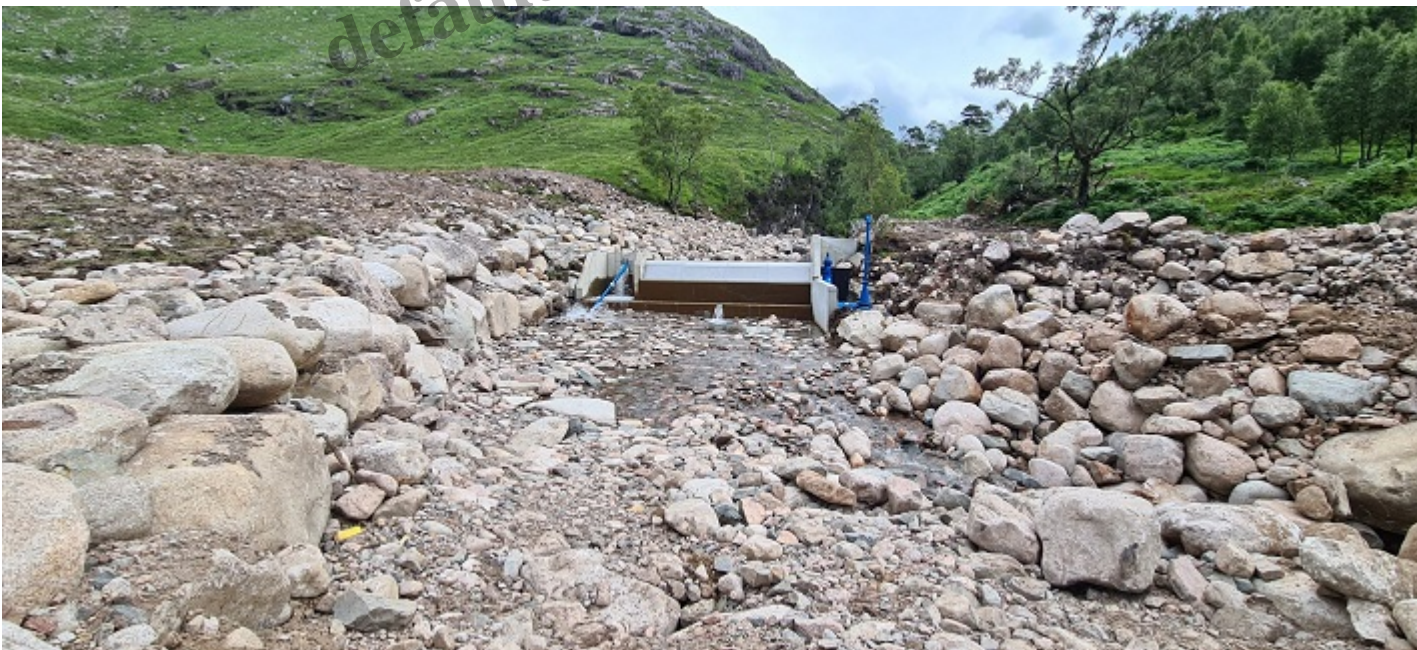
Minor/secondary intake on the Allt Coire Ghuibhsachan (coire of the pines).

The area of ground affected by the construction is extensive and has wrecked the approach to what was once a beautiful gorge. The work is not yet finished but at present the bed of the re-engineered watercourse appears at high risk of being washed away as happened with the Gynack overflow above Kingussie ([see here](#)), a problem that has still not been solved five years later.

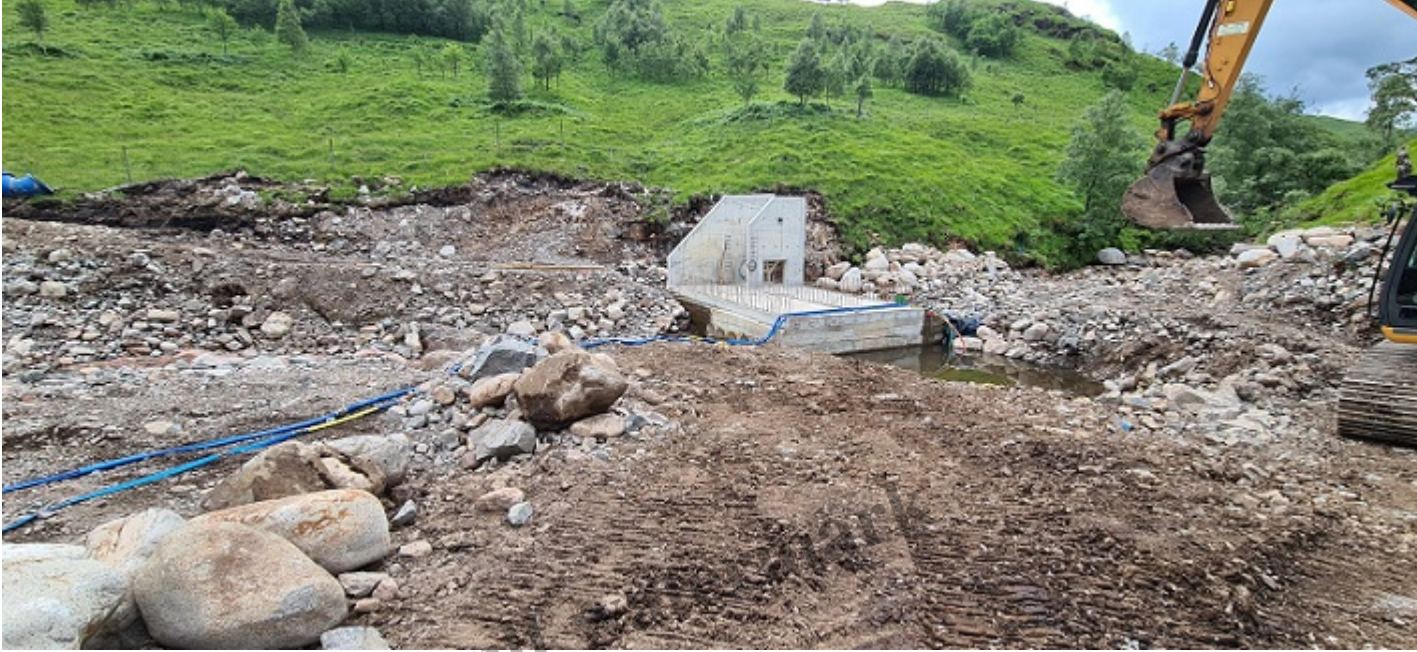
The main/primary intake

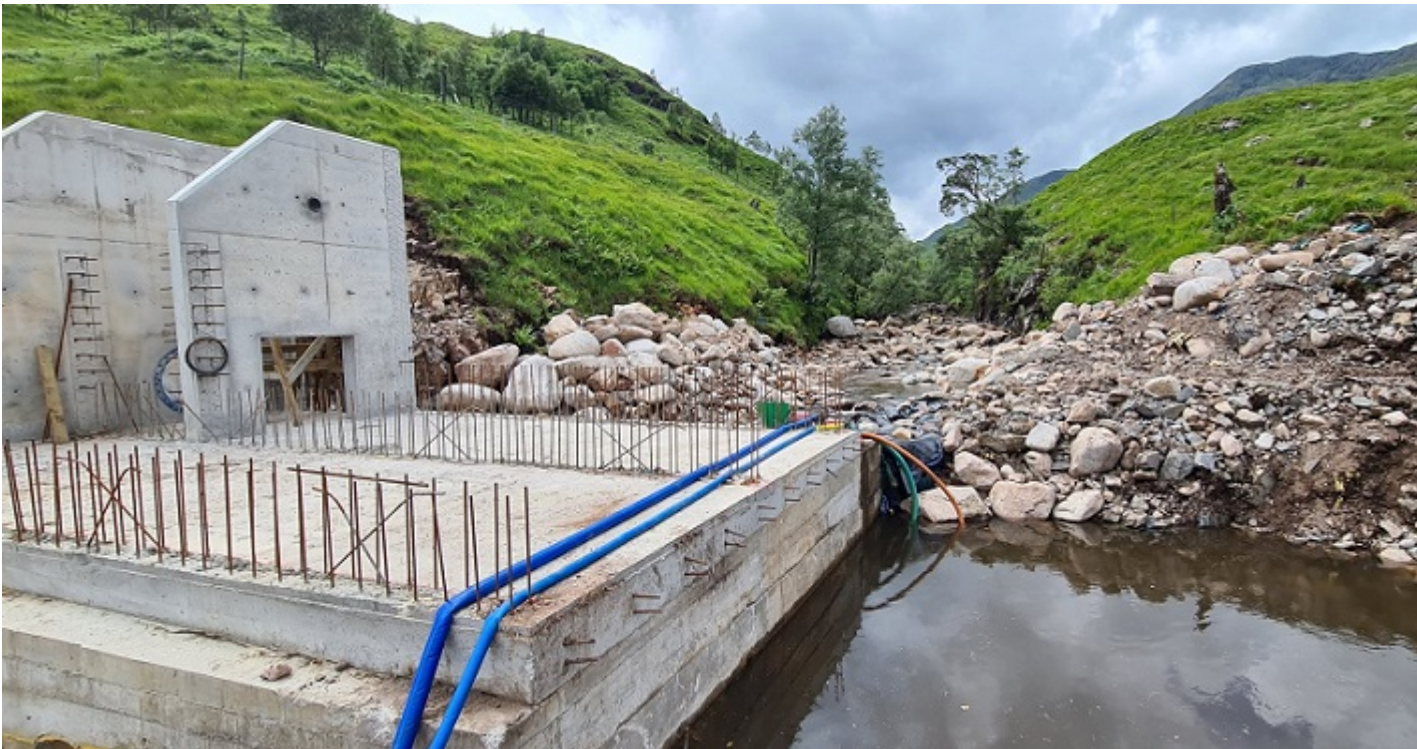
The main intake from closer up

*“They said that the water levels will reach as high as the re-bar on the wall, roughly where the circle is cut out. Roughly, to give you an idea.”*

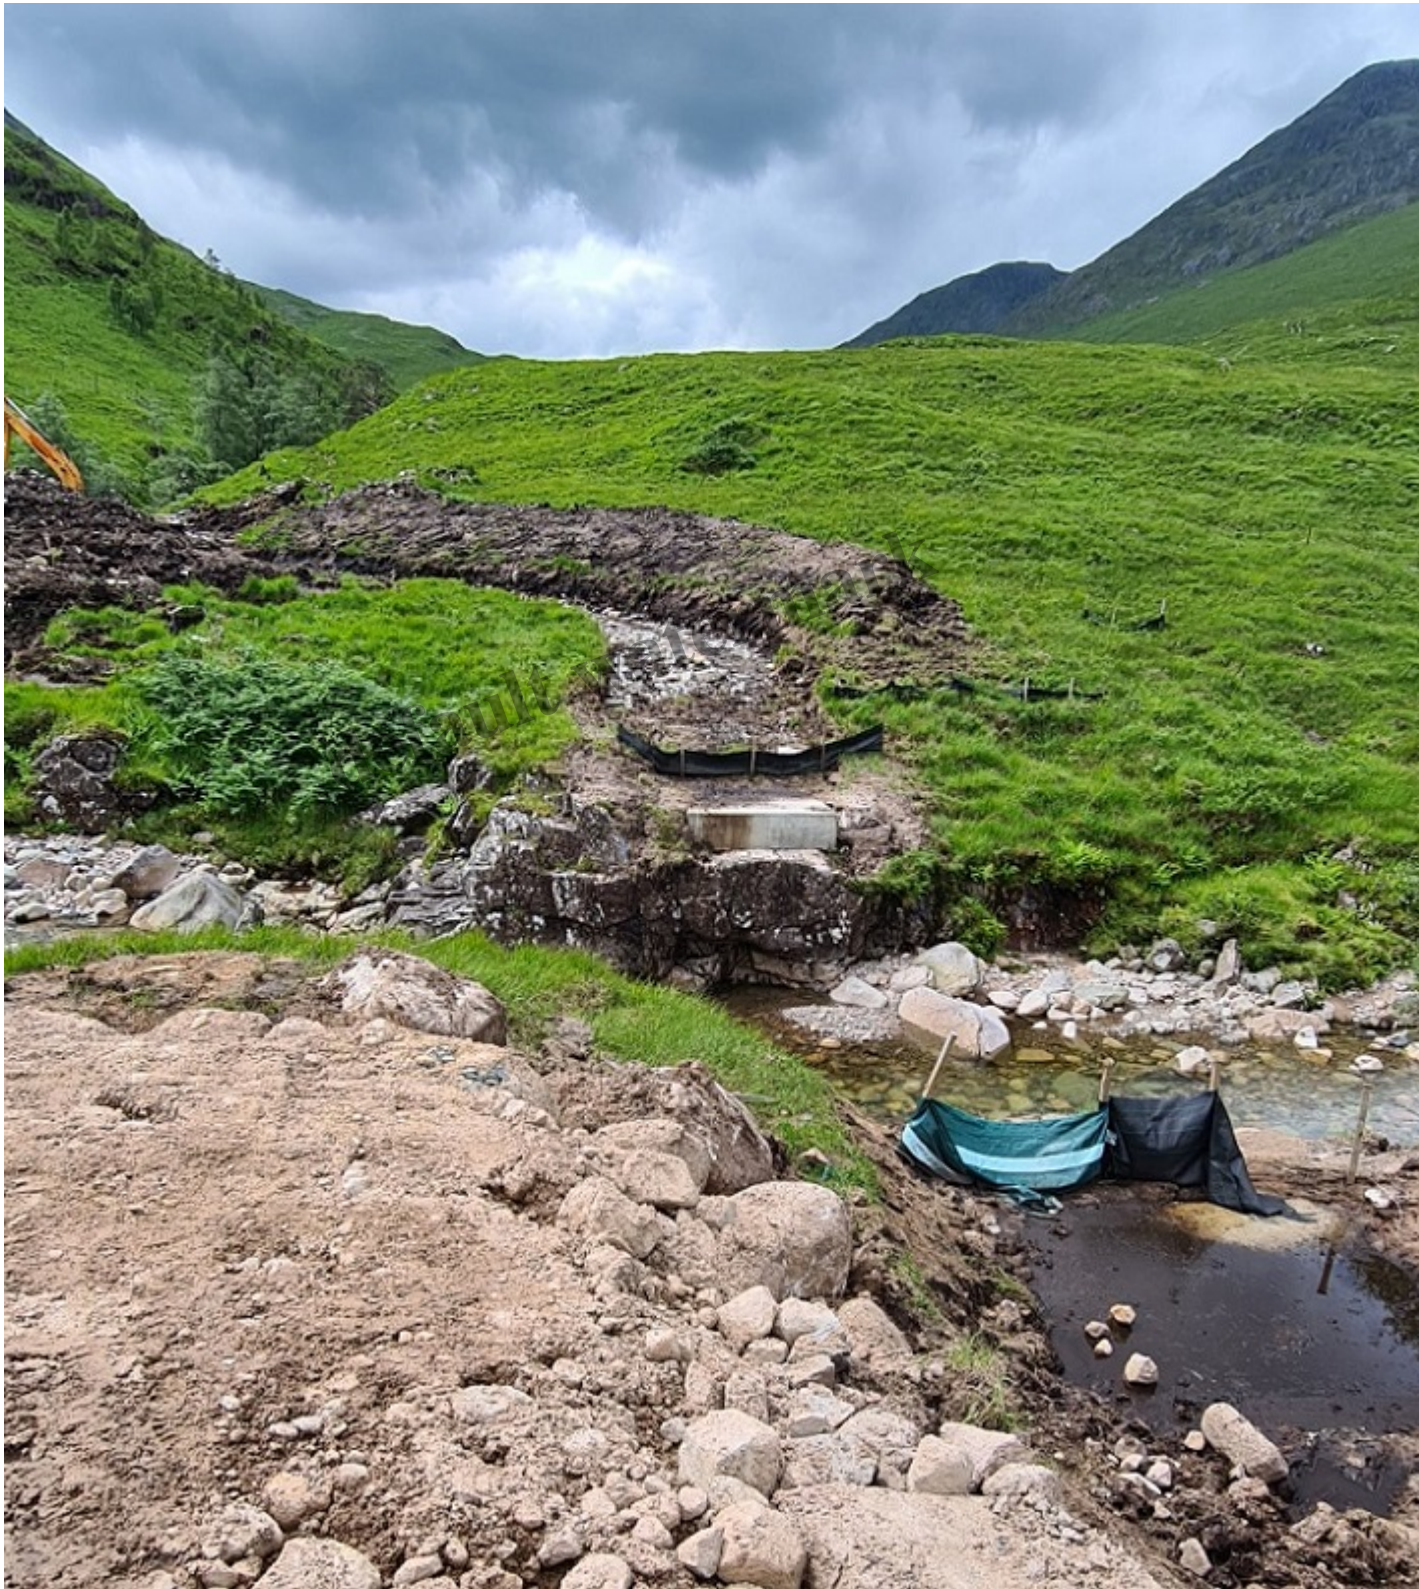
Construction track through peat to the intake with concrete foundation for bridge

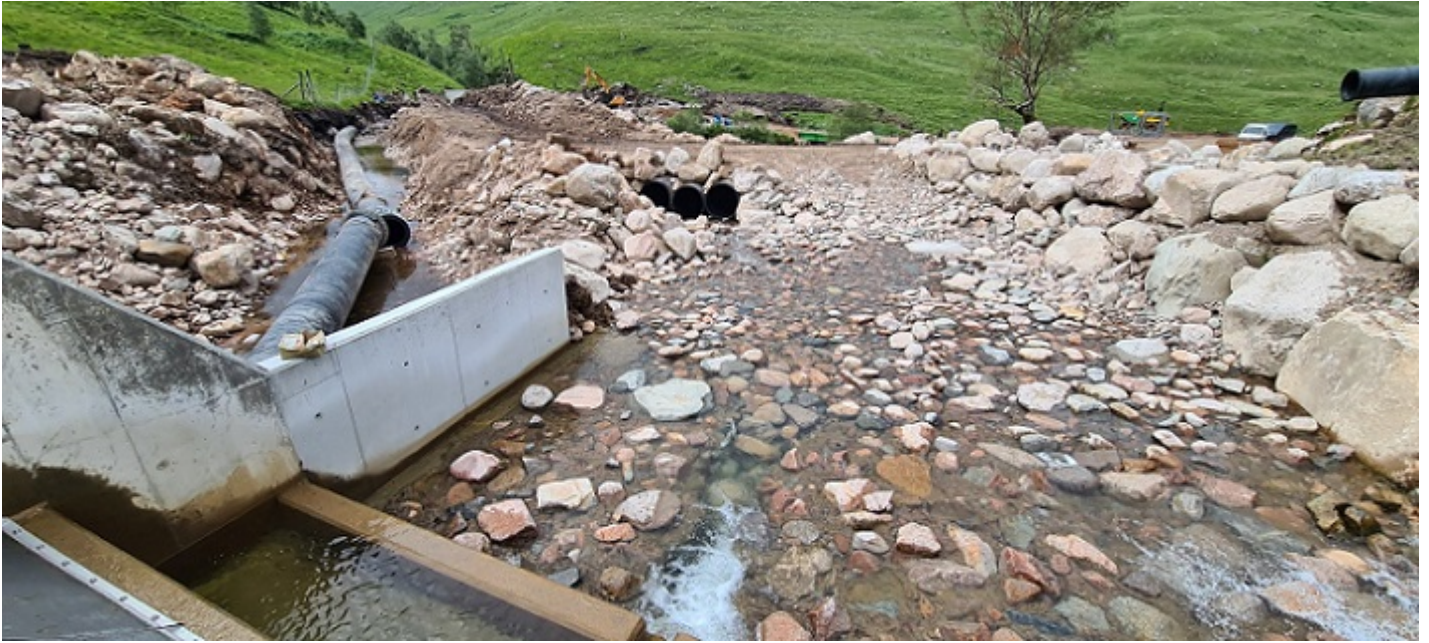
*“The minor extraction point. Water flows over the ‘weir’ into the capture and down through the black pipe to the main extraction, then down hill to the station. There are temporary works still in place and will be removed when the pipes are connected.”*

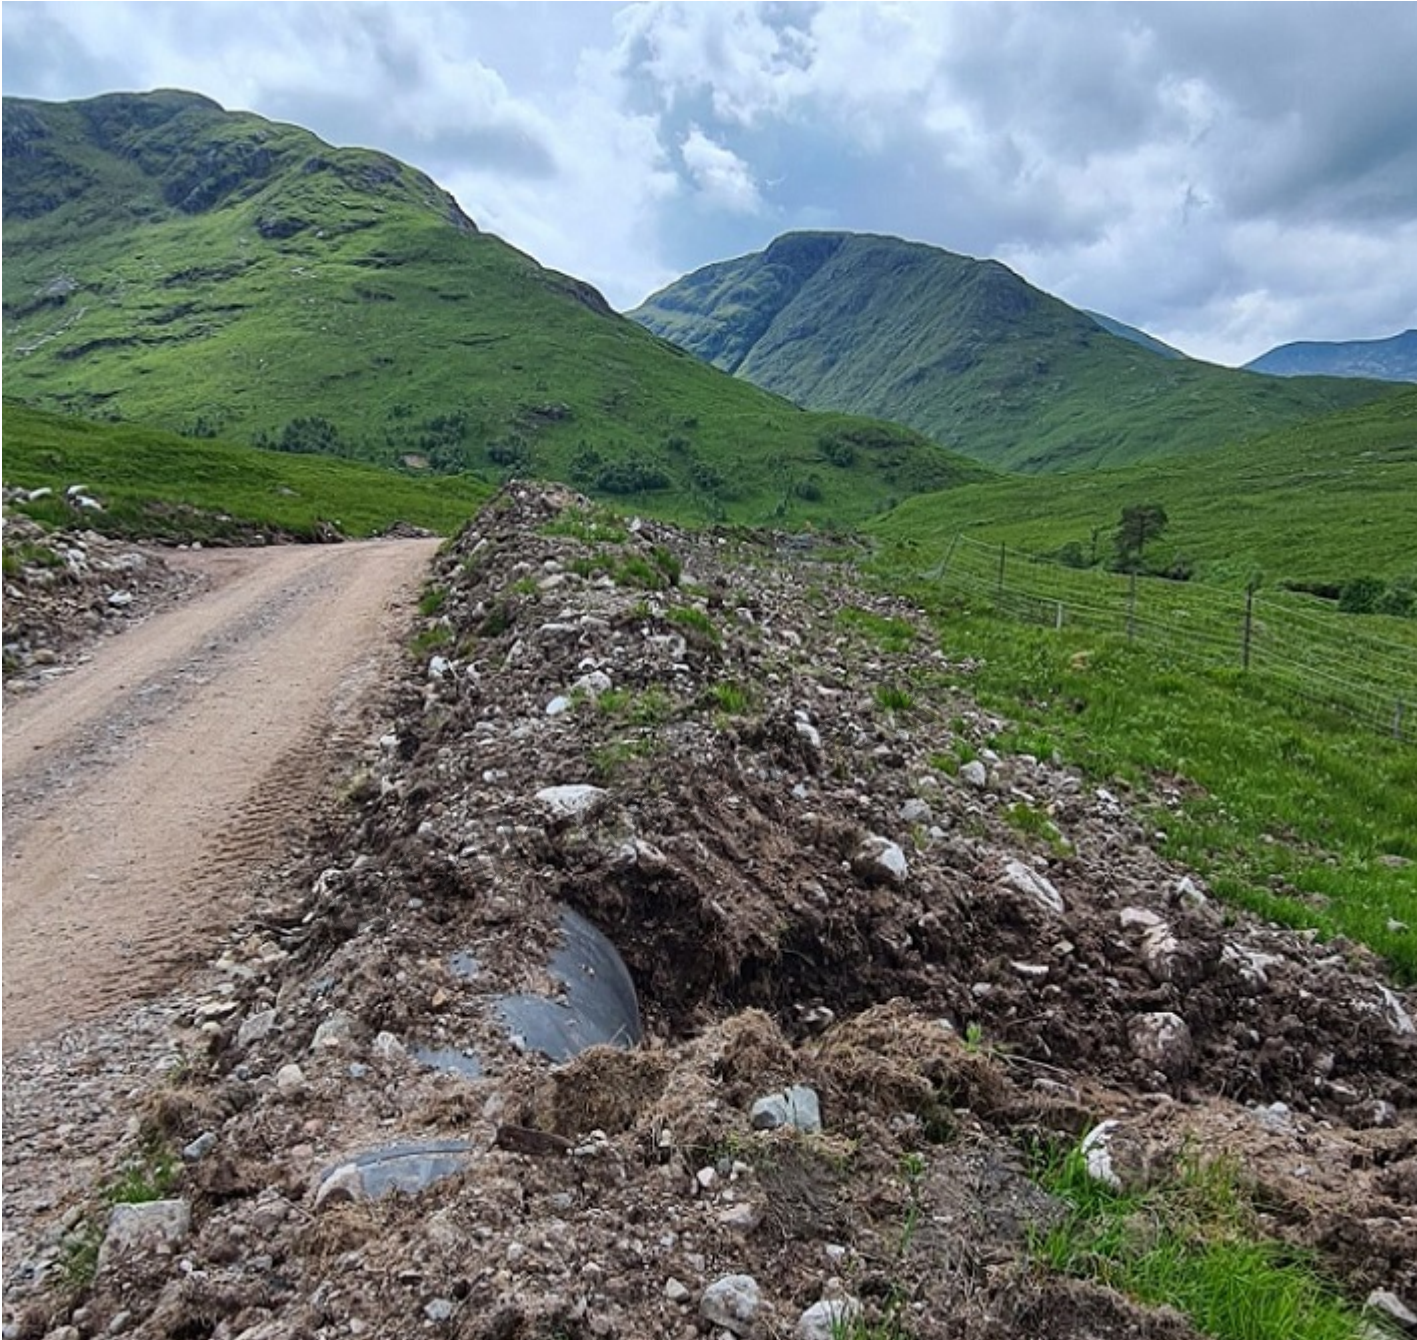
The construction track and pipeline to the intakes.

The short section of exposed pipe in this photo illustrates that sections of the pipeline have not been buried deep enough. Because of this the line of the pipe will form a new ridge across the landscape while its smooth surface is likely to shed any turf and vegetation placed on top (as in the photo). The result is likely to be a highly visible half buried pipeline, worse than a properly buried pipeline and probably worse than leaving it in the open air on a less conspicuous line ([see here](#)).

Moreover since material that was lifted from above the line of the track appears to have been used to

cover the pipe there looks like a shortage of vegetation to cover up the new road.

According to the planning consent issued by Highland Council the trenches for the pipes are supposed to open for only a short-time to promote effective restoration of the ground while the construction tracks are to be removed entirely..
