Highlands and Islands Enterprise and the funicular Court Cases. Part 2.

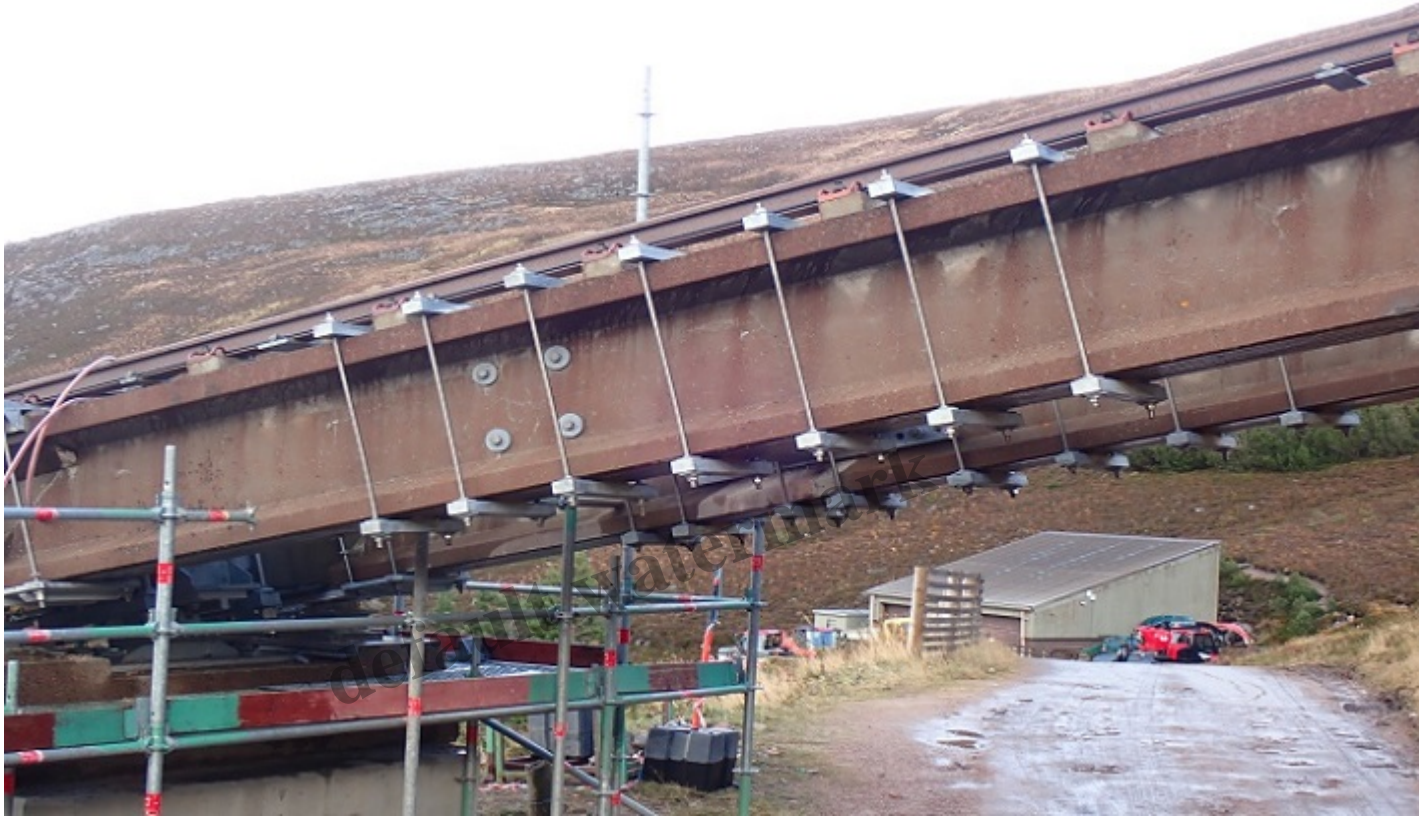
Photo 1. Steel braces reinforcing the “I” beam: there are seven visible on the near beam, eight on the beam behind. What are they all for? Photo credit Parkswatch reader.

Photo (1) top & (2) are of the same part of the track, but compare the amount of reinforcement on the upper "I" beam in photo (1) to the lower seen in photo (2)! What is wrong with the upper beam? It is obviously in a worse state than the lower!

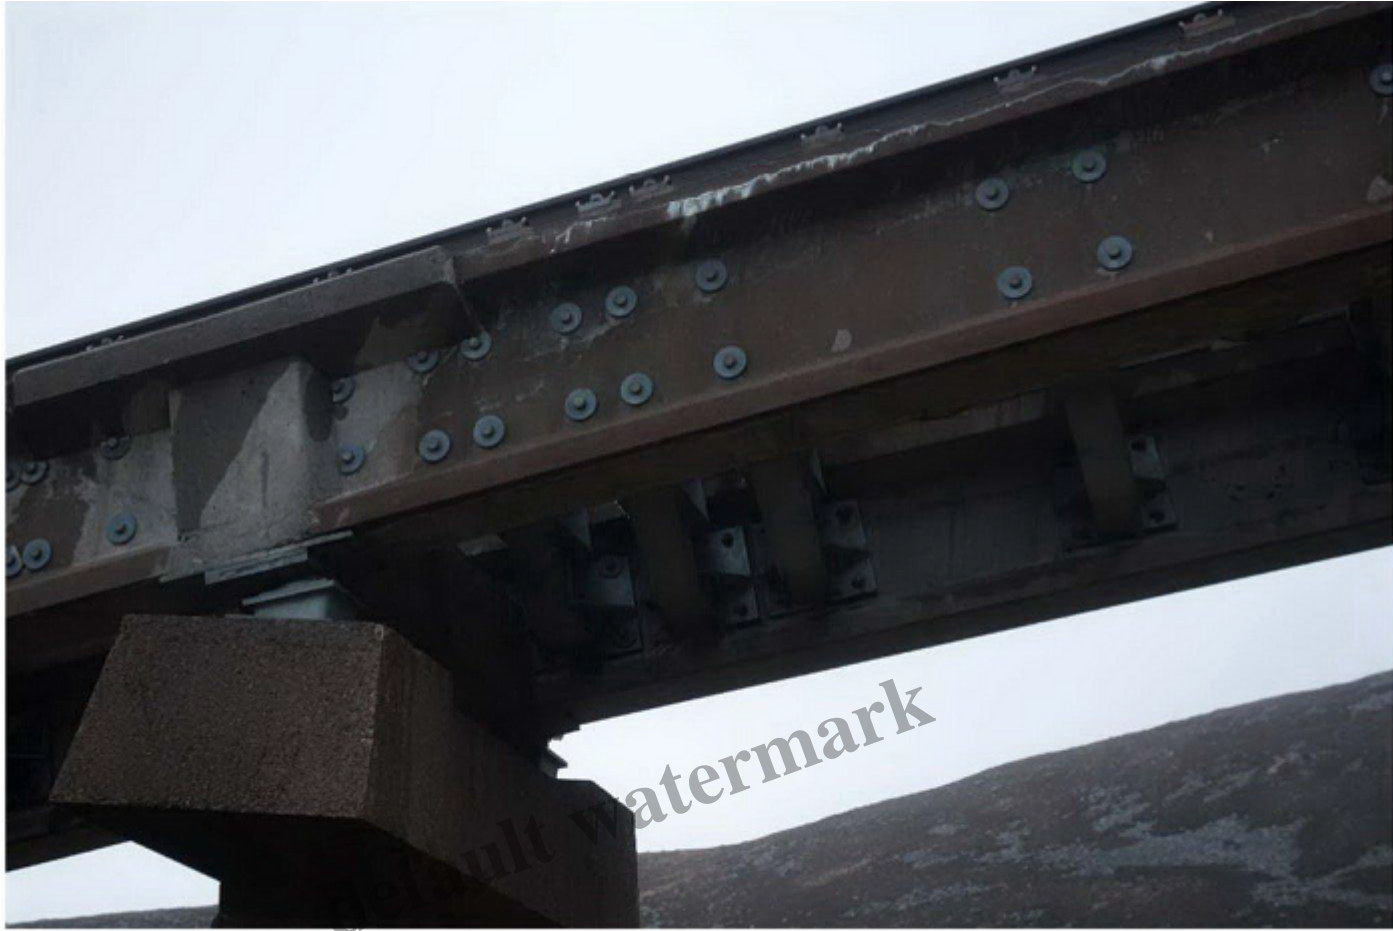
View of side face of Beam 51/R

2.2 A crack was clearly seen running along the length of the beam positioned at about mid height of the top flange. It appeared to extend from the lower end up to about mid span. See appendix B for a sketch and photo showing this.

- The writer has been carrying out annual inspections for the last three years. This feature was observed **for the first time during last year's inspection.***
- The crack is evident on both sides of the beam at the same height and over the same length*

- *The crack is particularly evident due to calcite bleed, showing up white. This was seen as significant at the low end, diminishing along the length.”*

5.1 It was concluded that *the observed crack were a developing situation, due to the fact that it was only first noticed in 2016 and that the calcite bleed is more developed at one end.*

5.2 *It is thought that the problem is a latent defect within the original fabrication of the beams, most likely due to a cold joint within the concrete pour.*

5.4 *If left the beams will continue to deteriorate and stability issues would arise.*

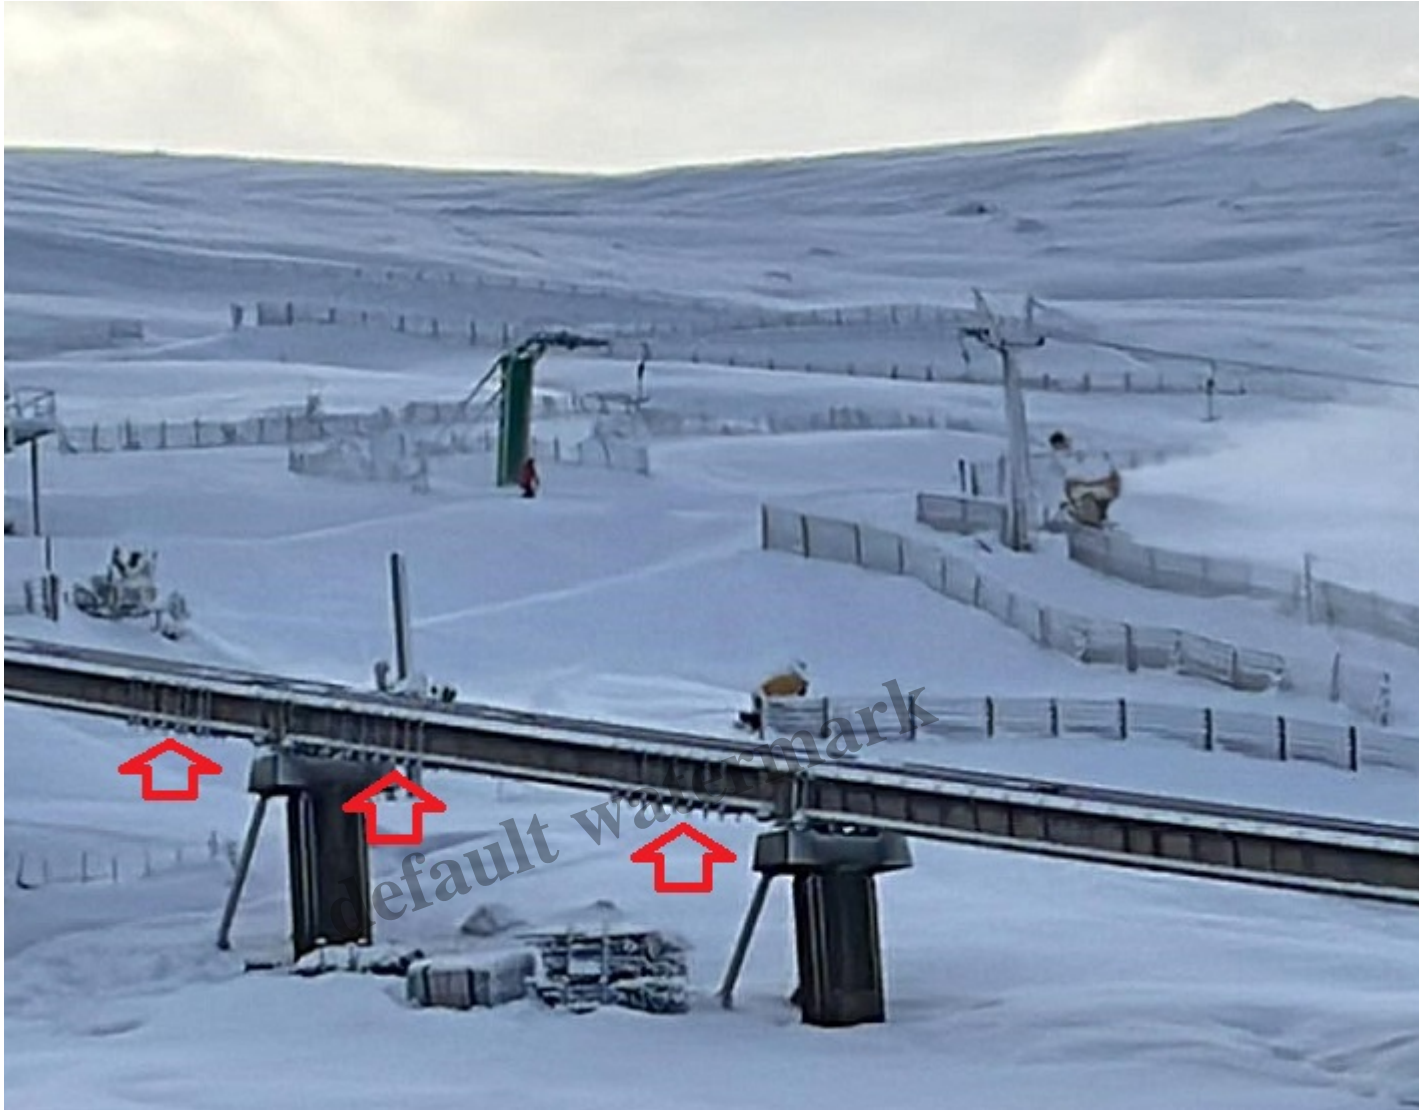
Photo 3 (notice one snow-making machine is in use, a second not). Photo credit parkswatch reader

And then on photos (3) & (4) the reinforcing, as far as can be seen, is mostly at the insitu blocks, **but** look again at photo (3). The upper two “I” beams have quite a substantial amount of reinforcing, again suggesting the beams aren’t strong enough. Is all this reinforcing an attempt to strengthen the “I” beams and prevent further delamination? It certainly looks like it.

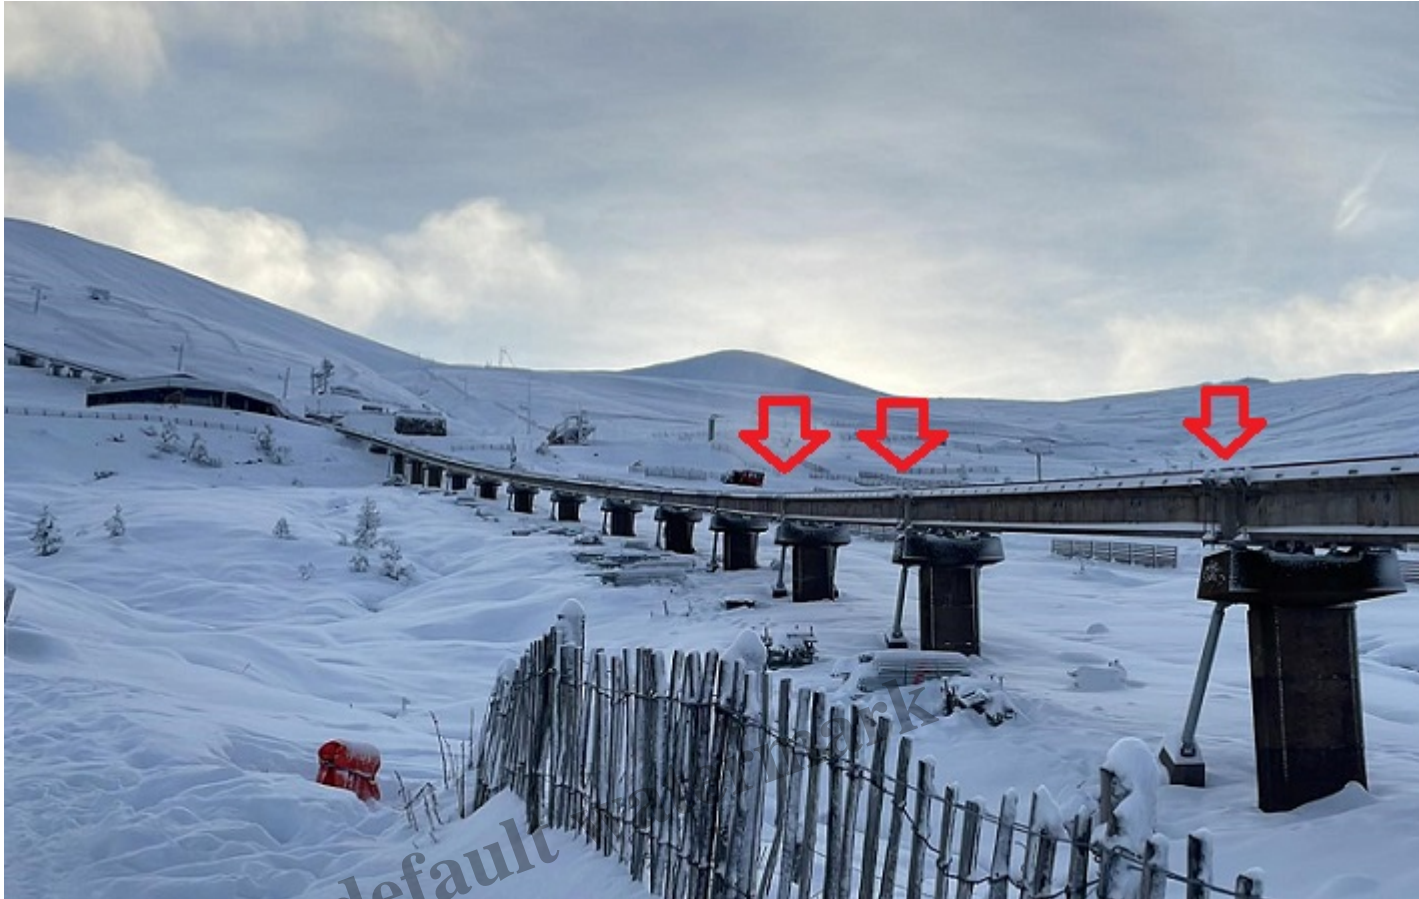
Photo (4) Red Arrows point to reinforcing by insitu blocks. Photo credit parkswatch reader.
